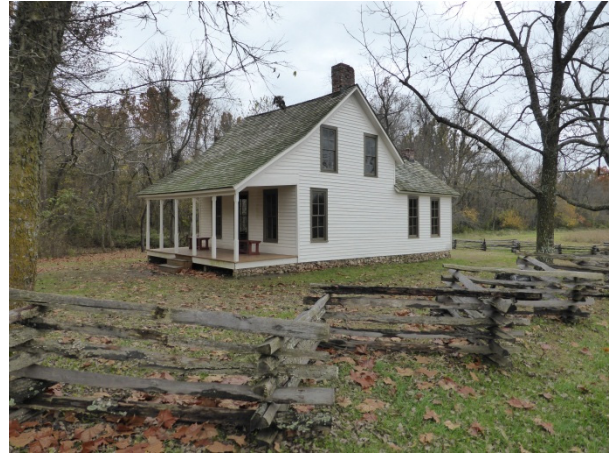
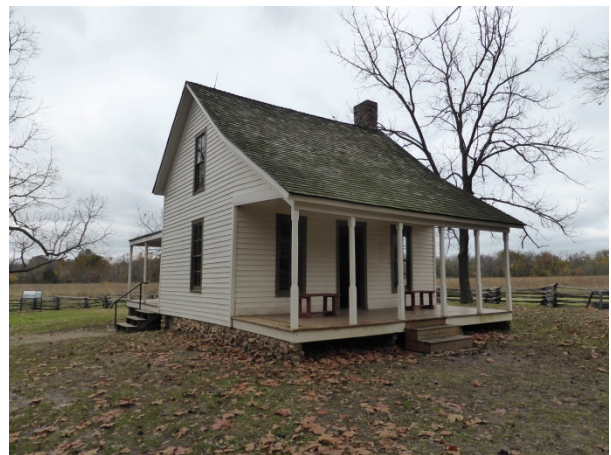
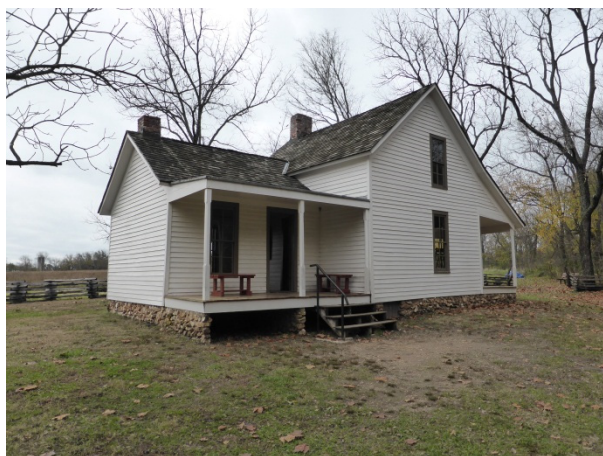
FIGURE 126. The Moses Carver house, view looking southwest toward the side and principal facade.

FIGURE 127. The Moses Carver house, view looking northwest toward the principal facade.

1 **FIGURE 128.** The Moses Carver house, view looking
2 northeast towards the rear porch.

11 The house is generally in good condition and is
12 well maintained. The paint coating at exterior
13 wood siding, trim, and window sashes is
14 performing well, although the transparent porch
15 floor finish is worn and in fair to poor condition
16 due to wear and weathering. Some minor
17 settlement has occurred since the building was
18 rehabilitated in 2005. Evidence of this settlement
19 occurs at the southwest and southeast corners of
20 the house; the settlement is causing some
21 separation of wood trim elements at the porch
22 floors and wood siding (refer to Figure 131). The
23 rubble stone masonry foundation is in good
24 condition. It appears that the stone was repointed
25 in 2005, but it is unknown if the entire foundation
26 was rebuilt. The exterior wood doors are in good
27 condition; they are somewhat protected from the
28 elements by the cover offered by the porches. The
29 open riser wood stairs are in fair condition and

30 exhibit some wear and deterioration.

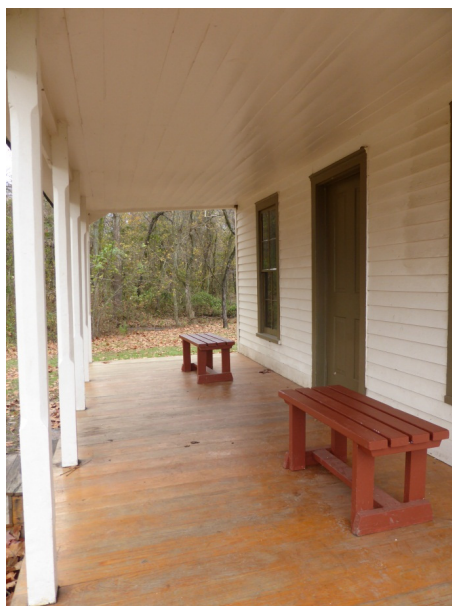
5 **FIGURE 130.** The front porch of the Moses Carver
6 house.

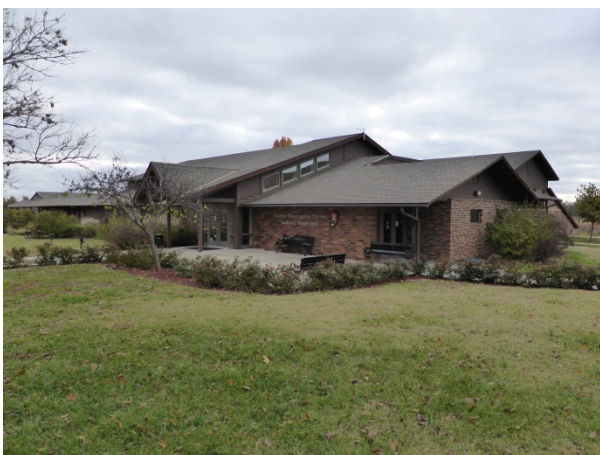
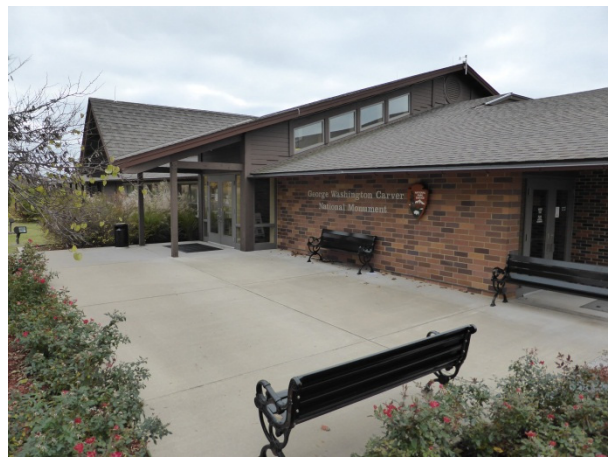
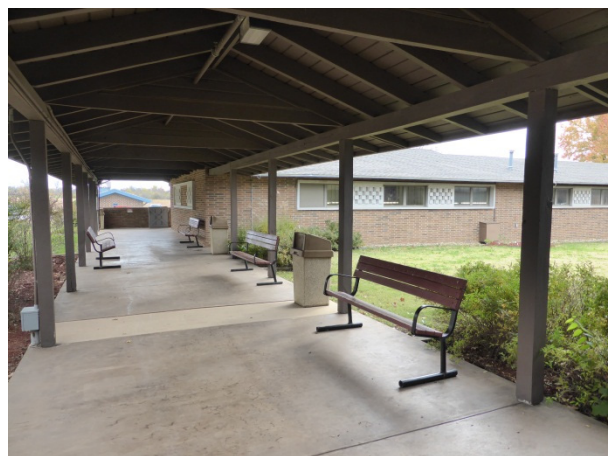
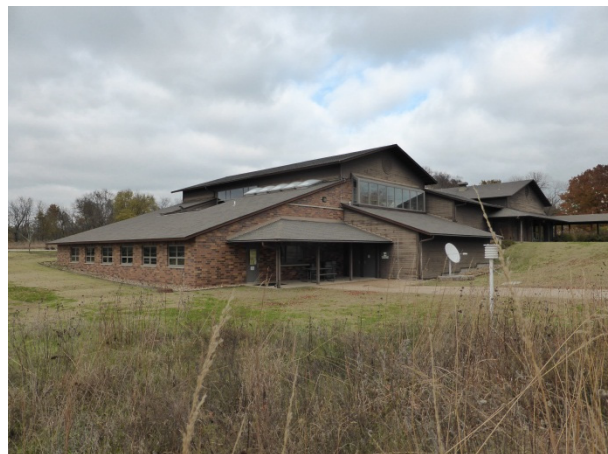
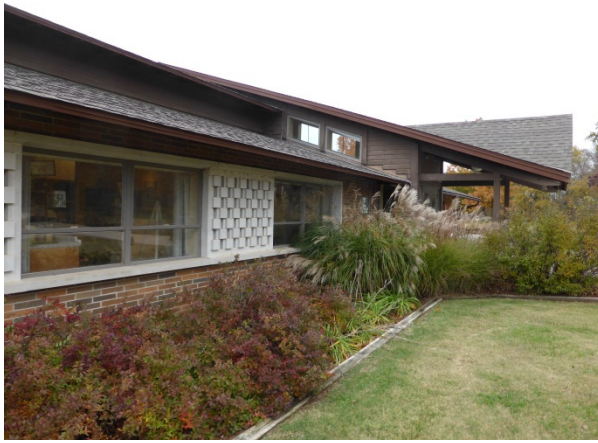
The visitor center is generally in good condition but contains some areas where materials are experiencing advanced deterioration. The brick masonry is in good condition, with no evidence of settling or deteriorated mortar. Limestone window sills and decorative panels, while containing some organic growth or dirt, are generally in good condition. The steel windows are in good to fair condition with some peeling paint and deteriorated sealant. New clad wood window units appear to be performing well and are in good condition. Three-tab asphalt shingles covering the roof are in good to fair condition. Most roof edges do not have gutters or downspouts and contain painted metal drip edging and wood fascia. Roof areas fitted with gutters and downspouts are located at the north and east entrance areas and at the high roof areas that drain to the courtyard between visitor center and maintenance building. The perimeter of these roof areas have half-round profile gutters and round downspouts painted to match the wood fascia. The majority of the wood fascia and metal drip

edges, gutters, and downspouts are in good condition, but paint failure is widespread. Wood siding is in various states of repair, from fair to deteriorated. Many areas of rotted wood siding were observed, especially at exposed high roof/wall junctions. The majority of the paint coatings at areas of wood siding was either faded or deteriorated. Other painted wood surfaces at underside of the eaves and the covered breezeway are in good condition.

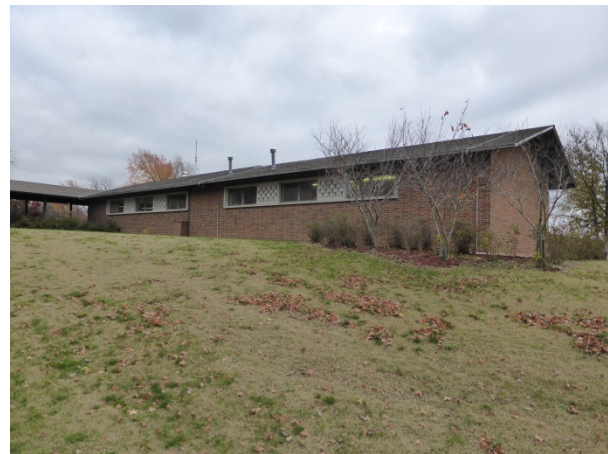
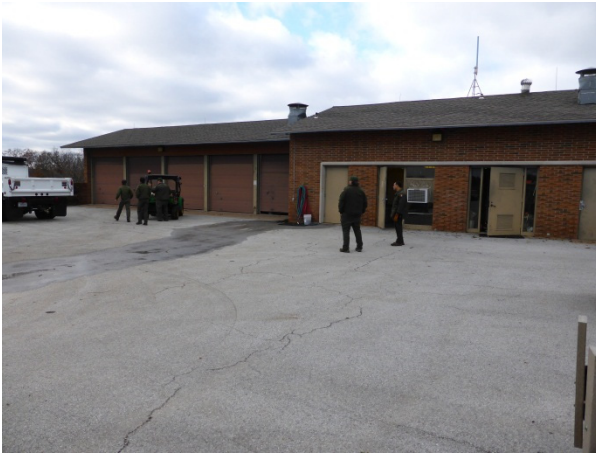
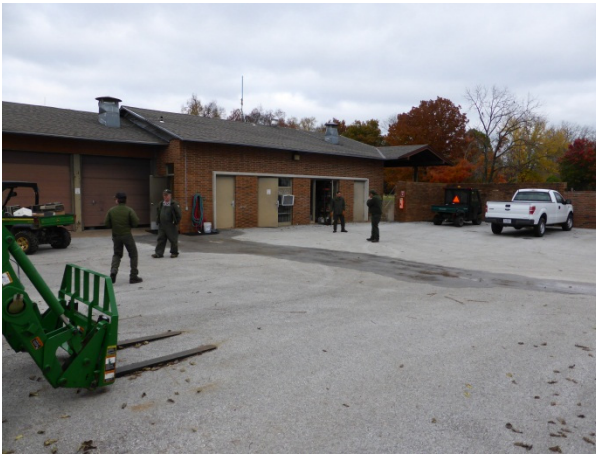
FIGURE 139. The maintenance building, view looking southeast.

1 **FIGURE 140.** The maintenance building, view looking
2 northwest from the maintenance yard.

3 **FIGURE 141.** The maintenance building, view looking
4 northeast from the maintenance yard.

32 The maintenance building is generally in fair
33 condition but contains some areas which are
34 experiencing advanced deterioration. Brick
35 masonry is in good condition, with no evidence of
36 settling or deteriorated mortar. Limestone
37 window sills and decorative panels, while
38 containing some organic growth or dirt, are also in
39 good condition. Steel windows are in good to fair
40 condition, with some peeling paint and
41 deteriorated sealant. Three-tab asphalt shingles
42 and the majority of the wood fascia and metal drip
43 edges are in good condition, but paint failure is
44 evident. The overhead doors appear to be
45 operable and in fair condition. The low brick
46 masonry walls surrounding the maintenance yard
47 are in poor condition. Large areas of spalling
48 masonry and eroded mortar are evident at the east
49 and west sections of the enclosure wall.

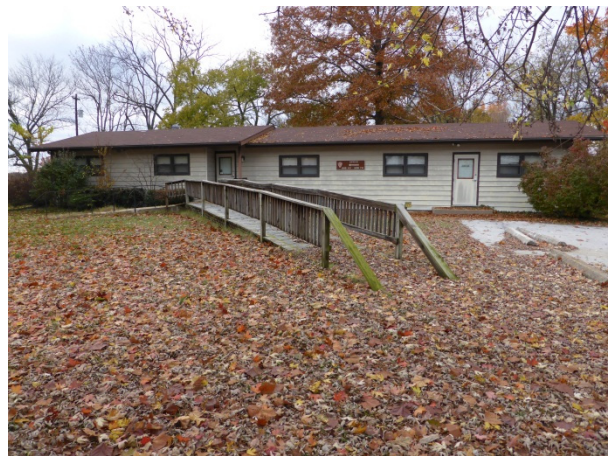
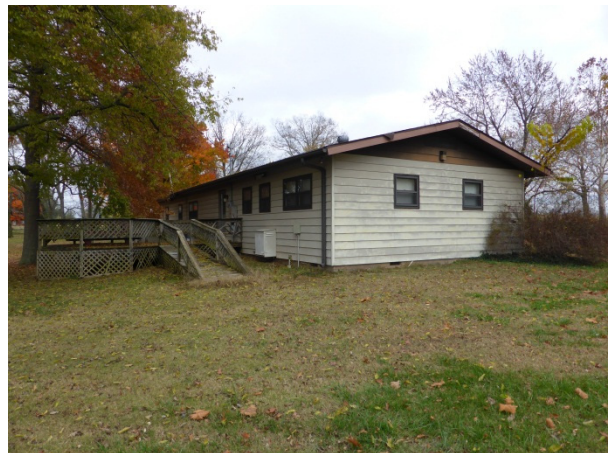
FIGURE 144. The Superintendent's residence, view looking northwest towards main front door.

FIGURE 145. The Superintendent's residence, view looking east towards the rear deck.

The residence is generally in fair to poor condition. The siding, while mostly intact, shows signs of fading paint and deterioration. Some metal fascia panels are missing, and many are loose, allowing water into the cladding systems and causing deterioration of wood wall elements. Shingle roofing systems are also in fair to poor condition. Several loose and detached asphalt shingles are evident. Paint and sealant at the wood windows is also in poor and deteriorated condition. Both wood ramps and the rear deck contain organic growth and many warped and rotted members. Two large ground mounted HVAC units located at the rear of the house are ducted into the main house. These units are apparently still in use to provide heating and cooling to the residence but their age and condition is unknown.

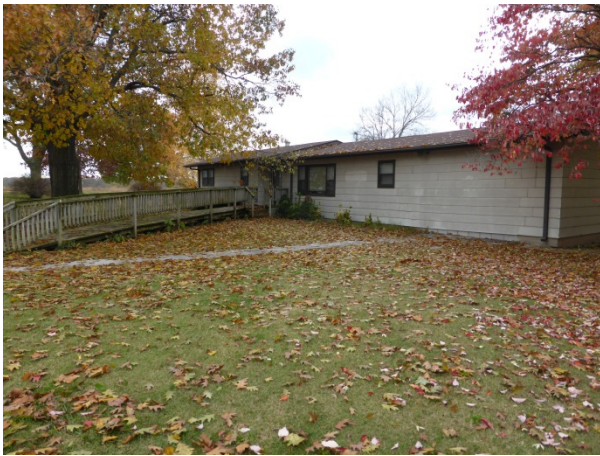
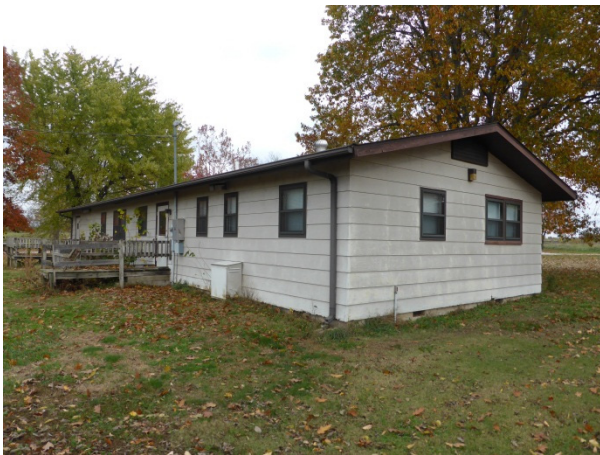
1 **FIGURE 148.** The Historian's residence, view looking
2 northwest towards the front door.

3 **FIGURE 149.** The Historian's residence, view looking
4 east towards the rear of the structure.

27 The residence is generally in poor condition. The
28 siding is deteriorated, with fading paint and areas
29 of rot or deterioration. Wood fascias are warped
30 and have severely deteriorated paint coating. Paint
31 and sealant at the wood windows are also in poor
32 and deteriorated condition. The wood ramp and
33 two rear decks contain many warped, rotted, and
34 missing members.

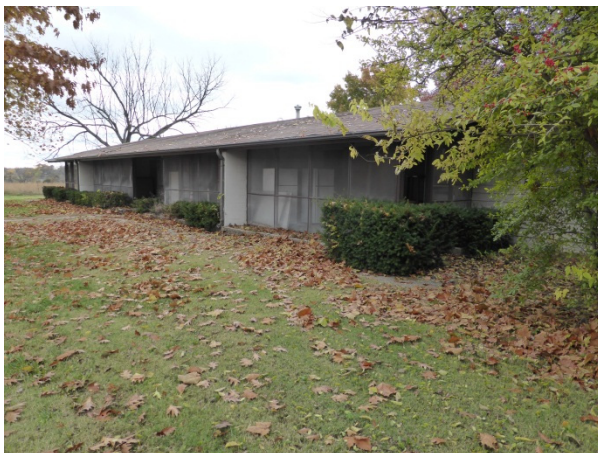
29 **FIGURE 152.** The four-unit seasonal housing building,
 30 view looking northwest towards the front of the
 31 complex.

The four-unit seasonal housing building is generally in fair to poor condition, and does not meet universal accessibility standards. The cedar siding, while mostly intact, contains large areas of paint failure and wood deterioration. Wood fascia boards have extensive paint failure and are warped. The asphalt shingle roofing is in fair to poor condition. Several loose and detached asphalt shingles are in evidence. Many downspouts are missing, allowing water to pool around building foundations. Paint and sealant at the wood windows is also in poor and deteriorated condition.

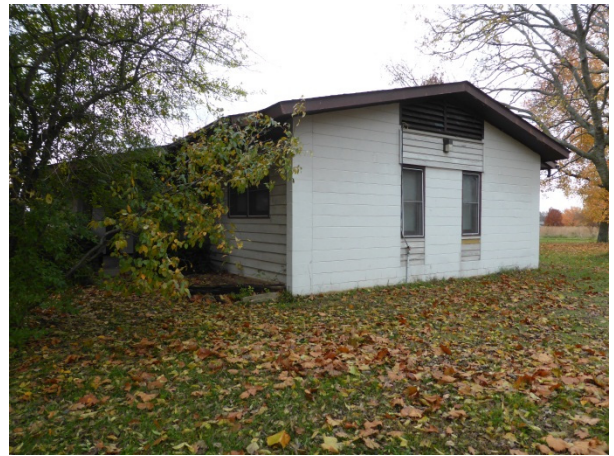
32 **FIGURE 153.** The four-unit seasonal housing, view
 33 looking towards the west facade.

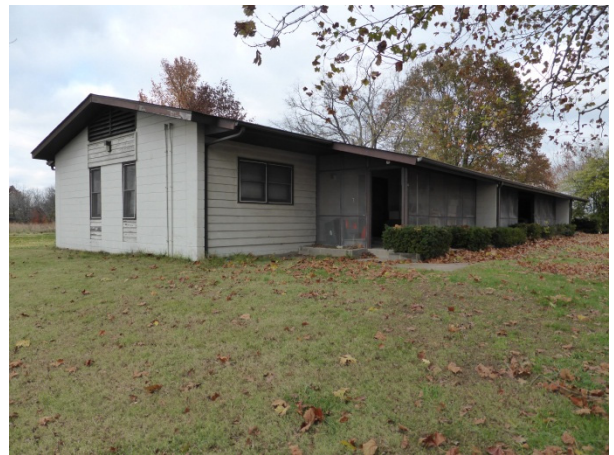
34 **FIGURE 154.** The four-unit seasonal housing building,
 35 view looking northeast.

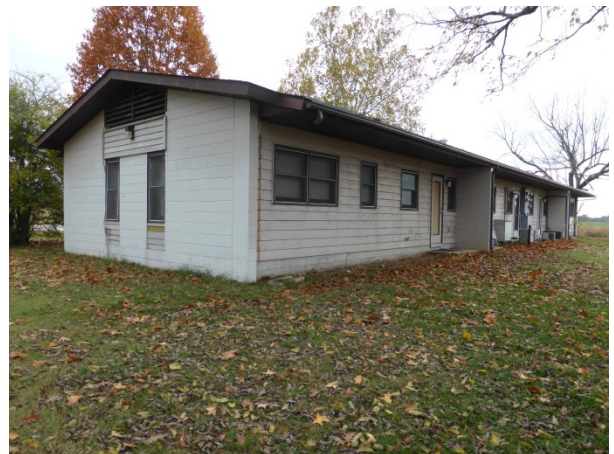
36 **FIGURE 155.** The four-unit seasonal housing building,
 37 view looking towards the east facade and rear of the
 38 complex.

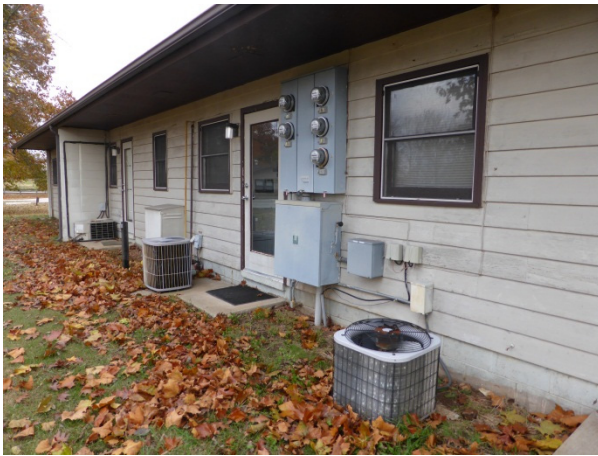
FIGURE 156. Detail of the rear of the building, showing stoops, condensing units, and electrical service features.

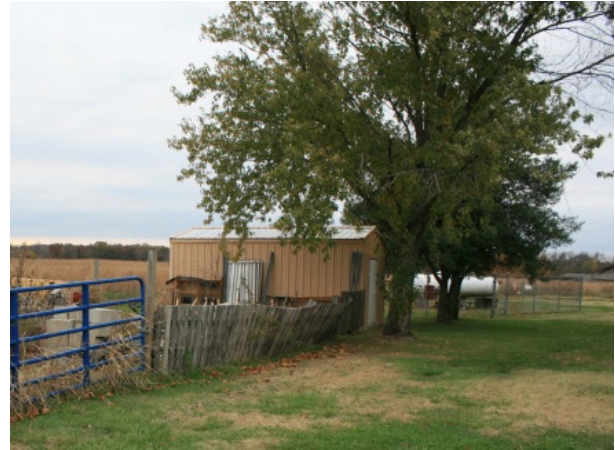
FIGURE 157. A small storage shed is located in the fenced storage yard southwest of the housing complex.

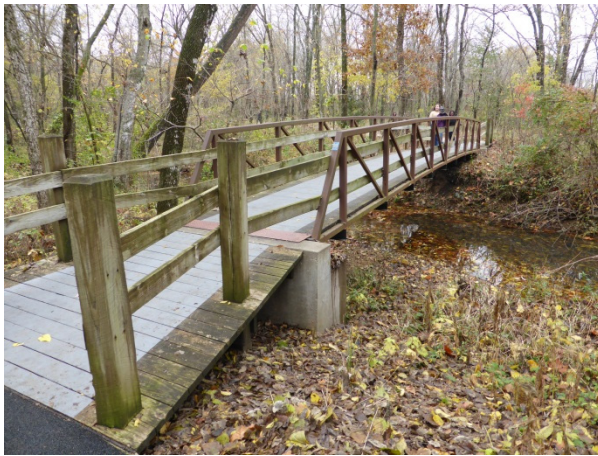
1 **FIGURE 158.** Bridge 1, view looking north and
2 showing the approach ramp and bridge truss
3 configuration.

31 Both bridges are in good to fair condition. The 2x6
32 wood railings are warped and contain organic
33 growth. Several elements of the wood approach
34 structures also have rotted wood components
35 including vertical posts and railings. Corten steel
36 elements appear to be in good condition and are
37 performing well. Paint at the wooden bridge floor
38 is worn in some areas and also contains organic
39 growth.

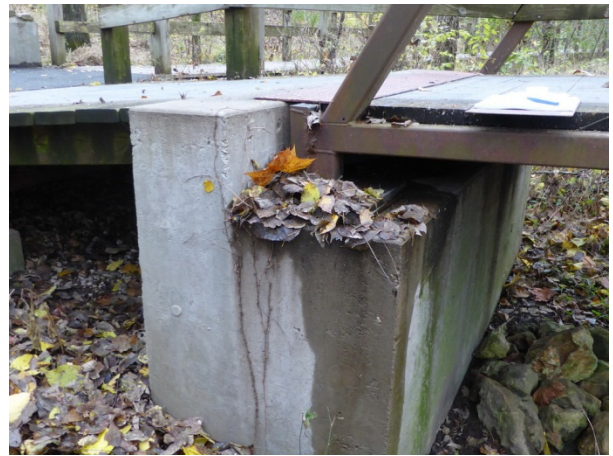
21 **FIGURE 160.** Detail of the concrete foundation stem
22 wall on Bridge 1.

6 The bridges are identical in design, structure, and
7 material. The bridges utilize two Corten tubular
8 steel trusses with a 2x6 wood pedestrian walk
9 situated between the trusses. The bridge truss
10 assembly rests on thick concrete stem wall
11 foundations at either side of the stream
12 (Figure 160). Dimensional treated-wood approach
13 ramps edge the end of each bridge to match the
14 grade of the bridge walk surface with the trail
15 system. The steel truss bridge sides also contain
16 two 2x6 wood railings to fill the gaps between the
17 diagonal truss members. The center of the bridge
18 wood walking surface is painted with a gray
19 sanded paint to improve traction and prevent
20 slippage (Figure 161).

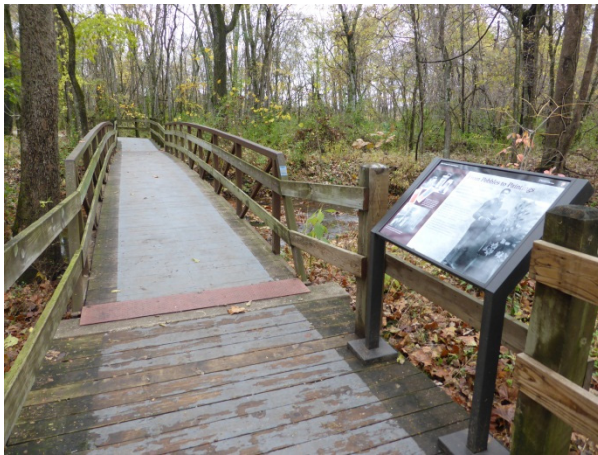
4 **FIGURE 159.** Bridge 2, view looking south from the
5 approach ramp.

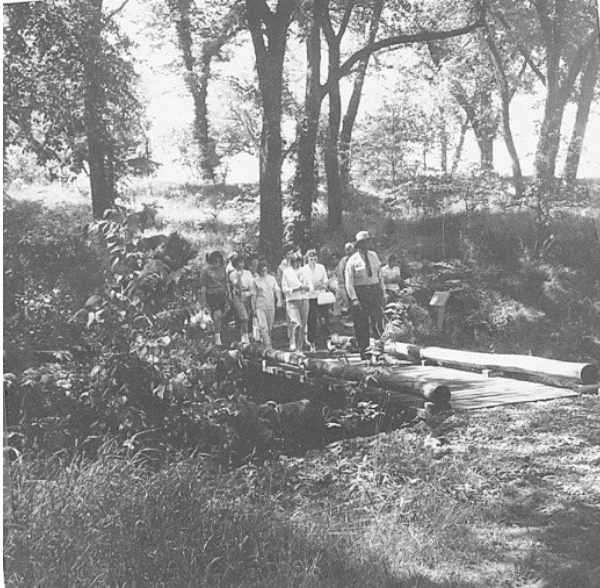
7 **FIGURE 162.** A footbridge crossing Carver Branch in
8 1963. Source: George Washington Carver National
9 Monument photo collection.

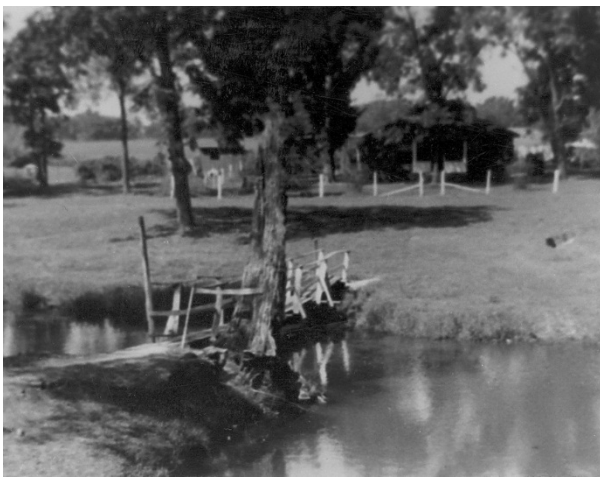
10 **FIGURE 163.** Footbridges were used to cross streams
11 during Shartel ownership, such as this bridge
12 pictured in 1938. Source: George Washington Carver
13 National Monument photo collection.
