## Riprap Condition Report

# **MUIR WOODS NATIONAL MONUMENT**

## **2016 REDWOOD CREEK RIPRAP ASSESSMENT**

March 2017

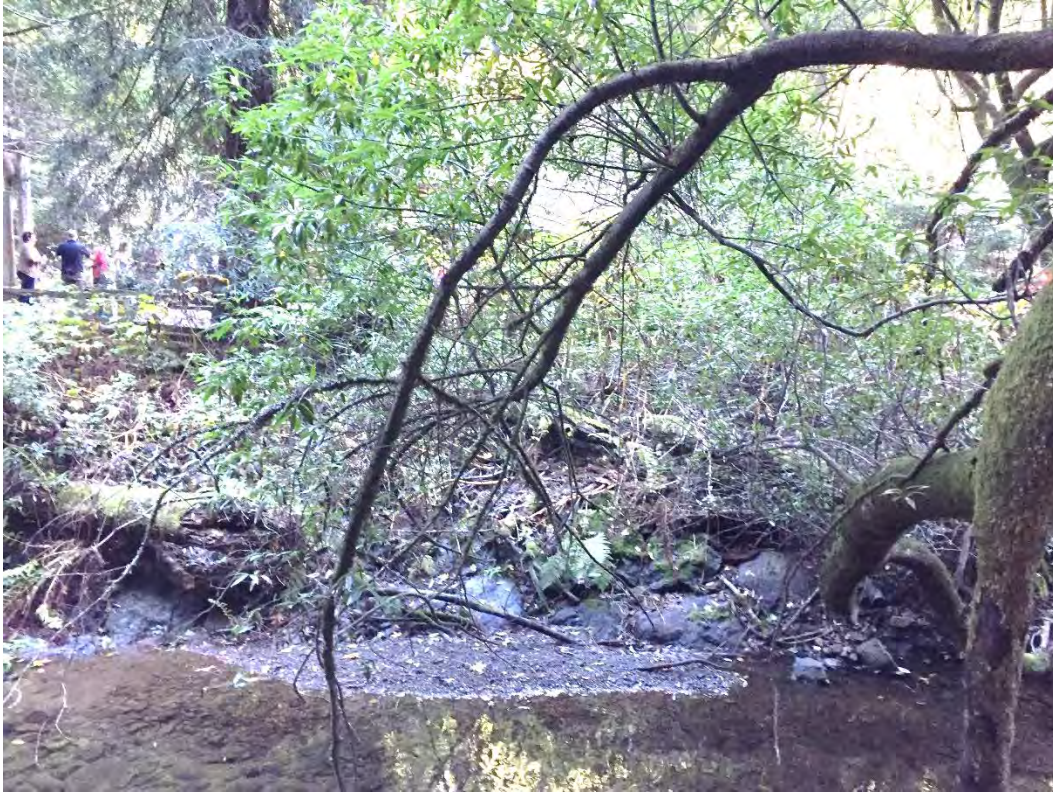
Section L1A is located immediately southwest of the Visitor Center and Entrance Plaza (Figure 4). It was previously measured at about 150 feet long and 6 feet high (NHE 2016). In 2000, it was recorded as a well-stacked embedded wall of medium-sized boulders (Peterson 2000). It is not visible from park trails or the Visitor Center. Little of the section was visible from the creek banks and creek bed during the November 2016 field visit. There are medium-sized boulders partially obscured by heavy vegetation in the roughly 30-foot stretch west of center, but plant cover made condition difficult to ascertain (Figure 5). The balance of this Section L1A (a 30 foot stretch to the west and a roughly 90 foot stretch to the east) appears to have been completely engulfed in vegetation and woody debris, although it may have fallen away. The overall condition of Section L1A is poor or not visible. Note: this segment would be removed under alternatives B, C, D, and E.

**Figure 5.** Section L1A, center stretch view north-northeast from creek bed, showing tightly placed medium sized rock revetment in fair-good condition behind tree trunks and vegetation

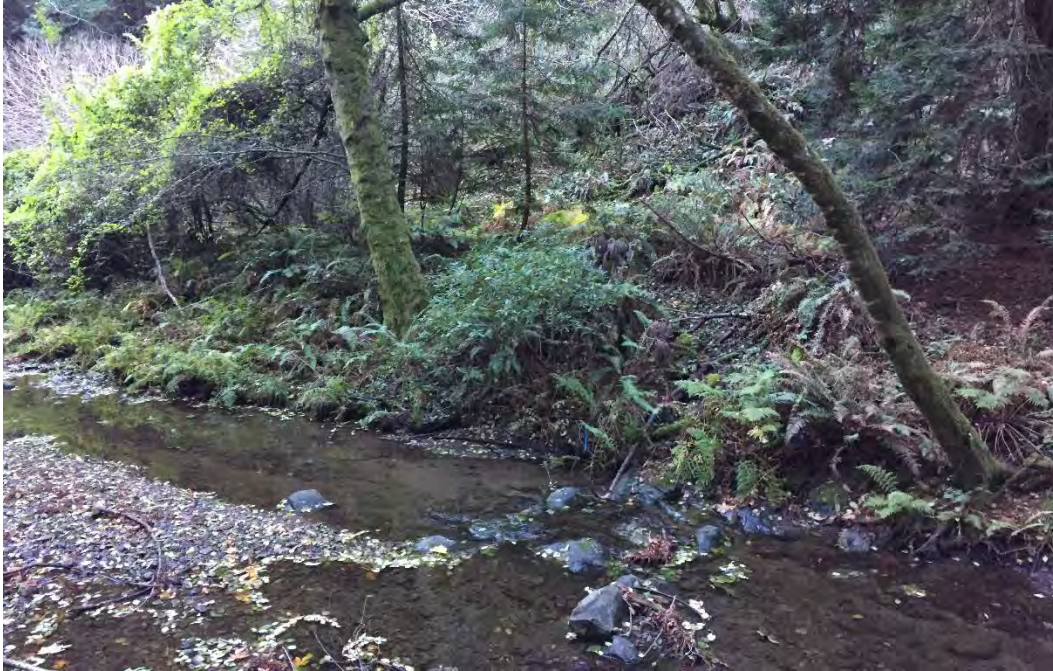
Section R1A stretches from across the creek from the Entrance Plaza and Section L1A nearly to Bridge 1 (Figure 6). It has been measured at 344 feet long and almost 7 feet high (NHE 2016), consistent with observed conditions in November 2016. In 2000, it was documented as consisting of well-stacked large boulders (Peterson 2000). The section is visible from the Boardwalk. Although the location of this section is observable from the Boardwalk, the creek bank is heavily overgrown with ferns and seasonal vegetation, and only small stretches of its rocks were visible from the creek bank and creek bed in November 2016. The uniform shape of the creek bank, however, indicates the presence of rock retaining walls in fair to good condition (Figures 7-8). The roughly 40-foot eastern stretch slightly more visible and in better condition (Figure 9). Although heavily overgrown, the overall condition of Section R1A is fair to good. Note: this segment would be removed under alternatives B, C, D, and E.

**Figure 7.** Center-west stretch of Section R1A, view south-southwest from creek bed, showing riprap of medium-sized rocks in good condition beneath vegetation and with trees growing from some areas

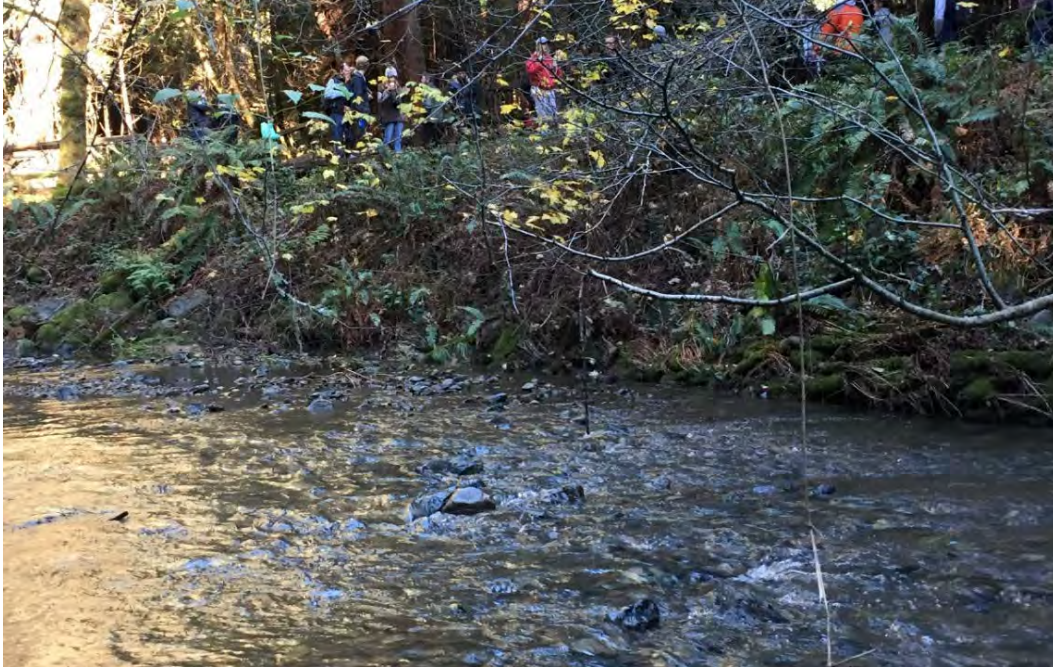
Section L1B is located directly adjacent to Section L1A to the northwest and continues upstream under and past Bridge 1, across the stream from most of R1A and all of R1B (Figure 10). It has been measured at roughly 245 feet long and 5.5 feet high (NHE 2016). In 2000, it was documented as consisting largely of boulders that were buried in the bank and not visible (Peterson 2000). These measurements were generally consistent with its observed condition in December 2016, especially toward the west end, which is mostly obscured by vegetation (Figure 11). Very little of the section is visible from park trails. The stretches that are not obscured by vegetation consist of large- and medium-sized rocks and are in relatively good condition (Figure 912). Section L1B is in fair to poor condition overall.

**Figure 11.** Stretch of L1B obscured by vegetation, view northwest from right bank, with large loosely-stacked stones visible left of frame

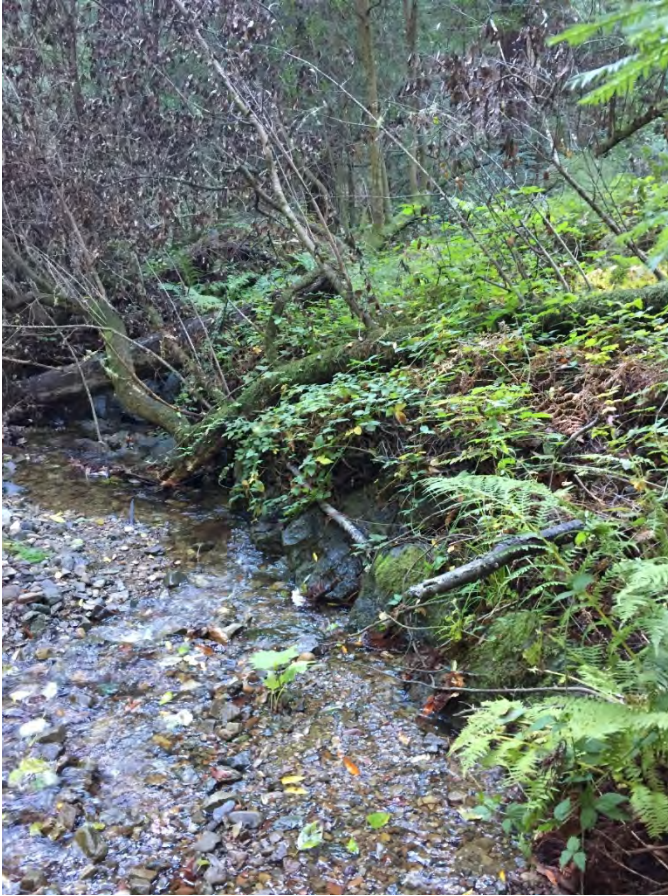
Section R3B is located just across the creek to the west from the Pinchot and Emerson trees (Figure 29). It has been measured at 150 feet long and about 2.5 feet tall (NHE 2016), consistent with observed conditions in November 2016. In 2000, it was documented as disassembled, “non-embedded”, and consisting of a single course of small boulders (Peterson 2000). The section is visible from park trails and the Emerson Tree area. Although the area is visible, heavy seasonal vegetation and woody debris make observation of the section, especially the north stretch, difficult, but there appears to be at least one course of boulders present throughout (Figures 30-31). R3A, which is adjacent to the south and supports the trail, is more visible and consists of at least 2 courses. The overall condition of Section R3B is fair to poor, and it consists of only 1-2 courses in contrast to most sections which have 3 or more courses.

**Figure 30.** South stretch of Section R3B, view south from creek bed, showing low riprap obscured by ferns and woody debris

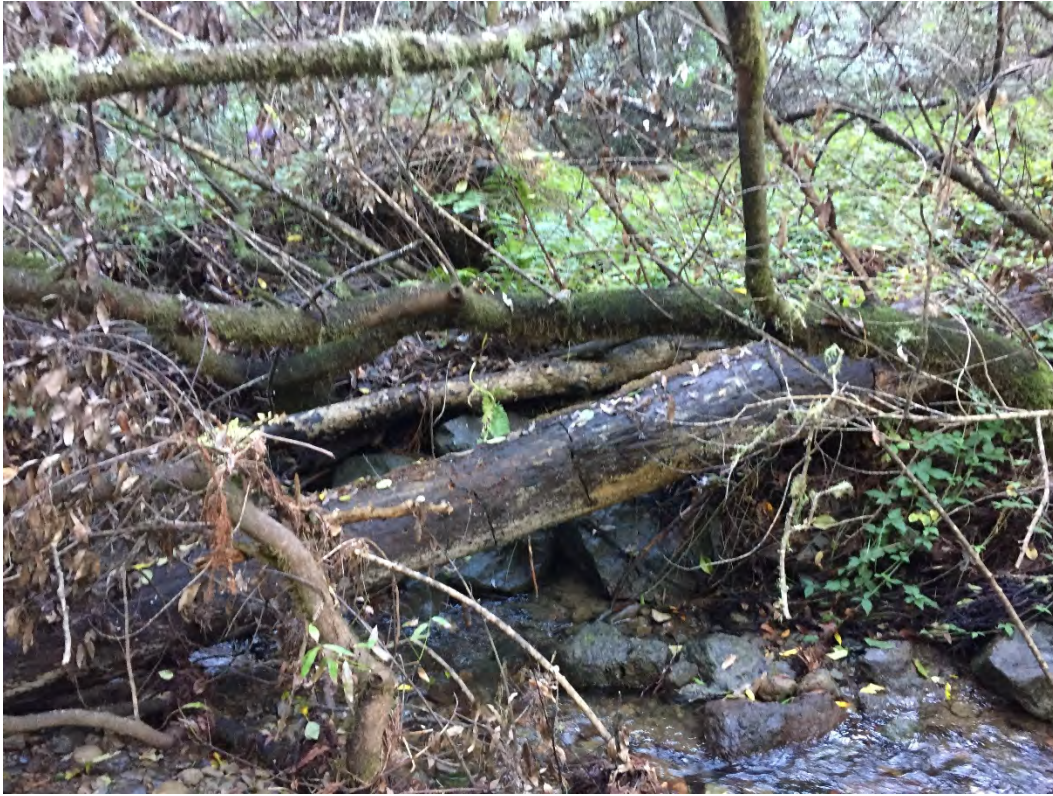
**Figure 31.** Detail, Section R3B low rock wall is visible behind woody debris

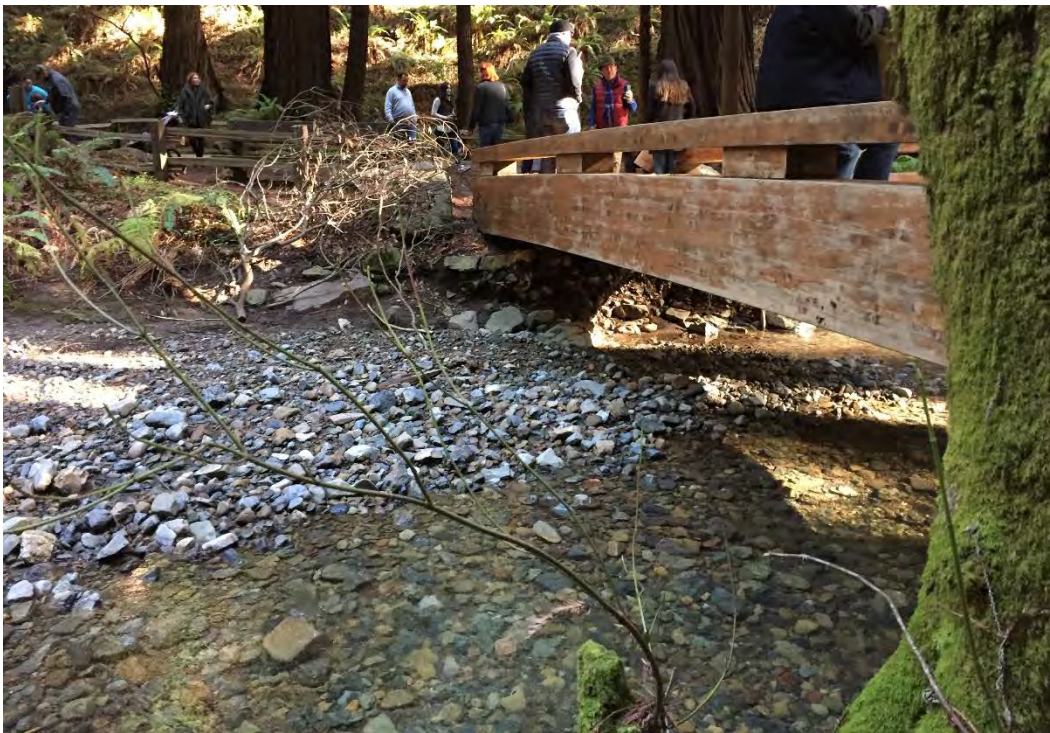
Section L4 is located directly under and at either end of Bridge 2 (Figure 38). It has been measured at roughly 46 feet long and 4 feet tall (NHE 2016). In 2000, it was documented as loosely-stacked, disassembled, and “non-embedded,” (Peterson 2000). Measurements are mostly consistent with observed conditions in December 2016. It consists of rocks that, while mostly small, are variable in size and loosely stacked, and is in poor condition overall (Figures 39-40). It is visible from Bridge 2 and the right bank trail.

**Figure 40.** View of Section L4 from right bank, camera facing north, with little intact riprap in place

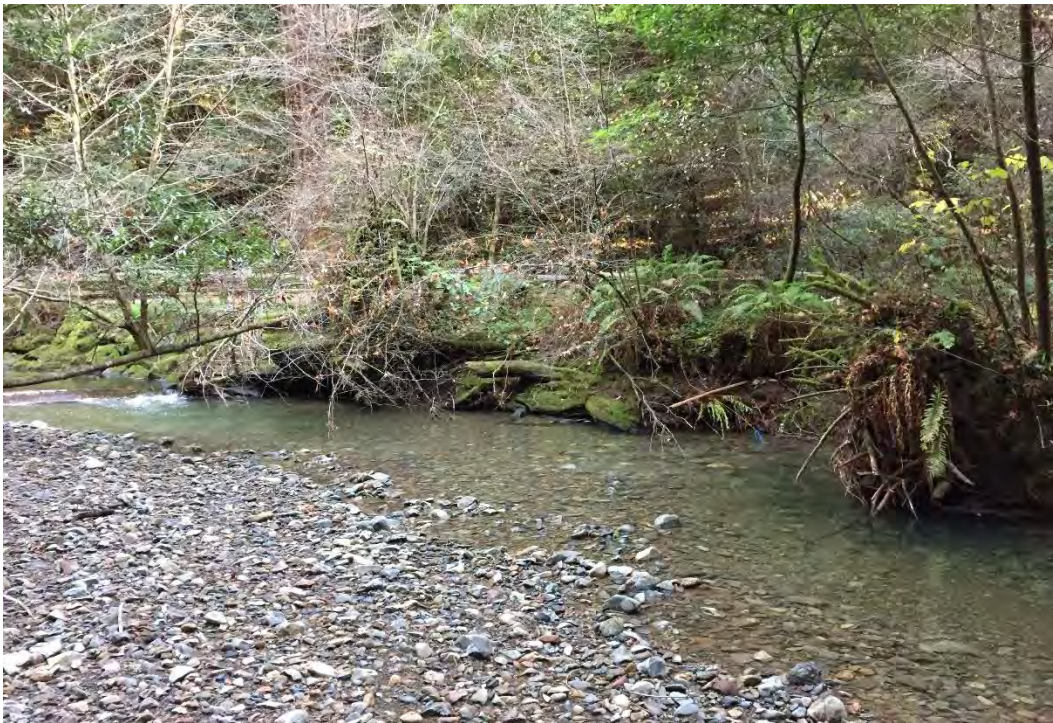
**Figure 46.** Section L5, from right bank, camera facing northeast, showing woody debris, ferns, and seasonal vegetation with small areas of rock revetment visible left of frame and at center

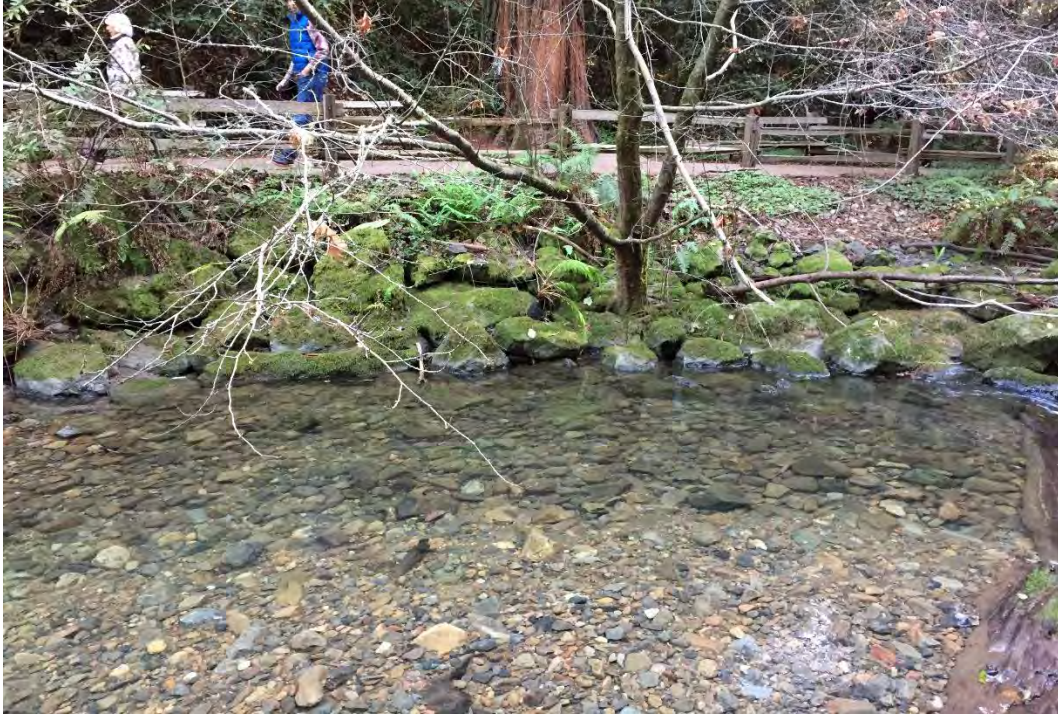
Section L5 wraps around the curve where the creek turns and flows north-south upstream of Bridge 2 (Figure 44). It has been measured at roughly 79 feet long and just under 6 feet tall (NHE 2016). In 2000, it was documented as a loosely stacked and “disassembled wall” of medium-sized boulders (Peterson 2000). At the time of the December 2016 visit, parts of the section were obscured by seasonal vegetation and more durable woody debris (Figures 45-46), but visible stretches were consistent with recorded observations. Section L5 is visible from park trails. It is in good condition in the middle and poor condition at the ends (Figure 47). The section overall is in fair to good condition.

**Figure 47.** East end of Section L5 and trail, camera facing east, showing rocks displaced by tree and falling away

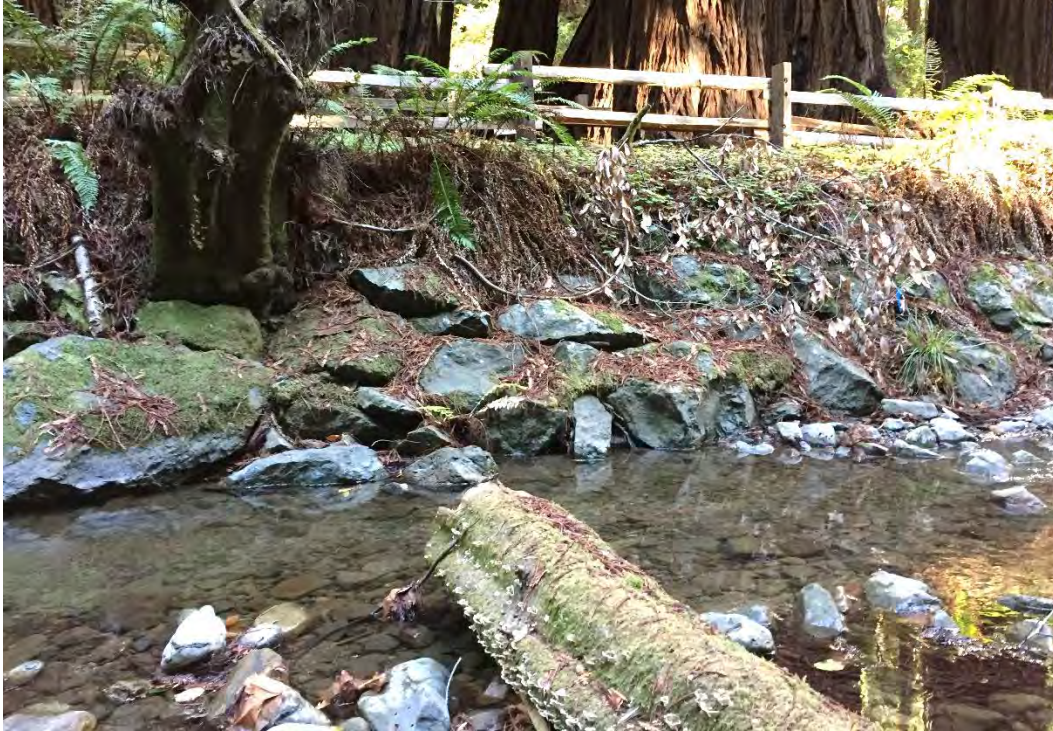
**Figure 58.** Center-east section, view northeast from creek bed showing well-stacked boulders beneath tree stump, ferns, and the trail

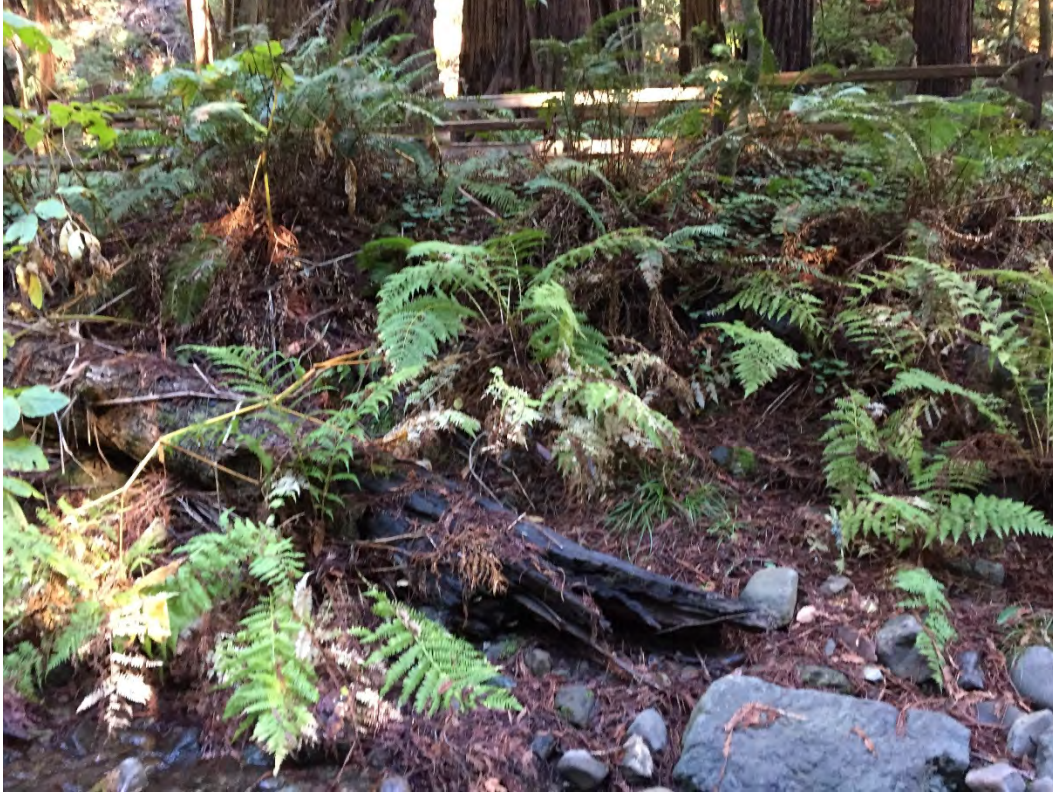
Section L7 is located adjacent to Cathedral Grove and supports the western arm of the trail that splits off from Redwood Creek Trail before the grove (Figure 55). It has been measured at about 141 feet long and 5 feet high (NHE 2016). Observed conditions in November 2016 revealed a roughly 110-foot by 5-foot wall. In 2000, it was documented as consisting of medium boulders. The 2000 report called out loosely-stacked, well-stacked, buried, and “embedded non-wall” conditions in the section (Peterson 2000). Although these different conditions must have been observed in different stretches, no details about their specific locations were recorded. The section is visible from the Hillside Trail, although ferns and woody debris partially obscure much of the upper course. Section L7 consists of boulders of variable size with the largest forming the lower course. This results in a wall that is more tapered from bottom to top than most other sections. Roughly 110 feet of its west stretch is in fair to good condition (although rocks are not as carefully fit together as in the most finely wrought sections). Roughly 15 feet at the west end of the section is in fair to poor condition (Figure 56), while the 95 feet at the center are in good condition, with boulders that are clearly stacked intentionally (Figures 57-58). The east 30 feet, as recorded in 2000, has either fallen away or is obscured by vegetation (Figures 59-61). Overall Section L7 is in fair to good condition.

**Figure 61.** Detail, eastern stretch where wall has either fallen away or been engulfed in vegetation

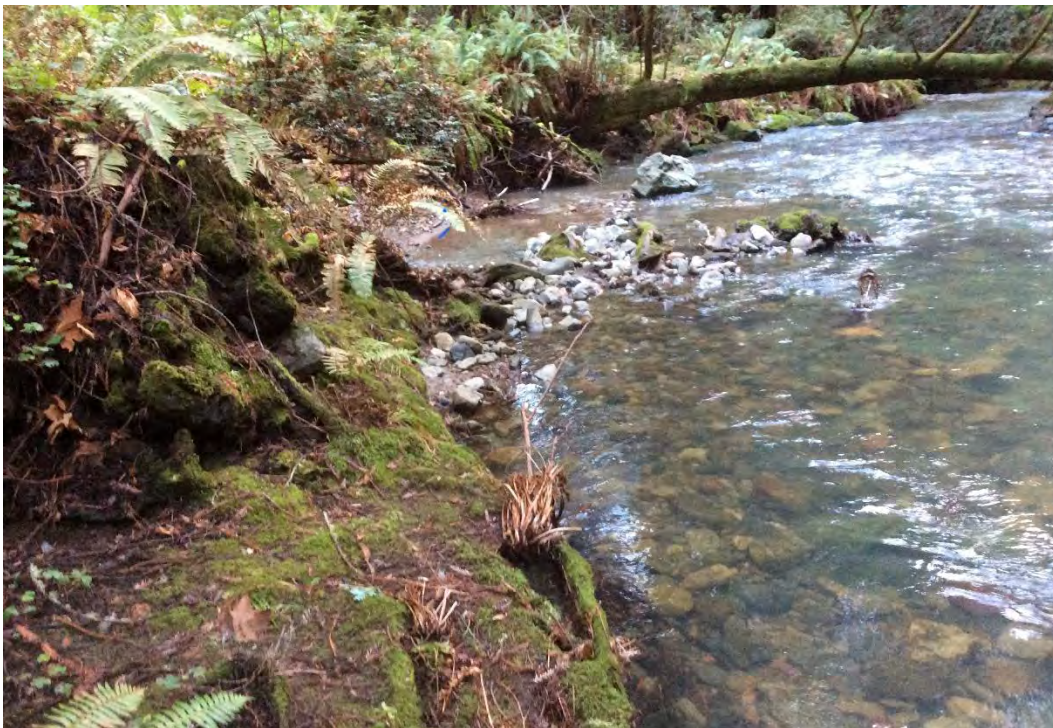
Section L9 is located immediately upstream from Section L8.5 (Figure 67). It has been measured at almost 23 feet long and almost 10 feet tall (NHE 2016). In 2000, it was documented as consisting of a combination of loosely stacked wall and “disassembled non-wall” made of medium-sized boulders (Peterson 2000). Measurements were consistent with observed conditions at the time of the December 2016 field visit. Although individual rocks were not directly visible, close inspection of the bank reveals that it consists of small boulders embedded in dirt or covered with moss (Figures 68-69). L9 is much less vertical than other sections, and may have shifted into a more horizontal position over the decades, or may originally have been designed differently than most sections. Its location is not visible from park trails. The section is in fair to poor condition overall.

**Figure 69.** Section L9, view southwest from left bank, showing nearly horizontal riprap of small rocks under moss in foreground

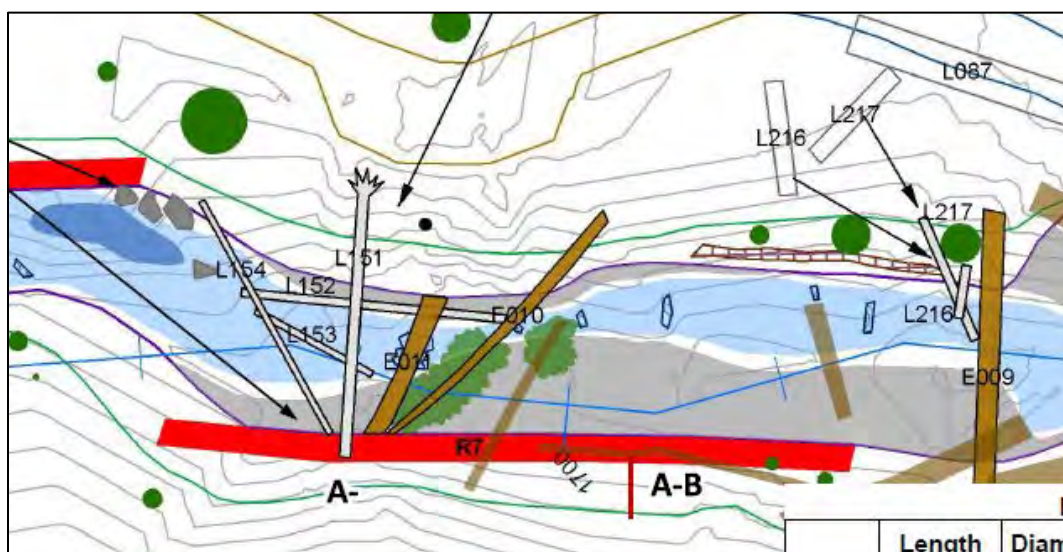
**Figure 70.** Section R7 Condition Assessment

Section R7 is located across the creek and roughly 150 feet upstream of Cathedral Grove (Figure 70). It was previously measured at about 115 feet long and just under 4 feet high (NHE 2016). The length is consistent with observed dimensions in November 2016, although most of its visible stretches are no more than about 3 feet high. It was documented as a loosely-stacked wall of medium-sized boulders in 2000 (Peterson 2000). The section is visible from the Redwood Creek Trail. Its roughly 60-foot northwest stretch is in very good condition, and consists of 2-3 courses of tightly stacked boulders of variable size (Figures 71-72). The 55-foot southeast stretch is largely obscured by vegetation, but, where visible, consists of carefully placed medium-sized boulders (Figure 73). Overall Section R7 is a low wall in good to very good condition.

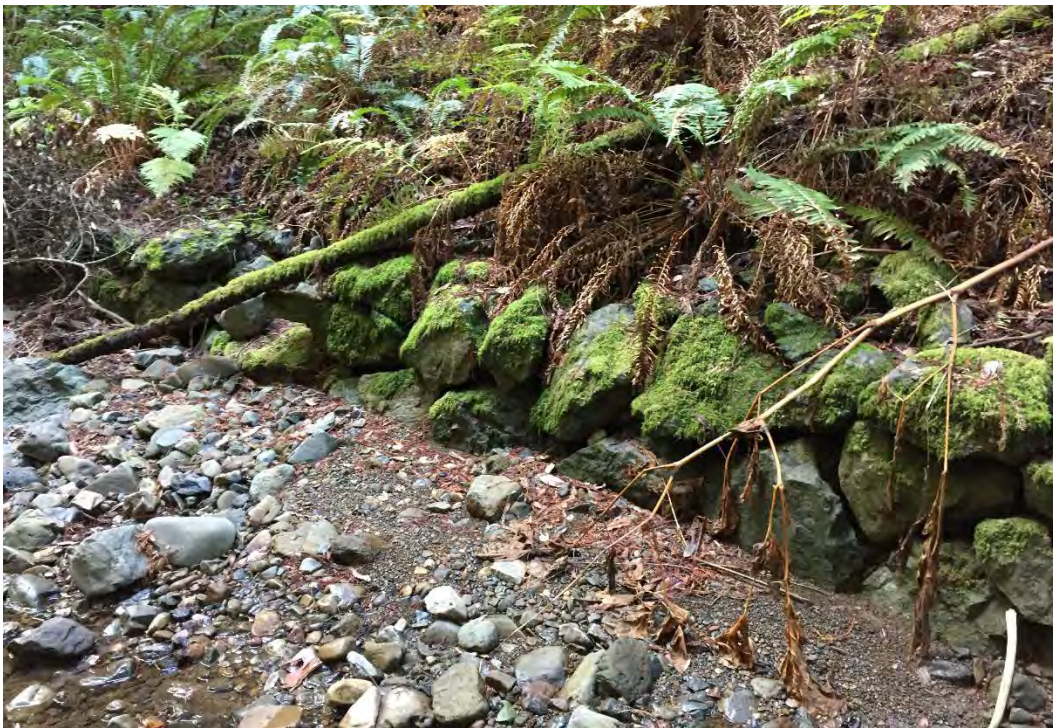
**Figure 72.** Detail, northwest stretch, showing 2-3 courses of tightly stacked boulders of variable size with ferns and small amounts of woody debris

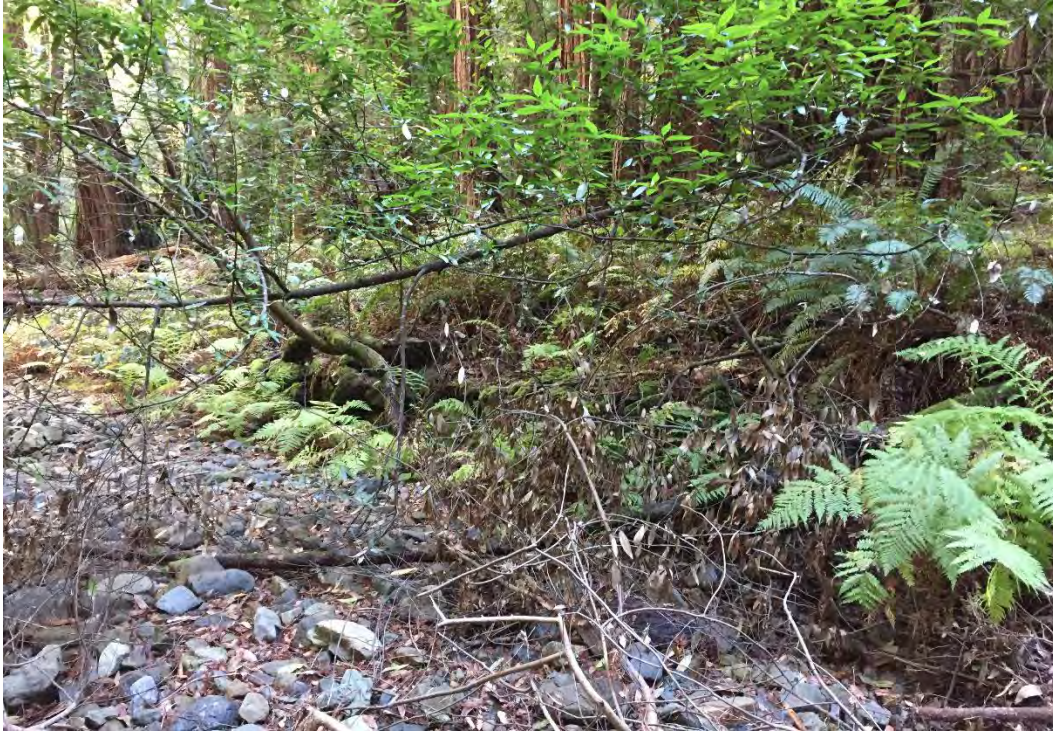
**Figure 73.** Southeast stretch, view southeast from creek bed, well-stacked wall visible center frame behind ferns, small trees, and seasonal vegetation

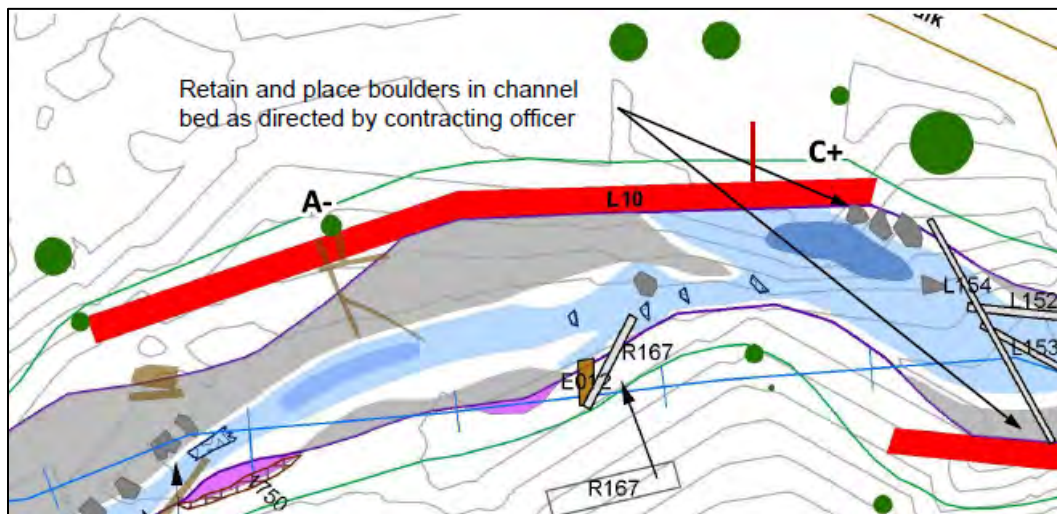
**Figure 74.** Section L10 Condition Assessment

Section L10 is just across the creek and upstream from Section R7 (Figure 74). It has been measured at about 130 feet long and 5.5 feet tall (NHE 2016), consistent with observed conditions in November 2016. In 2000, it was documented as a well-stacked wall of large boulders (Peterson 2000). Its location is visible from the Hillside Trail. Although partially overgrown with ferns and other vegetation, it remains in excellent condition, with large boulders intentionally placed in 3-4 courses (Figures 75-76). A 30-foot stretch at its eastern end is in poor to fair condition (Figures 77-78). Overall, Section L10 is in good condition. Its condition and craftsmanship make it one of the better sections targeted for removal.

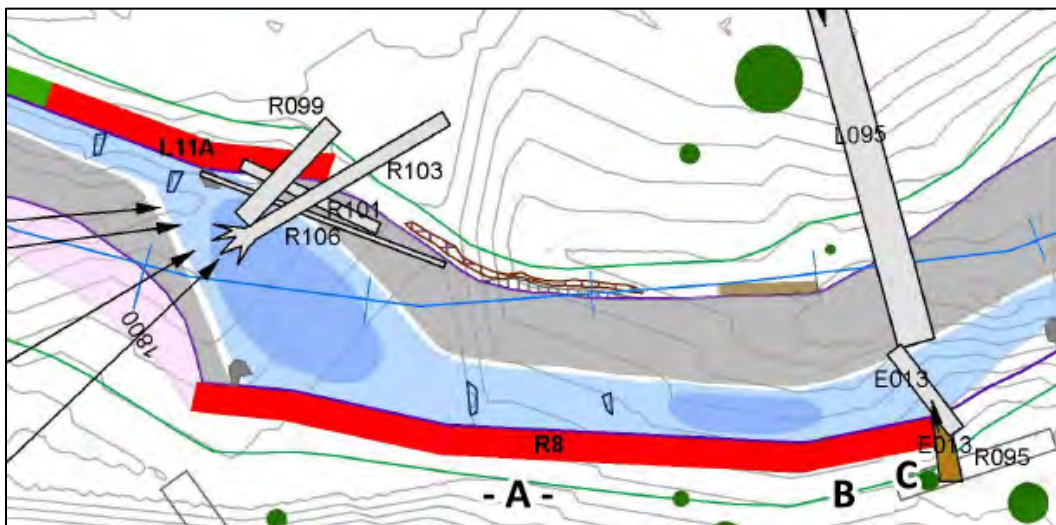
**Figure 79.** Section R8 Condition Assessment

Section R8 is located across the creek and upstream from Section L10 (Figure 79). It has been measured at about 110 feet long and 3.5 feet tall (NHE 2016), consistent with observed conditions in November 2016. It was documented in 2000 as a loosely stacked wall of medium boulders. Roughly 80 feet at its west stretch consists of carefully placed and tightly stacked boulders (Peterson 2000). The location of the section is visible from the Redwood Creek Trail. The majority of the section consists of medium-sized boulders, with smaller rocks fit in to form a relatively solid wall of 3-4 courses (Figures 80-82). A small area (roughly 5 feet long) at the east end is in poor condition, with a 15-foot stretch center-east in good condition (Figure 83). The overall condition of Section R8 is excellent. Its condition and craftsmanship make it one of the finest sections targeted for removal.

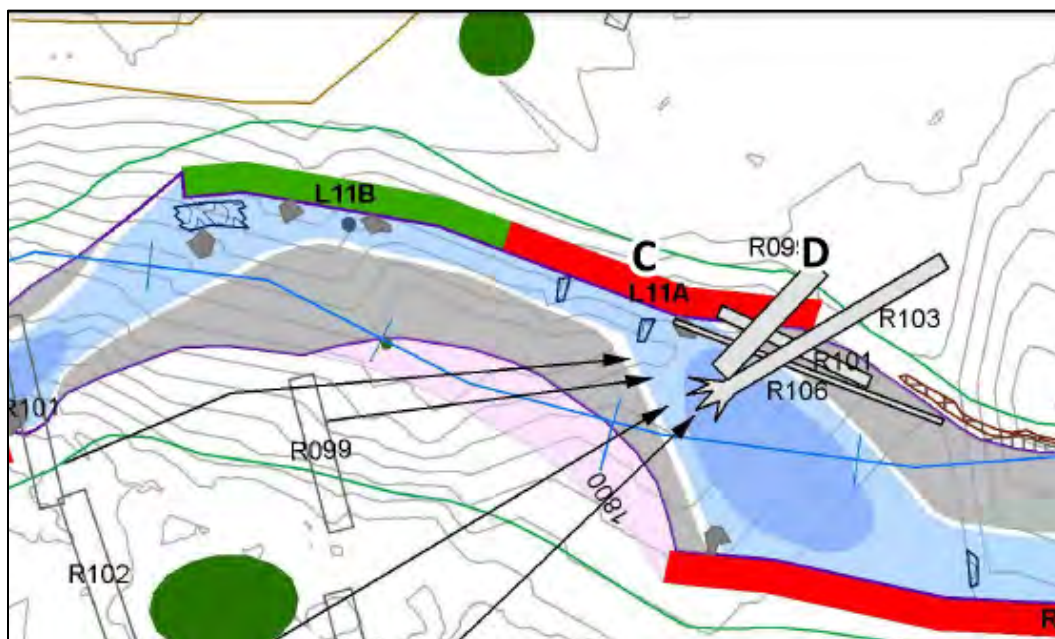
**Figure 84.** Section 11A Condition Assessment

Section L11A is located across the creek and just upstream from Section R8. It is connected at its west end to Section L11B, which is not slated for removal (Figure 84). It is about 25 feet long, while the adjacent Section L11B is close to 60 feet (NHE 2016). It is just under 6 feet tall (NHE 2016). In 2000, Section L11 was documented as loosely-stacked and “embedded non-wall” of medium-sized rocks (Peterson 2000). No details were recorded to differentiate the west and east stretches of L11. It is visible from the Hillside Trail. The dimensions are consistent with those observed in November 2016, but it is difficult to discern the exact dividing line between L11A and L11B. What appears to be L11A’s west stretch is in fair-poor condition (Figure 85), while the east stretch (about 15 feet long) is completely missing and/or in poor condition (Figure 86). The overall condition of Section L11A is poor.

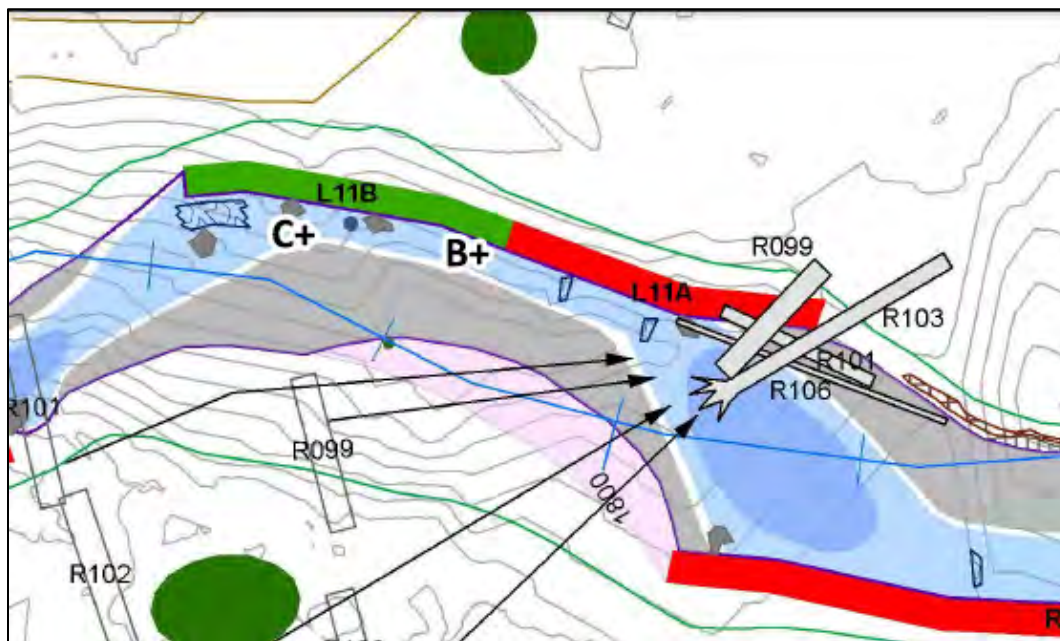
**Figure 87.** Section L11B Condition Assessment

Section L11B is directly adjacent to and northwest of Section L11A (Figure 87). It has been measured at about 26 feet long and just over 8 feet tall (NHE 2016). In 2000, it was documented as a loosely stacked wall (Peterson 2000). Its length appeared generally consistent with observed conditions at the time of the December 2016 field visit, although it appeared to be only about 5 feet tall. Its location is visible from the Hillside Trail. Its downstream stretch is in very good condition, with tightly stacked medium-sized rocks (Figures 88-89). The upstream stretch may also be in good condition based on the shape of the bank, but it is less visible due to moss, ferns, and seasonal vegetation (Figure 90). Section L11B is in overall good condition.

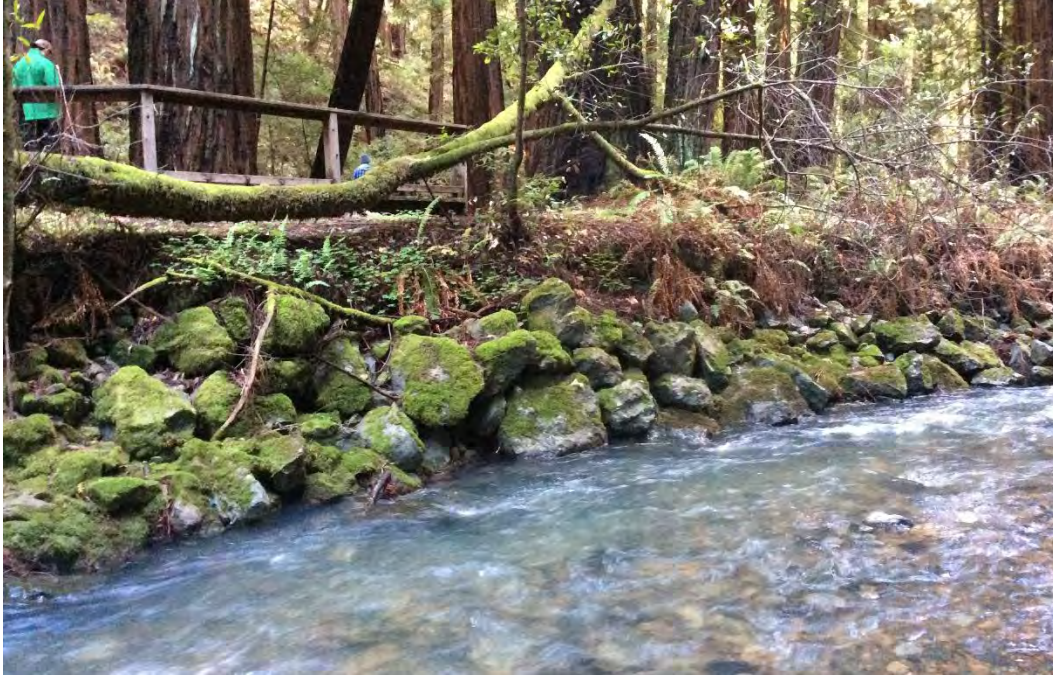
**Figure 88.** Downstream stretch of Section L11B looking east from creek bed, showing riprap in very good condition, with tightly stacked medium-sized rocks below fern growth

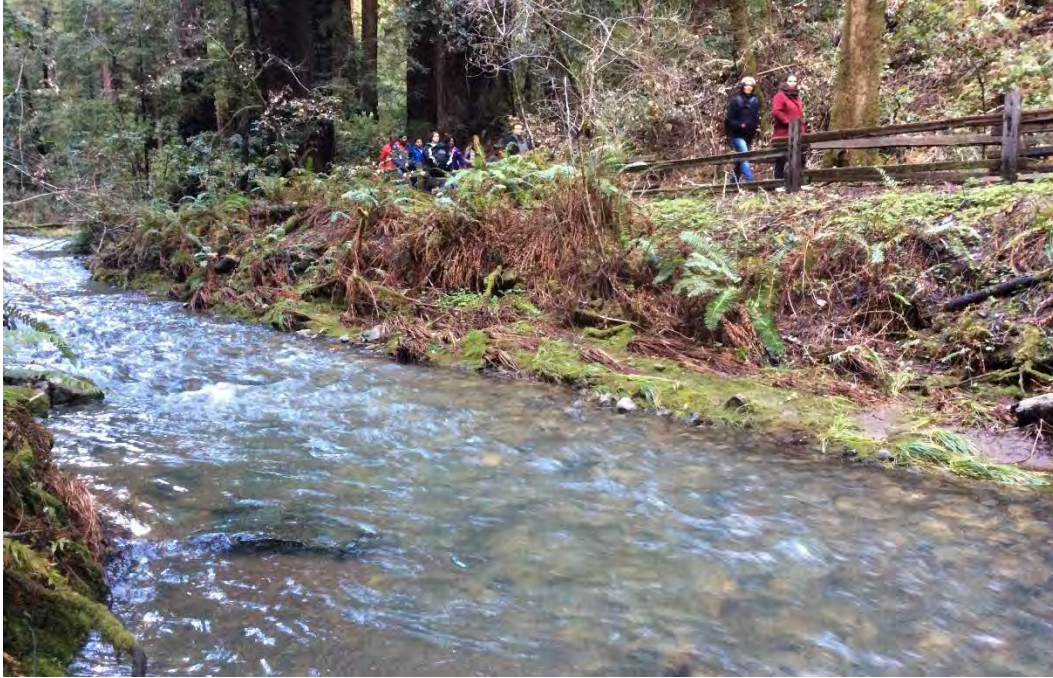
**Figure 90.** Upstream stretch of Section L11B, view north from right bank, showing riprap not visible possibly due to profusion of moss, ferns, and seasonal vegetation

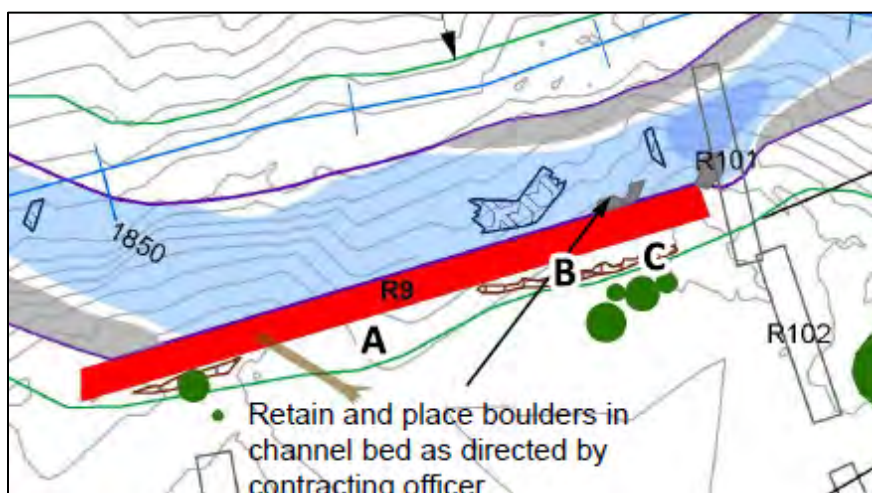
**Figure 91.** Section R9 Condition Assessment

Section R9 is located just across the creek and upstream from Section L11 (Figure 91). It has been measured at roughly 80 feet long and about 6.5 feet tall (NHE 2016). The length is consistent with its observed condition in November 2016, but it appears to be only about 3 feet high. In 2000, the section was documented in two parts, with small and medium boulders recorded in a variety of conditions (Peterson 2000). Its location is visible from the Redwood Creek Trail. Its small and medium boulders are tightly stacked into 3 to 4 courses that form a nearly upright wall (Figure 92). Its roughly 60-foot west stretch is in excellent condition (Figure 93), with some collapsing on the east stretch due to tree root interference (Figure 94). Small areas are obscured by fern growth and seasonal vegetation. The overall condition of Section R9 is excellent. Although small, it is one of the better sections targeted for removal.

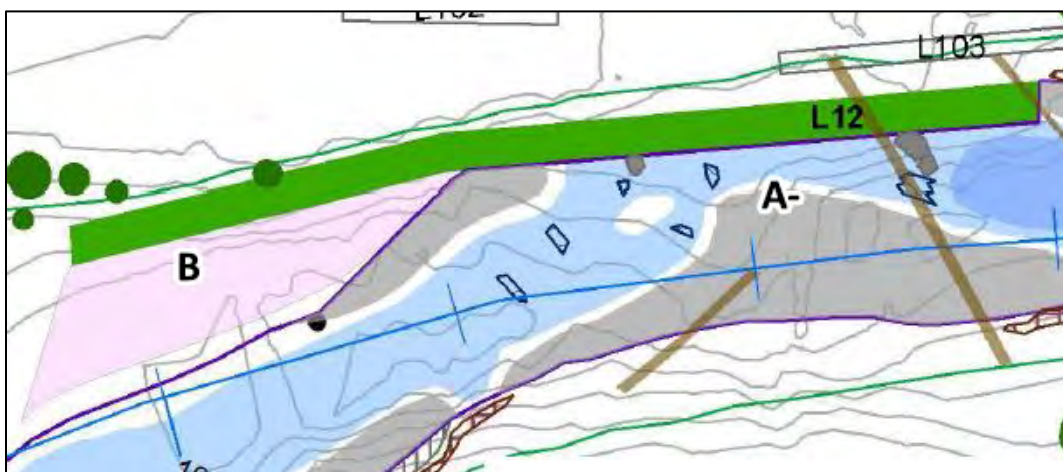
**Figure 95.** Section L12 Condition Assessment

Section L12 is located along the creek to the south of where Fern Creek Trail diverges from the Redwood Creek Trail (Figure 95). It has been measured at almost 105 feet long and about 5 feet tall (NHE 2016). In 2000, it was documented as an embedded wall made of medium and large boulders that was well-secured at some parts (Peterson 2000). Its measured dimensions were consistent with those observed at the time of the December 2016 field visit. Its location is not visible from park trails. It consists of a loosely stacked stretch of medium-large to large boulders at the roughly 30-foot upstream (west) stretch. There is a roughly 6-foot wide strip of embedded toe material in front of this stretch that appears to have been installed along with the riprap (Figure 94). The rocks in the downstream 2/3 of the stretch are the same size range but are tightly-stacked and in excellent condition (Figures 97-98). There is no toe material in front of the 75-foot downstream stretch. Overall Section L12 is in very good condition. Note: this segment would be removed under alternatives D and E.

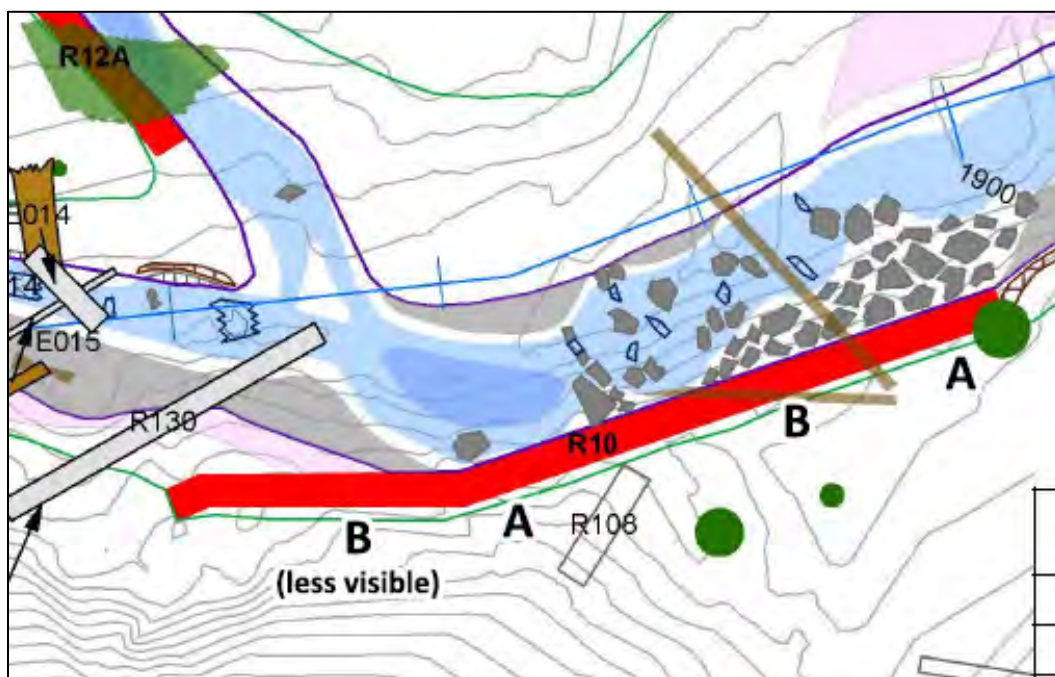
**Figure 99.** Section R10 Condition Assessment

Section R10 is located across the creek from where the Fern Creek Trail diverges from the Redwood Creek Trail (Figure 99). It was measured at roughly 100 feet long and nearly 6 feet tall (NHE 2016), consistent with observed 2016 conditions. In 2000, it was documented as a well-stacked wall of large boulders, and also documented as “fallen” (Peterson 2000). It is not known what where the fallen section was observed. Section R10 is in a location that is not visible from park trails. Its west 25 feet are difficult to see due to heavy fern growth, but close inspection reveals that it appears to be in good condition (Figure 100). The 75-foot east stretch is in excellent condition, except for about 20 feet of good condition at its center (Figure 101). Rocks vary in size, and are tightly fitted into 5 to 6 courses, with the larger boulders on the lowest course. Its eastern 50 feet have a large amount of toe material or a check dam consisting of large boulders in the creek bed adjacent to the section (Figures 102-103). The overall condition of Section R10 is excellent to very good despite being obscured by seasonal and more permanent woody vegetation.

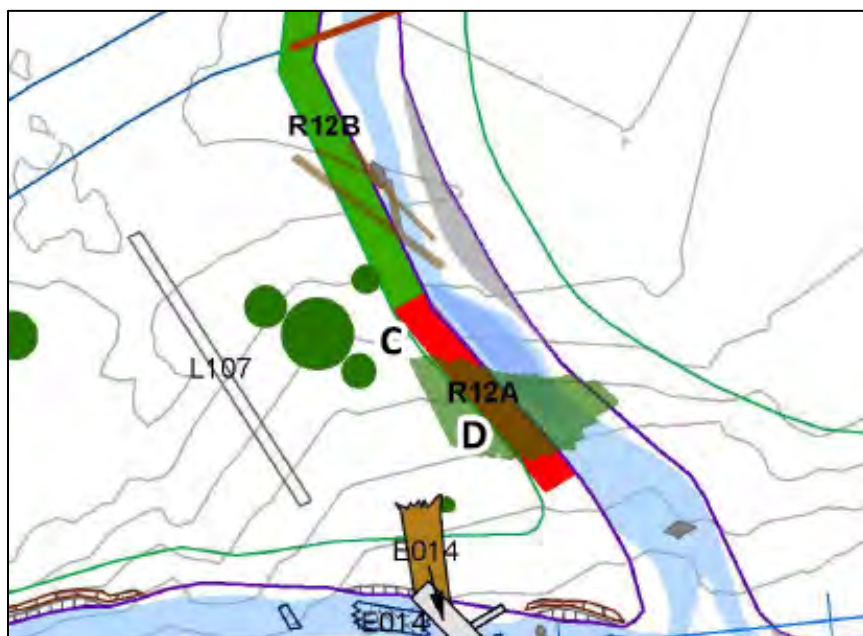
**Figure 104.** Section R12A Condition Assessment

Section R12A is located on Fern Creek just upstream from its confluence with Redwood Creek (Figure 104). It was measured at about 40 feet long and 4 feet high (NHE 2016), consistent with observed conditions in November 2016. In 2000, Section R12A was documented as well- and loosely-stacked large and small rocks (Peterson 2000). It is adjacent to R12B, and the exact dividing line between the sections is difficult to discern. Section R12A is visible from the Redwood Creek Trail. Its north stretch (adjacent to R12B) is in fair condition, but tree roots have apparently destroyed all but this roughly 10-foot stretch (Figure 105). The south stretch is missing or in poor condition. The overall condition of Section R12A is poor.

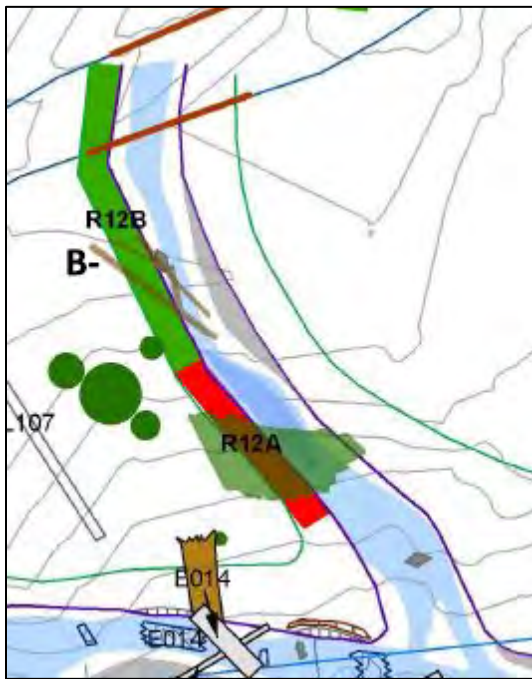
**Figure 106.** Section R12B Condition Assessment

Section R12B is located on Fern Creek, north of where it meets Redwood Creek and connected at its south end to Section R12A (Figure 106). It has been measured at almost 43 feet long and just over 4.5 feet tall (NHE 2016). In 2000, it was recorded as a combination of loosely stacked and embedded wall made of small and large boulders, consistent with its observed condition in December 2016 (Figures 107-108) (Peterson 2000). It is visible from park trails. Although difficult to see the rocks because of the bridge over its north end and ferns along the bank, careful inspection shows they are well stacked and medium-sized. Section R12B is in good condition overall.
