## Riprap Condition Report

# **MUIR WOODS NATIONAL MONUMENT**

## **2016 REDWOOD CREEK RIPRAP ASSESSMENT**

March 2017

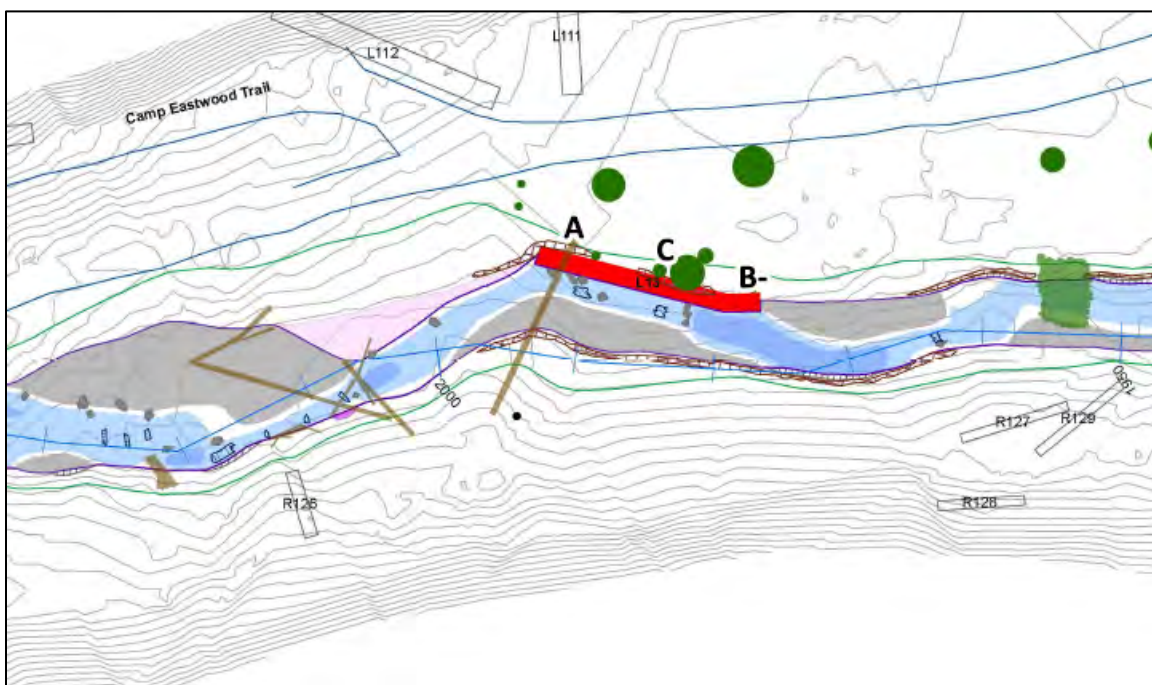
**Figure 113.** Section L13 Condition Assessment

Section L13 is located just southeast of the intersection between Camp Eastwood Trail and Redwood Creek Trail (Figure 113). It was measured at roughly 60 feet long and 5 feet high (NHE 2016), consistent with its observed condition in November 2016. When it was documented in 2000, it was recorded as a loosely stacked wall of medium-sized boulders that had fallen into the creek (Peterson 2000). Overall, the section is a well-stacked wall of medium-sized boulders that have clearly been intentionally placed. The roughly 25-foot western stretch is in excellent condition (Figures 114-115). The 15-foot central section, where tree roots have pushed rocks into the creek, is in poor condition, and the under layer of smaller rocks is visible (Figure 114). The 20-foot eastern stretch is in good condition (Figures 117-118). The overall condition of Section L13 is good. It is visible from Hillside Trail. Its condition and craftsmanship make it one of the finest sections targeted for removal despite the small area of deterioration at its center.

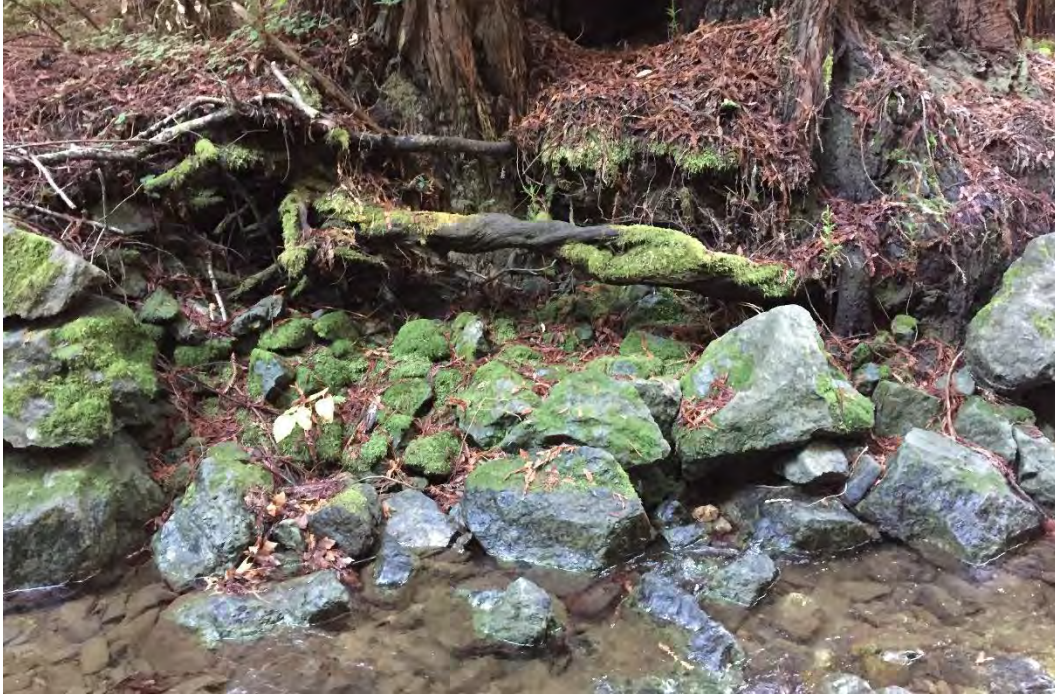
**Figure 116.** Central stretch showing large rocks pushed out by tree roots and smaller rocks used for backfill exposed

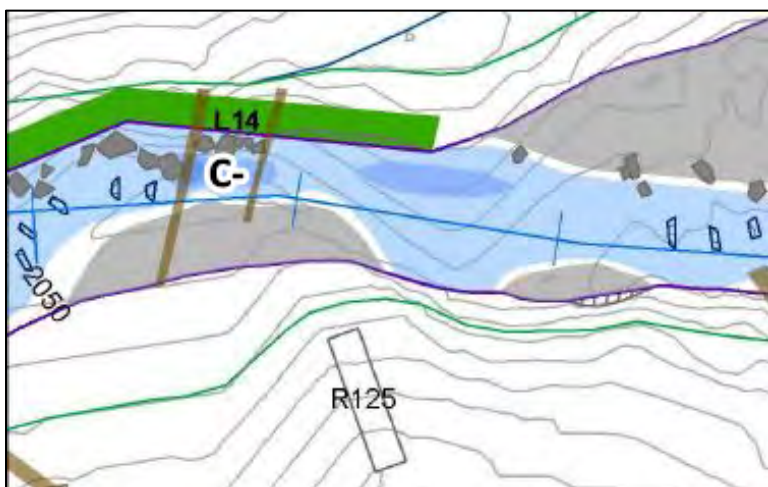
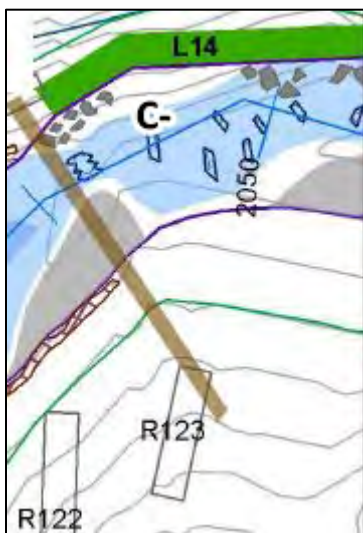
Section L14 is located west of the start of Camp Eastwood Trail, just east of a bend in the creek (Figures 119-120). It has been measured at almost 79 feet long and around 6 feet high (NHE 2016). In 2000, it was documented as a combination of well-secured embedded wall, loosely stacked wall, “embedded non-wall”, and boulders fallen into the creek, composed of a variety of sizes of boulders ranging from very small to medium (Peterson 2000). It is not visible from park trails and could not be accessed at the time of the December 2016 field visit. However, one photograph of its center stretch was discovered in a 2014 report, which shows jumbled boulders of varying size (ESA 2014) (Figure 121). The larger boulders have fallen into the creek, while some of the smaller stones used for backfill is visible still embedded in the bank. The overall condition of Section L14 appears to be very poor and somewhat unstable.

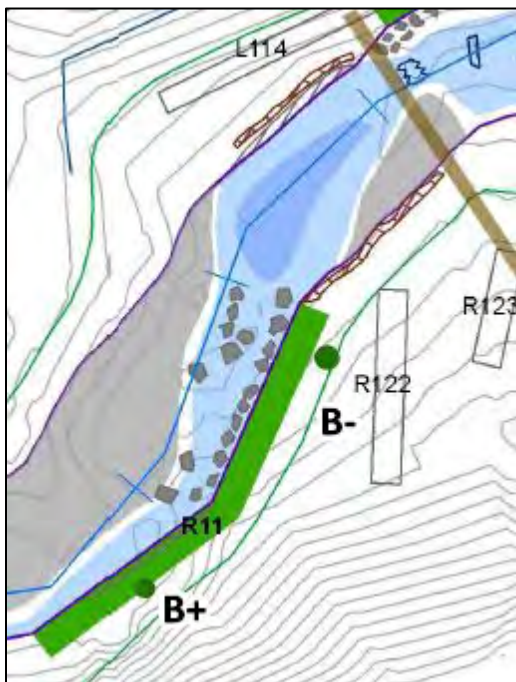
**Figure 122.** Section R11 Condition Assessment

Section R11 begins to the southwest of the end of Section L14 and runs alongside most of the short northeast-southwest segment at this part of the creek (Figure 122). It has been measured at roughly 49 feet long (NHE 2016). In 2000, it was documented as a well-secured, “embedded wall” composed of medium-sized and large boulders. These measurements were consistent with the observed condition at the time of the December 2016 field visit (Figures 123-124). It is visible from park trails. The east end is more covered by seasonal and woody vegetation and in worse condition, while the west end is more visible and contains larger rocks. The overall condition of the section is good.

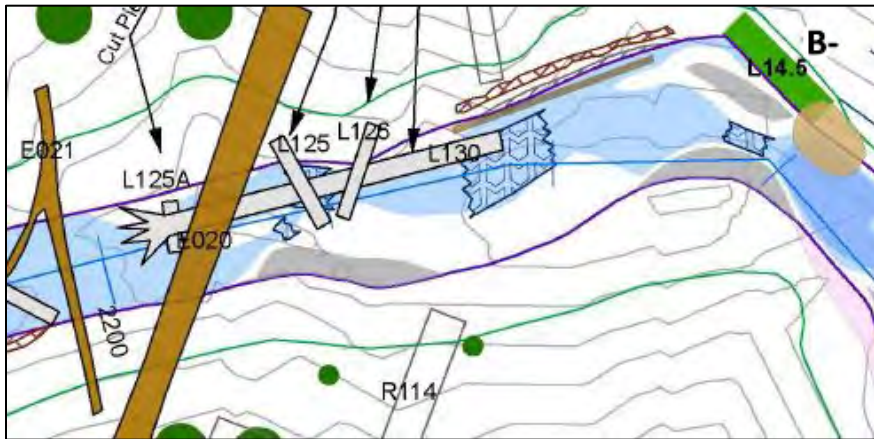
**Figure 125.** Section L14.5 Condition Assessment

Section L14.5 is located northeast of Bridge 4 at a curve in the creek (Figure 125). It has been measured at just under 20 feet long (NHE 2016), which was consistent with observed conditions at the time of the December 2016 visit. It is not visible from park trails and consists of loosely stacked rocks of variable size that range from large to medium (Figure 126). It is in fair condition.
