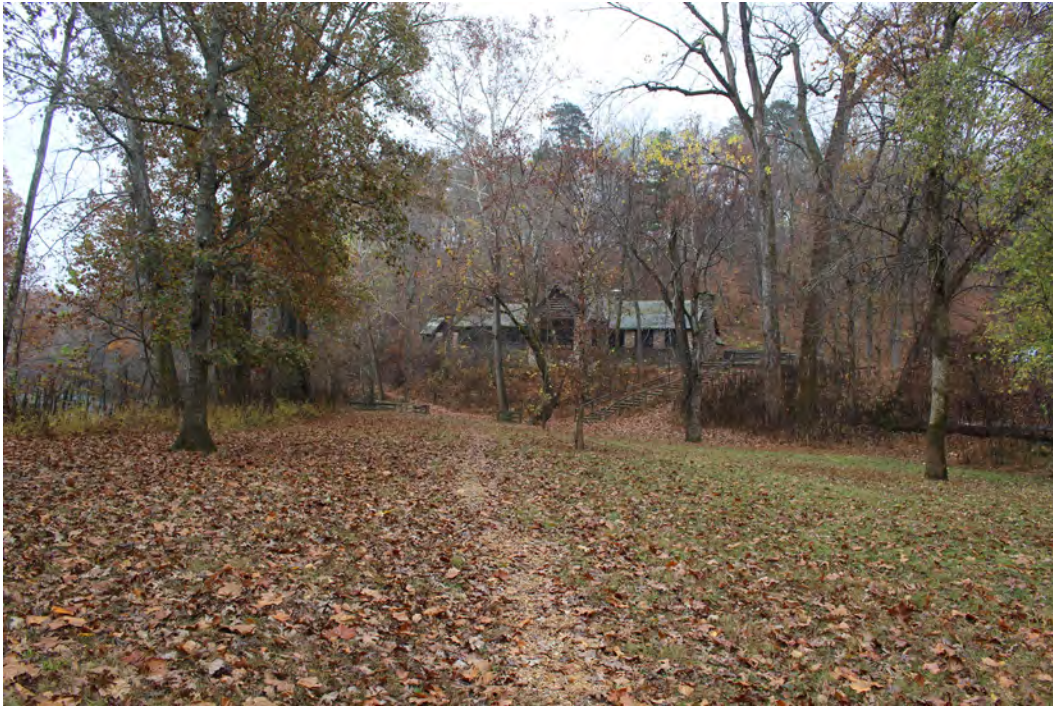
1 altered or removed. A few original species,
2 *vinca major* for example, are now considered
3 invasives. Vegetation at the Dining Lodge
4 (HS-422) has become overgrown. The loss
5 of understory vegetation, especially shrubs,
6 is diminishing the integrity of the setting.
7 Historically this area was deliberately planted
8 with shrubs arranged in natural groupings
9 and the landscape was maintained with a
10 more manicured appearance than presently.
11 Some encroachment of native vegetation is
12 evident, especially near buildings and along
13 trails. Some trees are in poor health and are
14 hazardous in high visitor use areas, near
15 buildings, recreation areas, and trails. Some
16 invasive species have propagated in natural
17 areas, threatening the health of the oak
18 hickory forest.

Figure 3-47. The vegetation around the Dining Lodge (HS-422) helps to blend the building with the landscape. (Mundus Bishop 2015)

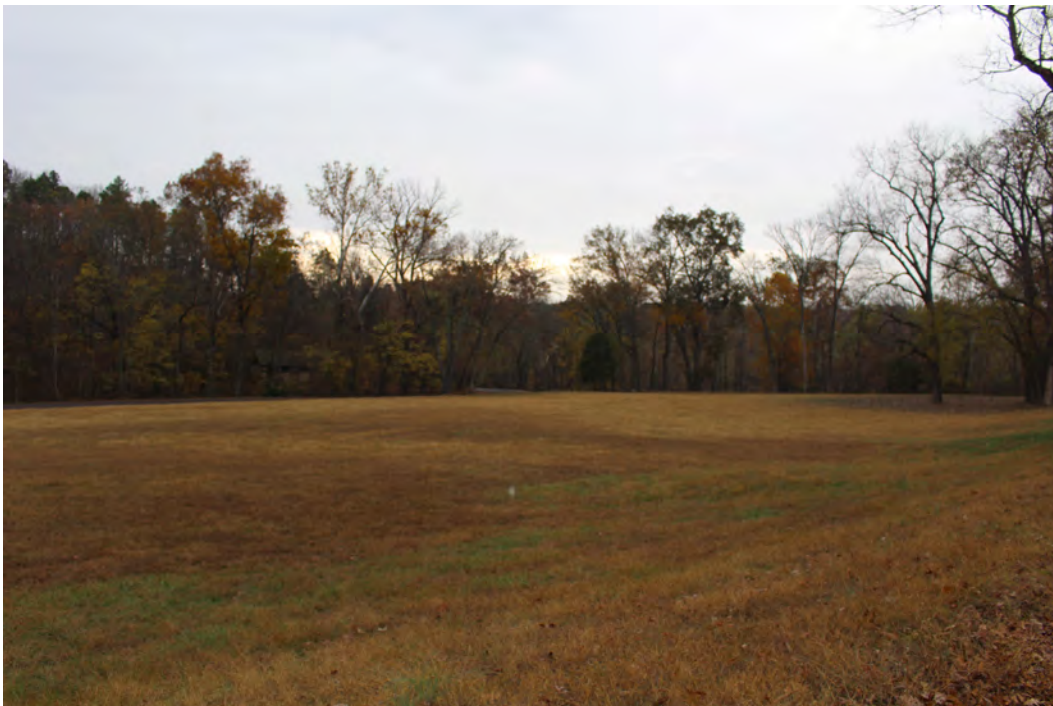
Figure 3-48. The playfield is one of the few areas of maintained, mown lawn. Shade trees have been added at the edges of the lawn. (Mundus Bishop 2015)

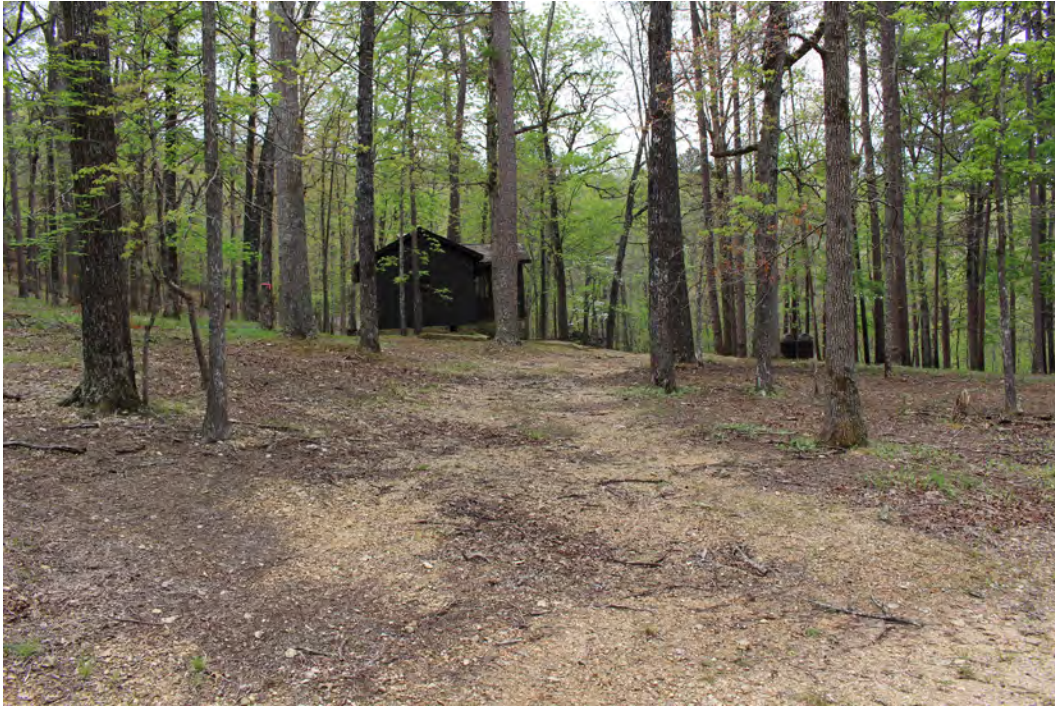
Figure 3-49. The vegetation of the cabin area includes oak / pine forest, found on narrower ridges with acidic soil. (Mundus Bishop 2016)

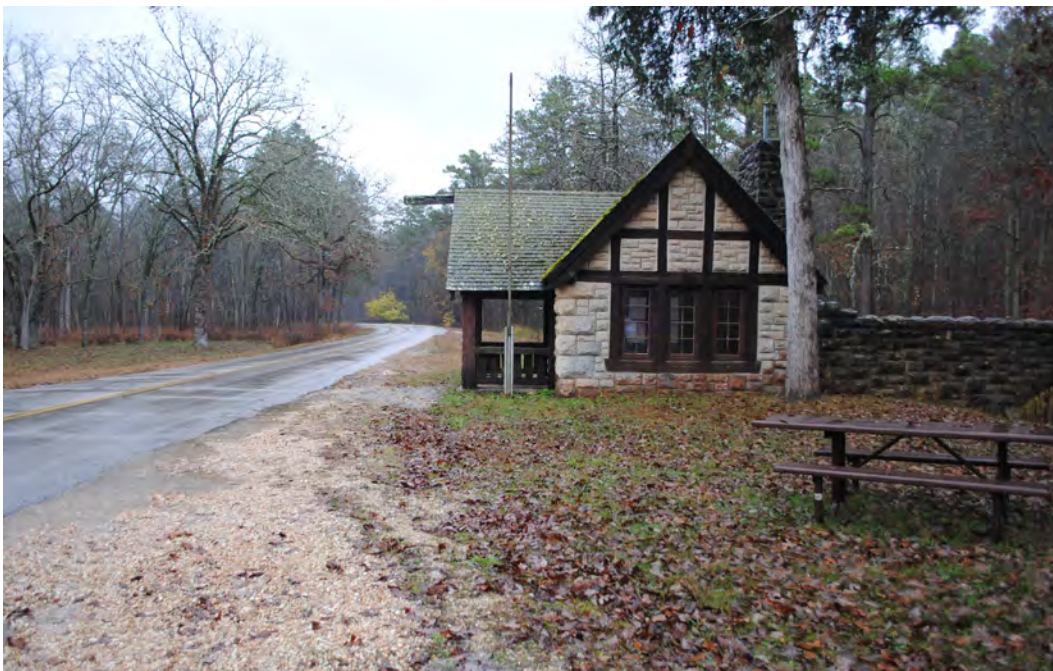
BUILDINGS AND STRUCTURES			
Entrance Building			
Feature	Description	Condition	"Contributing / Non-Contributing"
Entrance Building (HS-432) (1936)	Rustic style building, 20'x16' single story side with gabled roof, and a 7'x14' open cross gable porch. Half-timber construction with irregular coursed cut stone walls, with a cut stone exterior chimney, and an interior bathroom in a rear 4'-5"x 9' projection. Cut stone paving at building entrance. Historically used as visitor center.	Fair	Contributing
Entrance Portal Walls (HS-432A) (1936)	Two cut stone wall sections form an arc, 151'-6" long that extends across both sides of Entrance Drive. Ends terminate in large stone piers. Wire and wood fence extends from south wall to west. Drainage is accommodated through semicircular arches in each wall. South wall extends from, and is attached to Entrance Building (HS-432). North wall includes a wood gate across a foot path / old equestrian road. A cattle guard built of steel railroad ties originally crossed the road between the two walls.	Fair	Contributing

Figure 3-56. Entrance Building (HS-432). (Mundus Bishop 2015)

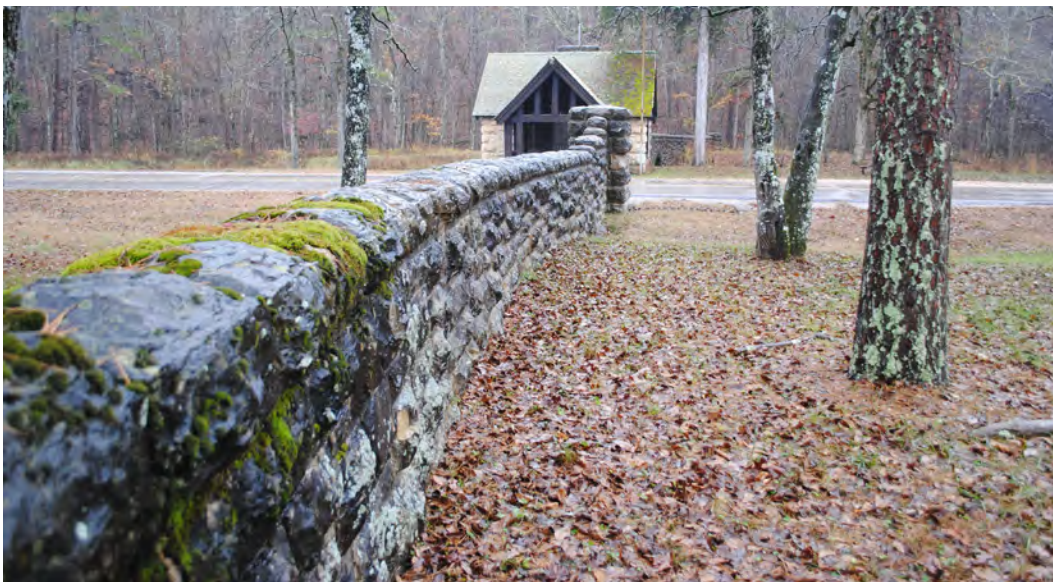
SMALL SCALE FEATURES			
Entrance Building			
Feature	Description	Condition	"Contributing / Non-Contributing"
Entrance Portal Walls (HS-432A)	re: buildings and structures	Fair	Contributing
Flagpole		Fair	Contributing
Wood Gate (1934)		Fair	Contributing
Wire and Wood Fence (1934)	Extends from south Entrance Portal Wall (HS-432A) to west, parallel to Entrance Drive	Fair	Contributing
Stone and Concrete Culvert (1934)	Extends under Entrance Drive, just north of Entrance Building (HS-432).	Fair to Good	Contributing
Electrical Box	On east side of south wall, just south of drainage ditch	Good	Non-contributing
Power Line	Public line, extended from Entrance Building (HS-432) to Maintenance Area, to cabins to Dining Lodge (HS-422) from outside source. Transformers remain at Main Parking Area (HS-714) for the Museum (HS-420) / Dining Lodge.	Good	Non-contributing
Museum			
Feature	Description	Condition	"Contributing / Non-Contributing"

Figure 3-58. Entrance Portal Walls (HS-432A). (Mundus Bishop 2015)

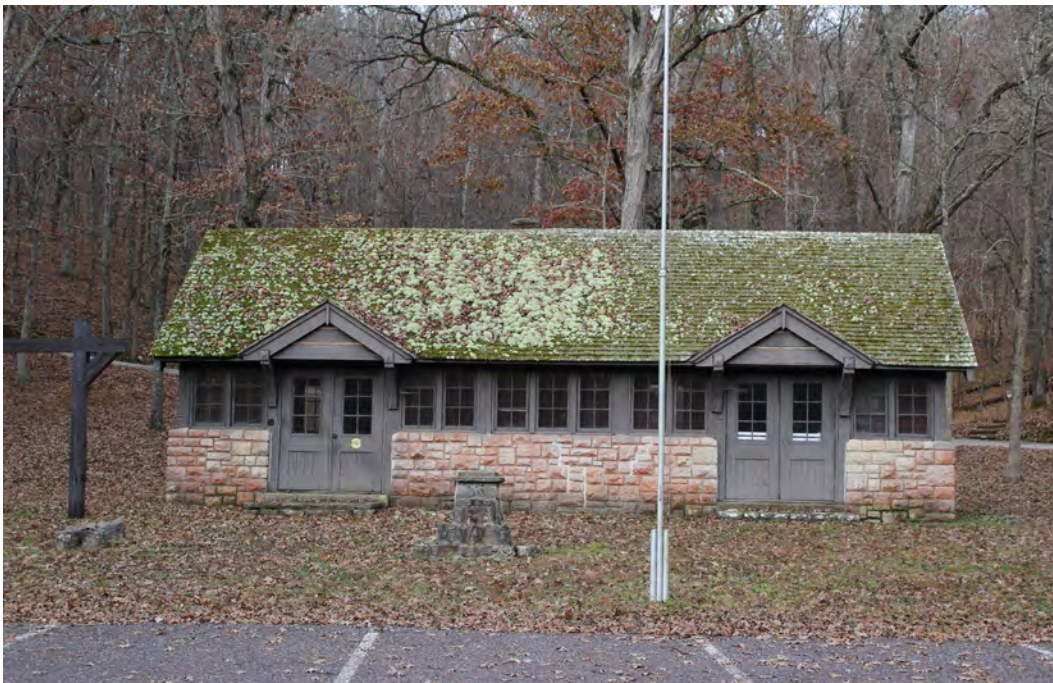
Museum			
Feature	Description	Condition	"Contributing / Non-Contributing"
State Park Museum Building (HS-420) (1936)	Single story two room gabled building, 18'x 42' with a 9'x18' extension, with oak half-timber framing and coursed stone infill and gable pediments on curved brackets. Interior has concrete floor, exposed ceiling construction, and ribbon windows of 6-light casements. Entrances have stone thresholds, 58" x 77" in size, and 9" step.	Good to Fair	Contributing
Pump House (HS-443) (1936)	Single story structure, 10' x12' one room building with a 5'x10' coursed cut stone porch, built with half-timber framing with irregular coursed cut stone infill, an asymmetrical gable roof with cedar shingles, and concrete floor.	Good	Contributing

Figure 3-64. Museum (HS-420). (Mundus Bishop 2015)

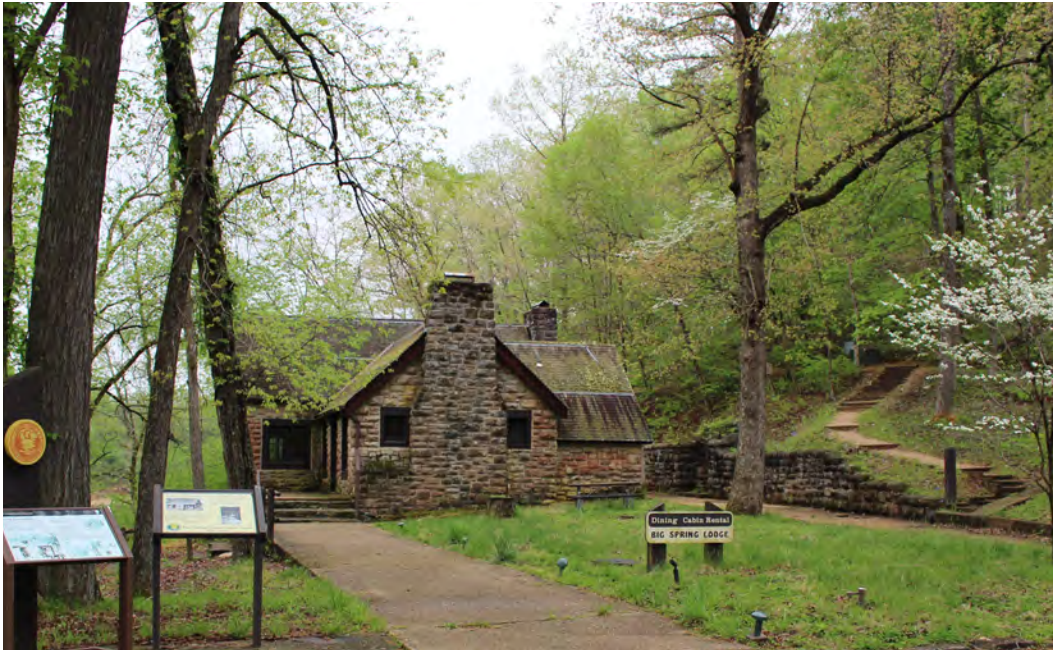
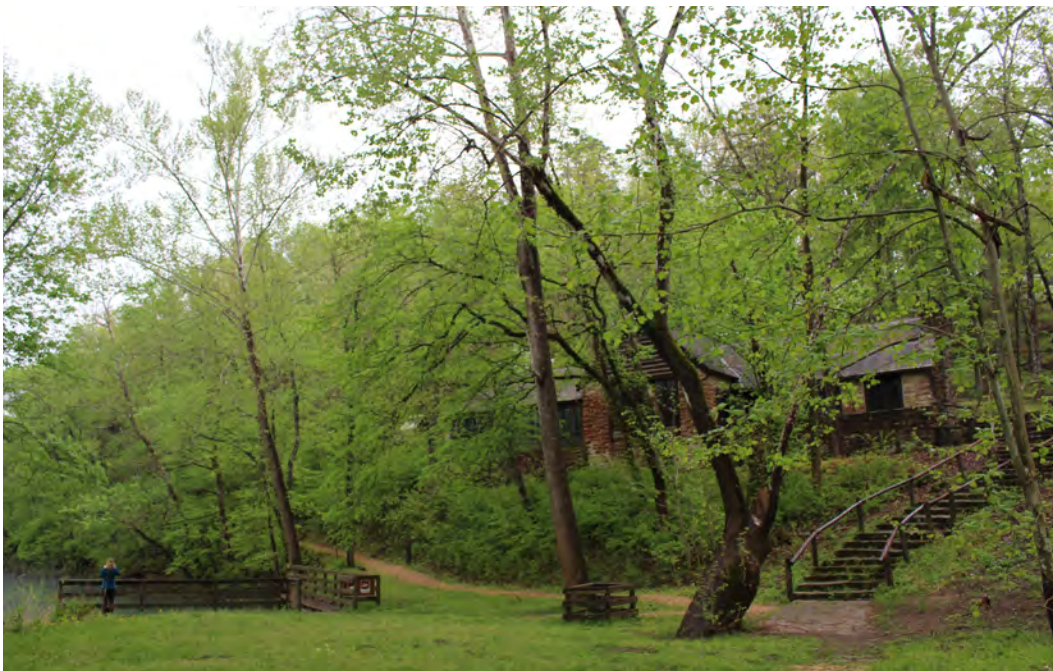
Dining Lodge			
Feature	Description	Condition	"Contributing / Non-Contributing"
Dining Lodge (HS-422) (1934 to 1936) and Help's Quarters	Single story, Rustic style cross-gabled building, 31'x 122' in size, with half-timber and coursed stone masonry walls and logs in the gable ends. Building has two porches, massive exterior stone chimney. Windows throughout are 6-light casements with 4-light transoms. Large stone terrace on south end has concrete overlay, and is building entrance, with low stone wall and three (3) stone masonry steps with concrete overlay and uneven riser heights.	Good to Fair	Contributing
Dining Lodge Retaining Wall and Fountain (HS-422A) (1936)	130' long retaining wall ranging in height from 8'-6" to 10'-6," wall steps to grade on south end. Built of cut stone set in irregular courses, wall creates the service courtyard. At the building, the wall is stepped back and raised with a circular fountain set in front.	Good to Fair	Contributing

Figure 3-67. The Dining Lodge (HS-422). (Mundus Bishop 2016)

Figure 3-68. Dining Lodge (HS-422). (Mundus Bishop 2016)
