## OLD MICHIGAN ISLAND LIGHTHOUSE

### Chronology of Alterations and Use

1 *Old Michigan Island Lighthouse Photographs, 2009*

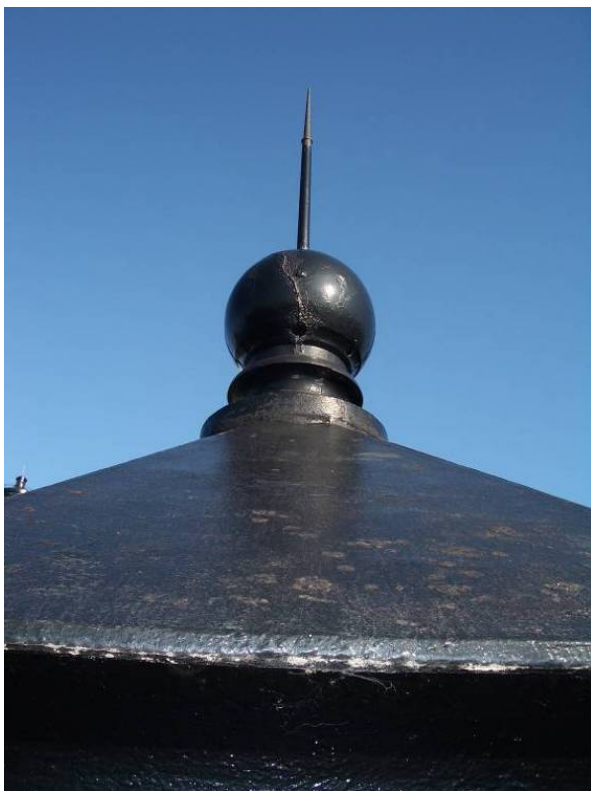
Rust-jacking is causing the roof panels of the lantern to separate. Further investigation is required to determine the extent of the corrosion to the cast iron panels and/or the fasteners. Sealants and coatings should be used to protect the cast iron from further deterioration. The extent of the damage should be checked at least annually and corrective action taken if the damage continues.

1  
2 *MI-OLH-38: Lantern roof (Source: A&A IMGP2760)*  
3

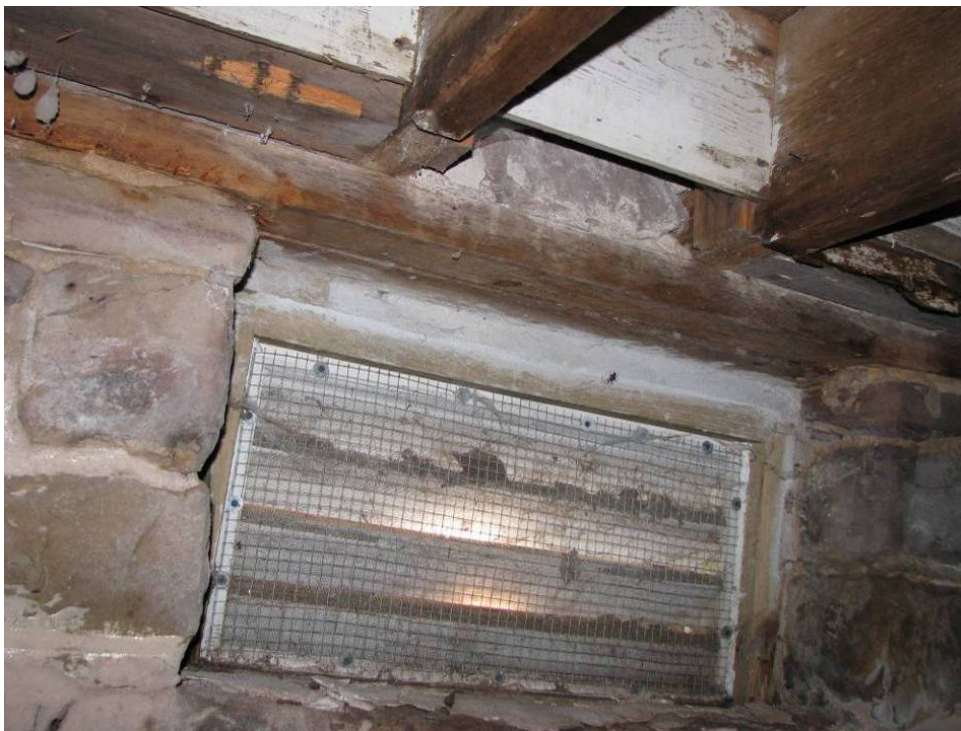
MI-OLH-43: Joist header above basement window (Source: Martin/Martin)

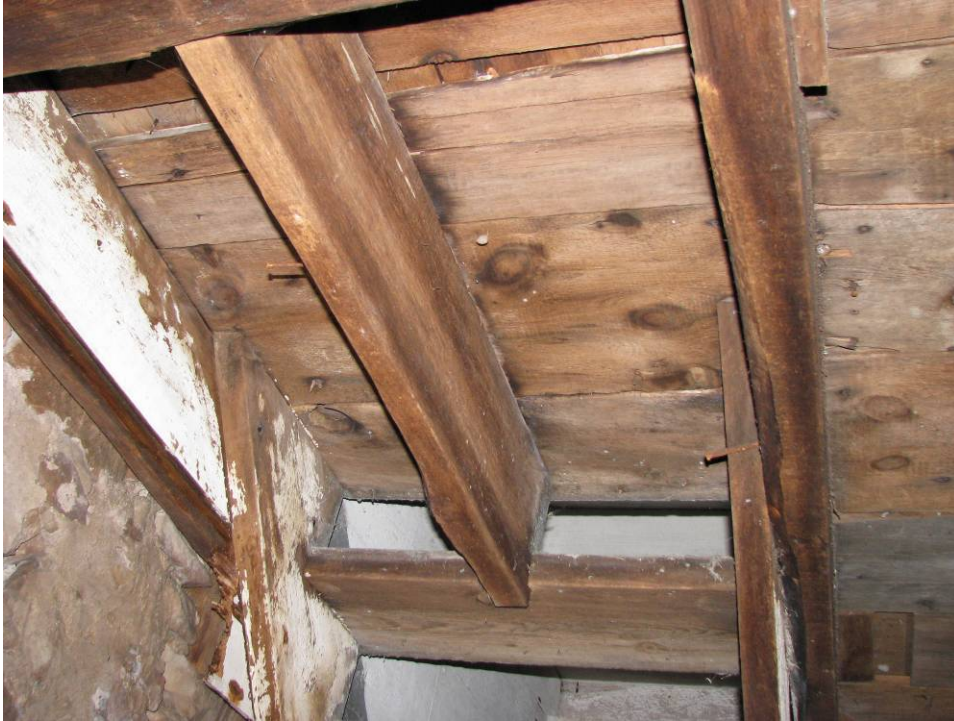
MI-OLH-44: Joists at stair (Source: Martin/Martin)

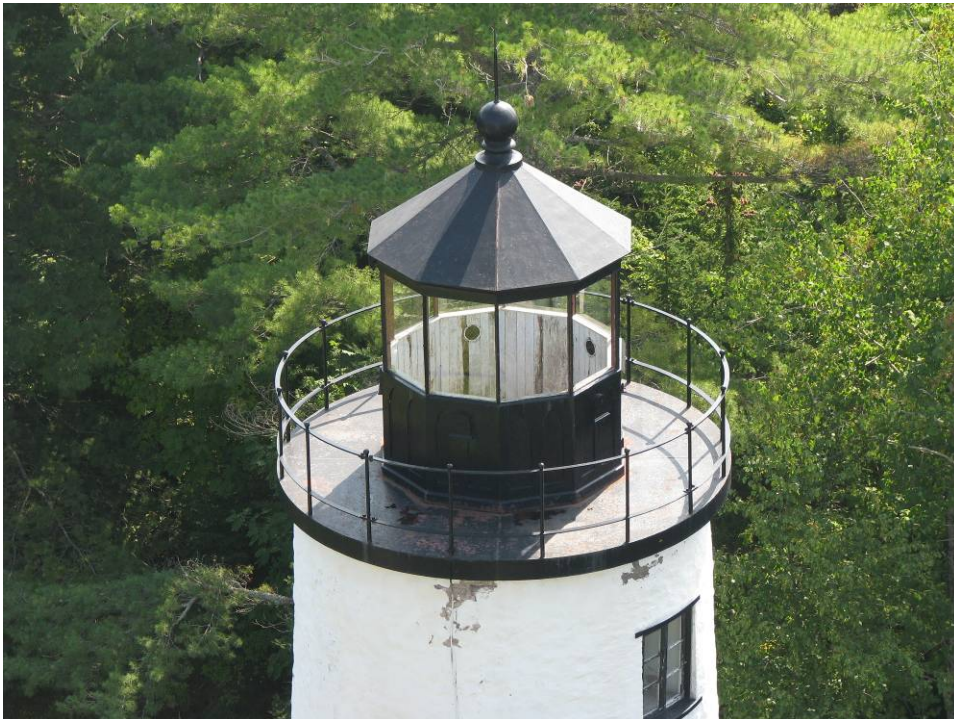
MI-OLH-45: Sealed joints in roof (Source: Martin/Martin)

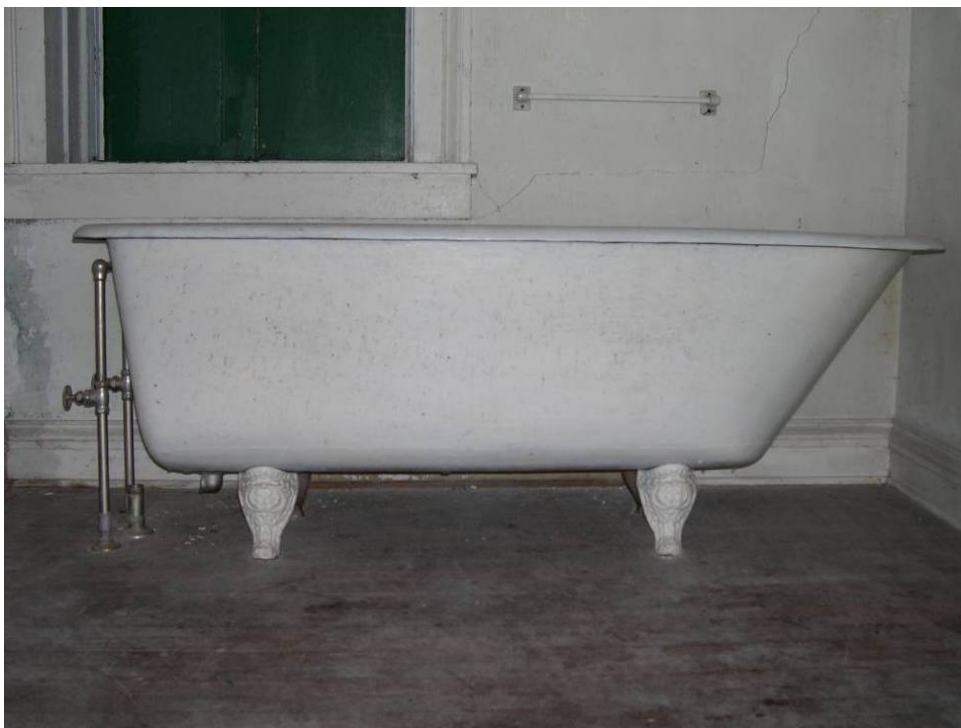
The existing plumbing fixtures and plumbing piping are no longer functional and are inconsistent with pre-1928 target time period. It is recommended that the plumbing fixtures and piping be removed. The clay sewer pipe serving the building should be capped below grade.

MI-OLH-46: Cast iron bathtub in watch room/bath (Source: RMH)

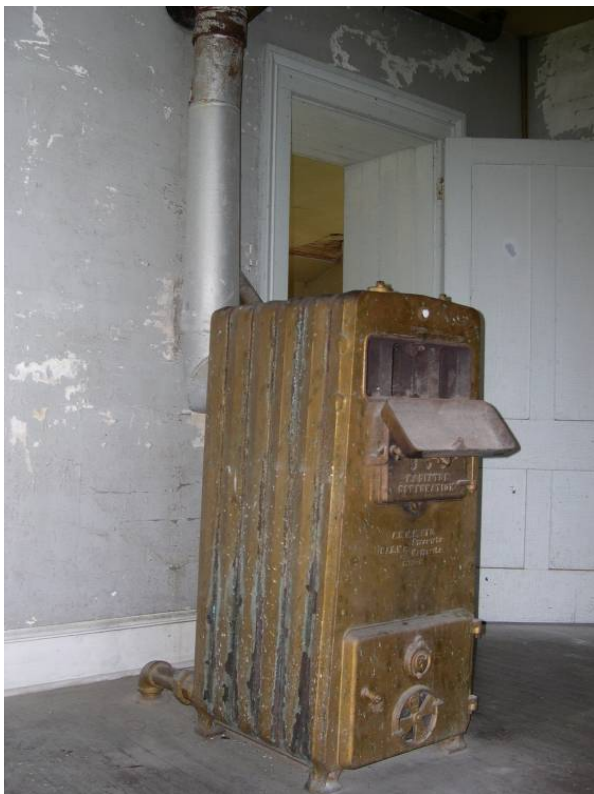
The existing heating system consisting of a cast iron boiler, piping, and radiators are no longer functional and are inconsistent with pre-1929 target time period. It is recommended that the heating system and all associated components be removed.

MI-OLH-47: "Contento" Boiler in living room (Source: RMH)
