CULTURAL LANDSCAPE REPORT • HISTORIC STRUCTURE REPORT

APOSTLE ISLANDS NATIONAL LAKESHORE
LIGHT STATIONS OF MICHIGAN ISLAND, OUTER ISLAND, DEVILS ISLAND,
LONG ISLAND AND SAND ISLAND
VOLUME III

100% DRAFT
MARCH 2011

VOLUME III OF VI: OUTER ISLAND CLR/HSR

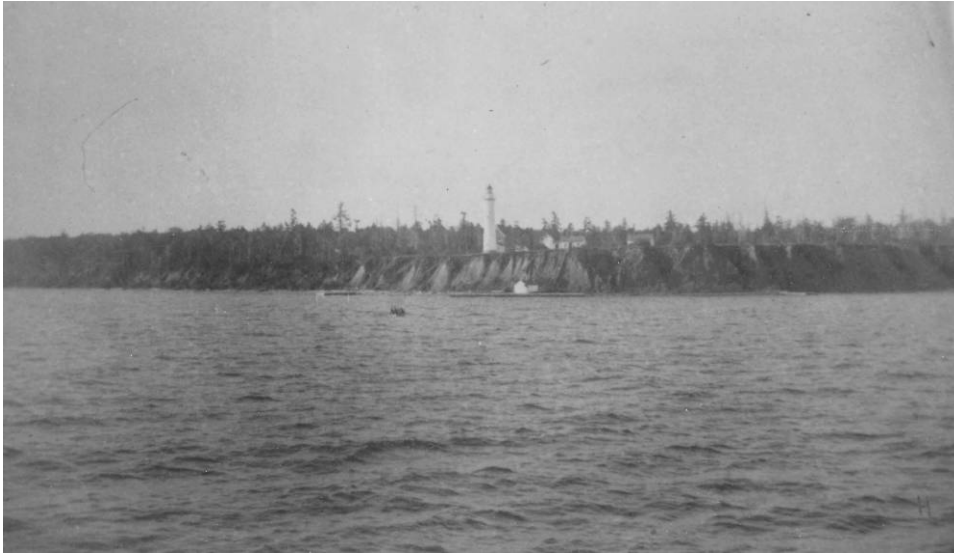
Views and vistas are an important contributing feature to the cultural landscape of the Outer Island Light Station. The loss of these diminishes the integrity of the light station.

Site Image OI-33: View to Tower from Lake Superior; above, 1891 (Source: NPS APIS Archives); below, current view obscured by encroaching vegetation, 2009 (Source: MBD P1010831.JPG)

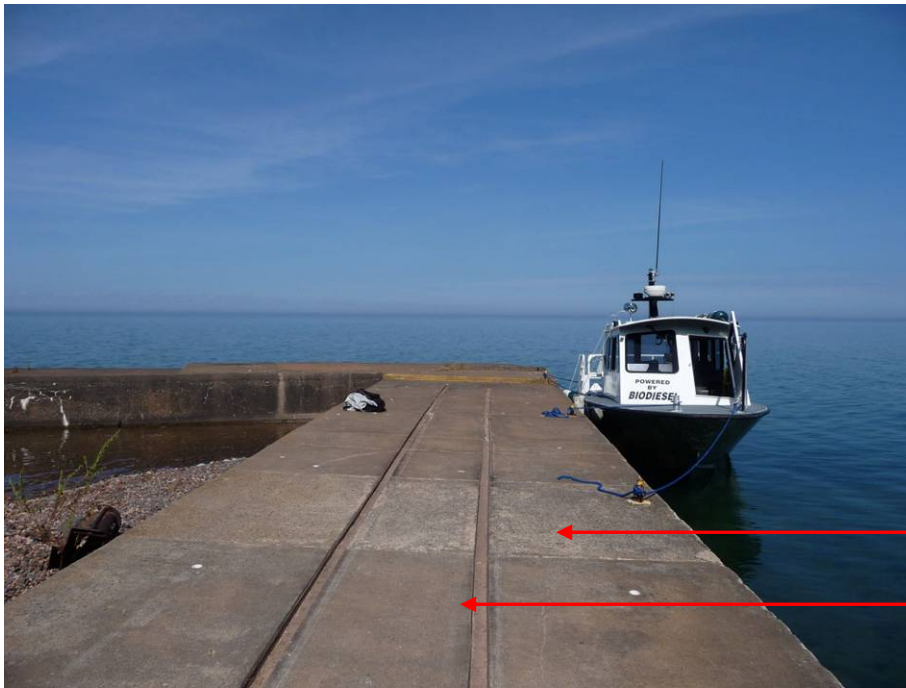
Feature	Site Image #	Description	Condition	Contributing? /Rationale
Boat Dock (c. 1958)	OI-39, OI-40	see above	Good	Contributing
Tramway (c. 1934)	OI-41, OI-42, OI-43	see above	Good	Contributing
Tram Tracks (c. 1934)	OI-39, OI-42, OI-44	see above	Good	Contributing
NPS Vault Toilet (1970–2009)		NPS wood-framed Vault Toilet	Good	Noncontributing – contemporary Compatible
Remnant Cabin		A remnant cabin exists in the forest east of the Light Tower and Keepers Quarters

Site Image OI-39: Concrete boat dock viewed from the south, tram tracks in center, 2009 (Source: MBD P1010860.JPG)

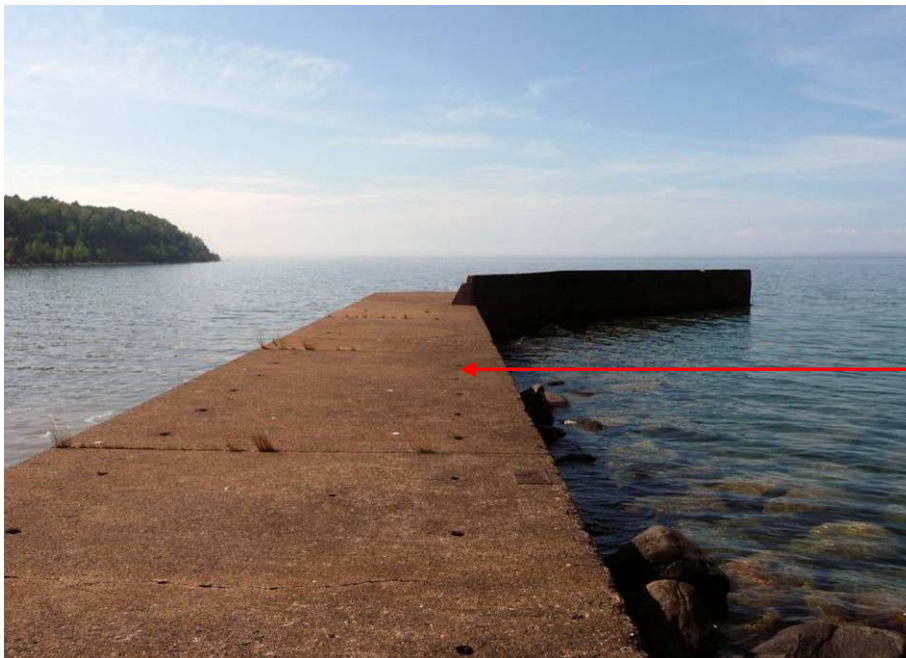
Site Image OI-40: Western portion of concrete boat dock, viewed from the east, 2009 (Source: MBD P1010863.JPG)

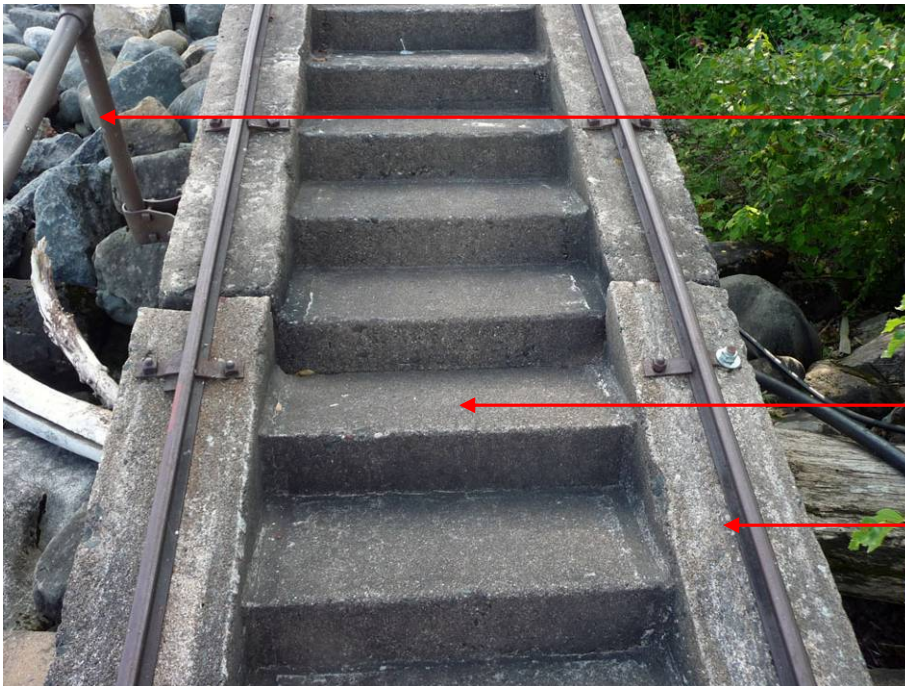
The tramway is in good condition and retains all of its original elements including: concrete structural supports with footings and stairs, steel handrail, and cast iron tram rails.

Site Image OI-42: Tramway steps and tram tracks, 2009 (Source: MBD P1010868.JPG)

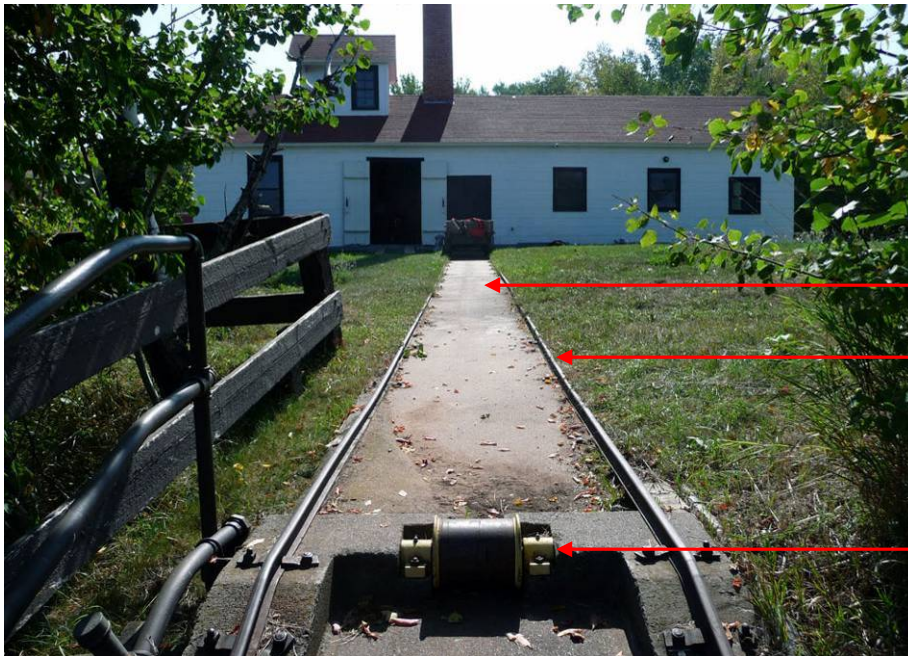
Site Image OI-43: Tramway concrete footing, 2009 (Source: MBD P1010844.JPG)
