Small Scale Features

| TITLE OF PROJECT CULTURAL LANDSCAPE REPORT | |
| TITLE OF DRAWING EXISTING CONDITIONS | |

| UNITED STATES DEPARTMENT OF THE INTERIOR | | OUTER ISLAND LIGHT STATION | |

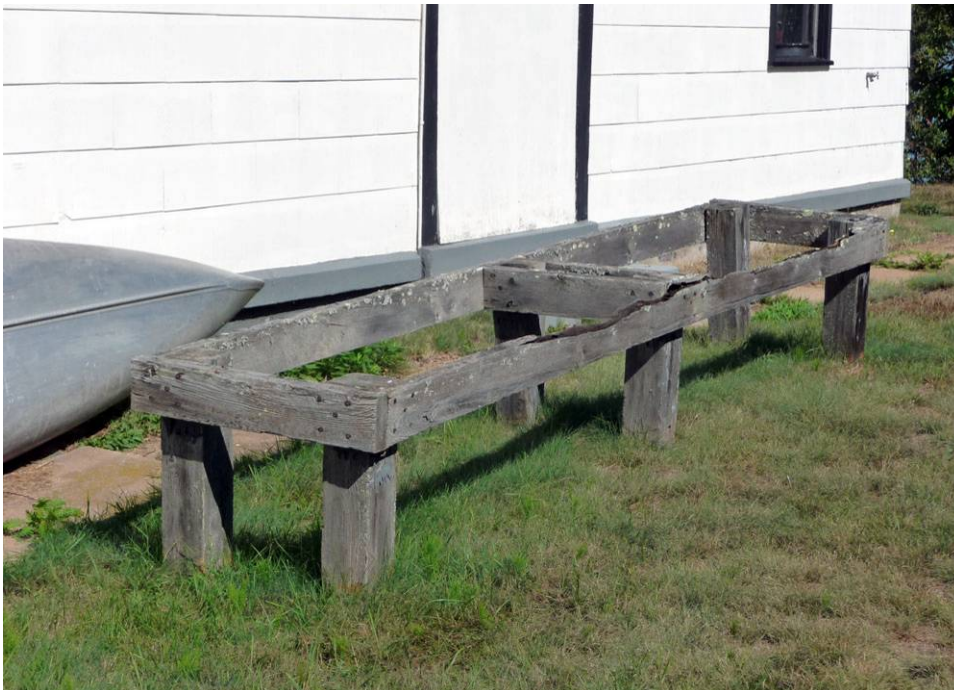
Site Image OI-57: Concrete foundation and wall, 2009 (Source: MBD P1010925.JPG)

| Feature | Site Image # | Description | Condition | Contributing? /Rationale |
|--|---|---|---|--|
| Concrete Foundation and Wall (1901-1938) | OI-57 | 12' x 12' concrete foundation, 1' tall, 6" wide and (2) 2.5' tall, 6' long, 1' wide walls west of Fog Signal Building. Wood planks sit atop the walls. Historic photographs indicate this area was used for chopped wood and oil storage. | Concrete: Good Wood: Poor | Contributing; Historic photographs indicate this area was present during the Light Station period and modified during the Coast Guard Period |

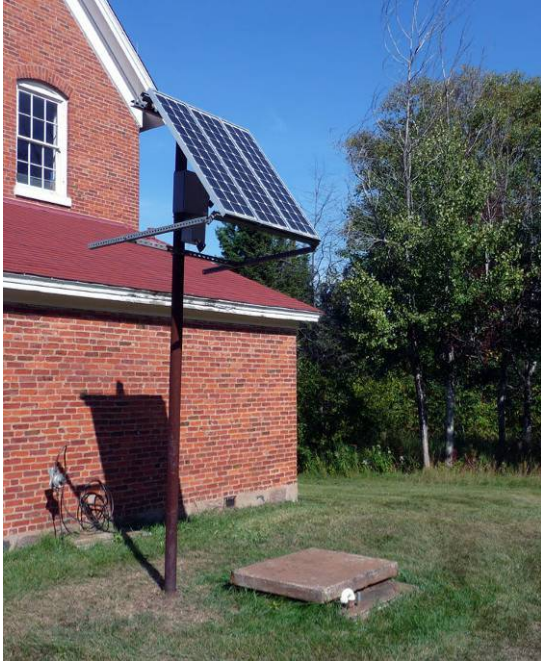
| Feature | Site Image # | Description | Condition | Contributing? /Rationale |
|---|---|--|---|--|
| Concrete Footing (date unknown) | OI-60, OI-63 | Circular concrete footing with 2' diameter. | Good | Noncontributing, safety hazard |

Site Image OI-60: Solar panel and fiberglass battery storage unit at the south side of the Keepers Quarters, wood planks at right, and concrete footing in foreground, 2009 (Source: MBD P1010960.JPG)

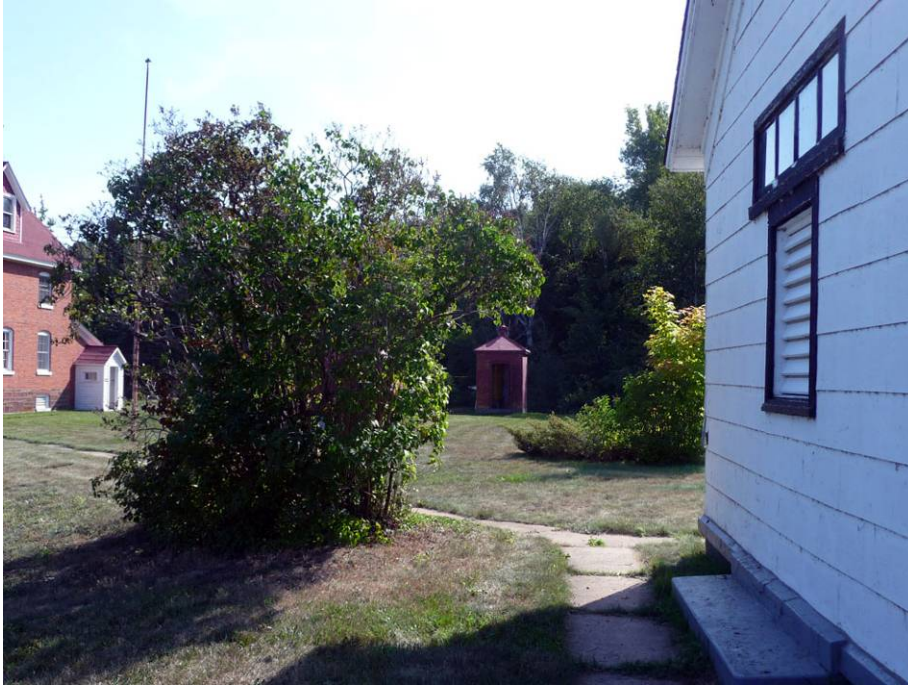
Site Image OI-72: Lilac near Fog Signal Building, 2009 (Source: MBD P1010933.JPG)

| Feature | Site Image # | Description | Condition | Contributing? /Rationale |
|---|---|---|---|---|
| Lilac at Fog Signal Building | OI-72 | Lilac near southeast corner of Fog Signal Building | Good | Contributing; See text |
