Small Scale Features

LaPointe Site

LONG ISLAND LIGHT STATION CLR TREATMENT

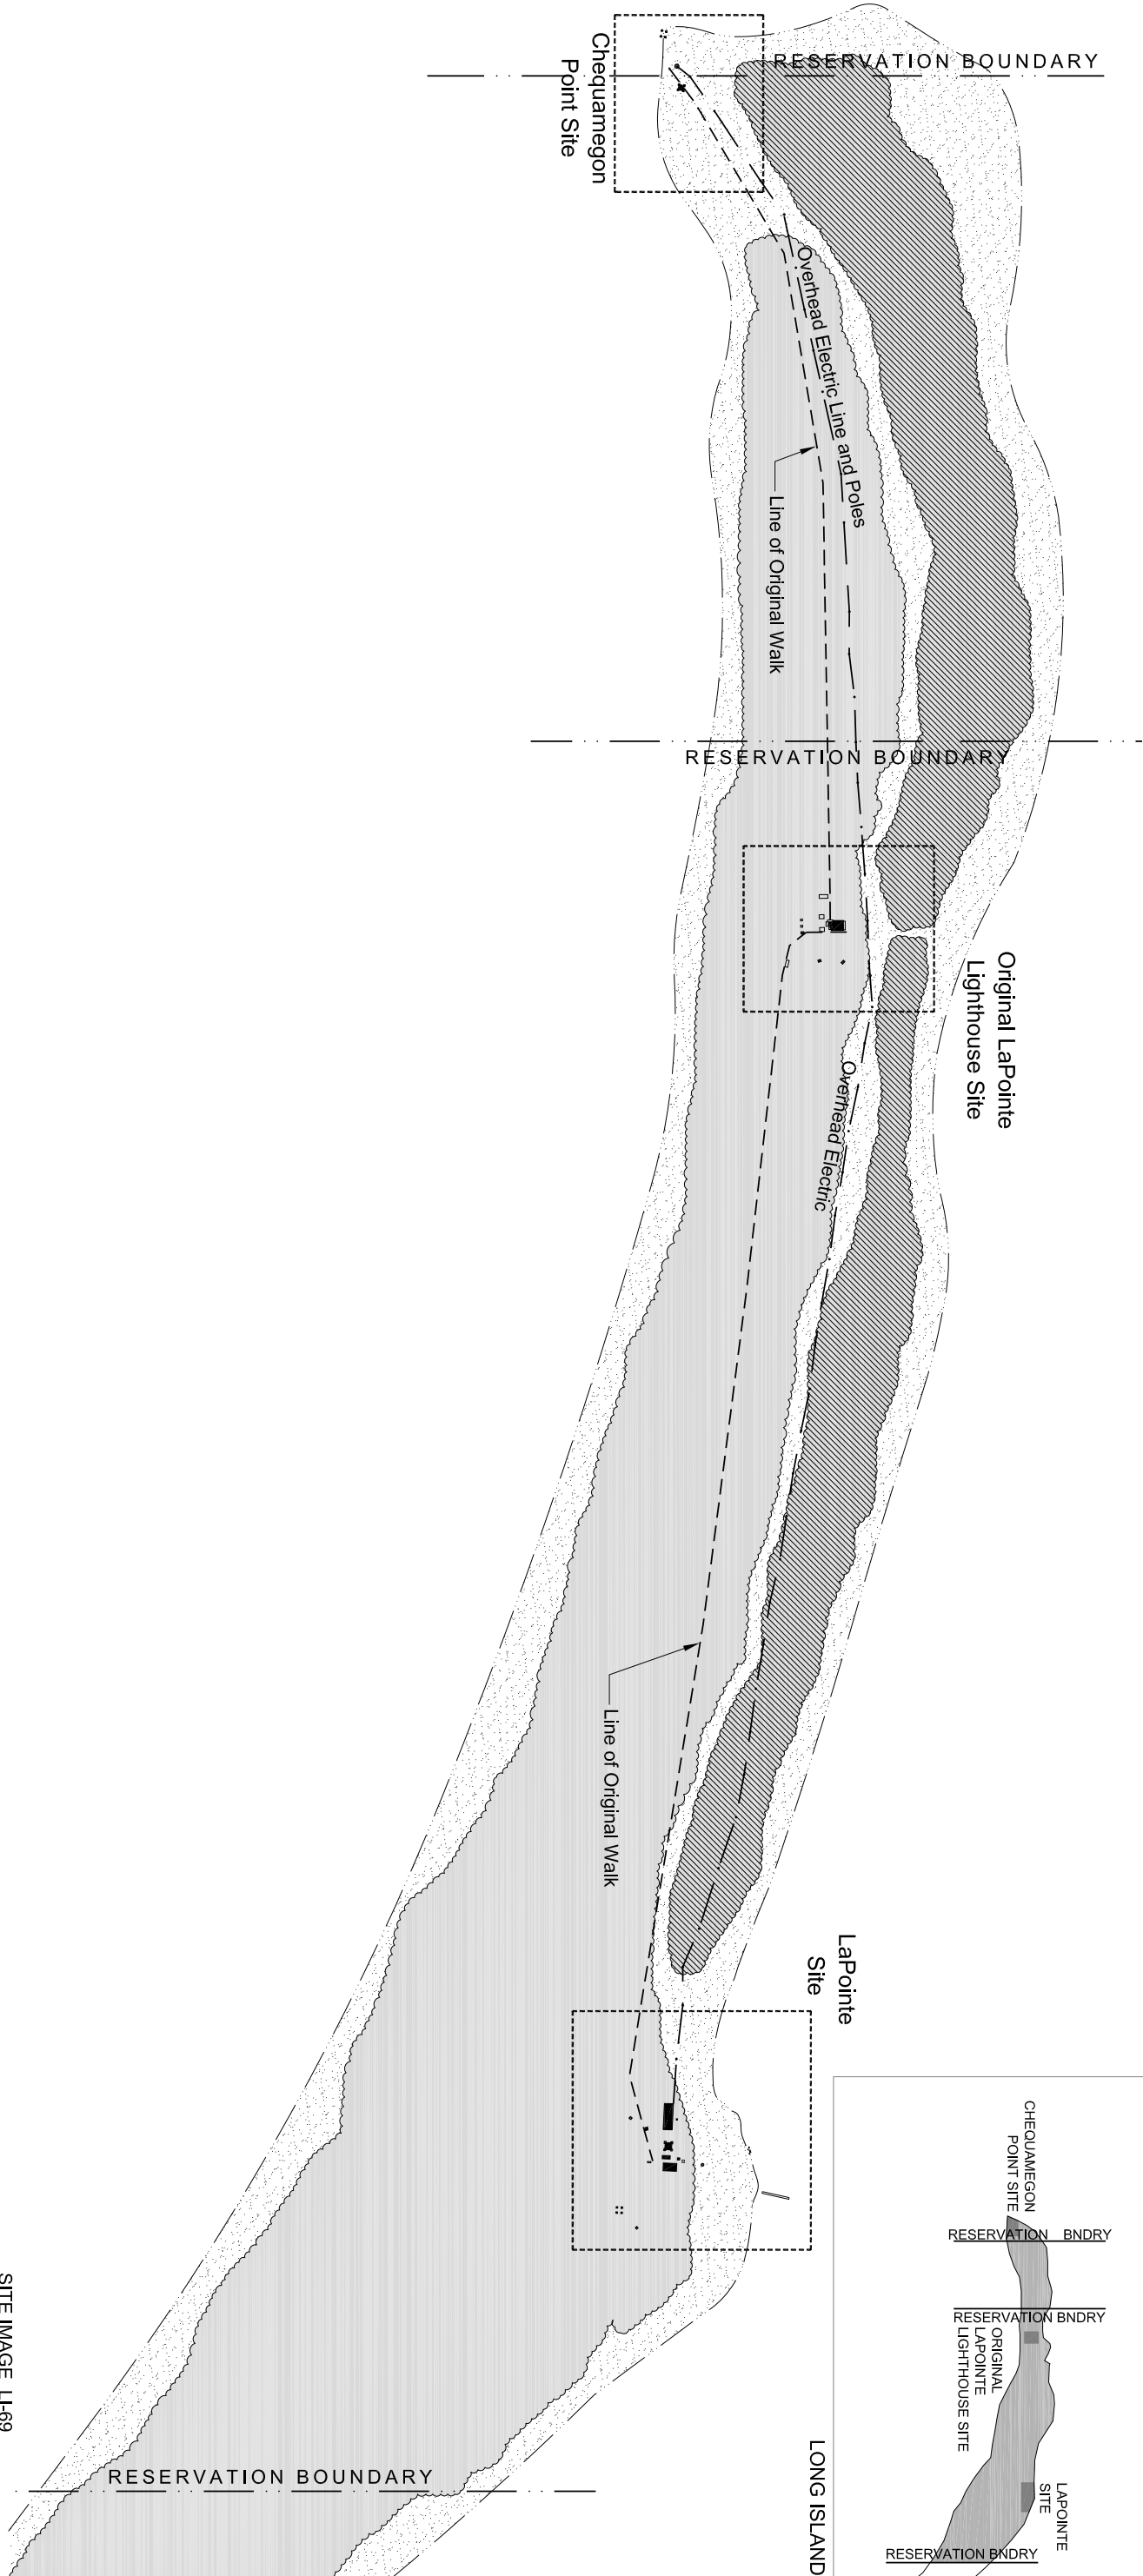
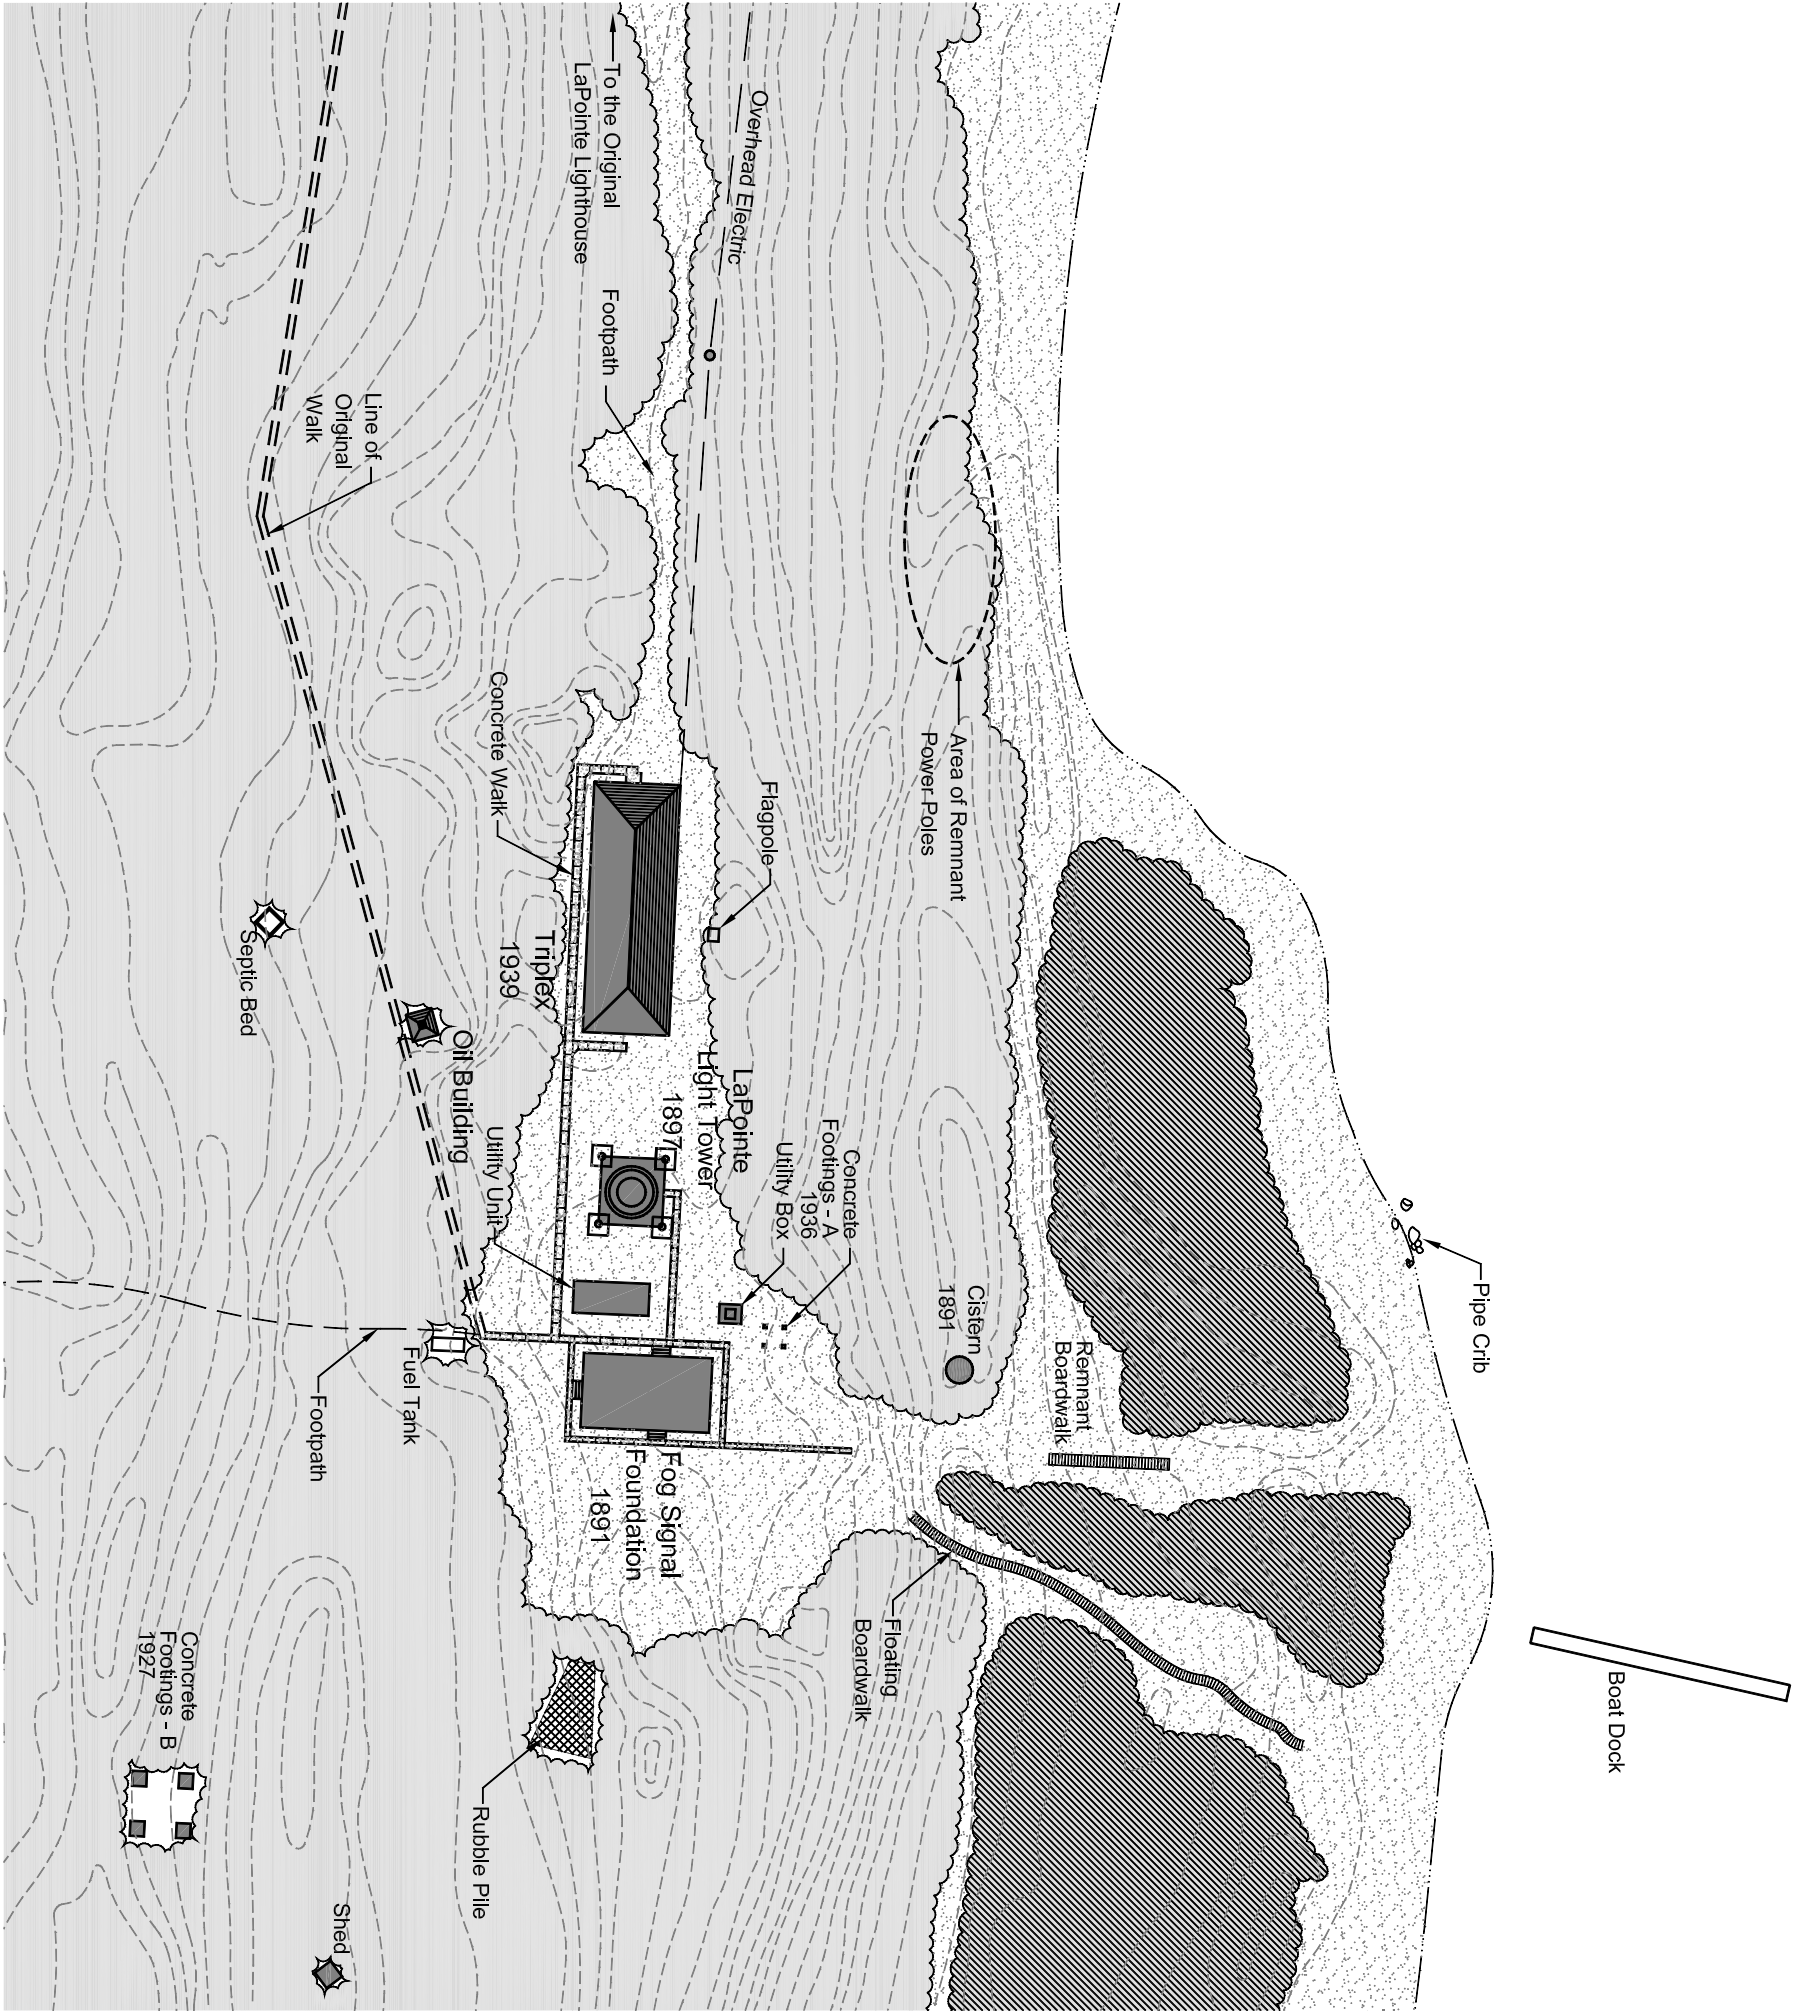
TITLE OF PROJECT CULTURAL LANDSCAPE REPORT	
TITLE OF DRAWING EXISTING CONDITIONS	
UNITED STATES DEPARTMENT OF THE INTERIOR APOSTLE ISLANDS NATIONAL LAKESHORE	LONG ISLAND - RESERVATION BOUNDARY NAME OF PARK APOSTLE ISLANDS NATIONAL LAKESHORE REGION MIDWEST COUNTY ASHLAND STATE WISCONSIN

The vegetation features, primarily related to the cleared area at the LaPointe and Original LaPointe Lighthouse sites are in poor condition. The vegetation features at Chequamegon Point are in good condition.

The cleared area of the light station sites are an important contributing feature. The relationship between the extent of the cleared area and forest vegetation on the reservation has changed significantly since the period of significance. The extensive encroachment of forest vegetation diminishes the integrity of the cultural landscape.
