TRIPLEX

Chronology of Alterations and Use

1 *Triplex Photographs, 2009*

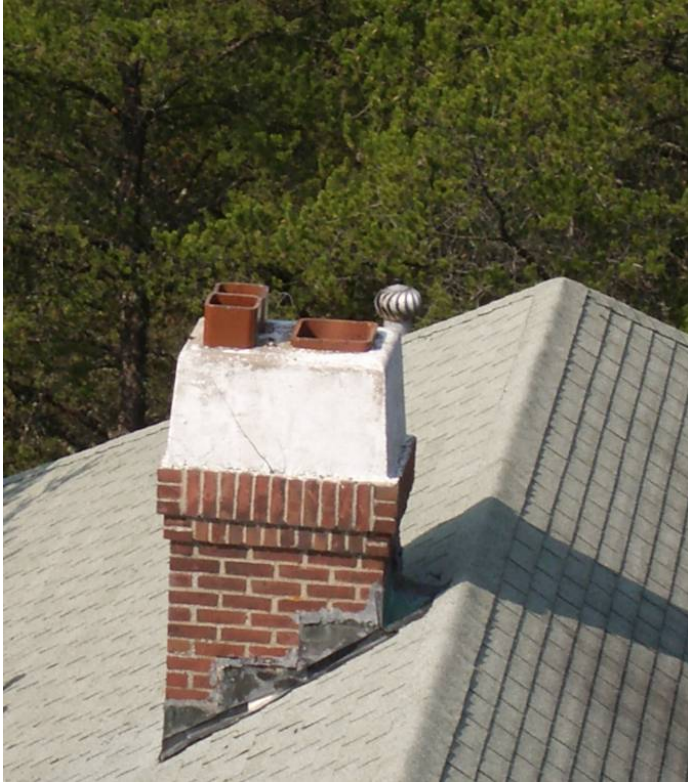
LI-TX-06: Chimney, east elevation (Source: A&A IMGP2986)
