1 **Table SI-2: Vegetation**

1 *Vegetation Photographs*

SAND ISLAND CLR TREATMENT

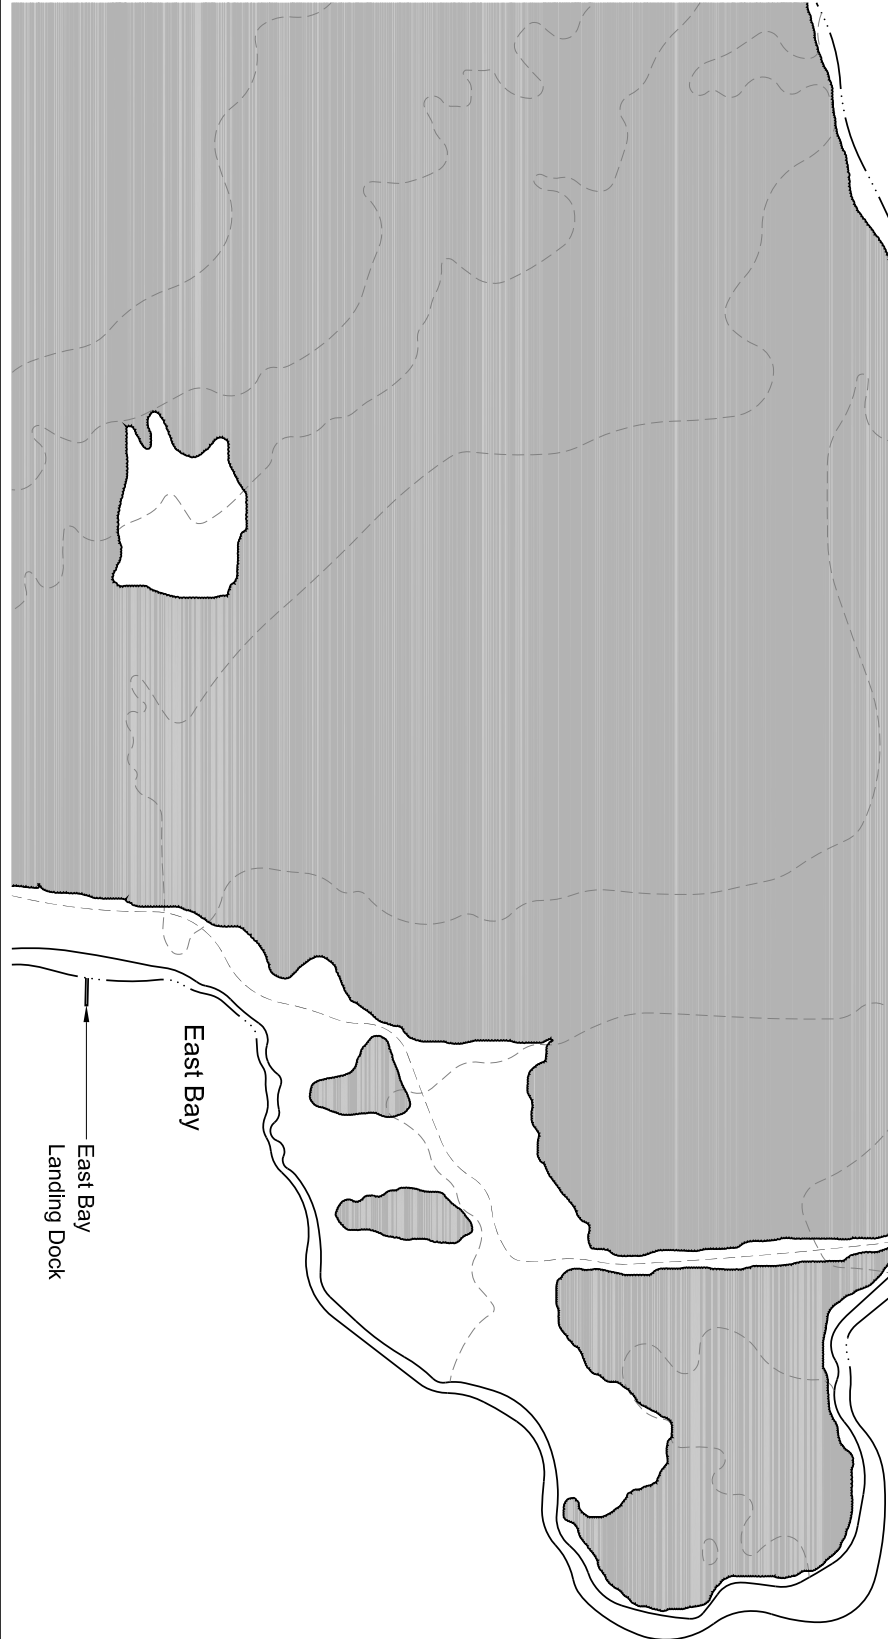
Analysis: Reservation. Historic drawings and photographs indicate that a larger cleared area existed on the north edge of the reservation than that which exists today. The cleared area has continued to reduce from approximately 3.7 acres at the end of the period of significance to approximately 1.8 acres in 2009. During the Light Station period the light station grounds were maintained as low vegetation. The original larger clearing provided the necessary openness to allow for the light to be seen from Lake Superior. The clearing also provided a protected area south of the Light Station Quarters for livestock and a garden. The area south of the Light Station Quarters was maintained as an open clearing and contained a fenced garden area and two sheds. Today, the majority of this clearing has been filled by encroaching forest and the garden area is nonextant. Clearing work done during the NPS period has reduced the amount of forest encroachment from its peak in the 1960s. Brush piles remain from this work. The cleared area of the light station is a contributing feature. The relationship between the extent of the cleared area and forest vegetation on the reservation has changed since the period of significance. Vegetation in the former boathouse area has also encroached into the historic clearing at that location. The extensive encroachment of forest vegetation diminishes the integrity of the light station.

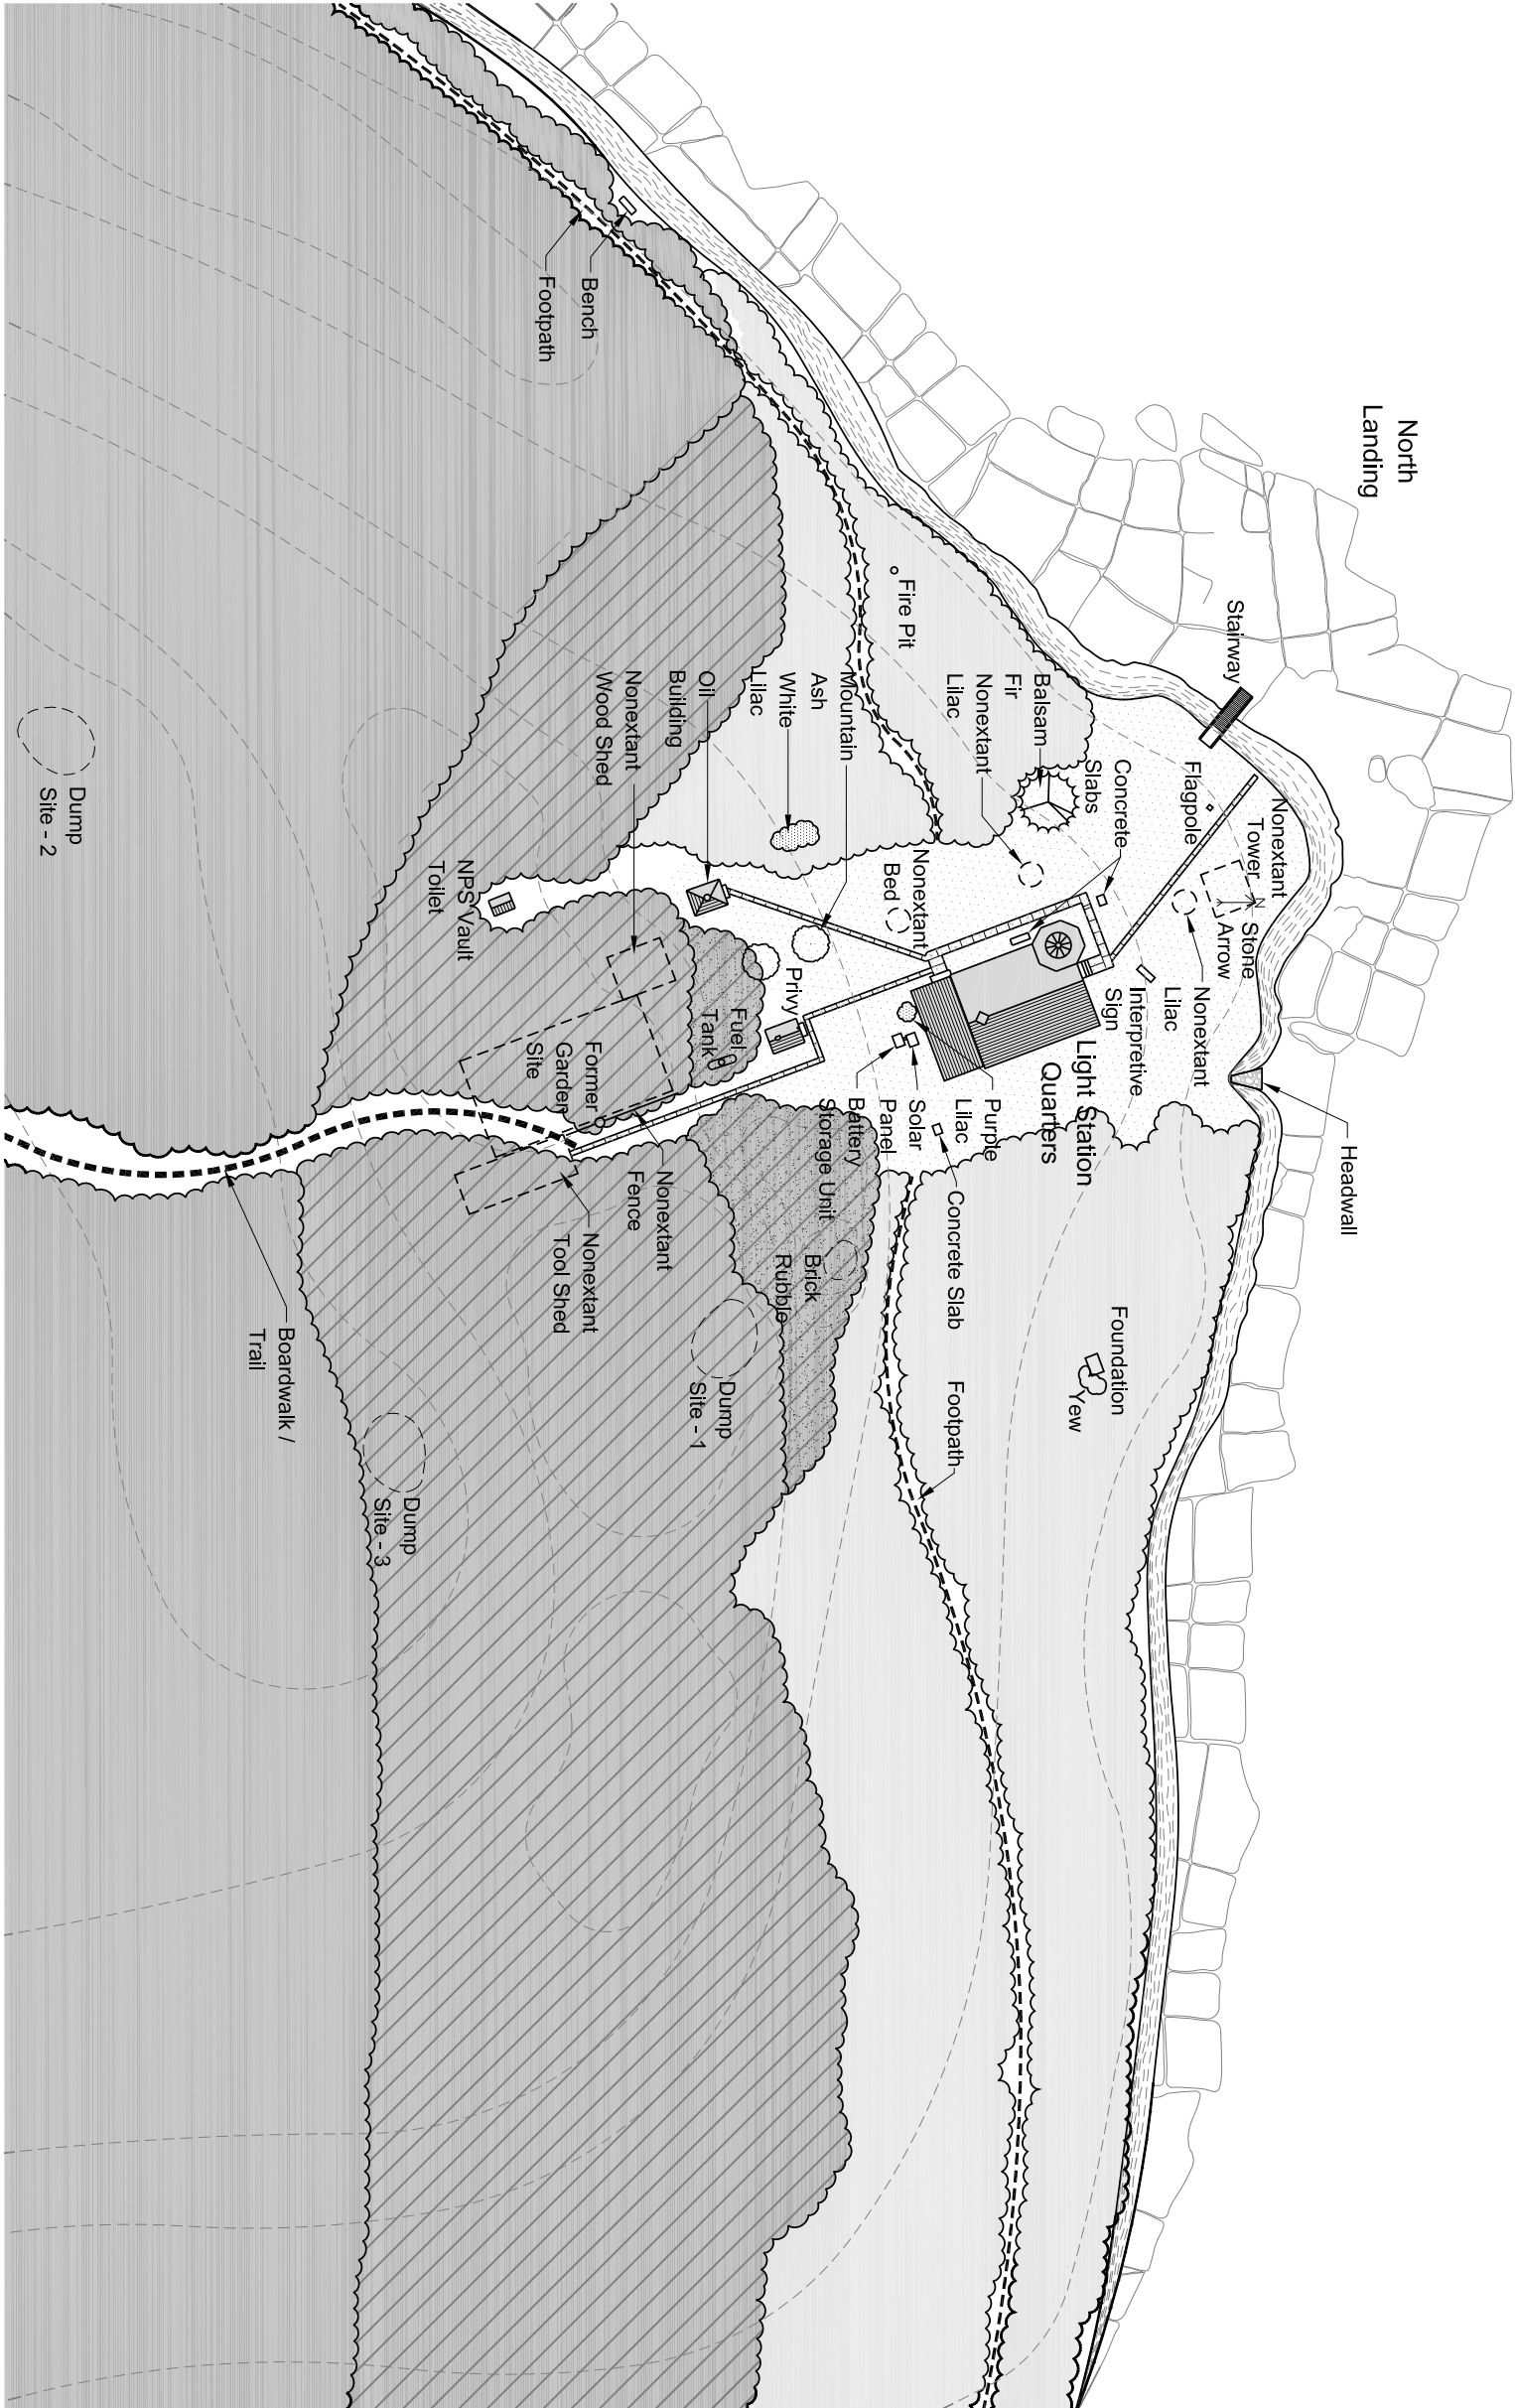
SITE IMAGE SI-65

The condition of the vegetation on the light station grounds is fair. The cleared area of the light station is in poor condition.
