**CONDITION ASSESSMENT
OF MAIN STRUCTURAL
MEMBERS OF**

WAPAMA

- *A Historic Steam Schooner*

February 2006
Project No. 187-6530
NRRI/TR-2006/03

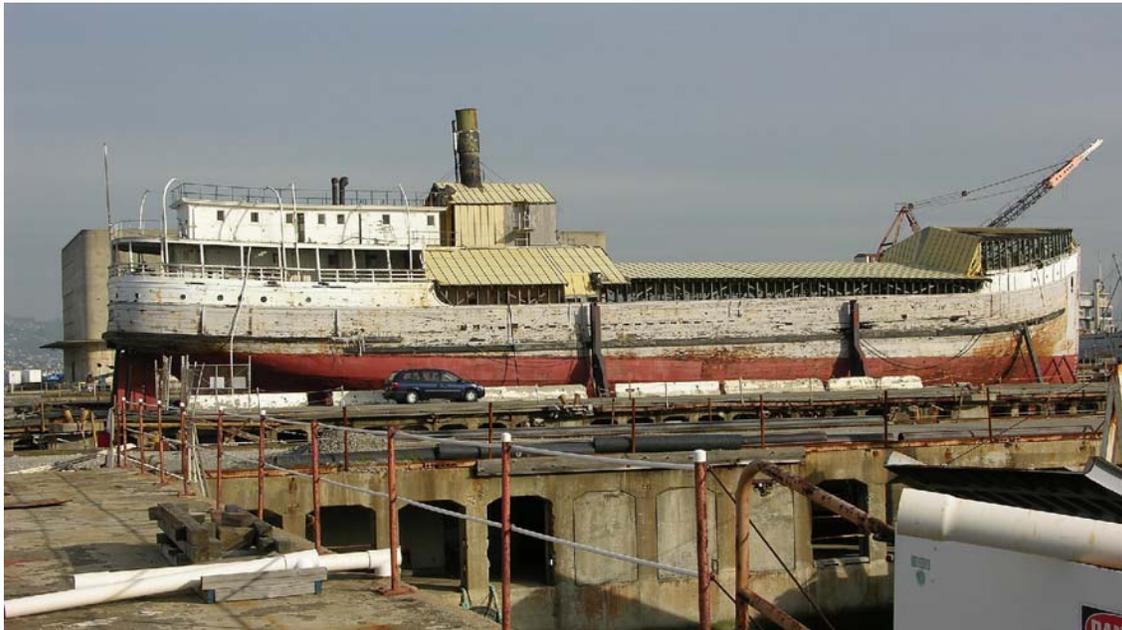
In 1980, the vessel can no longer remain afloat due to severe deterioration and was hauled out of water and placed on Barge 214, berthed at Pacific Drydock Co., Alameda. Since that time she has remained on the barge and received limited maintenance. Currently, the vessel resides on Barge 214 in a flooded graving dock at the Richmond Reserve Shipyard in Richmond, California and is unsafe for public access (Figure 2).

Figure 2. A recent photo of the WAPAMA placed on Barge 214 at Richmond Reserve Shipyard in Richmond, California (Photo taken on January 2006).

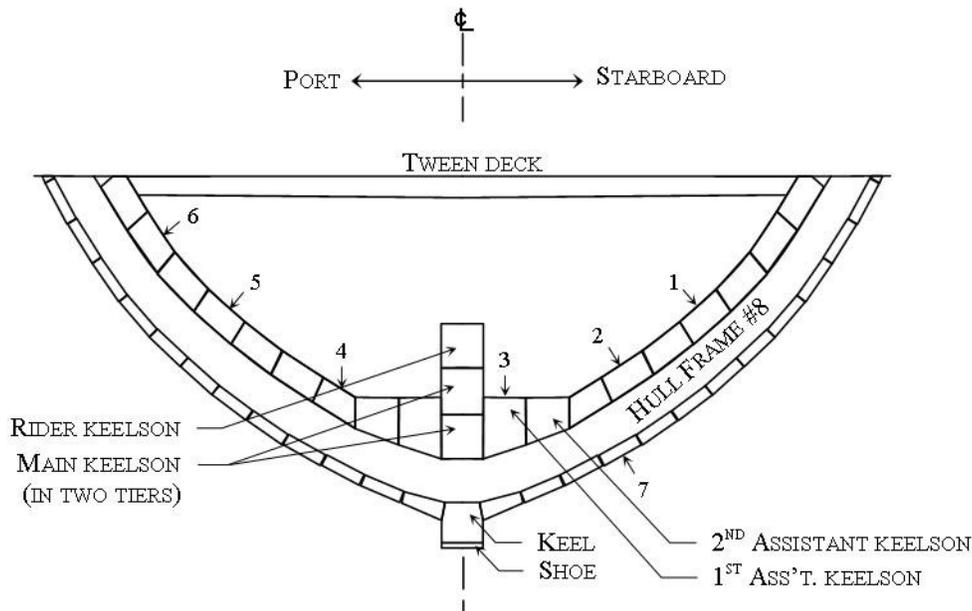
Figure 4. Schematic of drilling locations for the cross-section at frame 8.

A total of seven micro-drilling resistance measurements were collected from the hull assembly at frame 8 (Figure 4). Safety concerns limited our access to the smaller area underneath the tween deck, therefore no data was collected from tween deck beams. From the interior of the vessel, five micro-drilling locations penetrated downward through ceiling planks and a portion of the hull frame. One additional micro-drilling location penetrated into the first assistant keelson (starboard). From the exterior of the vessel, one micro drilling location on the starboard side penetrated upward through strake planks and a portion of the hull frame. The thickness of the interior ceiling and/or exterior strake planking varied and resulted in differing penetration levels into the main frame members.

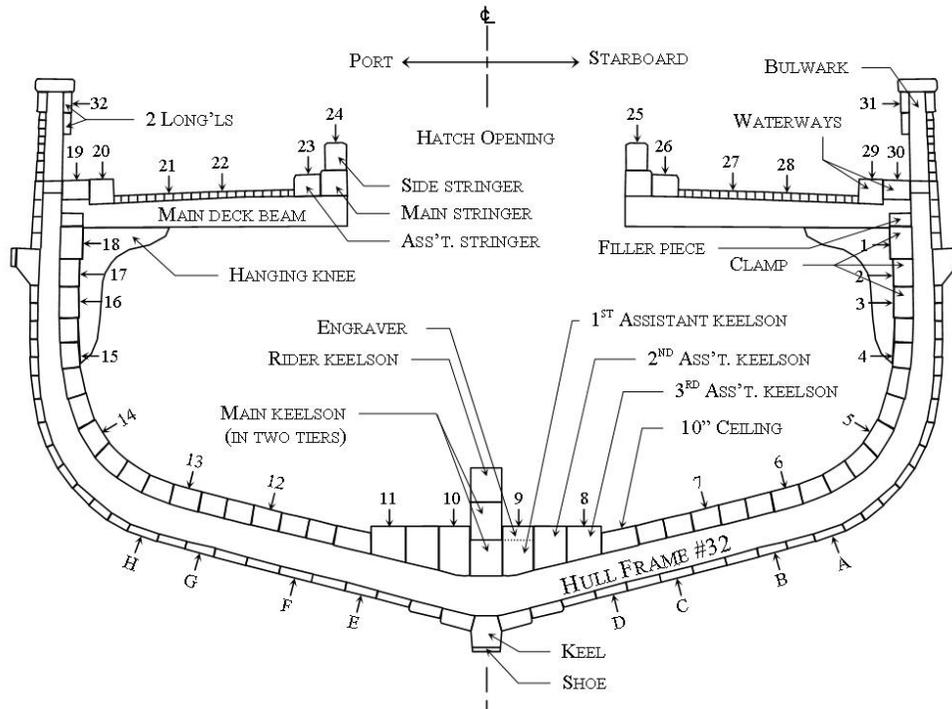
Figure 5. Schematic of drilling locations for the cross-section at frame 32.

A total of forty micro-drilling resistance measurements were collected from the hull assembly at frame 32 (Figure 5). Eighteen micro-drilling locations were from the interior portion of the hull assembly and penetrated into clamps, ceiling planks, and assistant keelson members. Fourteen micro-drilling locations were from topside of the main deck and penetrated into bulwarks, waterways, decking, stringers, and assistance stringers.

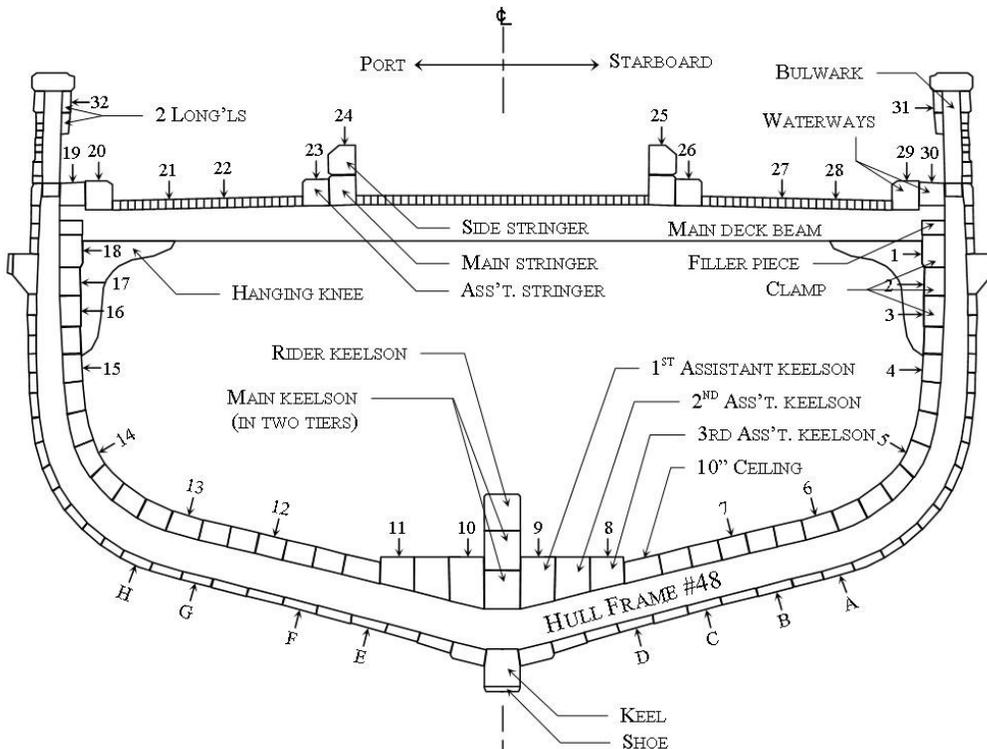
Figure 6. Schematic of drilling locations for the cross-section at frame 48.

A total of forty micro-drilling resistance measurements were collected from the hull assembly at frame 48 (Figure 6). Eighteen micro-drilling locations were from the interior portion of the hull assembly and penetrated into clamps, ceiling planks, and assistant

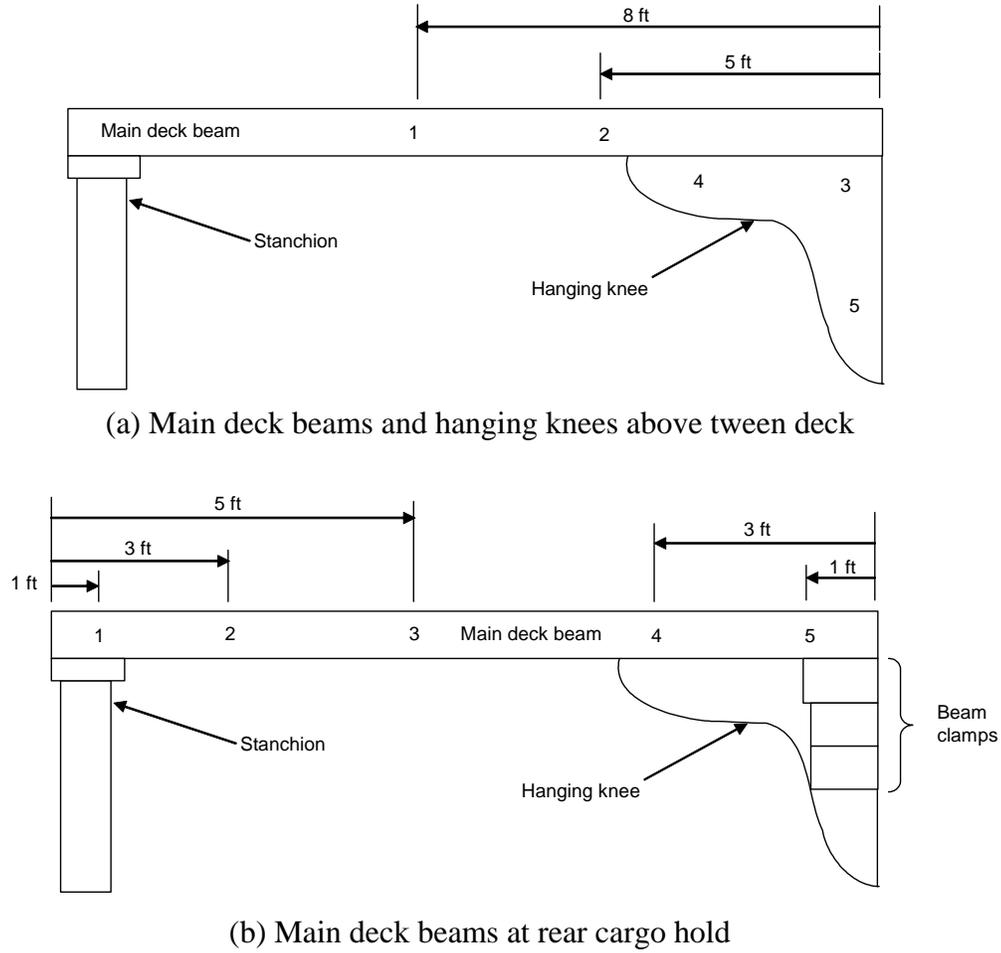
Figure 13. Stress wave testing locations for portside main deck beams.

Stress wave transmission data was collected from the main deck beams at two areas on the ship's portside (Figure 13). Five test locations were located in the main deck beams above the tween deck including some at the hanging knees (Figure 13a). Five test locations were also located in the rear cargo hold between the main hatch and the cabin deck (Figure 13b). A summary of the condition of the main deck beams is provided in Table 2 and Figure 14.

The condition of the main deck beams at rear cargo hold varied. Decay to severe decay is present at the beam ends over the stanchion for most beams. The exception is the deck beam located near hull frame 44 which is sound. At the beam ends near the outer hull frame, only the beam at hull frame 40 shows decay, the beams near frames 38 and 46 shows moderate decay and the beams near 42, 44, and 48 are generally sound. The condition of the main deck beams away from their supports is mostly sound with moderate deterioration detected at some beams. The main deck beam in the best condition is at hull frame 44. Severe deterioration was present only at the end support (over the stanchion) at hull frame 42.
