# SAGAMORE HILL LIGHTING MASTER PLAN

**John G. Waite Associates**  
New York, New York

21 January 2011

**FMS** **FISHER MARANTZ STONE**  
Partners in Architectural Lighting Design

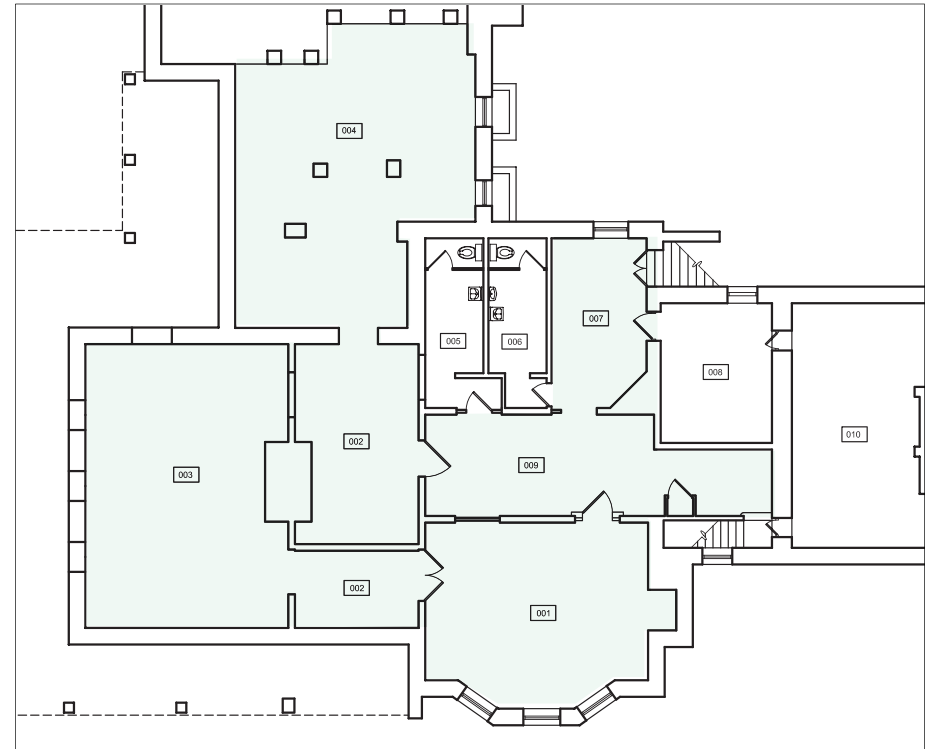
BASEMENT ENLARGED PLAN

1. Clean areas are generally lighted to an adequate level with surface mounted 1'x4' T8 fluorescent fixtures with wrap-around lenses.
2. Mechanical rooms are typically lighted with ceiling mounted sockets with incandescent A lamps and controlled locally.
3. It was noted that the interior house lights are time clock controlled but the manual override switch (used when entering the house after hours) is not conveniently located by the entry door forcing someone to walk thru darkness to get to the (override) light switch.

5. Our understanding is that the lighting override switch is located in the basement at the panels. It is recommended to have a switch or occupancy sensor located at the first floor entry door so someone would not need to negotiate through a dark house to get to the light switch.

1. It was noted that the house lighting timer override switch is not near the Basement entry door requiring one to negotiate through the dark to find the switch. A local switch more convenient to the entry is recommended.

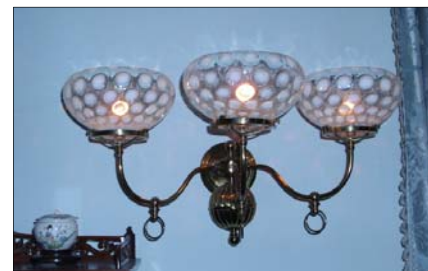
HISTORIC SCONCE

1. Light wall and white ceiling finishes, coupled with light colored furnishings and the tall windows on three sides makes this perhaps the best lighted room in the house.
2. The two x 3 head historic sconces also contribute to the overall bright impression of the room.
3. The sheer window treatments allow a maximum amount of daylight through the full height of the window into the room.
4. Awnings were still in place on the south facing window.

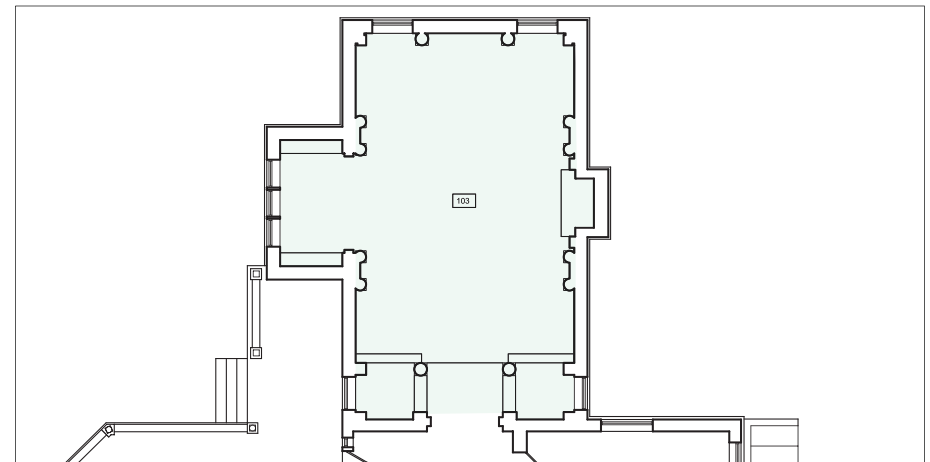
RM 103 NORTH ROOM ENLARGED PLAN

5. The large size of this room results in Visitors being a long distance from many of the objects and magnifies the problems caused by the high contrast, glare and low light levels.

6. There are three table lamps in the room that are good visual accents but add little illumination.
7. Awnings were still in place on the west facing windows.

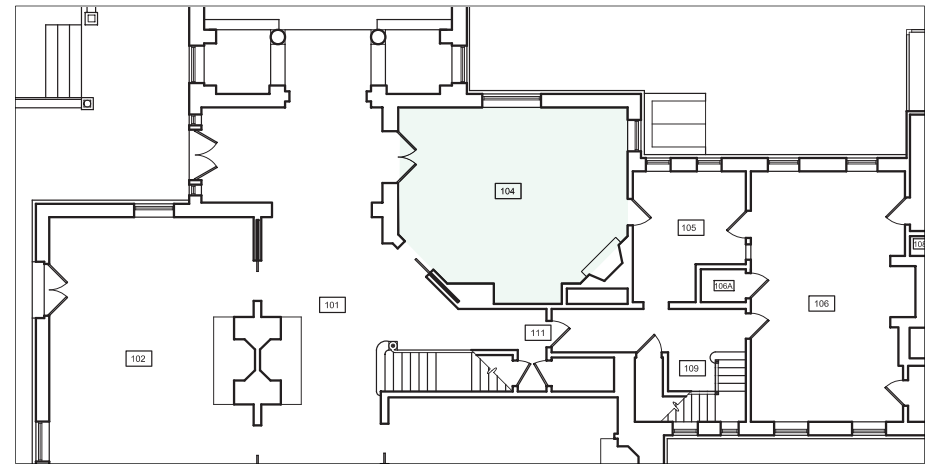
RM 104 DINING ROOM ENLARGED PLAN

4. The HSR reports that the four original gas brackets were replaced with "electric wall brackets with two lights" so presumably the current fixtures were installed at a later point.

5. The 3 headed sconces were observed to be quite large given the scale of the room and the lamps somewhat bright.
6. The historic sconces were observed to be quite bright, perhaps partly due to these being powered by the 120V supply system in the house.

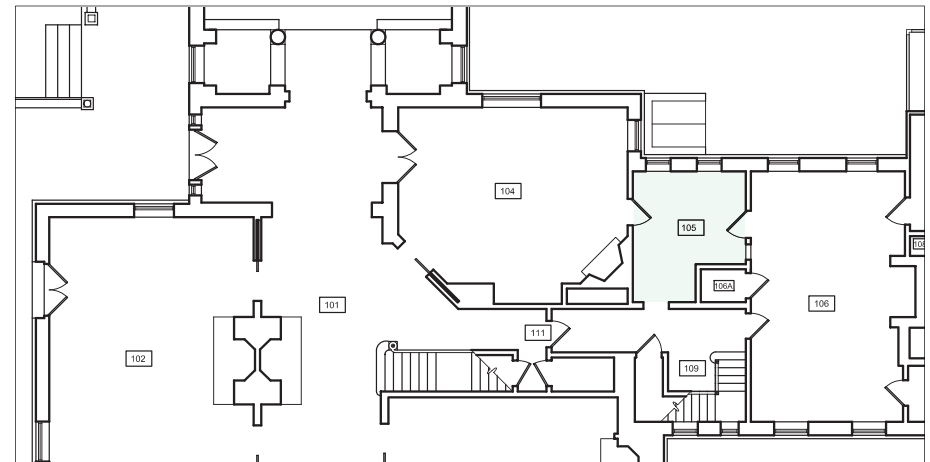
RM 105 PANTRY ENLARGED PLAN

1. The Pantry has dark walls, dark wood millwork and floors, and a white ceiling.
2. When viewed from the hallway, one of two windows is on the opposite wall. While this would normally create problematic glare, the daylight from the neighboring window as well as an out of view light fixture provides enough internal illumination to offset the brightness of this window.
3. The sheer window treatments and white shades maximize the amount of daylight.
4. There is a floor mounted supplemental fluorescent light fixture located to increase light levels on the wall opposite the floor safe. The fixture was either not lighted or not operable during this visit.

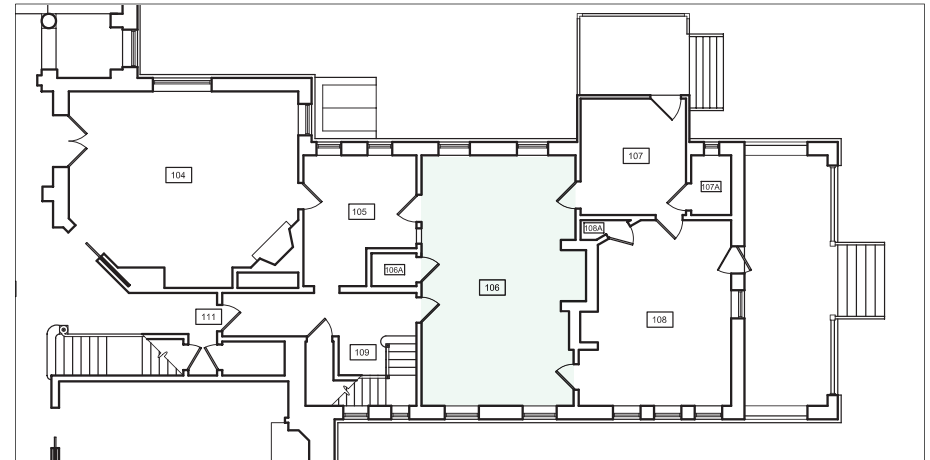
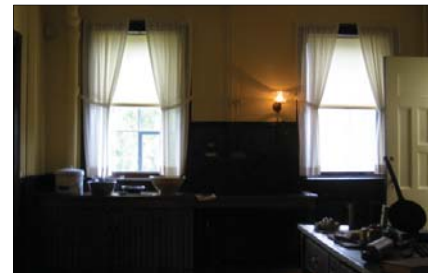
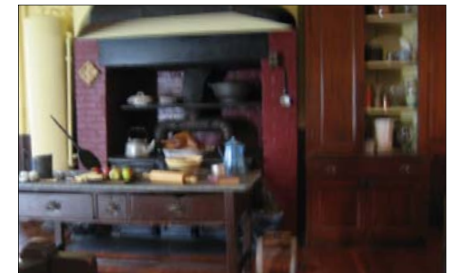
RM 106 KITCHEN ENLARGED PLAN

1. The two large windows on each the north and south walls provide a generous amount of daylight that is maximized by the light colored walls and ceiling.
2. The two small historic wall sconces would not provide much light after dark.

1. We heard no issues related for this room and found none, no recommendations required.

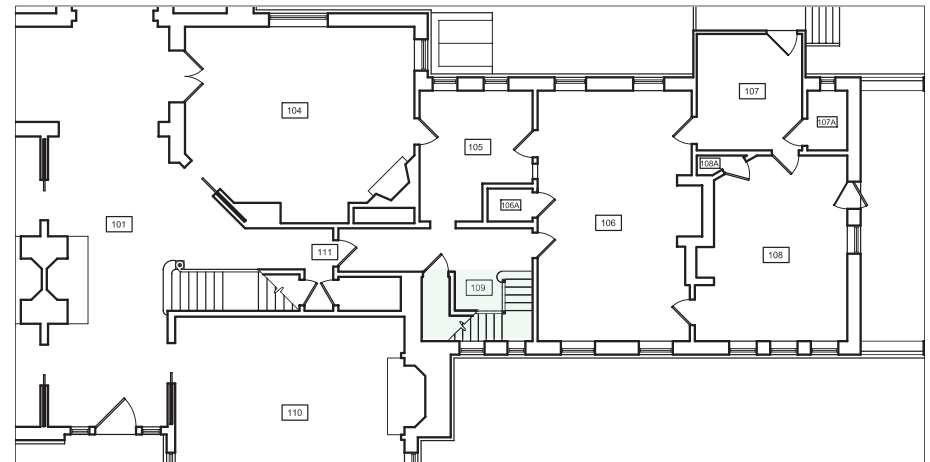
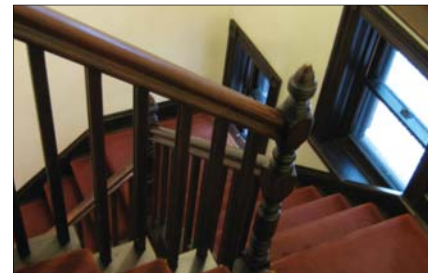
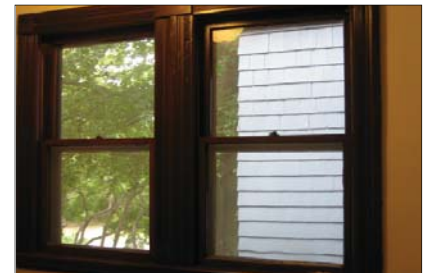
RM 109 REAR STAIR ENLARGED PLAN

1. This stair has many windows on the adjacent wall which negate the need for any electric lighting during the day.
2. The light wall and ceiling finishes, coupled with the ceiling mounted light fixture provide ample electric light.

1. We heard no issues related for this room and found none, no recommendations required.

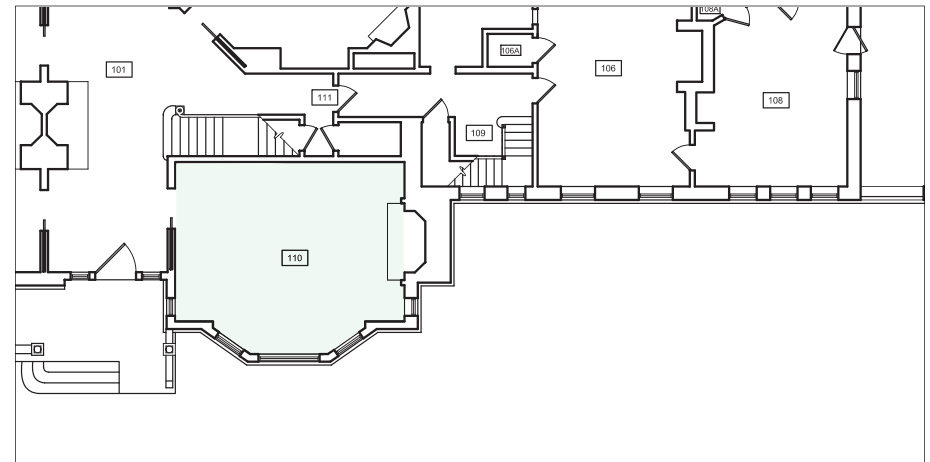
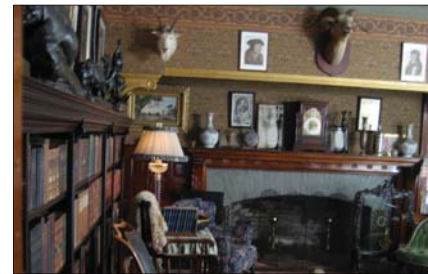
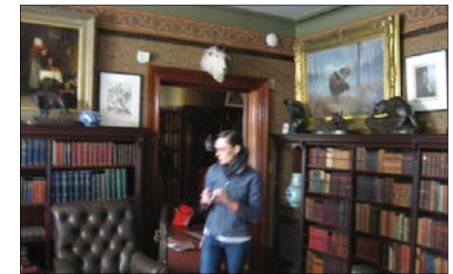
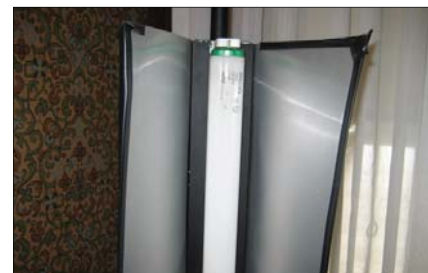
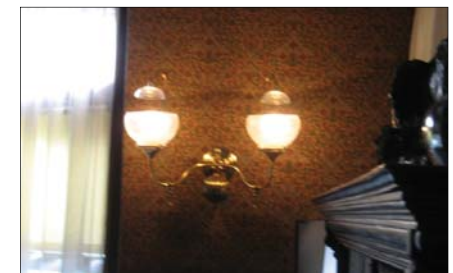
RM 110 LIBRARY ENLARGED PLAN

1. It was observed that later in the afternoon, this room became increasingly dark as the daylight dropped, revealing the lack of adequate electric light.
2. The dark wall finishes, dark wood millwork filled with books and shallow niche around the fireplace contribute to the low key condition.
3. There are three historic table lamps, one historic floor lamp and one x 2 headed historic sconce. Most of these fixtures are clustered in the southwest corner of the room leaving much of the remaining portion of the room under-lighted. There is also a floor mounted fluorescent fixture concealed from view in the southwestern corner of the room.
4. Awning was still in place on the center bay window (only).

1. Light reducing film is recommended for the bay windows.
2. Concealed supplementary electric light to be added to allow better visibility of cabinet and contents. This may be served by the existing floor mounted fixture which was not operating during our visit.

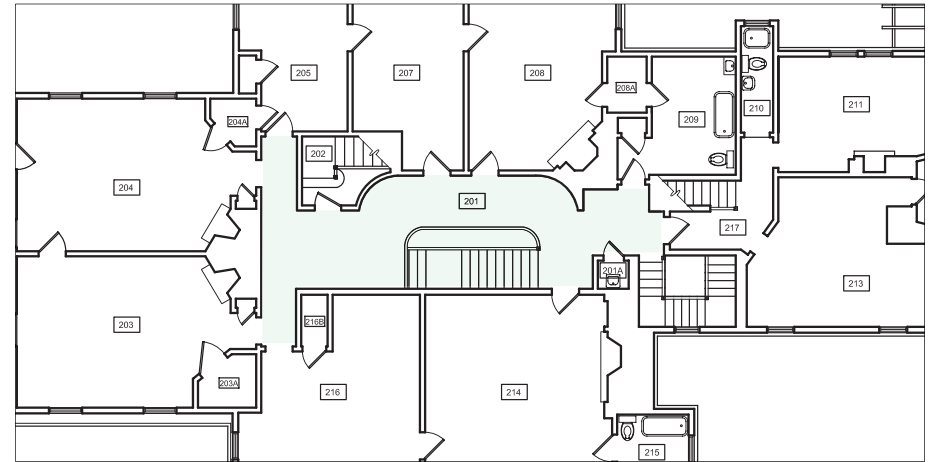
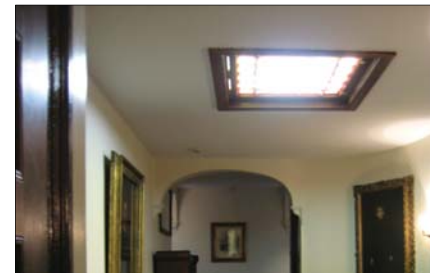
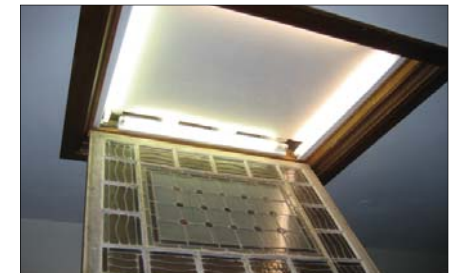
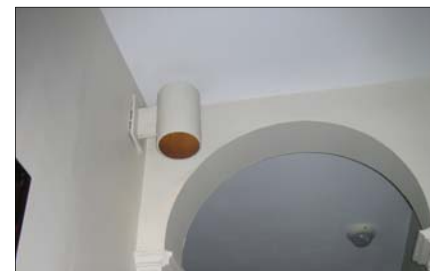
RM 201 STAIR ENLARGED PLAN

5. Light level half way down the stairs was measured to be 0.7 fc and 1.9 fc on the second floor.
6. The near white walls and ceiling contribute to the well lighted space.

7. The west end of the hall leading to the Master bedroom and Gate Room contains two surface mounted cylindrical downlights in these otherwise small but unlighted area.

1. Restoring the skylight in the Stair Hall is highly recommended to restore high quality light to the core of the house. Besides illuminating the Stair Hall, this element would have a significant positive impact on the Entry Hall below.

2. We also recommend that supplementary electric light be incorporated into the restored skylight. The purpose of the electric light is to lengthen the times of year that the laylight produces useful light in the house. If done successfully, the electric light would not be discernible from the daylight.

3. In the event that the skylight is not able to be restored, we recommend making the light box above the laylight deeper to accommodate more lamps and better diffusion. This would allow the laylight to produce more light, hide the visible fluorescent lamps and better replicate its original skylight function. This recommendation must of course be researched by the Architectural team to confirm if it is possible.

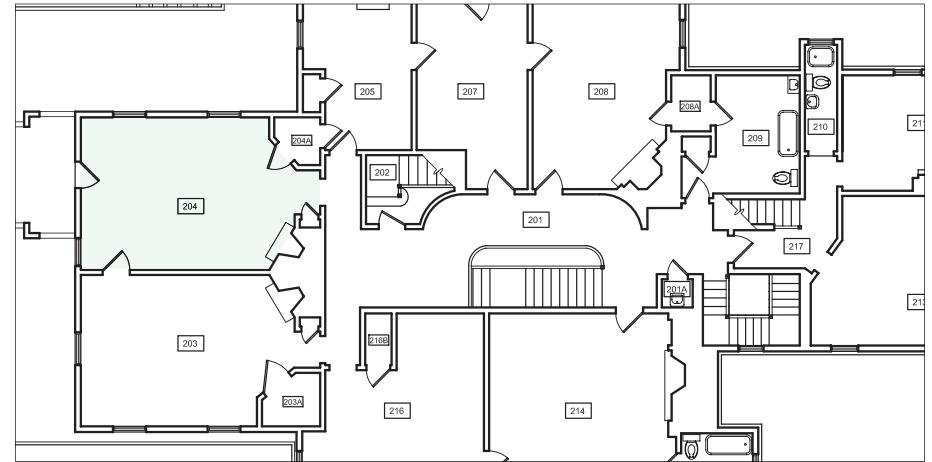
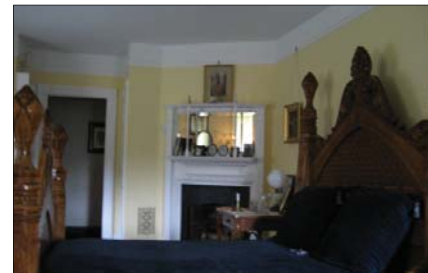
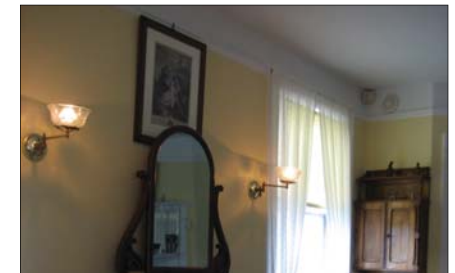
RM 204 MASTER BEDROOM ENLARGED PLAN

1. The second floor bedrooms typically have light wall finishes and multiple windows which provide for well lighted environments.
2. As is typical for most residential bedrooms, there are typically (historic) wall sconces and table lamps in these rooms that contribute little overall illumination.

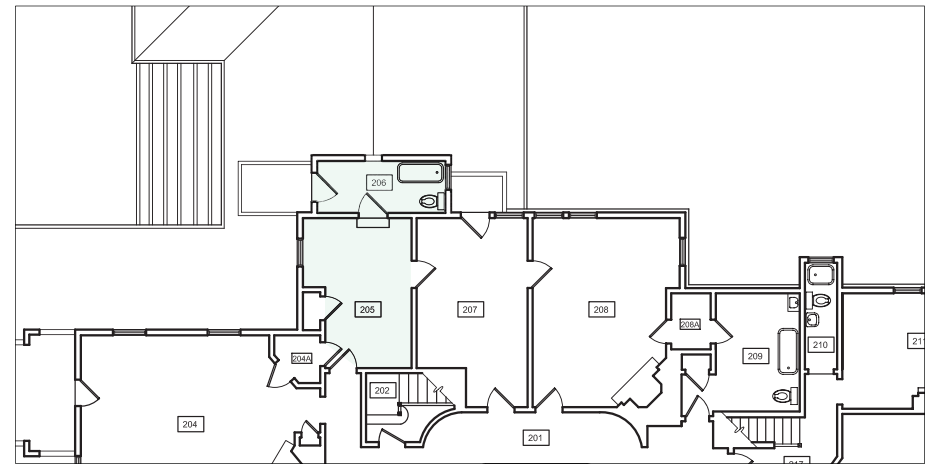
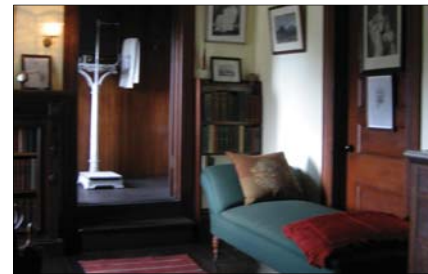
RM 205/ 206 DRESSING/ BATH ENLARGED PLAN

1. The Dressing Room and adjacent bathroom are similar to the bedrooms in that there is an abundance of daylight which does not require the electric sources to do much “work” during the daytime hours.
2. The dressing room also has light wall finishes which help show the number of objects of visual interest. The bathroom has dark wood paneling but the bathroom windows easily allows the few objects to be appreciated.
