## Condition Assessment

## **ARCHITECTURAL**

The Carter G. Woodson Home is in poor condition. The building has been vacant for many years and the constant infiltration of water because of a leaking roof had caused significant to the exterior envelope, the wood and masonry structure and the interior finishes. Although the East Elevation is in good condition, the remaining elevations are in poor condition. Because of rot and termite damage to portions of the wood support system, the main stair is sagging as are the floors in several of the rooms. The deteriorating wood framing members in conjunction with open and failing mortar joints has caused near collapse of the west wall elevation at the third floor and the southwest corner of the two story addition. The lack of heat and proper ventilation of the interior along with the high level of water infiltration has led to damage of the plaster walls, the decorative wood elements and the wood flooring.

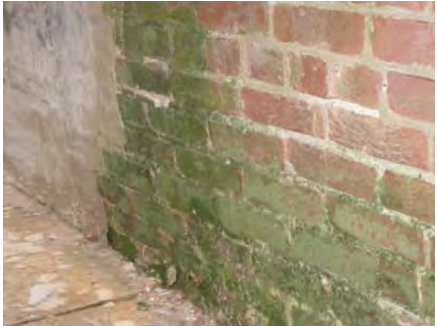
| EXTERIOR BRICK | SYMBOL | CONDITION | LOCATION | EXAMPLE IMAGE |
|---|---|---|---|---|
| | BIO GR | Biological Growth | South Elevation, Brick Below East Elevation Entry Stair | |
| | Unwanted growth or infestation of fungi, algae, microbes or plants that may result in organic staining and bio-deterioration of the pore structure of the masonry. (Photo: South elevation at grade.) | | Biological growth is associated with excess moisture in protected areas and is related to fluctuations in temperatures. It often occurs where there is not adequate drainage of rain water. It also provides the perfect environment for insect and animal infestations, and may indicate elevated moisture levels within the substrate. | |

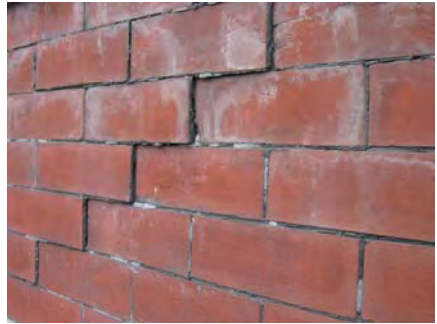
| EXTERIOR BRICK | SYMBOL | CONDITION | LOCATION | EXAMPLE IMAGE |
|---|---|---|---|---|
| | CJ | Crack Through Masonry Joint | Discrete locations on North, East, South and West Elevations | |
| | A crack that follows the mortar joints of the brick and doesn't translate through the brick. In some cases these cracks result in brick displacement. (Photo: East Elevation – note that photo also shows displacement of brick outward) | | Joints open due to weathering or differential stresses from movement within the building envelope. The mortar can be further damaged with salts and moisture migration. | |

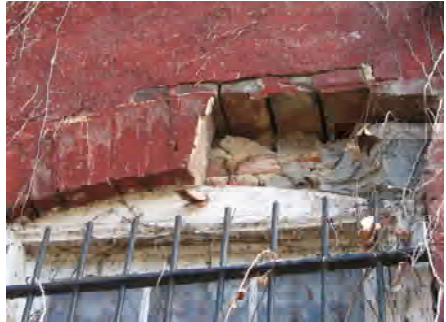
| EXTERIOR BRICK | SYMBOL | CONDITION | LOCATION | EXAMPLE IMAGE |
|---|---|---|---|---|
| | MI-B | Missing Brick | North, West and South Elevations | |
| | Brick units that have dislodged completely from the masonry wall or that have been removed. (Photo: West Elevation - Two Story Structure - above Window W108). | | Caused by deterioration of mortar, allowing brick to shift in combination with differential movement resulting in brick fully dislodging from masonry arch or wall. Deterioration of mortar and resulting loss of brick has also been accelerated on the West and North Elevations due to excessive plant growth on the elevations, trapping moisture in joints. | |

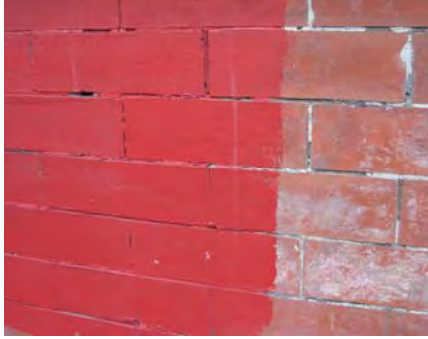
| EXTERIOR BRICK | SYMBOL | CONDITION | LOCATION | EXAMPLE IMAGE |
|---|---|---|---|---|
| | <b>P/G</b> | <b>Paint/Graffiti on Brick</b> | East Elevation | |
| | Red paint has been applied directly to the brick below and partially above the marble water course. (Photo: East Elevation above marble water course). | | Paint has frequently been applied to the East Elevation to cover over graffiti as a substitute for cleaning the spray paint directly off the brick. | |

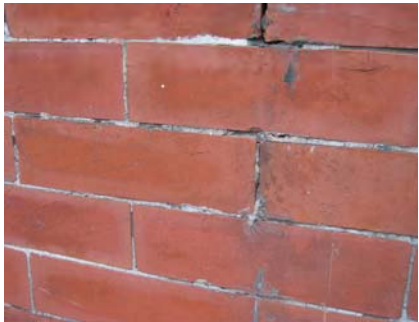
| EXTERIOR BRICK | SYMBOL | CONDITION | LOCATION | EXAMPLE IMAGE |
|---|---|---|---|---|
| | SMJ | Sealant at Mortar Joints | East Elevation | |
| | Application of sealant over the existing mortar or into open mortar joints. Aged sealant is now failing (Photo: East Elevation directly above water course). | | Sealant was applied as an effort to repair the failing thin mortar joints on the East Elevation. This repair is inappropriate due to the potential for the sealant to trap moisture within the mortar joints, which will accelerate deterioration of both the mortar and the brick. | |

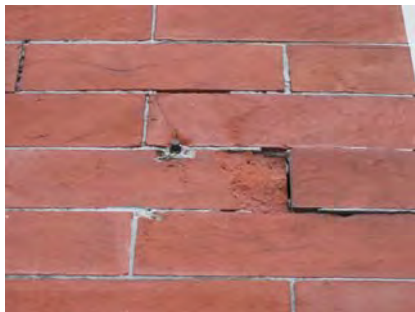
| EXTERIOR BRICK | SYMBOL | CONDITION | LOCATION | EXAMPLE IMAGE |
|---|---|---|---|---|
| | SP-B | Brick Spall | East Elevation | |
| | Detachment of brick fragment from brick unit. (Photo: East Elevation above window W102). | | Spalls may be caused by pressure within wall, expansion of embedded ferrous elements or from repair materials that are overly hard in comparison to the surrounding substrate. | |

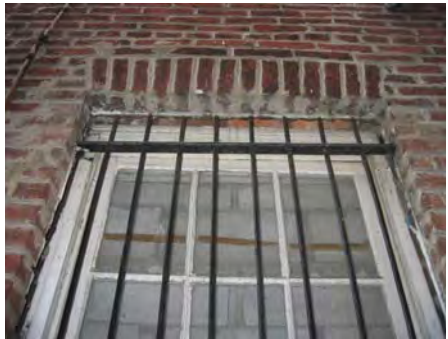
| EXTERIOR METAL | SYMBOL | CONDITION | LOCATION | EXAMPLE IMAGE |
|---|---|---|---|---|
| | GR | <b>Metal Grille</b> | East Elevation Basement and First Floor Windows, All West and South Elevation Windows | |
| | Metal security grille bolted to anchors set in mortar joints at brick masonry. (Photo: South Elevation - Window W105). | | Security grilles were installed to prevent vandalism and forced entry to the building. Ferrous metal anchors set in masonry joints have rusted and caused damage to adjacent masonry. | |

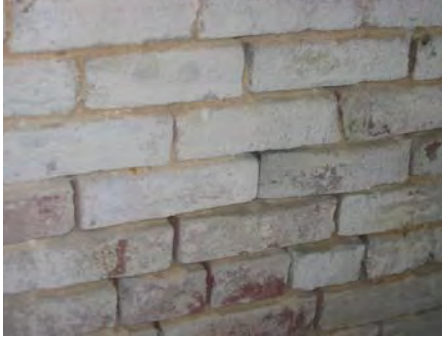
| INTERIOR BRICK | SYMBOL | CONDITION | LOCATION | EXAMPLE IMAGE |
|---|---|---|---|---|
| | OJ-I | Interior Open Joints | Basement North Elevation | |
| | Complete or partial loss of pointing mortar. This provides access for moisture migration into the masonry substrate and may also result in potential structural instability. (Photo: North Elevation at Basement). | | Joints open due to differential stresses from movement within building envelope and can be further damaged with salts and moisture migration as a result of flooding of the basement. | |

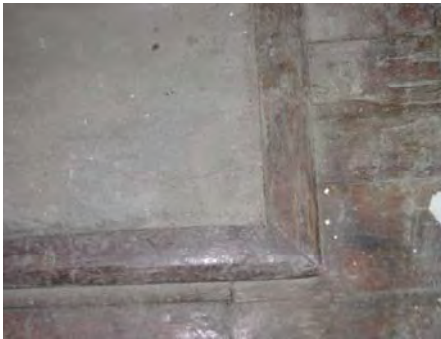
| INTERIOR STONE | SYMBOL | CONDITION | LOCATION | EXAMPLE IMAGE |
|---|---|---|---|---|
| | SS | Stone Soiling | Fireplace Hearths – Rooms 104, 105 | |
| | This problem type refers to any foreign matter (inorganic or organic) which accumulates on a building surface over time, commonly referred to as dirt, grime, or other residue. (Photo: Stone hearth at fireplace in Room 105). | | Building has been abandoned for a significant amount of time, and deterioration of interior ceiling and wall finishes has resulted in accumulation of debris on the floors. | |

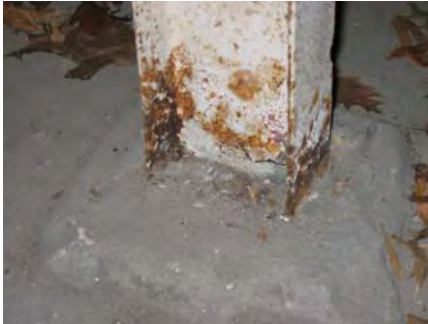
| INTERIOR METAL | SYMBOL | CONDITION | LOCATION | EXAMPLE IMAGE |
|---|---|---|---|---|
| | SR | Surface Rust at Steel | Steel Columns and Beams at Basement | |
| | Corrosion of metal due to consistent exposure to moisture. Corrosion may affect the color, texture, or form of the metal object and may cause staining to surrounding materials (Photo: Steel column in Basement). | | Corrosion is caused by continuous moisture exposure in conjunction with lack of maintenance of paint coating on steel. Frequent infiltration of rain water into the basement due to the lack of a water tight exterior envelope is also accelerating the corrosion. | |

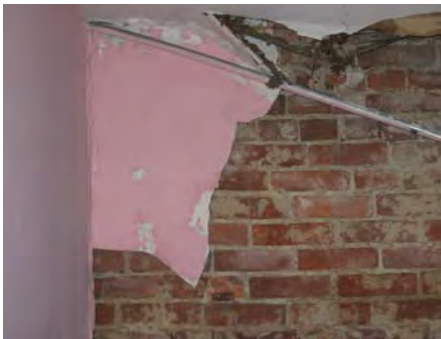
| INTERIOR PLASTER | SYMBOL | CONDITION | LOCATION | EXAMPLE IMAGE |
|---|---|---|---|---|
| | PL-L | <b>Complete Loss of Plaster from Lath or Masonry</b> | Interior Elevations of Rooms 103, 110, 205, 210, 305 | |
| | Complete breakdown of bonding of scratch coat keys with wood lath or bonding of scratch coat with brick masonry resulting in loss of plaster. (Photo: Loss of plaster at South Elevation of Room 210). | | Consistent water infiltration as a result of failing roof and open mortar joints along the exterior masonry walls results in plaster holding moisture causing a weakened bond between the plaster and the substrate, eventually resulting in failure. | |

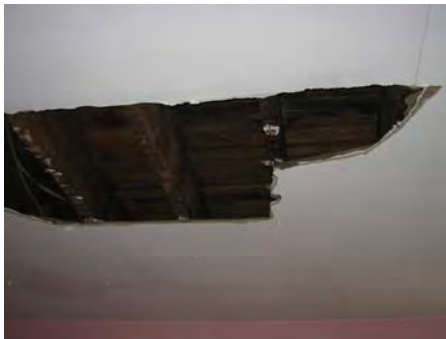
| INTERIOR PLASTER | SYMBOL | CONDITION | LOCATION | EXAMPLE IMAGE |
|---|---|---|---|---|
| | PL-LWBD | <b>Complete Loss of Plaster Wall Board</b> | Ceilings of Rooms 102, 103, 105, 110, 201, 203, 205, 210, 305 | |
| | Separation and loss of plaster board from either wood lath or wood structure resulting in complete failure of board. (Photo: Ceiling of Room 203). | | Consistent water infiltration as a result of failing roof resulting in plaster board absorbing moisture. Deflection of structure causes nails attaching wall board to lath or wood structure to fail. | |

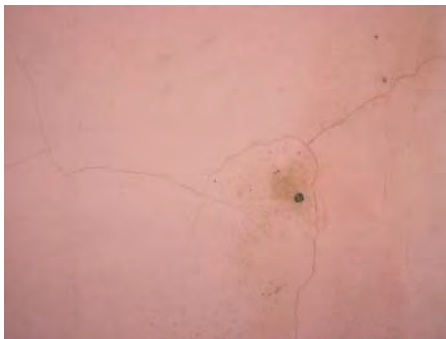
| INTERIOR PLASTER | SYMBOL | CONDITION | LOCATION | EXAMPLE IMAGE |
|---|---|---|---|---|
| | PL-HC | <b>Hairline Crack in Plaster Wall</b> | Interior Elevations of Rooms 102, 104, 105, 201, 202, 203, 205, 302, 303 | |
| | Crack through the surface of the plaster that does not extend into substrate (Photo: Crack at East wall of Room 302). | | Hairline cracks in plaster throughout the building are a result of continued settlement of structure, significant fluctuation in temperature and moisture levels. | |

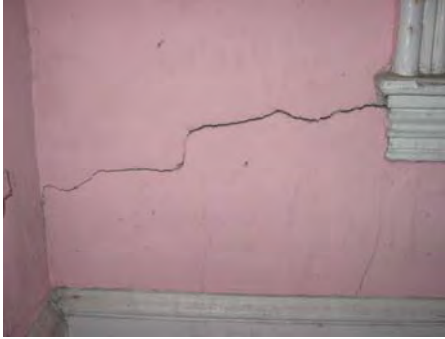
| INTERIOR PLASTER | SYMBOL | CONDITION | LOCATION | EXAMPLE IMAGE |
|---|---|---|---|---|
| | PL-MC | Major Crack in Plaster Wall | Interior Elevations of Rooms 102, 103, 104, 105, 110, 201, 202, 203, 205, 208, 210, 301, 303, 305 | |
| | Crack through surface material that may extend into substrate. (Photo: Crack at East wall of Room 101). | | Cracks may open in plaster due to differential stresses from movement of the building envelope or substrate settlement. If element becomes unstable, it could lead to loss of material. | |

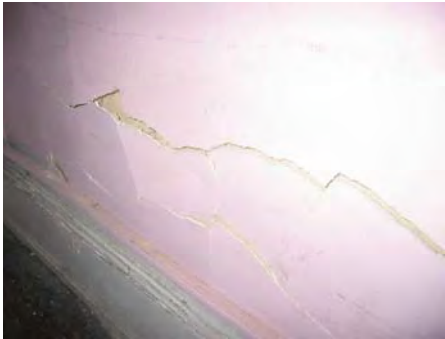
| INTERIOR PLASTER | SYMBOL | CONDITION | LOCATION | EXAMPLE IMAGE |
|---|---|---|---|---|
| | PL-S | Separation of Plaster from Wood Lath or Masonry | Interior Elevations of Rooms 102, 105, 201, 301, 305 | |
| | Partial breakdown of bonding of scratch coat keys with wood lath or bonding of scratch coat with brick masonry resulting in partial separation of plaster from substrate. (Photo: Loss of plaster at South Elevation of Room 210). | | Consistent water infiltration as a result of failing roof and open mortar joints along the exterior masonry walls results in plaster holding moisture causing a weakened bond between the plaster and the substrate, eventually resulting in separation. | |

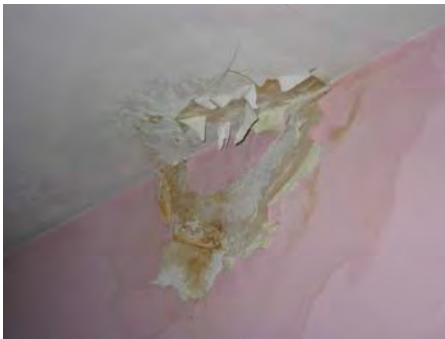
| INTERIOR PLASTER | SYMBOL | CONDITION | LOCATION | EXAMPLE IMAGE |
|---|---|---|---|---|
| | PNT-W | Failed Paint on Wall | Interior Elevations of Rooms 102, 202, 301 | |
| | Breakdown of paint coating. (Photo: Failed paint at Room 301). | | This condition indicates that the walls are holding significant moisture, weakening the bond between the paint and the plaster substrate. The source of the moisture must be controlled before any repainting to ensure a new coating will last, and to prevent additional interior damage. | |

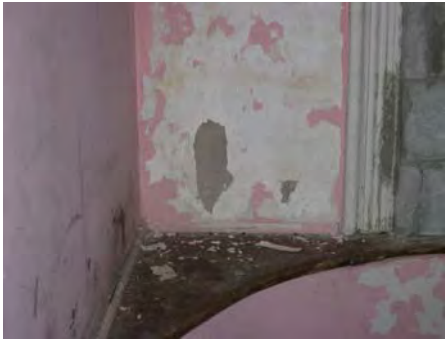
| INTERIOR PLASTER | SYMBOL | CONDITION | LOCATION | EXAMPLE IMAGE |
|---|---|---|---|---|
| | WDM | Severe Water Damage | Interior Elevations of Rooms 103, 201, 202, 205, 301, 305 | |
| | The irreversible loss of scales, flakes, or layers from a surface. This may occur on interior plaster due to moisture penetration, deterioration from salts, or inherent properties in the material. (Photo: South Elevation Detail - Room 201). | | Severe water damage at walls is a sign of a serious water infiltration problem. Once the water infiltration begins, the plaster will retain the moisture and the problem will continue to spread. | |

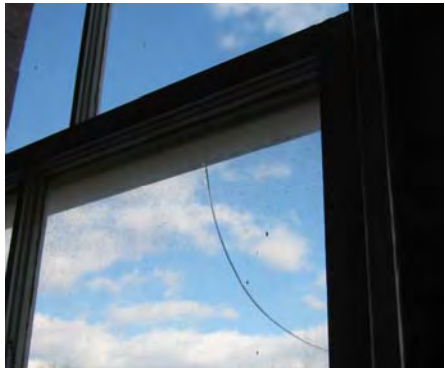
| INTERIOR WINDOWS | SYMBOL | CONDITION | LOCATION | EXAMPLE IMAGE |
|---|---|---|---|---|
| | W-CRK | Cracked or Broken Window Glass | Windows W102, W106, W201, W202, W206, | |
| | Cracked glass window unit. (Photo: East Elevation - Interior of Window W202). | | Cracked glass may be a result of impact or differential movement within the frame due to fluctuations in relative humidity/temperature from the exterior to the interior. | |

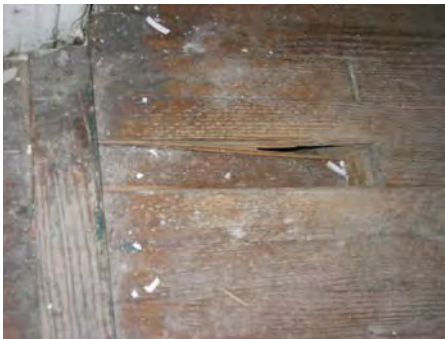
| INTERIOR WOOD FLOORS | SYMBOL | CONDITION | LOCATION | EXAMPLE IMAGE |
|---|---|---|---|---|
| | WD-FF | Failed Floor Board | Flooring at Rooms 208, 301 | |
| | Pine strip flooring has failed, resulting in unstable floor boards. (Photo: Failed floor board at Room 208 entry). | | Continuous exposure to moisture has resulted in wood rot and failing of select wood members. | |

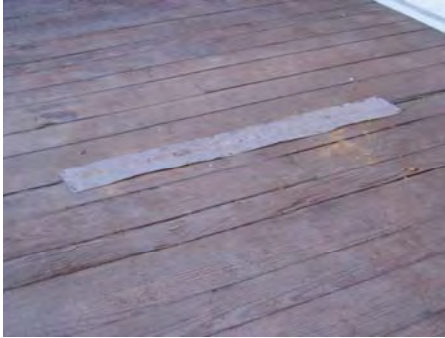
| INTERIOR WOOD FLOORS | SYMBOL | CONDITION | LOCATION | EXAMPLE IMAGE |
|---|---|---|---|---|
| | WD-PC | Incompatible Metal Patch | Flooring at Rooms 102, 104 | |
| | An incompatible wood patch has been installed in locations where there has been significant wear to the flooring. (Photo: Metal floor patch in Room 104). | | The pine plank flooring is a very soft flooring material that is susceptible to significant wear if not properly maintained. The finish coat of the wood flooring has been completely worn away resulting in significant wearing of the floor boards, causing in splintering and gaps. | |

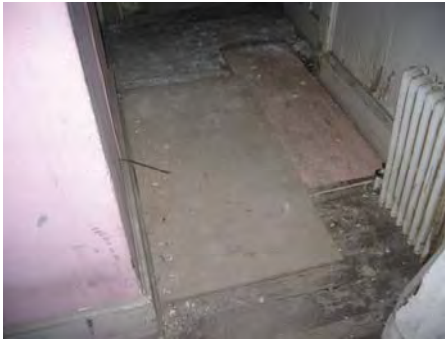
| INTERIOR WOOD FLOORS | SYMBOL | CONDITION | LOCATION | EXAMPLE IMAGE |
|---|---|---|---|---|
| | WD-PC | Plywood Patch | Flooring at Rooms 103, 109, 201, 305 | |
| | Plywood panel sheathing has been installed at locations where the existing wood floor is failing. (Photo: Plywood panels at Room 103). | | In order to maintain safe access to the entire house plywood panels were installed in select areas where the flooring and/or supporting structure below had failed due to wood rot or termite damage. | |

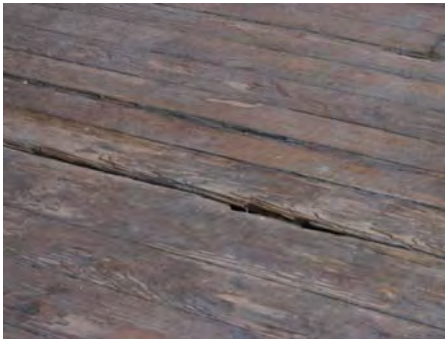
| INTERIOR WOOD FLOORS | SYMBOL | CONDITION | LOCATION | EXAMPLE IMAGE |
|---|---|---|---|---|
| | WD-SW | Significant Wear | All Interior Wood Floors | |
| | Significant wear of the wood surface resulting in exposed and pronounced grain. (Photo: Wear at floor of Room 303). | | The pine plank flooring is a very soft flooring material that is susceptible to significant wear if not properly maintained. The finish coat of the wood flooring has been completely worn away resulting in significant wearing of the floor boards, resulting in splintering and gaps. | |

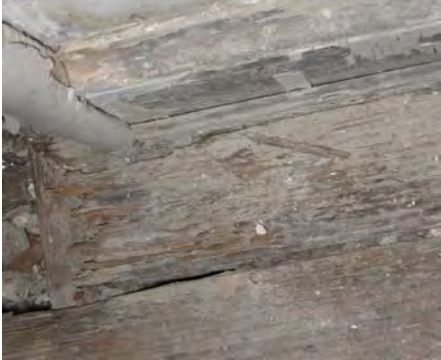
| INTERIOR WOOD FLOORS | SYMBOL | CONDITION | LOCATION | EXAMPLE IMAGE |
|---|---|---|---|---|
| | WD-TD | Termite Damage | Wood Flooring in Rooms 103, 201, 301, 305 | |
| | Deterioration and loss of section of wood as a result of termite infestation. (Photo: Termite damage at wood floor - Room 305). | | Continuous water infiltration in combination with cool temperature and little air circulation provides an ideal environment for termites to thrive. The most significant termite damage has occurred in direct correspondence with areas below two primary roof leaks. | |

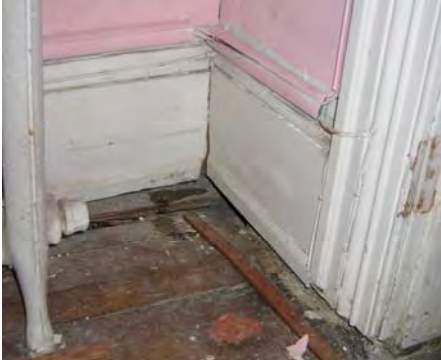
| INTERIOR WOOD FLOORS | SYMBOL | CONDITION | LOCATION | EXAMPLE IMAGE |
|---|---|---|---|---|
| | WD-SFL | Sagging Floor | Flooring at Rooms 103, 109, 110, 201, 208, 210, 301 | |
| | Floor structure is failing resulting in flooring sagging in discrete locations. (Photo: Sagging of wood floor at Southwest corner of Room 109). | | The wood joists have separated from the masonry because of moisture damage, termite damage or deflection, resulting in unsupported section of floor. | |

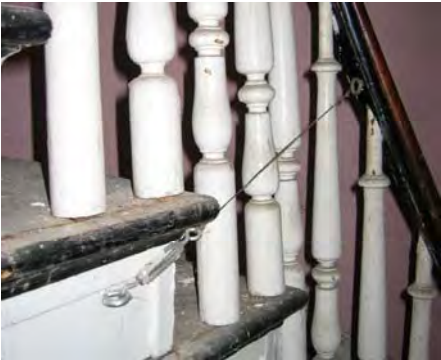
| INTERIOR WOOD STAIR | SYMBOL | CONDITION | LOCATION | EXAMPLE IMAGE |
|---|---|---|---|---|
| | STR-IR | Unstable Railing | Main Stair - First to Second Floor | |
| | The failing support structure of the Main Stair has caused the main railing to be unstable and it has lost capacity for significant lateral load. Metal cables and screws have been installed to maintain tension, and thus stability, in the railing. (Photo: Temporary support devices installed at first floor railing). | | The first floor framing below this stair lost significant section due to termite damage, resulting in the stair sagging and the railing, becoming unstable. Although the stair support has been sistered with new structure, the railing still remains unstable. | |

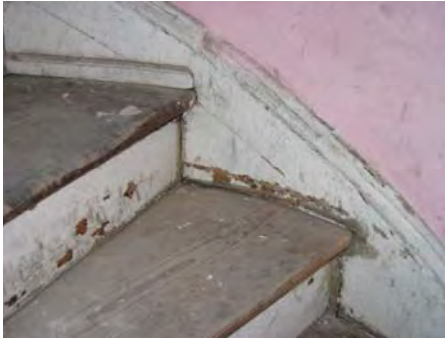
| INTERIOR WOOD STAIR | SYMBOL | CONDITION | LOCATION | EXAMPLE IMAGE |
|---|---|---|---|---|
| | STR-ST | Sagging Tread | Main Stair - First to Second Floor | |
| | <p>The failing support structure of the Main Stair has caused the stringer to sag, resulting in the shifting of most stair treads leading from the first to the second floor. (Photo: Sagging Stair treads at first floor)</p> | | <p>Similar to the stair railing, the stair treads have shifted in conjunction with the stair stringer as a result of the termite damage to the stair support structure.</p> | |

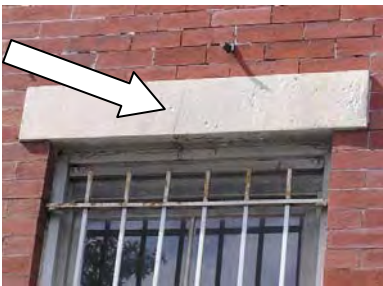
**Figure 4-016:** Crack in lintel at window W101. (RSA, 2006)

Visible shifting of the brick above the second floor lintels may be indicative of a lintel problem at the inner wythes of brick. It may also be caused by the result of localized masonry movement or mortar deterioration. The lintel above window W101 at first floor has a vertical crack at midspan (Figure 4-016). This type of midspan crack typically indicates excess flexural stress, which may result from a localized load increase from expanding embedded metal or may originate from a localized material weakness. There is no apparent settlement of the brick above associated with this cracked lintel.

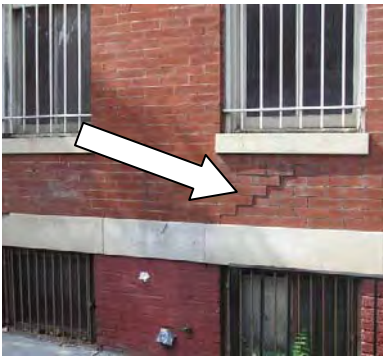
**Figure 4-017:** Shifting brick. (RSA, 2006)

Shifting in masonry is noted above the basement windows W002 and W003 as well (Figure 4-017). Water stains and a slight outward bulging in the brick are also apparent in this area. Water infiltration and subsequent mortar deterioration and expansion of iron ties in the masonry above the basement may be a possible cause.

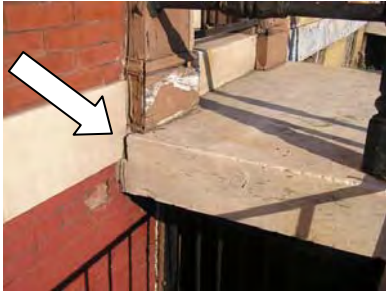
**Figure 4-018:** Spalling at front door. (RSA, 2006)

Spalling and delamination are visible at the iron cramps along the limestone lintels and watertable above the basement windows. These conditions do not represent a structural concern at this time, however architectural treatment is warranted – see architectural recommendations.

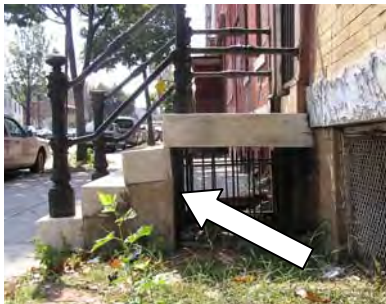
**Figure 4-019:** Stone rotation at front stoop, facing south. (RSA, 2006)

The front stoop has some visible structural problems (Figure 4-019). The landing constructed of a single stone slab. At the stone bearing along the main building wall, localized masonry deterioration is apparent. In addition, the stone slab appears to be sloping inward toward the building wall. This is likely the result of the front steps rotating outward toward the sidewalk due to settlement. It is possible that there is not a footing at the front of the steps and settlement of soil behind the basement stair wall is causing the observed movement.

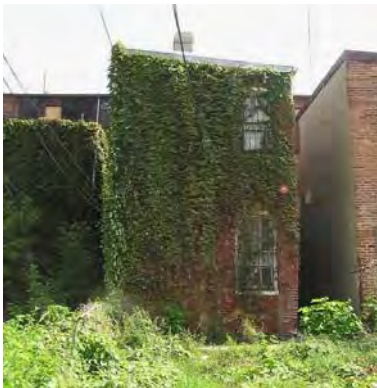
**Figure 4-021:** West elevation. (RSA, 2006)

Observation of the west elevation presented the worst structural conditions found on the house. The west elevation was almost entirely covered with biological growth during our initial visit, and was subsequently removed by the National Park Service. This type of plant growth on masonry is detrimental because it allows for the retaining of moisture at the surface of the masonry. Also, propagation of the small root anchoring systems of the plants through the bricks causes cracks and loosening of mortar. Figure 4-020 and 4-021 show the rear elevation before and after removal of this biological growth.

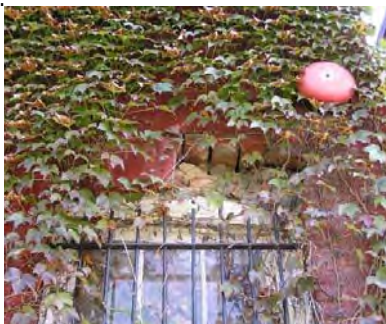
**Figure 4-022:** Loose and missing bricks at top of window W107. (RSA, 2006)

Severe brick deterioration is evident at window openings W107 and W210. Figure 4-022 & 023 show the top and bottom of window W107. At the top of this window, bricks are missing from the arch, and at the bottom, brick units and mortar joints are cracked and the wall bulges outward.

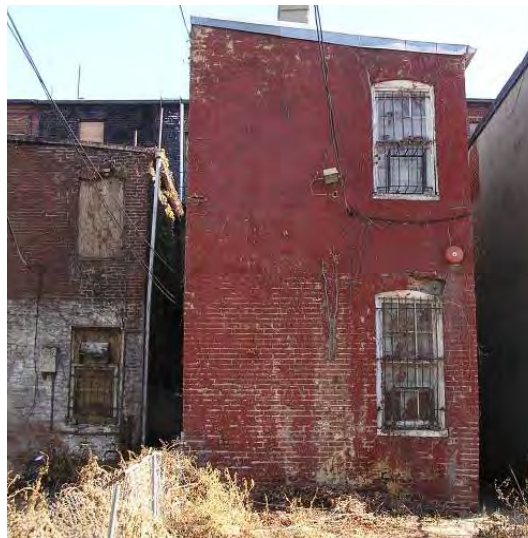
**Figure 4-020:** West elevation after plant removal. (RSA, 2006)

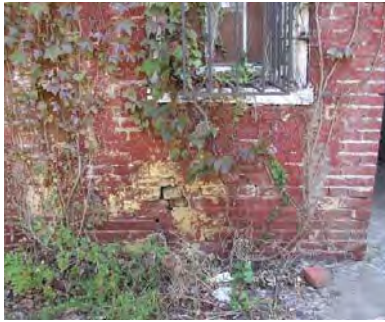
**Figure 4-023:** Loose bricks and rotting wood sill at window W107. (RSA, 2006)

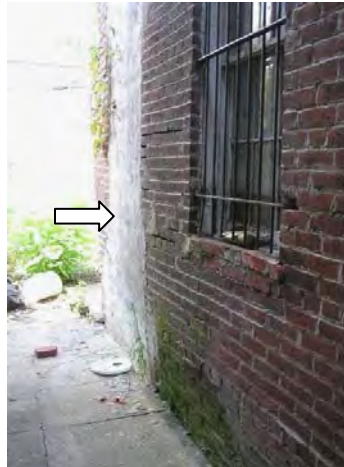
The south elevation shows signs of further structural problems. The wall below the door opening D110A at this elevation is bulging outward above the foundation. Many open mortar joints and cracking are evident here as well. The rotation appears to take place near the bottom of the south elevation in its transition from the foundation wall (if present) at grade and the first floor of the Period 2 addition which bears on the south wall at approximately 2 feet above grade - see Figure 4-025.

**Figure 4-025:** South elevation, outward building of brick. (RSA, 2006)

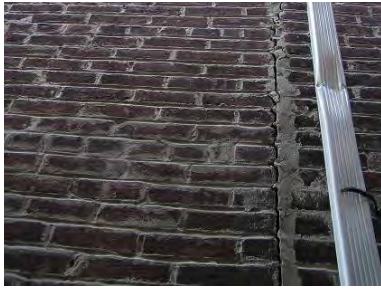
Figure 4-027 depicts spalling and missing brick at the painted iron security grilles of the first floor window – W208. The observed conditions are largely the result of excess and sustained moisture intrusion within the masonry. Subsequent freeze-thaw cycling and the development of rust with embedded iron elements results in displacement and disassembly of the masonry. Foundation movements and the loss of bracing from the interior wood floor diaphragms appear to also be associated with the excessive movement in the masonry. Such movement is also manifested in the separated mortar joint running along the joint between the Period 1 and Period 2 two-story construction - Figure 4-028.

**Figure 4-028:** Separation of mortar at joint, between Period I and Period II construction. (RSA, 2006)

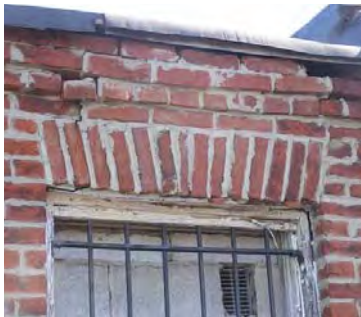
**Figure 4-031:** Brick masonry shifting above flat arch and interior lintel of window W304. (RSA, 2006)

Brick above the window W304 lintel (Figure 4-031) are loose and bulging out of plane. The exterior flat arch has been apparently rebuilt or repaired, evidenced by relatively recent re-pointing, however additional shifting and displacement is evident subsequent to the repairs. Figure 4-032 depicts additional diagonal cracking below the window sill of window W303 at this same wall.

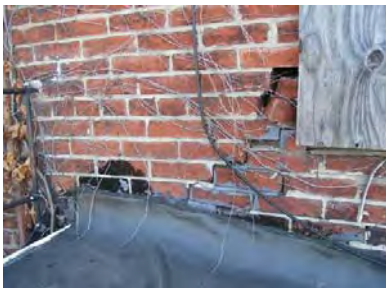
**Figure 4-032: Photo 18.** Diagonal cracking below window W303) at west wall. (RSA, 2006)

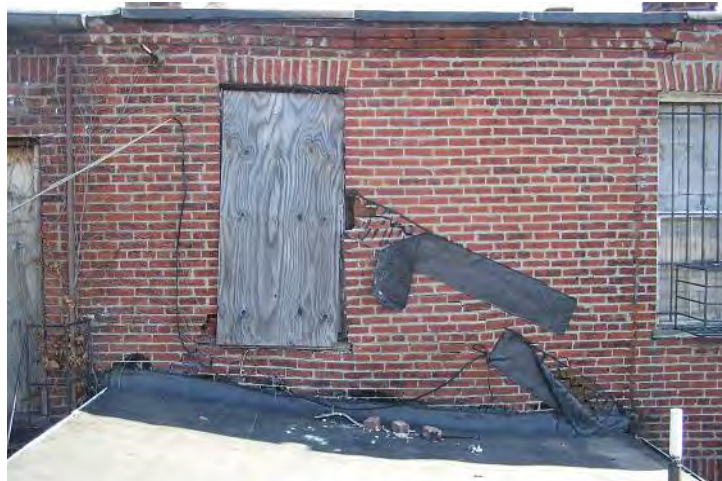
**Figure 4-030:** Roof and west elevation at third floor. (RSA, 2006)

The joint where the lower roof meets the west elevation of the three-story structure significant deterioration was noted, largely due to water intrusion where the roof abuts the base of the exterior masonry wall (Figure 4-030). The poor condition of the exterior west wall at the third floor is visible from this vantage point. The wall is deflecting downward and has extensive cracking. EPDM roofing has been used to patch some cracks, however the repairs have failed and the damaged areas are open to the elements and allow direct water infiltration (Figure 4-029). The wall is sinking due to a failing support beam below that spans sidewall to sidewall at the stair inside (see SSK-3).

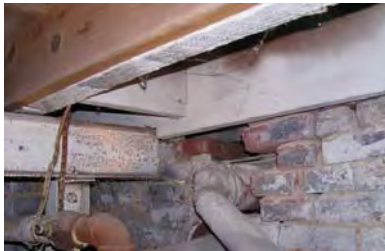
**Figure 4-035:** Steel beam not bearing on brick as it should. (RSA, 2006)

The joists bear on pockets in the brick masonry walls and are continuous over a line of steel beams and posts, running east-west at 4'-8" from the north wall (Figure 4-034). The steel beam (6-1/8" depth, 3-3/8" flange width) bears on steel posts (5" depth, 3" flange width) spaced at approximately 7'-4" feet on center. In general, the bearing condition of the joists in the area west of the stair has been compromised due to wood and masonry deterioration. Many joists have rotted in the masonry pockets due to moisture or insect infestation. Many of the joists also fail to bear properly on the steel beam (Figure 4-035).

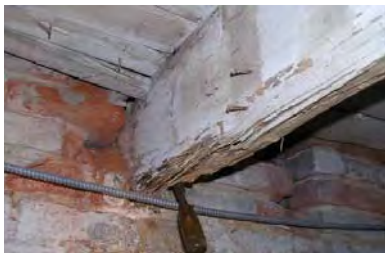
**Figure 4-036:** Rotted bearing condition. (RSA, 2006)

A number of the floor joists in the western area of the basement have rotted at the bearings as shown in Figure 4-036.

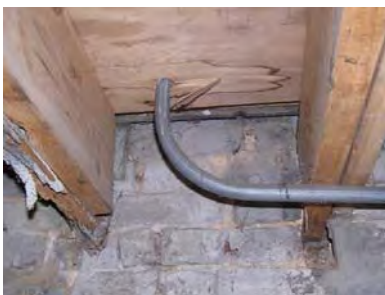
**Figure 4-037:** Insufficient Joist Bearing at north wall. (RSA, 2006)

Repairs on the joists have been attempted and many of the joists have been sistered or partially lapped with new lumber. Unfortunately, most of the repairs have been executed improperly. Much of the sistered lumber falls short of the bearing wall, leading to a condition of limited or no bearing (Figure 4-037).

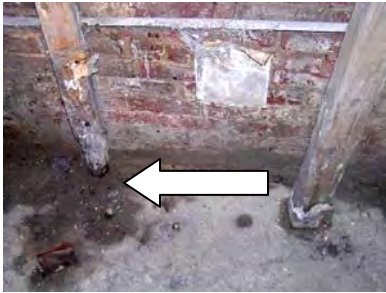
**Figure 4-038:** Base of column severely deteriorated. (RSA, 2006)

Joists near the southwest window opening W003 do not have proper bearing at the masonry wall. Wood posts (4x4) at the window are deteriorated, and one of the bases has rotted almost completely (Figure 4-038).

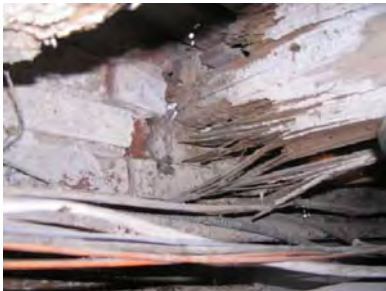
**Figure 4-039:** Rotted bearing end of stair framing. (RSA, 2006)

The stairs into the basement are sagging considerably. Closer inspection revealed that the stairs frame into floor joists that have completely lost their bearing at the masonry wall. In addition, many of the joists have clear signs of past termite infestation. Though the insect infestation appears currently inactive, the damage has taken its toll on the load-bearing capacity of the joists (Figure 4-039 and Figure 4-041).

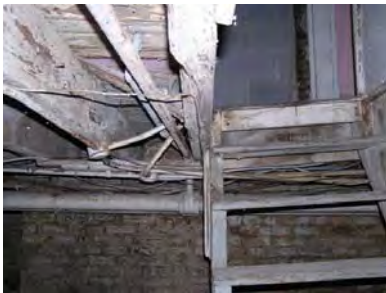
**Figure 4-041:** Sagging at stairs. (RSA, 2006)

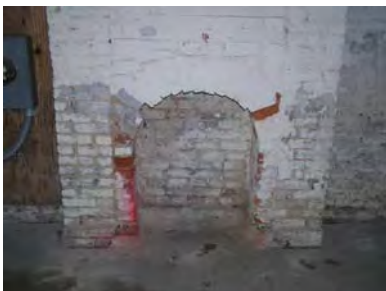
**Figure 4-042:** Fireplace, deterioration – southeast end. (RSA, 2006)

The fireplace in the basement is suffering from joint deterioration and deteriorating brick in the arch (Figure 4-042). The fireplace is headed off with a 2"x9 ¾" timber beam; however, the trimmers are insufficiently supported along the face of the chimney (Figure 4-043). It appears that the wood beam along the face of the chimney has been cut so that it no longer spans across the chimney width.

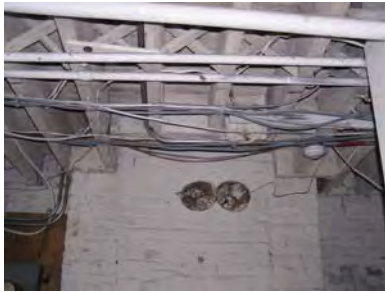
**Figure 4-043:** South chimney with insufficient trimmer support. (RSA, 2006)

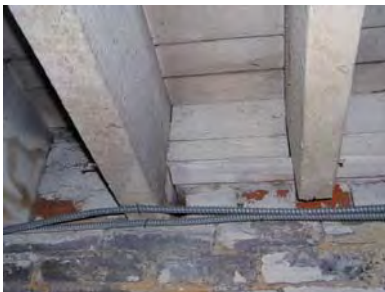
Joists within the width of the chimneys frame into a 2½"x9½" header along the north wall by mortise and tenon connections (Figure 4-044). The header opposite the west chimney is missing its bottom 4 inches and is cracked horizontally through the full span right at the tenons. The deterioration may be the result of a previous overstress condition; however, the similar header opposite the east chimney appears sound.

**Figure 4-044:** Header corresponding to party wall chimneys – splitting at north wall header. (RSA, 2006)

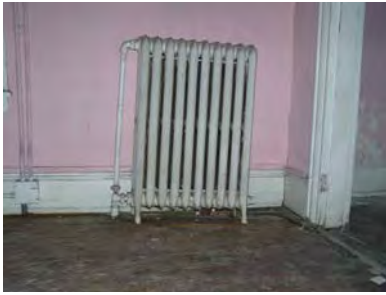
The first floor presents significant areas of sagging and displacement, particularly at the Period 2 two-story addition to the west. As depicted in Figure 4-045, the flooring in Room 110 suffers severe deterioration of both floor framing and perimeter masonry bearing walls. The framing in this location is over the crawlspace and has rotted and displaced along the south bearing conditions. The load bearing masonry, particularly along the window lines, has shifted and begun to disassemble. In Room 109, where the basement below transitions from crawl space to basement, there is further sagging of the floor (Figure 4-046). This is due to the rotted bearing ends of the floor joists observed from the basement area below.

**Figure 4-046:** Room 109 - Floor sagging at first floor. (RSA, 2006)

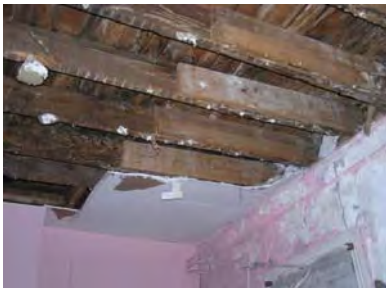
**Figure 4-047:** Sistered floor joists visible from first floor. (RSA, 2006)

Figure 4-047 illustrates the sistered second floor joists as visible from Room 110 on the first floor. The joists are  $1\frac{3}{4}$ " x  $7\frac{1}{2}$ " @ 16" o.c. These repairs do not currently appear sufficient to provide adequate strengthening of this floor, with insufficient lap lengths and connections between original joist and added sister, and the joists were observed to have poor bearing on the south wall. The joists have shifted from their bearings and represent a disengagement of the floor diaphragm from the masonry bearing wall. This lack of diaphragm bracing plays a significant part in the amount of masonry movement and cracking observed in this area.

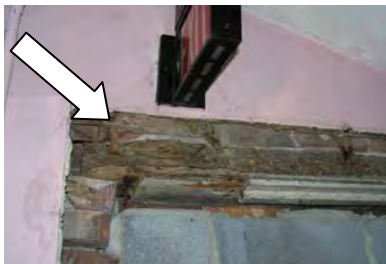
**Figure 4-048:** Deterioration at lintel of door D103A. (RSA, 2006)

The wood lintel above the door D103A along the south alley has severely deteriorated, likely due to the combined effects of sustained moisture infiltration and termite damage (Figure 4-048).

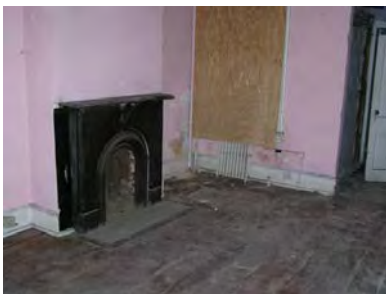
**Figure 4-050:** Room 105 - Fireplace in room east of stairwell. (RSA, 2006)

The fireplace in Room 105, east of the stairwell, appears to be missing a lintel (Figure 4-050). This can be observed from within the fireplace area, looking upward into the chimney. The brick masonry is arching at this time and the observed condition does not represent a significant instability.

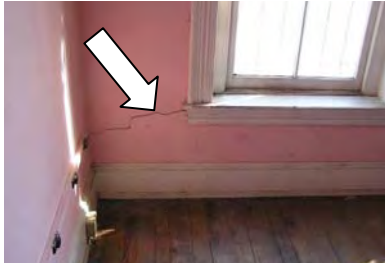
Room 104 exhibits extensive cracking in the wall plaster and around the windows. One typical diagonal crack is depicted in Figure 4-051 at window W102, corresponding to shifting in the masonry observed from the exterior. Though much of the plaster deterioration is architectural in nature (see

**Figure 4-051:** Room 104 - Crack at bottom lintel of window. (RSA, 2006)

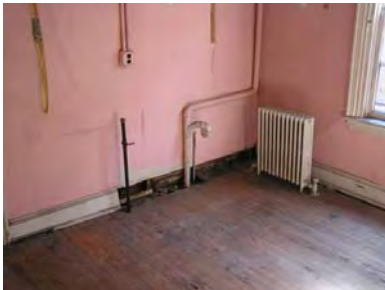
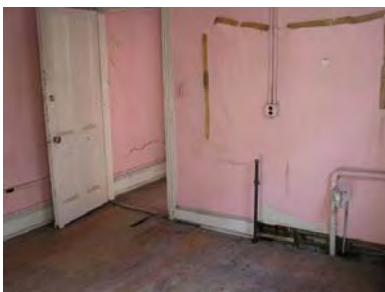
**Figure 4-054:** Room 208 - Floor sagging below east wall. (RSA, 2006)

**Figure 4-055:** Room 208 - Floor sagging below east wall. (RSA, 2006)

In Room 208, significant deflection of the floor framing along the east wall is visible (Figure 4-054 & 4-055). Closer inspection of the framing below the base of the stud wall shows evidence of previous repairs and modification. It appears that the beam below the east wall was at one time spliced near its south end; however the splicing detail appears to have been inadequate and failed, resulting in the downward deflection along this wall.

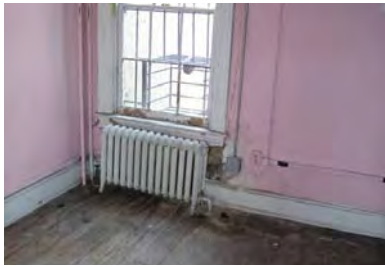
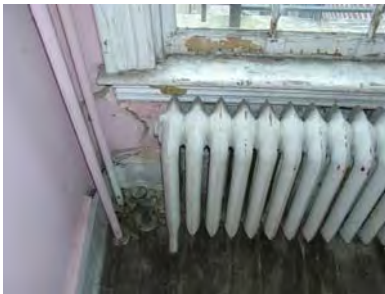
**Figure 4-056: Photo 44.** Room 205 - Cracking at window along west wall, original construction. (RSA, 2006)

**Figure 4-058:** Room 205 - Cracks in wall. (RSA, 2006)

In Figure 4-056, 4-058, 4-059 & 4-060, significant cracking is evident below the sill at window W204 of Room 205. This is likely the result of a lintel or arch failure above the first floor window below. The window opening and radiator likely have contributed to increased moisture levels. As a result, it is likely that localized floor framing deterioration may also be found in this area. Typical third floor framing in this area consists of 2" x 9 ¾" wood joists @ 16" on center.

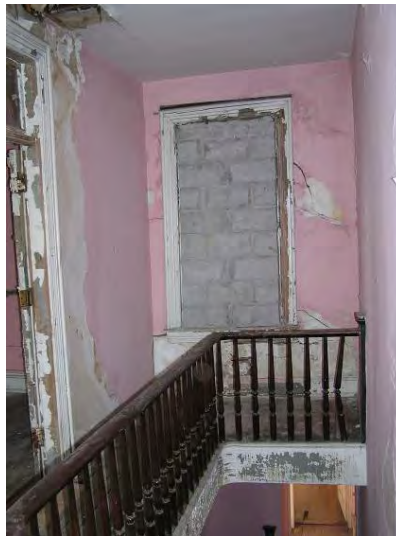
**Figure 4-060:** Room 301 - Top of staircase, third floor. (RSA, 2006)

Figure 4-060 shows a CMU in-filled window (W303) at the top of the staircase on the third floor. Diagonal crack patterns in the wall at this window indicate that the wall is deflecting downward with the wall supporting the stairwell. Diagonal cracks in the west wall of Room 305 suggest this same type of settlement (Figure 4-061). Substantial cracking of the plaster is indicative of large movements in the exterior masonry, which is corroborated by observations from the exterior. The movement corresponds to the severe deterioration of the built-up wood transfer beam at the third floor framing level, which was observed from the floor level below.

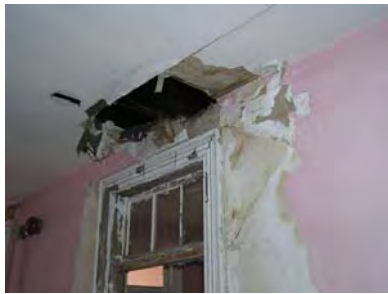
**Figure 4-062.** Room 305 - Ceiling damage. (RSA, 2006)

Ceiling failure is evident on the third floor at the partition wall south of the staircase. This plaster failure is primarily due to water damage, but some localized fire damage was also observed (Figure 4-062). The finish damage appears to correspond to previous framing damage, which has since been repaired.

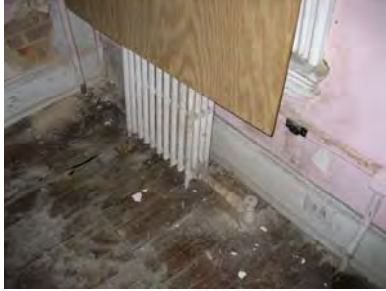
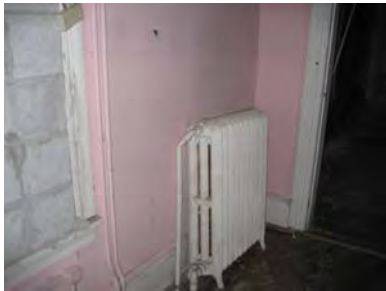
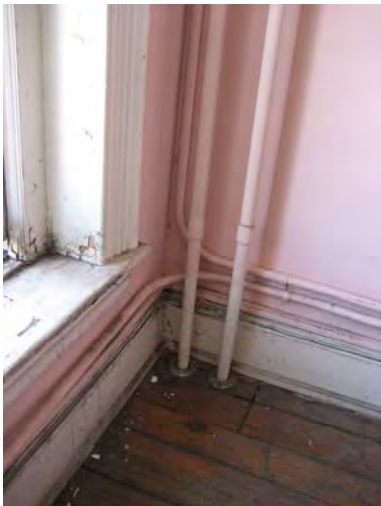
**Figure 4-072:** View of typical radiator and surface mounted conduit. (Photo: GHT, 2006)

**Figure 4-073:** Typical radiator. (Photo: GHT, 2006)

**Figure 4-074:** Radiator Pipes. (Photo: GHT, 2007)

The building has no air conditioning system and the existing heating system is based on a gas fired boiler that feeds hot water to radiators throughout the building. The entire system is currently inoperable. The typical radiators are covered with multiple layers of paint on the exterior, and the inside of the radiators and associated piping is corroded and oxidized. Figures 4-072 and 4-073 demonstrate the condition of the typical radiators. A further description of all radiator types can be found in the Section 3: Physical Description – Interior. These radiators all date to Period 3 and are all manufactured by the American Radiator Company. After cleaning, they could potentially be reused. The piping for this heating system was installed late in Period 2 or in early Period 3 and was thus run exposed along the walls and ceilings. This piping, if replaced, could be used with the reconditioned existing radiator units as part of a new heating system.

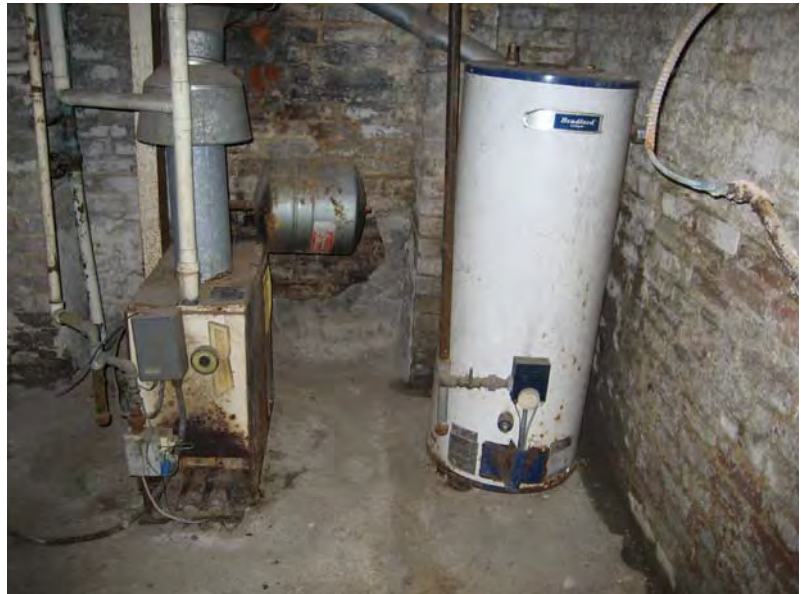
**Figure 4-075:** Existing boiler and water heater. (Photo: GHT, 2007)

The backbone of the existing heating system is the existing boiler. The existing gas fired boiler was installed in 1989 and is located in the basement at the northwest corner. The boiler was manufactured by Hydro-Therm and the following information was recorded from the label on the unit: Model Number HC-100B, Serial Number NW-6688, Net IBR capacity of 68,700 BTU/H output with input of 100,000 BTU/H. This boiler is a replacement for an earlier boiler. One can see that the vent pipes for the existing boiler have been retrofitted into a hole to the flue that once received vent pipes from an earlier boiler. There is no information available for this earlier boiler. The boiler flue is extended and connected to outside through the sleeve in the exterior wall. The boiler has lost its controls and is not in operable condition.

The gas service for the house enters the house at the east side on Ninth Street at street level. The gas meter has been removed and the gas piping appear to date to the 1950's. The existing gas fired domestic hot water heater depicted on the right side of figure 4-075 is located in the basement is manufactured by Bradford. The tank size is approximately 18" round by 46" tall and about approximately 40 gallons of capacity. The water heater flue was extended and connected to outside through the sleeve in the exterior wall, see figure 4-087. The domestic water heater is connected with gas but the hot water supply and building system piping was forcibly removed. Future operation of this hot water heater is questionable.

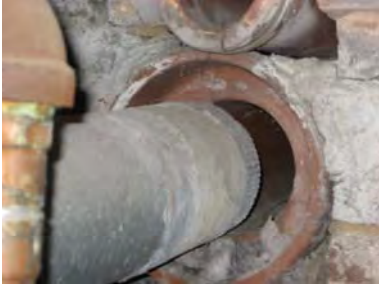
**Figure 4-076:** Boiler exhaust connection to flue. (Photo: GHT, 2007)

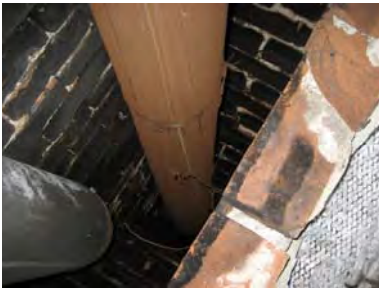
**Figure 4-077:** Metal tubes in flue as evidence of early duct work. (Photo: GHT, 2007)

Based on the indication of a fuel tank on one of the 1980's existing conditions drawings, it is assumed that the existing mechanical system prior to radiators had an oil furnace with fuel oil tank located in the basement. The design team also observed the metal tubes in the flues at both fireplace locations. The tubes penetrate the walls at the basement, and were noted at the first and third floors. Based on the fireplace grilles in place and the circular collar on the back of these grilles, the original heating system for the building is believed to be an early hot air ducted system that circulated the hot air via metal ducts that elbowed to grilles on each floor. These ducts were then attached to the furnace in the basement.

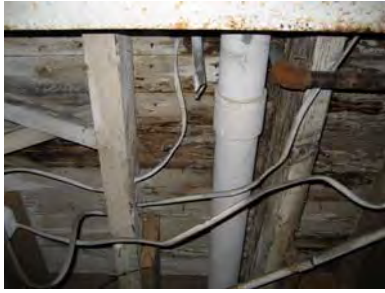
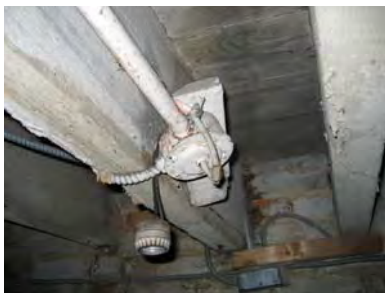
**Figure 4-079:** Wiring in the basement. (Photo: GHT, 2006)

**Figure 4-080:** Wiring in the basement. (Photo: GHT, 2006)

the basement is not consistently secured to the ceiling joists and will need to be further supported if they remain.

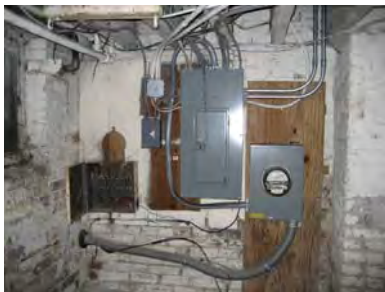
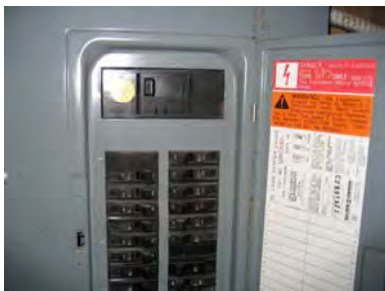
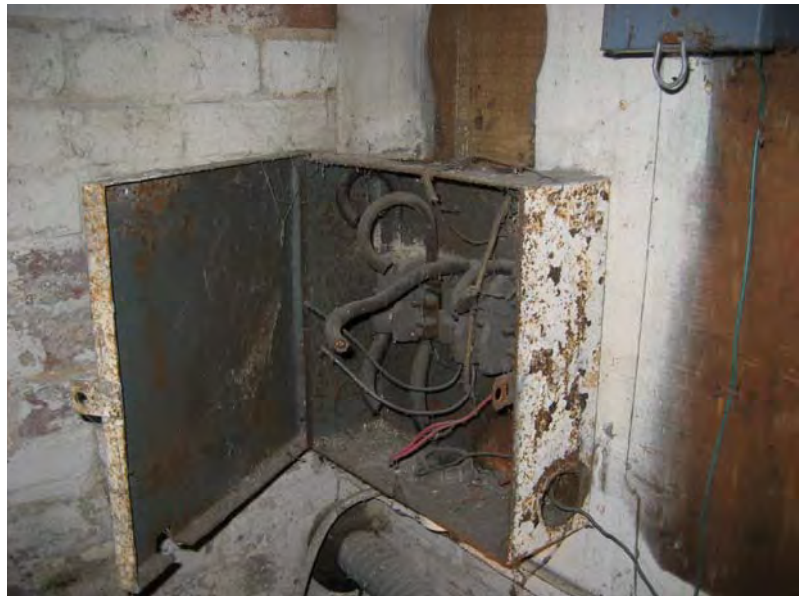
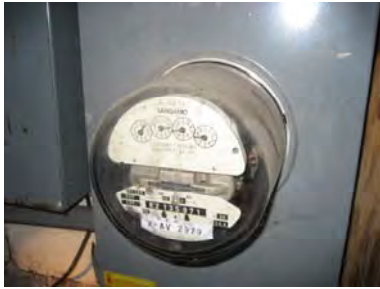
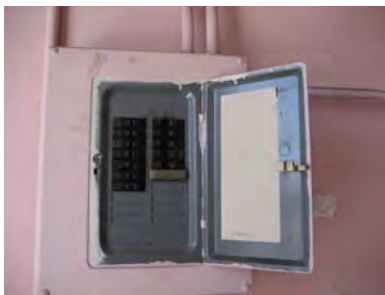
**Figure 4-081:** Electrical panels and electric meter in the basement. (Photo: GHT, 2006)

**Figure 4-082:** Modern breakers in electrical panel in basement. (Photo: GHT, 2006)

**Figure 4-083:** Old electrical panel. (Photo: GHT, 2007)

**Figure 4-084:** Detail of modern electrical meter. (Photo: GHT, 2007)

**Figure 4-085:** Electrical panel in room 203. (Photo: GHT, 2007)

The electrical service was upgraded probably at the same time the surface raceway was installed in 1989. The primary electrical panel is located in the basement. The location of an earlier electrical power service is apparent from the abandoned meter socket figure to the left of the new service and meter. The electrical service is in good condition. The size is presumed to be 200 amps single phase 120 / 240 volts manufactured by Square D. The rating of the breaker was not visible at the time of inspection. A sub panel manufactured by Square D was installed on the second floor in Room 203 and serves the power requirements on this level; this panel is in acceptable condition and could be used for future loads as calculations would permit. The electrical panels described in the basement and second floor are the only two electrical panels in the house.

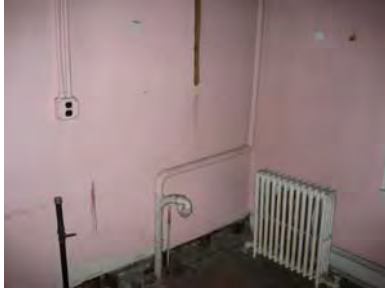
**Figure 4-087:** Radiator, radiator piping, sink and gas piping (Photo: GHT, 2006)

The building has two bathrooms and a kitchen area. Room 108 has a porcelain toilet and a sink both manufactured by Gerber. Room 207 has a porcelain toilet and sink. The sink was made by Gerber, similar to the first floor bathroom sink, but the toilet was made in Venezuela. This bathroom also has an enameled metal tub/shower. In Room 208, PVC piping extends out from the wall indicating where a sink was removed. Similarly, gas piping has been cut that indicated where a stove was once located (Figure 4-087)

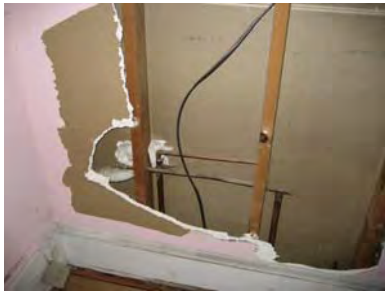
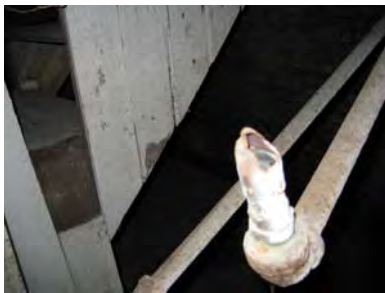
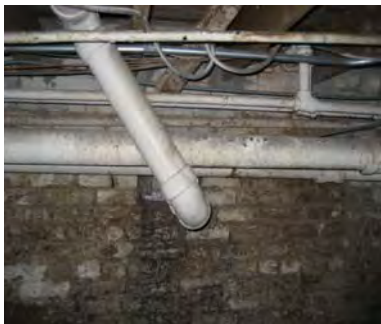
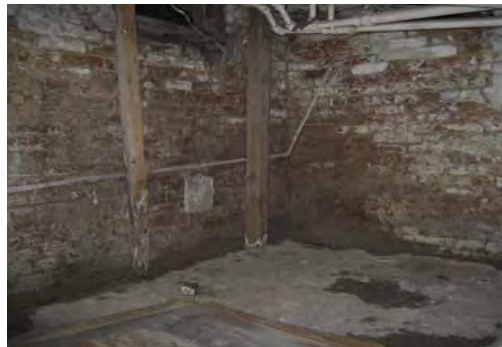
**Figure 4-088:** Remaining piping that has been cut. (Photo: GHT, 2006)

**Figure 4-089:** Remaining piping that has been cut. (Photo: GHT, 2006)

**Figure 4-090:** PVC sanitary waste pipe. (Photo: GHT, 2006)

Much of the hot and cold copper pipe has been removed; remaining copper pipe was left in place only because it was difficult to get to. The integrity of the pipe pieces that remains is questionable. See figures 4-088, 4-089, 4-089, 4-090 & 4-091 for a representation of the remaining piping. Because of the age of the remaining copper pipe used for hot and cold water in the house, piping was joined together with hi content lead in the sweat fittings. If the existing water pipes were to remain the lead content of the water could potentially be unacceptable. It is recommended that the water be tested for lead. All lead fittings must be replaced.

**Figure 4-091:** Remaining piping. (Photo: GHT, 2006)

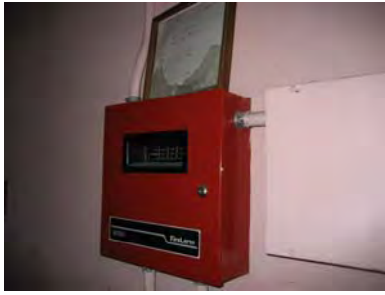
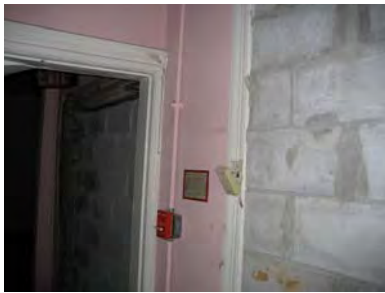
**Figure 4-092:** Fire alarm system.  
(Photo: GHT, 2006)

**Figure 4-093:** Fire alarm system.  
(Photo: GHT, 2006)

The building had a fire alarm system installed in accordance with the 1989 drawings that were filed with the building department, see figures 4-092, 4-093, & 4-094 and also see Appendix D – Archival Documents. The control panel for this system is in the front entry hall (room 102) and was installed surface mounted. The pull stations, strobes and bells are located at the stairs on each floor. The graphic above the main control panel is seen in figure 4-096. Operation of the present system is questionable. Even if the existing system operated correctly, it would not meet today's fire code or ADA requirements. The pull stations are mounted above ADA height and the flashing lights are not bright enough. The existing mounting heights of the pull device are mounted 8 to 12 inches higher than the required code height. The candela rating of the strobes used on the system is too low and does not meet candela rating of today's fire code. Lastly the fire alarm bells would require to being adjusted to the proper sound level. The exterior fire alarm bell meets the current commercial code. The existing fire alarm system does include heat detectors. These heat detectors were only installed in the basement only.
