## Condition Assessment

## **ARCHITECTURAL**

The Carter G. Woodson Home is in poor condition. The building has been vacant for many years and the constant infiltration of water because of a leaking roof had caused significant to the exterior envelope, the wood and masonry structure and the interior finishes. Although the East Elevation is in good condition, the remaining elevations are in poor condition. Because of rot and termite damage to portions of the wood support system, the main stair is sagging as are the floors in several of the rooms. The deteriorating wood framing members in conjunction with open and failing mortar joints has caused near collapse of the west wall elevation at the third floor and the southwest corner of the two story addition. The lack of heat and proper ventilation of the interior along with the high level of water infiltration has led to damage of the plaster walls, the decorative wood elements and the wood flooring.

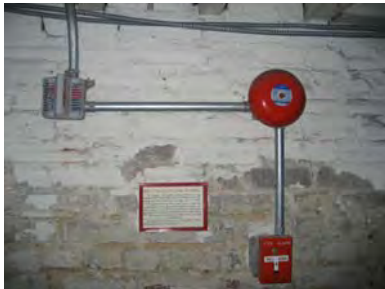
**Figure 4-093:** Fire alarm system.  
(Photo: GHT, 2006)

The building had a fire alarm system installed in accordance with the 1989 drawings that were filed with the building department, see figures 4-092, 4-093, & 4-094 and also see Appendix D – Archival Documents. The control panel for this system is in the front entry hall (room 102) and was installed surface mounted. The pull stations, strobes and bells are located at the stairs on each floor. The graphic above the main control panel is seen in figure 4-096. Operation of the present system is questionable. Even if the existing system operated correctly, it would not meet today's fire code or ADA requirements. The pull stations are mounted above ADA height and the flashing lights are not bright enough. The existing mounting heights of the pull device are mounted 8 to 12 inches higher than the required code height. The candela rating of the strobes used on the system is too low and does not meet candela rating of today's fire code. Lastly the fire alarm bells would require to being adjusted to the proper sound level. The exterior fire alarm bell meets the current commercial code. The existing fire alarm system does include heat detectors. These heat detectors were only installed in the basement only.

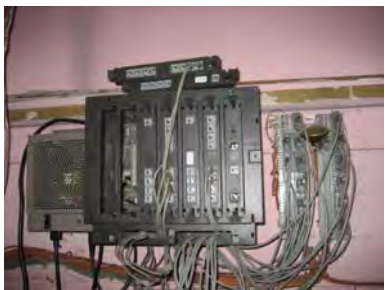
**Figure 4-094:** Fire alarm system.  
(Photo: GHT, 2006)

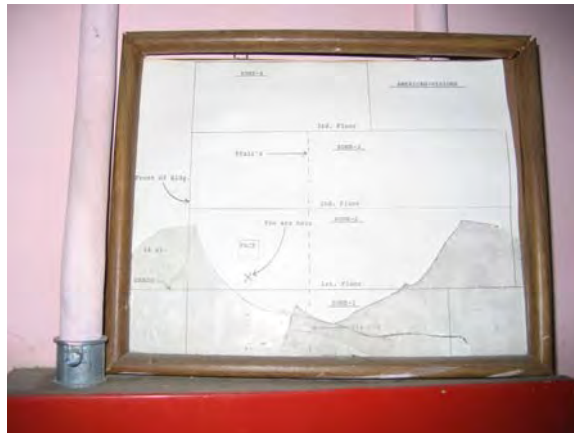
**Figure 4-096:** Graphic above the main control panel. (Photo: GHT, 2006)
