CULTURAL LANDSCAPE REPORT, AQUATIC PARK

SAN FRANCISCO MARITIME, NATIONAL HISTORICAL PARK

NATIONAL PARK SERVICE
PACIFIC WEST REGION
2010

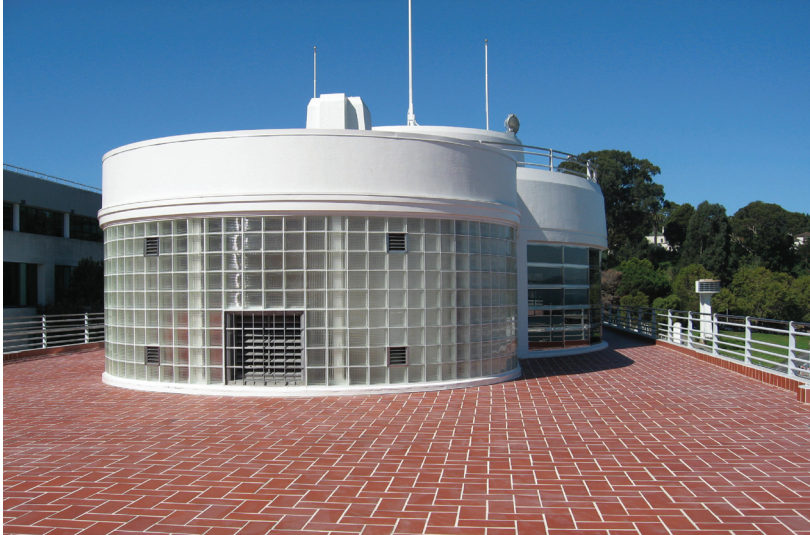
Figure 55. Rehabilitation work at the Bathhouse in 2008 included the installation of a new stainless steel window system; and a modern waterproofing system for the building roofs with new roof tiles to match the historic ones that could not be salvaged. The rehabilitated glass block pantry is now the elevator lobby on the 3rd floor. (NPS, 2008)

The most recent renovations to the building include replacement of 90 percent of the windows and doors in the building with a new system that preserves the appearance of the original design and conservation of the wall mural in the lobby. (Figure 55)

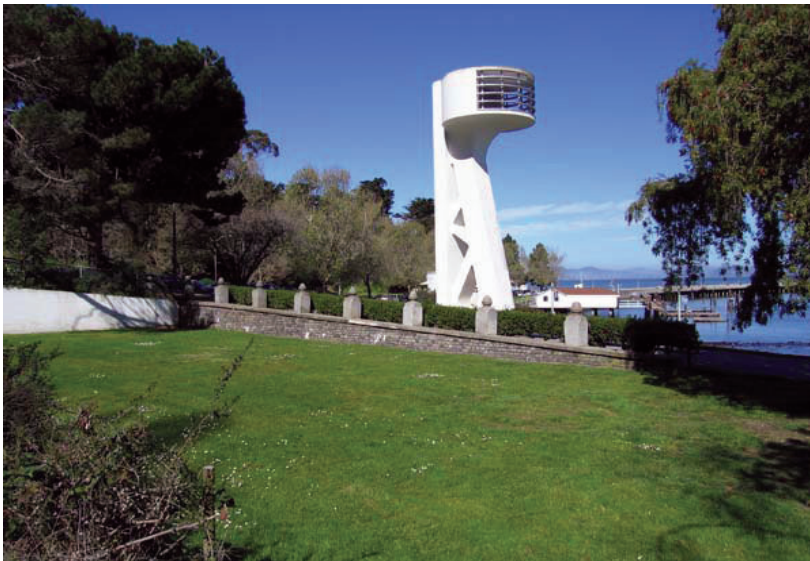
Figure 62. West Speaker Tower. View looking north. (NPS, 2007)

across the face. (Figure 62) A metal ladder providing access to the back of the speaker housing has been removed. The cover grille on the East Speaker Tower has also been removed (but will be repaired and replaced). Like other structures built by the WPA, the speaker towers were designed by William Mooser Jr. in the Streamlined Moderne style, and are integral structures in the designed landscape. Planting beds at the base of each tower historically incorporated plants that were maintained in a manner that reinforced the architectural character of the towers.

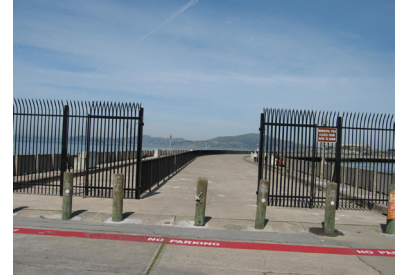
Today the pier is in very poor condition due to saturation by seawater and deterioration of metal rebar. In 2008, the park installed a fenced gate at the entrance to the pier for safety reasons, and in 2009 most of the west (bay) side of the structure was also fenced to prevent access to the most deteriorated portion of the structure. The National Park Service is in the process of planning a major rehabilitation project to repair and stabilize the structure. (Figure 64)

Figure 64. Fencing was added to the Municipal Pier in 2008 and 2009 to enhance safety until structural improvements can be completed. View looking north. (NPS, 2010)

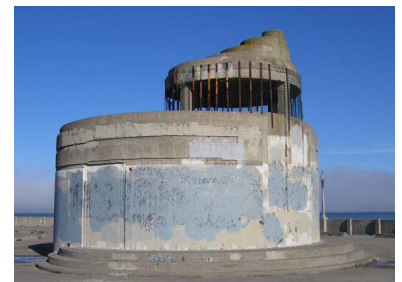
The convenience station and lifesaving station at the end of the pier was less than 50 percent complete when the WPA turned the project over to the city. These structures remain unfinished today. The circular building was designed to match the other two convenience stations in Aquatic Park. Only the rough concrete exterior was constructed. Access to the unfinished building is by bolted hatches on the roof. The interior rooms are currently filled with rubble and water. (Figure 65)

Figure 65. The unfinished convenience station at the end of the Municipal Pier. (NPS, 2007)

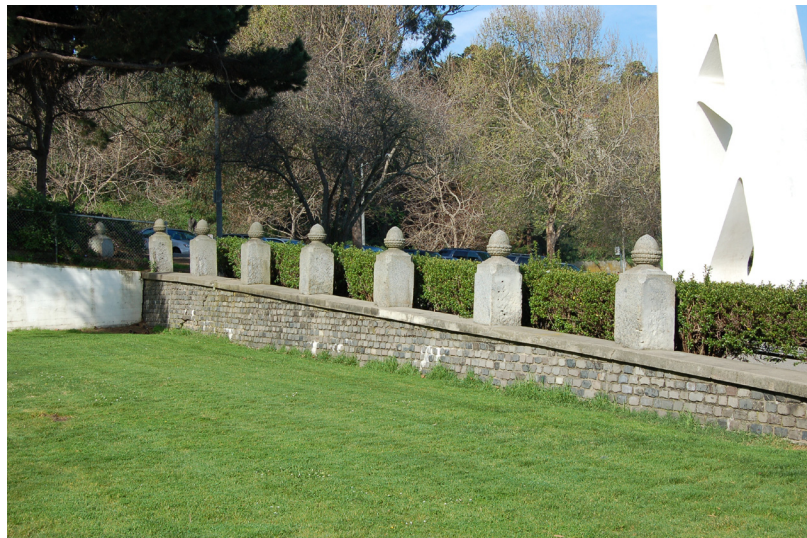
Figures 67. Stone masonry retaining wall as it appears today near the Bocce Ball Courts. A considerable amount of backfilled was used after the pumping station was removed to create a level grade on the south side of the structure. View looking west towards Van Ness Avenue. (NPS 2007)

exception of a single acorn finial, the east section of the wall is largely buried and the west side, including the curved portion of the wall, was removed at an unknown date. (Figures 66, 67)

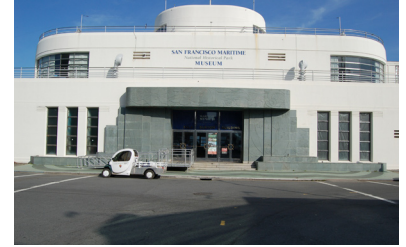
Figure 86. Front façade of the Bathhouse. View looking north. (NPS, 2006)

- Restore and maintain the historic slate façade on the south side of the building as the primary entrance to the building. (Figure 86)
- Restore the historic planting beds on both sides of the entry (see the section, “Recommendations: Vegetation, Bathhouse Plantings”).

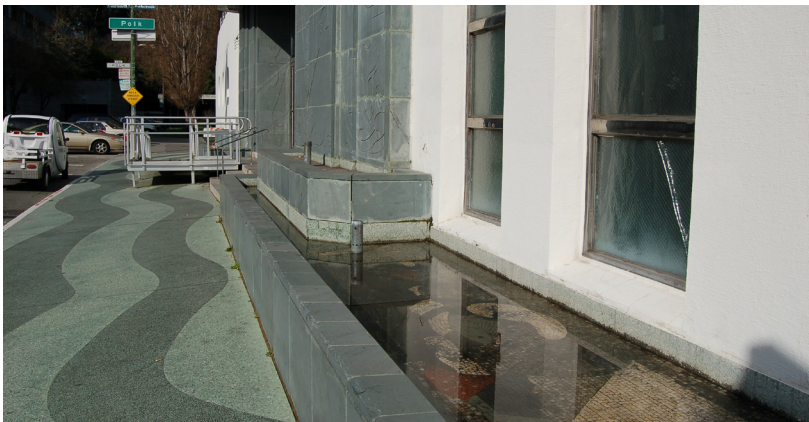
Figure 87. One of the two fountains that flank the entrance to the Bathhouse and could be restored as part of an overall landscape rehabilitation. (NPS, 2006)

- Complete rehabilitation of the fountains on the front (south) façade of the building and complete conservation of the stone and mosaics. (Figure 87)

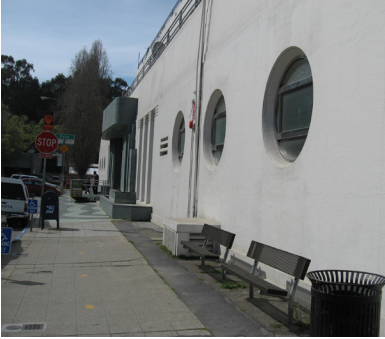
Figure 88. Northeast side of the entrance to the Bathhouse with a variety of non-compatible features such as benches, trash cans, city street signs, utilities, and public mailbox. (NPS, 2010)

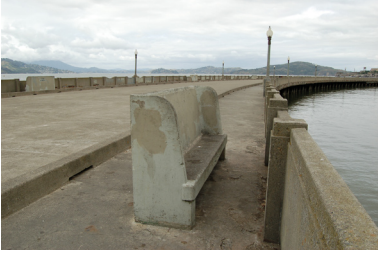
Figure 91. Historic concrete bench, parapet walls and curbing, light standards, and other site features associated with the Municipal Pier. (NPS, 2007)

- Consideration should be given to restoring and/or rehabilitating site furnishings along the decking of the Municipal Pier based on the preferred treatment for the structure. Replacement of these features with replica or “period” furnishings is not recommended. (**Figure 91**)

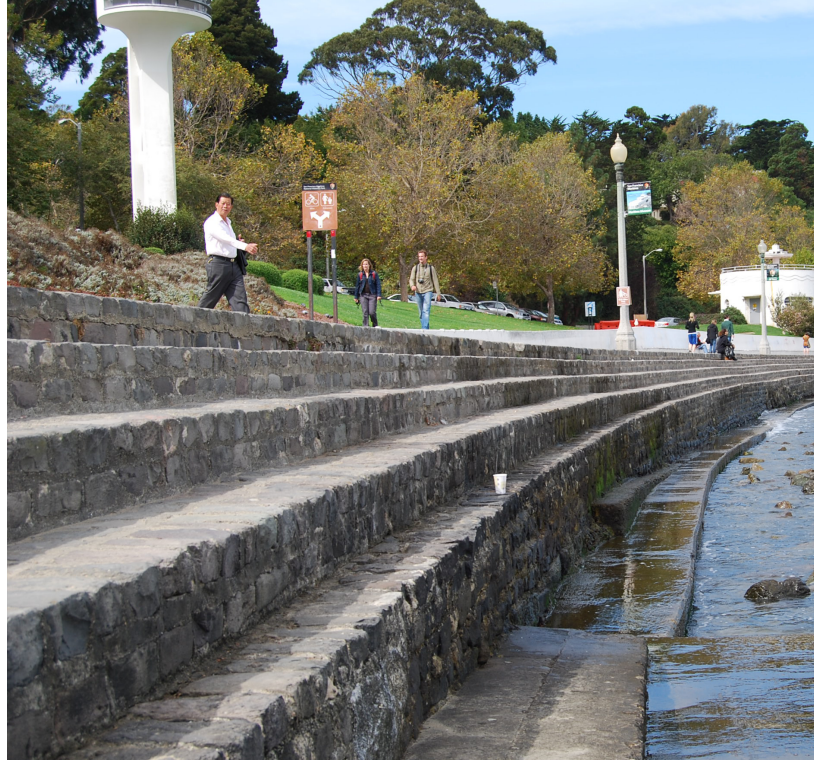
The Seawall and steps that extend the entire length of the cove from the East Convenience Station to the Municipal Pier are generally in good condition, with just a few cracked and missing basalt blocks. Stone curbs throughout the site are also in relatively good condition. Exceptions are a missing section of curb near the Sea Scouts building and damaged curbs near the West Convenience Station. Recommendations address repair and replacement. (Figure 93)

Figure 93. One of the earliest structures built during the historic period, the Seawall around the cove is in relatively stable condition. (NPS, 2009)

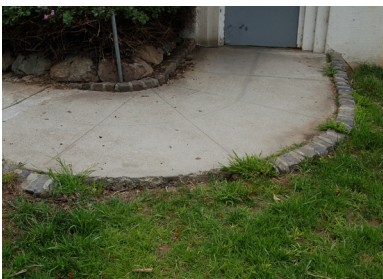
Figure 94. Missing block curbing at the West Convenience Station should be repaired using in-kind materials. (NPS, 2007)

- Replace the missing portion of the stone curbs as needed using compatible materials and appropriate restoration techniques. (Figure 94)
- Repairs to all historic stonework should be done in consultation with a historical architect or preservation mason.

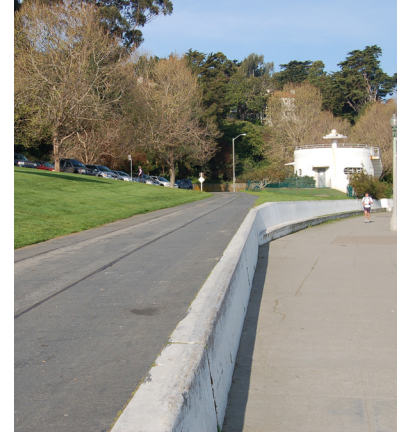
The low concrete retaining wall that borders the Beach Promenade from the West Bleachers to the West Convenience Station shows signs of wear, exposure, and damage resulting from use by skateboarders and bicyclists (“grinders”). Some of the hardware installed on the eastern portion of the promenade wall to discourage skateboarders has broken off, damaging the wall. Recommendations address repair and maintenance.

Figure 95. Concrete retaining wall between the Beach Promenade and the State Belt Railroad tracks. View looking west (NPS, 2007)

- Preserve and protect the integrity of the Beach Promenade Retaining Wall.
- Discourage recreational use by skateboarders. Maintain the use of deterrent bolts on the wall to prevent damage. Although currently damaged in places, existing bolts appear to deter many skateboarders. (Figure 95)

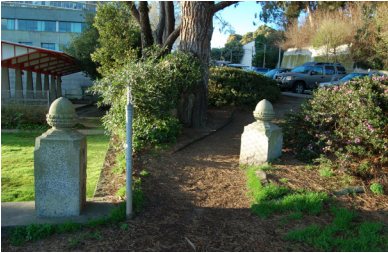
Figure 97. Remnant features of the original stone retaining wall as it wrapped around the park to Van Ness Avenue. View looking south. (NPS, 2008)

The stone retaining wall that borders the Bocce Ball Courts was one of the earliest structures built during initial construction of Aquatic Park. It was built to accommodate site grading for the extension of Van Ness Avenue and the State Belt Railroad grade. Based on historic photographs, the original wall was considerably longer than it is today and the grade difference from one side of the wall to the other appears to have been as much as 20 feet. The city water pumping station was located on the lower side of the wall where the Bocce Ball Courts are today. Photographs indicate that the wall was shortened in 1937 when additional grading was done to accommodate construction of new park buildings. Around 1942 the pumping station was removed and the area on the south side of the wall was backfilled, leaving only approximately 4 feet above grade at its highest end. The wall remains distinctive today for its stone construction and the granite acorn bollards on top of the wall. (Figure 97,98)

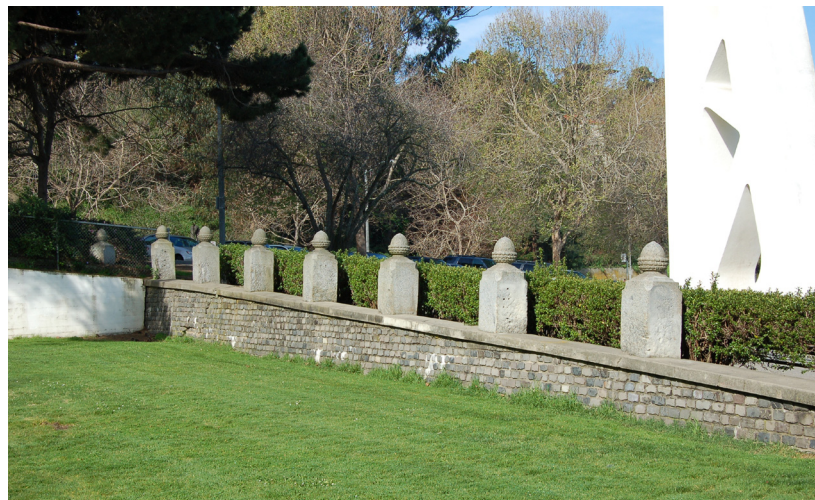
Figure 98. View of the stone retaining wall looking northwest from the lawn near the Bocce Ball Courts. The amount of exposed wall visible in the park today generally slopes to the east based on fill added to even the grade when the pump house was removed in the 1940s. (NPS, 2008)

- Inspect the wall annually to identify potential structural issues and damage to the stone surface. Repair damaged components in kind, matching materials and finish.
- Integrate preservation maintenance activities for inspection and preservation of the wall into FMSS.
- Ensure that any future park development affecting the historic character of the stone retaining wall (such as development of historic

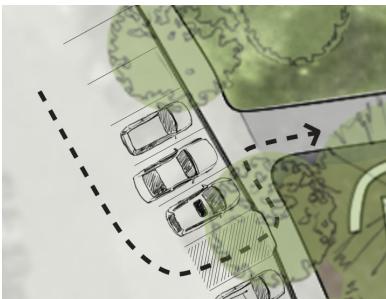
Figure 99. A slight realignment on Van Ness Avenue for bicycles routing through Aquatic Park provides a simple mechanism to slow the speed of cyclists and reduce potential conflicts with pedestrians.

- Maintain the current alignment and width of the Upper Promenade, Beach Promenade, and Van Ness Avenue extension as primary historic circulation structures linking the park with adjacent areas. (Figure 99)

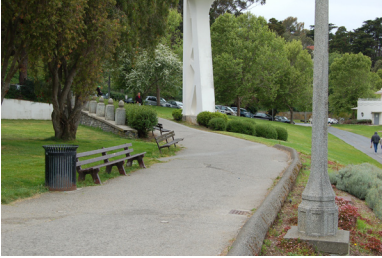
Figure 101. Rolled asphalt curbing along the Upper Promenade. View looking west. (NPS, 2008)

- Remove the raised asphalt and pre-formed concrete curbs around the East Speaker Tower and along the Upper Promenade. If curbs are currently needed to control water run-off and drainage, a low, narrow profile concrete curb is more compatible with the historic character and should be used in place of rolled asphalt curbs or pre-form concrete. (Figure 101)

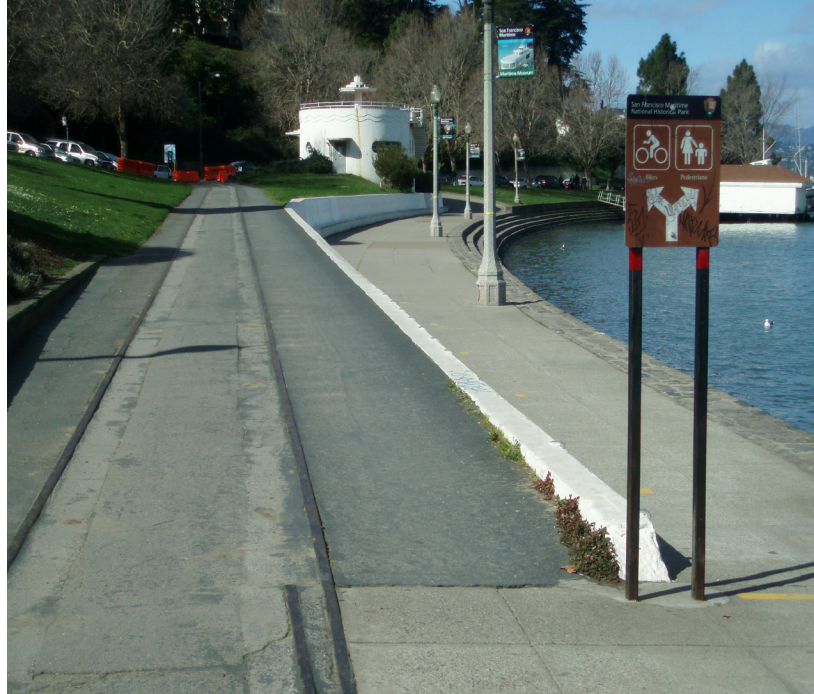
The elastic nature of the asphalt paving has a tendency to make it sag and separate around the rails. Today the uneven character of the rails and the asphalt bedding around them has the potential to create safety issues for bicyclists and other users of the park. Heavy truck traffic and frequent patches to the asphalt exacerbate the safety issue and create an adverse visual impact. (Figure 102)

Figure 102. In most cases the separation between bicycles routed on the upper walkway and tracks (left) and pedestrians along the shoreline on the Beach Promenade helps mitigate potential pedestrian/bicycle conflicts. Over the years, asphalt paving and patching around the tracks has created uneven surfaces and in some cases, presents safety hazards. This view looking west. (NPS, 2005)

- Replace existing asphalt paving around the State Belt Railroad tracks with concrete to create a more stable surface and track bed.
 - Ensure that new concrete pavement is finished flush with the top of the rails, without gaps, and the top of the rails are visible on the surface of the pavement.
 - Use a compatible concrete material, and finish for all future repairs and patches to the rail bed along the Beach Promenade, ensuring a smooth and level surface at grade.
- Maintain lawn and/or vegetation adjacent to the rail line to clearly delineate the historic dimension and edge of the alignment.
- Repair areas where impervious surface materials such as asphalt, gravel, or compacted earth have spread beyond the original edge of the walk and prevent the growth of vegetation. Replant with sod with mesh or geo-tech underlay to support edge treatments as needed.

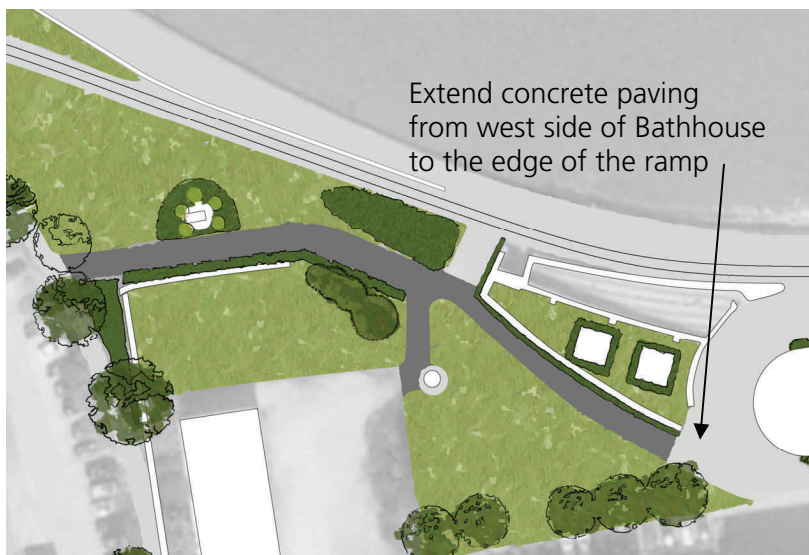
Figure 103. Plan view showing the extension of concrete paving west of the Bathhouse to the beginning of the Upper Promenade. (NPS, 2007)

- Resurface the walkway using concrete paving along the front façade of the Bathhouse (matching the paving on the east side), to the point where the Upper Promenade turns toward Van Ness Avenue (west of the ramp). Date-stamp new paving to differentiate it from existing materials. ² (Figure 103)

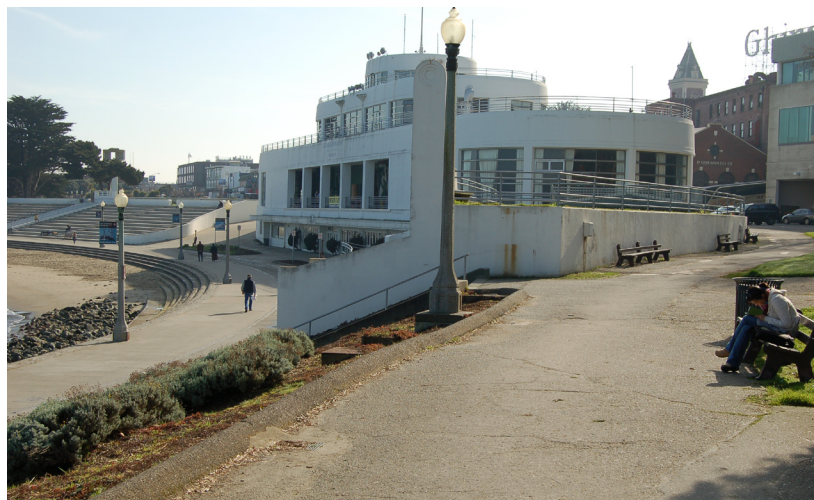
Figure 104. View of the Upper Promenade showing the rolled curb along the edge of the walkway and planting bed (left), and the patching and expansion of paving leaving a relatively undefined edge on the right side. (NPS, 2006)

- Rehabilitate areas where asphalt, gravel, or compacted earth have migrated beyond the edge of the promenade and are preventing vegetation growth. (Figure 104)
- Ensure that any future park development affecting the historic character of the Upper Promenade, such as development of a streetcar stop in this area, is considered and evaluated within the context of the historic designed landscape and potential impacts to the NHL district.
 - Assess potential adverse effects of new park development affecting the historic design of the Upper Promenade and develop appropriate mitigation measures in consultation with a historical landscape architect and/or cultural resource staff.

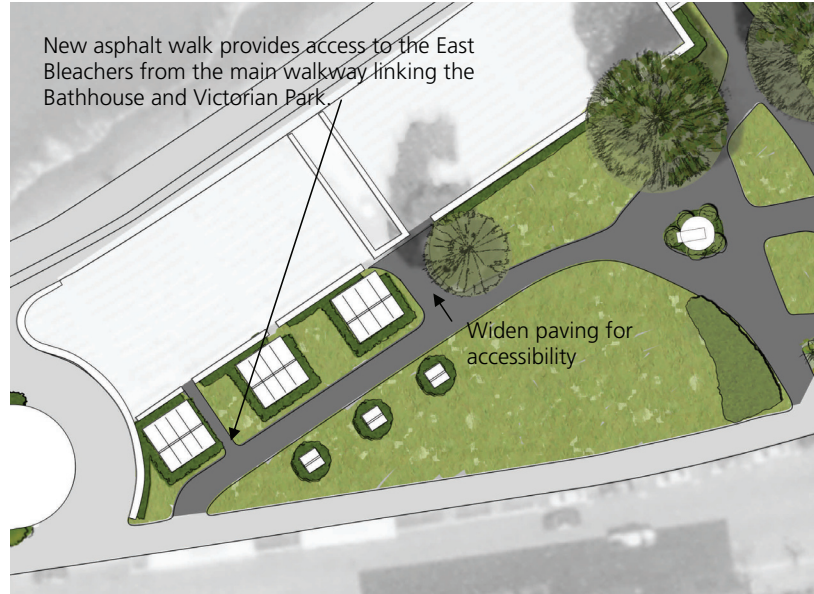
Figure 105. Plan view showing the areas behind the East Bleachers. (NPS, 2007)

- Restore the historic configuration, alignment, and width of walkways behind the East Bleachers as part of the rehabilitation of the East Bleachers.
 - Add a new access walkway on the west side of the East Bleachers between the skylights. (Figure 105)

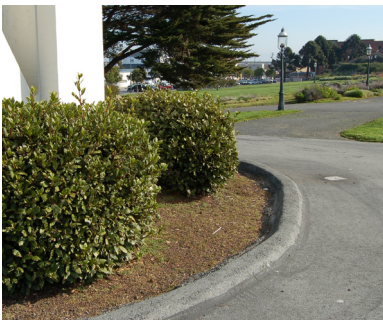
Figure 106. Raised asphalt curb around the East Speaker Tower planting bed. (NPS, 2008)

- Minimize the future surface patching of walkways in this area. When paving repairs become extensive, consider overall rehabilitation using either a slurry coat and chip seal or other material that is visually compatible with other walkways in the park.
- Remove the raised asphalt curb around the East Speaker Tower and replace with a simple asphalt pavement edge that is flush with the walkway. Correct drainage by re-grading adjacent beds or ground plane. If structure is still required to control runoff, use a low, formed-concrete edging material in a manner consistent with the curbing used on the west side of the site. (Figure 106)
- Remove the asphalt paving in the area of the removed Monterey pine tree (*Pinus radiata*) and reestablish lawn. Plant a new Monterey pine tree (*Pinus radiata*) and add mulch material around the trunk. (See Recommendations: “Vegetation”)

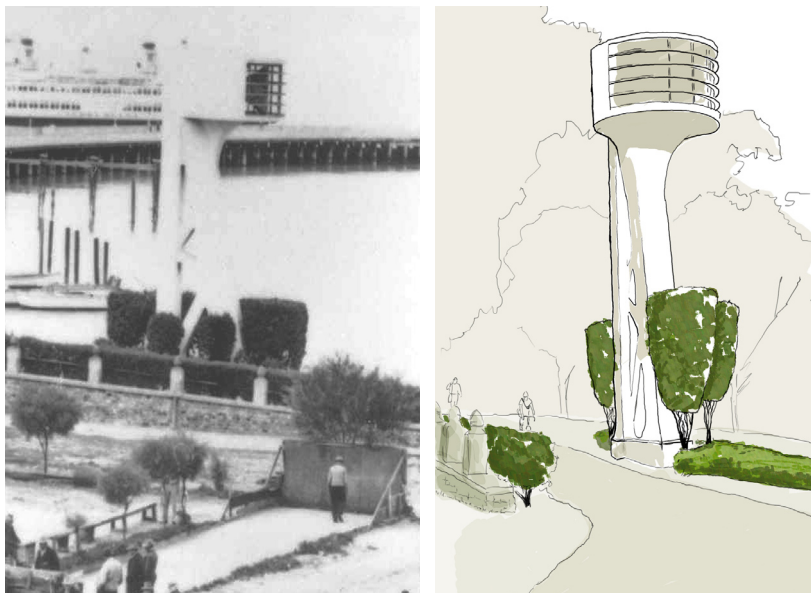
Figure 110 a&b. During the historic period, Grecian laurels planted around the West Speaker Tower were pruned into an urn-shape, with narrow base and broader top. Recommendations encourage the remaining laurels to be reshaped into a similar form. Left; Detail of historic view looking north from the Bocce Ball Courts, ca. 1952; Right: Concept showing proposed form for pruning existing and newly established laurels.

- Rehabilitate the planting beds around both speaker towers.
 - Amend and replenish soils as needed.
 - Remove and replace in kind existing shrubs in the bed with suitable species.
- Retain the existing Grecian laurels (*Laurus nobilis*) around the West Speaker Tower. Prune and reinvigorate to reestablish the historic character of these materials as a tall, vase-shaped plant. (Figure 110 a&b)

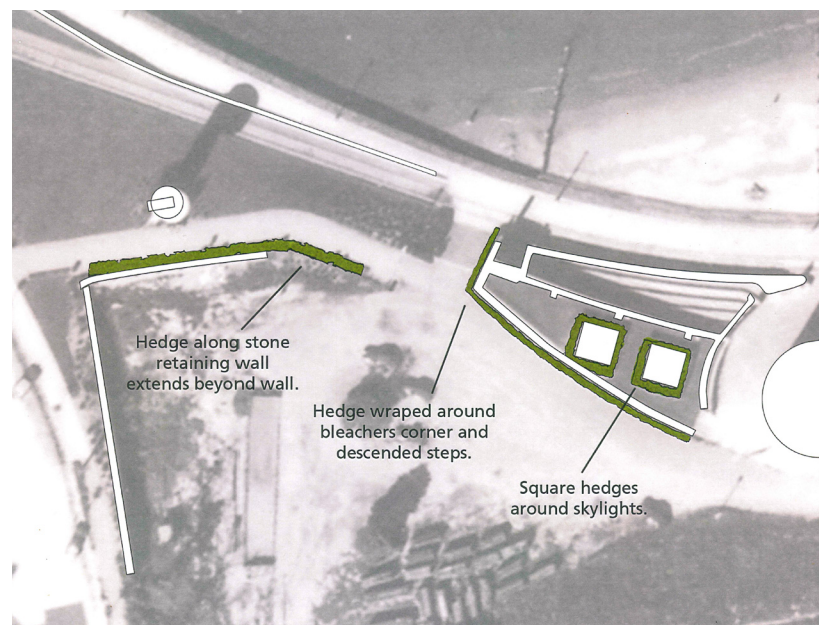
Like the East Bleachers, a broadleaf evergreen hedge extended along the south wall of the West Bleachers. Similar in character to the hedge along the East Bleachers, when the hedge reached the southwest corner of the West Bleachers, it wrapped around the wall and followed the wall along the steps and narrow planting bed leading down to the Beach Promenade. (Figure 113) Today the hedge is gone and the area between the bleacher wall and the Upper Promenade has been paved with asphalt.

Figure 113. Graphically overlaid on a 1948 aerial photograph of Aquatic Park are the hedges located on the west side of the park during the historic period. The hedges wrapped around the stone retaining wall and the wall behind the West Bleachers, stepping down to the Beach Promenade. Recommendations call for re-establishing these hedges. (Pacific Aerial Survey, 3-10-05, 1948)

- Restore the hedge behind the south wall of the West Bleachers, around the southwest corner of the wall, and down the steps.
 - Remove existing paving and redefine the extent and dimensions using historic photographs and treatment drawings.

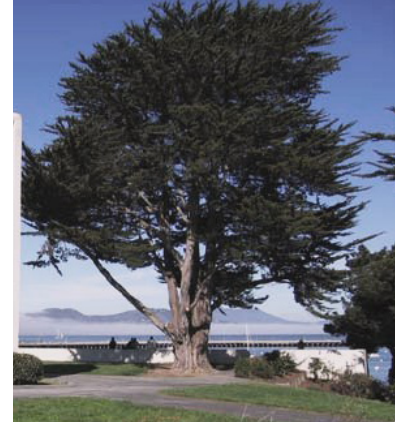
The Monterey cypress that is east of the bleachers within Victorian Park was also planted as part of the development in the 1960s. Although it is compatible with the character of the historic designed landscape of Aquatic Park, it is not historic. (Figure 116)

Figure 116. Planted in the 1960s during development of Victorian Park this Monterey cypress tree on the east side of the park is not historic, but is compatible with the character of the park. (NPS, 2008) .

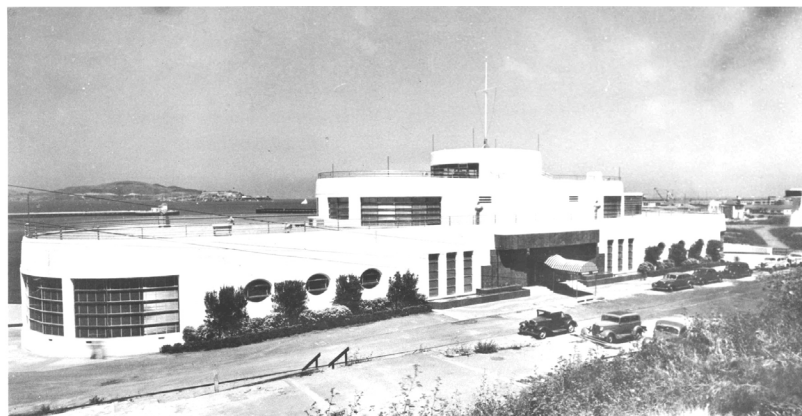
During the historic period ornamental plantings were used in front of the Bathhouse, along Beach Street, and along the north side of the building, facing the cove. In front, two planting beds extended along the foundation of the building on each side of the entrance. (Figure 117) While plantings within the beds changed at least once during the historic period, the character of the beds remained the same.⁶ By the mid 1940s each bed was composed of four tall, upright shrubs with an open form planted between the round porthole windows. Below these, shrubs were planted in a continuous row. A low hedge, not more than 18 inches high, lined the sidewalk in front of the shrubs. These beds

Figure 117. View of the Bathhouse from the hill north of Beach Street, showing the vegetation and character of plantings across the front façade of the building. View looking northeast, ca. 1940. (*San Francisco Maritime NHP, Historic Documents, Photograph Collection, P81-073,2n*)

were generally maintained to be formal in character with clipped edges and symmetry that reflects the architectural forms of the building. Since the historic period these beds have been removed and paved over with asphalt.

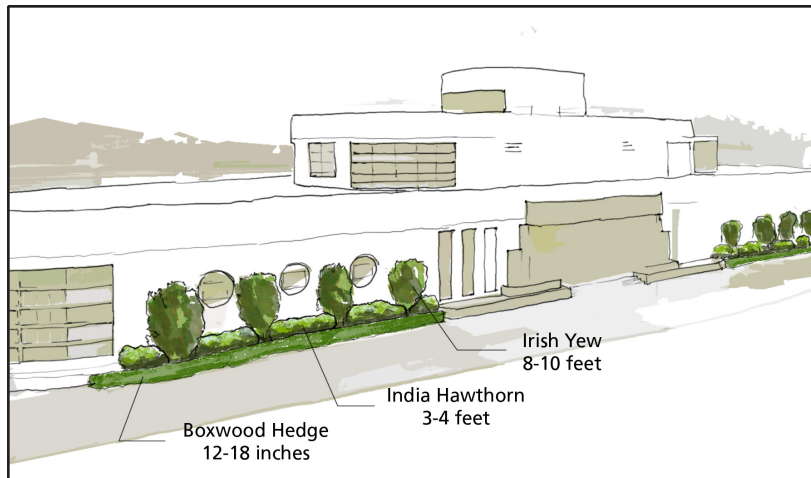
Figure 118. Treatment recommendations for plantings in front of the Bathhouse encourage restoration of non-extant planting beds and materials.

- Restore planting beds in front of the Bathhouse along the Beach Street sidewalk. (Figure 118)
 - Undertake restoration in conjunction with general rehabilitation of the façade, fountains, utility infrastructure, and removal of asphalt walkways along Beach Street.
 - Design planting beds to extend on each side of the building entrance from the end of the fountain to the end of the building.
 - Establish plants in each planter as follows
 - i. Four tall (8-10 feet) open-form shrubs such as *Taxus baccata* ‘stricta’ or similar.
 - ii. A grouping of flowering shrub (3-5 feet tall) such as *Raphiolepis indica* or similar.
 - iii. A low-growing hedge (12-18 inches in height) such as *Buxus microphylla japonica* or similar.

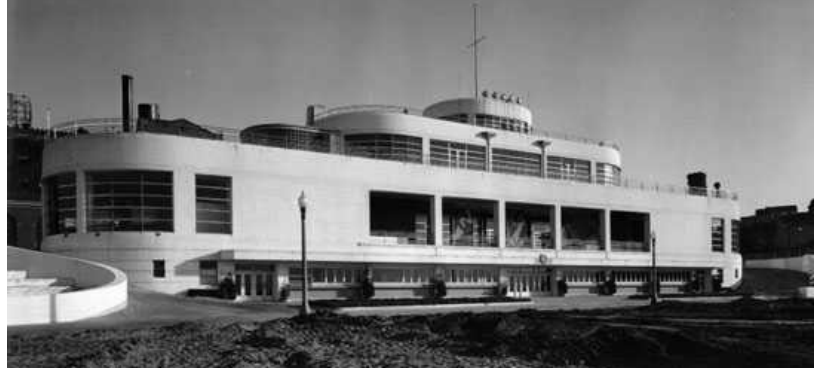
Figure 119. Historic view of the north side of the Bathhouse showing the placement of juniper plants in the planters along the foundation of the building. View looking southwest, n.d. (Courtesy of the San Francisco History Center, San Francisco Public Library AAA 6748)

On the north side of the Bathhouse, individual shrubs were planted in small planters between each set of windows. (Figure 119) Eight semicircular planters each contained one juniper shrub, maintained in an upright, irregular conical form. A longer bed was located at each end of the building. There is no indication that these planters ever contained more than a single shrub each. Today, six of the original eight junipers remain in the planters near the building; two of the junipers have been removed and their planters paved over with concrete. The long planting bed on the west end of the Bathhouse contains hebe shrubs, while the bed on the east side is empty. It is unknown if this material was used historically, but it is compatible with the historic design. Today the junipers appear in poor condition from either a lack of light in the shade of the building, or a lack of water due to the small planters and overhanging structure.

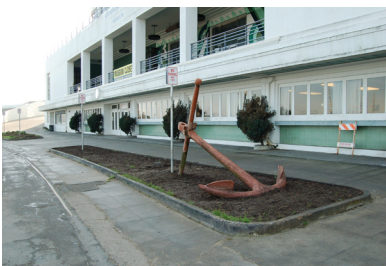
Figure 120. View of the existing juniper plants on the north side of the Bathhouse. View looking south east. (NPS, 2008)

Also on the north side of the Bathhouse are two, low median planting beds. (Figure 120) These beds are approximately 6-inches high and defined by a concrete curb. During the historic period, these beds contained vegetation, although the historical record is insufficient to determine the specific plant materials. Historic photos suggest that the planting beds may have contained very low shrubs or a low hedge around the edge of the beds, with lawn or groundcover in the center. Today the beds do not contain any vegetation.

- Restore the two missing planters on the north side of the building to reinforce the symmetry of the planting. Retain the hebe in the westernmost bed or replace with a similar shrub. Plant a matching shrub in the bed at the eastern end of the building.
- Plant eight shrubs in planters along the north side of the building. The long bed on the east end of the building should contain a shrub that matches the one on the west end. This may be accomplished either by planting a hebe to match the existing one on the west end, or by replacing the hebe and planting matching shrubs in both planters.
- Plant the two low planter medians on the north side of the Bathhouse with a suitable low-growing groundcover similar in character to *Rosemarinus* or *Juniperus sp.*

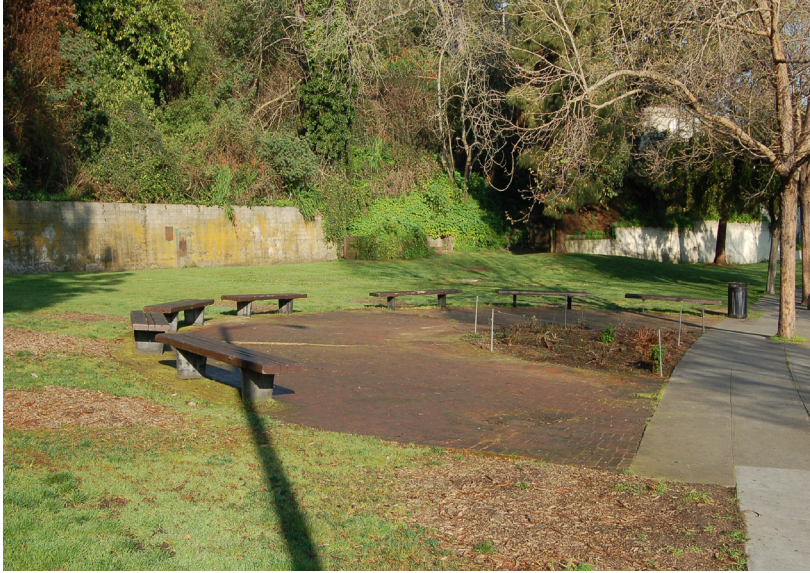
Figure 122. Several structures associated with the 1970 development of Pocket Park were removed in 2008 including the benches pictured here. Recommendations encourage additional rehabilitation to a more compatible setting adjacent to Aquatic Park. (NPS, 2008)

- Remove incompatible components of the pocket park including:
 - The brick paving and timber benches located in the pocket park. Replace with lawn.
 - The pine trees and fig trees currently growing into the allée of London plane trees.
 - The berms and contrived landforms.
- The missing portions of the sidewalk on the west side of Van Ness Avenue.
- Retain existing trees in the pocket park for shade. When they die or become hazard trees, they should not be replaced.
- Preserve the historic character of the street by protecting and maintaining the historic features, including the street lamps, concrete street surface, and London plane trees (*Platanus acerifolia*).
 - Preserve concrete streetlamp posts. Repair when necessary using compatible materials and techniques.

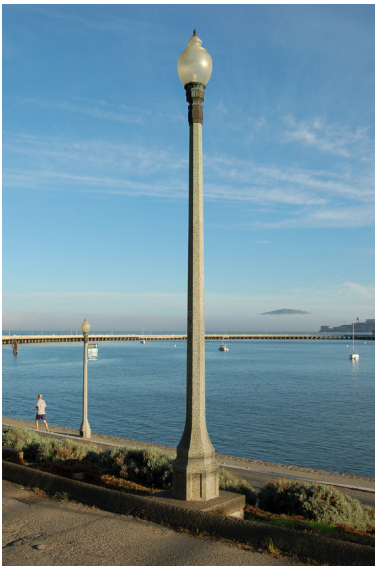
Figure 123. Historic lampposts remain in Aquatic Park along the Beach Promenade and Municipal Pier. (NPS, 2007).

- Preserve and maintain small-scale historic site features that contribute to the character of the NHL District.
 - Retain and repair as needed historic lampposts located along the Beach Promenade and in other areas throughout the park. (Figure 123)
 - Repair and reestablish as possible, the historic drainage features including grates and manhole covers.
 - Ensure that the historic basalt block curbing located along walkways is preserved and maintained in kind through the Facility Maintenance Software system (FMSS).
 - Document the historic small-scale features such as benches and light standards on Municipal Pier. Consider restoration of these features in the future rehabilitation and/or reconstruction of the structure.

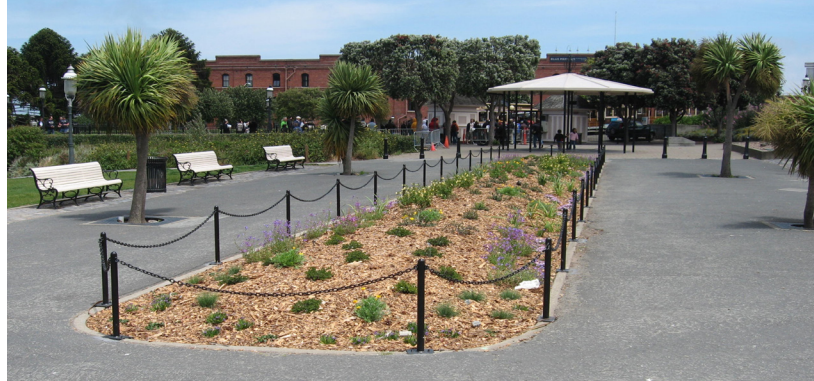
The primary issue with all vegetation in the upper plaza is the degree to which it can be maintained in good condition. Currently large numbers of people affect the planting beds in the upper plaza by creating social trails and shortcuts, trampling plants, and compacting the soil. Substantial amounts of trash and debris collect between plants in the beds and dead flower and seed stalks, and annual die back create an unkempt look. The wide variety of species adds to a wild appearance, and fast-growing species often require severe pruning to keep them from outgrowing the space.

Figure 127. Using funds from a First Bloom grant, the park worked with Boys and Girls clubs in the city to replant the planting bed in the center of the Victorian Park. pedestrian plaza The grant program emphasizes the opportunity to engage urban youth in garden projects where they can learn about the use of native plants in the landscape. (NPS, 2010)

- Remove plants currently in the planter down the center of the plaza and replace with low-growing materials and ground cover similar in character to *Juniperus*, *Cistus*, *Lantana*, Rosemary, *Hebe*, *Santolina*, and *Pelargonium*.
 - Consider installing a low profile (22 inches high) post-and-chain barrier around the plant beds to prevent pedestrian shortcuts and social trails through the beds.
- Plant low-growing shrubs, groundcover, or turf in the raised beds along Beach Street to improve overall conditions that result from the inappropriate use of these areas by the public. (Figure 127)
