Subject: NEPA and NHPA Clearance: 2011-041 Yosemite Valley, Correct Tecoya Dorm and Y Apartments Egress (39131)

Project: 2011-041 Yosemite Valley, Correct Tecoya Dorm and Y Apartments Egress

Hughes Associates, Inc. (HAI) has prepared this egress analysis report for Tecoya Dorms and Y Apartments to identify the existing egress conditions, identify egress deficiencies, and make recommendations for correction. The information within this report is based upon a site survey conducted on July 19, 2011 and documentation from the Condition Assessment conducted by others in 2008 for the Y Apartments. A Condition Assessment was not provided for the Tecoya Dorms. Compliance with accessibility provisions are not within the scope of services for this egress analysis and have not been reviewed.

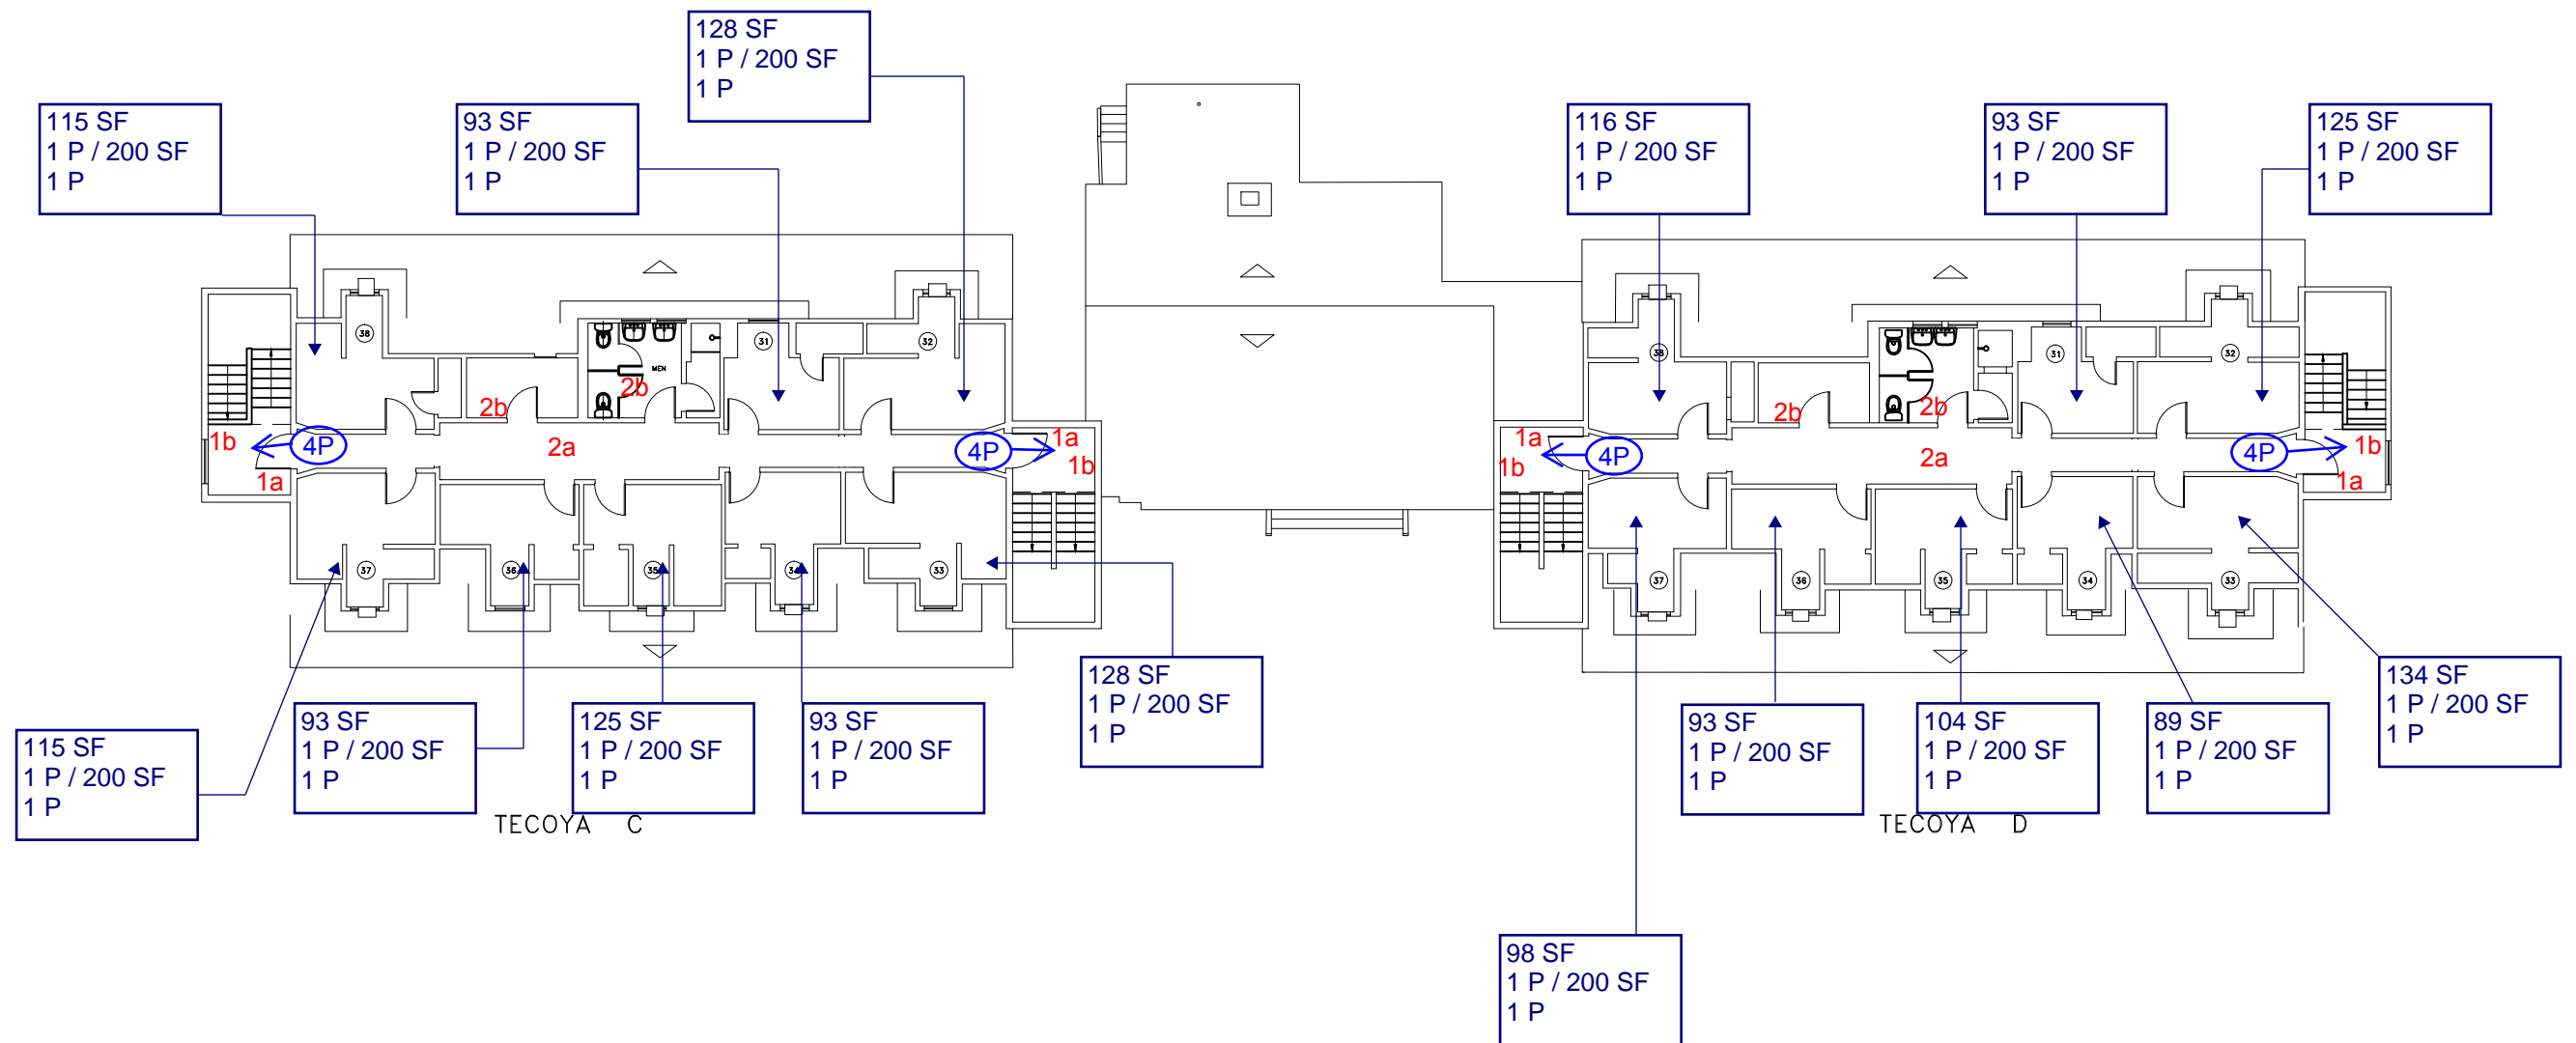
TECOYA C & D: THIRD FLOOR

1. Tecoya A – D, Egress Width: At the Third Floor of each of these buildings, the corridor narrows at both ends to a width of approximately 33 inches. For existing buildings, NFPA 101, Section 7.3.4.1.2 (referenced by NFPA 101, Section 29.2.3.1) permits the width of the exit access to be not less than 28 inches. Although the existing configuration complies with NFPA 101, the condition of a corridor narrowing in the path of egress travel is rather unusual. Therefore, the condition has been documented with the appropriate code reference to alleviate future concerns. The existing arrangement is also supported by CHBC, Section 8-502.2.

The Third Floor of each building serves a very small calculated occupant load of eight (8) persons. The dorm residents are non-transient occupants and are familiar with the paths of egress and conditions of egress. Because the buildings are not provided with elevators, occupants traverse the exit access path daily. Additionally, the provision of automatic sprinkler protection throughout each building is a significant enhancement to the life safety features of the building.

Recommendation: No modifications are feasible or warranted given the existing constraints of the building and occupant familiarity as noted.
