Canal Lockkeeper's House

Historic Structure Report

National Mall and Memorial Parks
Washington, District of Columbia

Prepared by:
QUINN EVANS ARCHITECTS
August 2011

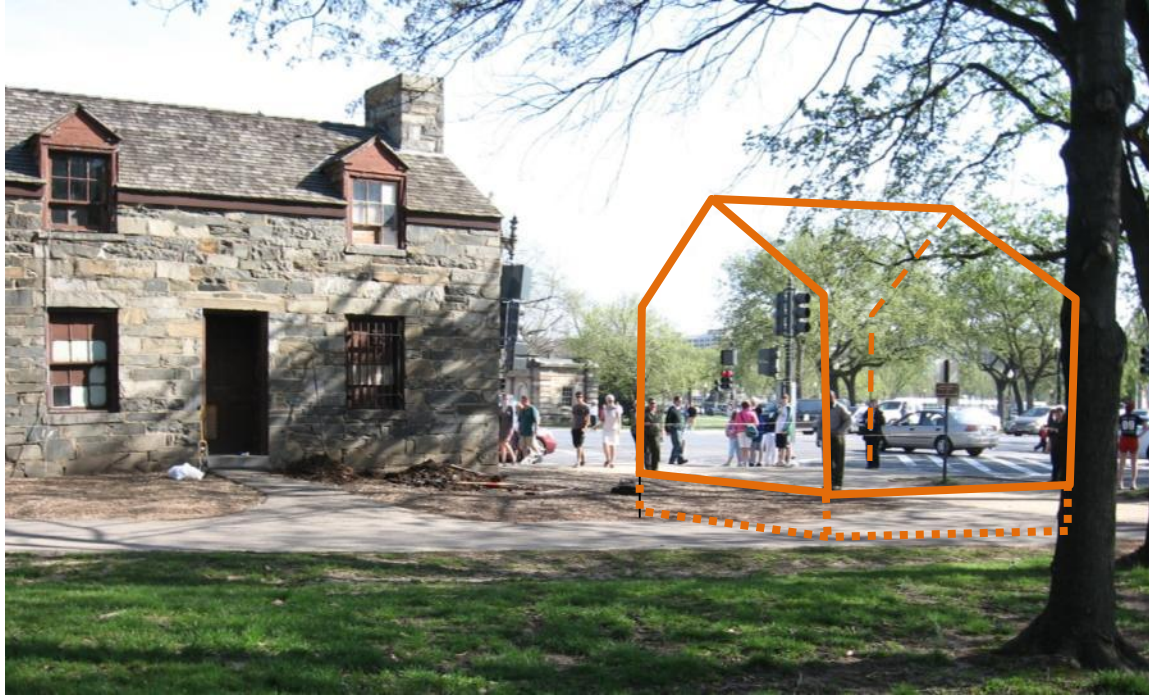
The NPS Resource Management preservation team for National Mall and Memorial Parks and Quinn Evans measured where the house originally stood (see figure 1.1.18). Then the team dug test pits along the south elevation under each of the windows in search of the foundation and signs of previous openings. A window lintel was found below grade under the existing southeast window (see figure 1.1.19). Another window lintel was found below grade under the existing southwest window (1.1.20). A concrete foundation with yellow, white, and orange colored aggregate was found. Based on the NPS Type II drawing for lockhouses and Lockhouse 16, additional test pits were dug

Figure 1.1.18. Locating the original location (QEA, April 02, 2010). Orange lines represent the lockhouse at its original location (49 feet to the east and 6 feet south) and lower elevation. The east side of the lockhouse's original location is at the current curb line of 17th Street. Dashed lines indicate the first floor at its original elevation, approximately 2 feet 3 inches lower than the current first floor elevation. The location was laid out by the NPS Resource Management preservation team for the National Mall and Memorial Parks and QEA.

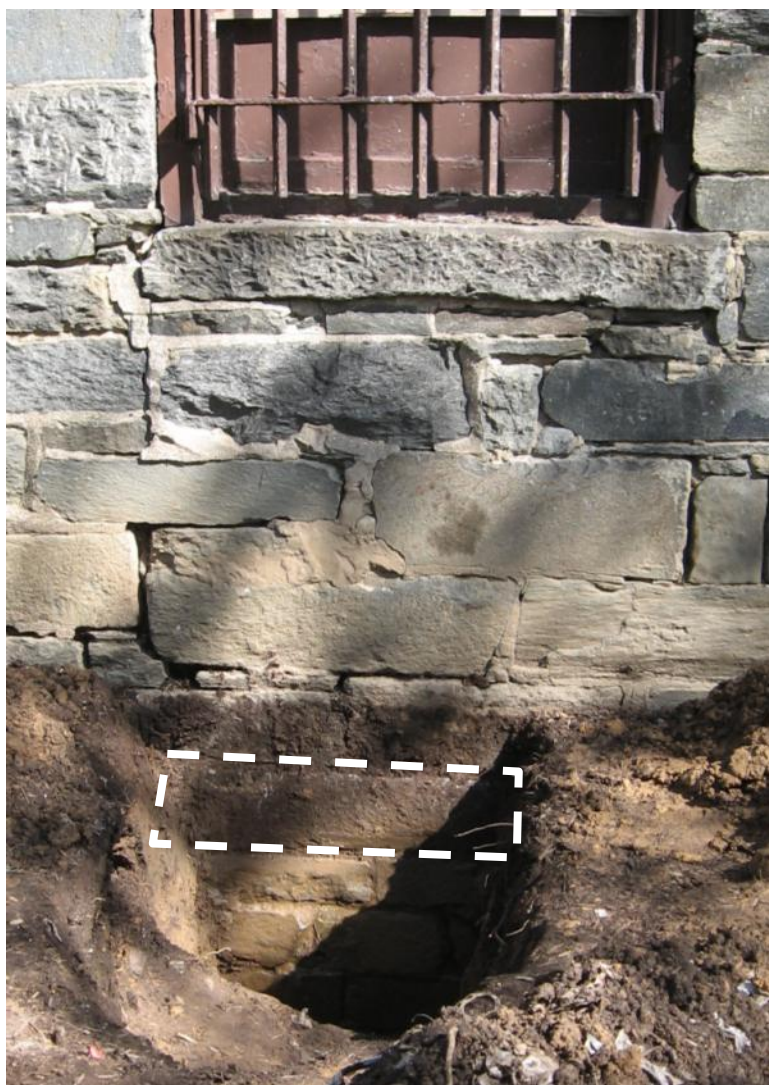
Figure 1.1.19. Test pit under the southeast window (QEA, April 02, 2010). Rectangle identifies a long, thin stone which is believe to be a window lintel from the cellar level dating to original construction.

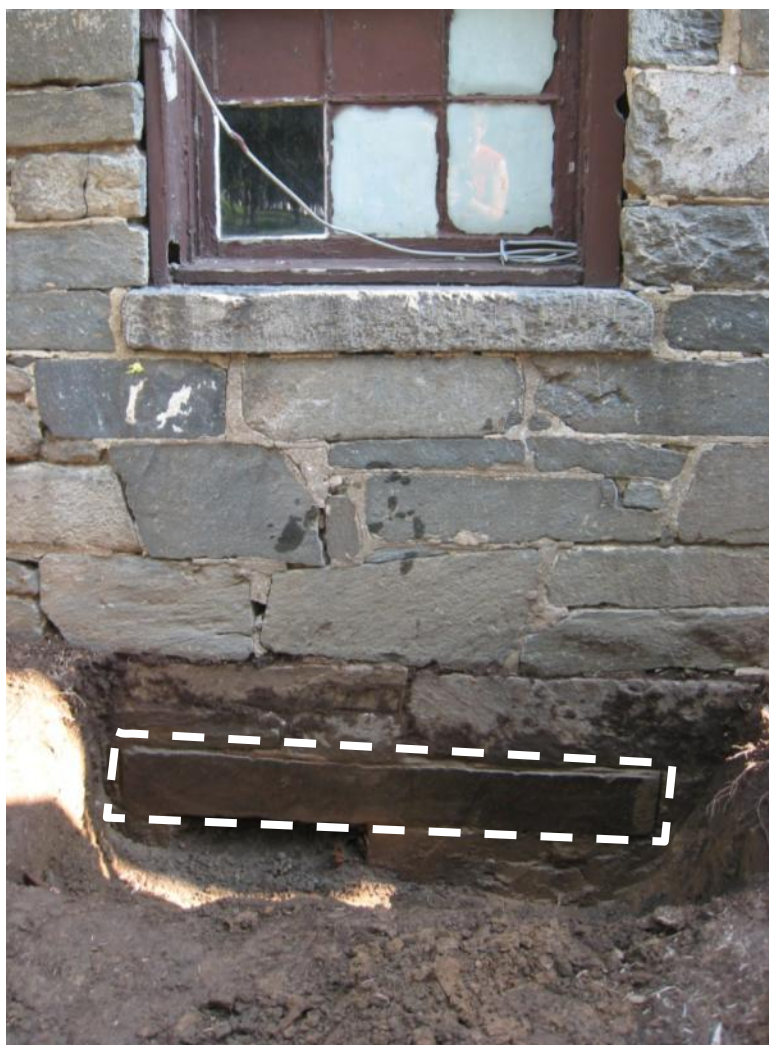
Figure 1.1.20. Test pit under the southwest window (QEA, July 20, 2010). Rectangle identifies a long, thin stone which is believe to be a window lintel from the cellar level dating to original construction.

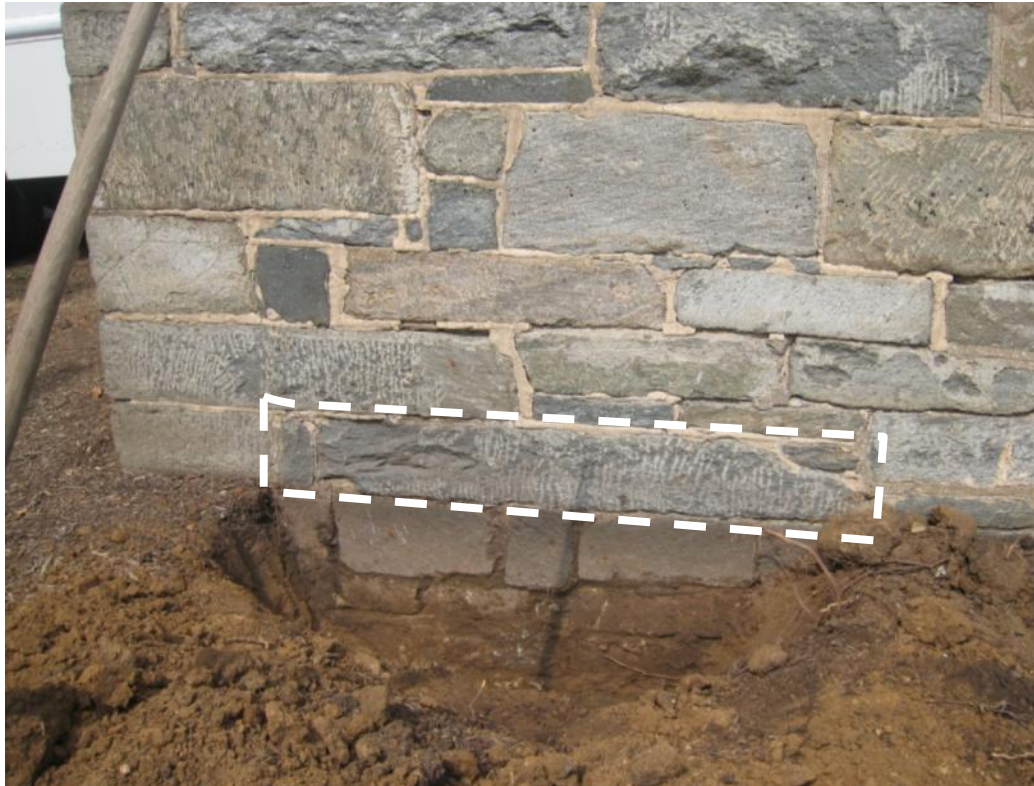
on the east and west elevations. A window lintel is apparent (above ground) on the east (see figure 1.1.21). No window lintel was found on the west (see figure 1.1.22). The findings shows that Lock House B was probably very similar to that of Lock House No. 16 (see figure 1.1.23 and 1.1.24 and Appendix 3.4).

Figure 1.1.21. Test pit along the east elevation near the southeast corner (QEA, July 20, 2010). The rectangle identifies a long, thin stone which is believe to be a window lintel from the cellar level dating to original construction.

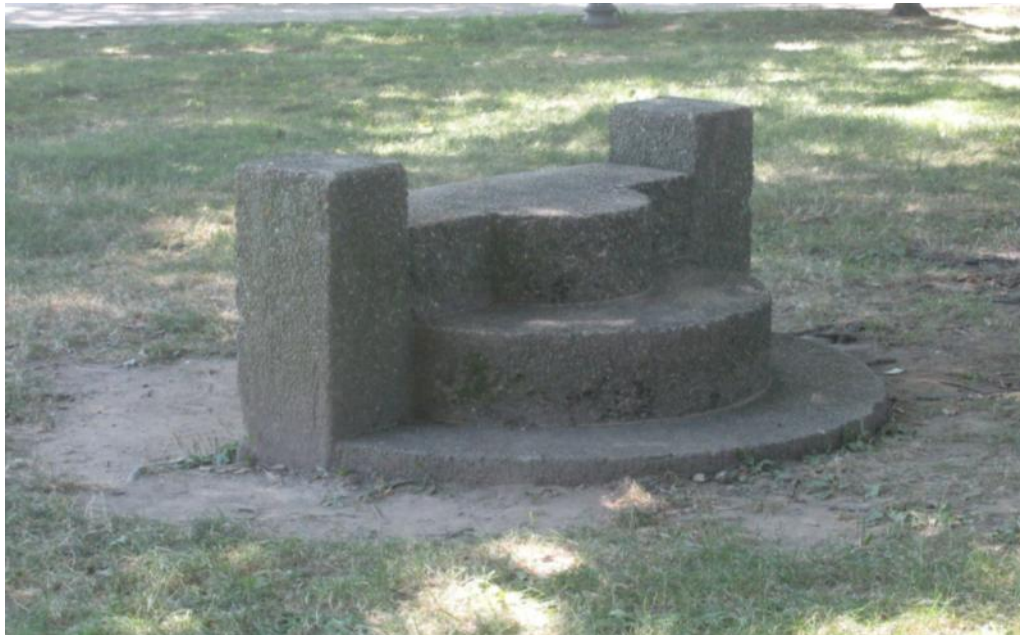
Figure 1.1.27. Mounting block dating from 1910's before it was temporarily removed by NPS in 2009 pending completion of the Potomac Park Levee project (QEA, July 2009).

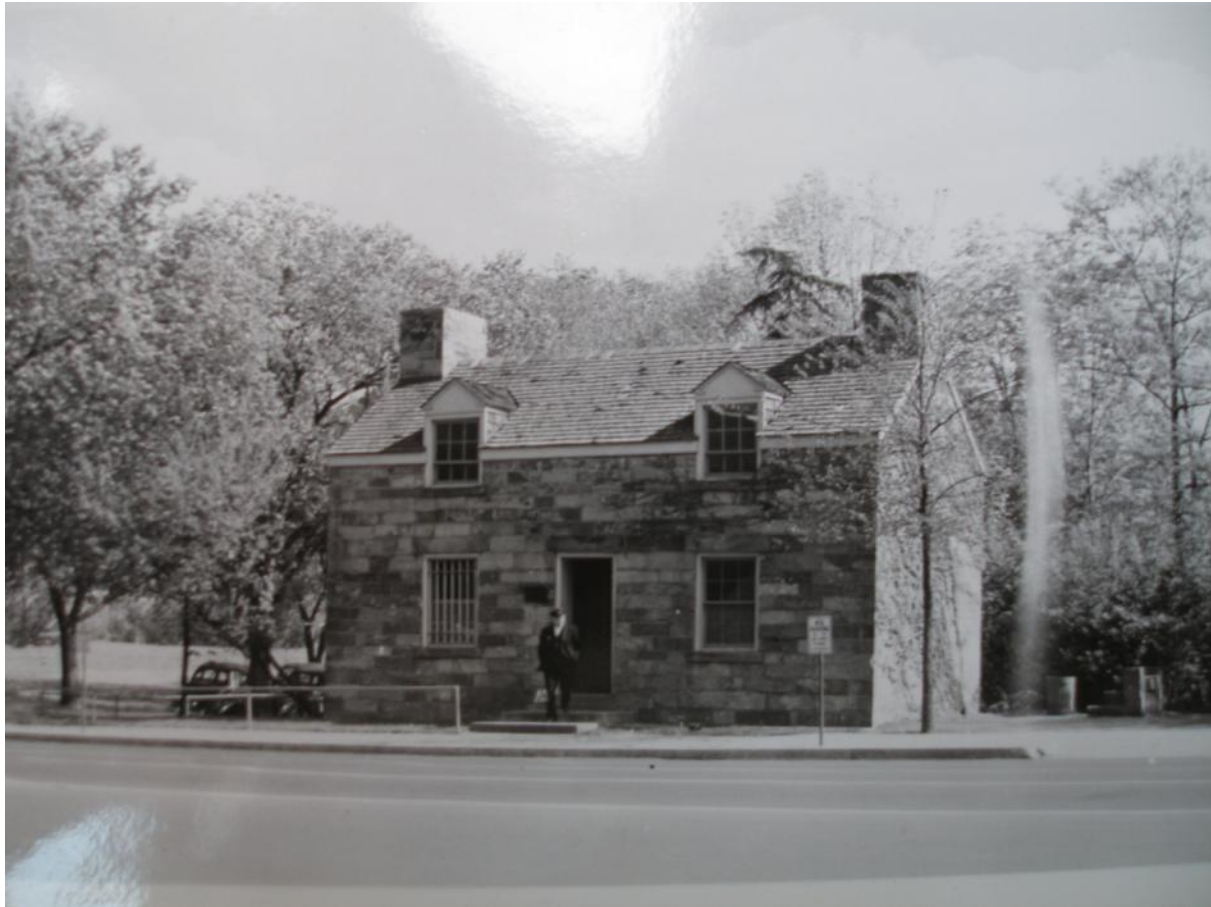
Figure 1.1.31. Lock House B, north elevation (1943). Constitution Avenue has been widened by this date as seen by the close proximity of the curb to the house. Note the pipe railing (not the current one), the security bars in the northeast window, the cupping of the wood shingles, the graffiti at the bottom left of the door, and the mounting block on the right side of the photo. There are three other photos of the north elevation and similar subject matter that date to 1943.

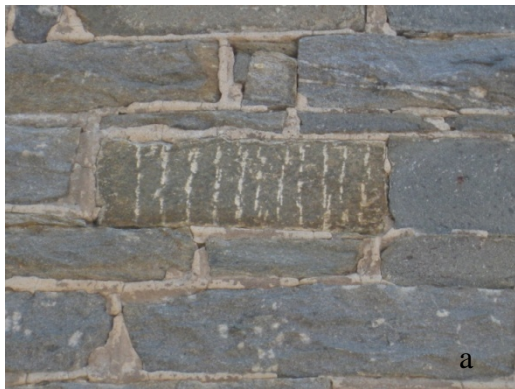
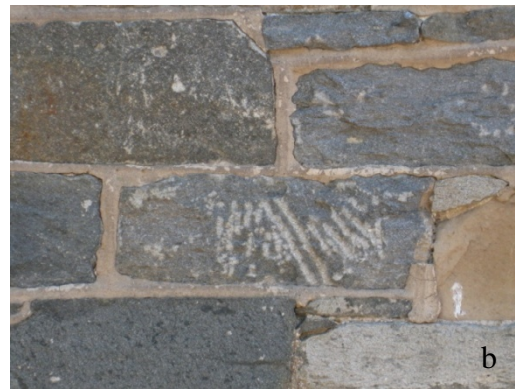
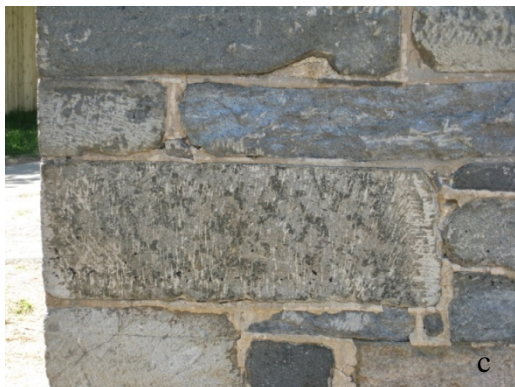
Figure 1.3. 4a, 4b, 4c Three different types of markings on stone. These markings could be quarry marks (tooling) or possibly for a stucco or plaster rendering.

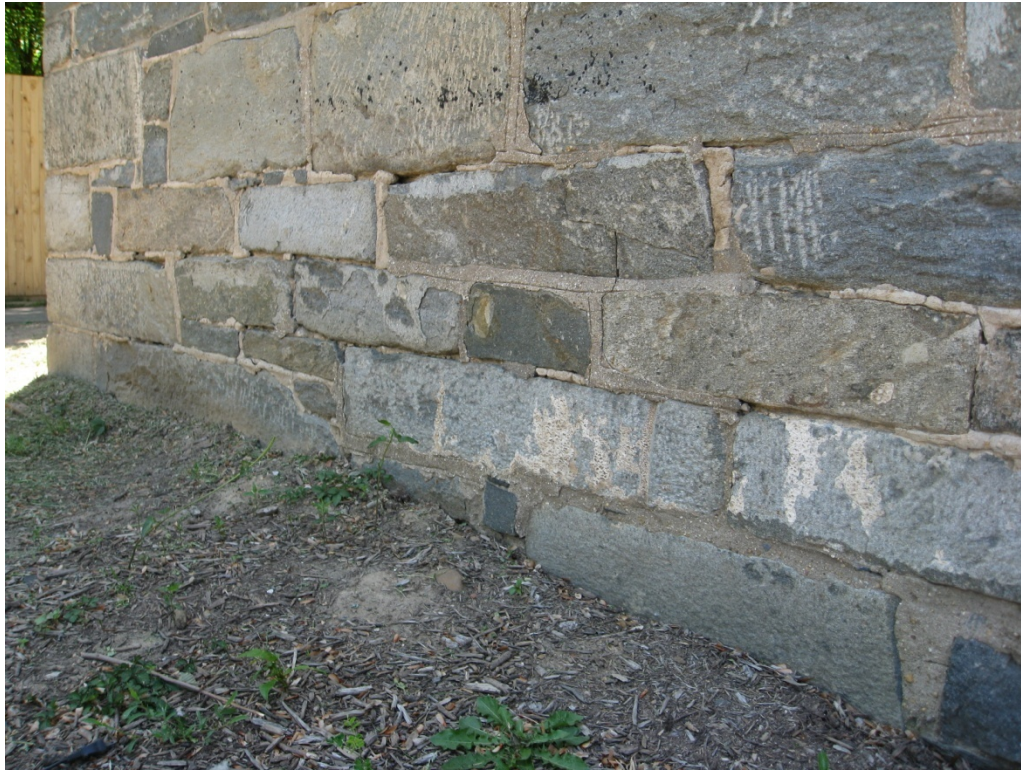
Figure 1.3. 5 East facade (QEA 2011). Note the two stones in the foreground which have remnants of a hard white coating on the surface of the stone. The remnants when disturbed became a fine white powder.

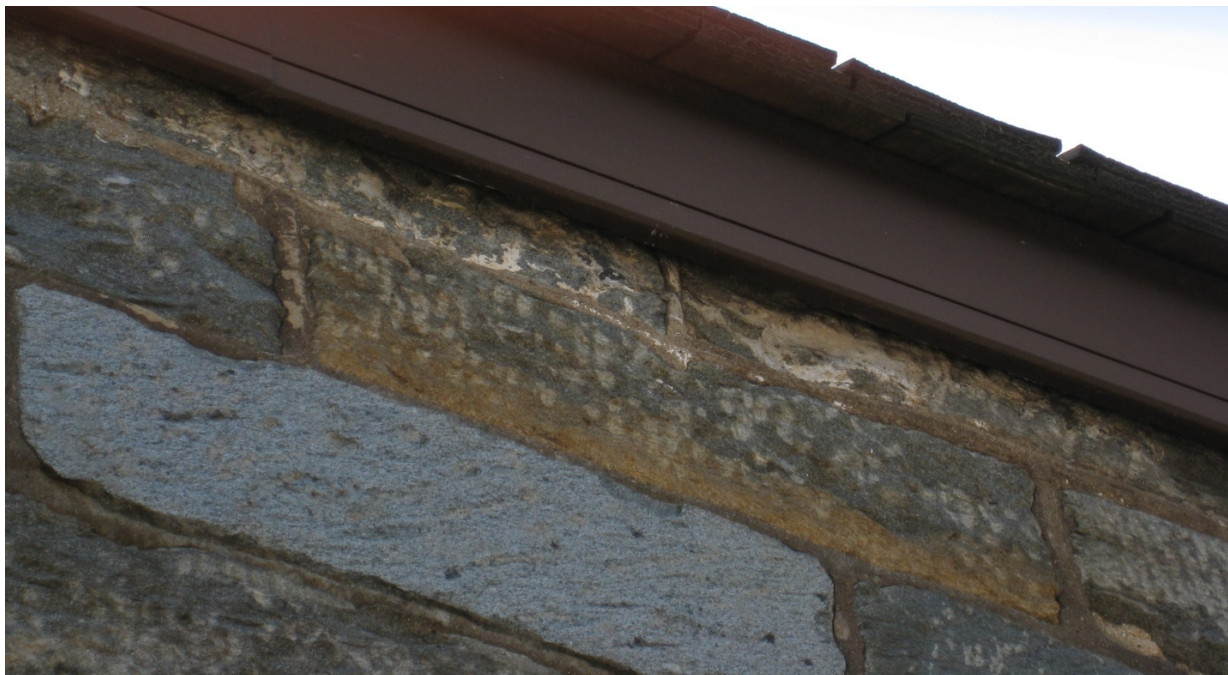
Figure 1.3. 6 South facade at the eave (QEA 2011). Note the remnants of a white coating on the surface of the stone. This instance and the one in the photograph above are evidence of a white coating that can be seen in the historic photographs.

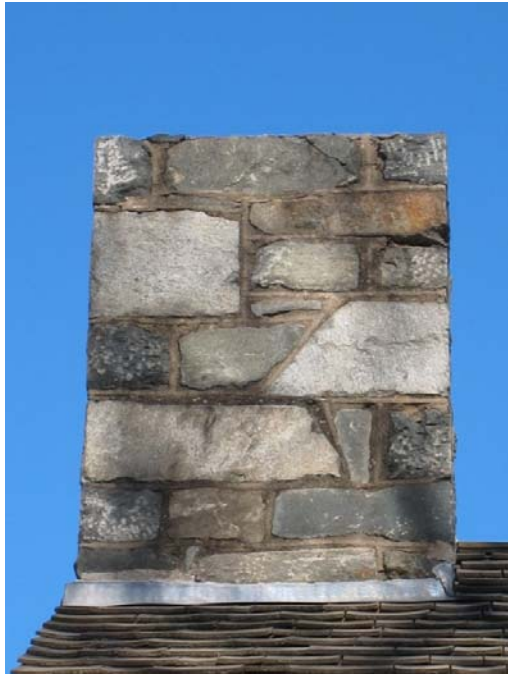
Figure 1.3. 11 Photograph looking north of the west chimney showing a dark brown mortar with raised profile joints.

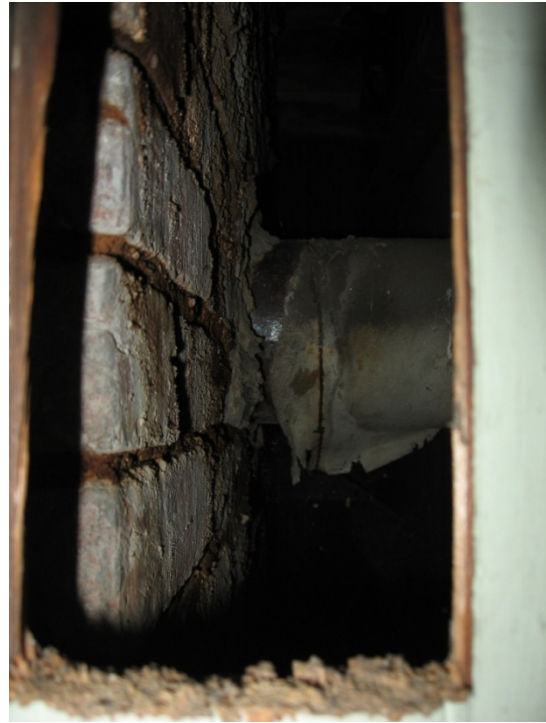
Figure 1.3. 15 View through hole in second floor northeast closet. Brick chimney is visible as is a flue that is now sealed off by the beadboard partition walls. (QEA, 2011).

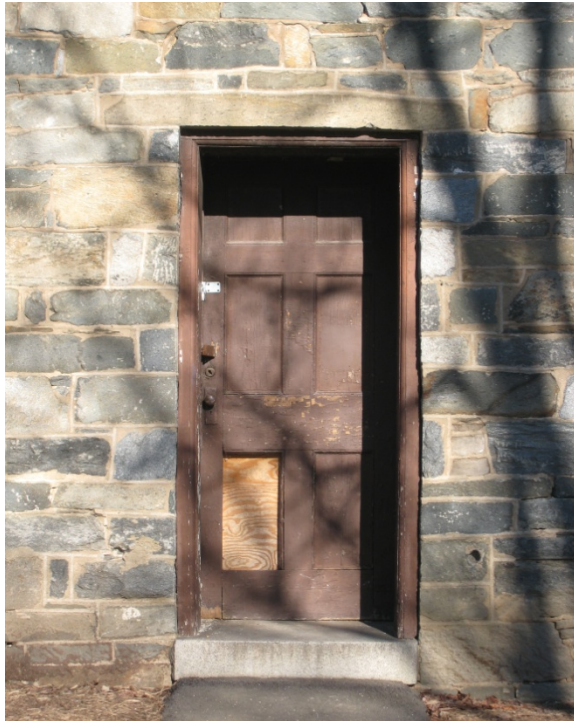
Figure 1.3. 16 Photograph of south door. Evidence seems to indicate this opening was created possibly during the 1916 renovations. It is not visible in an aerial photograph dating to ca. 1894. The stone lintel above is thinner than the other lintels around the house. Note the lighter colored mortar with a taller profile at the stones around the door. Note also the thin stone at the bottom left that was cut to make the opening. Note the lintel which is not as tall as the other lintels nor is it sandstone.

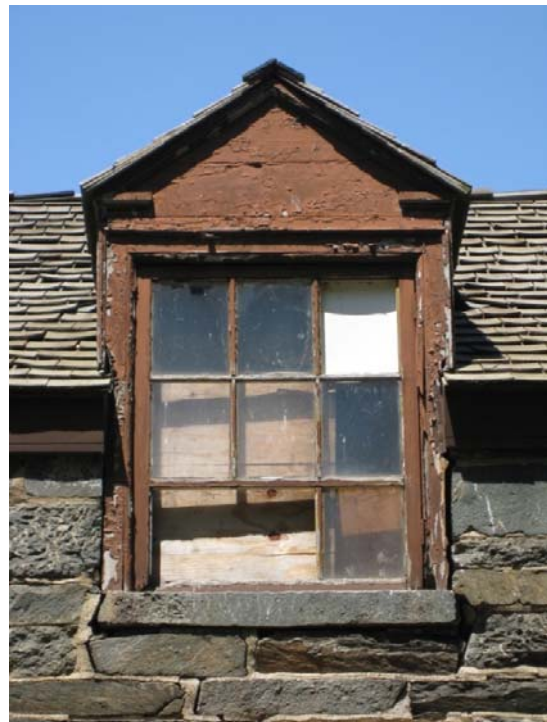
Many joints are in poor condition and mortar is crumbling (see Figures 1.4.3-6). The mortar will need extensive re-pointing. The large diagonal mortar separation on the north facade may have been caused from the relocation or traffic vibrations. Birds are nesting in large open mortar joints between the stone and the dormer windows.

Figure 1.4. 12 Southeast dormer window (#7) (QEA, 2011). Note the plywood where the glazing and muntin should be in the lower left of the sash. Additionally, this is the only dormer window that is a casement rather than a double hung window. Around the dormer is considerable loss of mortar. Birds and wasps have been nesting in these gaps.

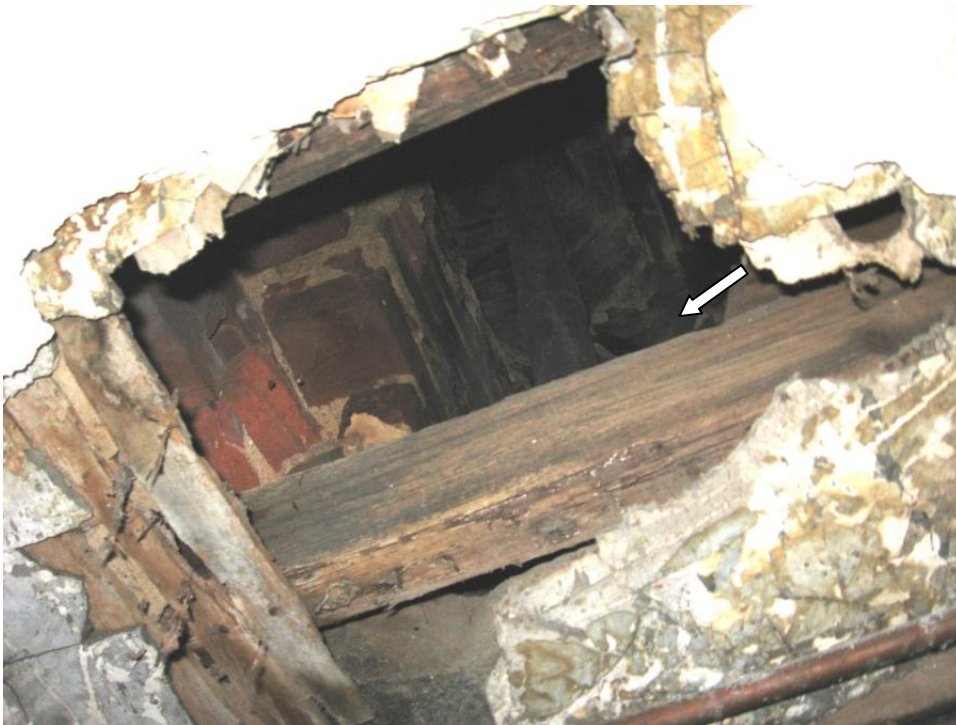
Figure 1.4.14 View through a hole in the ceiling along the west wall (QEA, 2010). Note the plumbing vent pipe (arrow) that extends up through what used to be a chimney. Note the bricks of the chimney.

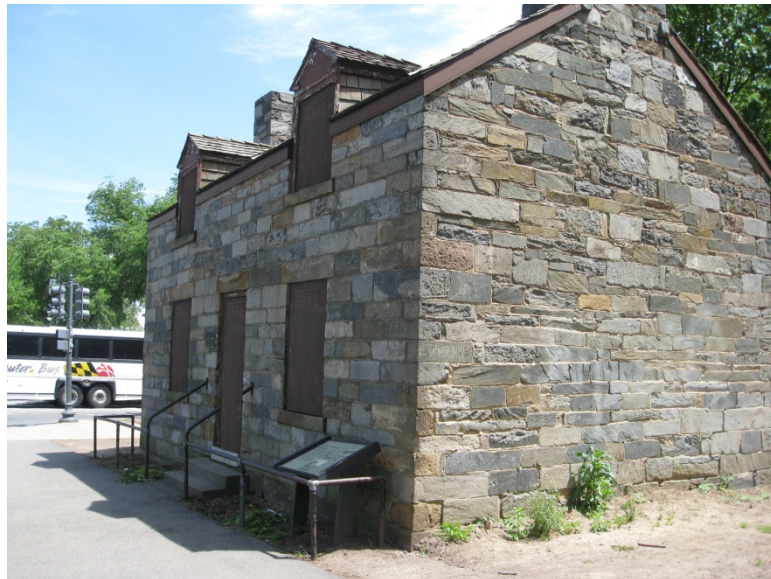
Figure 2.3. 7 Image of north facade with plywood protective covers.

The building has been unused for many years and the interior has recently been cleaned of debris. If a significant project were not possible in the near future, then the building should be secured and mothballed in the interim (see figure 2.3.7).⁴ There would be two primary project work elements:

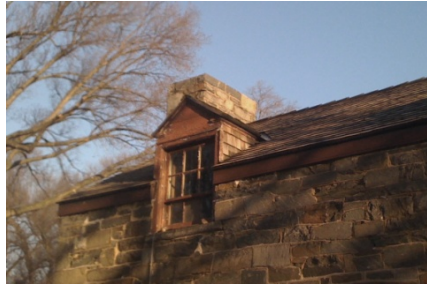
This roof assembly was installed in 2004 to match the assumed original roofing material type and appearance. This roof should have at least 30 years remaining service life. The 1836 specifications call for cypress shingles 18" long.
Stone Walls

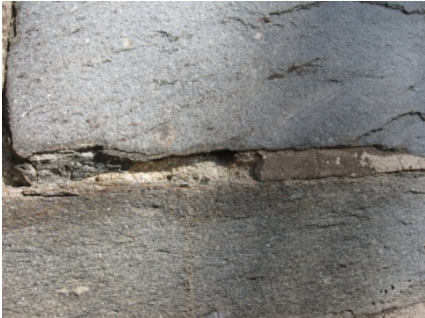
Mortar Joints - Original

<p>The 20th century raised rope joint mortar is at the right of this image. It is placed over a lighter mortar. This beige-colored mortar has some larger aggregate (the size of small peas) and also solid white lumps which are most likely lime. To the author, this mortar appears to be more typical of the early 19th century. This second mortar has maintained strength although it is obviously impacted by long term exposure to weather.</p>
Wood Windows and Trim

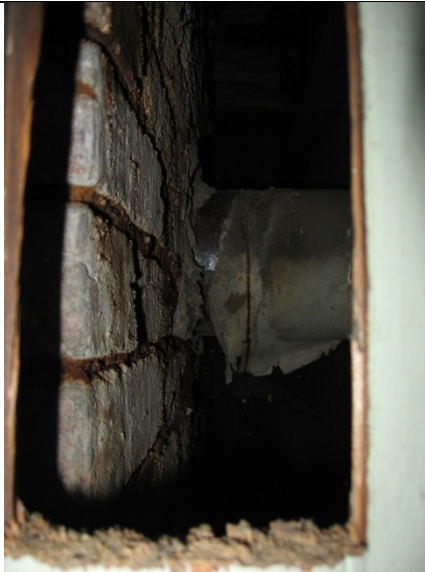
HISTORIC MATERIAL	PHOTO IMAGE	ANALYSIS & TREATMENT
Brick chimneys (seen within wall cavity - between masonry walls and beadboard)

<p>It is difficult to examine the brick chimneys. The west one was half demolished for the installation of the plumbing vent. This photo is of the east chimney. It's white surface could have been an interior finish. The flue into the chimney may have been for a stove but it the end of the flue is now cut off by the beadboard partition wall.</p>

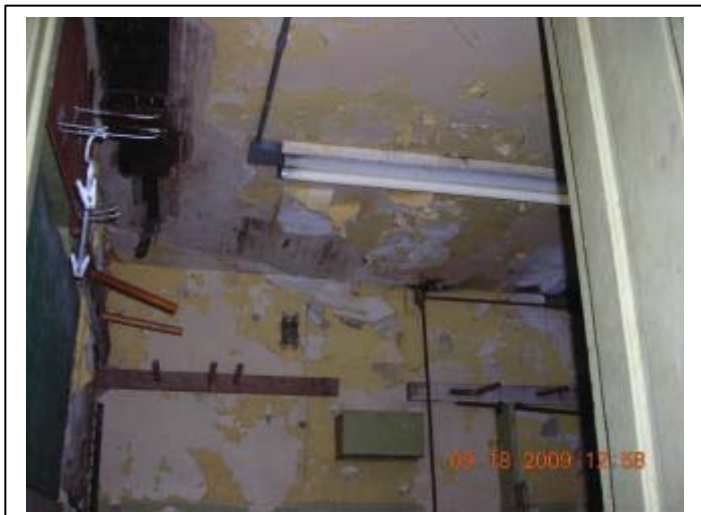
Chipping and peeling paint on plaster walls and ceiling inside the 1st floor, south side room.

Prohibited methods of lead paint removal include: sanding (except with equipment fitted with HEPA filters), burning with an open flame torch, or any methods, which produce uncontrolled dust or fumes (dry sweeping and shoveling). AMA recommends that workers involved in activities which may disturb lead contaminated debris have the proper training and utilize engineering controls, including but not limited to wet methods and HEPA vacuuming, during the proposed cleaning activities at the Lock Keeper's House. Within the EPA's Identification and Listing of Hazardous Waste (40 CFR Part 261), all lead-containing waste is to be handled and disposed of as hazardous waste unless TCLP (toxic characteristic leaching procedure) testing is performed and indicates otherwise. The waste shall be considered as hazardous when the concentration of lead exceeds 5 parts per million (ppm) by the TCLP. Metal components should be recycled, and glazed finishes are to be disposed of as general construction debris.

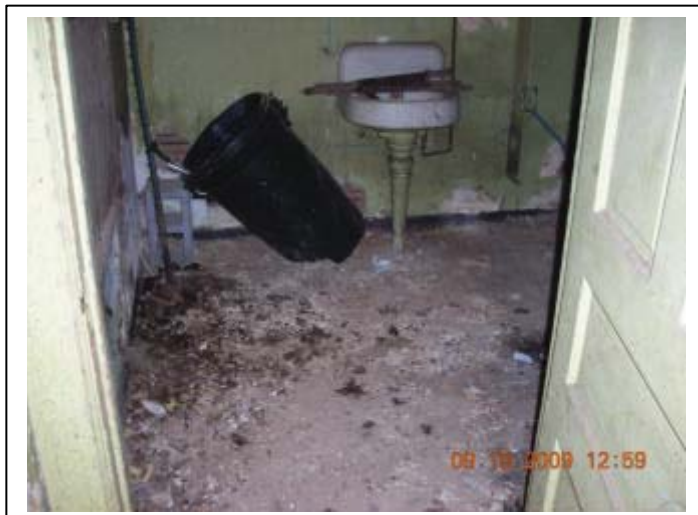
Paint chip debris on the concrete floor inside the 1st floor, south side room.

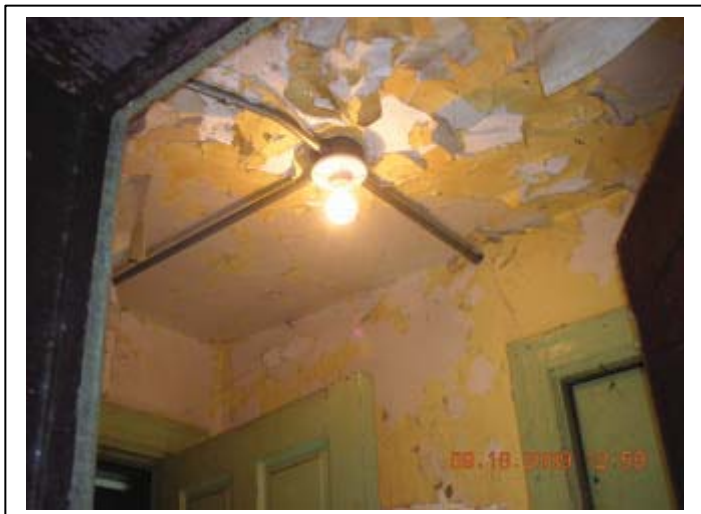
Chipping and peeling paint on plaster walls and ceiling inside the 1st floor, south side entrance foyer.

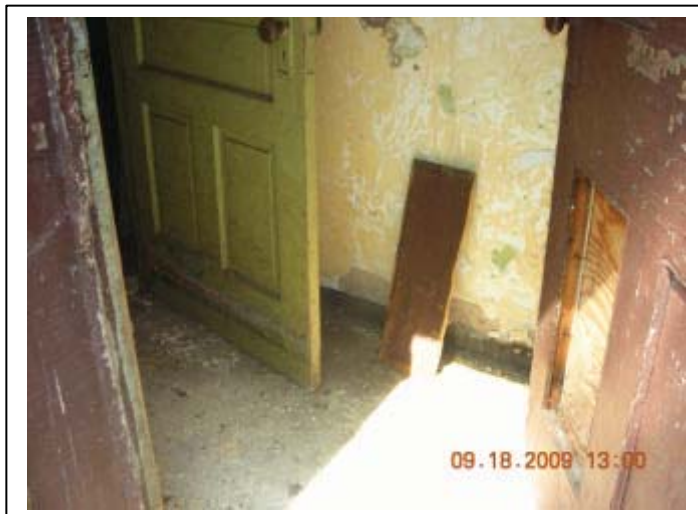
Paint chip debris on the concrete floor, and chipping and peeling paint inside the 1st floor, south side entrance foyer.

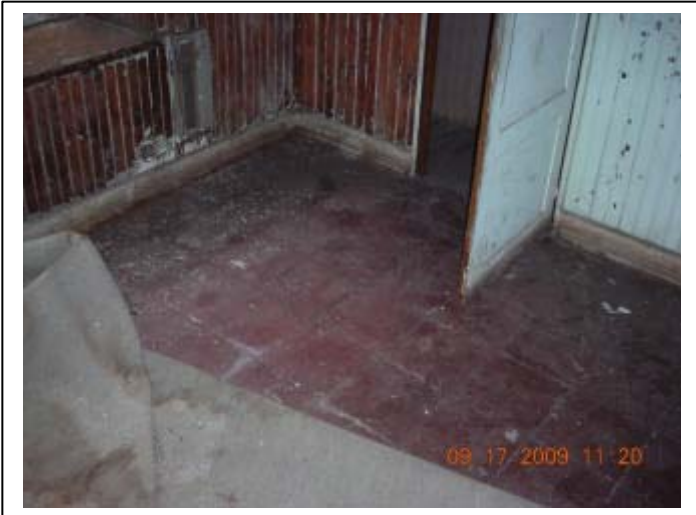
Paint chip debris on the 9"x9" brown floor tile inside the 2nd floor room.

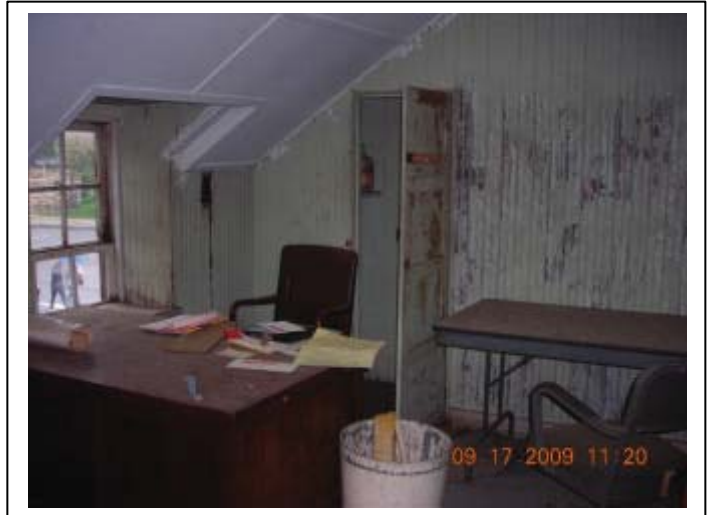
Chipping and peeling paint on wood walls and door inside the 2nd floor room.

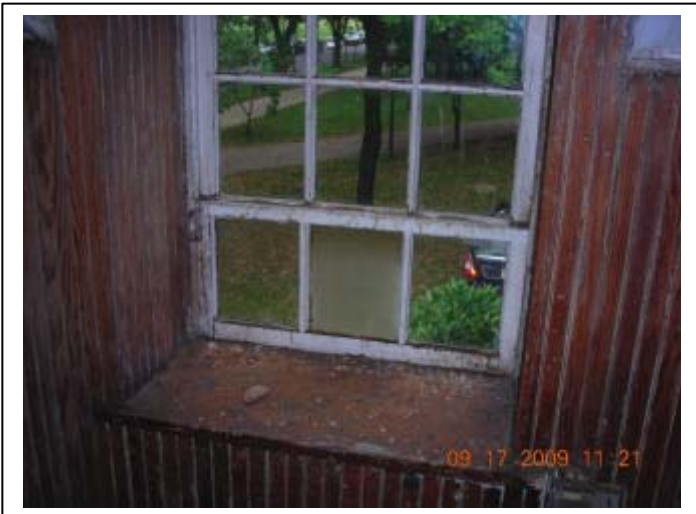
Chipping and peeling paint on the wood window system inside the 2nd floor room

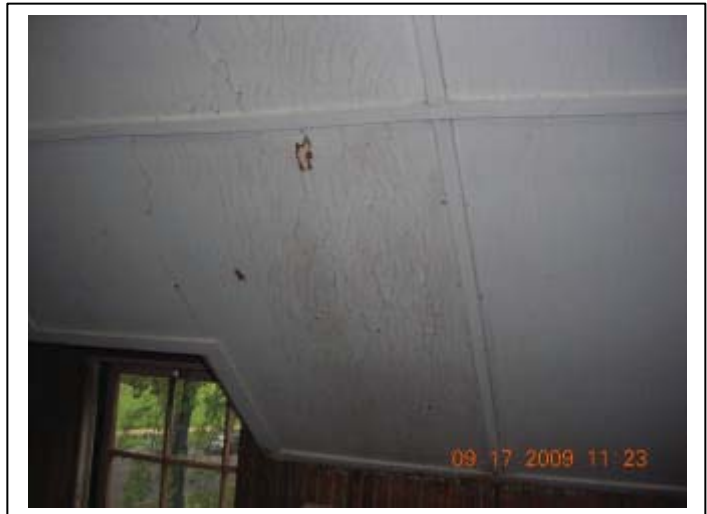
Chipping and peeling paint on the gypsum board ceiling inside the 2nd floor room.

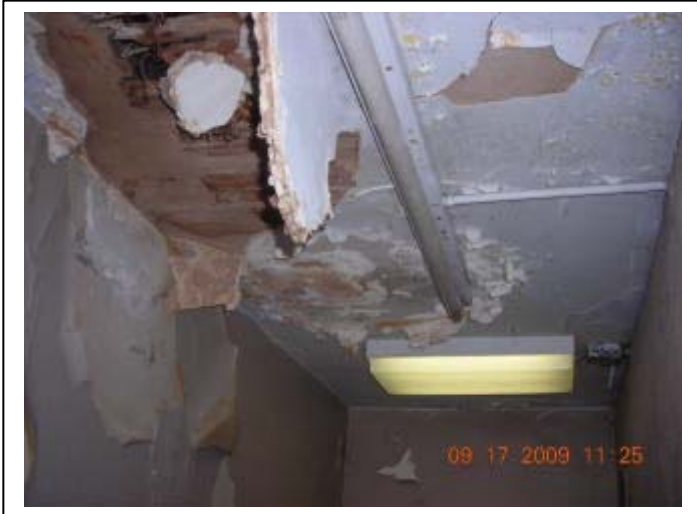
Chipping and peeling paint on the plaster ceiling and walls inside the 1st floor, north side bathroom #1.

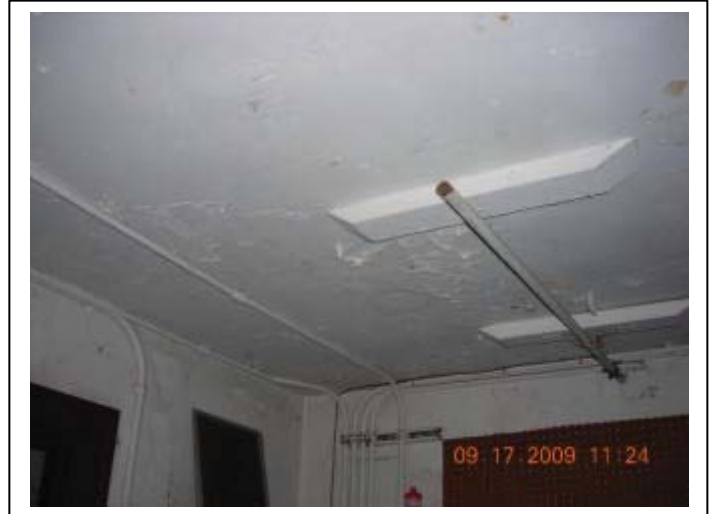
Chipping and peeling paint on the plaster ceiling inside the 1st floor, north side room.

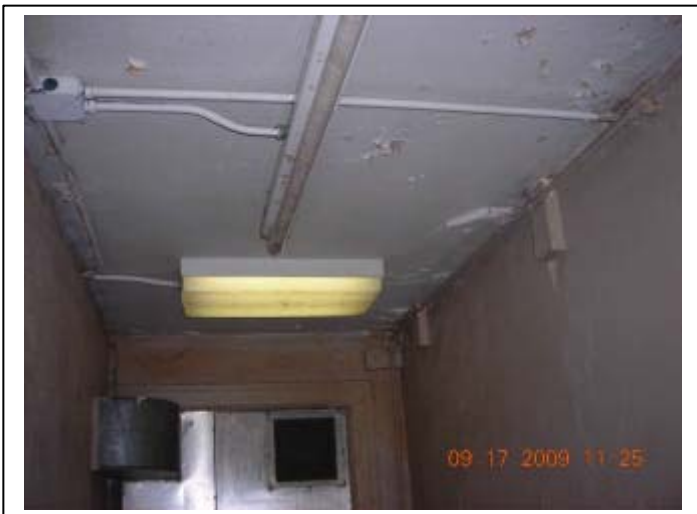
Chipping and peeling paint on the plaster ceiling inside the 1st floor, north side bathroom #2

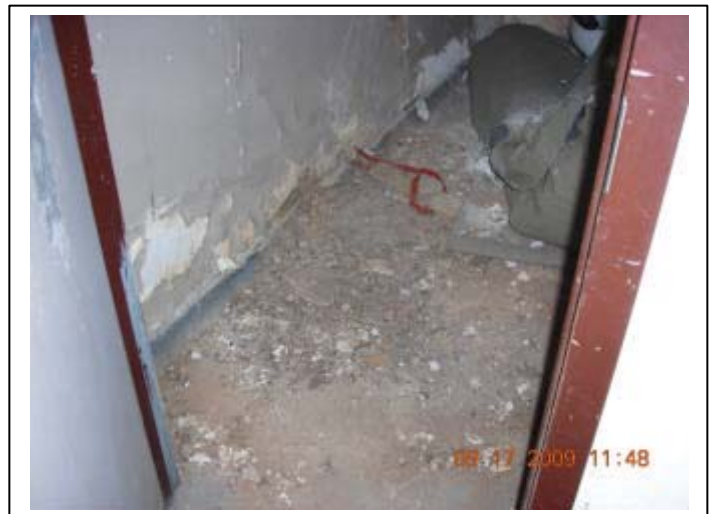
Paint chip debris on the concrete floor inside the 1st floor, north side bathroom #1.
