**Everglades National Park
Monroe County, FL**

**Engineering Analysis and Feasibility
of
Repairing or Replacing Failed Dams
and
Limiting Salt Water Intrusion in Cape Sable
Everglades National Park**

**Prepared by:
URS Corporation Southern
7650 Corporate Center Drive, Suite 401
Miami, Florida 33126-1220**

April 2012

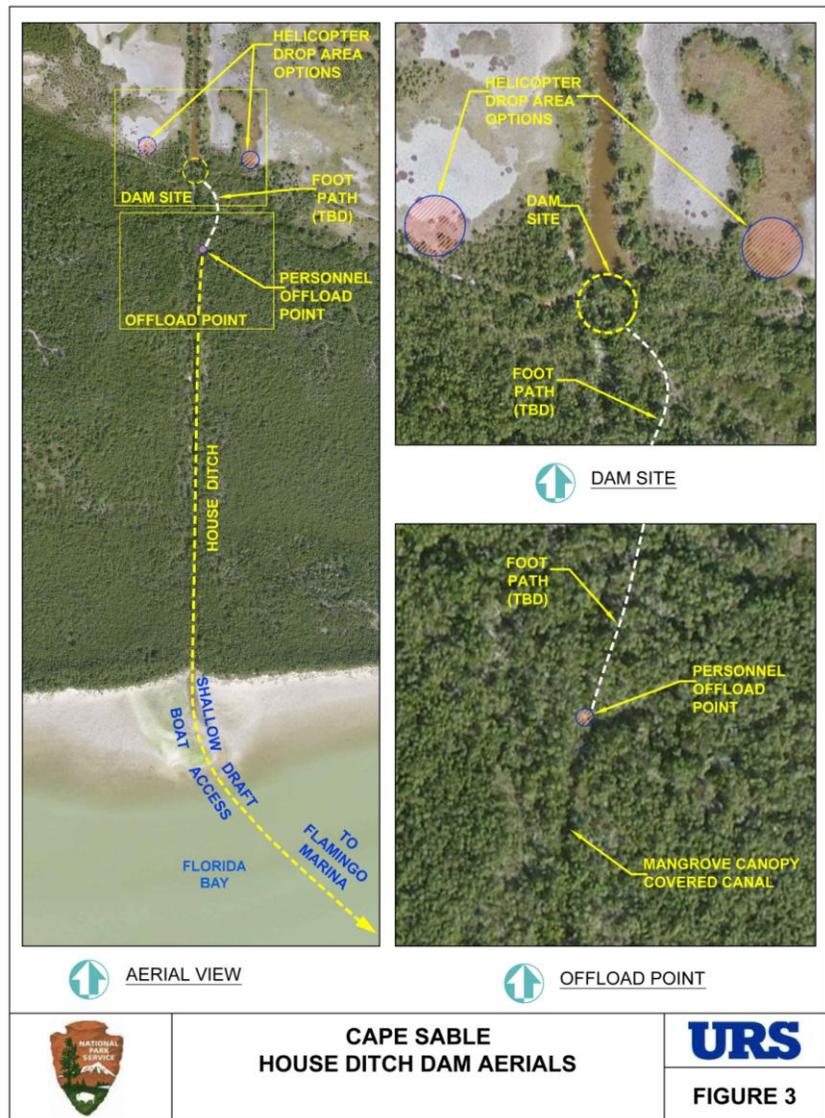
The dam/canal plug along the House Ditch is the most structurally intact of the 3 known remaining earthen dams on Cape Sable. Although this small dam and ditch plug has continued to slowly erode over the years, it appears to be structurally sound and there is no visible evidence of leaking or piping through the dam based on an inspection made in December, 2011. The earthen fill portion of the dam was recently estimated to be about 10 to 15 feet wide across the Coastal Prairie Trail.

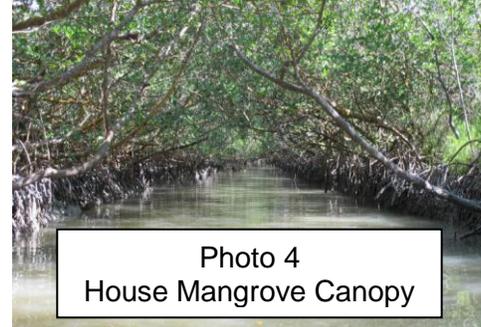
Photo 4
House Mangrove Canopy

3. Restricted foot access from off-load points through medium dense vegetation.
 - a. Approximate 15 – 20 minute walk in-land from off-load points to dam sites.

- b. Approximate 1/10 mile walk in-land from House ditch off-load point.
 - c. Approximate 2/10 mile walk inland from Slagle ditch off-load point.

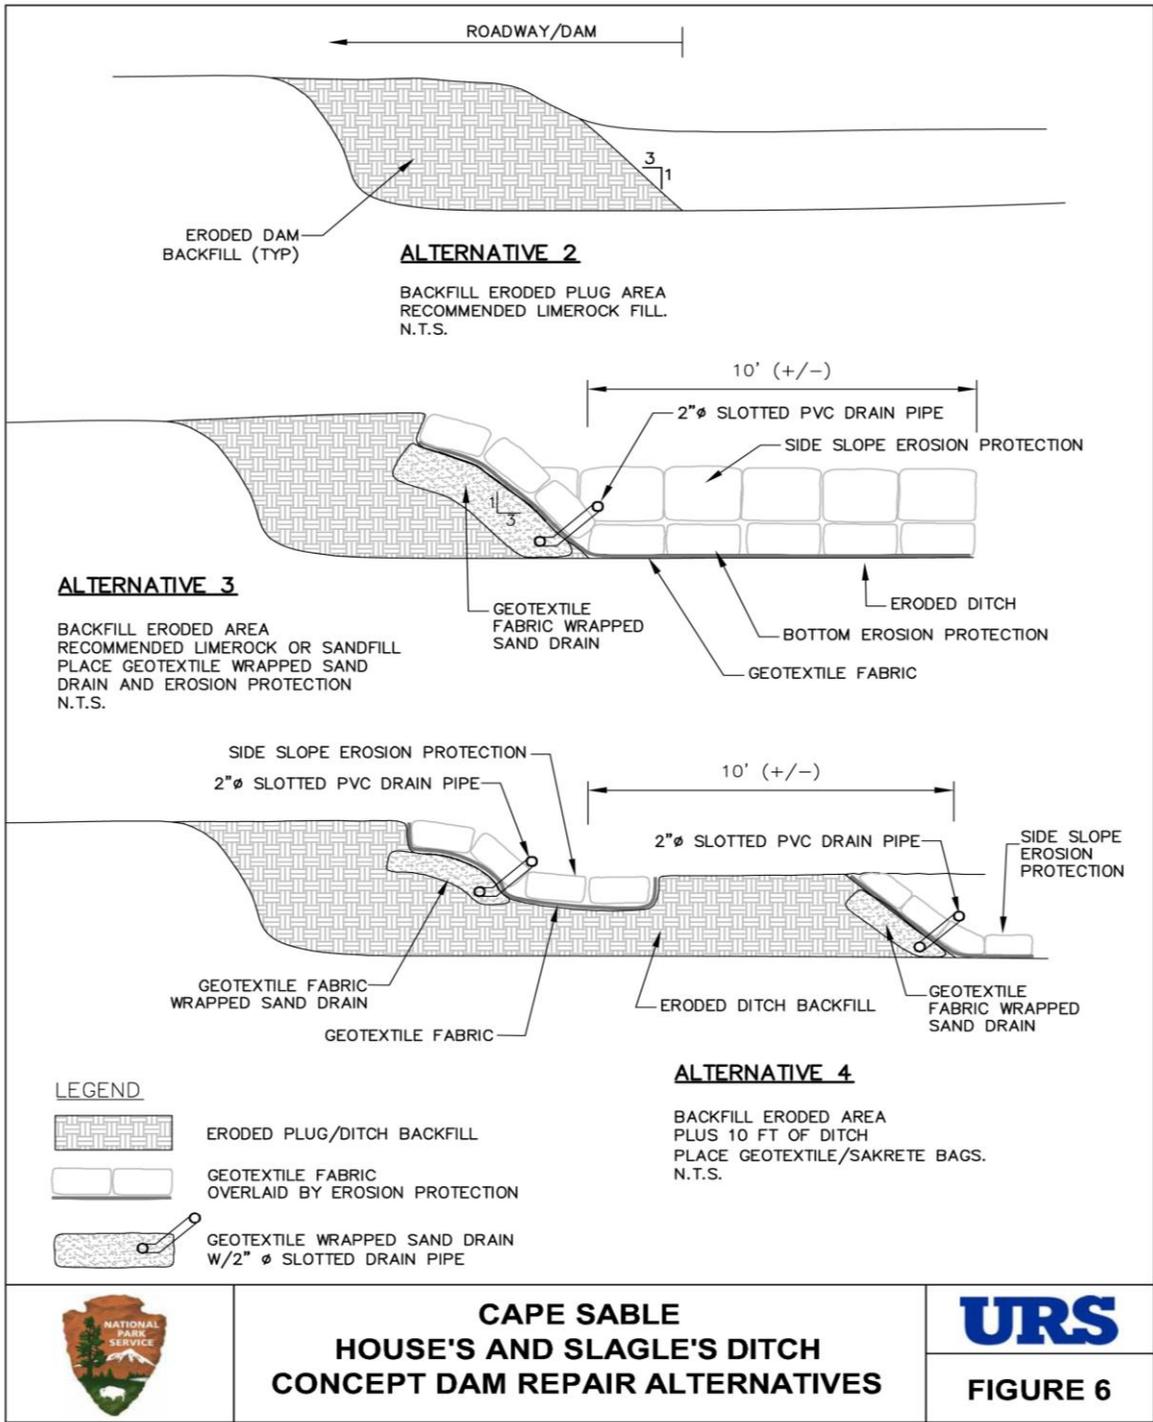
Alternative 2 through 4 are presented in the following Figure 6. Alternative 2 simply involves re-backfilling of the eroded dam ditch plugs with a gravelly limerock fill containing silty binder type fines. This alternative essentially re-establishes the dam section and is being further considered as it minimizes the amount of backfill material needed to affect the restoration work and therefore also minimizes the cost.

It is envisioned that locally available limerock fill, typical of that used for roadway base material in South Florida, will be used as backfill in the eroded area of the dam plug only. The backfill will be placed in sufficient quantities to only re-construct the original dam plug cross-section consistent with matching the adjacent dam slopes and elevation/grades. No other modifications would be provided to the dam plug area to provide any additional erosion protection other than that afforded by compacting the fill in-place and providing a fill material containing silty limestone fines. These silty fines will have a propensity to dry out and become dedicated and weakly cemented with time, therein providing a

slight cementation in the fill similar to that which exists in the present Dam plug fill. Additionally, it has been reportedly observed that the surface of the dam plugs may also have been further stabilized with a thin upper layer of cement mixed into or spread on the fill surface.

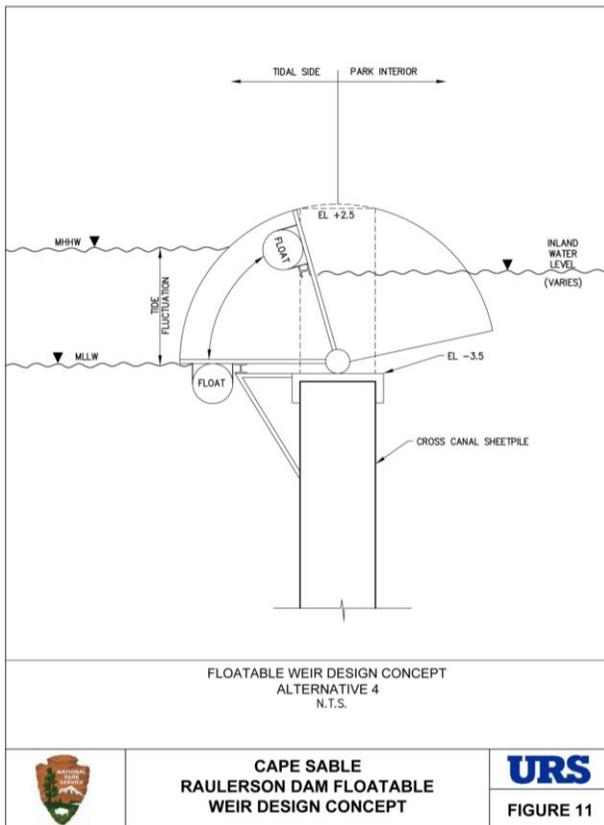
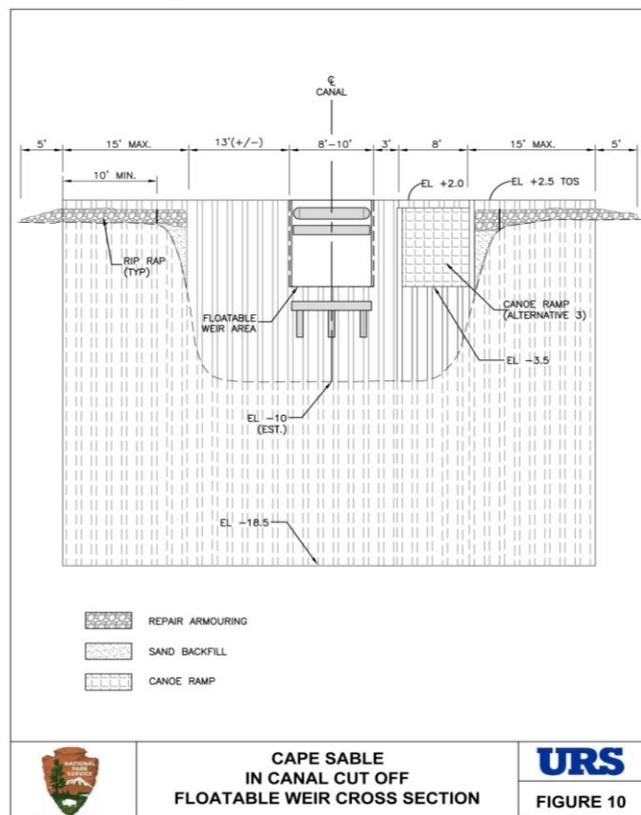
Alternative 4 is a modification of Alternative 2 in that an overflow discharge mechanism as conceptionally shown on **Figures 10 and 11** could potentially be incorporated into the dam which will allow for the outbound flow of brackish water from the Park during the periods of low tide levels on the tidally influenced downstream side of the cutoff dam. It is desirable from a water quality perspective to allow some of the brackish water that is being contained and mounded inland of the dam in the Cape Sable region to be discharged back to tide in a controlled manner over the floatable weir and through the cross canal sheet pile section during those times when inland and

upstream water levels become elevated relative to lower tide levels downstream of the dam.

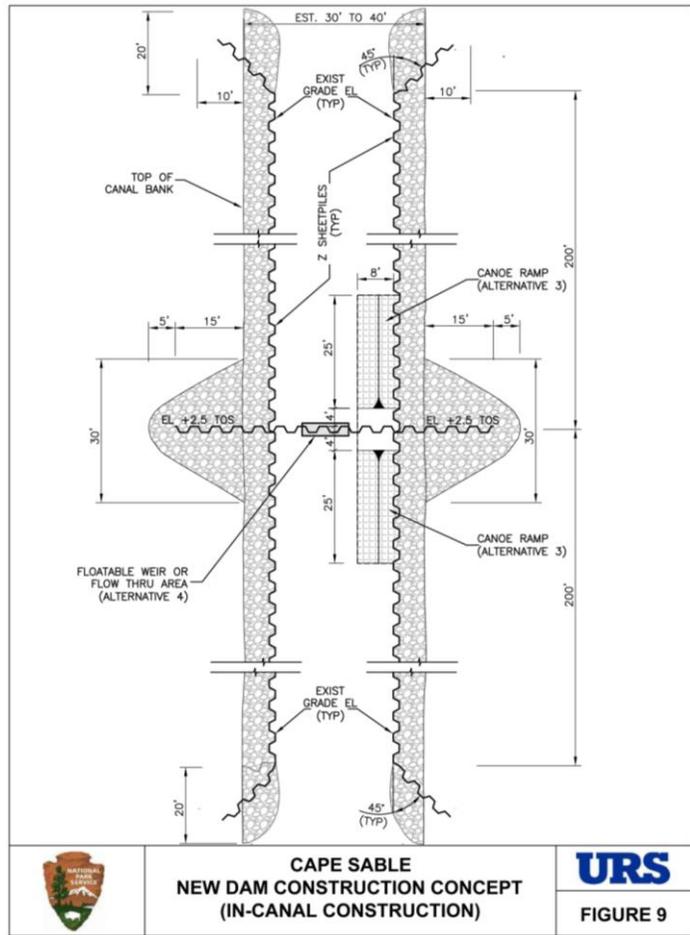
URS
FIGURE 9

The area around the inland extension and around the end of the inland sheet piling would be armoured with geotextile covered by 12 inch average to 18 inch sized rip rap needed to mitigate erosion action immediately adjacent to and at the end of the sheets. Additionally, dropping of the top elevation of the cross canal sheet piling below the initially proposed +2.5 ft. NAVD elevation will also be evaluated during subsequent modeling efforts.

In addition to the cross canal sheets, sheet piling would be installed along both canal banks both upstream (i.e. inland side) and downstream (i.e. East Cape Canal side) of the canal cutoff. The side bank sheet piling would be installed within a few feet of the edge of the canal bank and would be driven to an elevation of 0.0 to -0.5 feet below the prevailing ground surface. The intent of the side bank sheet piling is to allow for overland high tide events to flow around the cross canal cutoff sheet piling and then to re-enter the canal by flowing over the top of the side bank canal sheets. The small gap area between the side bank sheets and the pre-existing eroded canal side bank would be backfilled with sand fill to within 2 feet of the top of the sheets, a geotextile filter fabric placed and then the remainder of the gap would be filled with rip rap stone up to 18 inches in maximum size with a 12 inch average size. The side bank canal sheet piling and rip rap would provide a protected overflow area upstream and downstream of the main dam cutoff that would not become eroded by such over topping events.

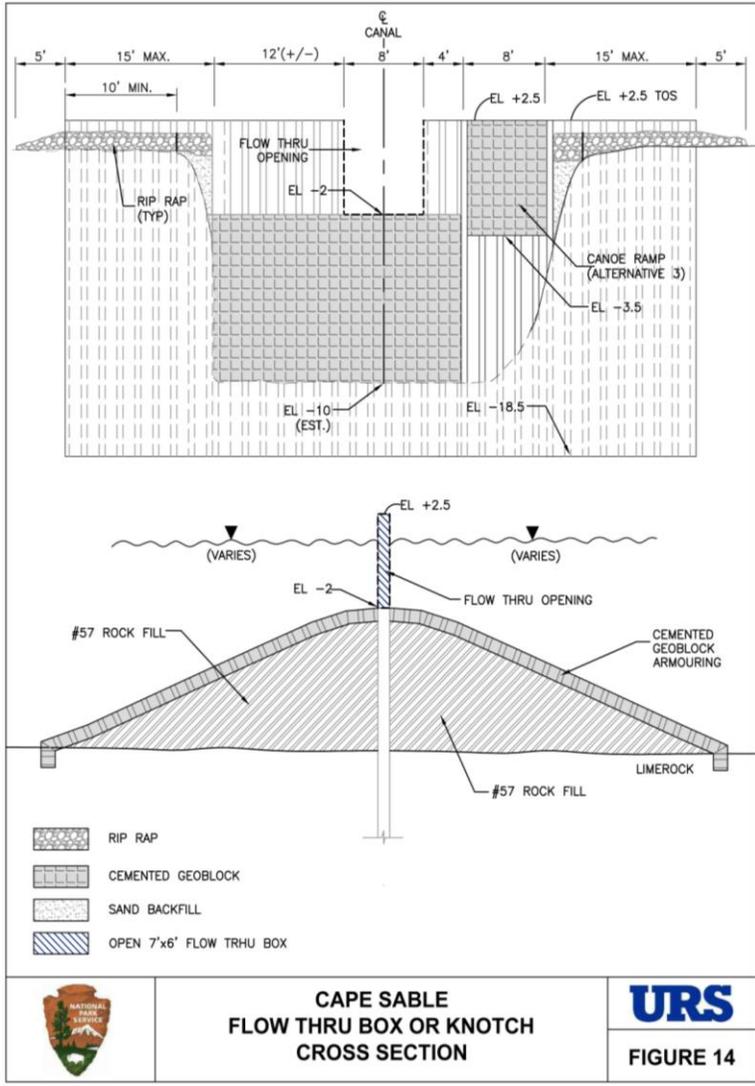
This Alternative 4 is a modification of Alternative 1 in that a flow-thru capability as shown on **Figure 14** would be incorporated into the dam which would allow for some unrestricted but partial flows of salt water into and out of the Park interior marshes. The opening would be significantly smaller than the creek cross section which would comply in concept with the stated intent of the Park to limit saltwater intrusion into the interior Cape Sable Region but, this concept would only restrict and limit such intrusions, not prevent them.

One viable solution however, is to provide a predetermined sized opening in the sheet pile dam cutoff wall as a fully notched opening in the sheet pile wall as shown on **Figure 14**. Such openings would allow for both inland and outward flow along the creek alignment however, due to the reduced size of the dam opening compared to the current canal cross section, the reduced size opening would inherently reduce and limit the flow volume thru the structure. Flow would be discharged in either direction into the sheet pile protected sections of the canal such that localized turbulent flow in the vicinity of the cutoff dam opening and just upstream or downstream thereof, would not cause any erosion of the adjacent canal slopes.
