Chapter 3. Existing Condition and Analysis / Affected Environment

1 This chapter presents the summary and
2 analysis of the current condition of the
3 archeological landscape of Hopewell
4 Culture NHP. Narrative text, diagrams, and
5 photographs describe the existing condition
6 using a series of landscape characteristics.
7
8 The condition assessment is undertaken to
9 understand the archeological landscape as
10 a whole. It identifies and documents those
11 qualities and features that contribute to the
12 park's historic character, retain integrity,
13 and contribute to the significance of the
14 landscape. Field reconnaissance, undertaken
15 in October 2014, assisted in the recording of
16 the archeological landscape.
17
18 This chapter is organized to present the
19 existing condition and analysis evaluation
20 for the study area first, which includes the
21 evaluation of landscape characteristics that
22 relate to the study area as a whole. This is
23 followed by a condition assessment and

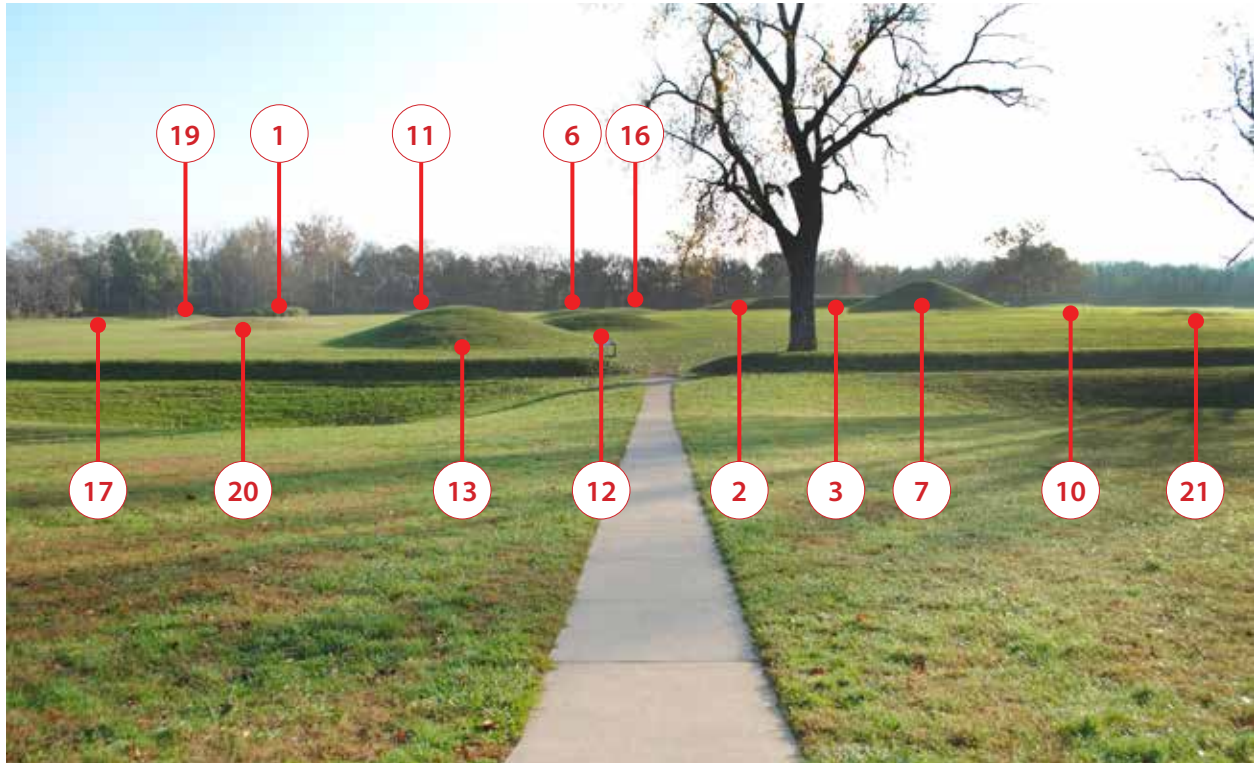
Figure 3-18. Mounds 17, 19, 20, 1, 11, 13, 6, 12, 16, 2, 3, 7, 10, and 21 are visible from the visitor center. (Mundus Bishop 2014)

1 *Mound 1* is a conical burial mound with
2 a diameter of 35 feet and is seven feet in
3 height. The mound is covered with vegetation
4 including trees, understory, and invasive
5 honeysuckle. Below-grade features are
6 unverified. This mound was leveled in 1917
7 for the construction of Camp Sherman. It was
8 reconstructed in the wrong location in 1921
9 by the Ohio State Museum. Mound 1 was
10 reconstructed again in 1969 in its original
11 location. Mound 1 is in good condition.

12
13 *Mound 2* is a conical burial mound with
14 a diameter of 90 feet and height of 10-
15 feet. Below-grade features are unverified.
16 This mound was leveled in 1917, and
17 reconstructed in 1921 by the Ohio State
18 Museum. Mound 2 is in good condition.

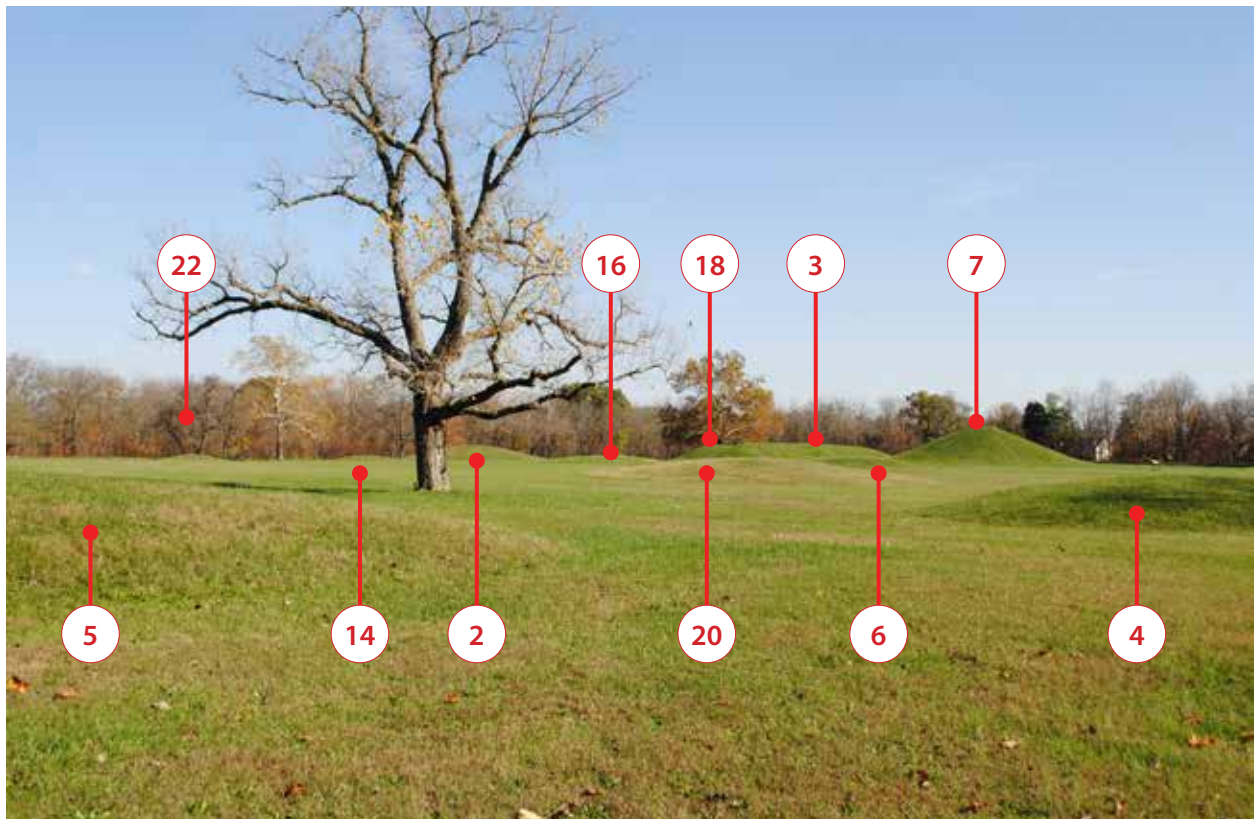
Figure 3-19. Mounds 5, 22, 14, 2, 16, 20, 18, 3, 6, 7, and 4. (Mundus Bishop 2014)

19
20 *Mound 3* is an oval burial mound, 50 feet by
21 140 feet wide, and ten feet in height. Below-
22 grade features are unverified. This mound
23 was leveled in 1917, and reconstructed in
24 1921 by the Ohio State Museum. Mound 3 is
25 in good condition.

26
27 *Mound 4* is an oval burial mound, 60 feet by
28 90 feet wide, and six feet in height. Below-
29 grade features are unverified. Mound 4 was
30 leveled in 1917, and reconstructed in 1921
31 by the Ohio State Museum in the wrong
32 location. Mound 4 was reconstructed in 1964
33 in its original location. Mound 4 is in good
34 condition.

35
36 *Mound 5* is 60 feet by 90 feet wide, and six
37 feet in height. Below-grade features are
38 extant. Mound 5 was leveled in 1917, and
39 reconstructed in 1921 by the Ohio State
40 Museum in the wrong location. Mound 5 was
41 reconstructed in 1965 in its original location.
42 Mound 5 is in good condition.

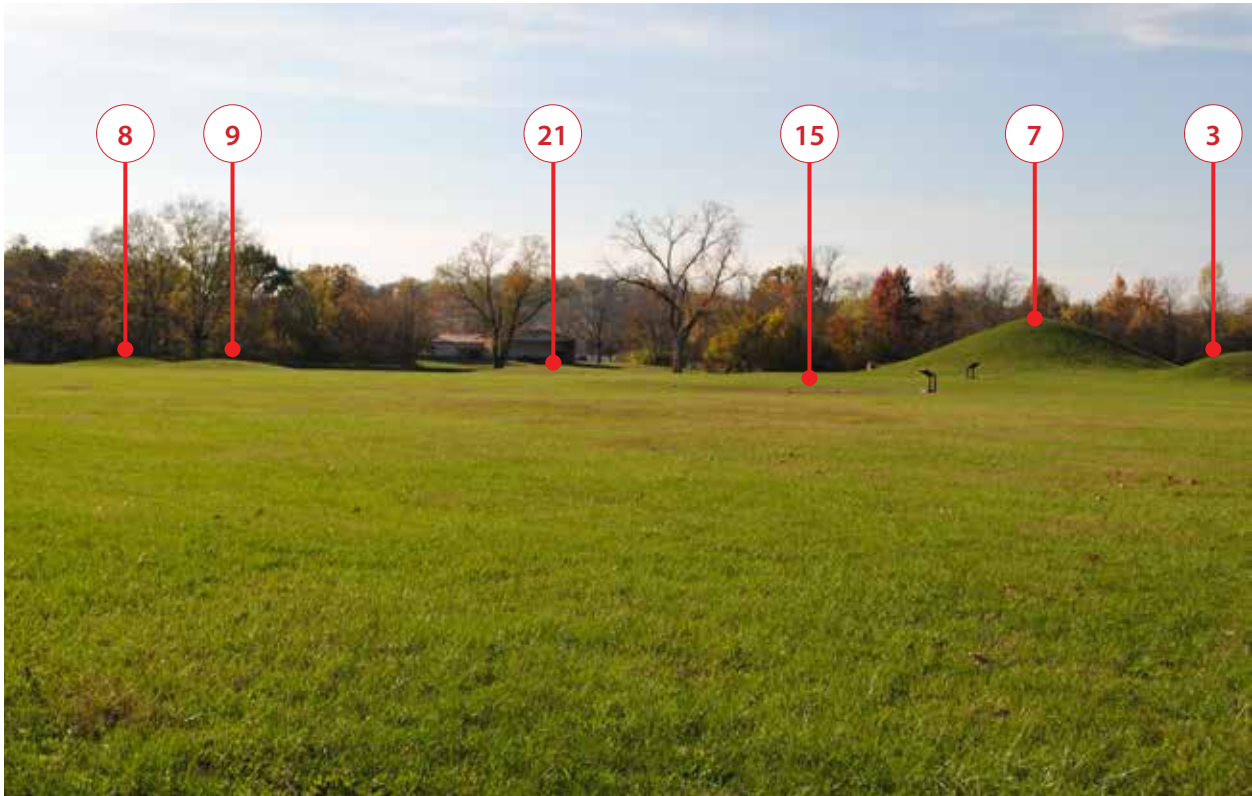
5
6 *Mound 7* is the tallest mound in Mound City
7 Group. It is a conical burial mound with a
8 100 foot diameter, and a height of 17 feet.
9 Below-grade features are extant. This was
10 reconstructed in the 1920s. Mound 7 is in
11 good condition.

12
13 *Mound 8* is a conical burial mound, 55 feet
14 in diameter and eight feet in height. Below-
15 grade features are extant. Mound 8 was
16 leveled in 1917, and reconstructed in 1926 by
17 the Ohio State Museum. Mound 8 is in good
18 condition.

19
20 *Mound 9* is a conical burial mound, 50 feet in
21 diameter and four feet in height. Below-grade
22 features are extant. Mound 9 was leveled
23 in 1917, a portion of the military plumbing
24 system disturbed below-grade features.
25 Mound 9 was reconstructed in 1926 by the
26 Ohio State Museum. It is unverified if this
27 mound was reconstructed in the 1960s or
28 1970s. Mound 9 is in good condition.

Figure 3-20. Mounds 8, 9, 21, 15, 7, and 3. (Mundus Bishop 2014)

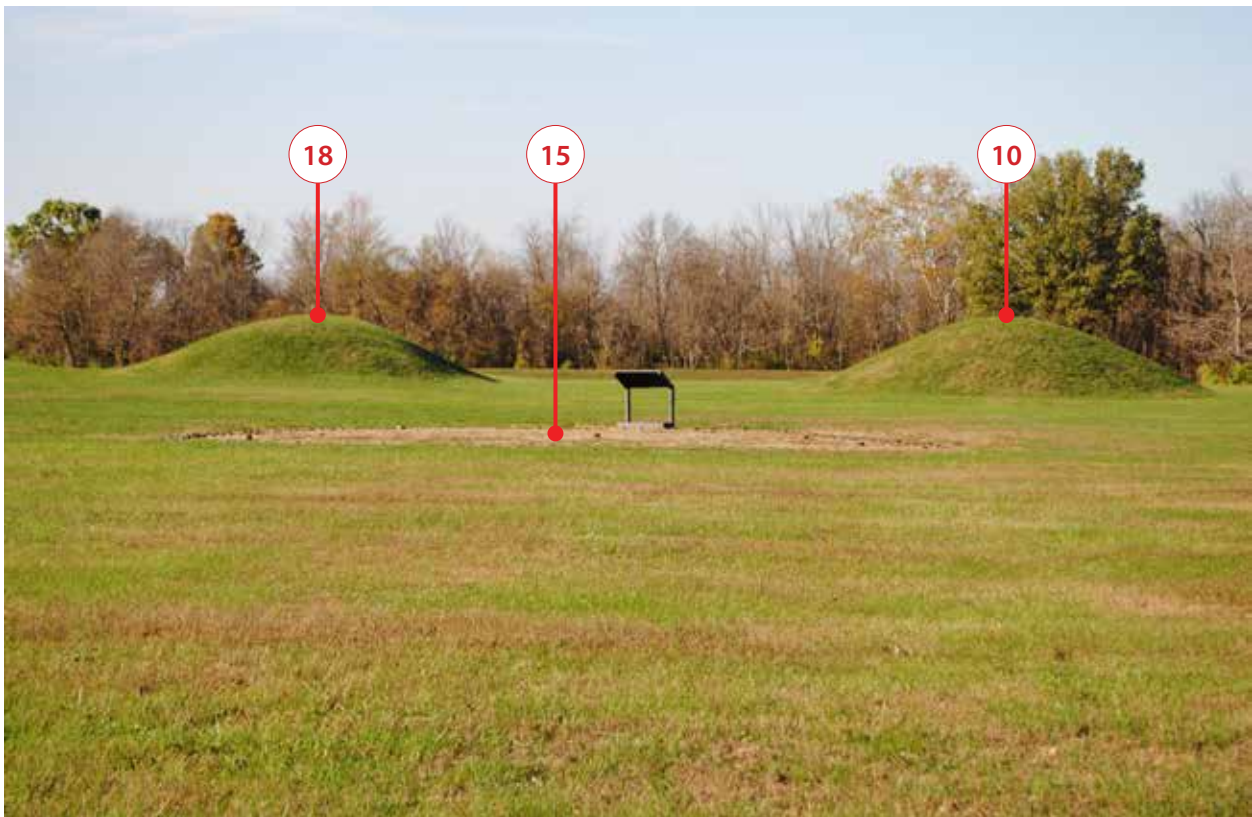
29
30 *Mound 10* is a conical burial mound 60 feet
31 in diameter, and three feet in height. Below-
32 grade features are extant. Mound 10 was
33 leveled in 1917, and reconstructed in 1922 by
34 the Ohio State Museum in the wrong location.
35 Mound 10 was reconstructed in 1963 in
36 its original location. Mound 10 is in good
37 condition.

Figure 3-21. Mounds 18, 15, and 10. (Mundus Bishop 2014)

17
18 *Mound 18* is a conical burial mound 90 feet in
19 diameter and ten feet in height. Below-grade
20 features are extant. Mound 18 was leveled
21 in 1917, and reconstructed in 1922 by the
22 Ohio State Museum. It is unverified if Mound
23 18 was reconstructed in the 1960s / 1970s.
24 Mound 18 is in good condition.

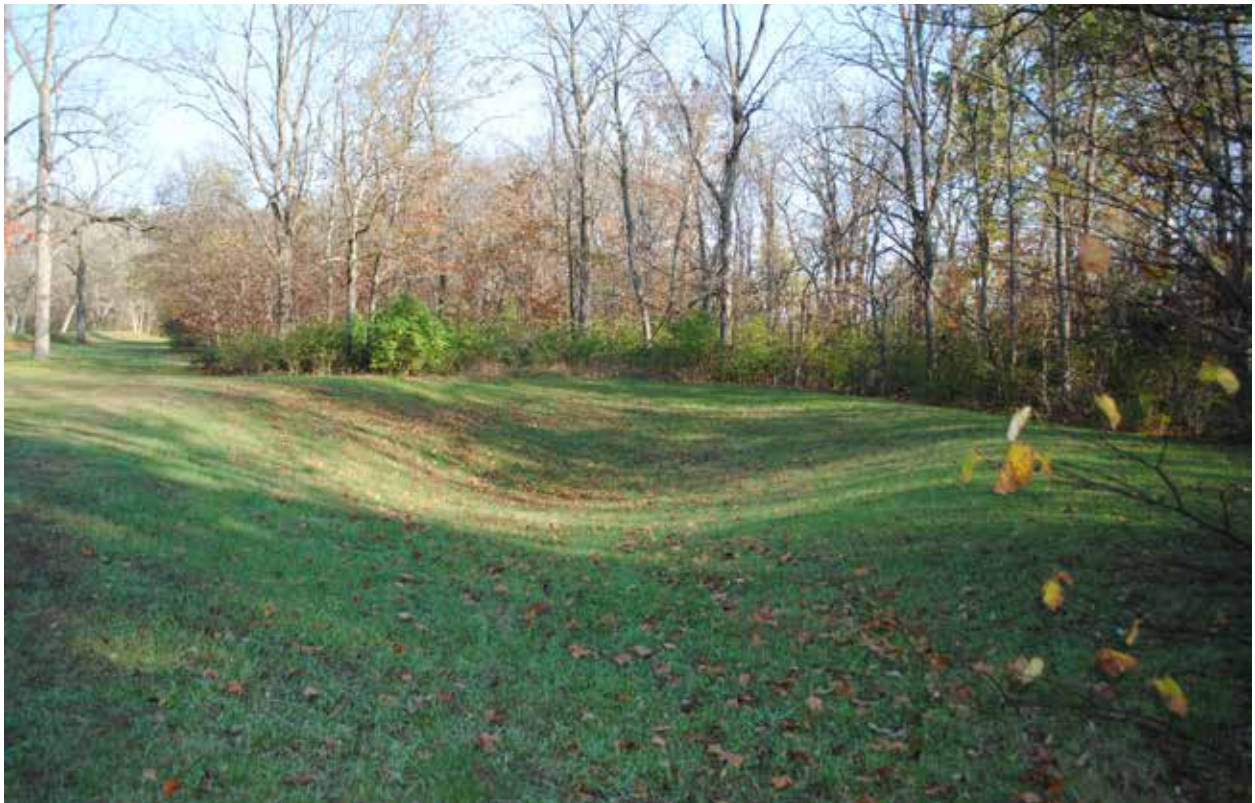
Figure 3-23. Eight borrow pits, varying in size, are outside the enclosure. (Mundus Bishop 2014)

1 Below-grade features associated with the
2 borrow pits likely exist. The 2010 magnetic
3 survey is limited to within the enclosure, but
4 does appear to indicate the two borrow pits
5 that flank the west gateway. The borrow pits
6 are maintained as mown lawn. These features
7 are in good condition. The borrow pits have
8 not been magnetically mapped to verify
9 locations and full extent of the features.

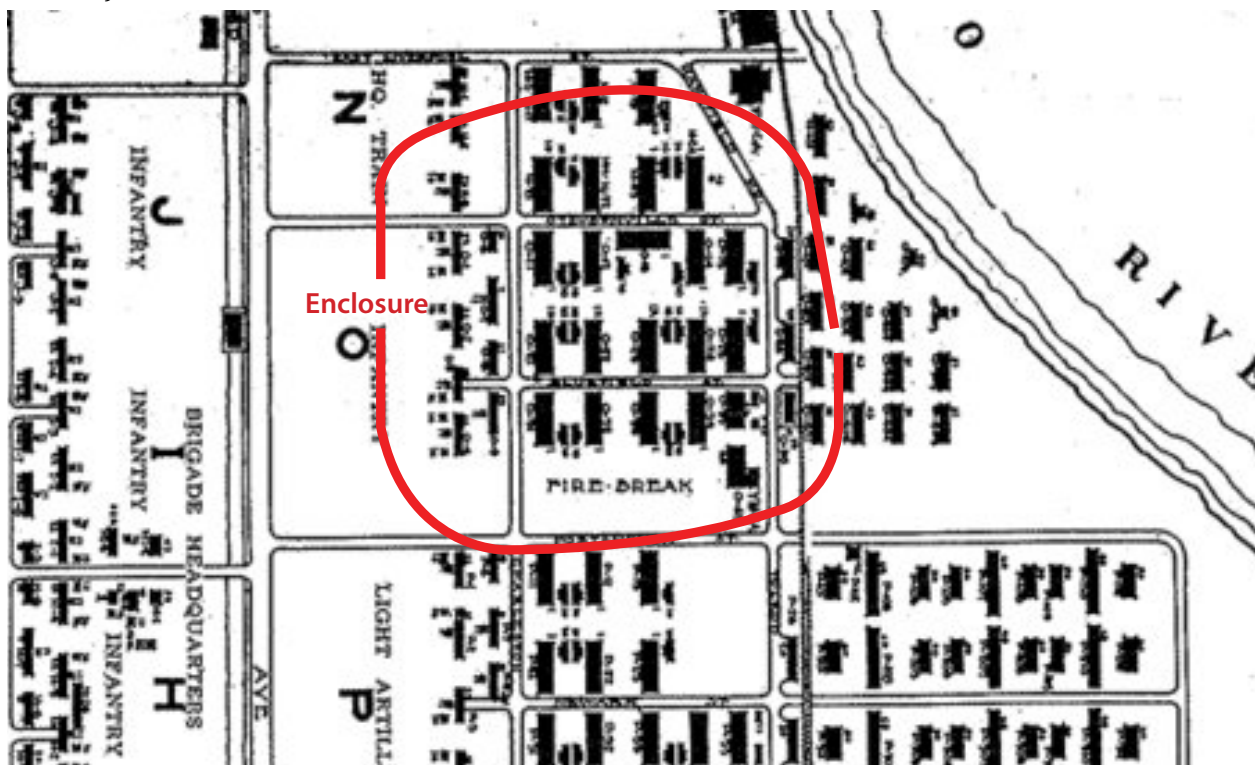
Figure 3-25. Above-grade features were leveled and removed for the construction of Camp Sherman during World War I. Only Mound 7 was not fully removed. (Hopewell Culture NHP Archives)

1 Major changes have occurred since the period
2 of significance. This includes late 19th and
3 early 20th century farming impacts, as well
4 as alterations by the construction of Camp
5 Sherman in 1917, and extensive archeological
6 excavations and reconstructions during the
7 1920s, 1960s, and 1970s.

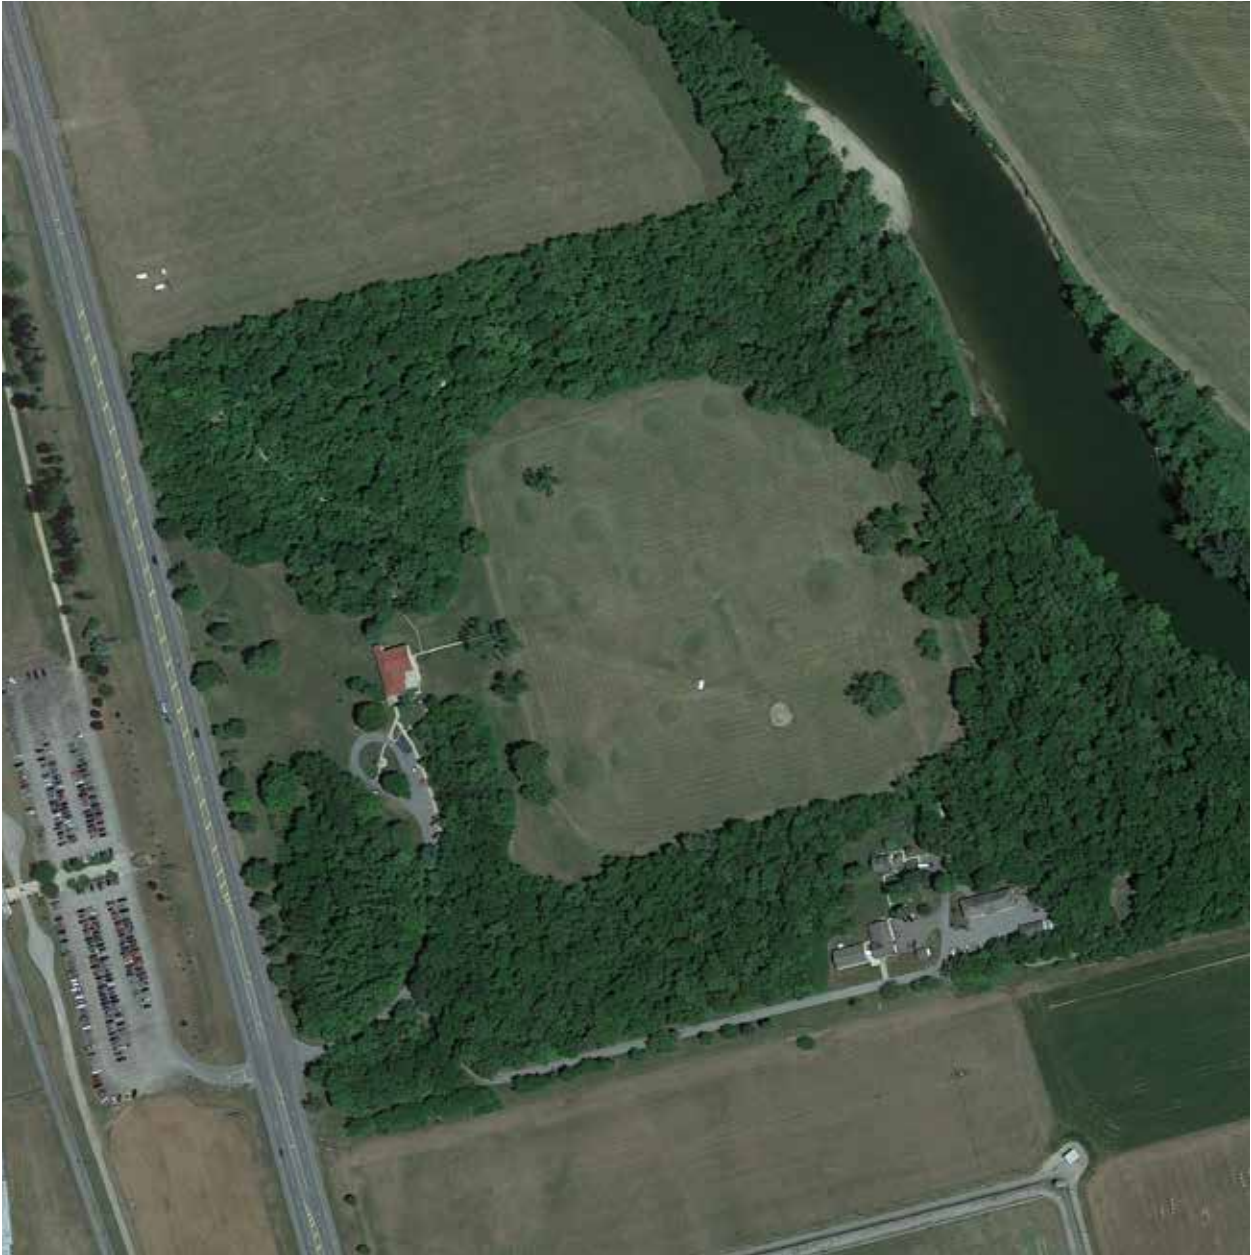
17
18 A magnetic survey completed in 2009 to
19 2012 confirms that extant below-grade
20 archeological features of the enclosure and
21 mounds are intact, and that the reconstructed
22 mounds are located in correct positions.

Figure 3-28. Magnetic survey confirmed that the reconstructed mounds evident today are archeologically accurate. (Google Earth)

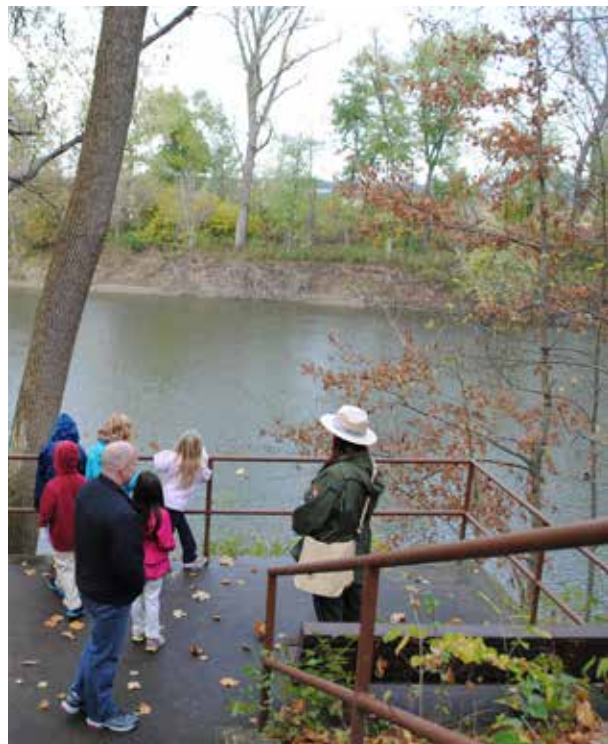
Figure 3-34. The lower overlook provides a view of the Scioto River. (Mundus Bishop 2014)

1 The river trail has two overlooks, lower
2 and upper, connected by stone steps. The
3 overlooks are paved in concrete, and are
4 approximately 15 feet by ten feet wide. The
5 lower overlook is connected to the stone
6 retaining walls, at an approximate height
7 of 5-feet. The stone walls are in good to fair
8 condition. The concrete-paved overlooks are
9 in good condition. Portions of the asphalt
10 paving are cracked and heaved, and are in
11 poor condition.
12
13 An 8 foot wide soft surface trail connects the
14 administration area to the visitor center. It
15 covered with mulch set over a fabric. This
16 trail is in good condition.
17
18 A dirt path occurs at the east gateway and
19 connects to the nature trail to the east. This
20 path measures approximately six feet wide.
21
22 A dirt path connects the enclosure's north
23 edge to the nature trail. The dirt path
24 continues into the field at the north of the

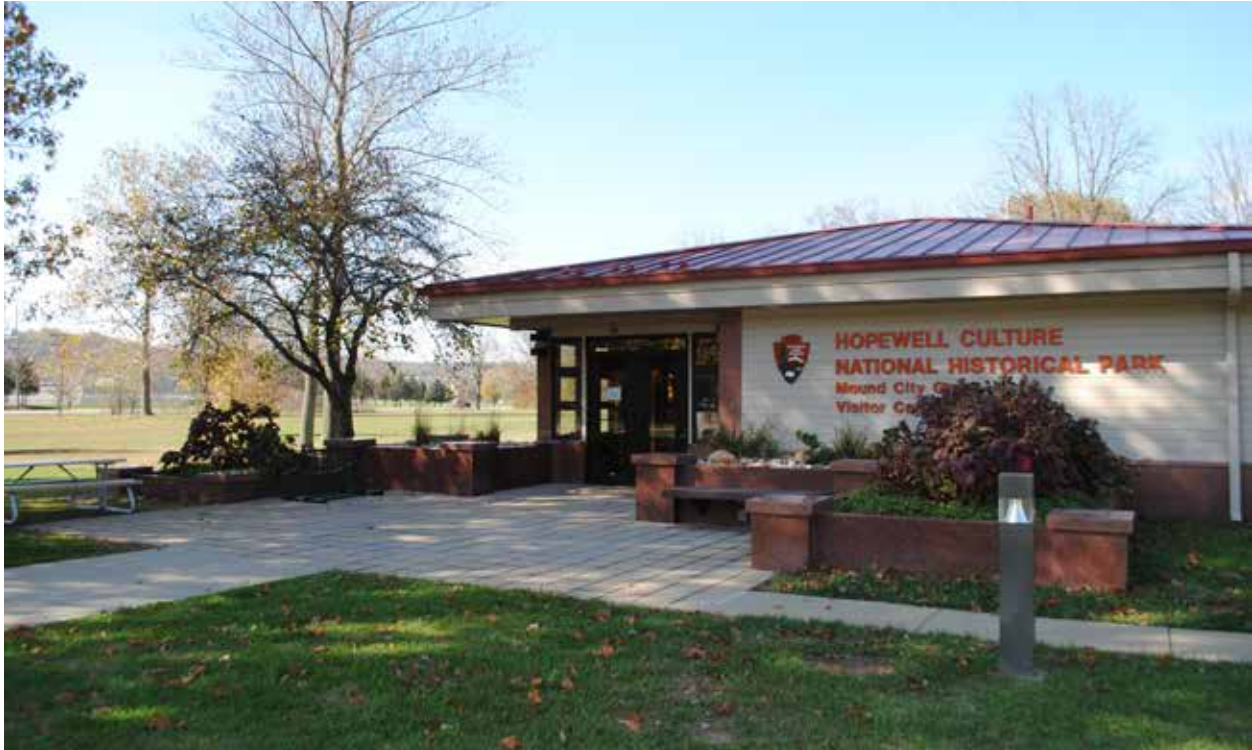
Figure 3-37. The visitor center serves as the main visitor contact point for the entire park. It includes an information desk, museum, restrooms, gift shop, and offices for interpretive staff. (Mundus Bishop 2014)

18
19 The Mission 66-era *visitor center* serves
20 as the main visitor contact point for the
21 entire park. It includes an information desk,
22 museum, restrooms, gift shop, and offices
23 for interpretive staff. It is a cement block,
24 masonry building with granite and masonry
25 accents, and a red metal roof. The visitor
26 center was built in 1959 and modified in
27 1992. It is in good condition.

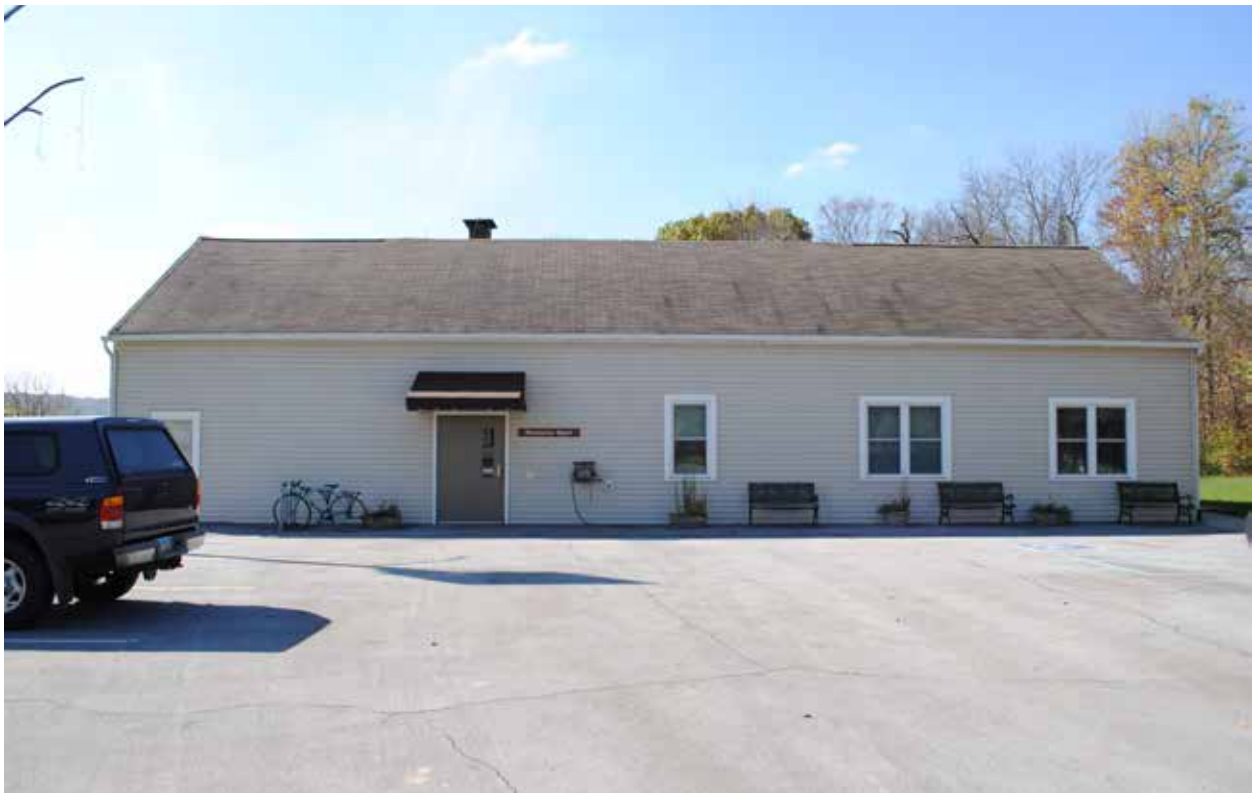
Figure 3-38. The resource management building has offices, library, archive and storage. (Mundus Bishop 2014)

28
29 The *resource management building* is a single-
30 story, vinyl-sided building. It houses offices,
31 library, and storage. This building is in good
32 condition.

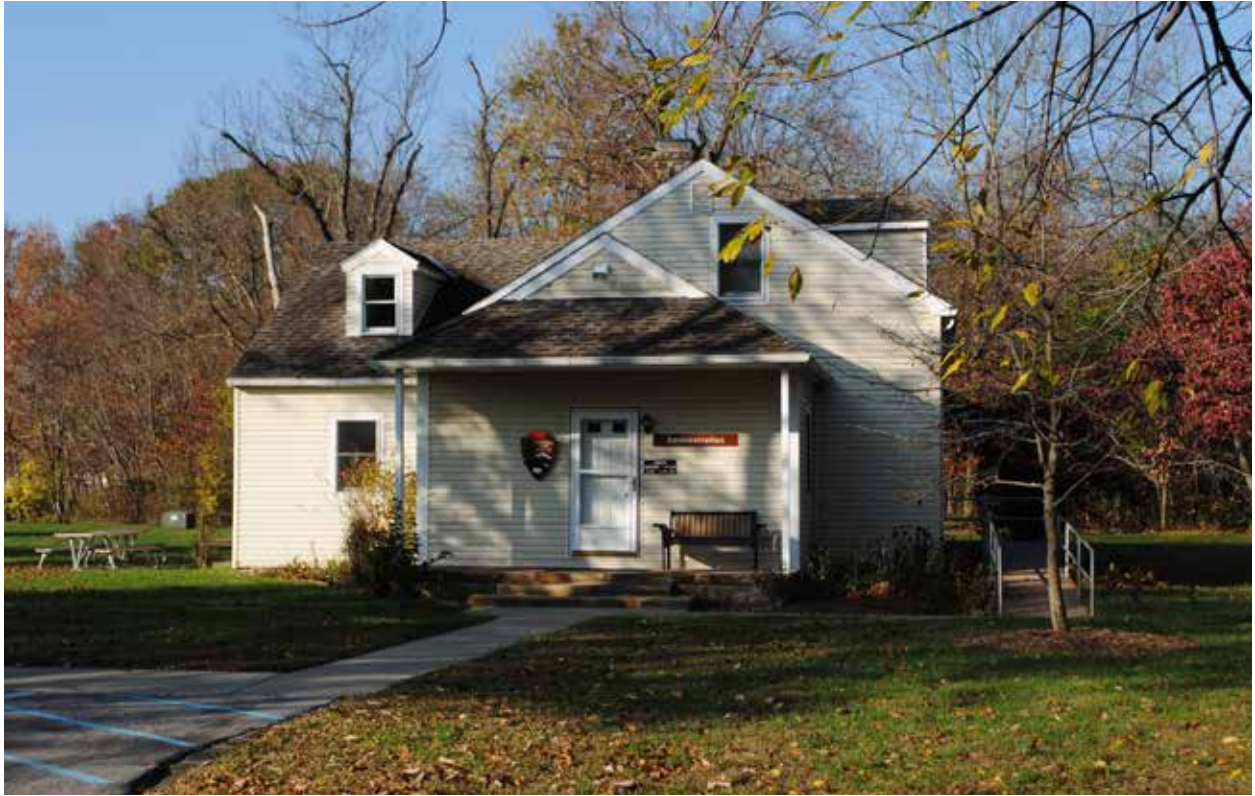
39
40 The *administration building* houses
41 administrative offices. It is a two-story wood
42 building with an asphalt shingle roof, a stone
43 foundation, and stone porch and steps. Three
44 stone steps with painted steel railing descend
45 to a basement on the south exterior of the
46 building. An accessible ramp is on the north
47 side. This building is in good condition.

Figure 3-39. Administration building has offices. (Mundus Bishop 2014)

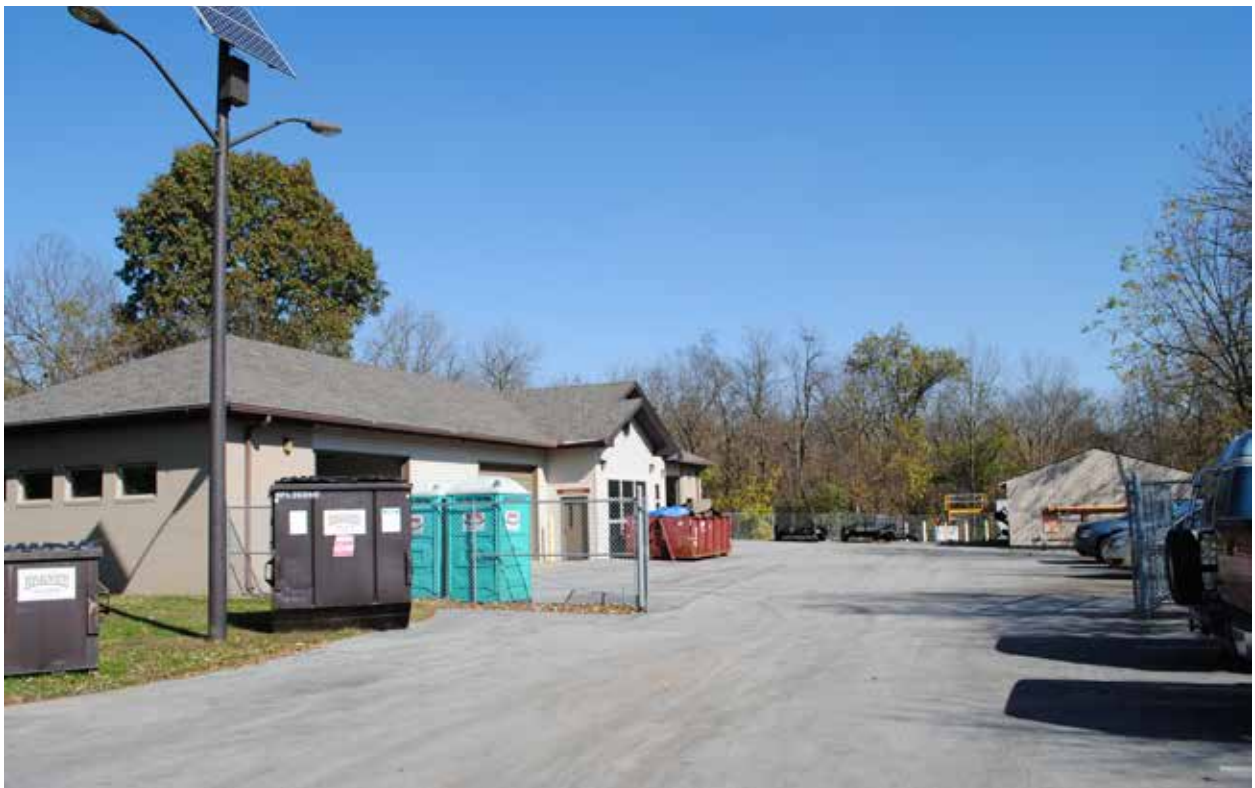
1 The *maintenance building* provides vehicular
2 and equipment storage, and a maintenance
3 shop. A fenced parking area and maintenance
4 yard is on the building's south side. The
5 building is 3,200 square feet, vinyl sided
6 with an asphalt roof. This building is in good
7 condition.

8
9 The *maintenance storage structure* is a single-
10 story, vinyl-sided tool shed with an asphalt
11 roof. It is within the maintenance yard. It is an
12 open-sided, used for equipment storage. The
13 shed is in good condition.

Figure 3-40. The maintenance building and yard. The maintenance storage shed is in the background. (Mundus Bishop 2014)

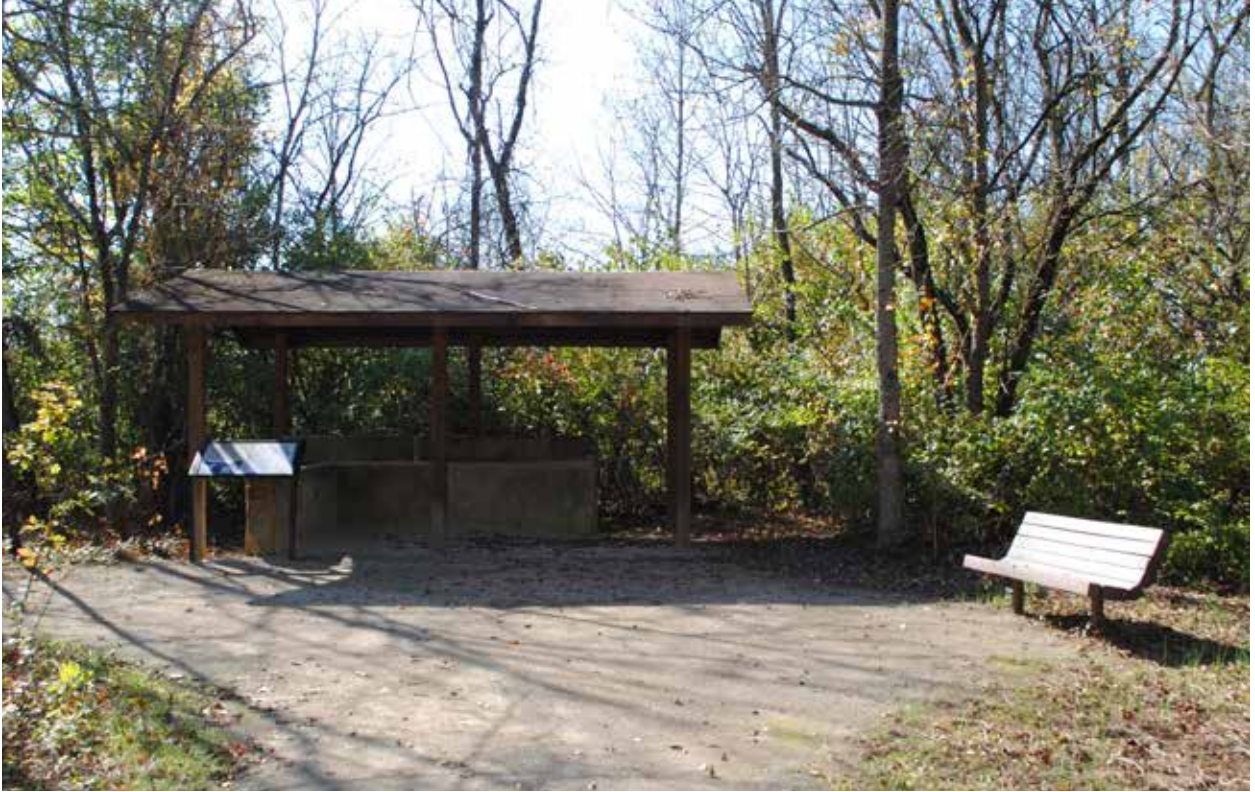
19
20 A wood-frame *shelter* is adjacent to the Ohio
21 Erie canal stones. The structure measures 16
22 feet by 12-feet. The roof is supported by six
23 beams. It has a decomposed granite / crusher
24 fines floor. The shelter is in good condition.

Figure 3-41. A wood frame shelter at the Ohio Erie canal stones wall. (Mundus Bishop 2014)

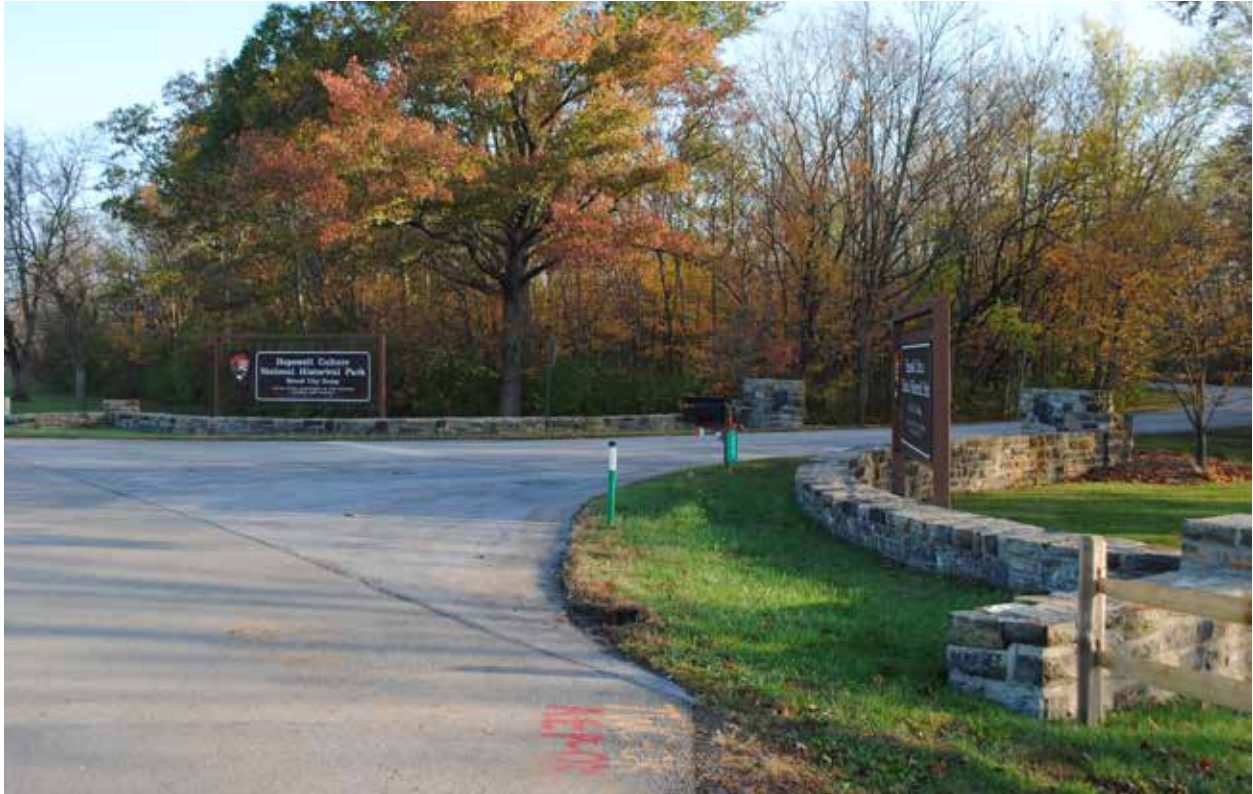
Figure 3-42. Stone entrance walls flank the entrance into the park. (Mundus Bishop 2014)

9
10 *Stone entrance walls* flank the entrance into
11 the park at the intersection of the entrance
12 drive with the highway. The two stacked
13 sandstone walls, are curved and two feet in
14 height with 3 foot tall columns at the ends.
15 The walls are in good condition.

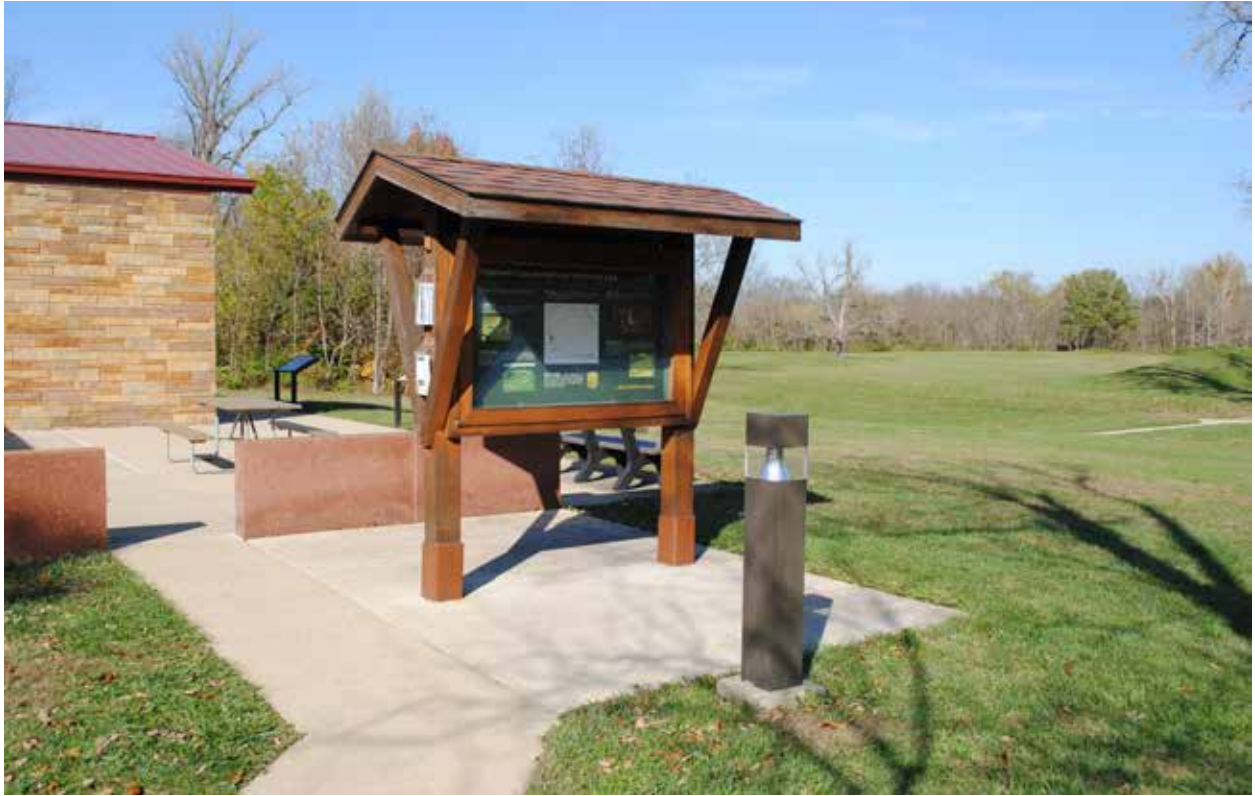
38
39 A *kiosk* with visitor information is at the
40 visitor center. The kiosk is wood frame on
41 painted steel, set on a concrete pad. It is in
42 good condition.

Figure 3-44. Kiosk at the visitor center. (Mundus Bishop 2014)

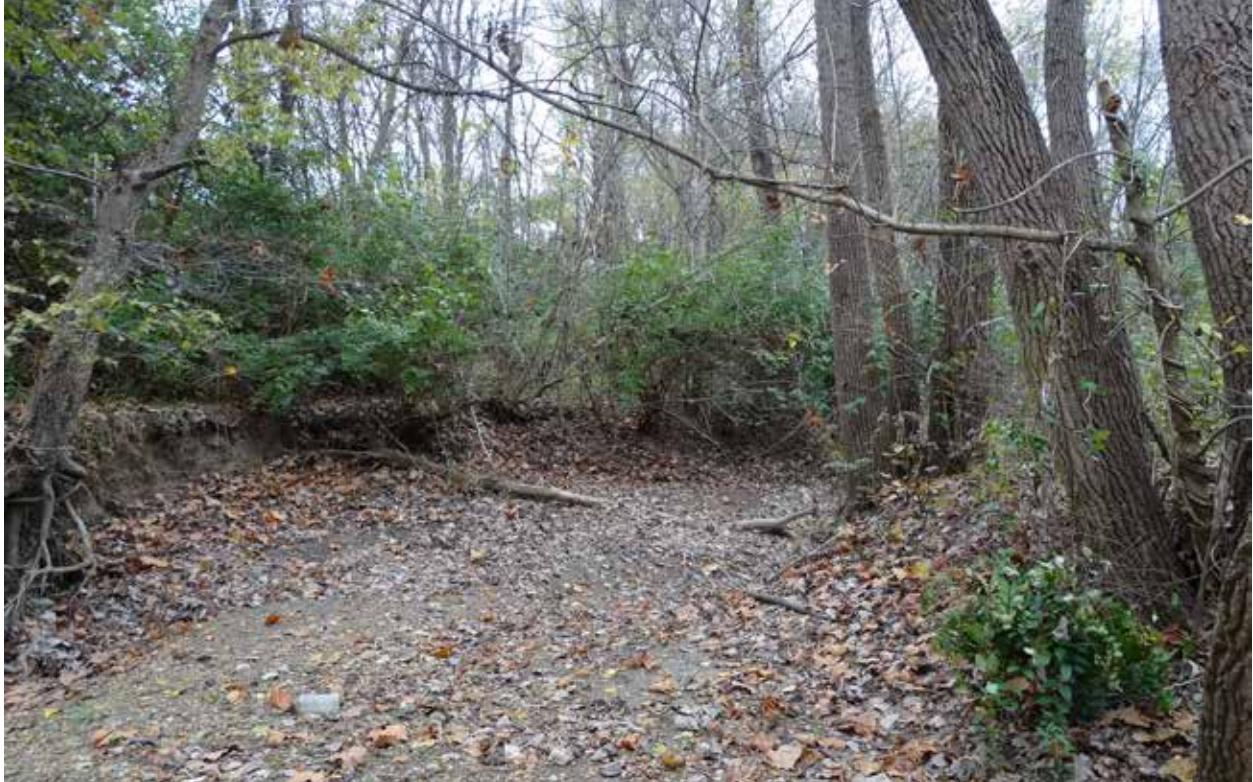
Figure 3-50. Though the stream is intermittent, the banks of Dry Run are deeply cut, October 2014. (Quinn Evans Architects 2014)

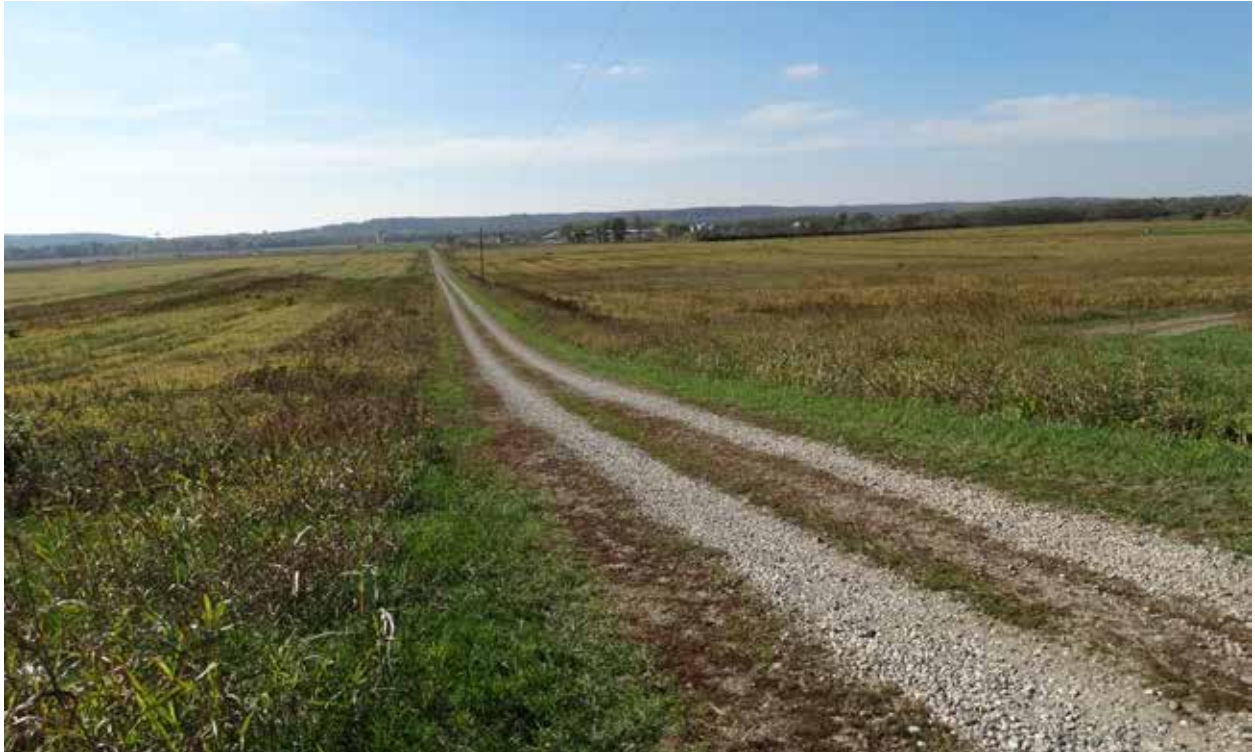
22
23 Pit Road and the access road pass through
24 the earthwork complex, and construction of
25 these roads may have impacted below-grade
26 features. The circulation routes that exist
27 today are not from the period of significance,
28 and are not contributing features.

Figure 3-58. Gravel road and utility lines cross through the south portion of the Square Enclosure, October 2014. (Quinn Evans Architects 2014)

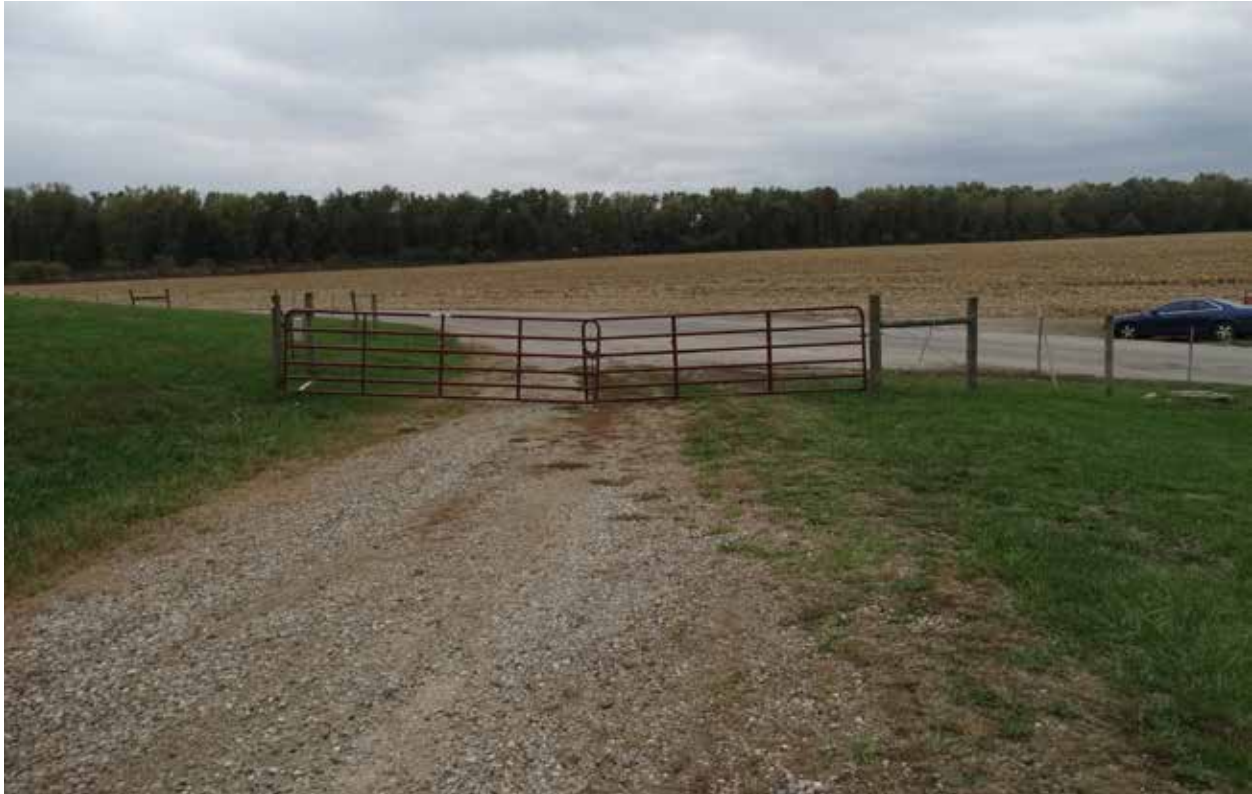
Figure 3-68. Gate at current entrance to NPS property, October 2014. (Quinn Evans Architects 2014)

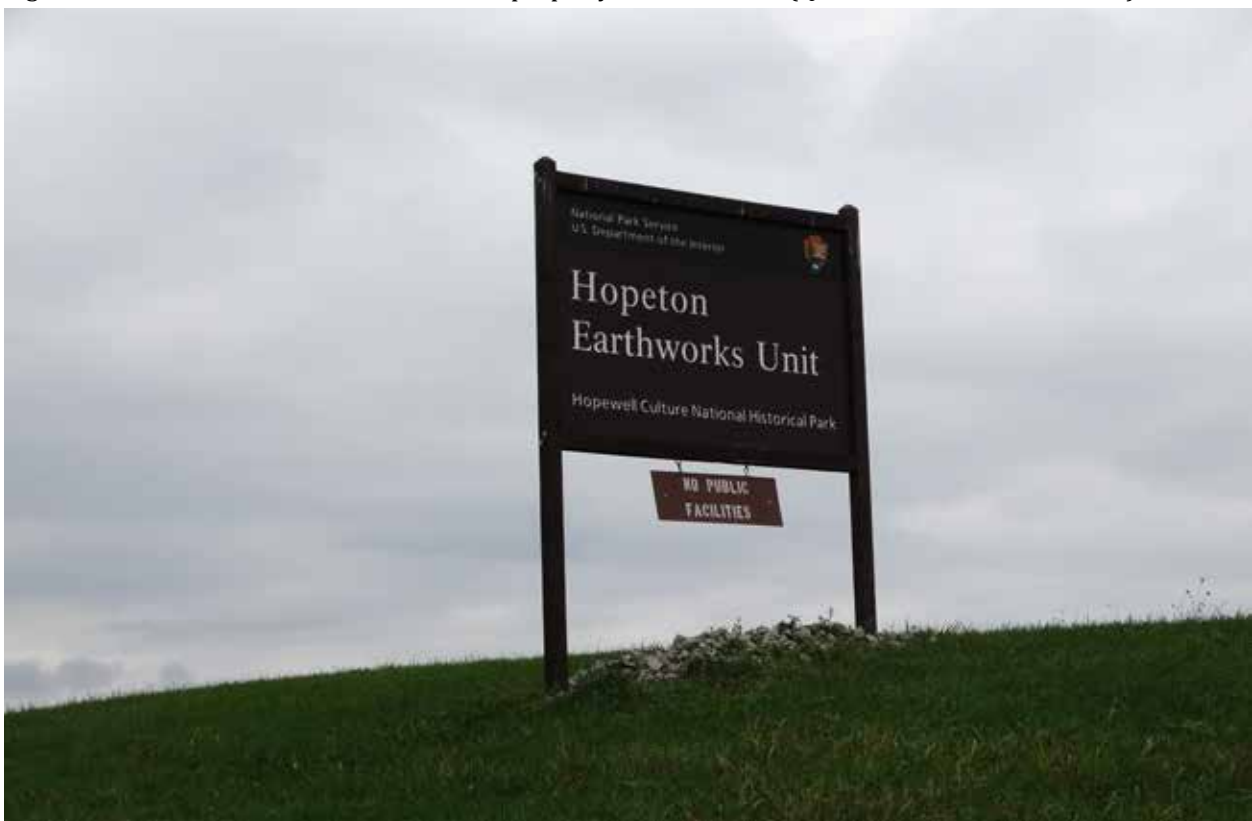
Figure 3-69. NPS park identifier sign, Hopeton Earthworks, October 2014. (Quinn Evans Architects 2014)

23
24 A Hopeton Earthworks park *identification*
25 *sign* is located to the east of Pit Road, which
26 provides access to the park unit from
27 Hopetown Road. The sign indicates that there
28 are "no public facilities" at the park unit. The
29 sign is in good condition. Additional signage
30 includes regulatory signage at the railroad
31 crossing at the east side of the property.

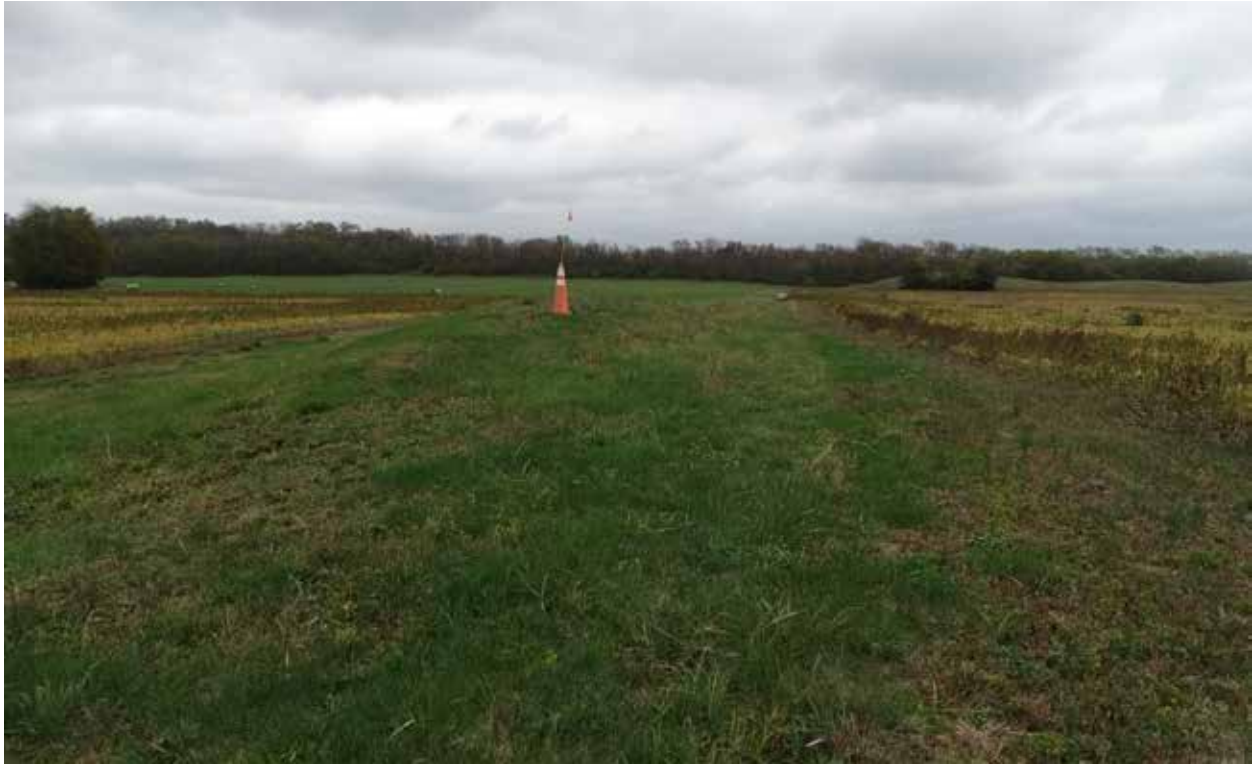
Figure 3-70. Traffic cone marks the northwest corner of the Square Enclosure, October 2014. (Quinn Evans Architects 2014)
