Chapter 3. Existing Condition and Analysis / Affected Environment

1 This chapter presents the summary and
2 analysis of the current condition of the
3 archeological landscape of Hopewell
4 Culture NHP. Narrative text, diagrams, and
5 photographs describe the existing condition
6 using a series of landscape characteristics.
7
8 The condition assessment is undertaken to
9 understand the archeological landscape as
10 a whole. It identifies and documents those
11 qualities and features that contribute to the
12 park's historic character, retain integrity,
13 and contribute to the significance of the
14 landscape. Field reconnaissance, undertaken
15 in October 2014, assisted in the recording of
16 the archeological landscape.
17
18 This chapter is organized to present the
19 existing condition and analysis evaluation
20 for the study area first, which includes the
21 evaluation of landscape characteristics that
22 relate to the study area as a whole. This is
23 followed by a condition assessment and

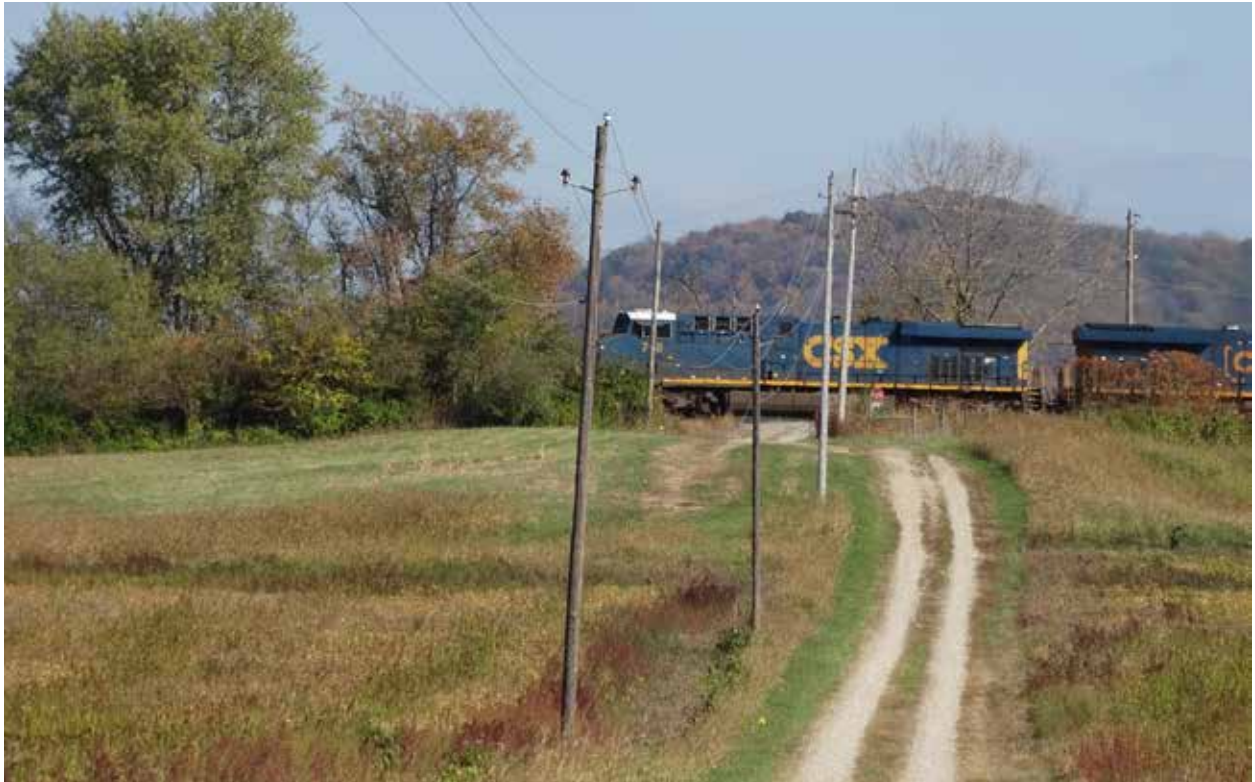
38
39 *Utility poles* and aerial lines run parallel to
40 the railroad on the east side of the property.
41 Another set of utility poles and aerial lines
42 extend along the north side of the east west
43 gravel road, passing through the southern
44 portion of the Square Enclosure and across
45 the earthen causeway, possibly disturbing
46 below-grade resources. At Pit Road, the

7 Small scale features at Hopeton Earthworks
8 are not from the period of significance,
9 and do not contribute to the archeological
10 landscape. The presence of utility lines within
11 the earthwork complex impacts views of the
12 archeological features, and installation may
13 have disturbed below-grade resources.

Figure 3-71. Utility poles cross the south portion of the Square Enclosure, October 2014. (Quinn Evans Architects 2014)

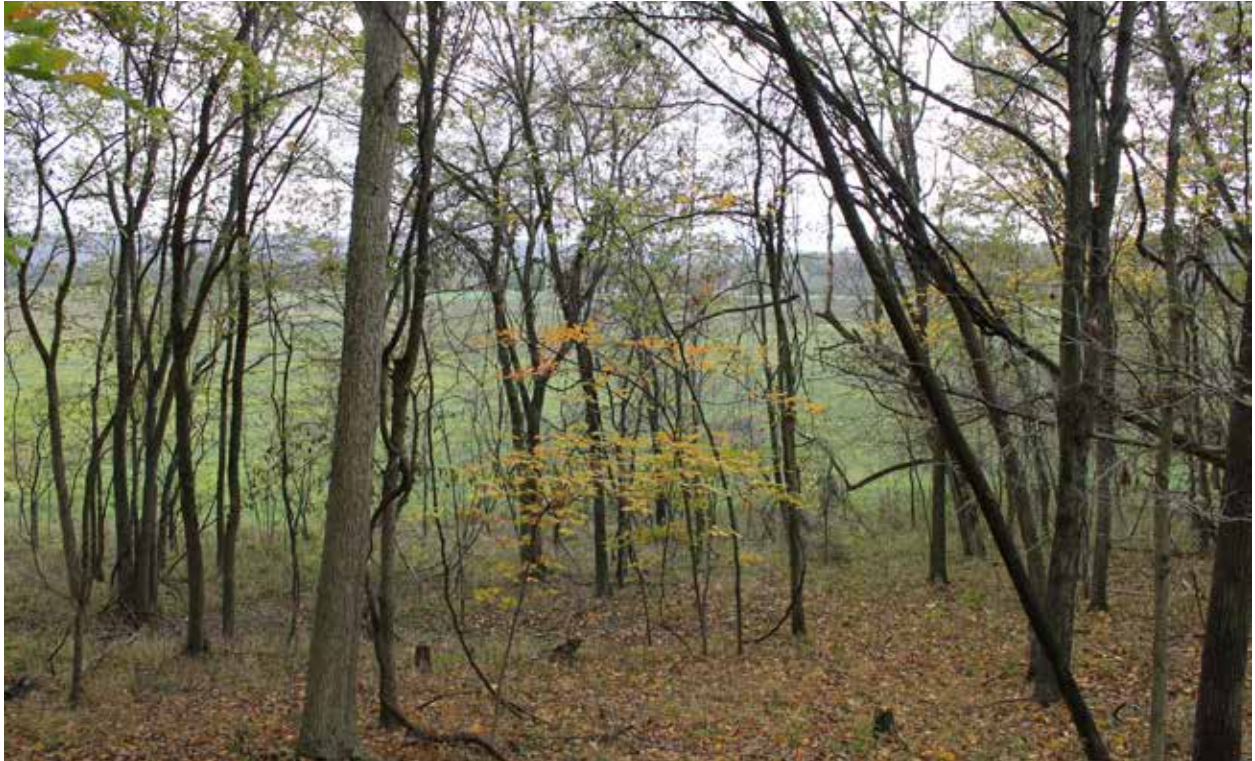
Figure 3-72. Typical view from the north section of the Great Enclosure, looking south toward Mound 25. Vegetation blocks the view of the first terrace, October 2014. (Quinn Evans Architects 2014)

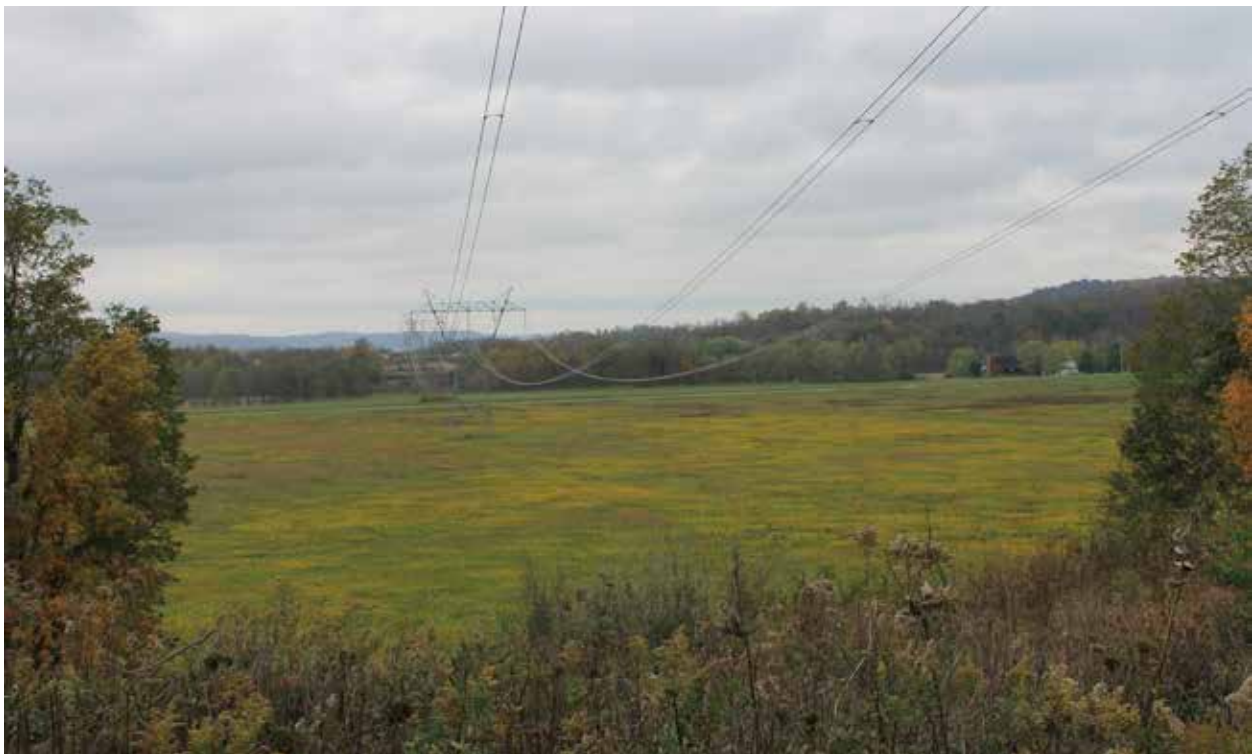
Figure 3-73. View from overlook at northeast portion of the earthwork complex, facing south. The view is maintained by clearing of vegetation for the utility easement. Vegetation on either side of the easement is encroaching on the view of the complex. October 2014. (Quinn Evans Architects 2014)

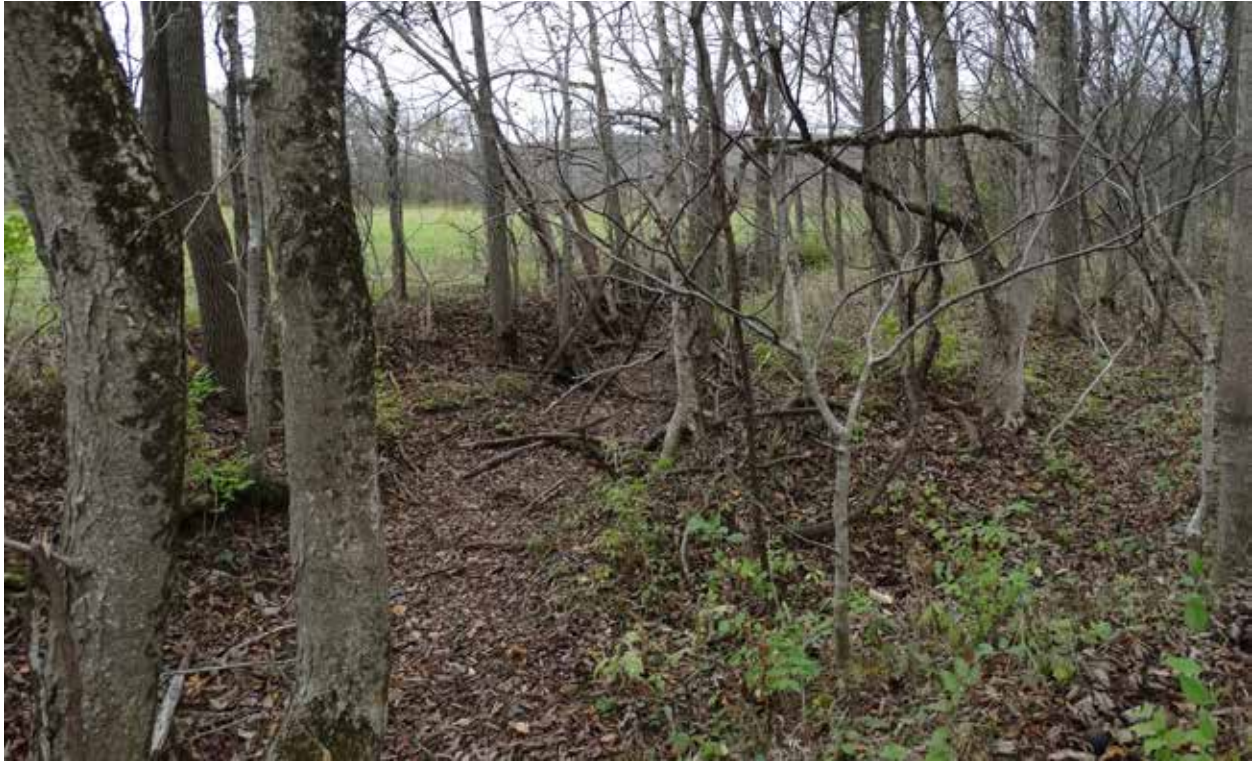
Figure 3-77. A constructed ditch along the west side of the enclosure, facing south, October 2014. (Quinn Evans Architects 2014)

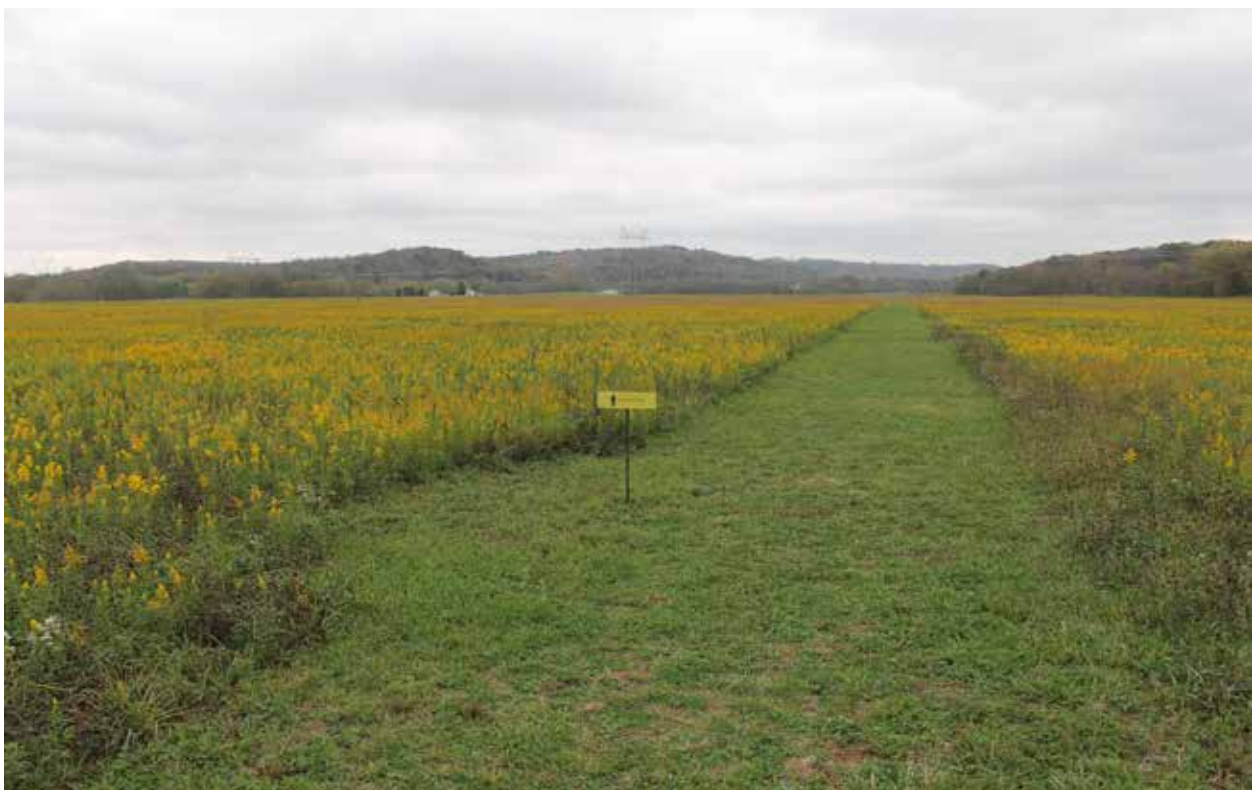
Figure 3-78. The outline of the Square Enclosure is mowed, and surrounding vegetation is not cut. This improves visibility and access to the features, October 2014. (Quinn Evans Architects 2014)

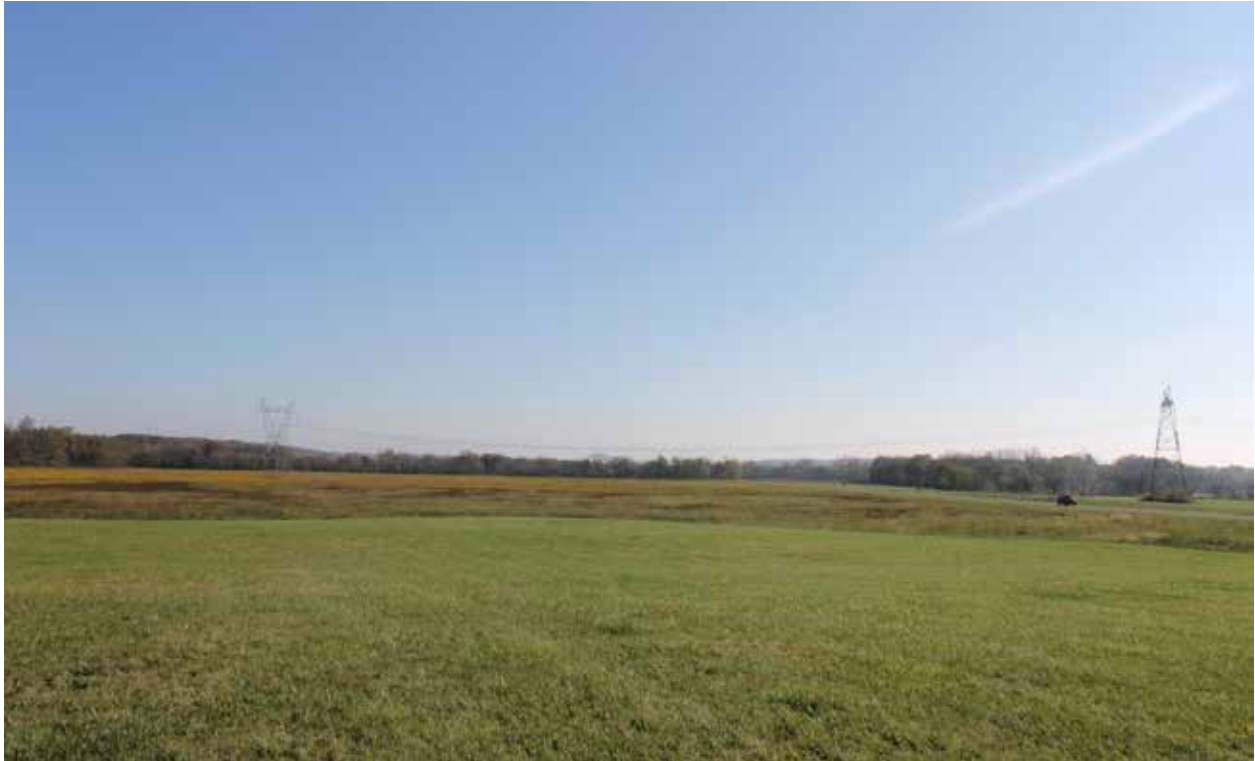
Figure 3-79. View southeast from Mound 25 toward the Great Circle. The Great Circle, D-Shaped Enclosure, and unverified mounds are not visible, October 2014. (Quinn Evans Architects 2014)

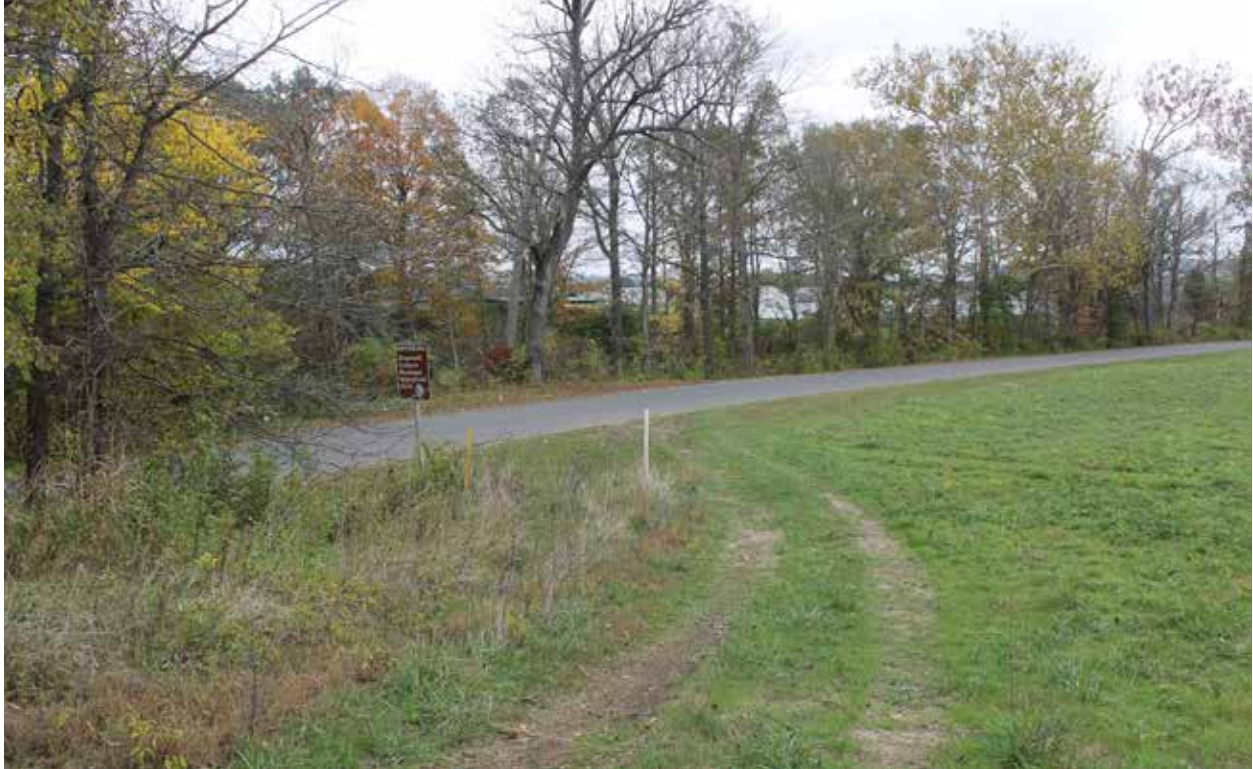
Figure 3-84. Maintenance road, on east side of NPS property looking east toward Maple Grove Road, October 2014. (Quinn Evans Architects 2014)

41 *A gravel road*, used as a maintenance access
42 road, connects Maple Grove Road with the
43 interpretive trail in the northeast corner of
44 the park. The road is rarely used, and is in fair
45 condition.
46

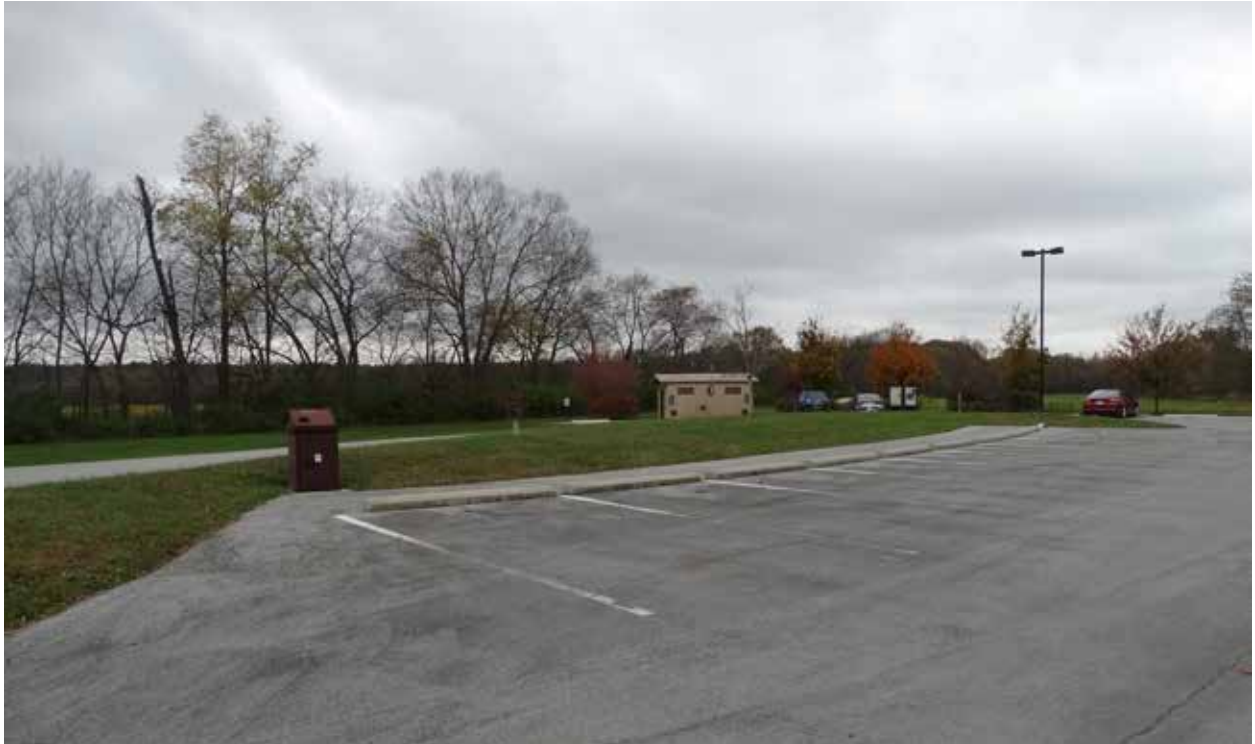
1 *A parking area* is on the north side of Sulphur
2 Lick Road in the southeast portion of the
3 park unit. The parking area has 48 spaces
4 and four bus spaces. From the parking area,
5 concrete paved sidewalks provide access to
6 restroom facilities, picnic shelter, waysides,
7 and an overlook. The parking pavement and
8 sidewalks are in good condition.
9

Figure 3-87. Parking area at Hopewell Mound Group, October 2014. (Quinn Evans Architects 2014)

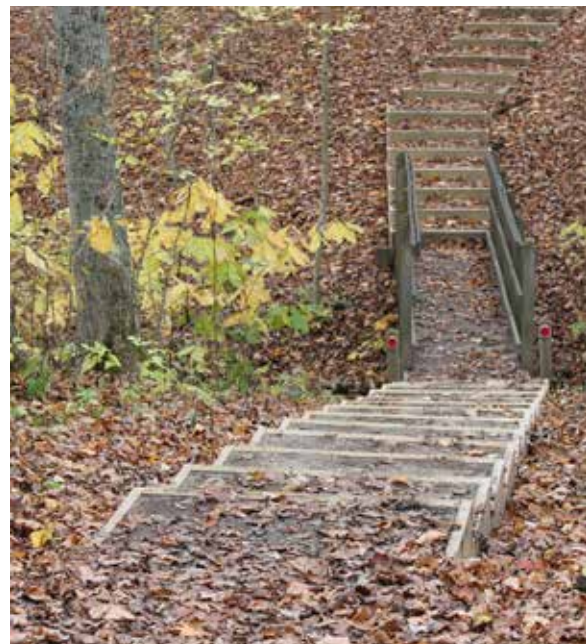
31 Wood bridges and stairs occur periodically
32 along the trail to navigate steep topography,
33 and wet areas. Bridges and stairs are new,
34 and are in good condition. This section of
35 the interpretive trail follows the outside of
36 the Great Enclosure down the slope to the
37 first terrace. It turns into the enclosure at
38 the bottom of the slope. The trail is in good
39 condition.
40

Figure 3-90. Wood staircase and bridge along interpretive trail, on the west side of the unit. In wooded areas, the interpretive trail has a dirt surface, October 2014. (Quinn Evans Architects 2014)

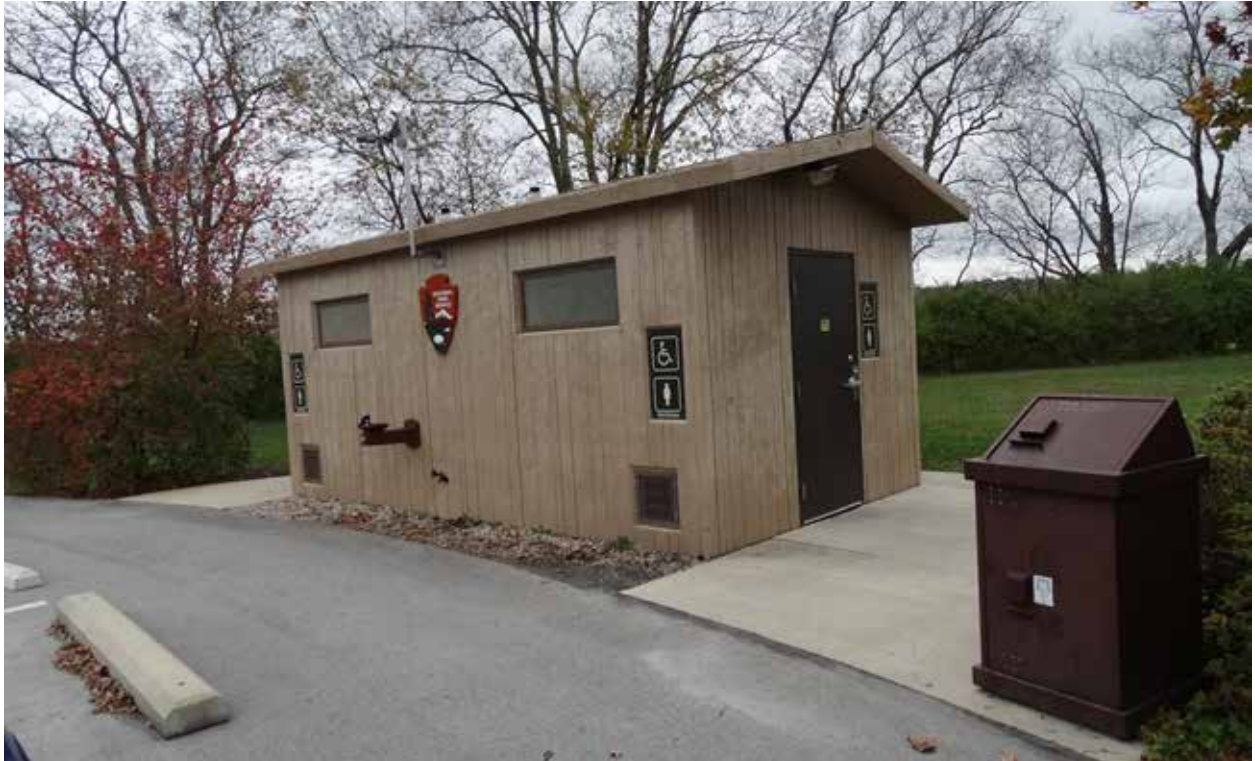
Figure 3-97. Comfort Station at Hopewell Mound Group parking area, October 2014 (Quinn Evans Architects 2014)

14
15 A *comfort station* occurs immediately to the
16 north of the parking area, providing restroom
17 facilities for visitors. The structure was built
18 after 2009 and is in good condition.

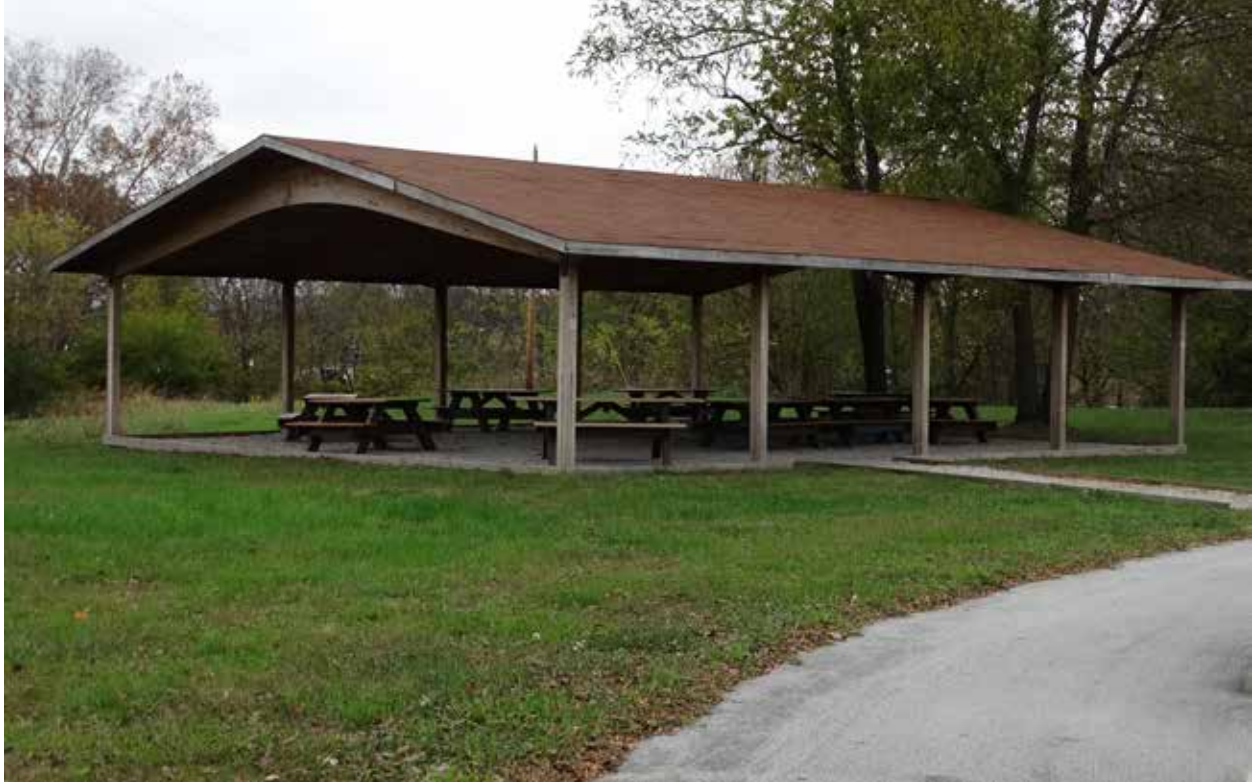
Figure 3-98. Picnic shelter at Hopewell Mound Group parking area, October 2014. (Quinn Evans Architects 2014)

19
20 A *picnic shelter* is situated east of the parking
21 area. The structure was built after 2009 and is
22 in good condition.

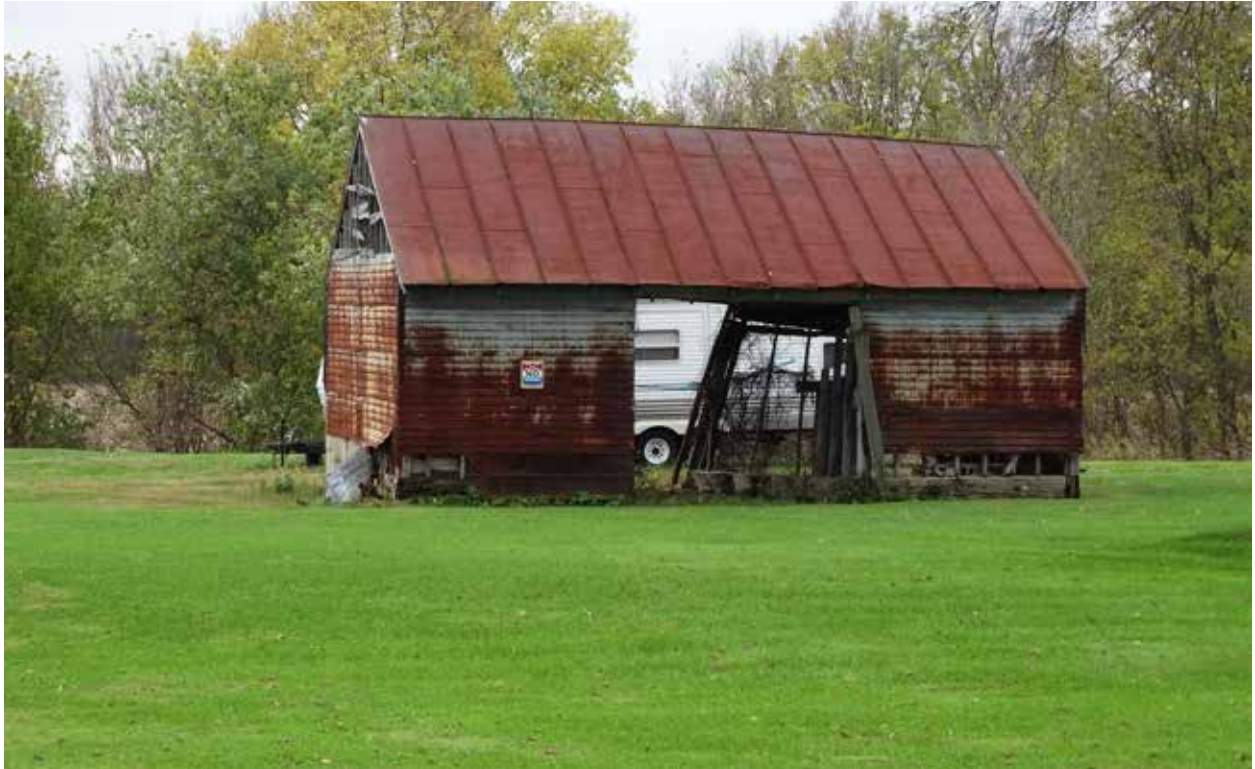
23
24 A *corn crib* is on the south side of Sulphur
25 Lick Road, immediately to the west of the
26 private garage. It was likely built in the
27 late nineteenth or possibly early twentieth
28 century. The corn crib is in poor condition
29 and in need of immediate stabilization.^{3.88}

Figure 3-99. Corn crib south of Sulphur Lick Road, October 2014. (Quinn Evans Architects 2014)

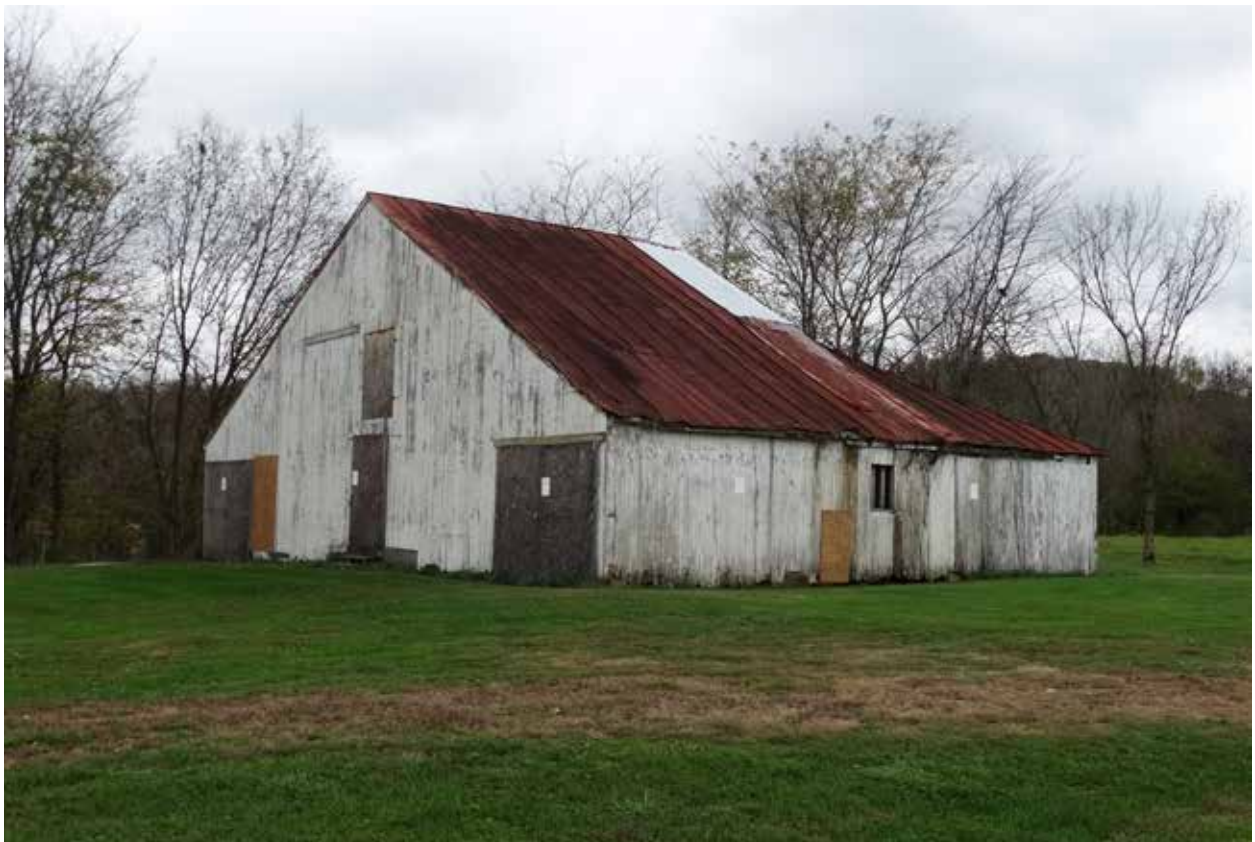
30
31 The *Hopewell barn* is west of the corn crib on
32 the south side of Sulphur Lick Road. The barn
33 is a significant example of the architectural
34 and agricultural history of Ohio. It was built
35 in the late eighteenth or early nineteenth
36 century using nontraditional carpentry
37 methods. (Fig. 28 barn 3.jpg) The barn is
38 in poor condition, in need of immediate
39 stabilization.^{3.89}

Figure 3-100. Hopewell barn south of Sulphur Lick Road, October 2014. (Quinn Evans Architects 2014)

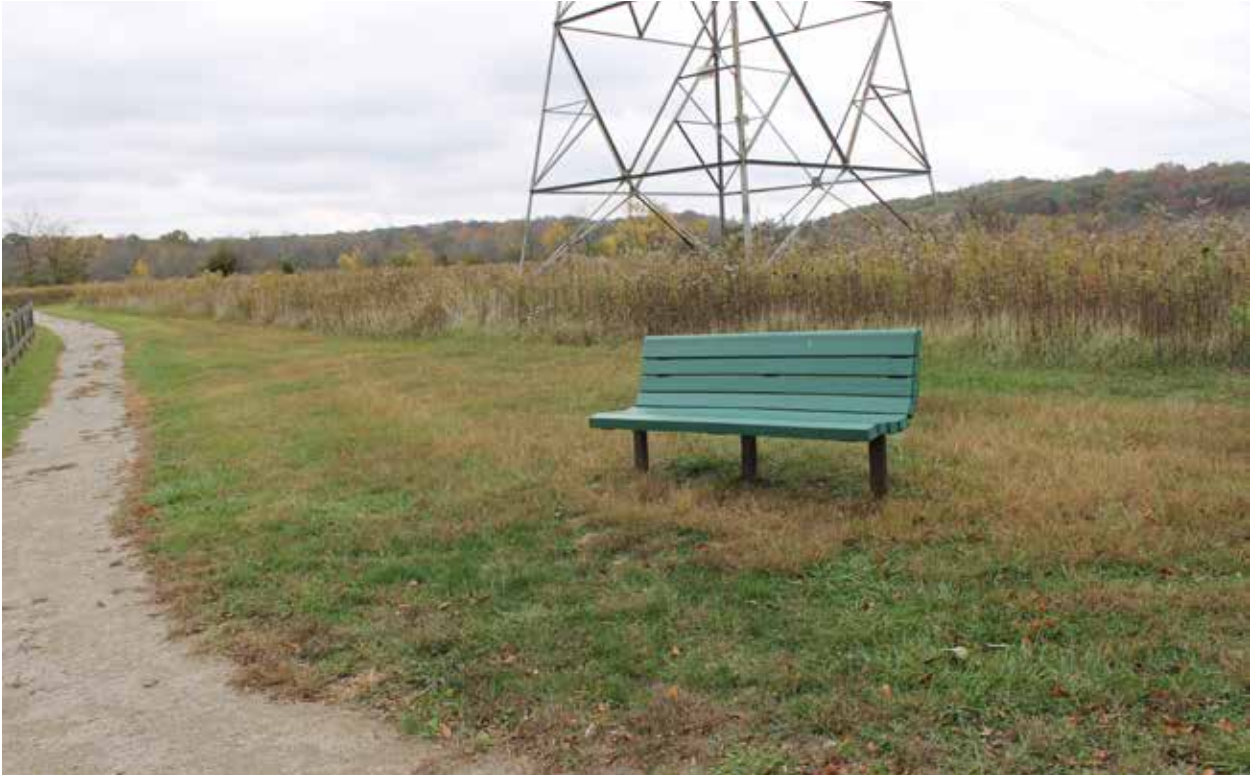
Figure 3-101. Proximity of transmission tower to overlook on the north side of the Great Enclosure, October 2014. (Quinn Evans Architects 2014)

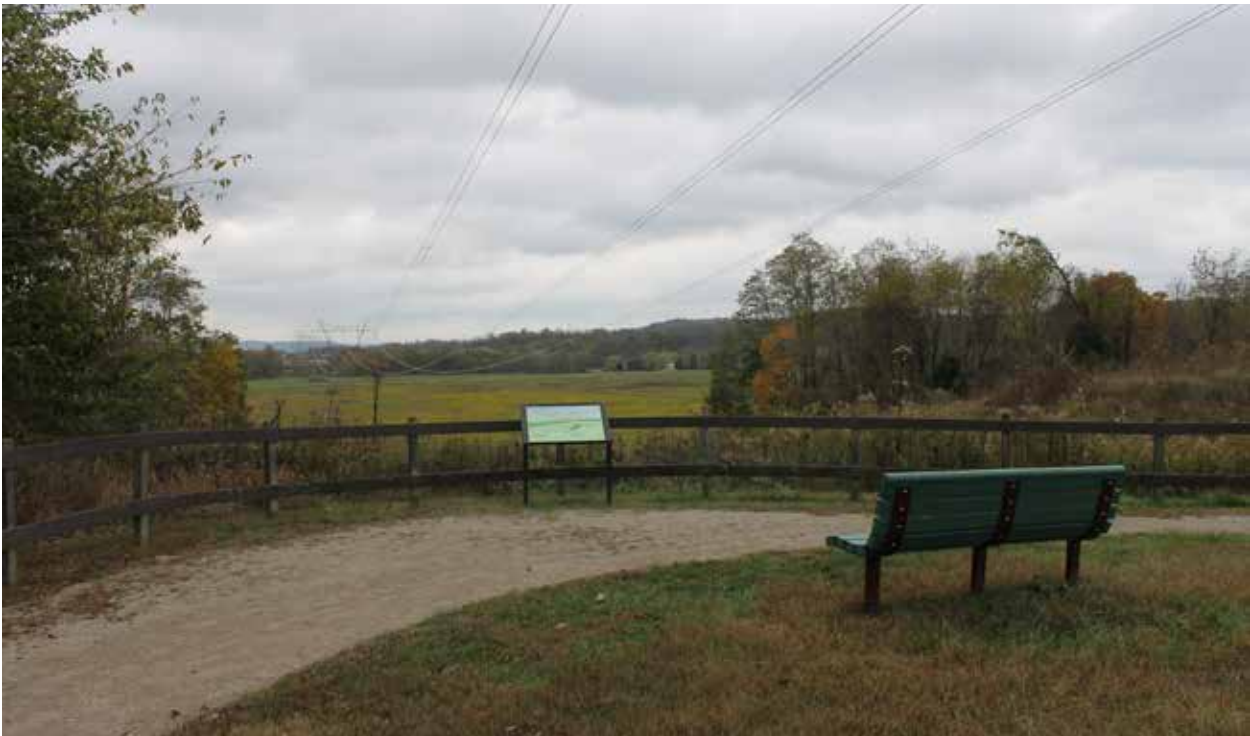
Figure 3-102. Views are open along the power-line that cuts through the Hopewell Mound Group Unit from northeast to southwest. The earthwork complex is visible from this vantage point, however, views are also opened up to the gravel quarry south of the park unit, October 2014. (Quinn Evans Architects 2014)

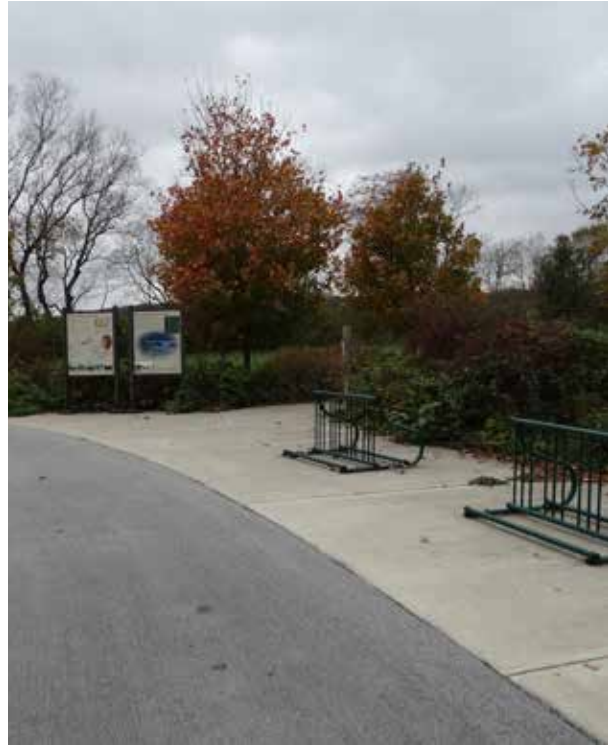
Figure 3-104. Small scale features in the Hopewell Mound Group parking area include bicycle racks, trash receptacles and signs. October 2014. (Quinn Evans Architects 2014)

1 Small scale features associated with the
2 parking area are regulatory signs, bike racks,
3 trash receptacles, lights, picnic tables, and a
4 bird house. They are in good condition.

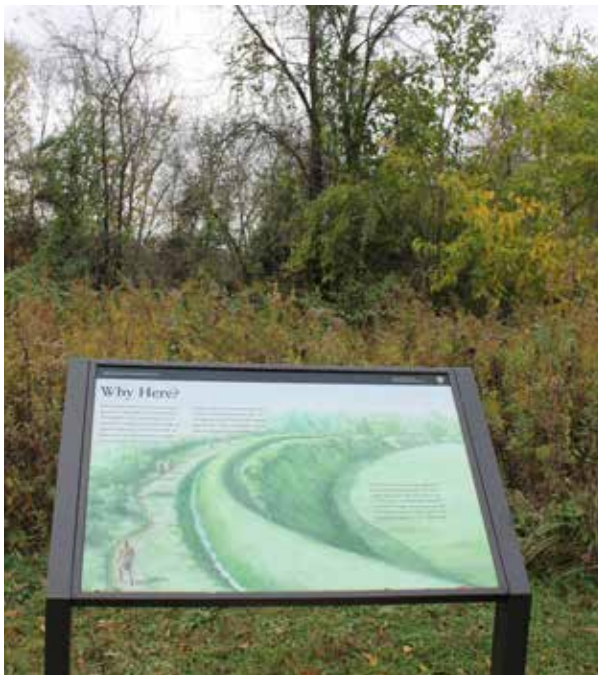
Figure 3-105. This sign, on the north side of the Great Enclosure along the interpretive trail, does not relate to archeological features or views. (Quinn Evans Architects 2014)

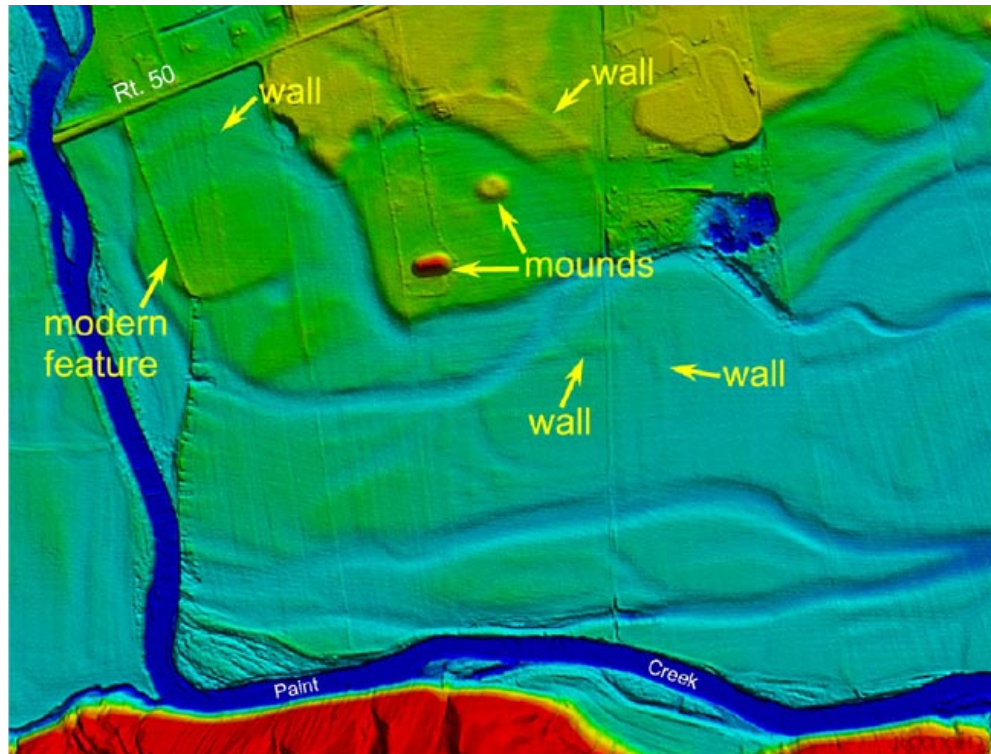
Figure 3-114. Only a small portion of the Large Circle is visible because it was reconstructed in 1927. The remainder of the Large Circle is evident on the LiDAR survey but difficult to discern from ground level. (Mundus Bishop 2014)

The extant above-grade features of the Large Circle are in poor condition, due to agricultural practices that have negatively impacted the condition of the earthwork.

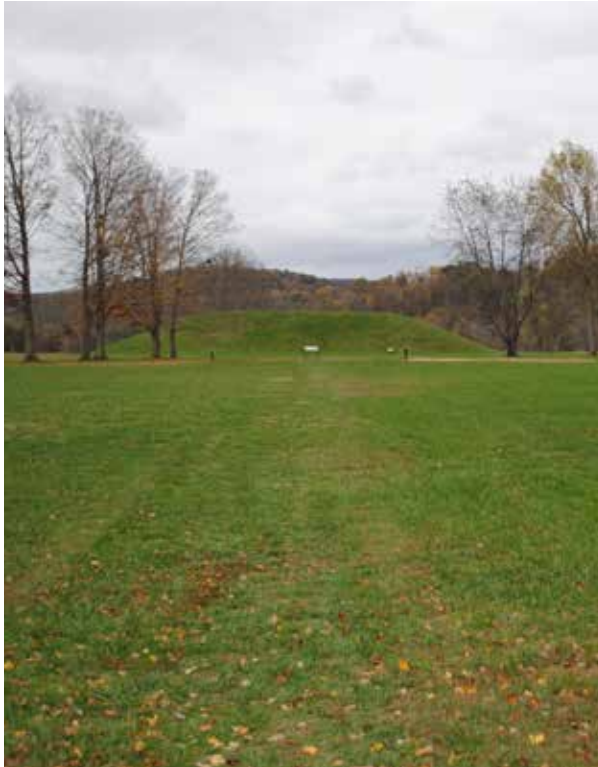
Seip-Pricer Mound is the largest mound within the earthwork complex, and the most visible feature. Seip-Pricer Mound is located at the approximate center of the Large Circle. It consists of a large elliptical, domed structure of sand, gravel, and soil, with a flat area on top of the mound. It is the third largest burial mound the Hopewell are known to have built and it measures 240 feet by 160 feet, and 30 feet high. The Seip-Pricer Mound is maintained with mown lawn. The Seip-Pricer Mound was reconstructed after extensive excavation in the past. Below-grade features are likely extant. The reconstructed mound is in good condition. The condition of the below-grade archeological features is unknown.

Figure 3-115. Seip-Pricer Mound is the largest mound within Seip Earthworks and the most visible feature. (Mundus Bishop 2014)

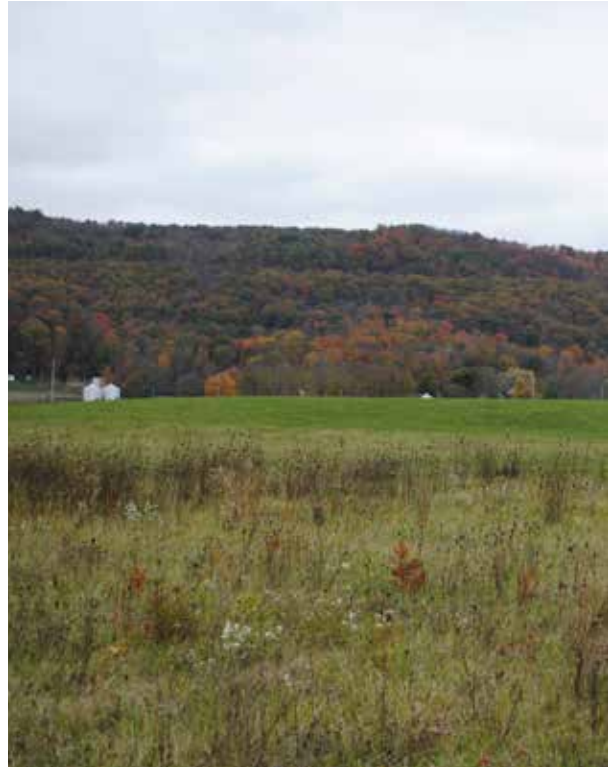
Figure 3-116. The Seip-Conjoined Mound, maintained as mown lawn, is four feet tall. (Mundus Bishop 2014)

11
12 The above-grade features of the Seip-
13 Conjoined Mound are in fair condition.
14 Past agricultural practices have negatively
15 impacted the earthwork. The condition of
16 the below-grade archeological features is
17 unknown.

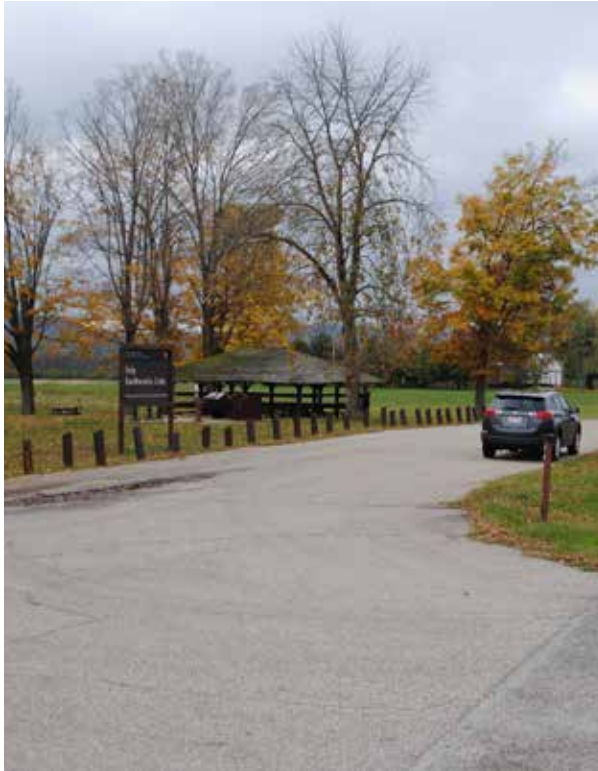
Figure 3-120. The parking area is asphalt paved with unmarked parking available at the perimeter of the drive. (Mundus Bishop 2014)

22 The *parking area* is asphalt paved, with
23 unmarked parking at the perimeter of the
24 drive. The parking area forms a loop drive,
25 approximately 24 feet wide, connecting on
26 either end to Highway 50. The parking area
27 has pot holes and is in fair to good condition.

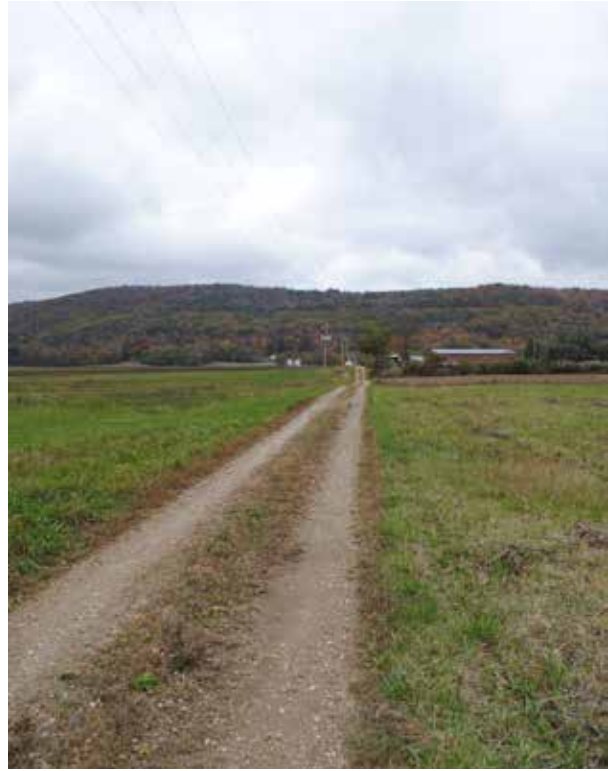
18
19 The above-grade features of the Large Square
20 are in fair to poor condition. Agricultural
21 practices and the construction of Dill Road
22 across the earthwork have negatively
23 impacted the condition of the above-grade
24 resources. The condition of extant below-
25 grade features is unknown.

Figure 3-121. Dill Road crosses the Large Earthwork. (Mundus Bishop 2014)

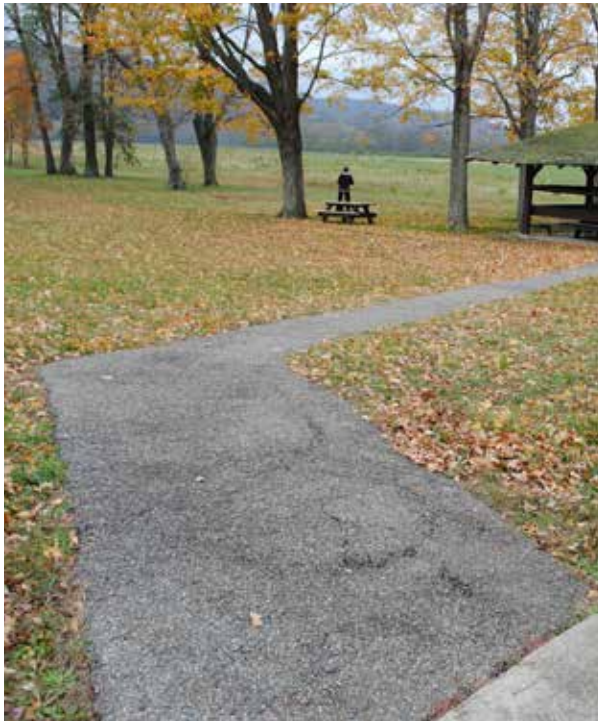
Figure 3-122. A five foot wide asphalt paved trail connects the parking area to two interpretive panels. (Mundus Bishop 2014)

5 A five foot wide *asphalt-paved trail* connects
6 the parking area to two interpretive panels
7 and a drinking fountain, and is in fair
8 condition. A five foot wide asphalt-paved trail
9 connects the visitor parking area to the picnic
10 shelter. This trail is in fair condition, with
11 pavement heaving in places.

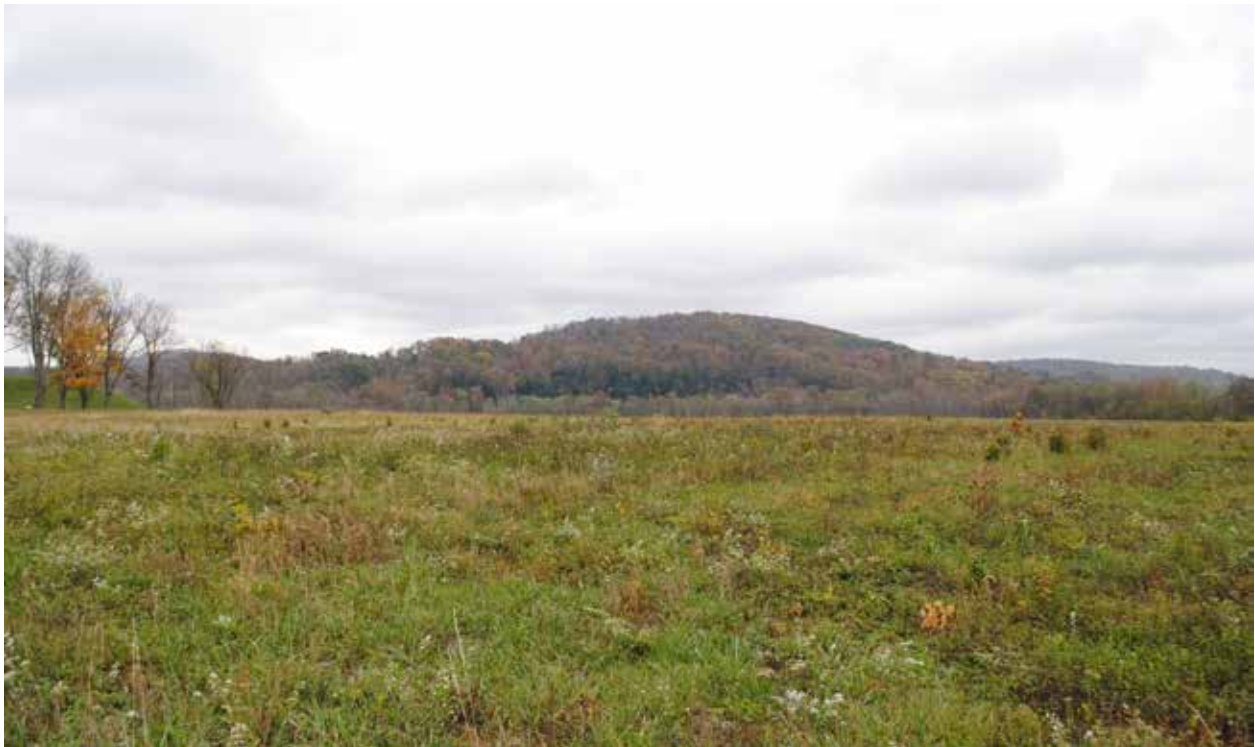
Figure 3-125. Most earthworks are covered with fallow fields that are periodically mown. This vegetation may obscure the visibility of features. (Mundus Bishop 2014)

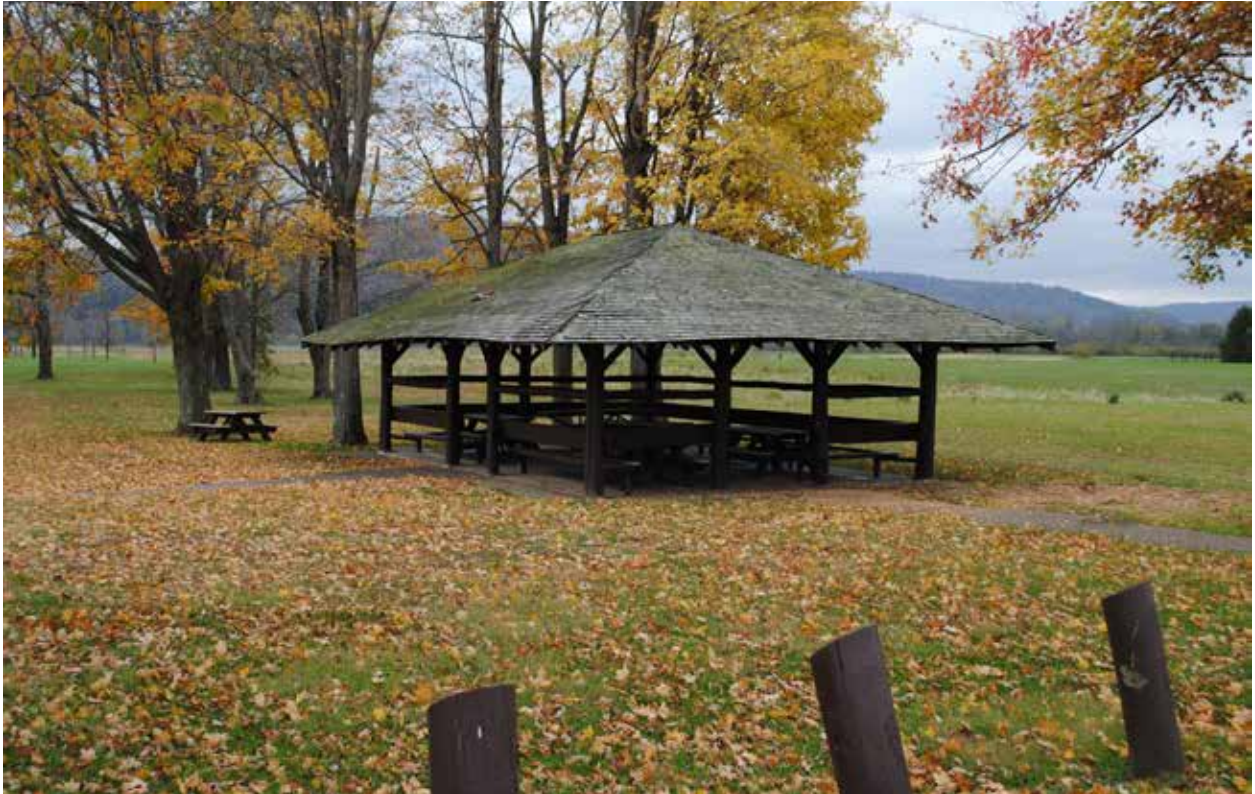
22
23 A wood frame *picnic shelter* is near the
24 parking area. The structure has turned
25 log posts and beams, wood shingles and
26 a concrete floor. Portions of the roof are
27 buckling. A painted wooden bench is located
28 on the outer edge. A three foot gravel edge is
29 on the southeast and south sides. An asphalt
30 edge on the east side is less than four foot
31 wide. The concrete floor is cracked, and
32 two posts area losing wood at the base. The
33 structure is in good to fair condition, but the
34 concrete floor is in poor condition.

Figure 3-128. The wood framed picnic shelter has turned log posts and beams, wood shingles and a concrete floor. (Mundus Bishop 2014)
