Chapter 3. Existing Condition and Analysis / Affected Environment

1 This chapter presents the summary and
2 analysis of the current condition of the
3 archeological landscape of Hopewell
4 Culture NHP. Narrative text, diagrams, and
5 photographs describe the existing condition
6 using a series of landscape characteristics.
7
8 The condition assessment is undertaken to
9 understand the archeological landscape as
10 a whole. It identifies and documents those
11 qualities and features that contribute to the
12 park's historic character, retain integrity,
13 and contribute to the significance of the
14 landscape. Field reconnaissance, undertaken
15 in October 2014, assisted in the recording of
16 the archeological landscape.
17
18 This chapter is organized to present the
19 existing condition and analysis evaluation
20 for the study area first, which includes the
21 evaluation of landscape characteristics that
22 relate to the study area as a whole. This is
23 followed by a condition assessment and

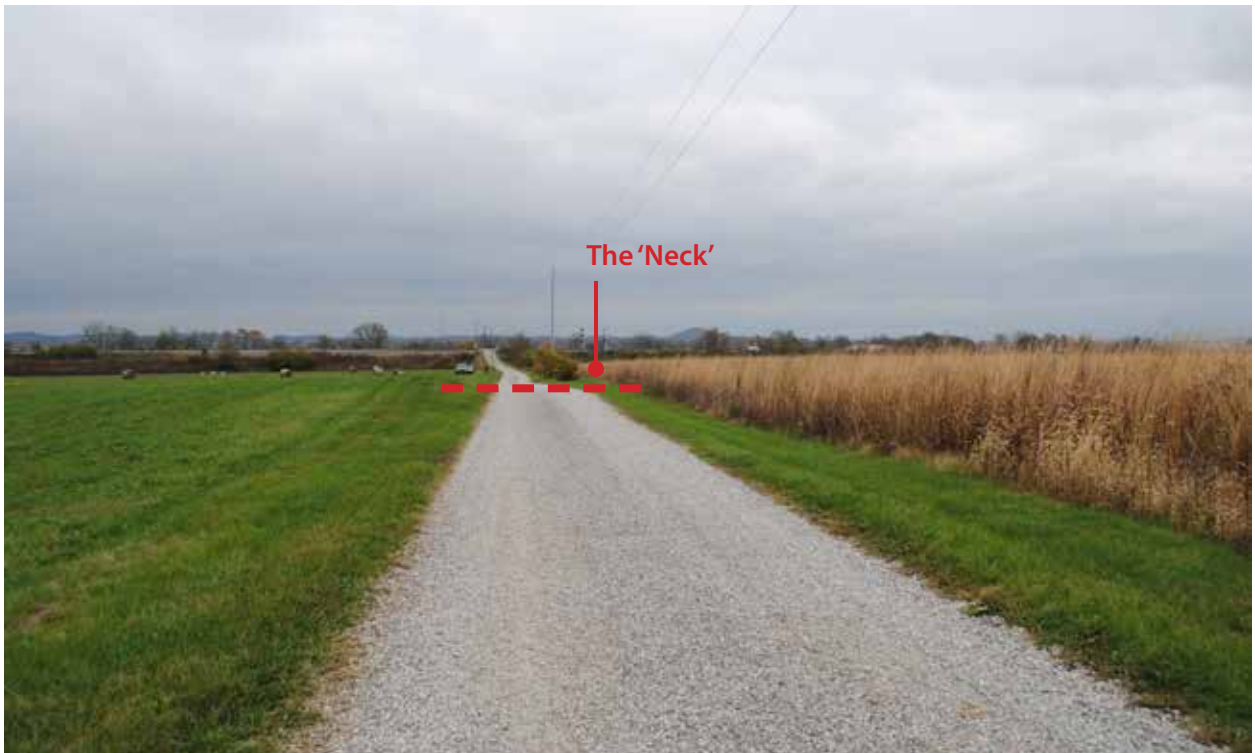
Figure 3-140. The gateway neck between the Octagon and Great Circle. Shown as a dashed line, is most visible at the gravel road. (Mundus Bishop 2014)

^{3.100} The magnetic survey reveals the extent of the extant below-grade Great Circle and the damage incurred by the gravel road.

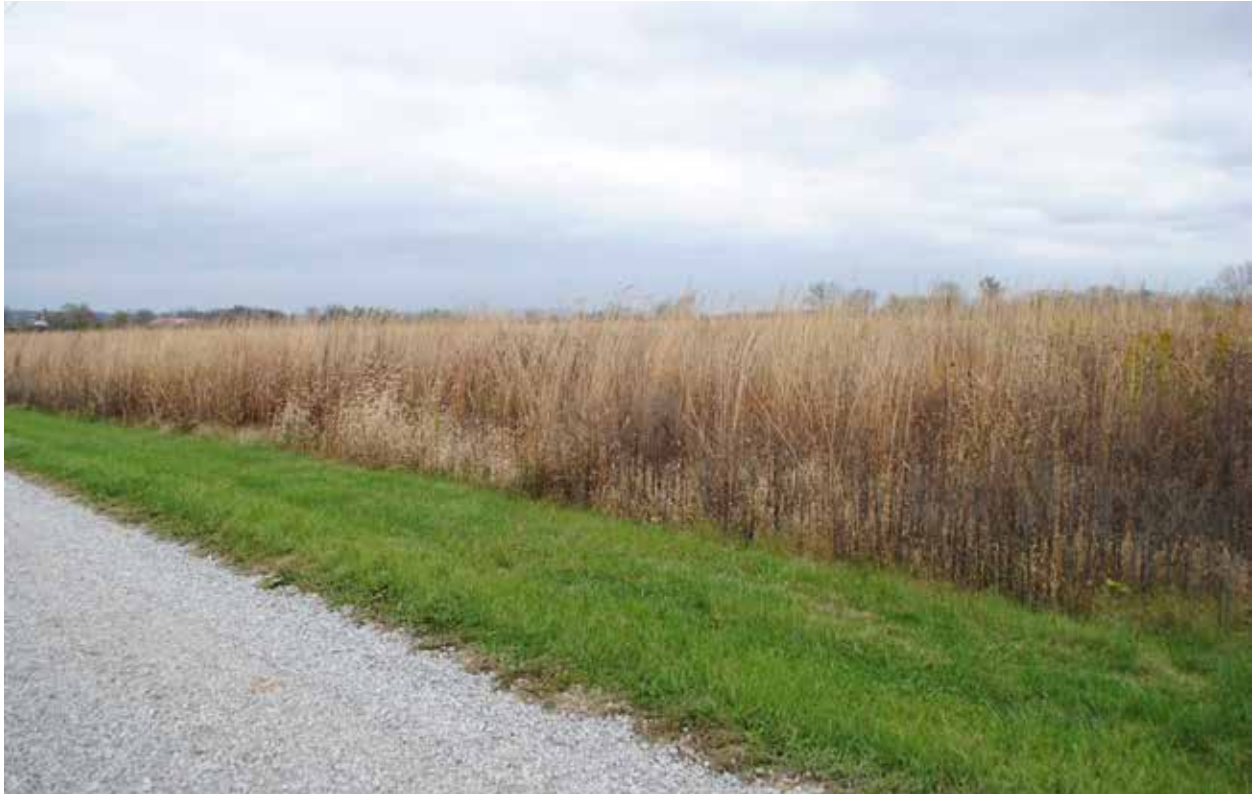
Figure 3-141. Due to the height and density of the native grassland vegetation, most portions of the Octagon are not visible. (Mundus Bishop 2014)

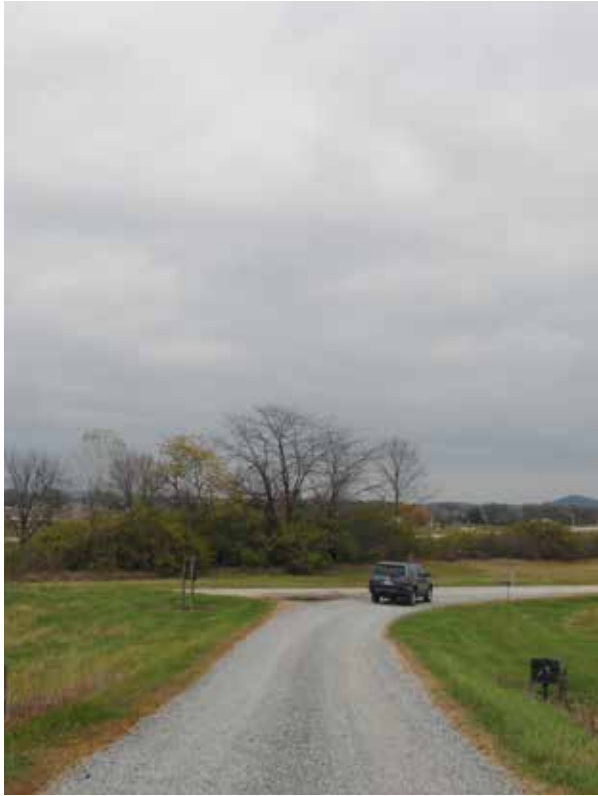
Figure 3-146. A gravel road provides egress / ingress for the private property. (Mundus Bishop 2014)

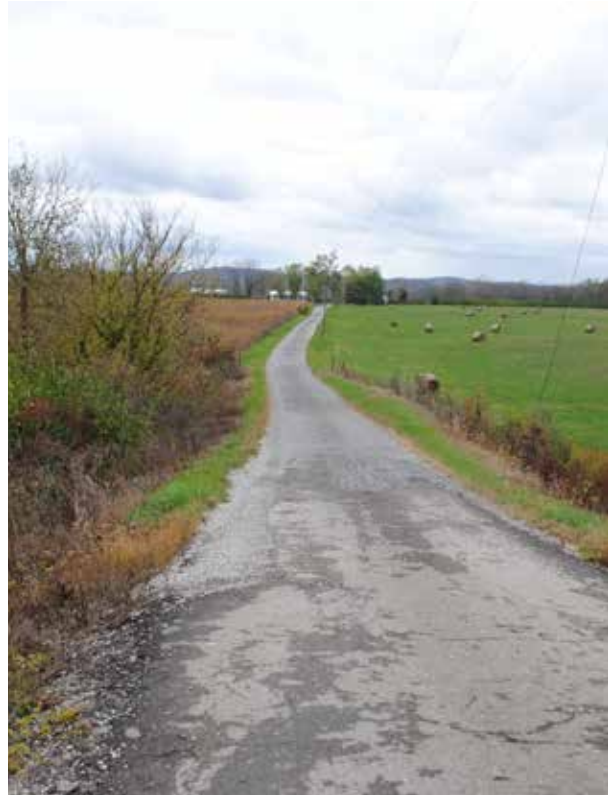
31
32 The above and below-grade features of the
33 Octagon are in good condition; however a
34 portion of the gravel road extends through the
35 north corner of the Octagon. It has eliminated
36 the portion of earthen walls where the road
37 crosses the Octagon, impacting the condition
38 of the earthwork.^{3.101}

Figure 3-147. The gravel road bisects the Octagon and a portion of the Great Circle. (Mundus Bishop 2014)

3 The gravel road traverses the earthwork
4 complex and damages the archeological
5 features; railroads distract from the
6 archeological landscape.

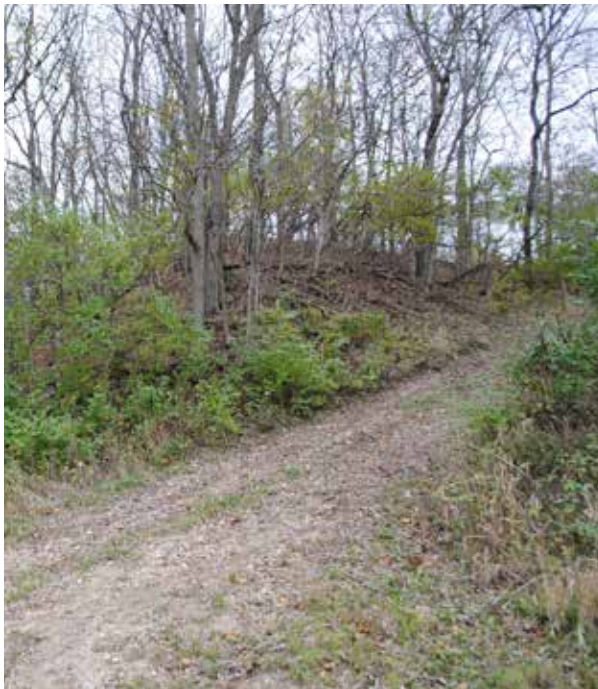
Figure 3-148. The gravel / dirt road provides access to the South Earthworks. (Mundus Bishop 2014)

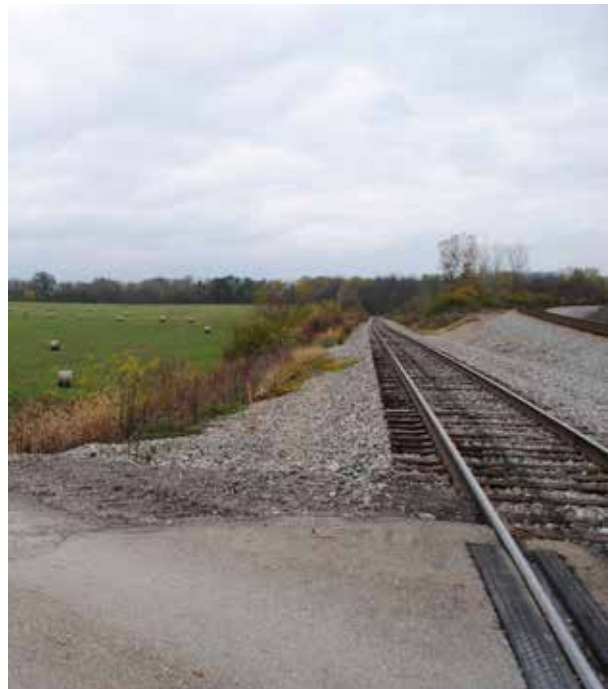
Figure 3-149. Railroad tracks are located just east of the complex on the northeast side. (Mundus Bishop 2014)

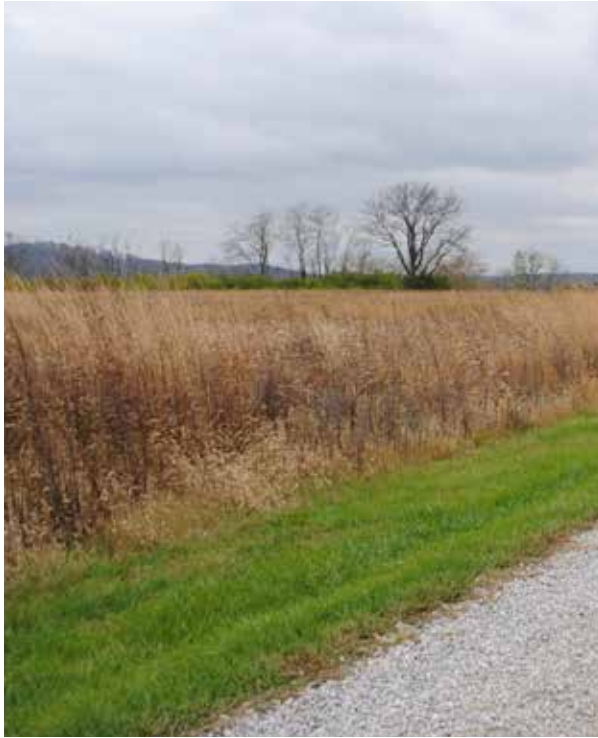
Figure 3-150. Mown lawn is on either side of the gravel drive; native grasslands is on the left. (Mundus Bishop 2014)

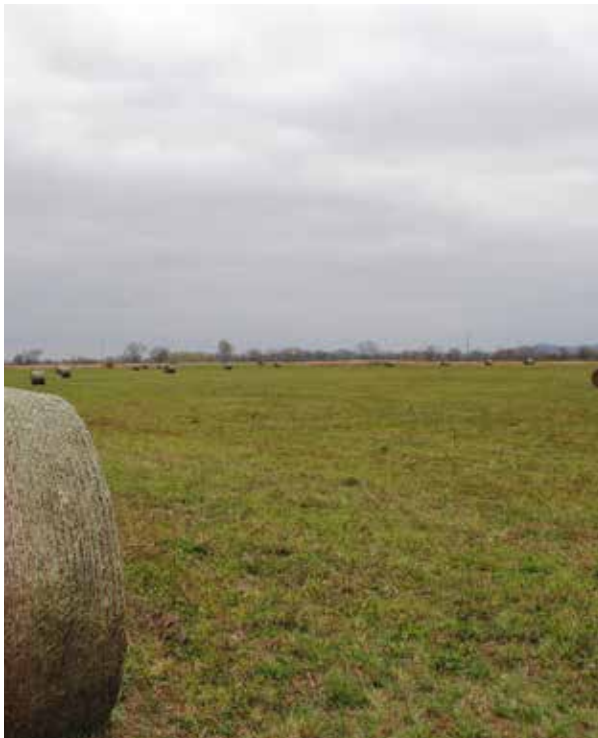
Figure 3-151. On the north parcel of NPS land, most of the land is cleared hay fields. (Mundus Bishop 2014)

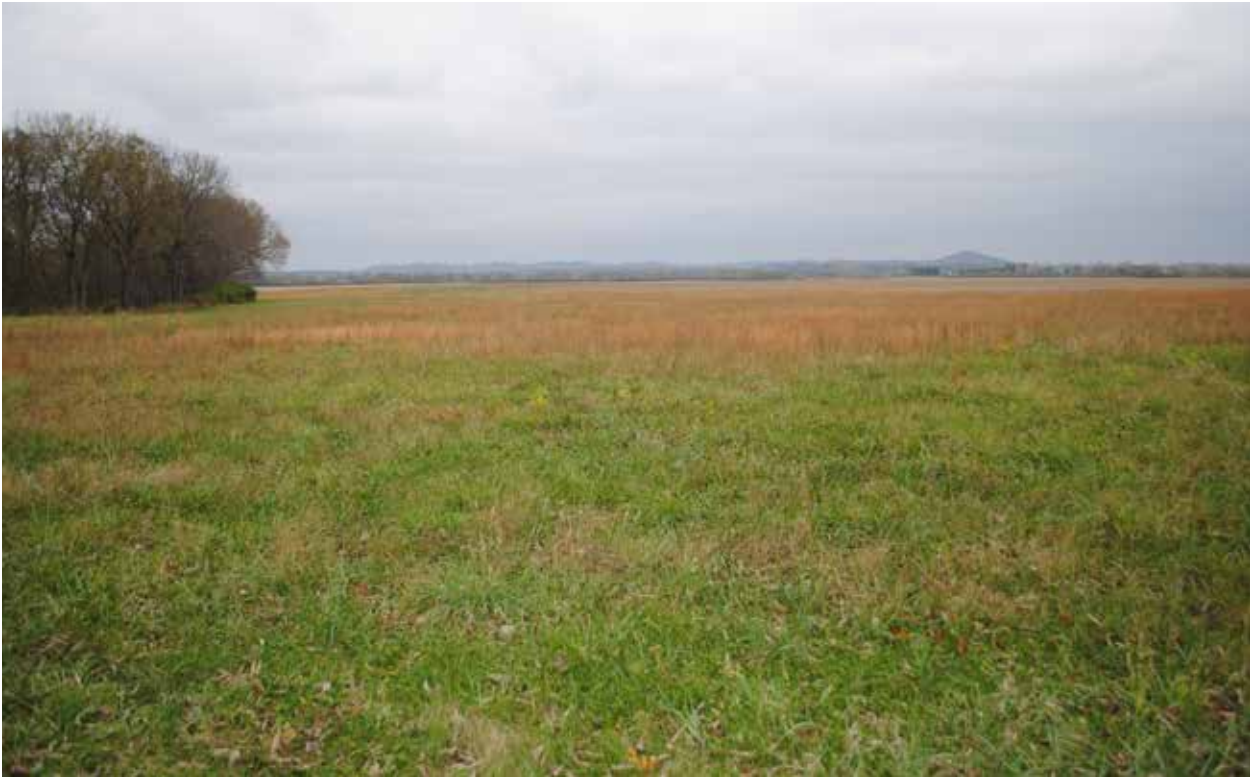
Figure 3-152. Mown hay field in the south tract. (Mundus Bishop 2014)

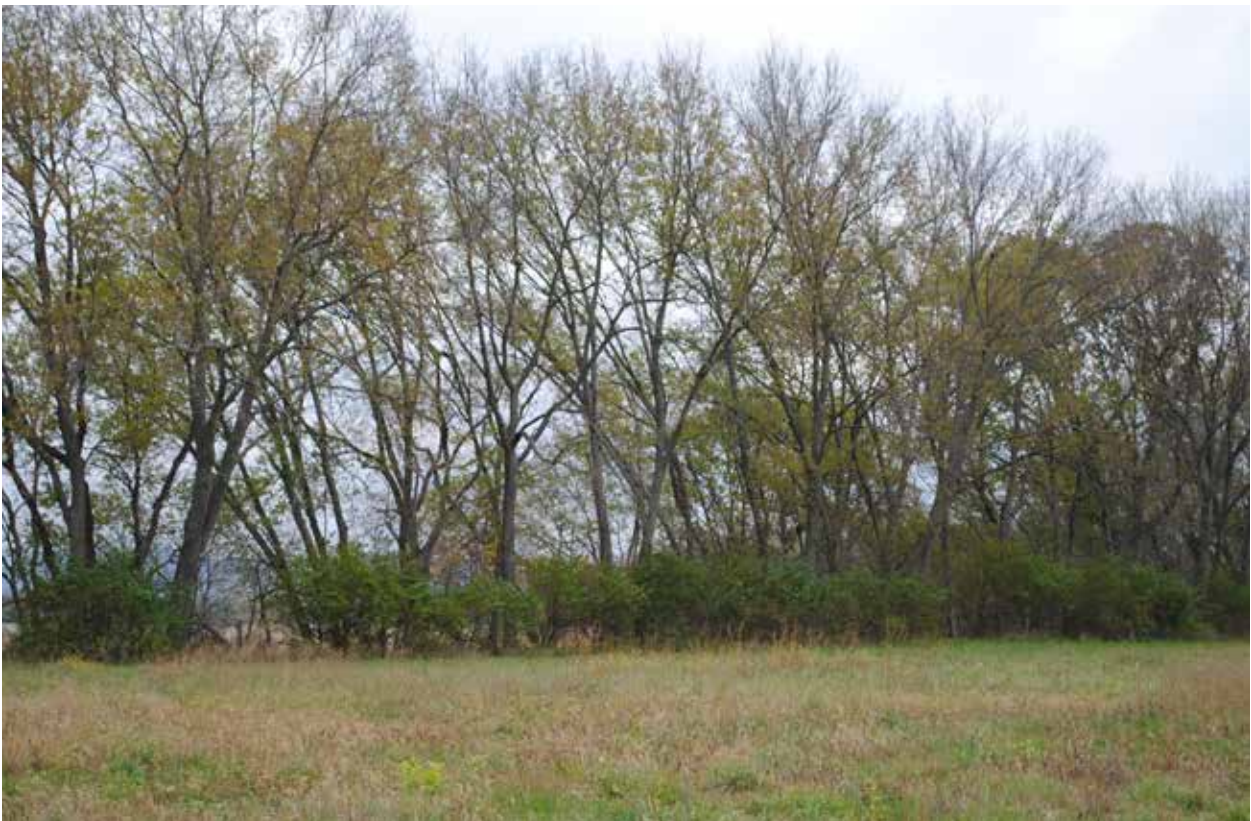
Figure 3-153. Vegetation at the south tract includes mown hayfields edged with hardwood forest. (Mundus Bishop 2014)

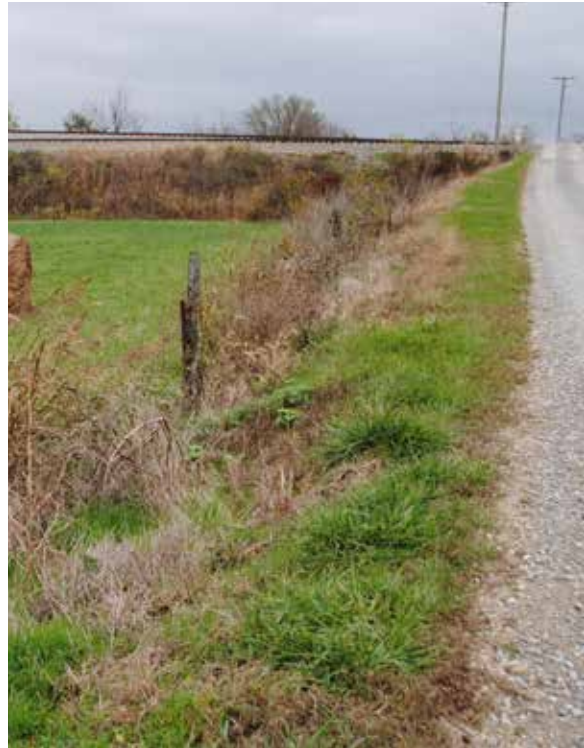
Figure 3-154. A barbed wire fence parallels a portion of the gravel entrance road. It continues adjacent to the railroad tracks and along property lines. (Mundus Bishop 2014)

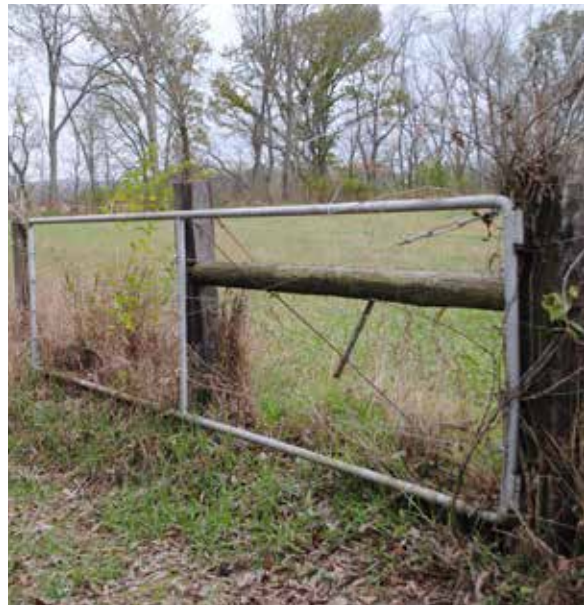
Figure 3-155. Access to the South Earthwork is via a metal gate at the southeast corner of the park unit. (Mundus Bishop 2014)
