Chubb Hollow

1 Maintenance Area

Big Spring Landscape Character Area

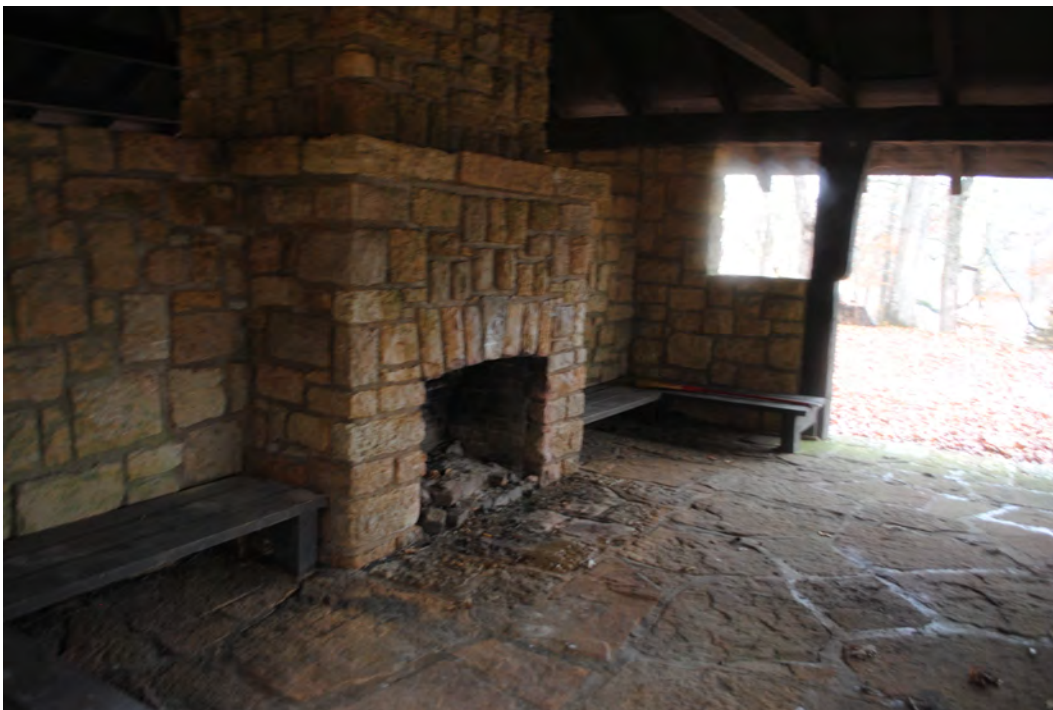
Figure 3-103. The Chubb Hollow Open Shelter House (HS-247) has a central chimney, and built-in plank benches. (Mundus Bishop 2015)

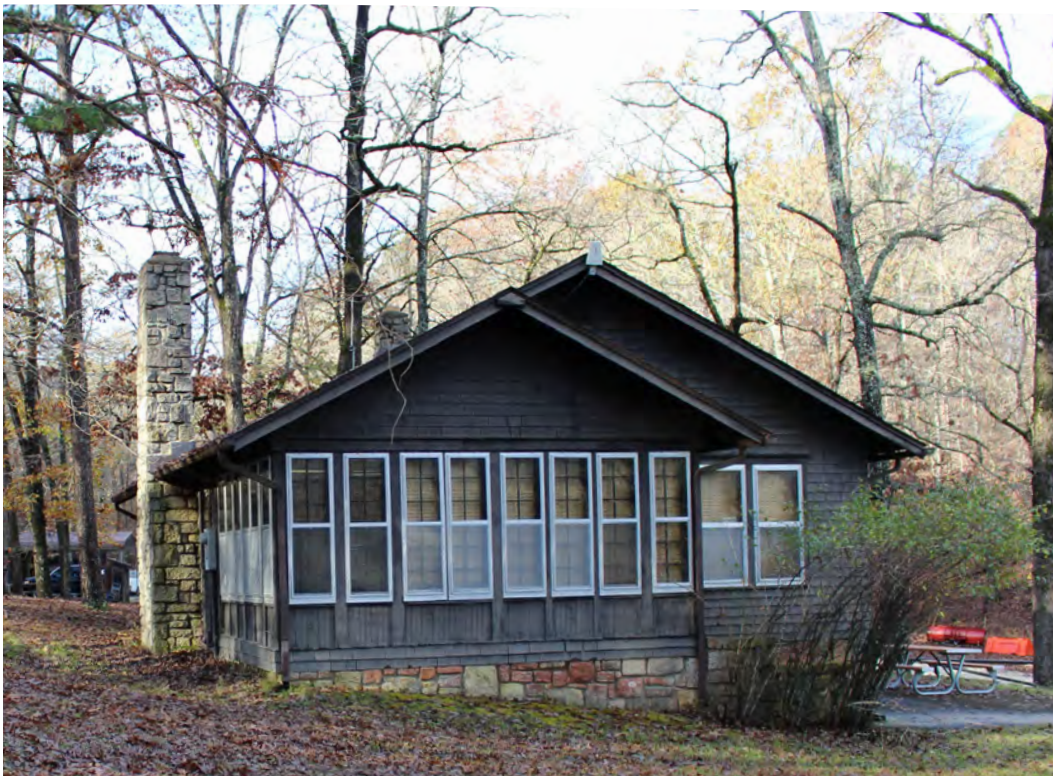
Figure 3-110. Cabin #416 (HS-416). (Mundus Bishop 2015)

Buildings and Structures			
Feature	Description	Condition	"Contributing / Non-Contributing"
Cabin 416 (HS-416) (1935)	Building - CCC built Rustic style, one and one-half story, asphalt shingle gable roof, timber framed cabin 39' x 32' with stone foundation basement, exterior stone chimney, and two screened porch entries with stone steps.	Good	Contributing
	Stone retaining wall - 3' tall stone wall with concrete mortar joints.	Poor / fair (reset failing stone; concrete repair doesn't match historic)	Contributing
	Terrace - Concrete slab 28' x 12', with one picnic table, connects the front and side entries.	Good	Non-contributing

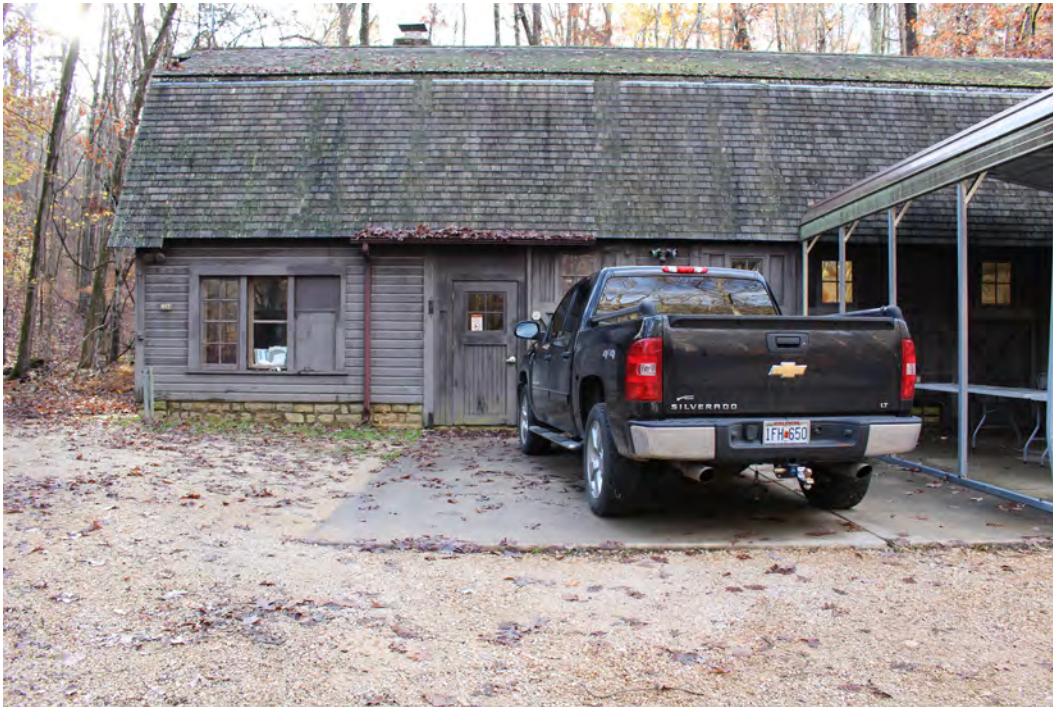
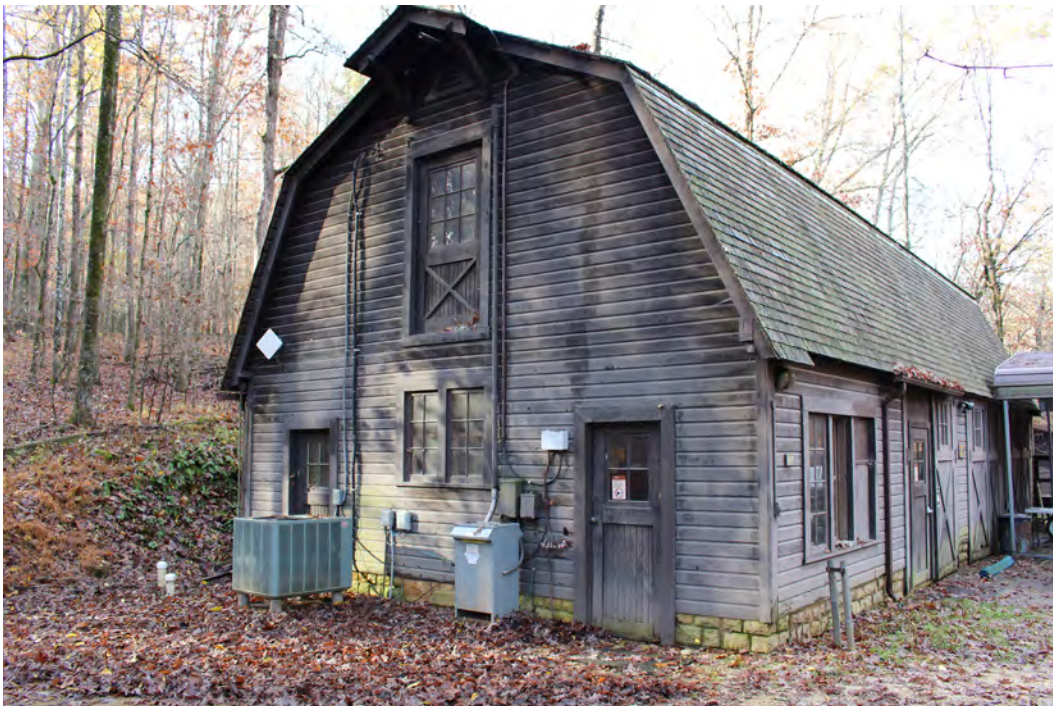
Figure 3-115. Maintenance Shop (HS-417). (Mundus Bishop 2015)

Buildings and Structures			
Feature	Description	Condition	"Contributing / Non-Contributing"
Maintenance Shop (HS-417) (1936)	Building - 25'x50' gambrel roof building with a cut-stone foundation and chimney, drop siding, and two pairs of outward swing garage doors. First floor interior has one large bay and two smaller offices. An exterior staircase at gable end leads to the second floor. Windows throughout are 6-lite wood sash. Metal canopy 28' x 16' is on the north side of the Maintenance Shop (HS-417). It has a concrete pad below the canopy and gravel on three sides. A concrete sidewalk connects from pad to wooden staircase on the west side of the building.	Good	Contributing
Maintenance Fuel Storage Tanks (After 1978)	Wood fenced area with propane tanks and maintenance equipment, associated with the Maintenance Shop (HS-417).	Good	Non-contributing
Maintenance Storage Building (HS-418) (1936)	Building - CCC built single story, front gable with asphalt shingle, one room building 20'-6"x20'-6" with a mortared cobblestone foundation, clapboard siding, 9-lite wood sash windows, and tongue and groove interior walls. Concrete steps to door with an "Electric Shop" sign overhead.	Fair (some rotting boards at bottom)	Contributing

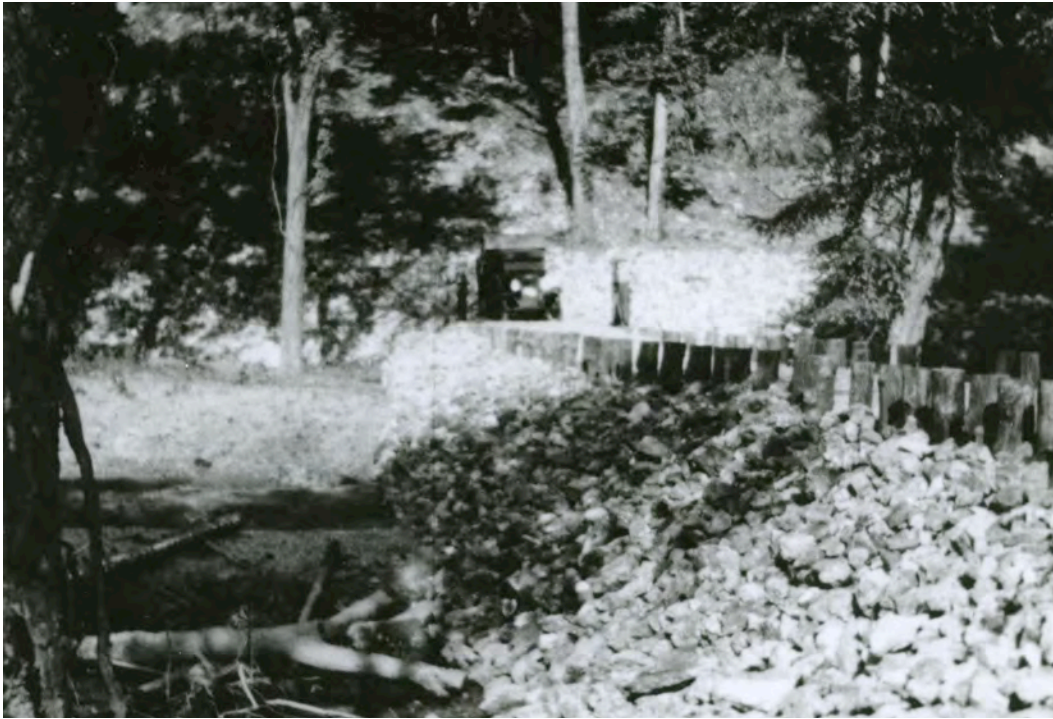
Figure 3-124. The Big Spring Stone Dikes (HS-711) were constructed of wood framing and rubble fill. They were also used as roads. Date unknown. (OZAR Archives)

10
11 The five Big Spring Stone Dikes (HS-711)
12 were built in 1934 along the slough to protect
13 Big Spring from flood waters. Of the five, Big
14 Spring Stone Dikes #3 and #5 remain, the
15 others have been damaged due to flooding.
16 Both were built of wood framing and rubble
17 fill. Big Spring Stone Dikes #5 (700' length) is
18 an integral part of the Slough Trail and is used
19 as a pedestrian crossing across the slough.
20 Big Spring Stone Dikes #3 (600' length) is
21 visible from the slough trail. The landforms
22 associated with the other three Big Spring
23 Stone Dikes remain, but they are difficult to
24 discern.

40 The constructed waterways have changed
41 since the period of significance, with some
42 features deteriorated due to flooding and
43 other natural processes. Even with these
44 changes, the Big Spring Stone Dikes (HS-711)
45 and stone embankments retain integrity and
46 contribute to the cultural landscape.
