## 1 **Buildings and Structures**

1 **Small Scale Features**

## 1 Vegetation

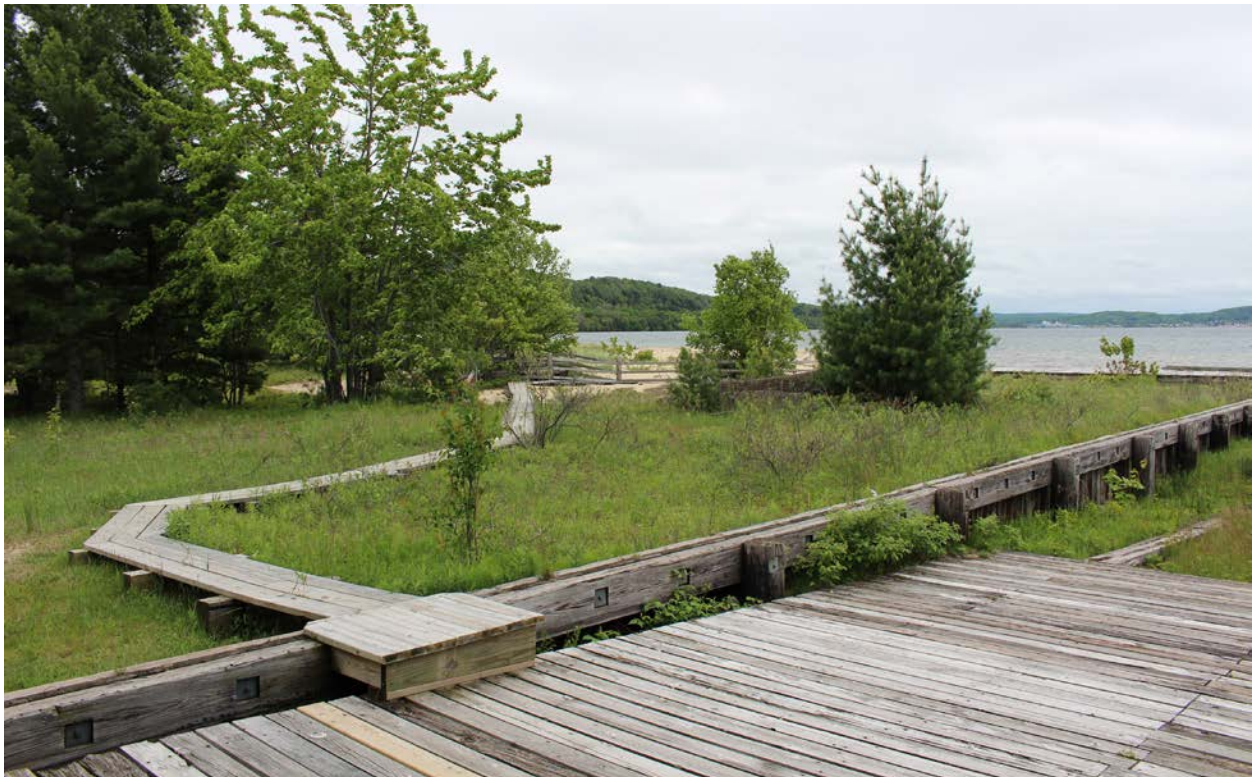
Figure 3-39. The boardwalk introduces a new, meandering circulation pattern to the landscape, which historically focused on straight, linear routes. (source: Mundus Bishop 2016)

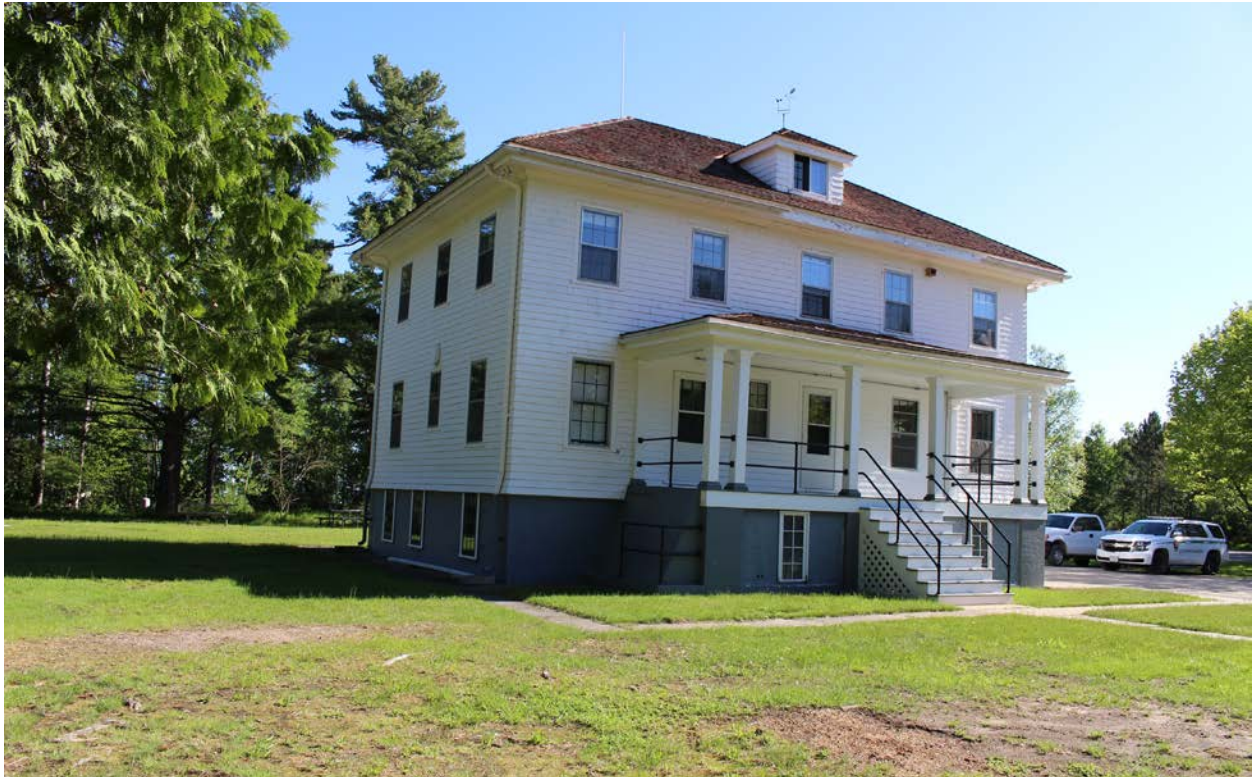
Figure 3-42. USCG Life Saving Station is the most prominent building in the landscape, with a formal arrangement of walks and lawn surrounding the structure. (source: Mundus Bishop 2016)

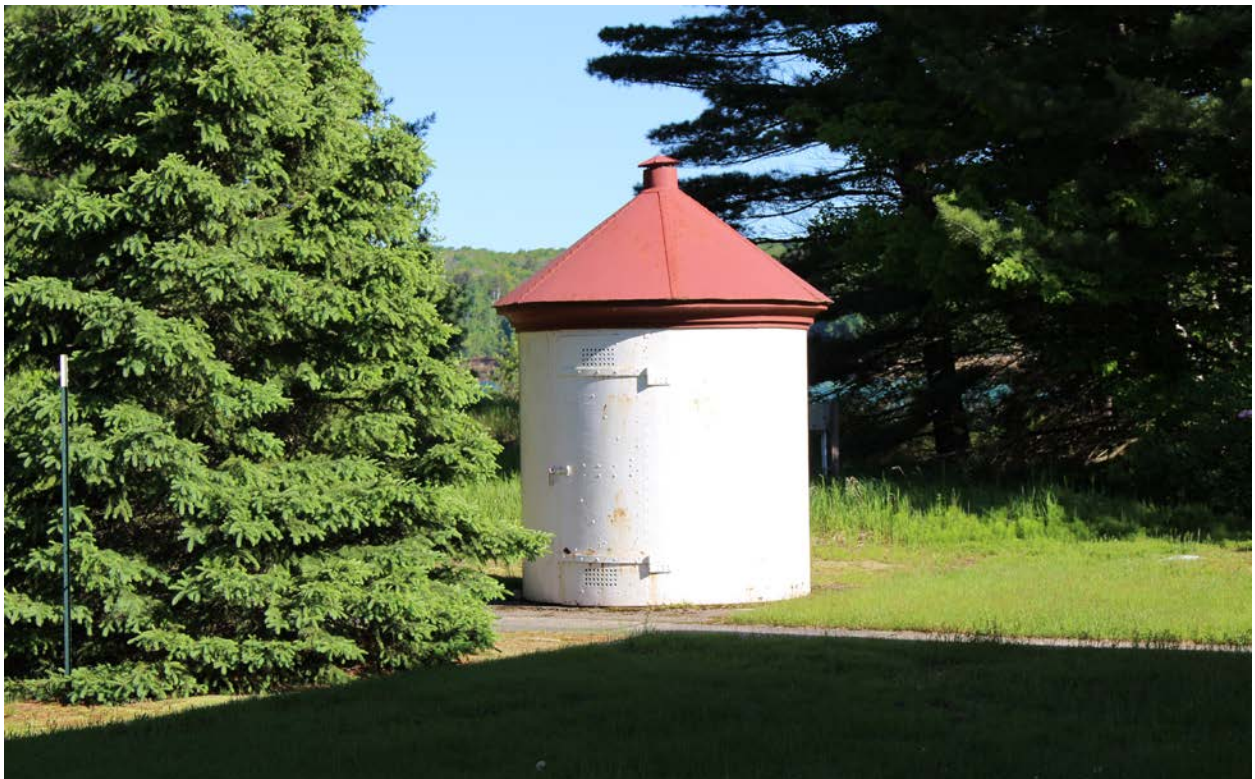
Figure 3-43. The Oil House is a prefabricated metal structure, placed to the northwest of the Life Saving Station. (source: Mundus Bishop 2016)

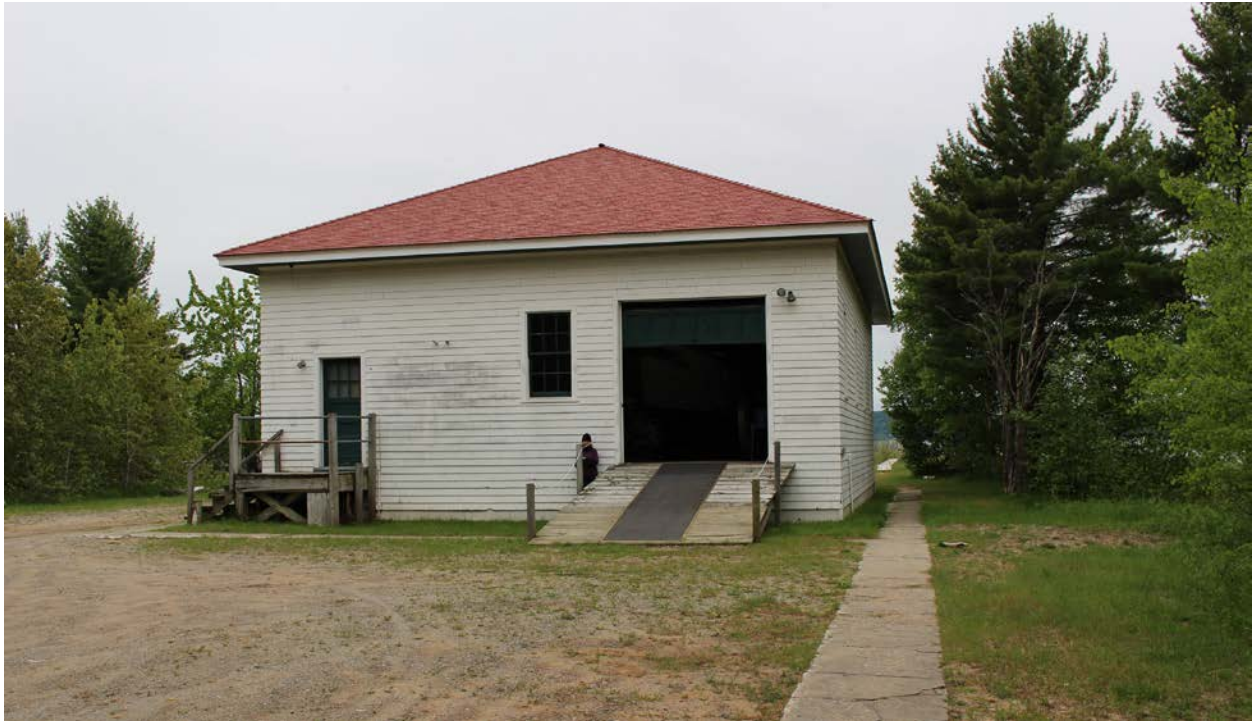
Figure 3-44. The Boathouse was constructed in the 1930s by the USCG, sited on the west side of the study area, facing Munising Bay. The east facade, above, originally had an exterior ramp and stairs. These features have been rebuilt in a similar fashion to the historic, but the exterior stair faces a different direction (south rather than east) and the ramp has been extended further to the east. (source: Mundus Bishop 2016)

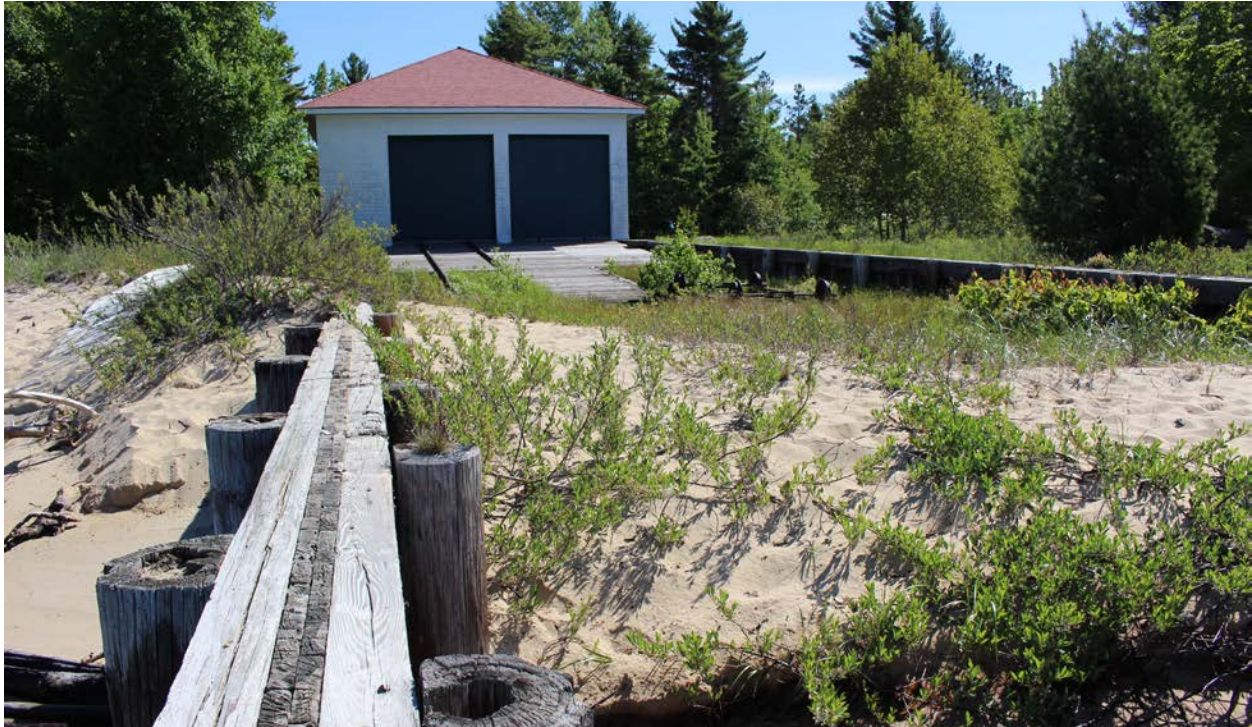
Figure 3-45. The Launchway, in foreground, was constructed of two bulkheads flanking either side, and two sets of metal rails that carried the USCG boats in and out of the water. When originally constructed, the waterline was closer to the Boathouse. The Launchway was extended in the 1940s as a result of the naturally shifting shoreline. (source: Mundus Bishop 2016)

<b>Launchway</b>	Wood ramp to water with (2) rail lines (1 extant). Edged with heavy timber bulkhead on either side. Lake end is partially obscured by sand and soil, vegetation in center. Trolley for moving boats, on south rail. (2) 2x6 framed box pedestrian decks access launchway from boardwalk at the south and steps at the north.	Fair to Poor	Contributing
<b>Lookout Tower Foundation</b>	(4) Concrete beveled tops with bolts, submerged in lake. Foundation is all that remains of the non-extant prefabricated metal Lookout Tower placed at the tip of Sand Point	Poor	Contributing
<b>Communications Tower Foundation</b>	Concrete level pad, metal foundations. All that remains of non-extant Communications Tower	Fair	Contributing
<b>Shop</b>	Non-Extant	N/A	N/A
<b>Garage Foundation</b>	Square concrete pad with center drain.	Fair	Non-Contributing
<b>Rock Revetment</b>	Angular rock; never properly placed = wrong size; from Lookout Tower to parking area	Fair	Non-Contributing

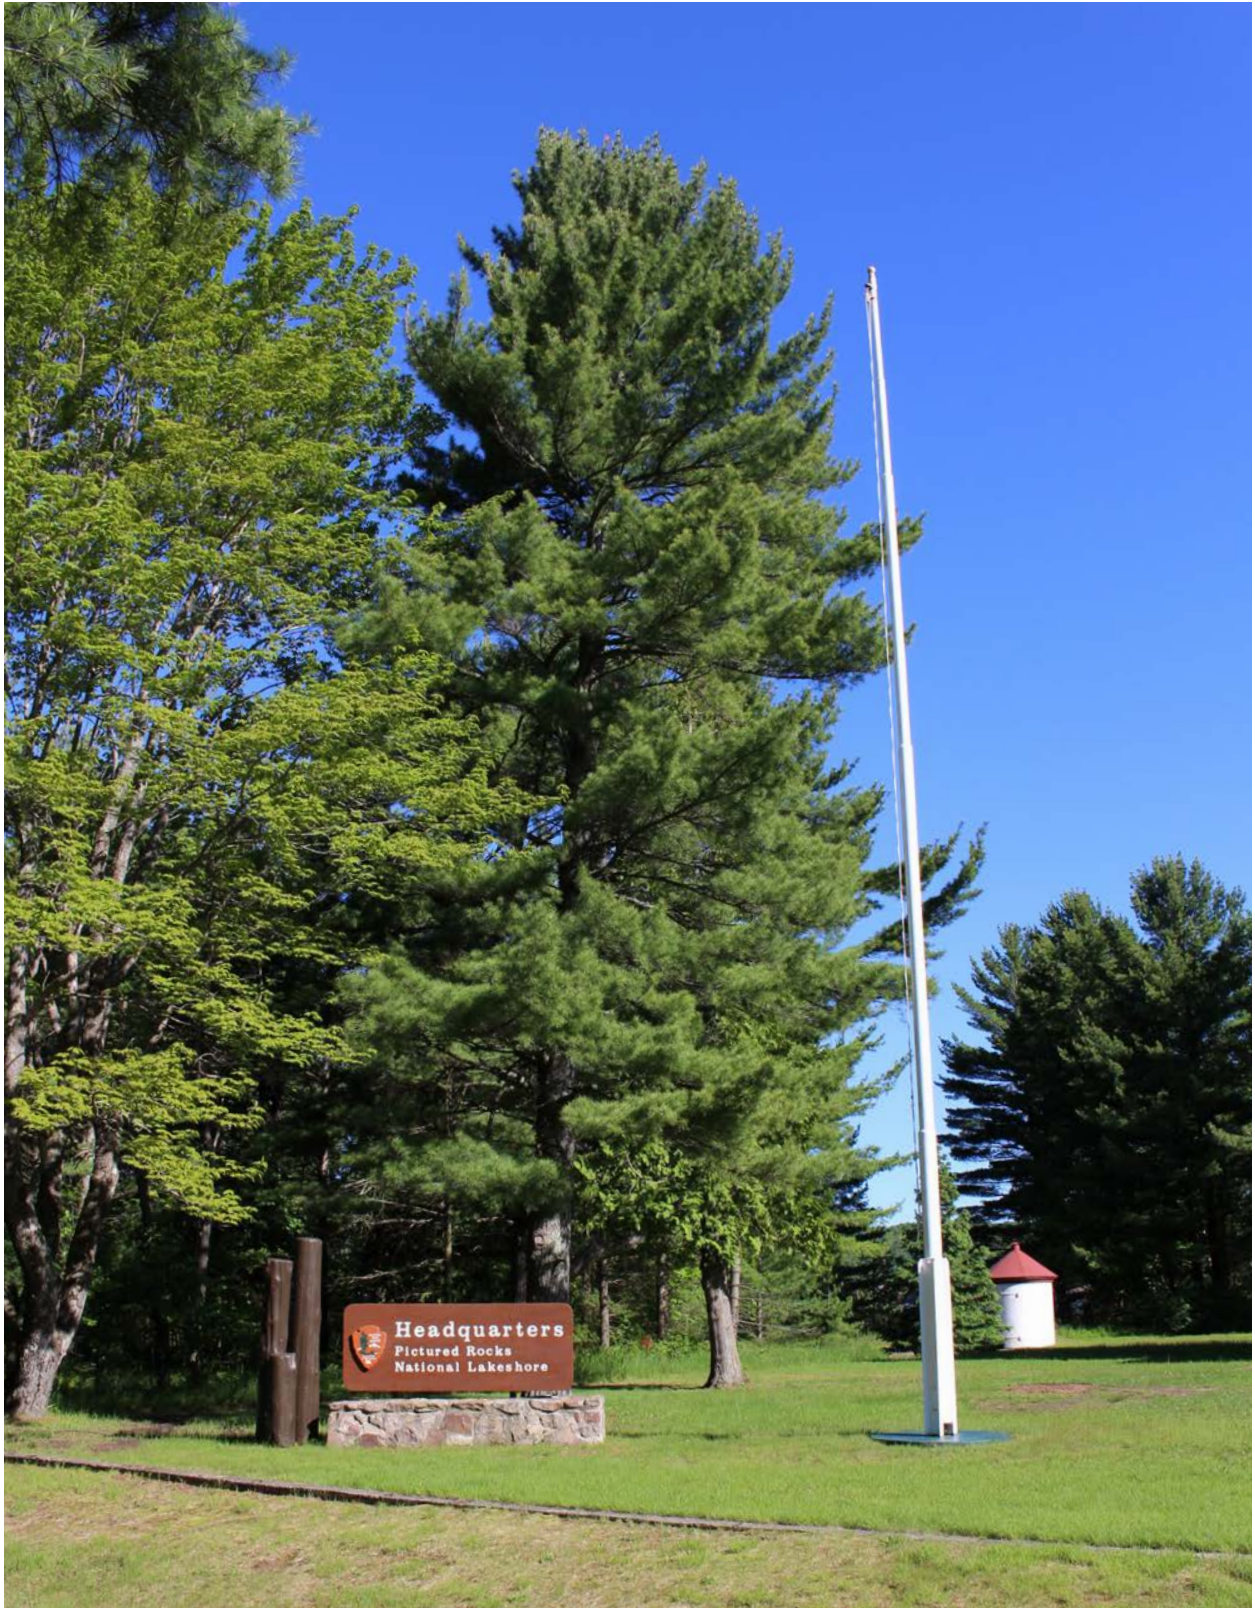
Figure 3-52. Historically significant small scale features include the original flagpole installed by the USCG, and the concrete curb that surrounds the Life Saving Station, in foreground. The Headquarters sign is a recent addition, but does not distract from the historic setting. (source: Mundus Bishop 2016)

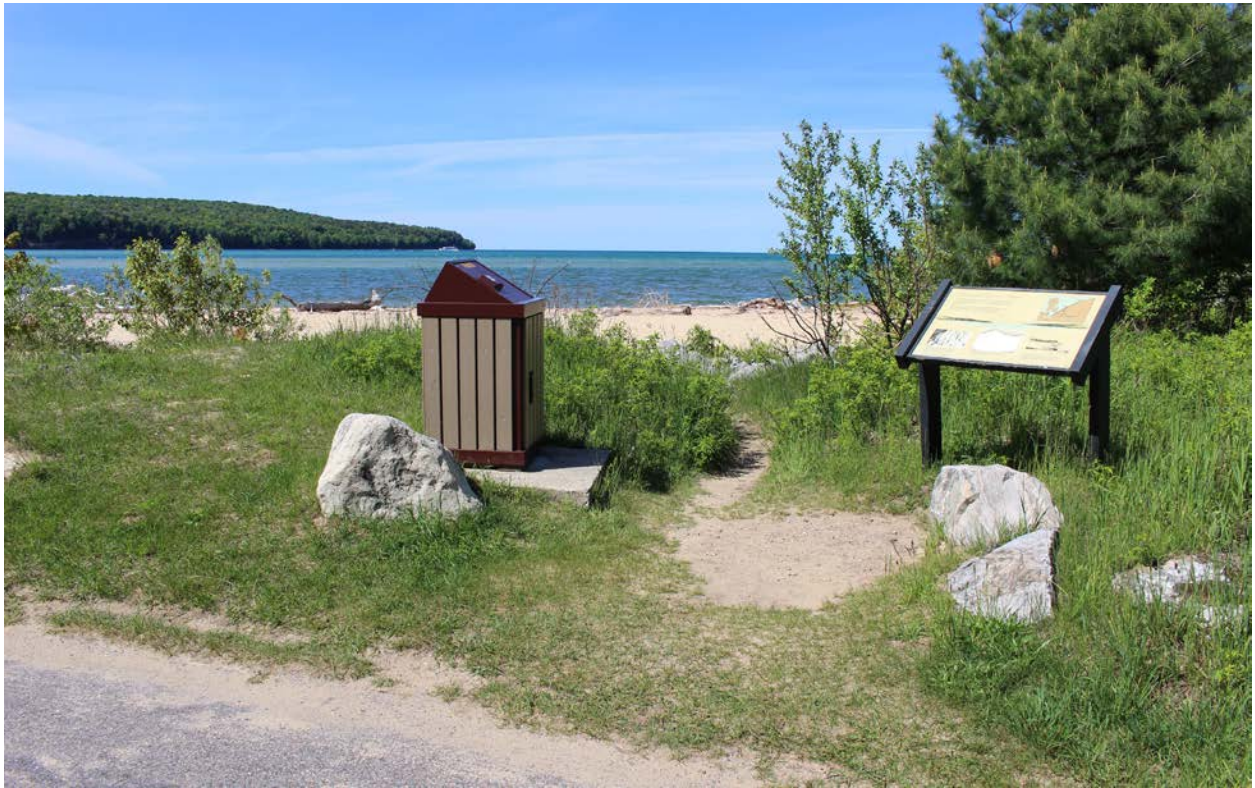
Figure 3-53. Non-contributing small scale features occur at the terminus of Sand Point Road, including wayfinding sign, trash receptacle, and the boulder edge along the turnaround. (source: Mundus Bishop 2016)

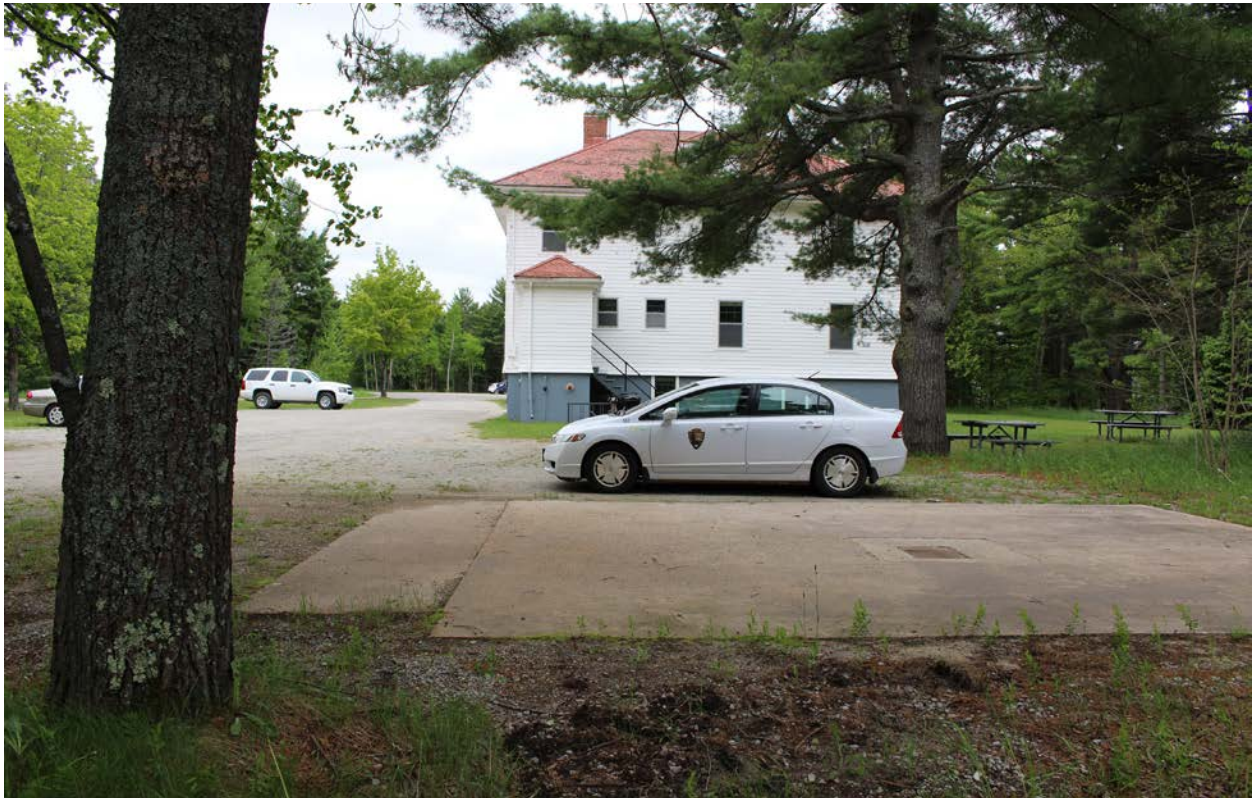
Figure 3-54. The concrete foundation remains of a garage that was added by the NPS and later removed. (source: Mundus Bishop 2016)

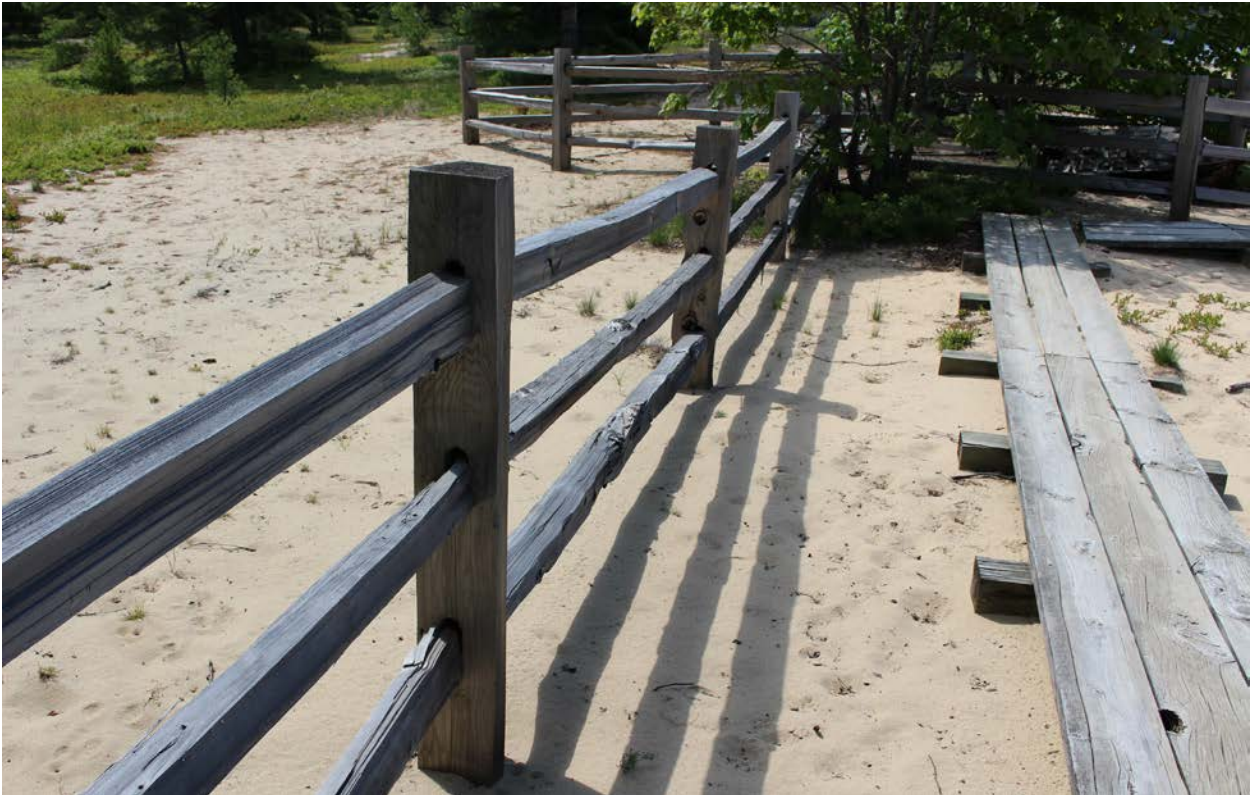
Figure 3-55. The split-rail fence, boardwalk, and boat hull in background, are non-contributing features. (source: Mundus Bishop 2016)

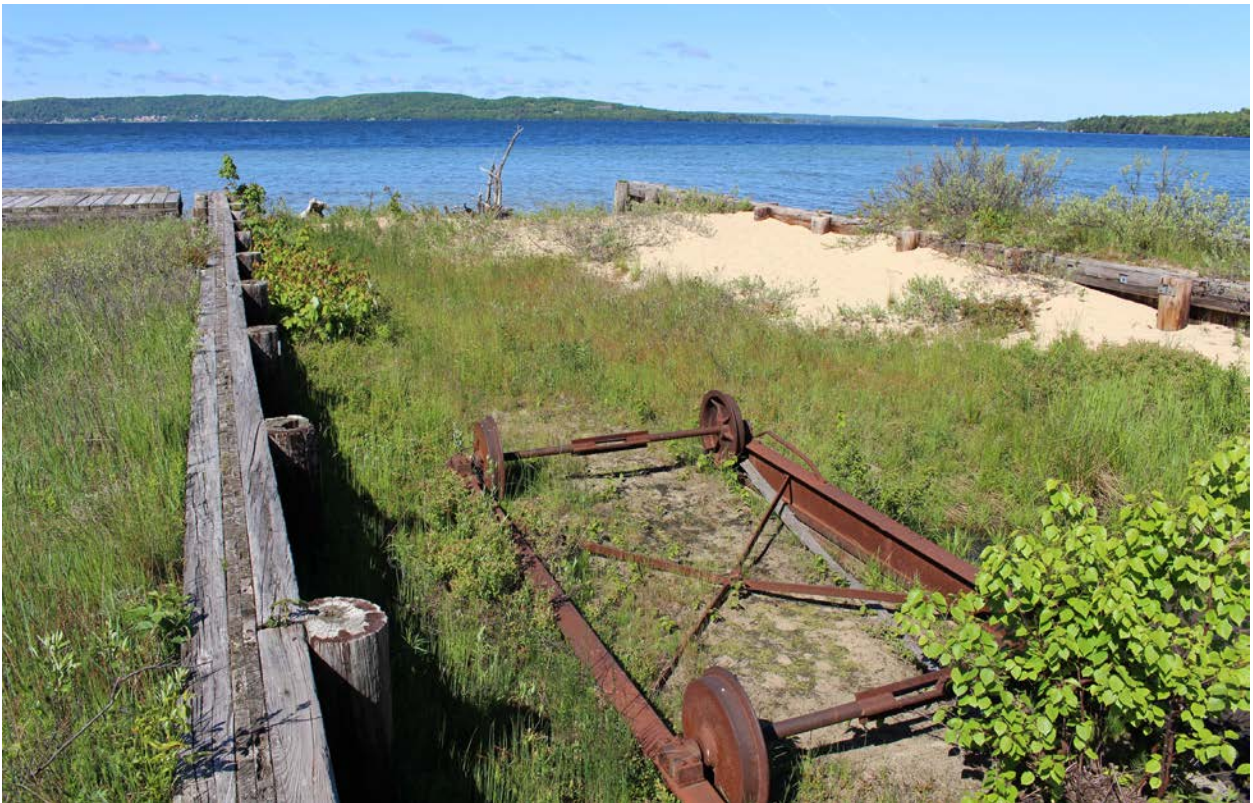
Figure 3-56. Boat trolley used to maneuver boats into the water along the rails. (source: Mundus Bishop 2016)

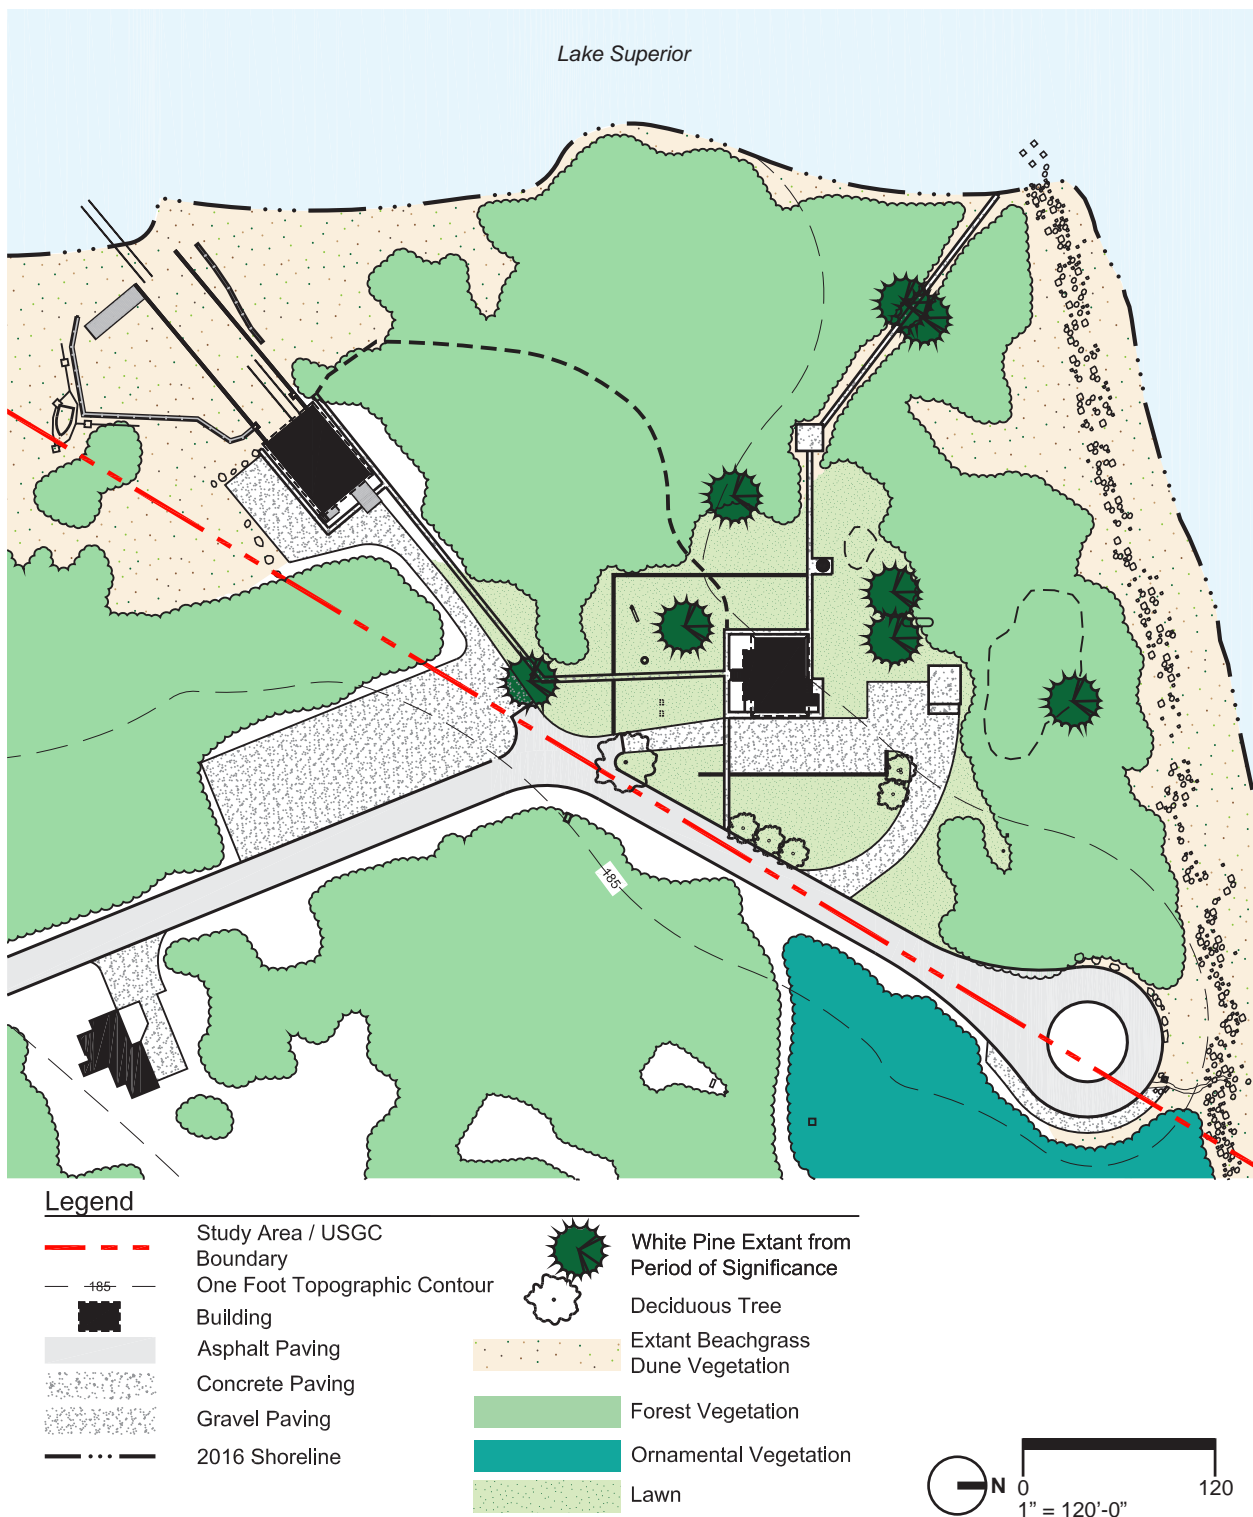
Figure 3-60. Existing vegetation includes native trees and shrubs, dune vegetation, and ornamental vegetation. Several white pine trees and a formal lawn are extant from the period of significance. (source: Mundus Bishop 2016)

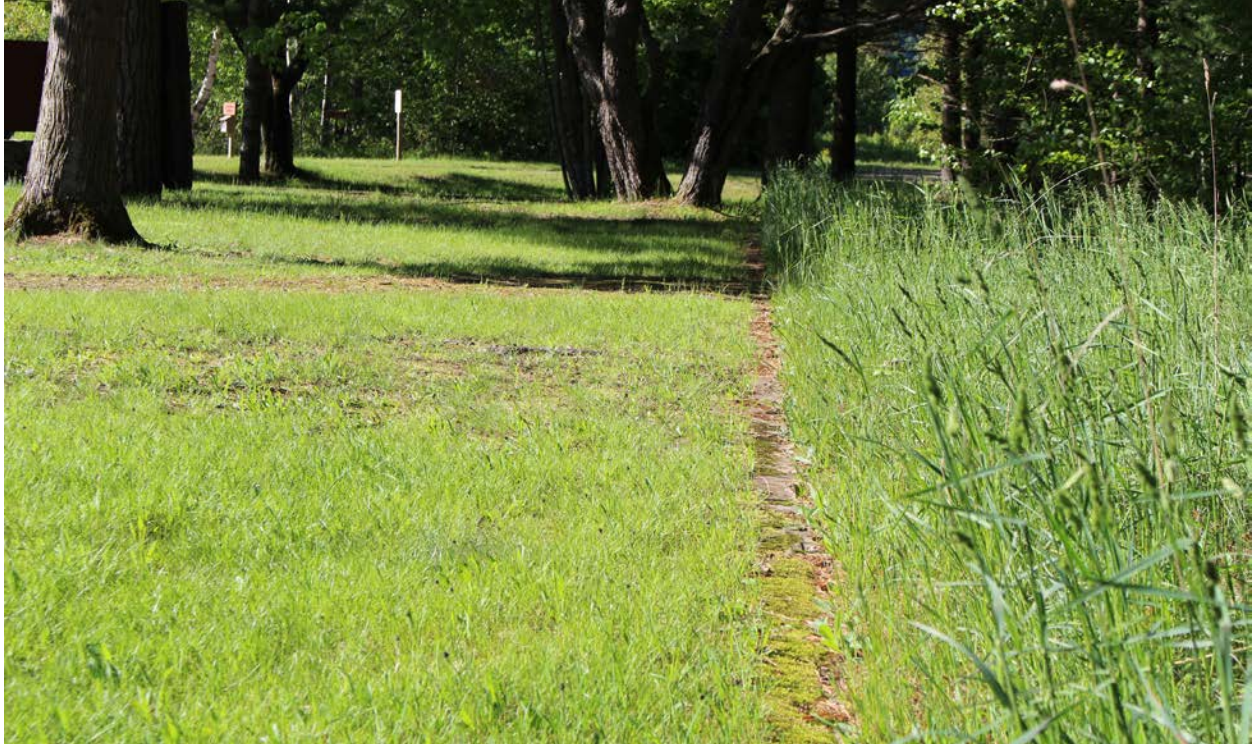
Figure 3-63. The concrete curb maintains the line between formal lawn and unmown lawn to the west, right side, of the photograph. (source: Mundus Bishop 2016)

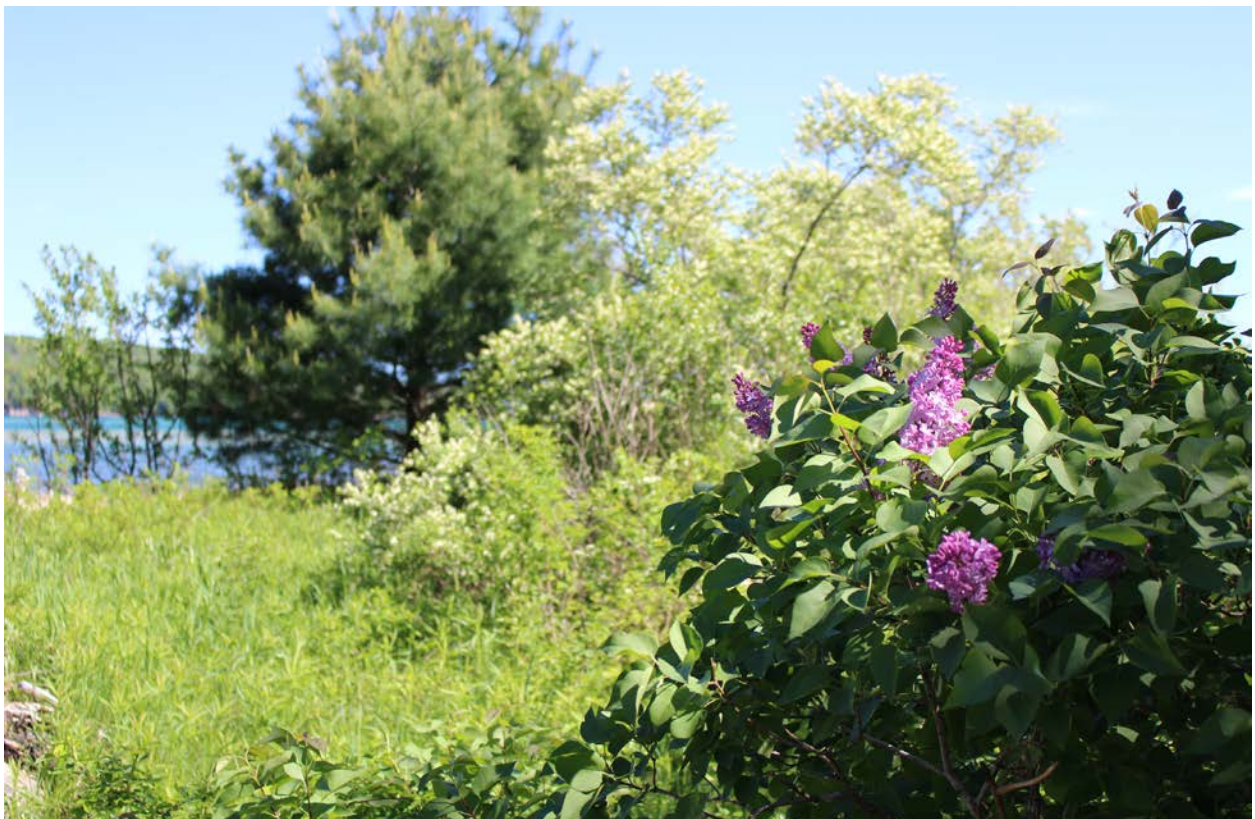
Figure 3-64. Ornamental vegetation remains from the former residences at Sand Point, including lilac, honeysuckle, lily of the valley, and apple trees. (source: Mundus Bishop 2016)
