FEBRUARY 2017		TITLE OF PROJECT CULTURAL LANDSCAPE REPORT AND ENVIRONMENTAL ASSESSMENT	
UNITED STATES DEPARTMENT OF THE INTERIOR		TITLE OF DRAWING ILLUSTRATION 3-2 USCG STATION EXISTING CONDITION PLAN	
PICTURED ROCKS NATIONAL LAKESHORE MUNISING, MICHIGAN		NAME OF PARK SAND POINT/MUNISING USCG LIFE SAVING STATION	
625-135194		REGION MIDWEST	STATE MICHIGAN
		COUNTY ALGER	3-7

## Existing Condition and Analysis by Landscape Characteristic

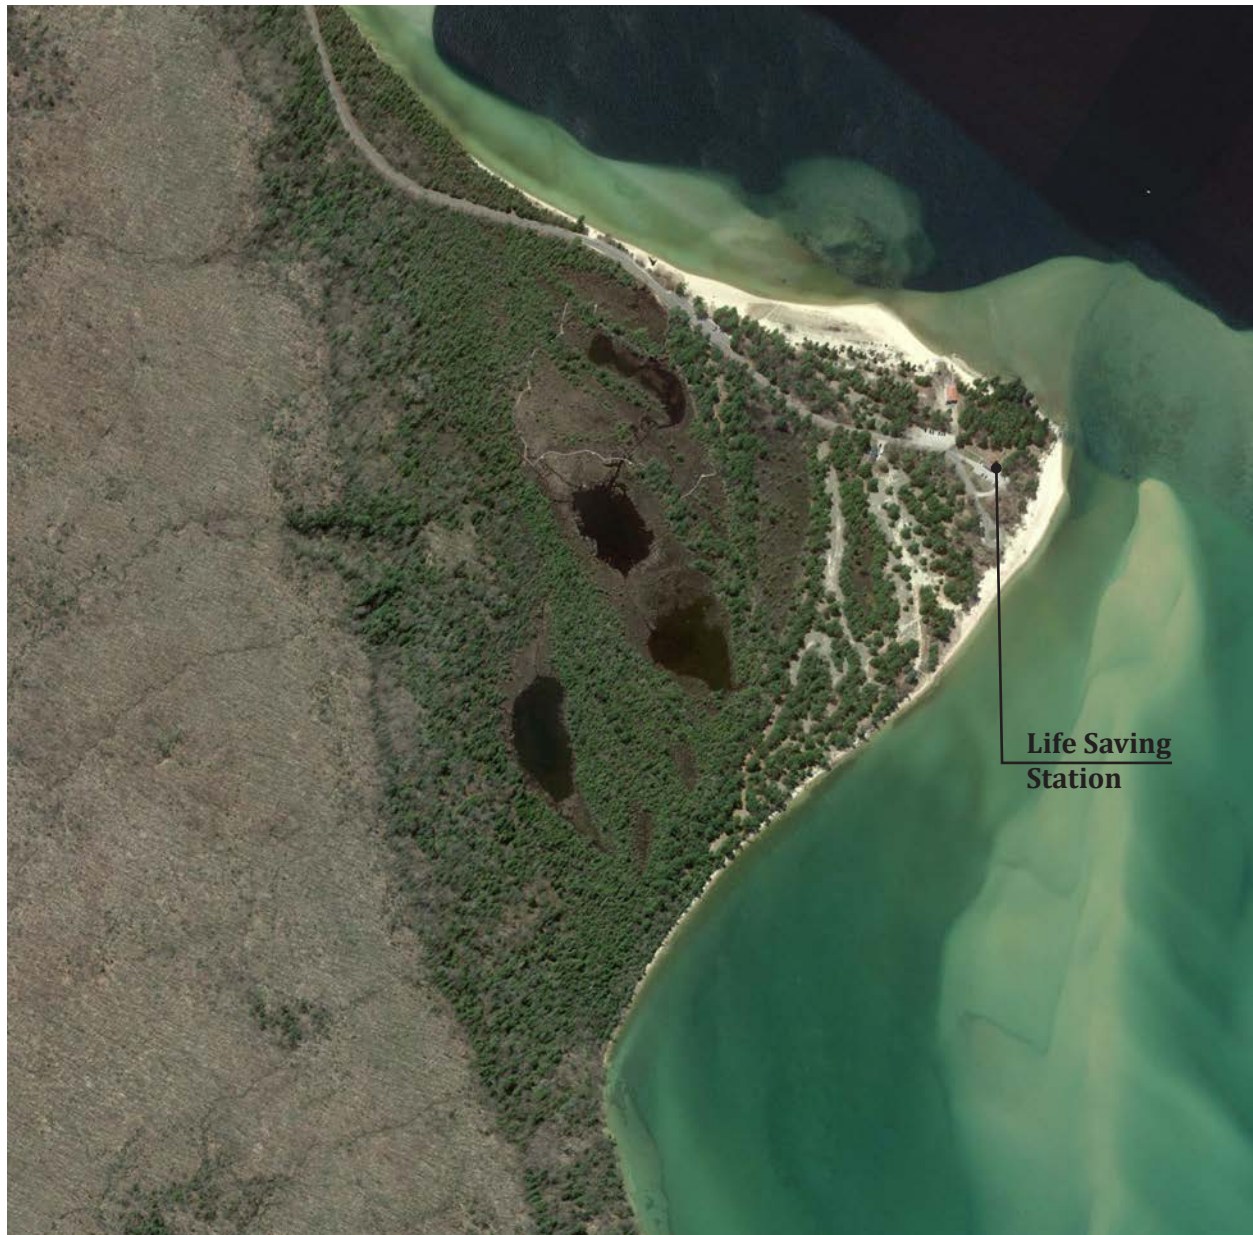
Figure 3-7. Since the 1970s the shoreline has shifted with additional sand accumulating south of the point. "Aerial of Sand Point, 2016." (source: Google Earth)

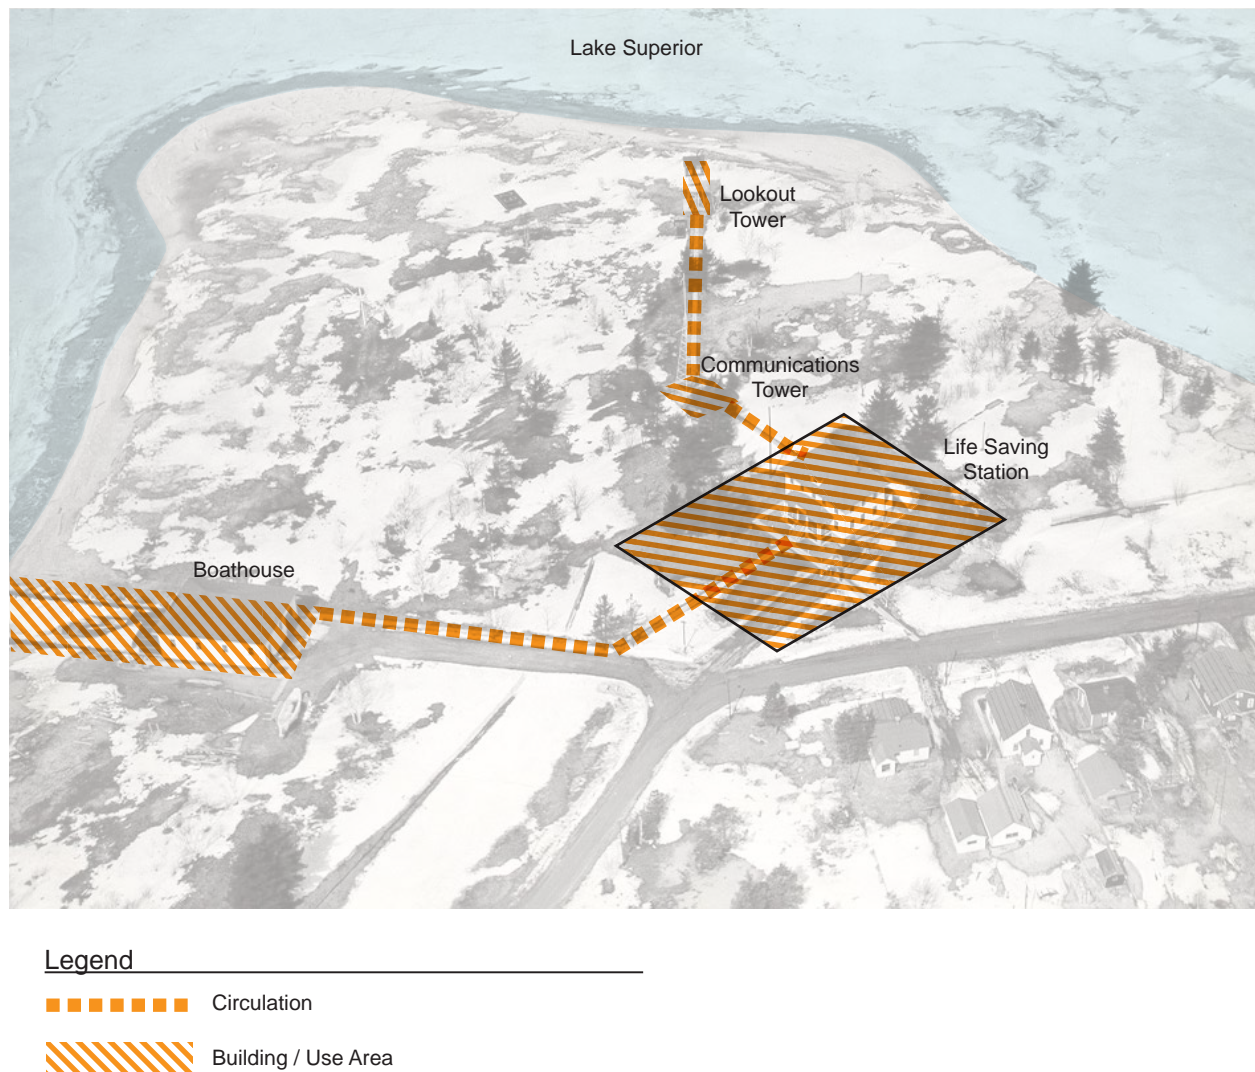
Figure 3-8. The four components of the Sand Point/Munising USCG Life Saving Station were integrated for successful operation – Lookout Tower, Communications Tower, Boathouse and Life Saving Station. These four spaces were connected visually by clearings in the vegetation and physically by walkways. The arrangement of the station was influenced by the geography of the point and arranged as an efficient system. These relationships have been diminished due to vegetation that obscures the visual relationship between these spaces and the poor condition of the walks. (source: PIRO Archives / Mundus Bishop 2016)

22 organization has been further diminished  
23 due to vegetation that obscures the visual  
24 relationship between spaces, and the  
25 poor condition of the walks that limits the  
26 connectivity that once occurred between use  
27 areas.

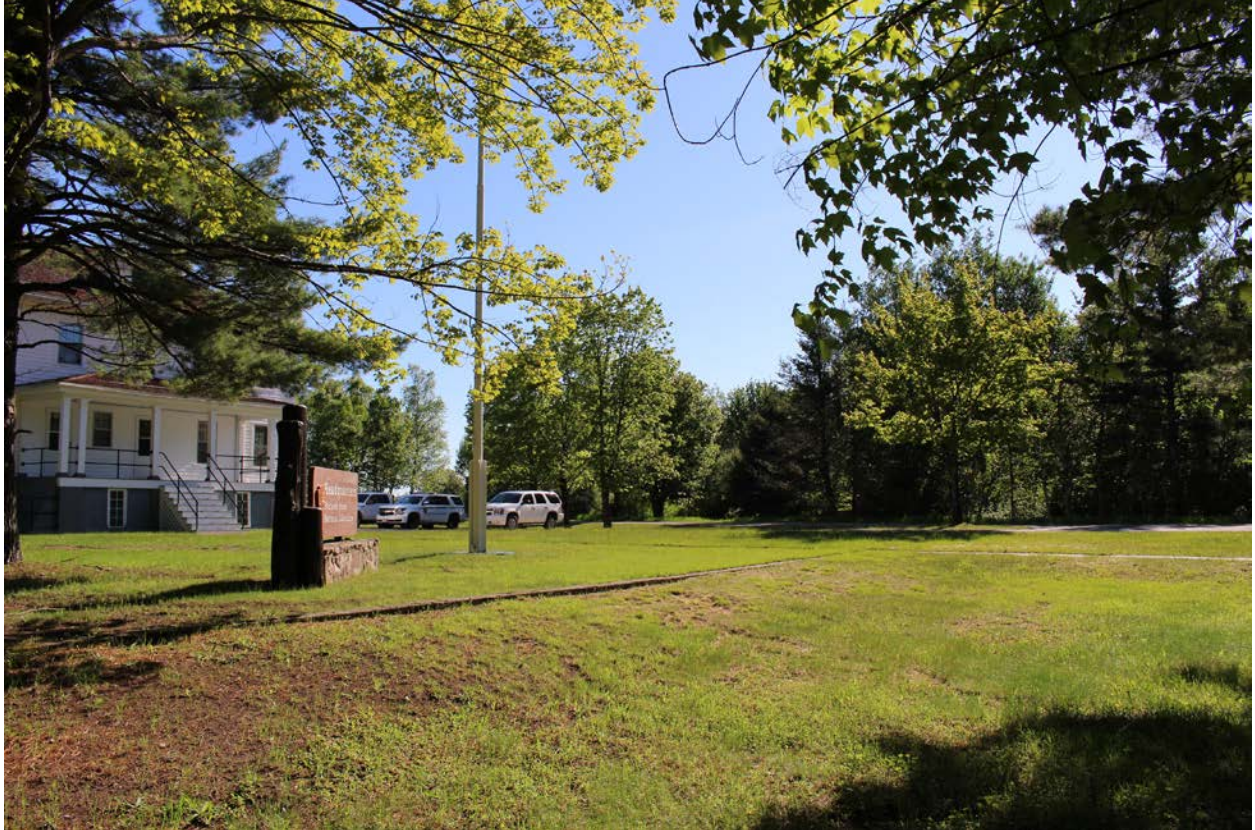
Figure 3-13. The topography is primarily level, with sand dunes creating small natural ridges across most of the study area. As part of the site design, the USCG modified the topography at the Life Saving Station, adding fill and leveling the space into a plinth, enclosed by a concrete curb, on which the building sits. This level topography remains from the period of significance but has been modified by the expanded staff parking area at right. (source: Mundus Bishop 2016)

27 The subtle change to the topography at  
28 the Munising Life Saving Station (HS-01)  
29 exists today and has been unmodified since  
30 the period of significance. An exception is  
31 near the staff parking area where the grade  
32 drops away from the building to the east  
33 more abruptly than it did historically. At the  
34 Launchway, the topography has changed since  
35 the period of significance due to sand that has  
36 washed into the launch. This does not reflect  
37 the historic condition and diminishes the  
38 integrity of the constructed topography.

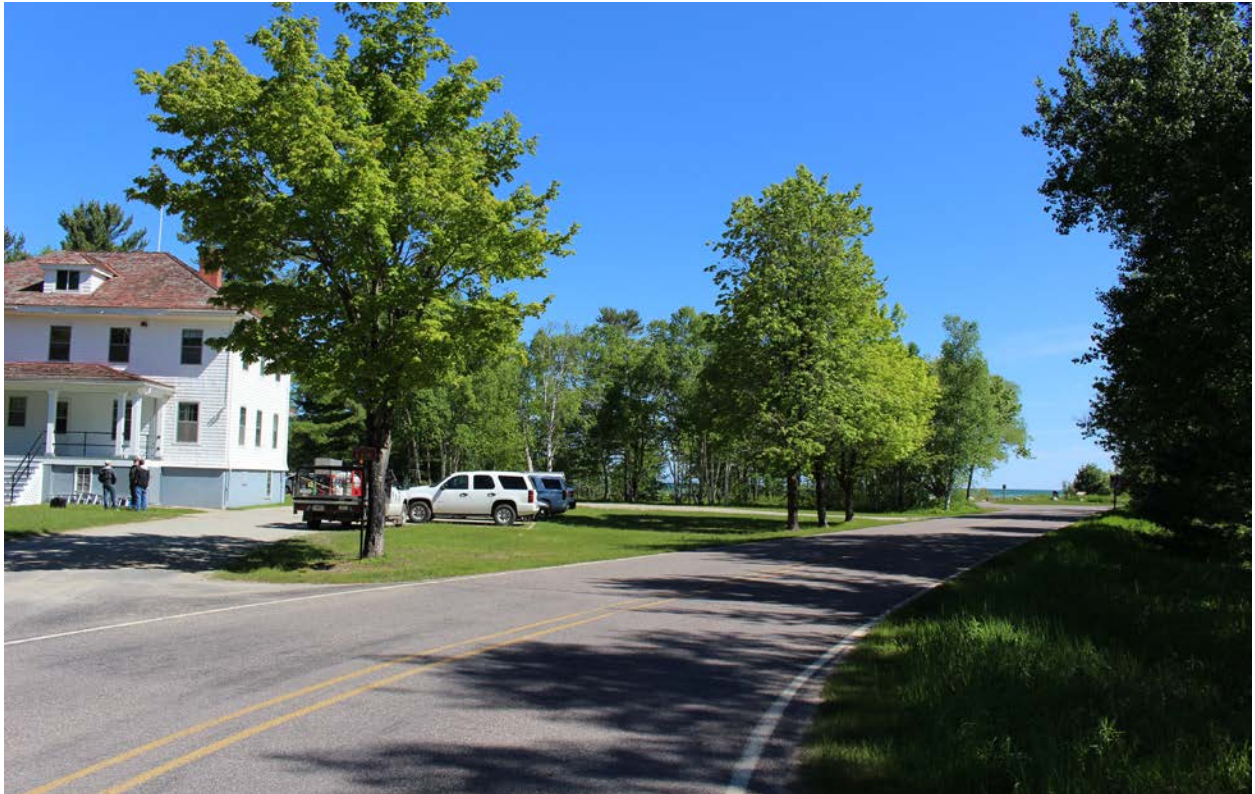
Figure 3-24. Sand Point Road provides access to a service road and staff parking area, which were expanded to the east after the period of significance by the NPS. (source: Mundus Bishop 2016)
