SAND POINT/MUNISING USCG LIFE SAVING STATION
PICTURED ROCKS NATIONAL LAKESHORE
Cultural Landscape Report and Environmental Assessment

February 20, 2017
Public Review Draft

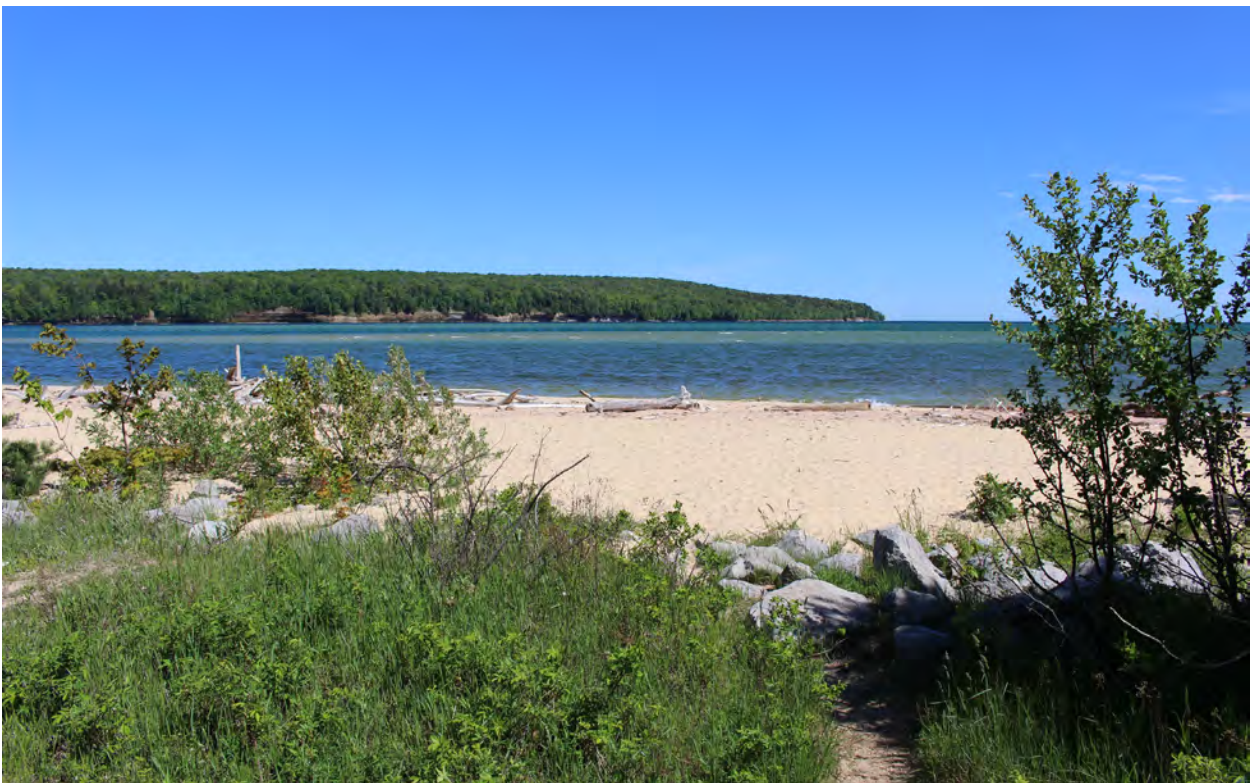
Figure 3-2. Lake Superior reached record setting water levels in the mid-1980s, resulting in very rapid retreat (erosion and inundation) of the northern Sand Point shoreline. The NPS added a rock revetment to the north edge of Sand Point, in foreground of photograph. The sand beach has rebuilt, but not to the extent that existed during the period of significance. (source: Mundus Bishop 2016)

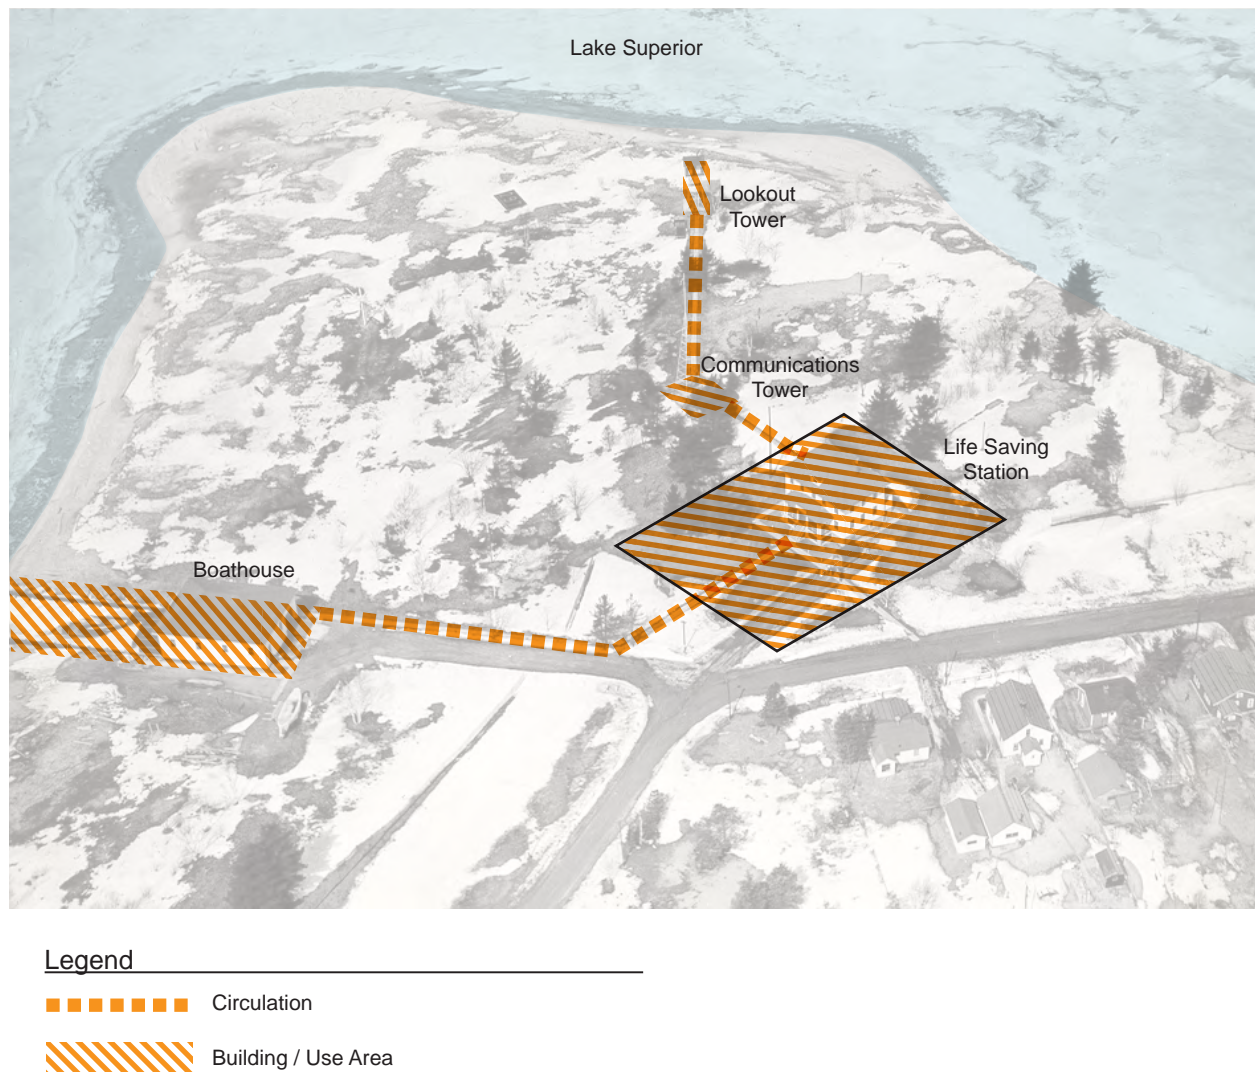
Figure 3-8. The four components of the Sand Point/Munising USCG Life Saving Station were integrated for successful operation – Lookout Tower, Communications Tower, Boathouse and Life Saving Station. These four spaces were connected visually by clearings in the vegetation and physically by walkways. The arrangement of the station was influenced by the geography of the point and arranged as an efficient system. These relationships have been diminished due to vegetation that obscures the visual relationship between these spaces and the poor condition of the walks. (source: PIRO Archives / Mundus Bishop 2016)

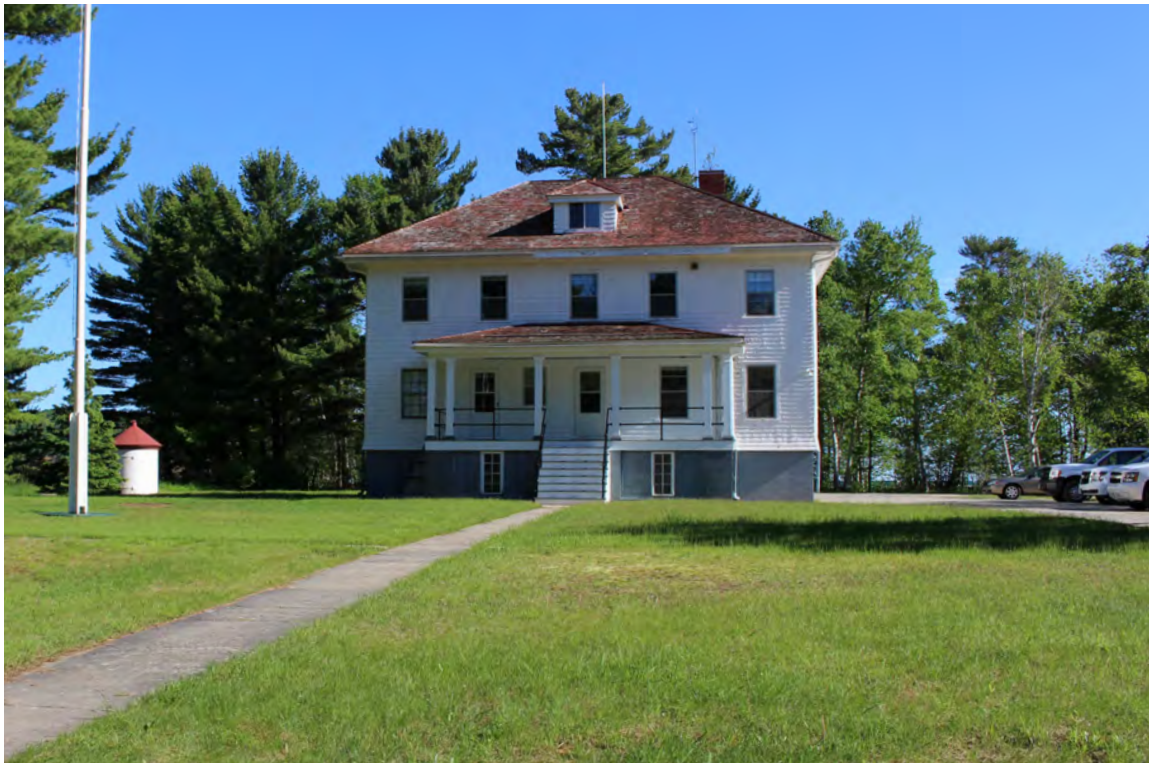
Figure 3-10. Since the period of significance, the spatial organization has been modified by the expanded staff parking area and loss of views to the water. (source: Mundus Bishop 2016)

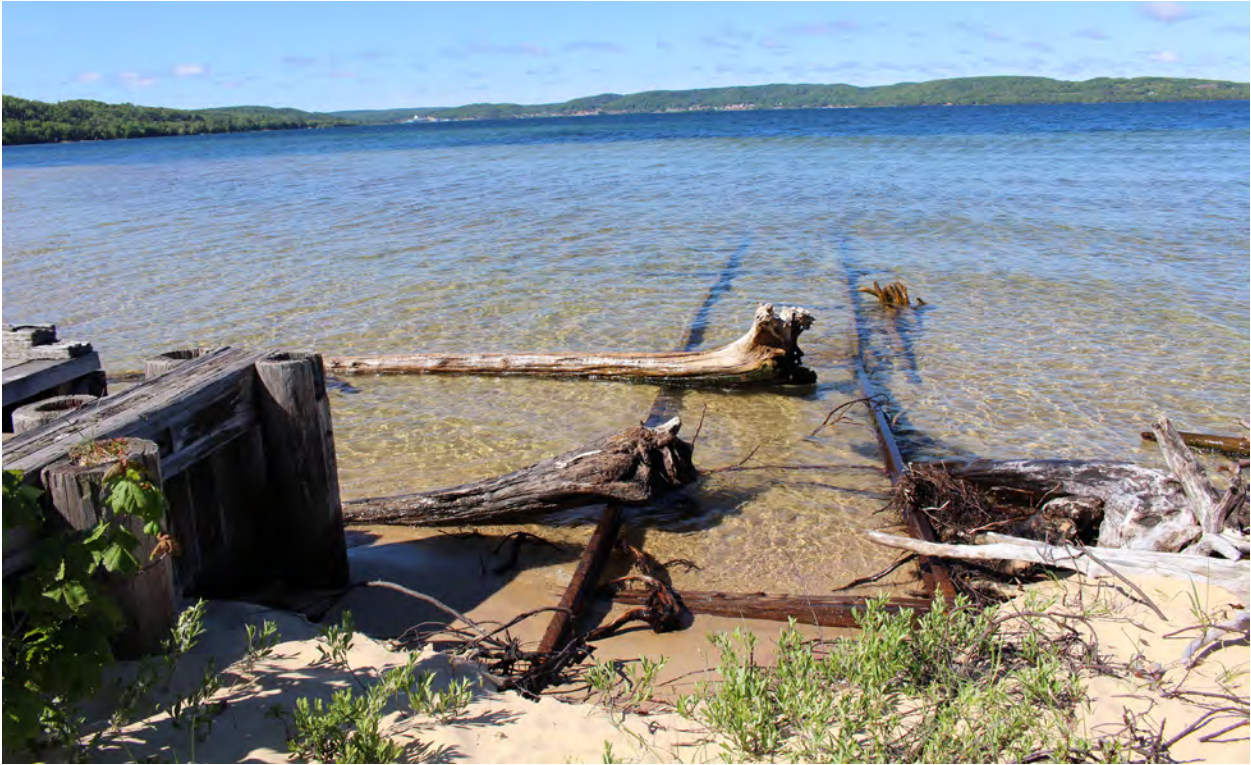
Figure 3-11. The Launchway was placed south of the point, in a sheltered location from strong winter storms. The twin sets of rails are partially extant. The dock, at left, is a reconstruction in an historic location at the end of the Launchway. (source: Mundus Bishop 2016)

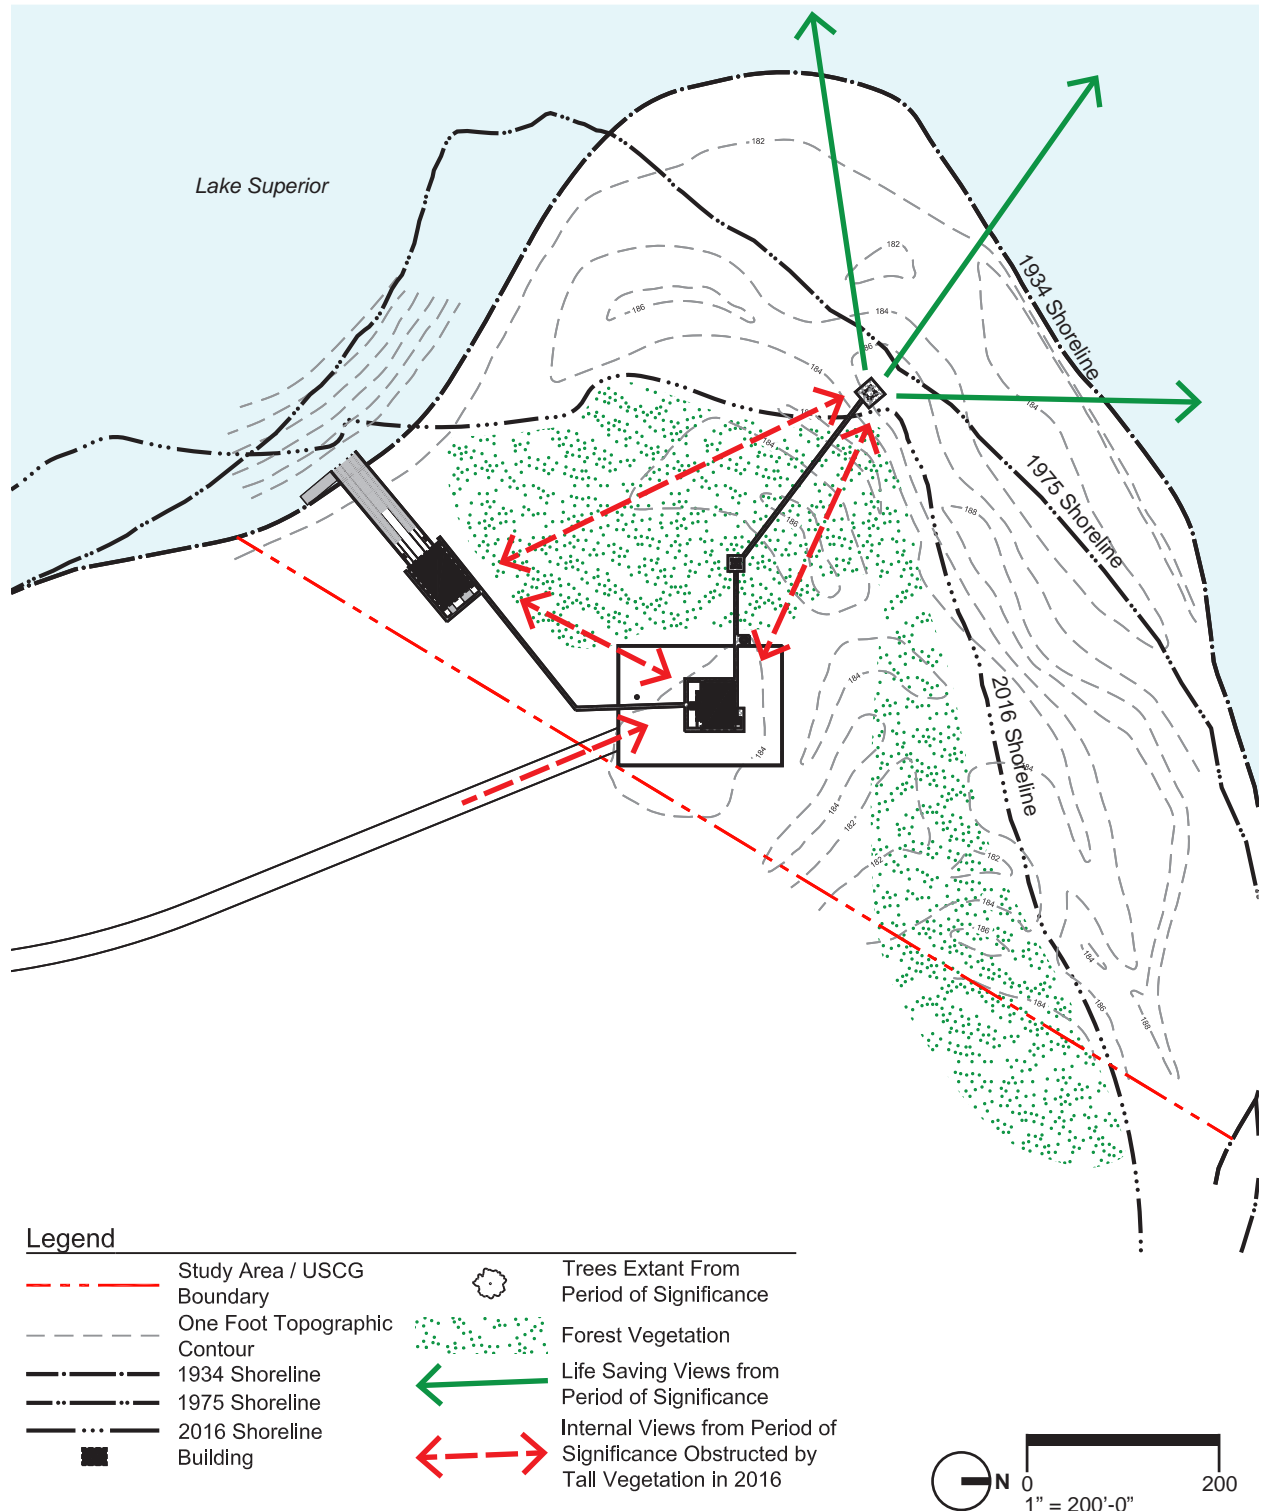
Figure 3-14. The views associated with the USCG development have changed since the period of significance. Historically the vegetation was less dense, allowing for open views across the study area. These views were essential to the successful life saving operations undertaken by the USCG. Over time vegetation has grown into the once open spaces, obscuring views to the water and the internal views and sight-lines between structures. (source: Mundus Bishop 2016)

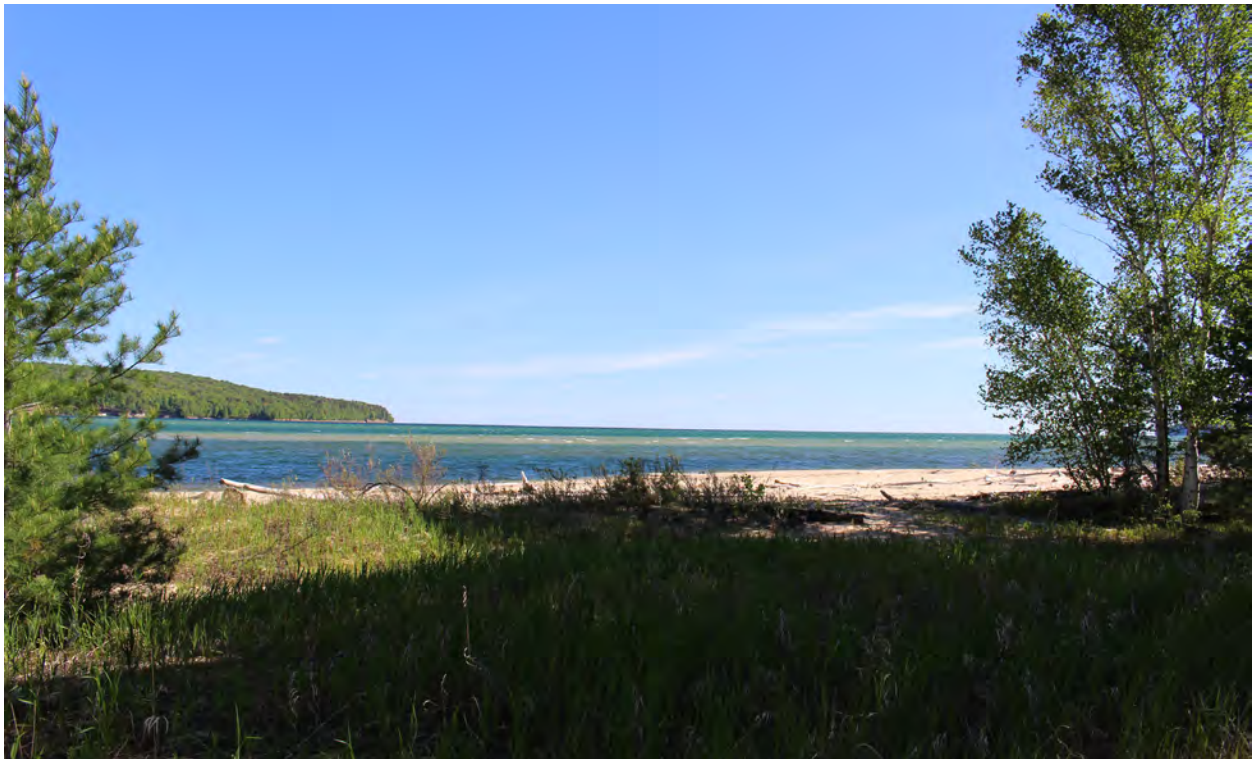
Figure 3-16. A similar view today, looking towards Grand Island. The view remains open across the beach but smaller trees encroach upon the view. (source: Mundus Bishop 2016)

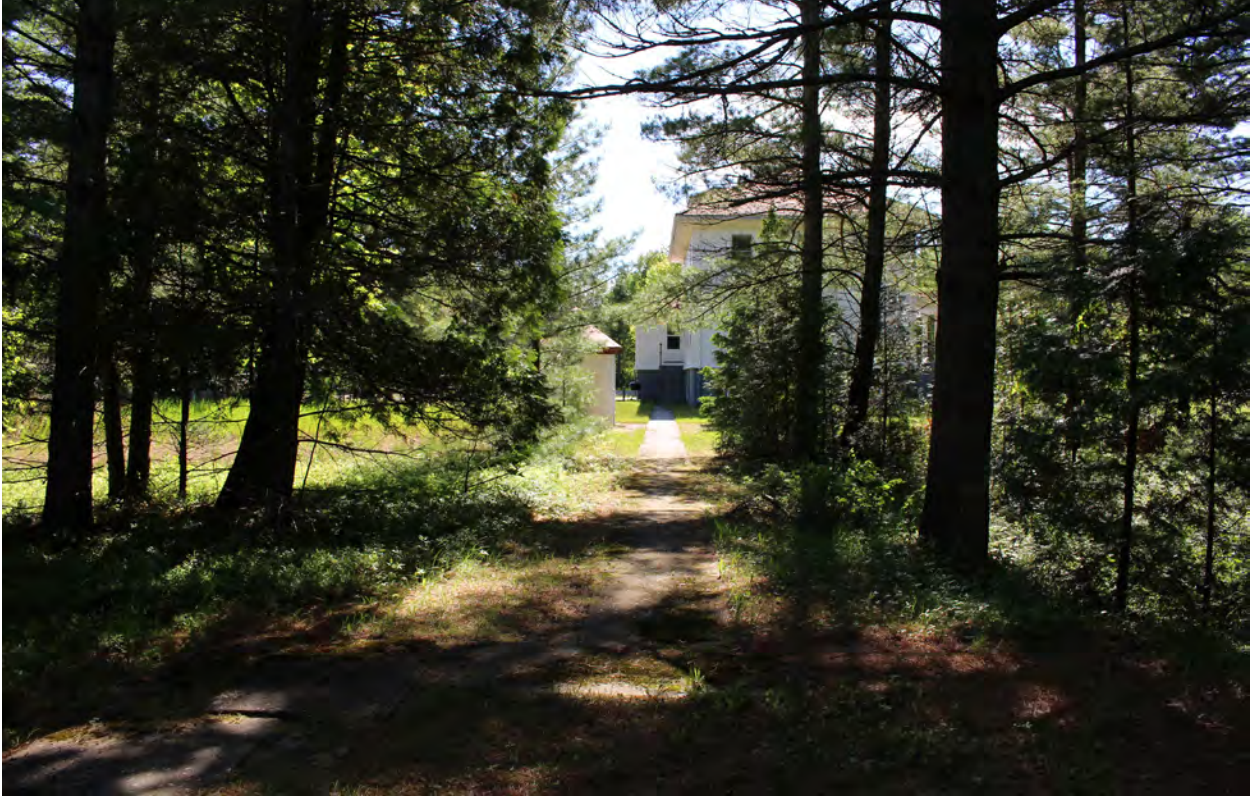
Figure 3-20. The walk to the former Communications Tower is covered with dirt and debris. Vegetation obscures the view between the Life Saving Station and the former tower. (source: Mundus Bishop 2016)

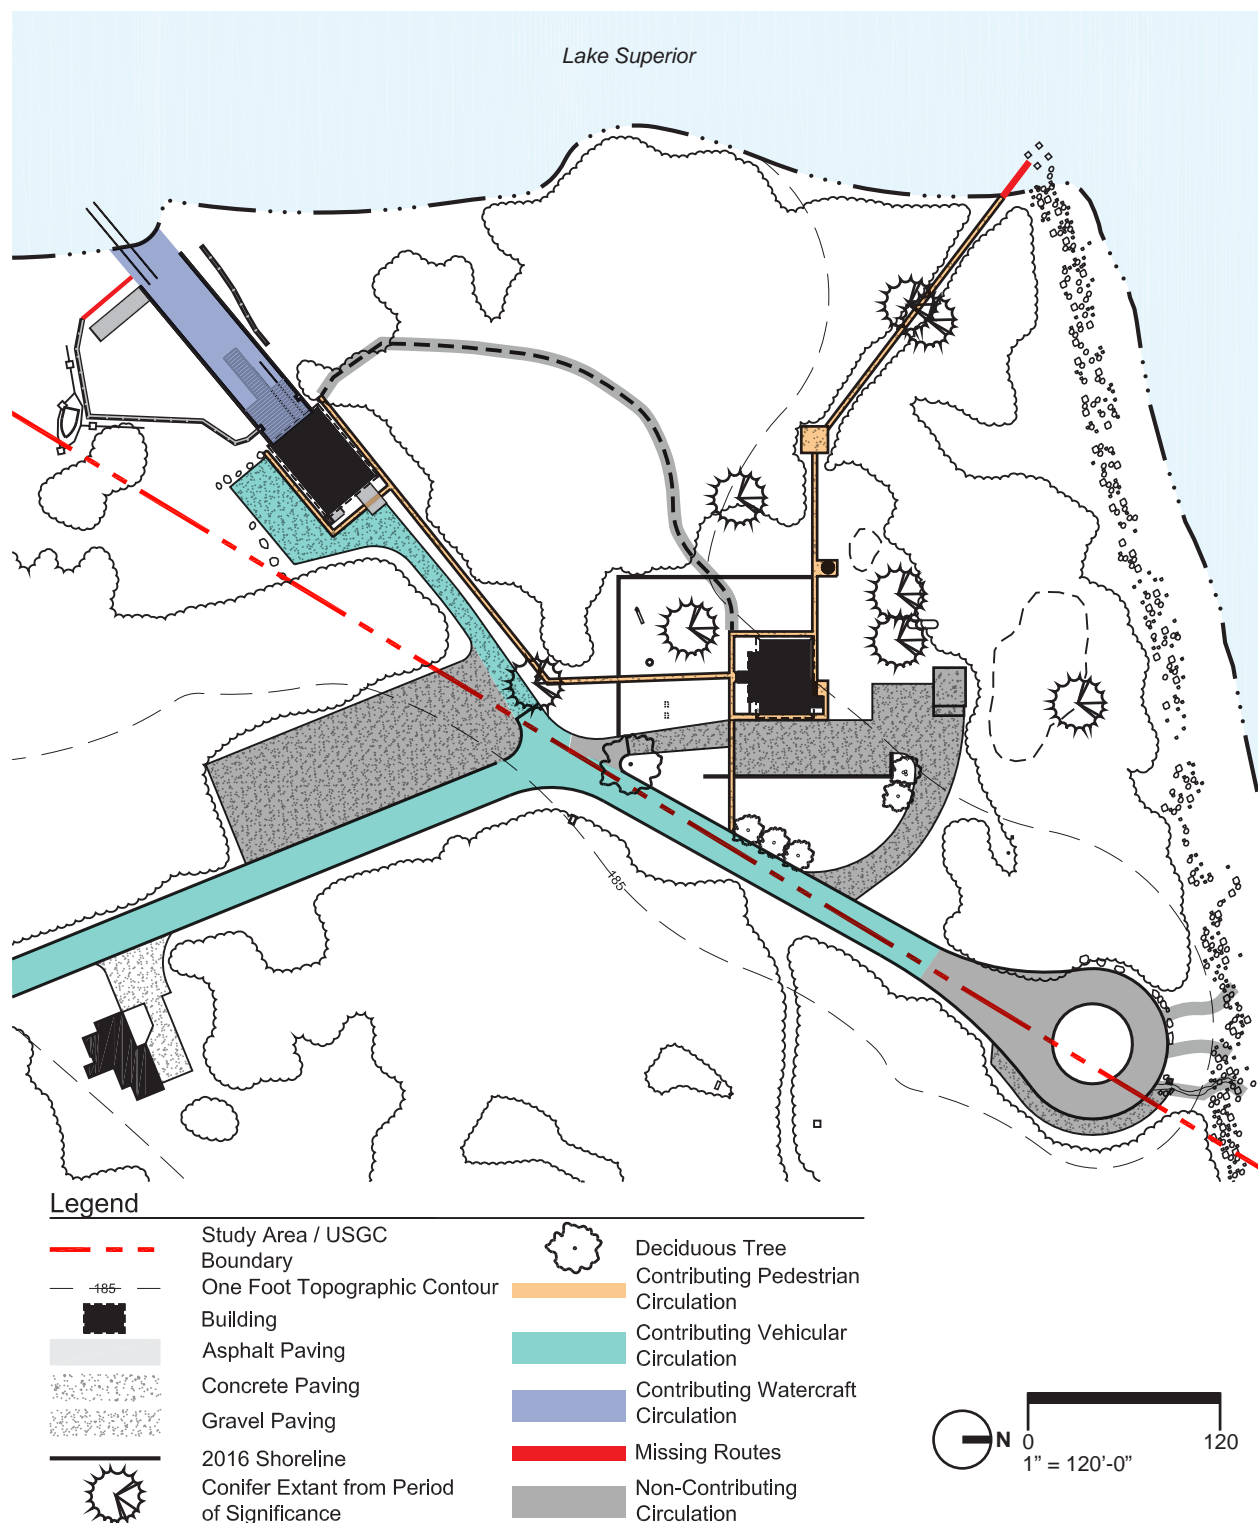
12
13 Pedestrian routes have remained as a system
14 of orthogonal paths connecting buildings
15 and use areas as originally built. Some walks
16 have been damaged, due to erosion of the
17 lakeshore, particularly at the northwest end
18 towards the Lookout Tower foundation, and
19 a portion of the Station Walk that extended to
20 the east. Near the Boathouse, the orthogonal
21 walks have been covered by a ramp on the
22 east side, and other portions are in poor
23 condition. The boardwalk and informal trails
24 are not part of the historic circulation pattern.

Figure 3-23. Circulation routes have remained in-tact from the period of significance. The overall circulation pattern remains, but the expanded vehicular circulation routes and poor condition of many walks threatens the integrity of the original design. (source: Mundus Bishop 2016)

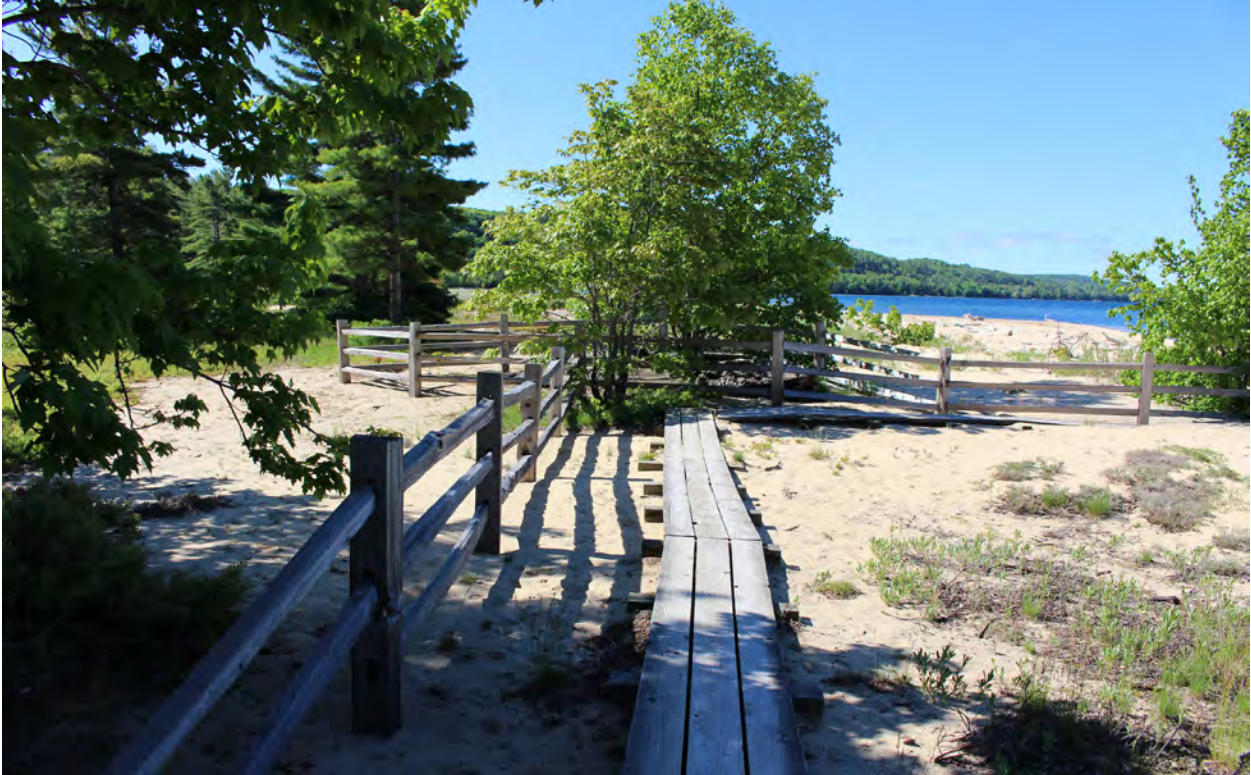
Figure 3-40. The boardwalk leads to the boat hull, behind fence in background, and then turns towards, where portions of the boardwalk are washed out. (source: Mundus Bishop 2016)

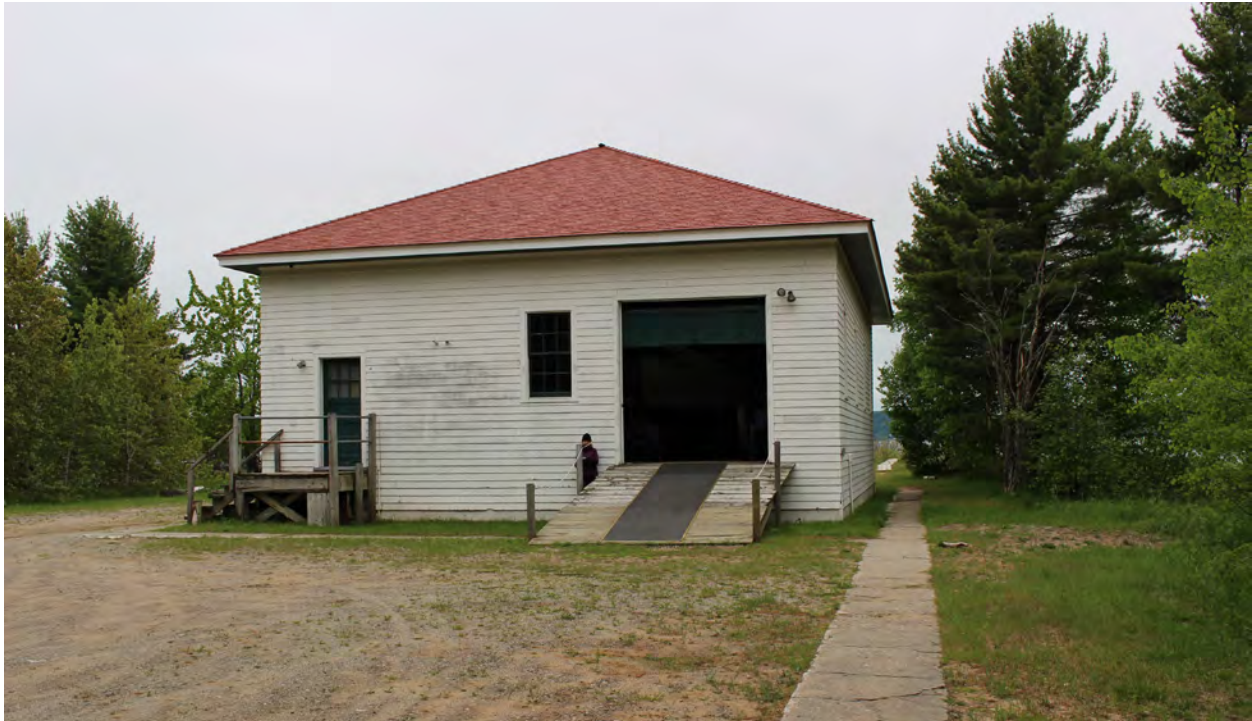
Figure 3-44. The Boathouse was constructed in the 1930s by the USCG, sited on the west side of the study area, facing Munising Bay. The east facade, above, originally had an exterior ramp and stairs. These features have been rebuilt in a similar fashion to the historic, but the exterior stair faces a different direction (south rather than east) and the ramp has been extended further to the east. (source: Mundus Bishop 2016)

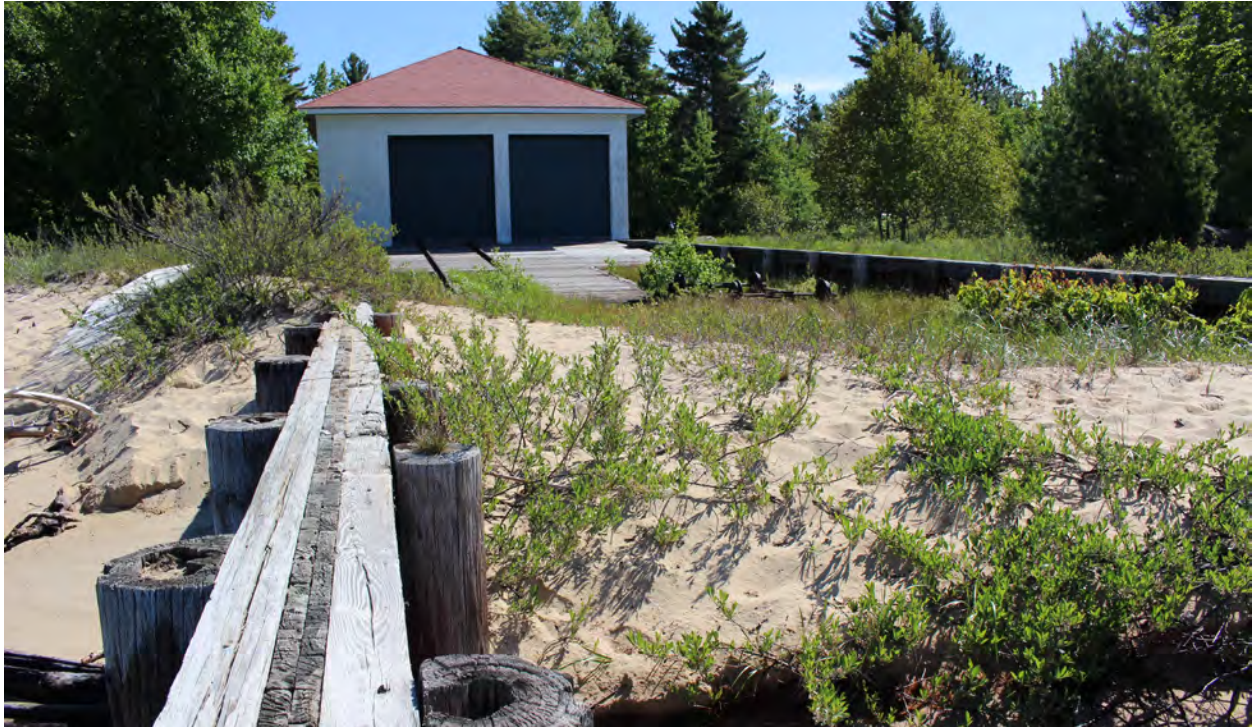
Figure 3-45. The Launchway, in foreground, was constructed of two bulkheads flanking either side, and two sets of metal rails that carried the USCG boats in and out of the water. When originally constructed, the waterline was closer to the Boathouse. The Launchway was extended in the 1940s as a result of the naturally shifting shoreline. (source: Mundus Bishop 2016)

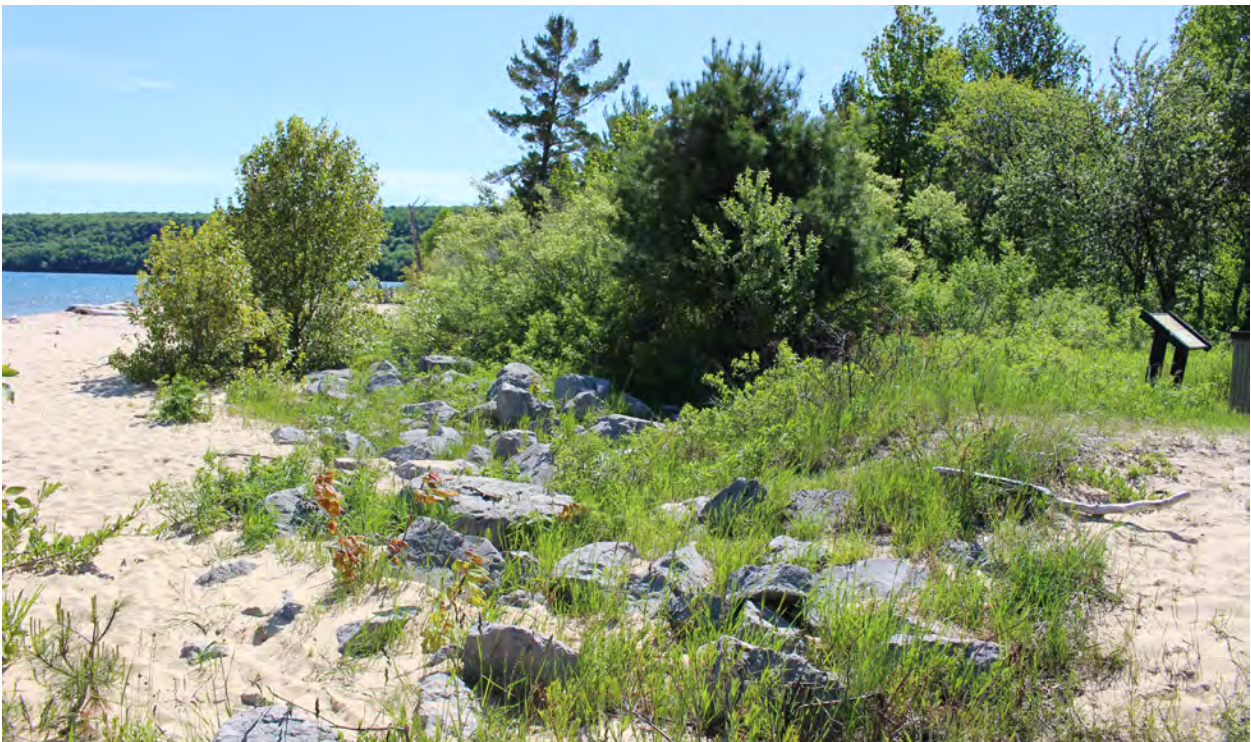
Figure 3-49. The rock revetment at the north edge of the study area is a non-contributing feature added in the early 1990s. It does not reflect the historic condition of the landscape. (source: Mundus Bishop 2016)

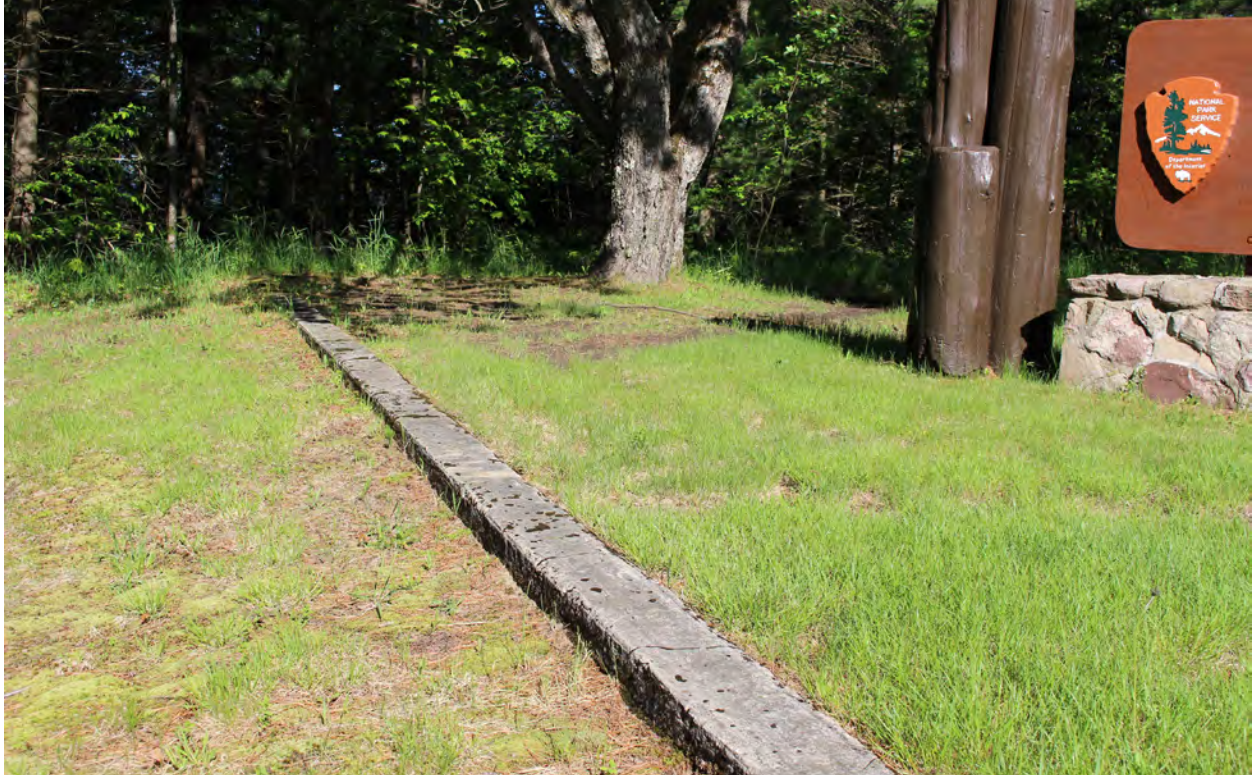
Figure 3-50. The concrete curb at the south edge of the Life Saving Station is the most easily seen portion of the curb that once framed the formal outdoor space around the building. (source: Mundus Bishop 2016)

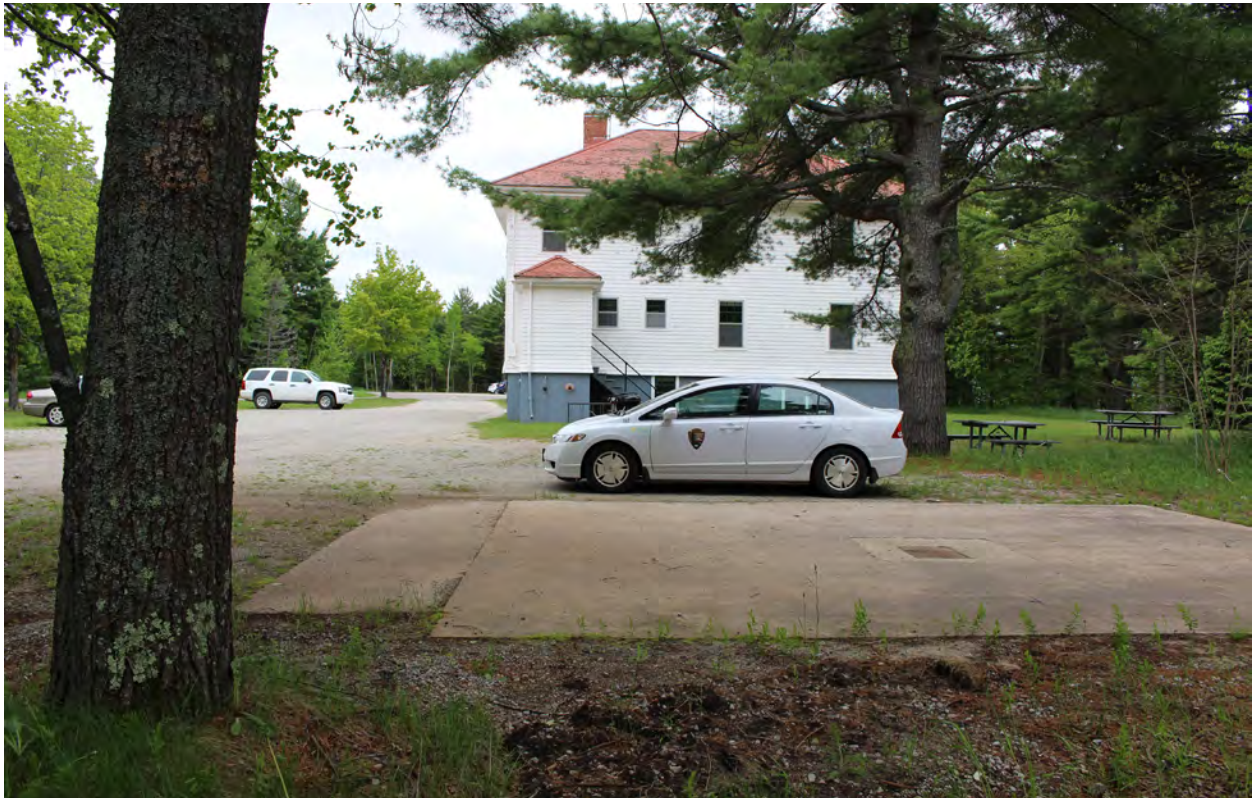
Figure 3-54. The concrete foundation remains of a garage that was added by the NPS and later removed. (source: Mundus Bishop 2016)

20	missing.	20	
21		21	
22	• Preserve the Communications Tower	22	
23	foundation and the Lookout Tower	23	
24	foundation. Consider adding a compatible,	24	
25	contemporary structure that would	25	
26	visually mark the height of these non-	26	
27	extant towers.	27	
28		28	
29	• Remove non-contributing garage	29	
30	foundation.	30	
31		31	
32	<u>Small Scale Features</u>	32	
33	• Repair the concrete curb around the	33	
34	Munising Life Saving Station (HS-01),	34	
35	revealing the full form of the curb.	35	
36		36	
37	<u>Vegetation</u>	37	
38	• Thin trees and vegetation where it	38	
39	encroaches on historic views to the water.	39	
40		40	
41	• Repair the lawn surrounding the Munising	41	
42	Life Saving Station (HS-01) to within the	42	
43	concrete curb as was the historic design	43	
44	intent.	44	
45		45	
46

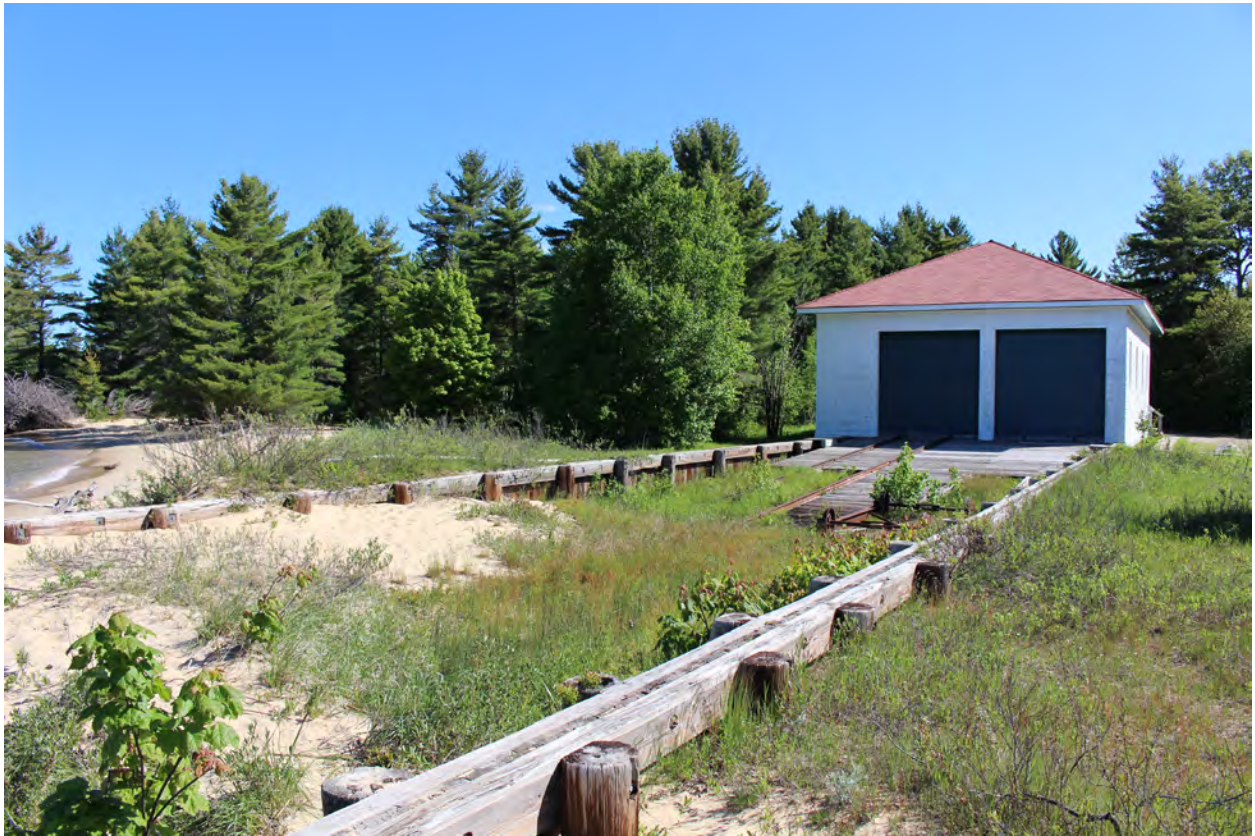
Figure 3-62. Since the closing of the station, dune grasses and smaller vegetation have regrown into once cleared areas, including within the Launchway. Note the view to Grand Island is no longer apparent due to growth of mature forest trees. (source: Mundus Bishop 2016)

- 2 • Thin woodland vegetation where it has
3 encroached upon historic views to the
4 water.
5
6 • Maintain existing lawn surrounding the
7 Munising Life Saving Station (HS-01) .
8
9 • Preserve extant trees that date from the
10 period of significance.
11
12
13
14
15
16
17
18
19
20
21
22
23
24
25
26
27
28
29
30
31
32
33
34
35
36
37
38
39
40
41
42
43
44
45
46

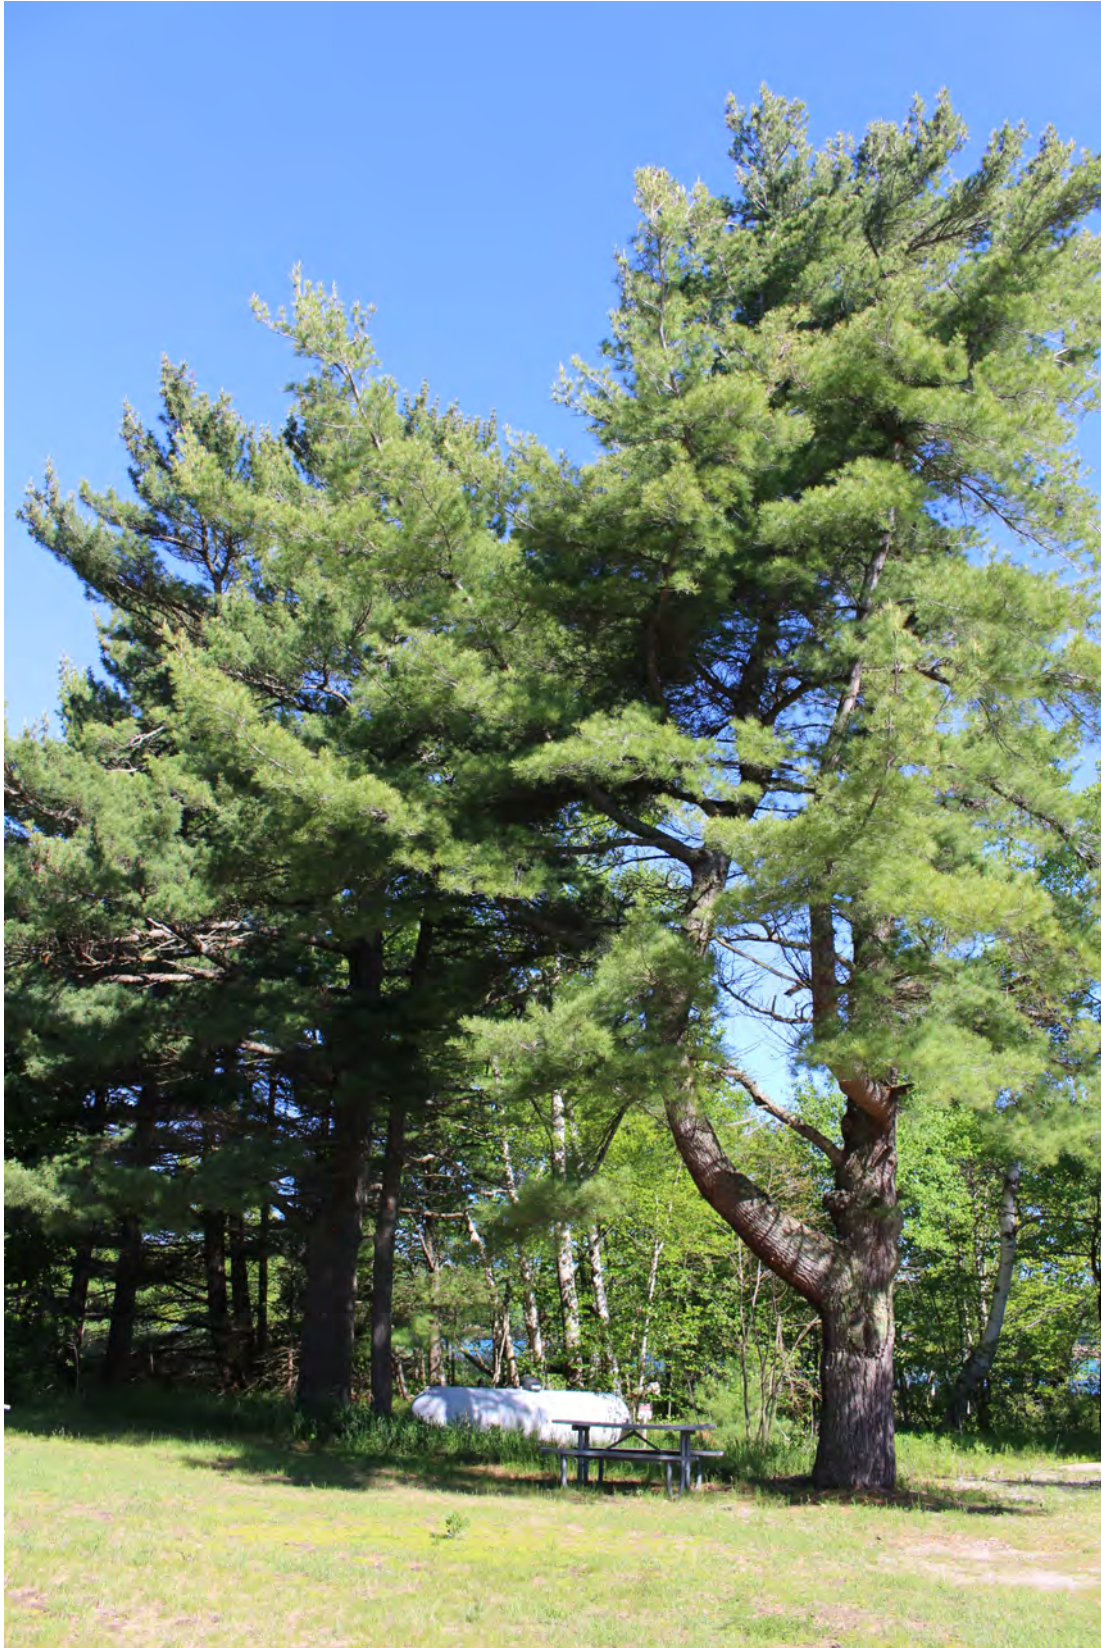
Figure 3-66. White pine trees from the period of significance are in good condition and contribute to the historic character of the station. (source: Mundus Bishop 2016)
