MAMMOTH HOT SPRINGS HOTEL

Historic Structures Report

Yellowstone National Park

March, 2015

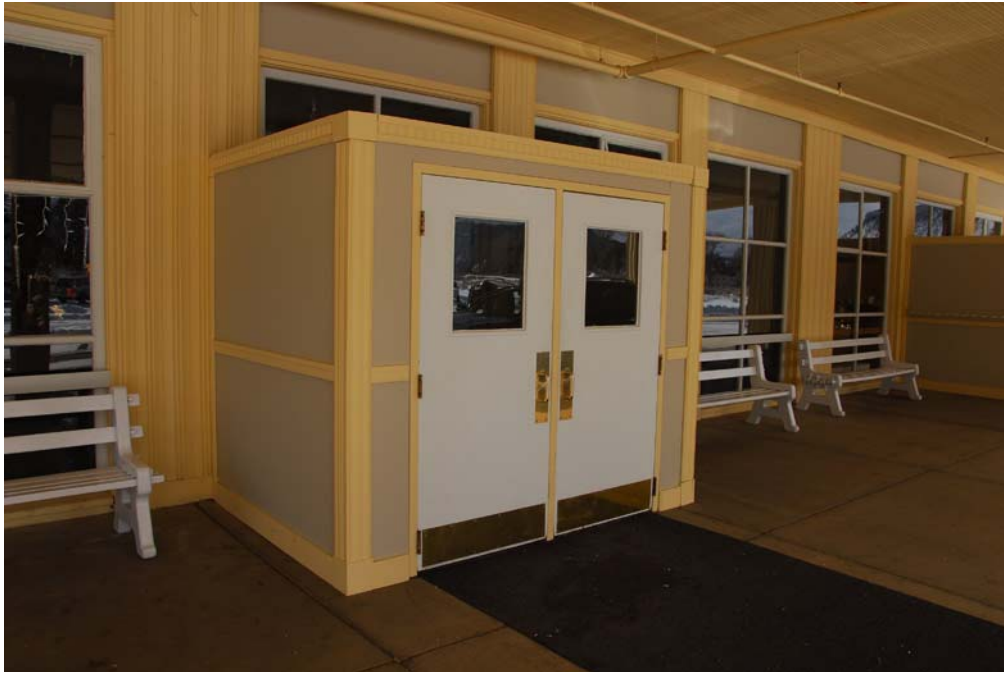
Figure 12: Looking northeast at the winter vestibule that is added to the front for protection from the weather. This vestibule does not work very well and takes away from the entrance.

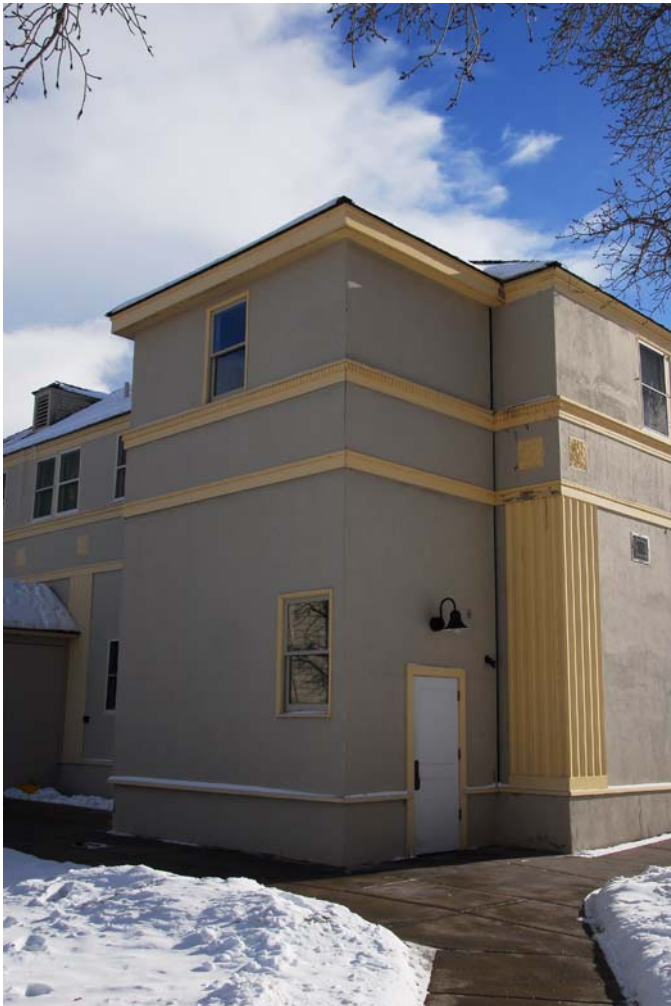
Figure 15: Looking southeast at the intersection of the added egress stair enclosure and the original building.

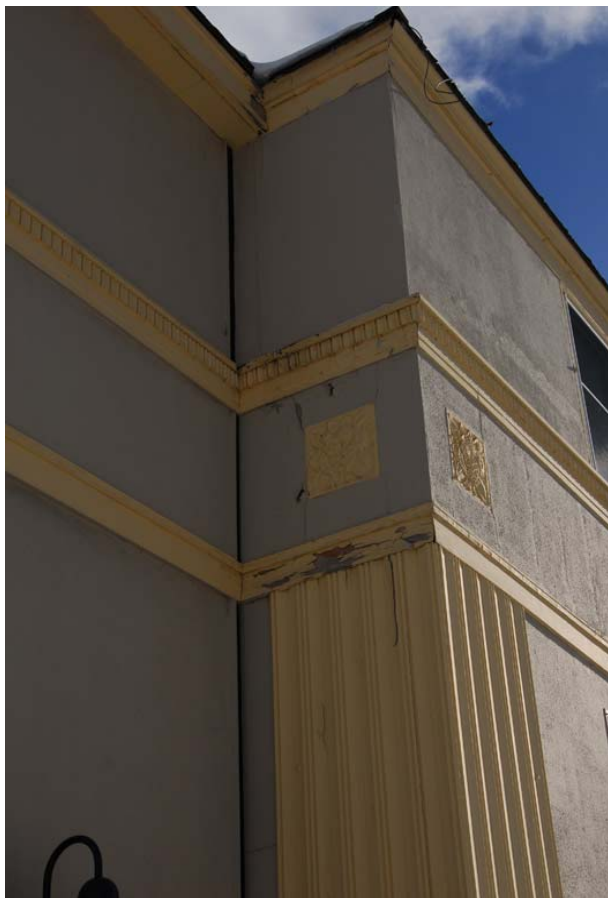
Figure 16: Looking southeast at the upper section of the added egress stair enclosure and the original building. Note the rotted cornice and other wood trim on the original building.

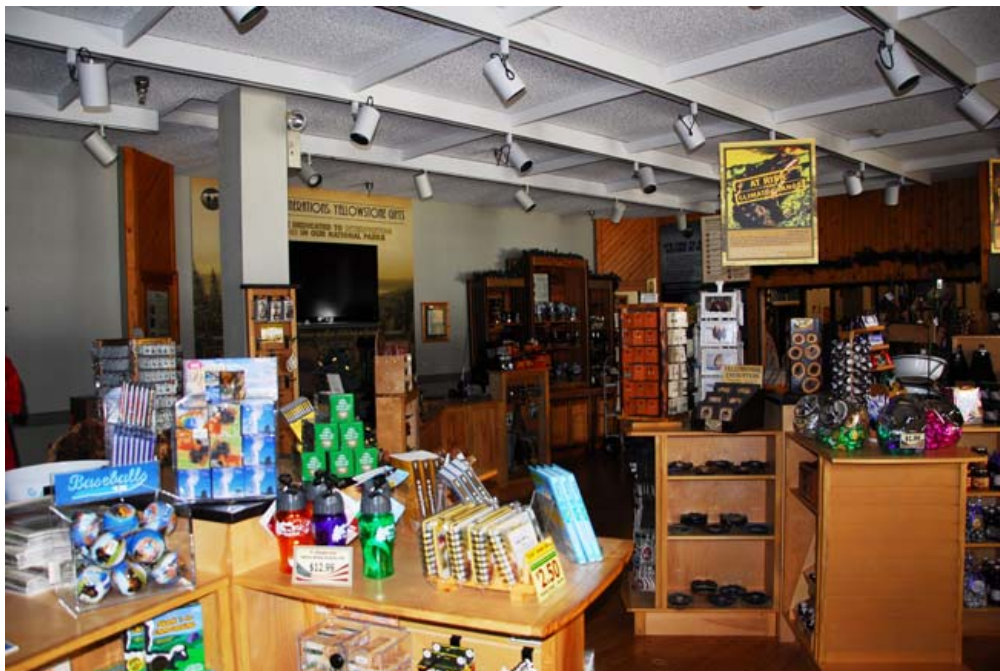
Figure 36: Looking north at the gift shop.

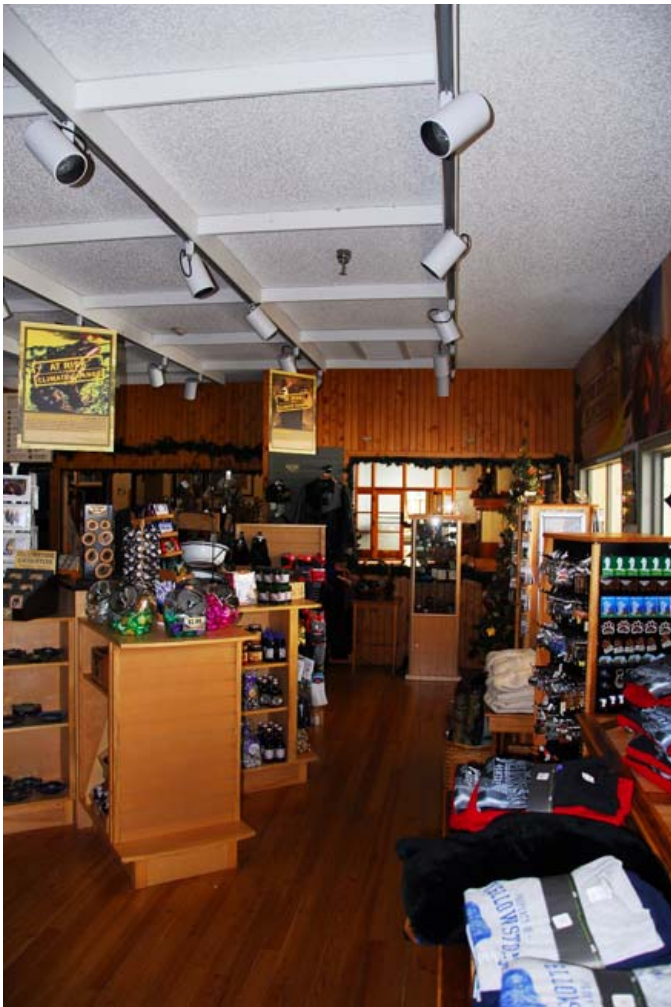
Figure 37: Looking east at the gift shop towards the lobby windows. The space is very crowded.

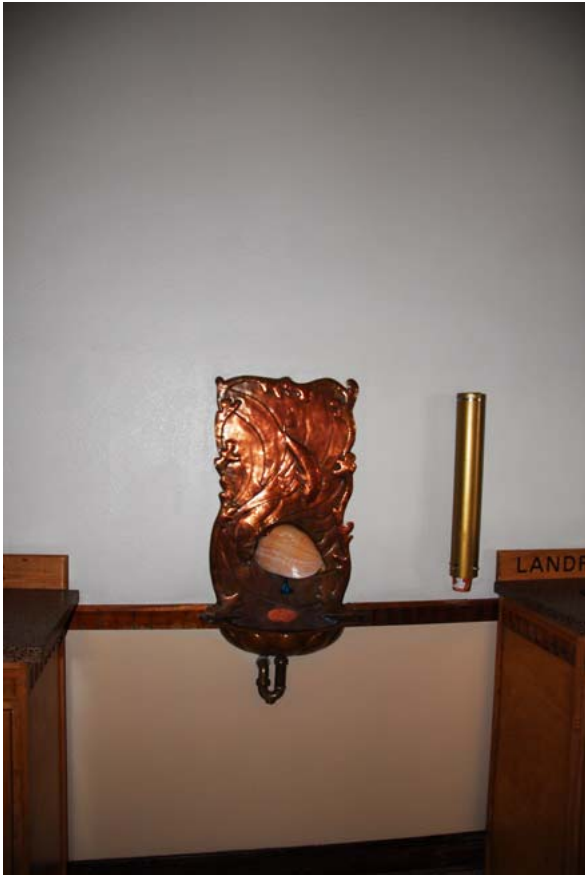
Figure 39: Looking north at the water fountain that had been removed and then replaced in the lobby. It is in good condition but is not easily operated.

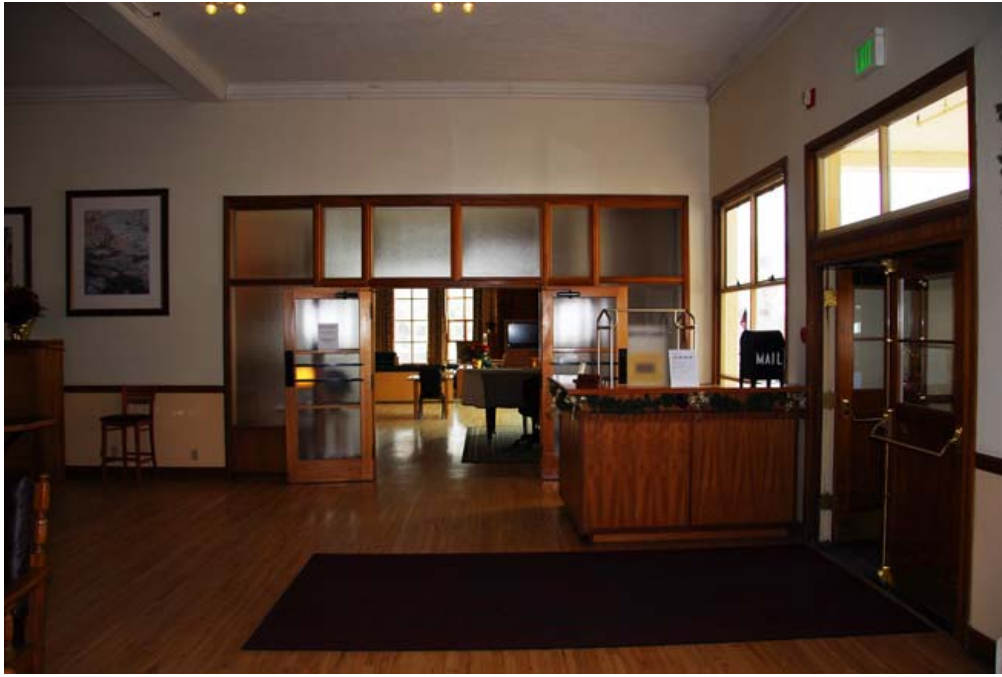
Figure 45: Looking east at the entrance to the Map Room. The doors and glass were remodeled in 1988 to be more compatible with the rest of the historic materials and design.

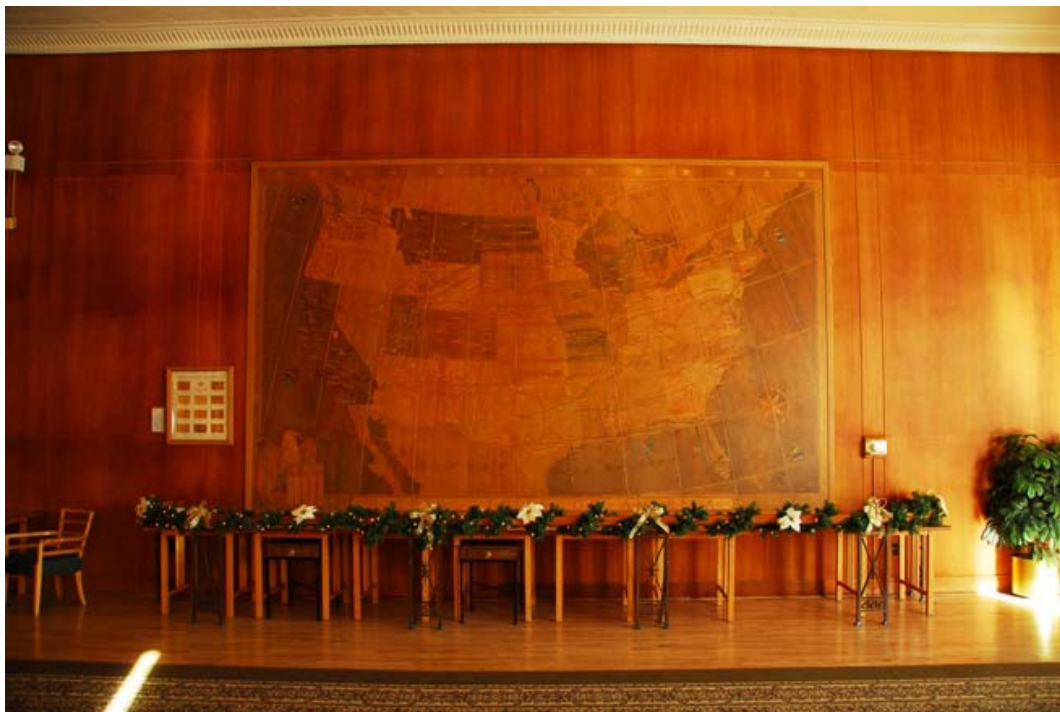
Figure 50: Looking north at the restored map in the Map Room. There are still some areas that are starting to delaminate because of the heat within and behind the wall.

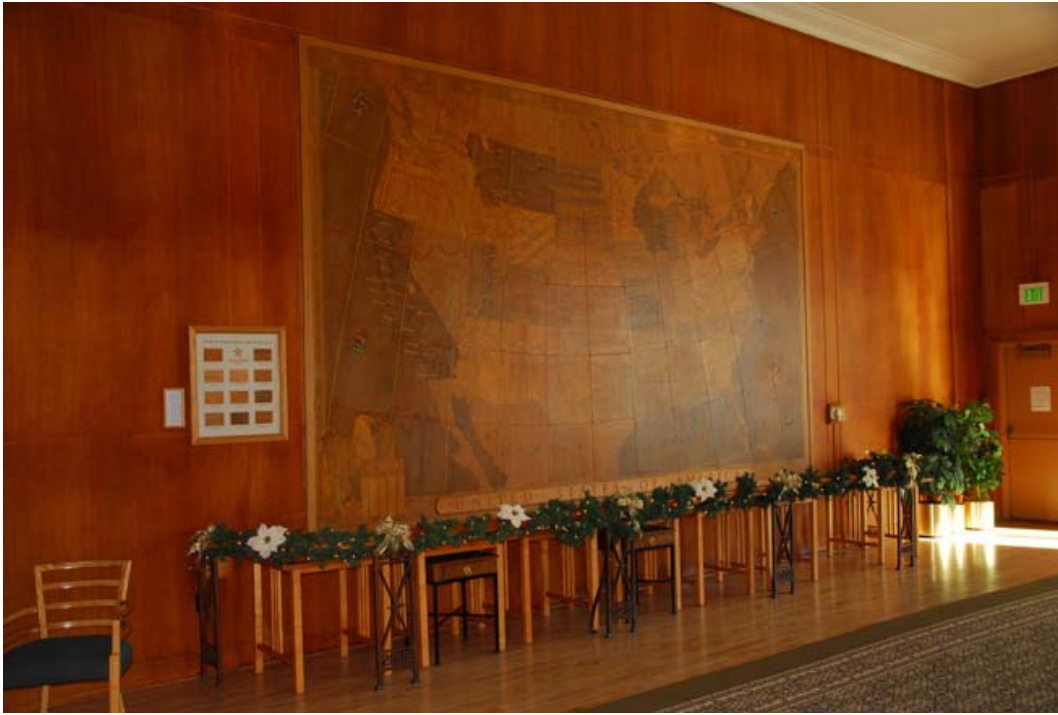
Figure 51: Looking northeast at the map and surrounding wall. The wood is weathered because the wood was exposed more to sunlight from the south before the windows were restored. Low E-glass was installed to cut down on the ultraviolet rays.

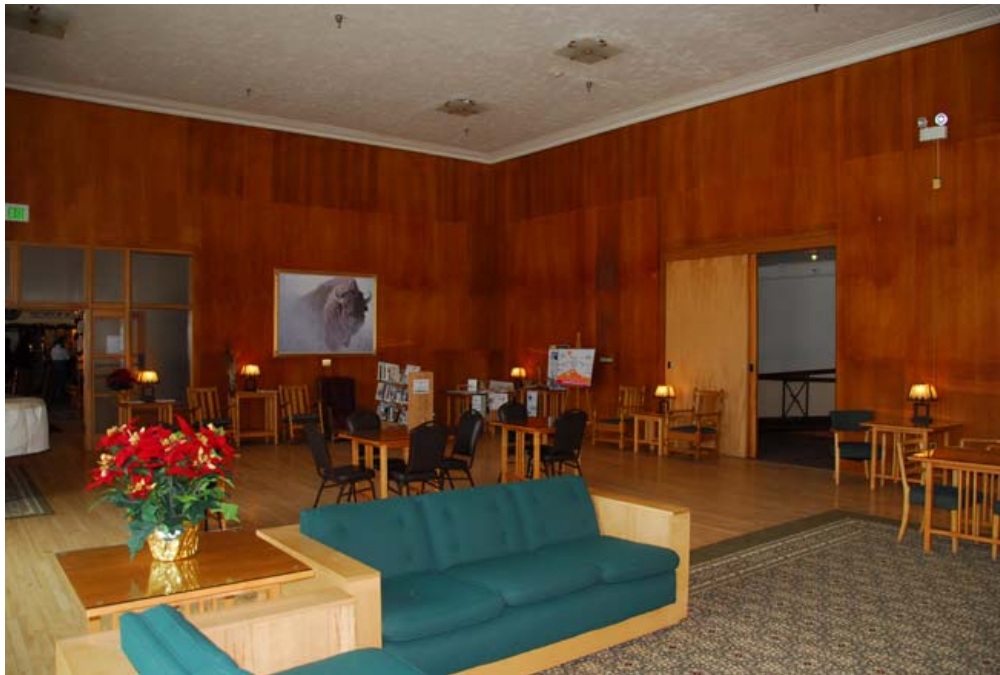
Figure 53: Looking north west at the Map Room. Note the sliding doors that were added to the room. They do not meet code for exiting unless they are kept open at all times.

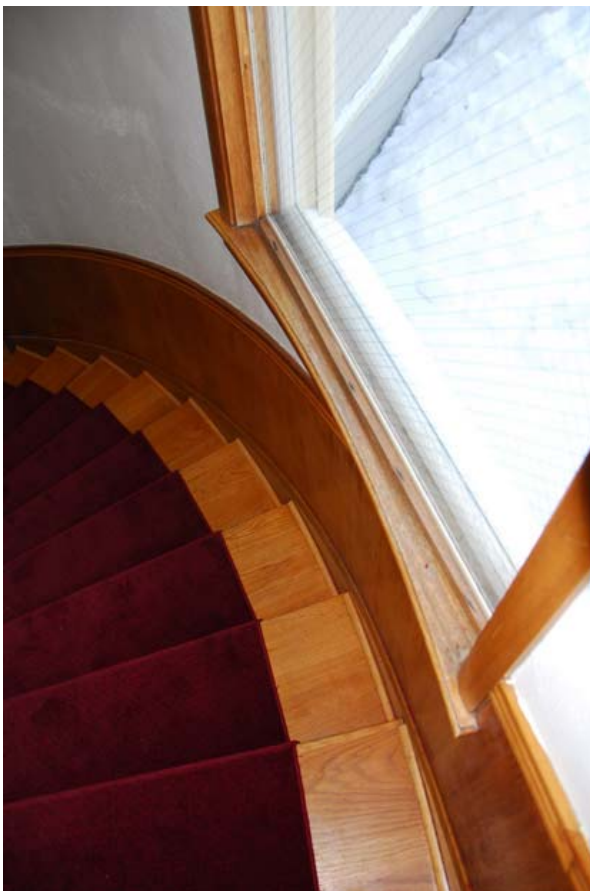
Figure 58: Looking down at the base of the windows along the stair. The windows are in poor condition because of addition of the interior fire glass required by code does not let the windows breathe and causes water to build up in the base.

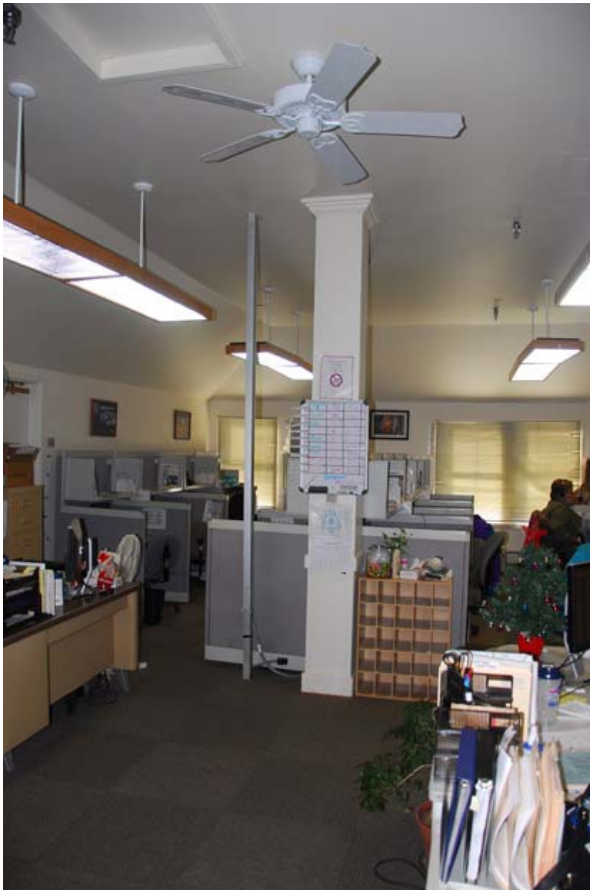
Figure 64: Looking south at the reservation office. Note the individual cubicles and the modern materials on the walls and trim. The column is original to the space.

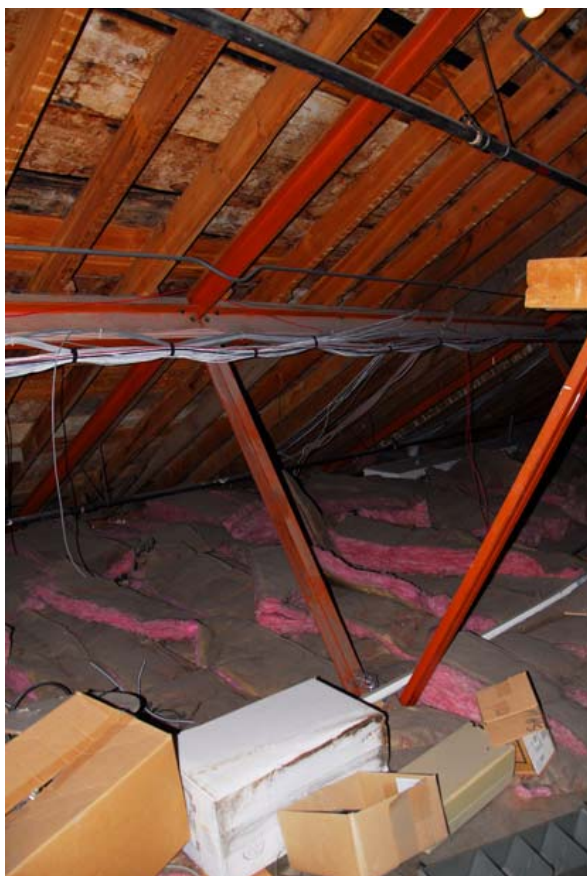
Figure 66: Looking east at the unfinished attic space over the Map Room. There is only a partial floor to access the area.

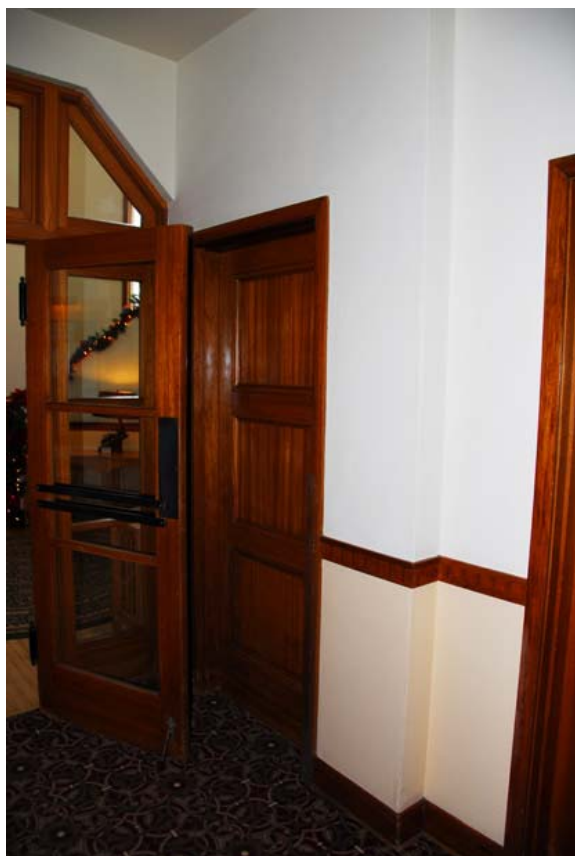
Figure 68: Looking at some of the original doors and chair rail in the space. The wood is in good condition with some minor repairs.

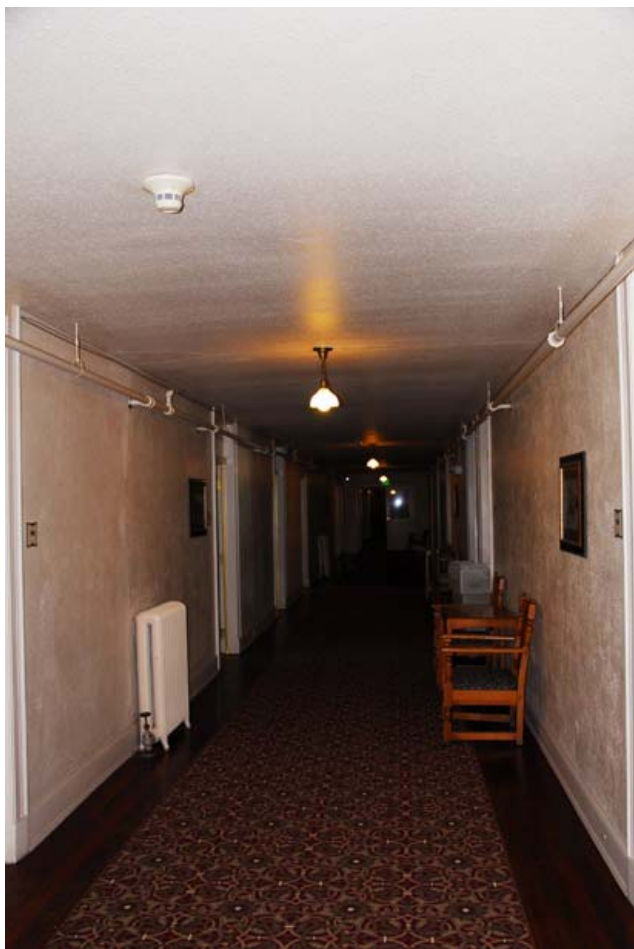
Figure 70: Looking north at the first floor corridor. Note the historic light fixtures in the center of the ceiling, original wood trim around the doors.

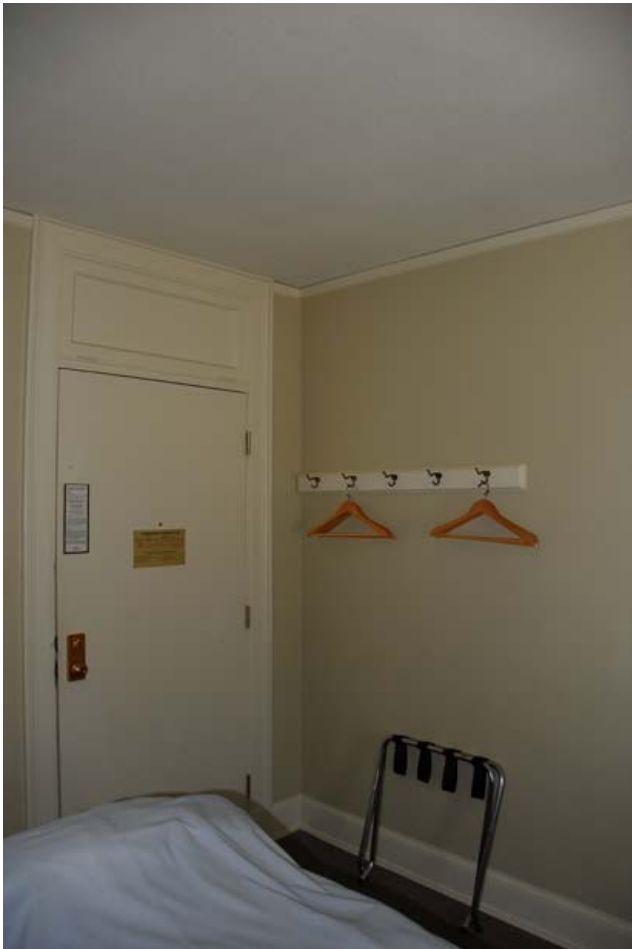
Figure 77: Looking west at Room 115, which does not have a bathroom and is typical of several rooms in the wing. Note the sink in the corner of the room. The room is generally in good condition with some wear around the doorways.

- Figure 77: Looking west at room 115 which does not have a bathroom and is typical of several rooms in the wing. Note the sink in the corner of the room. The room is generally in good condition with some wear around the doorways.

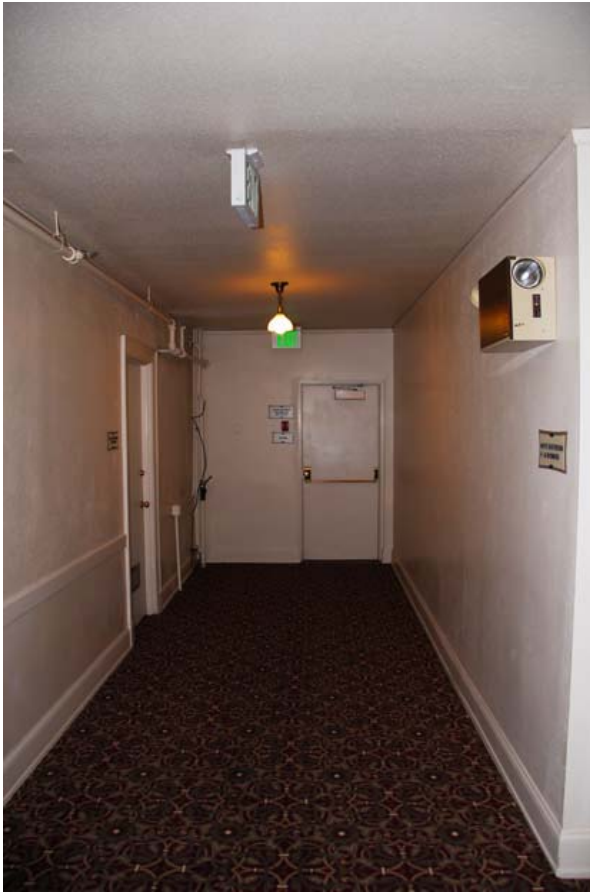
Figure 80: Looking west at the area to the men's bathroom and exit corridor. Note the modified chair rail and exposed fire suppression and detection systems.

- Figure 80: Looking west at the area to the men's bathroom and exit corridor. Note the modified chair rail and exposed fire suppression and detection systems.

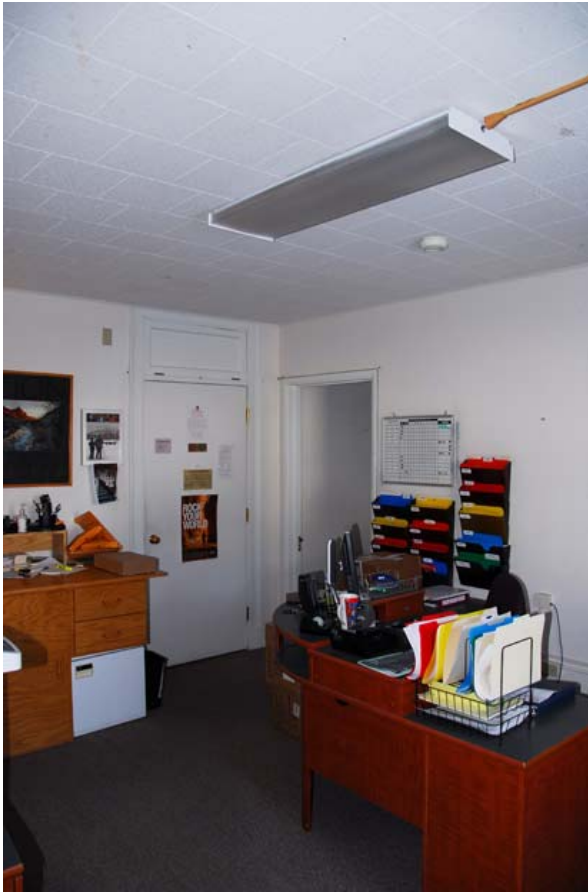
Figure 88: Looking south at some of the original wood paneled doors and trim in the office space. They are in good condition.

- Figure 87: Looking north at the office space.
- Figure 88: Looking south at some of the original wood paneled doors and trim in the office space. They are in good condition.

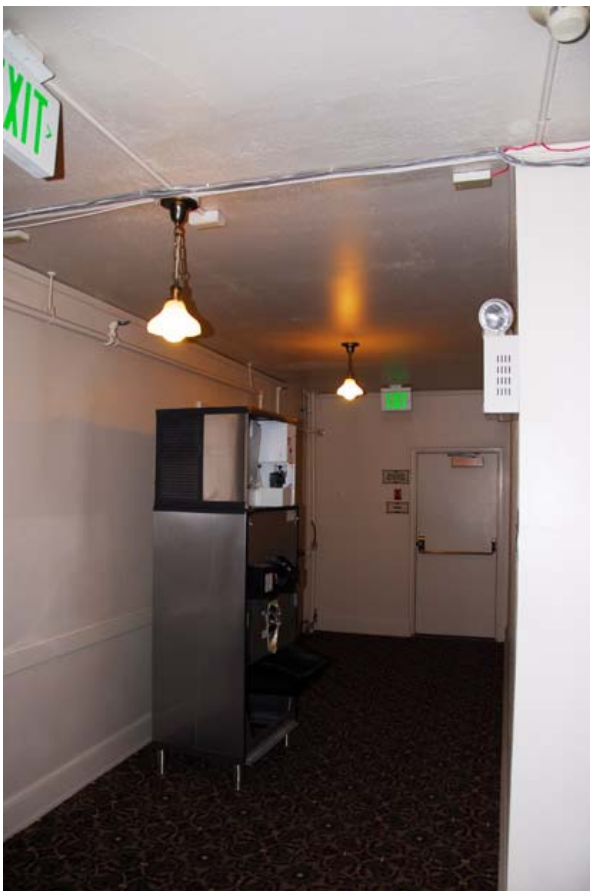
Figure 91: Looking west at the entrance to the women's bathroom in the corridor. The spaces have been remodeled and are in good condition.

- Figure 91: Looking west at the entrance to the women's bathroom in the corridor. The spaces have been remodeled and are in good condition.
- Figure 92: Looking west at the exit in the middle of the guest wing. Note the vending machine and exposed systems.

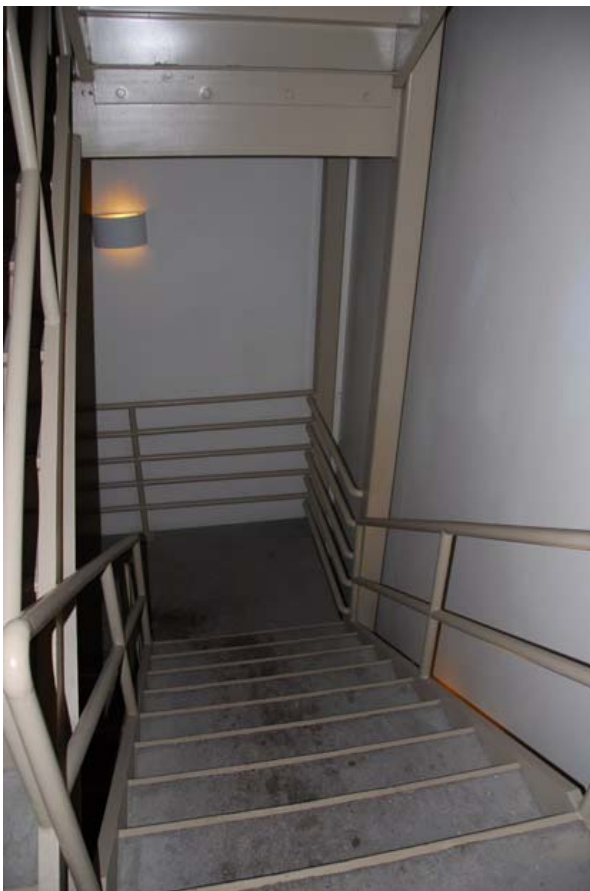
Figure 93: Looking west at the exit stair from the upper floors. These stairs are quite stark and uninviting, even though they are also used as an entrance to the wing.

- Figure 93: Looking west at the exit stair from the upper floors. These stairs are pretty stark and not very inviting even though they are also used as an entrance to the wing.

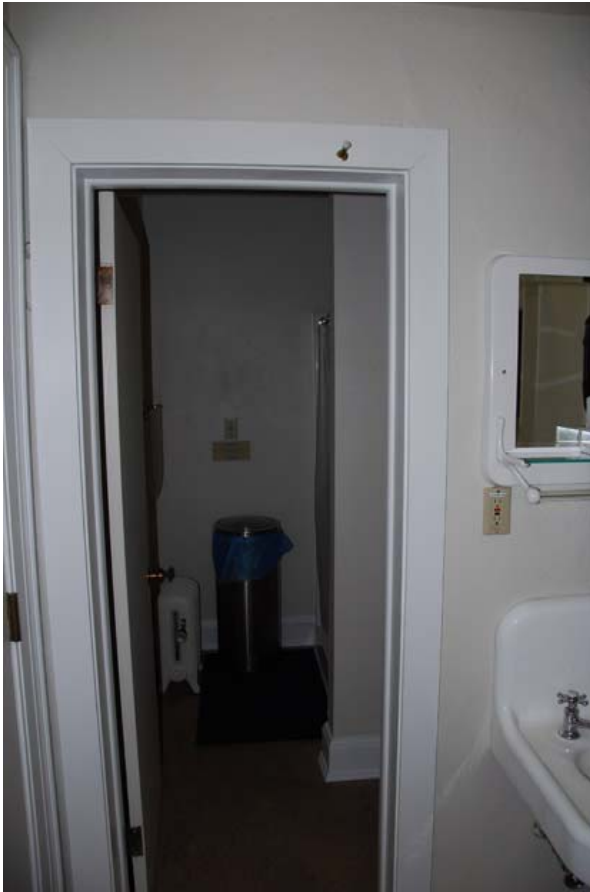
Figure 96: Looking west at the toilets and toilet stalls in the men's bathroom. The area around the window is exposed to moisture from condensation in the winter months.

- Figure 94: Looking west at the stair down to the exit from the second floor.
- Figure 95: Looking south at the entrance to the men's bathroom.
- Figure 96: Looking west at the toilets and toilet stalls in the men's bathroom. The area around the window is exposed to moisture from condensation in the winter months.

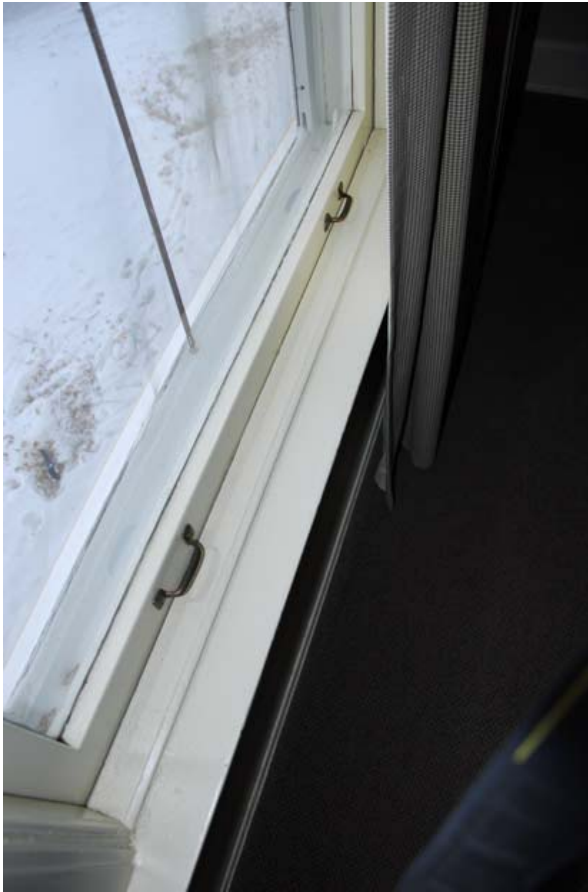
Figure 102: Looking east at the window and wall surfaces. The window is in fair to poor condition with the aluminum storm window on the outside.

- Figure 102: Looking east at the window and wall surfaces. The window is in fair to poor condition with the aluminum storm window on the outside.
- Figure 103: Looking at the base of a typical window. The sill is rotted in many places along with the bottom sash. The widow does not fit well within the frame and in some cases the sash can't close properly.

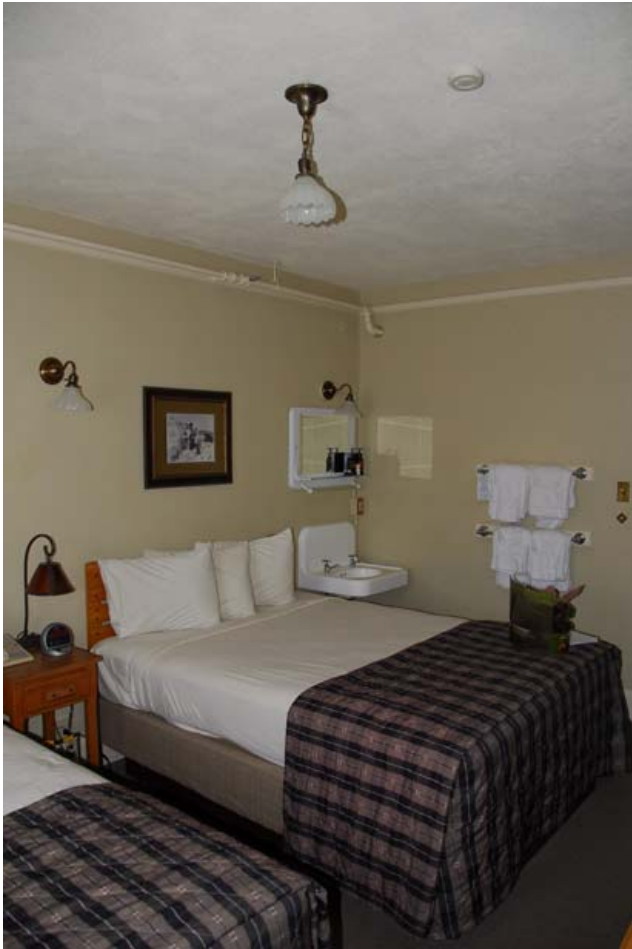
Figure 106: Looking southeast at the room. The room is generally in good condition. Note the historic light fixtures.

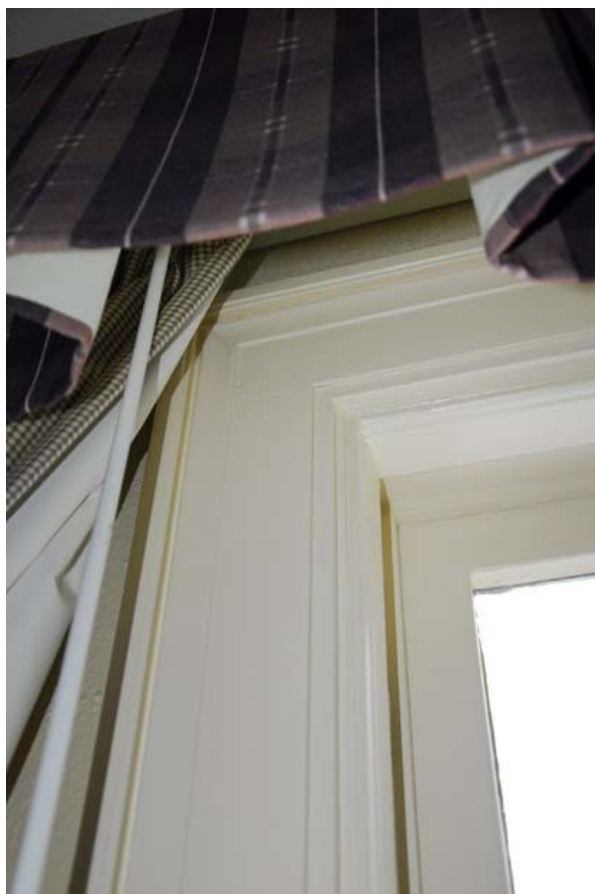
Figure 115: Looking at the trim at the head.

- Figure 115: Looking at the trim at the head.
- Figure 116: Looking at the trim along the jamb.
- Figure 117: Looking west at the sink area and access to the toilet room for women at the center of the third floor corridor. The spaces have been cleaned up with new paint and flooring.

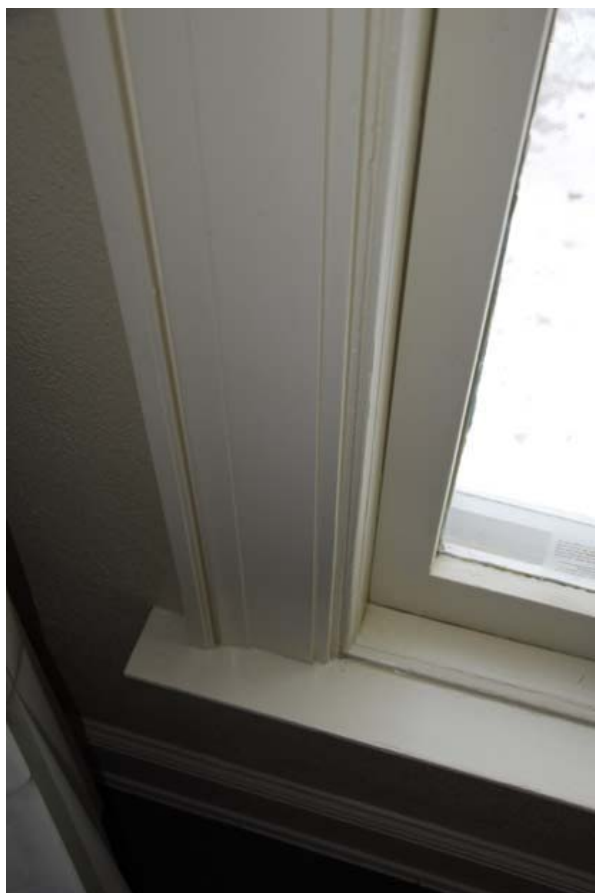
Figure 116: Looking at the trim along the jamb.

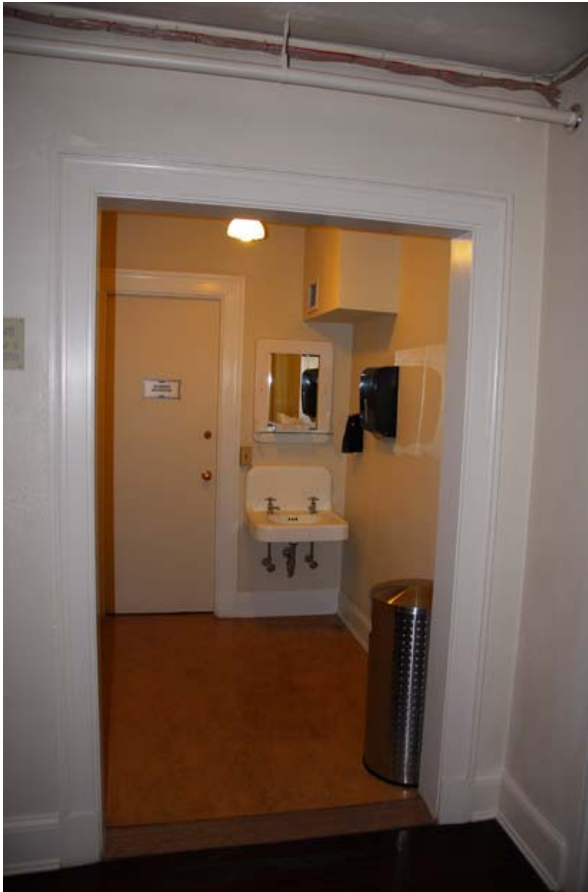
Figure 117: Looking west at the sink area and access to the toilet room for women at the center of the third floor corridor. The spaces have been cleaned up with new paint and flooring.

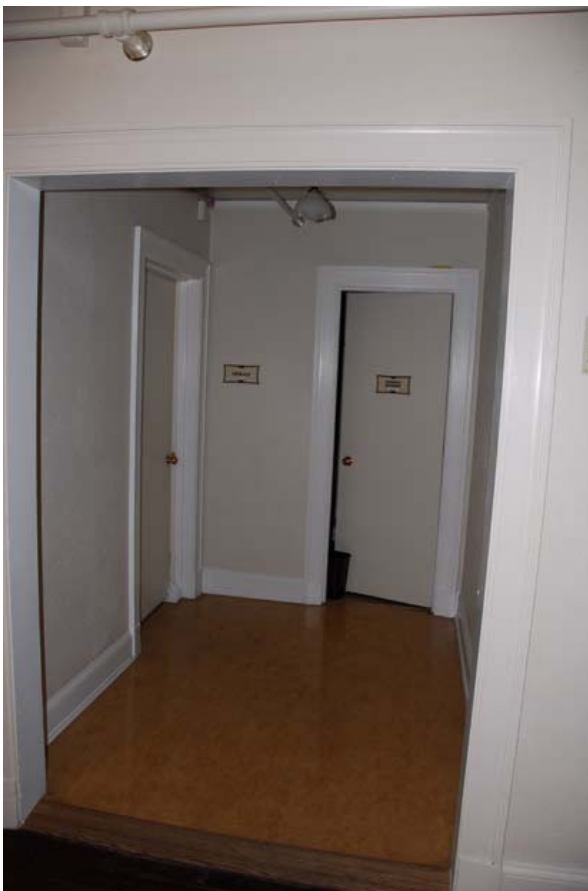
Figure 118: Looking west at the entrance to the women's showers along the third floor corridor. The showers have been remodeled and are generally in good condition.

- Figure 118: Looking west at the entrance to the women's showers along the third floor corridor. The showers have been remodeled and are generally in good condition.

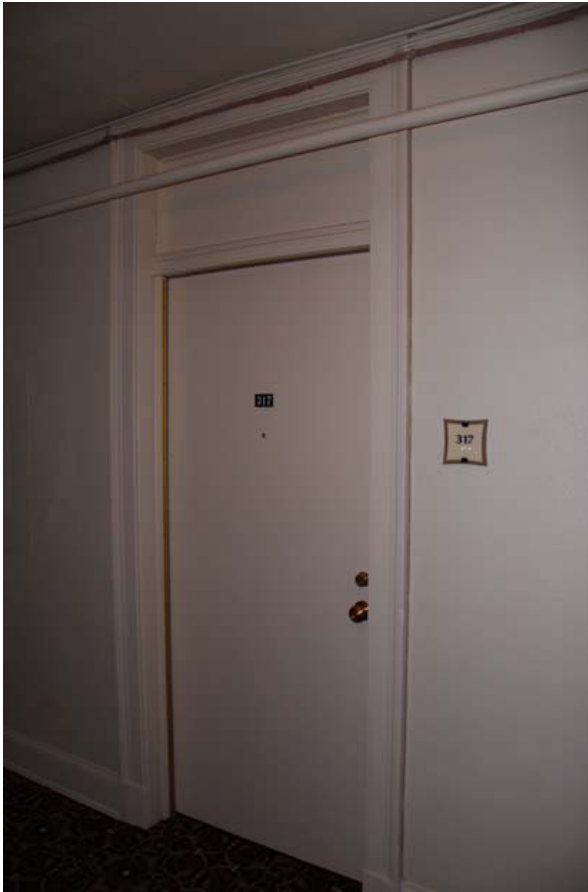
Figure 119: Looking northeast at the entrance door to Room 317. This room has an original bathroom in a larger room.

- Figure 119: Looking northeast at the entrance door to room 317. This room has an original bathroom in a larger room.
- Figure 120: Looking southeast at the room. Similar materials exist in all of the rooms and they have been well maintained.

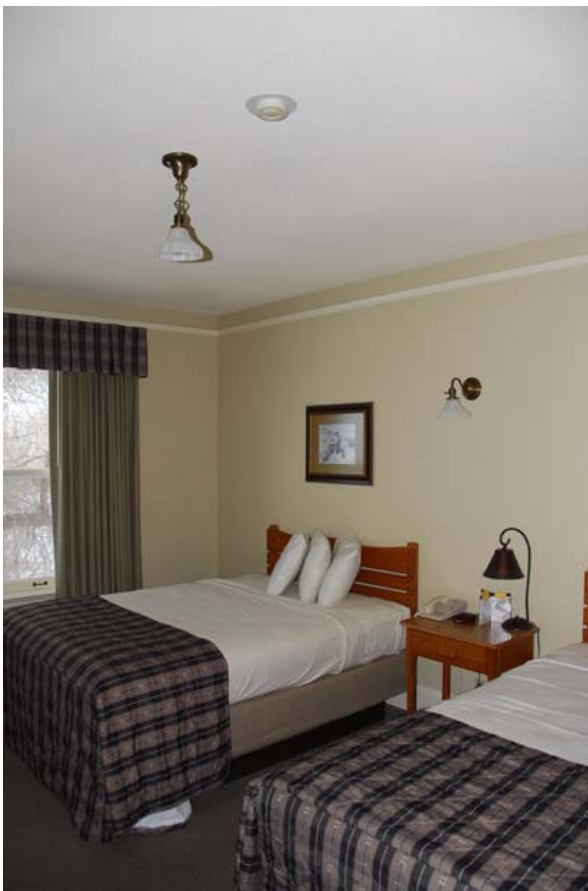
Figure 120: Looking southeast at the room. Similar materials exist in all of the rooms and they have been well maintained.

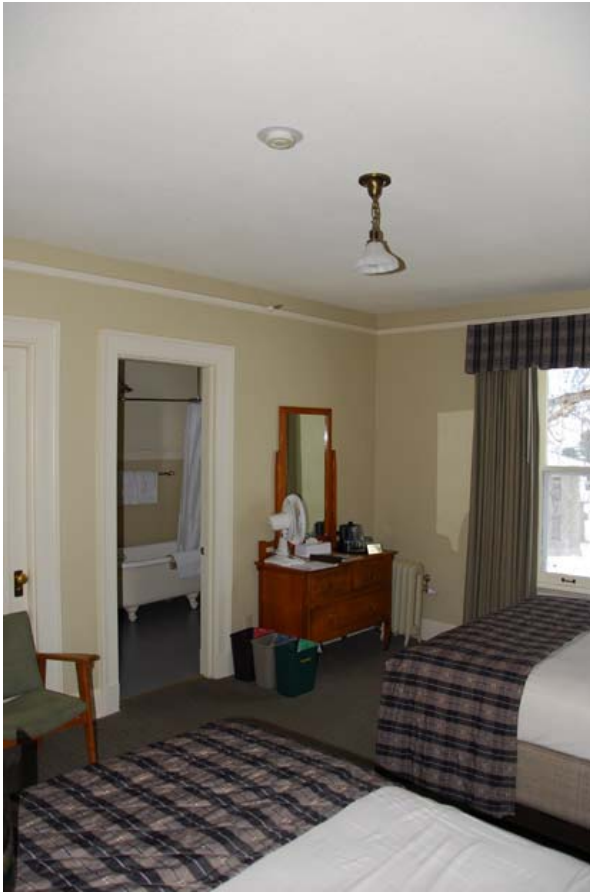
Figure 121: Looking northeast at the room. Note the entrance to the bathroom and small cast-iron radiator in the corner. The upper floors tend to be cold during the fall and winter seasons.

- Figure 121: Looking northeast at the room. Note the entrance to the bathroom and small cast-iron radiator in the corner. The upper floors tend to be cold during the fall and winter season.

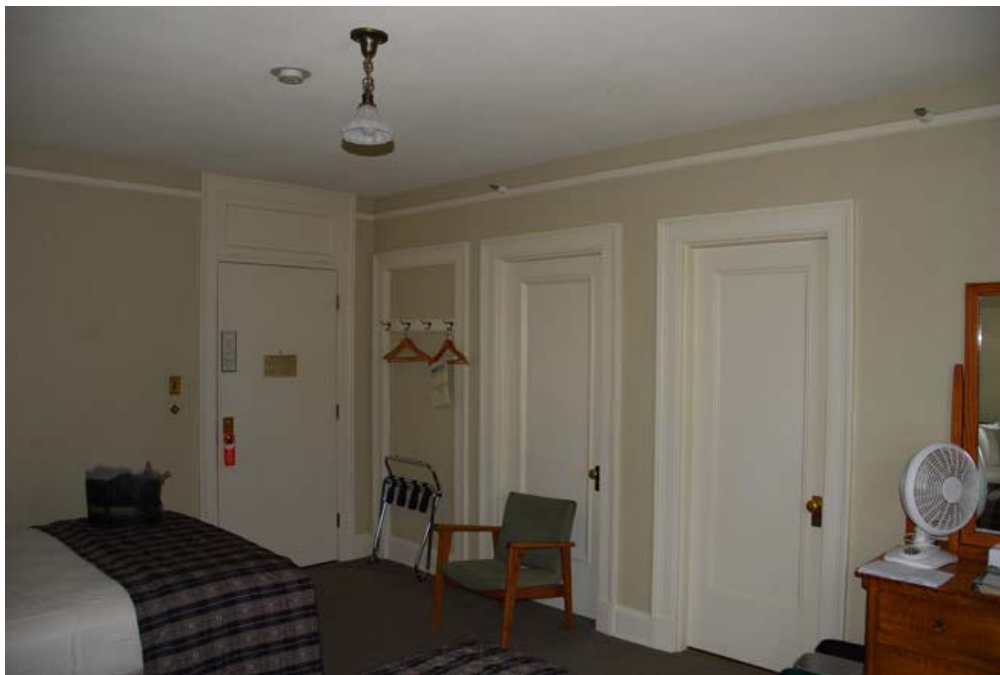
Figure 122: Looking northwest at the room entrance door and other doors. The first infilled door space has a shower behind it in the next room. The closet door and bathroom door are original to the space. They are in good condition.

- Figure 122: Looking northwest at the room entrance door and other doors. The first infilled door space has a shower behind it in the next room. The closet door and bathroom door are original to the space. They are in good condition.

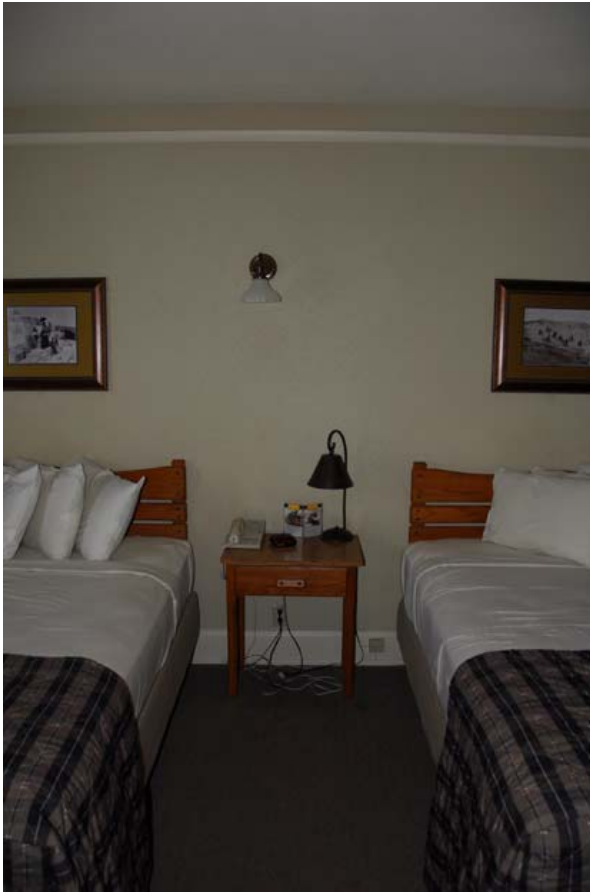
Figure 123: Looking south at the electrical in the center of the room. The electrical is minimal in the room and therefore, many things are plugged into a single circuit.

- Figure 123: Looking south at the electrical in the center of the room. The electrical is minimal in the room and therefore many things are plugged into a single circuit.

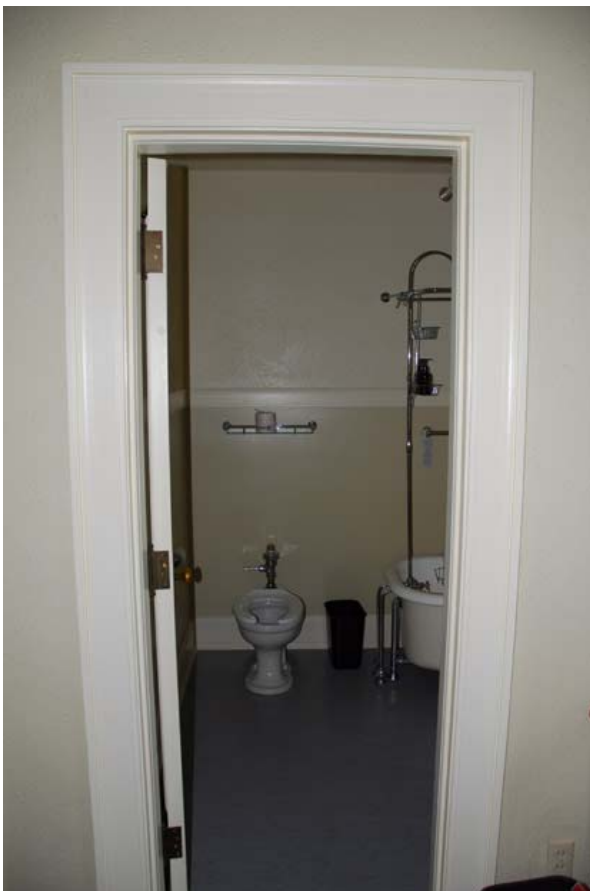
Figure 124: Looking north at the toilet in the bathroom.

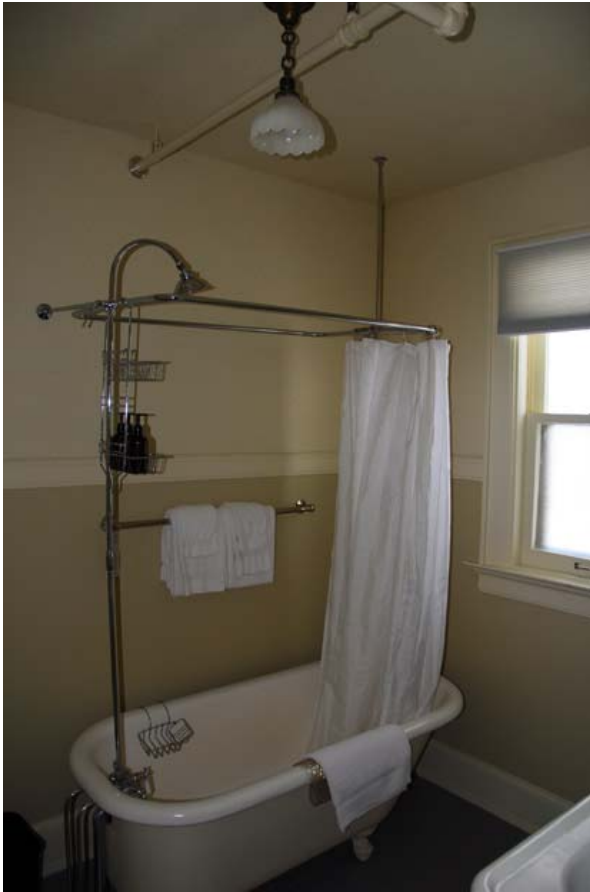
Figure 125: Looking northeast at the claw foot tub, which is original. The tub has been modified for showers.

- Figure 124: Looking north at the toilet in the bathroom.
- Figure 125: Looking northeast at the claw foot tub which is original. The tub has been modified for showers.

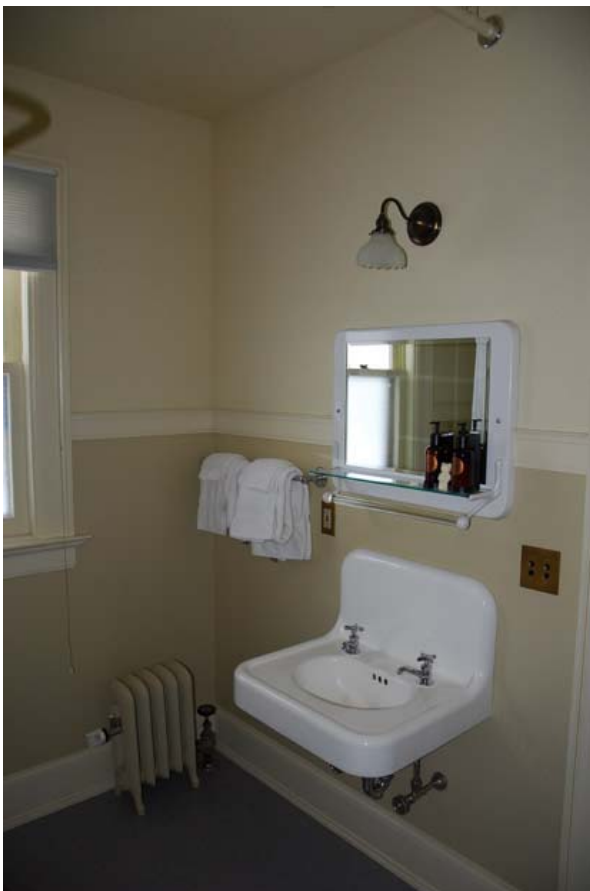
Figure 126: Looking southeast at the lavatory, which appears to be original to the 1938 remodel.
