MAMMOTH HOT SPRINGS HOTEL

Historic Structures Report

Yellowstone National Park

March, 2015

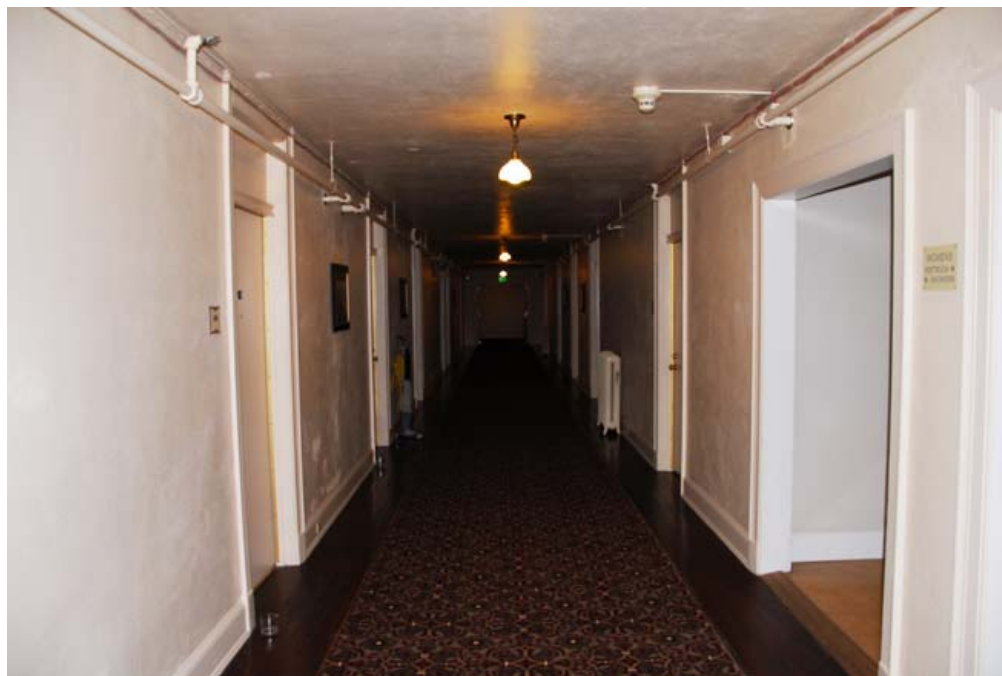
Figure 128: Looking south at the third floor corridor from the center of the wing. The women's bathroom is in the opening to the right. The historic ceiling fixtures exist throughout.

- Figure 128: Looking south at the third floor corridor from the center of the wing. The women's bathroom is in the opening to the right. The historic ceiling fixtures exist throughout.

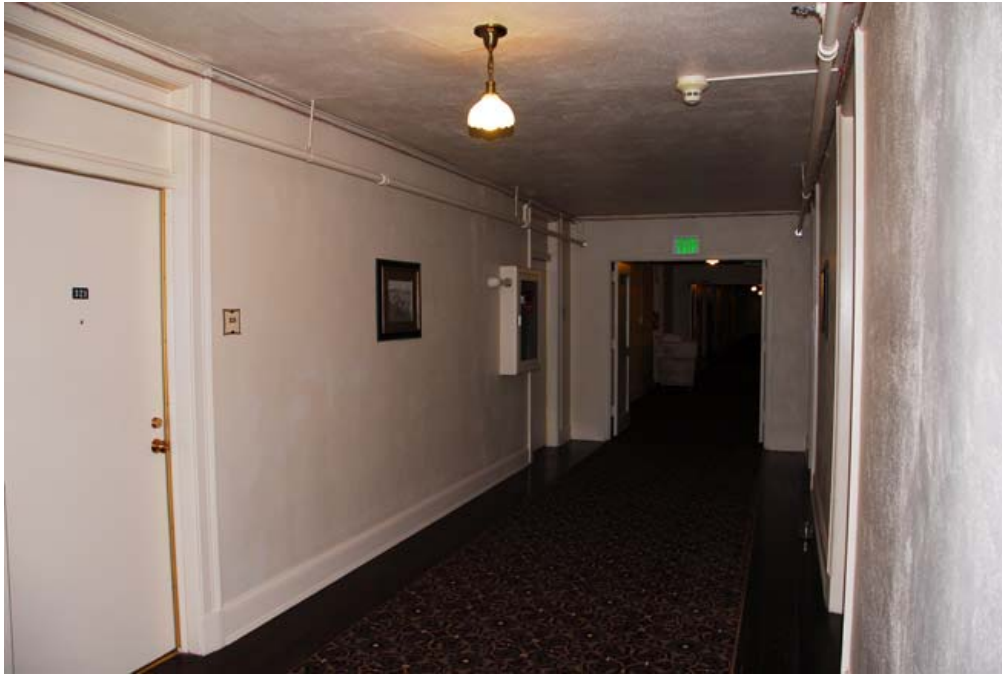
Figure 129: Looking south at the fire doors in the center of the third floor wing. Note the fire extinguisher cabinet next to the door opening.

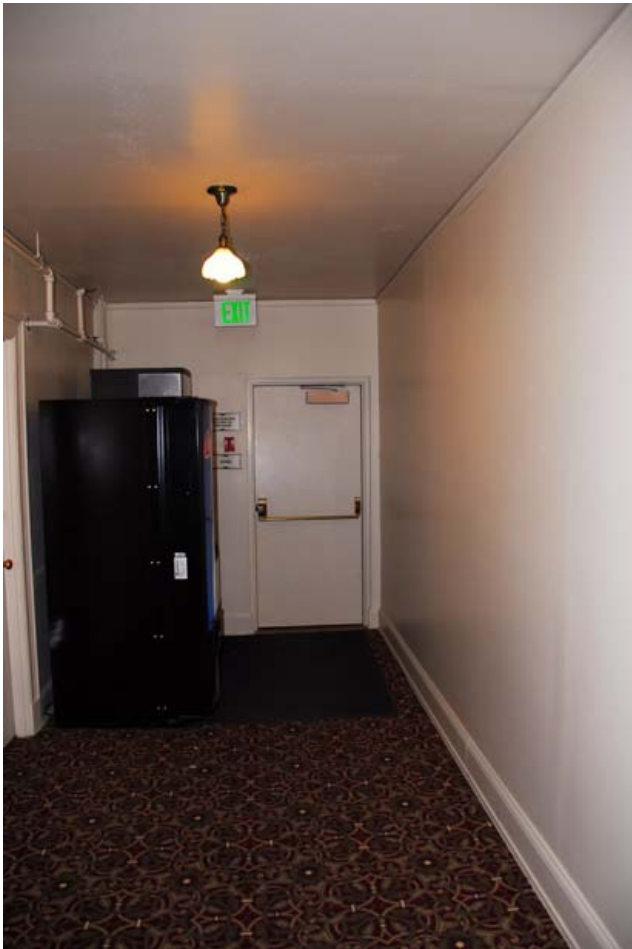
Figure 130: Looking west at the central exit from the floor. The men's bathroom is to the left, as well as the vending machine area.

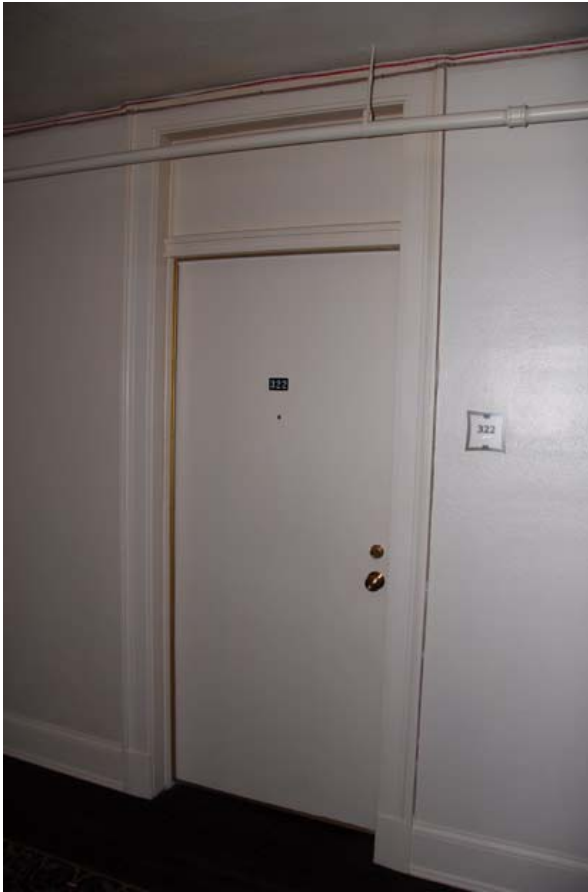
Figure 131: Looking southwest at a typical room door on Room 322.

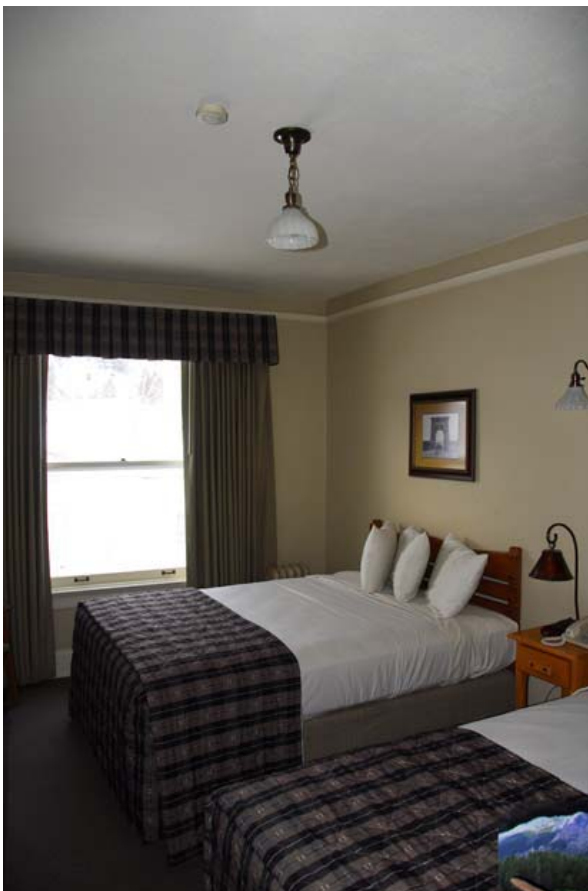
Figure 132: Looking northwest at the room. Again everything is typical with the exception that this room has an original bathroom that has been modified with a shower.

- Figure 131: Looking southwest at a typical room door on room 322.
- Figure 132: Looking northwest at the room. Again everything is typical with the exception that this room has an original bathroom that has been modified with a shower.

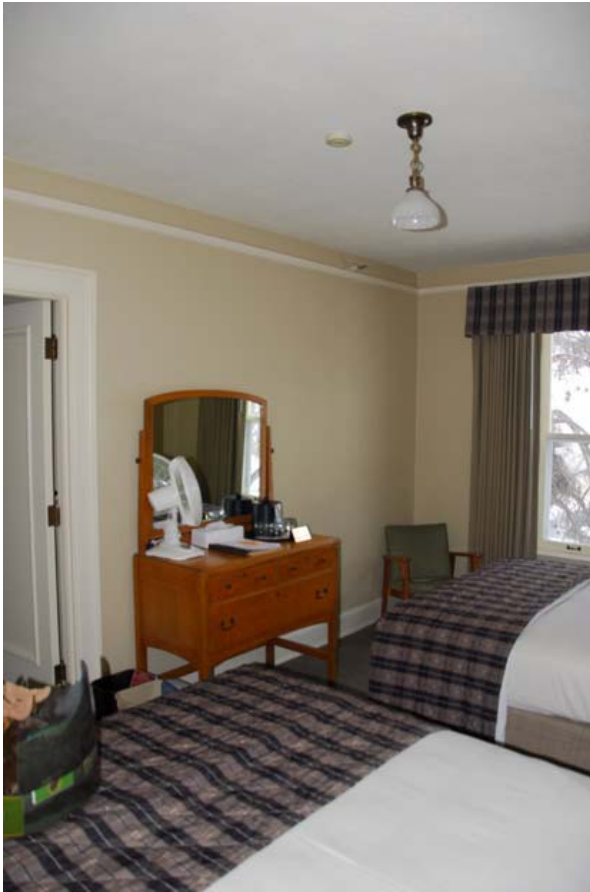
Figure 133: Looking southwest at the room. Note the historic ceiling fixture.

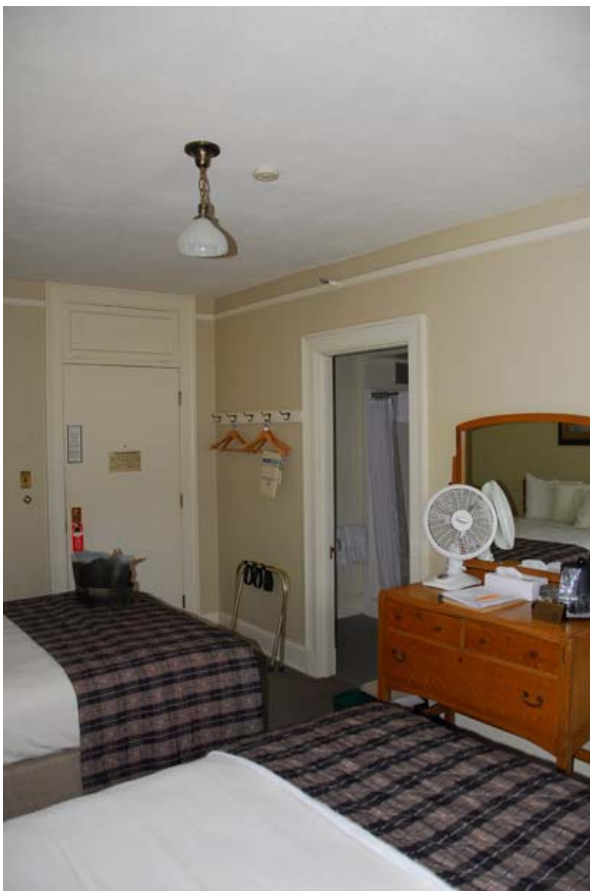
Figure 134: Looking southeast at the entrance door and the doorway to the bathroom. The door to the bathroom is original to the 1938 period of the hotel.

- Figure 133: Looking southwest at the room. Note the historic ceiling fixture.
- Figure 134: Looking southeast at the entrance door and the doorway to the bathroom. The door to the bathroom is original to the 1937 period of the Hotel.

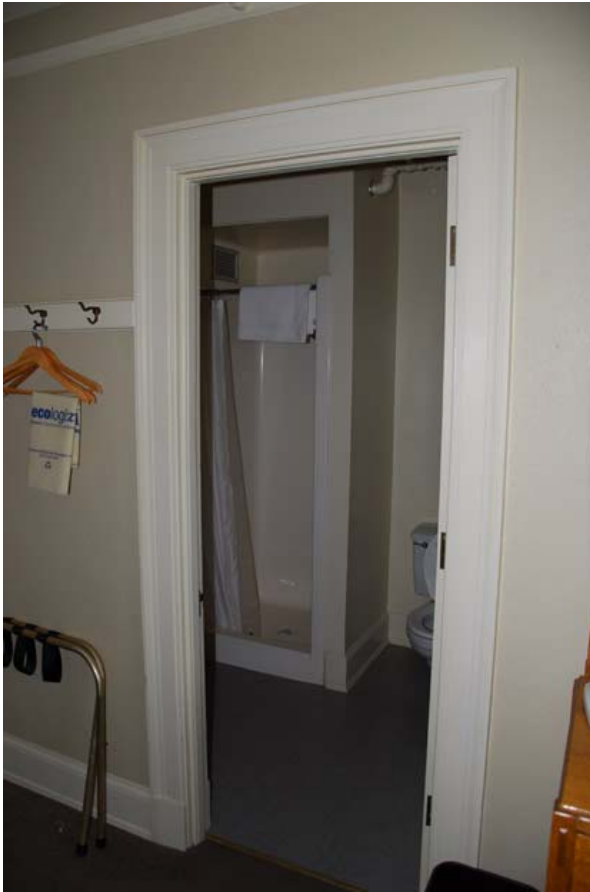
Figure 135: Looking south into the modified bathroom at the shower. The shower has been updated over the years.

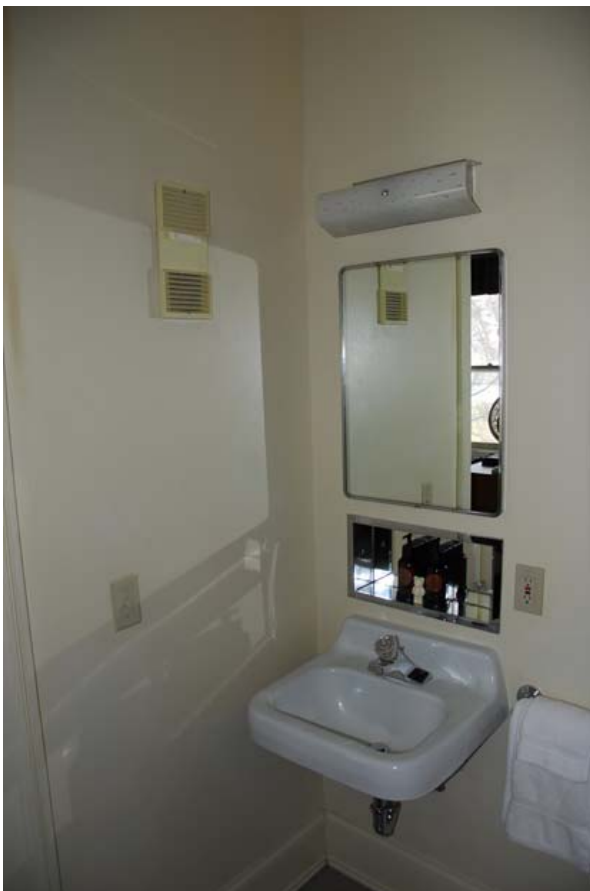
Figure 136: Looking east at mirror, sink, and light fixture that have been changed out over the years and not original to the period.

- Figure 135: Looking south into the modified bathroom at the shower. The shower has been updated over the years.
- Figure 136: Looking east at mirror, sink, and light fixture that have been changed out over the years and not original to the period.

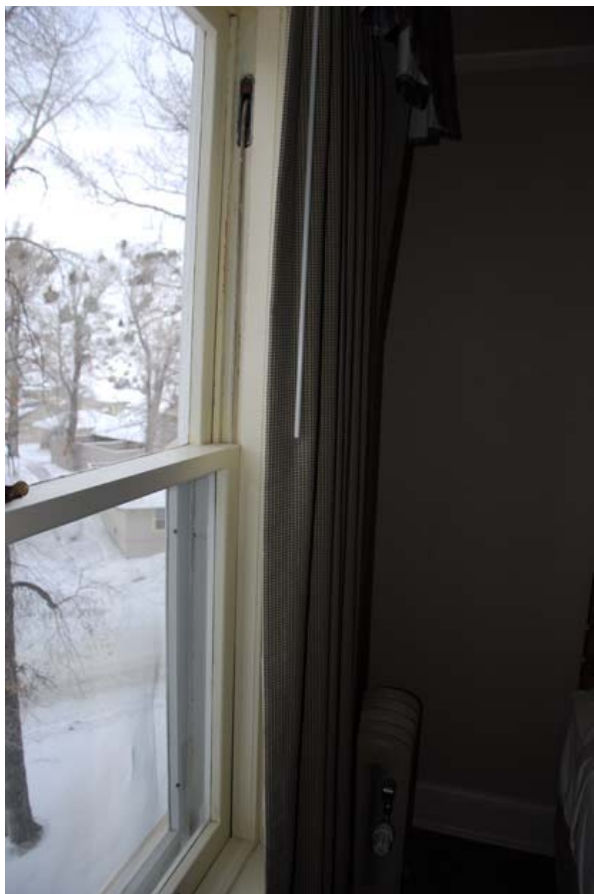
Figure 137: Looking northwest at a detail of a typical window in the wing.

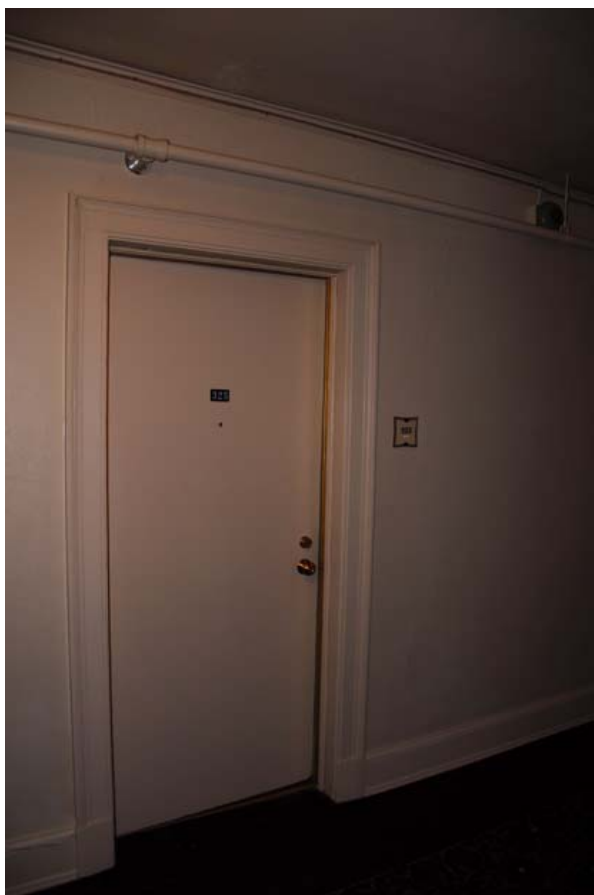
Figure 138: Looking southeast at the entrance door to Room 325. This is a typical room with an added bathroom with a toilet and shower.

- Figure 137: Looking northwest at a detail of a typical window in the wing.
- Figure 138: Looking southeast at the entrance door to room 325. This is a typical room with a added bathroom with a toilet and shower.

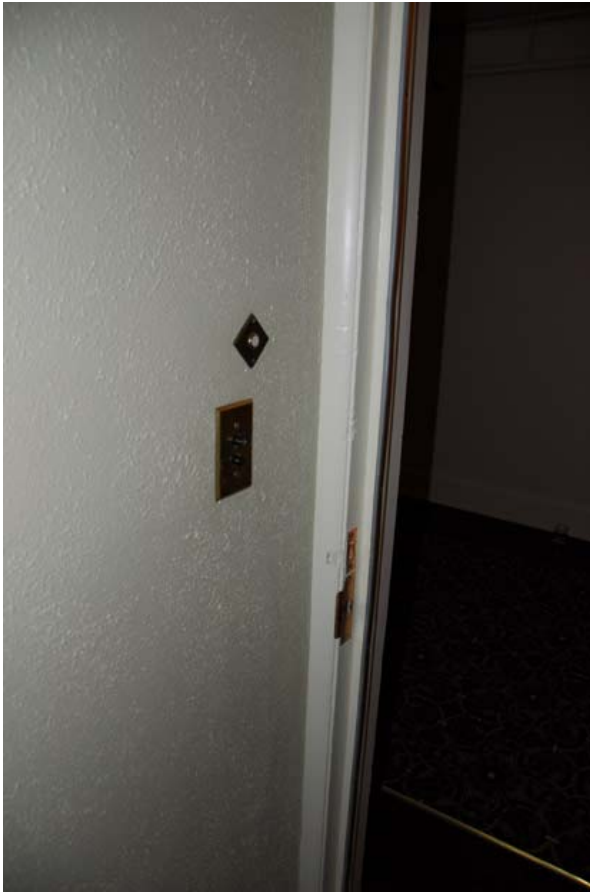
Figure 139: Looking at the door jamb that has been damaged, repaired and damaged again because of the change in locks and damage from abuse.

- Figure 139: Looking at the door jamb that has been damaged, repaired and damaged again because of the change in locks and damage from abuse.
- Figure 140: Looking southeast at the typical room materials and design that are original to the Hotel.

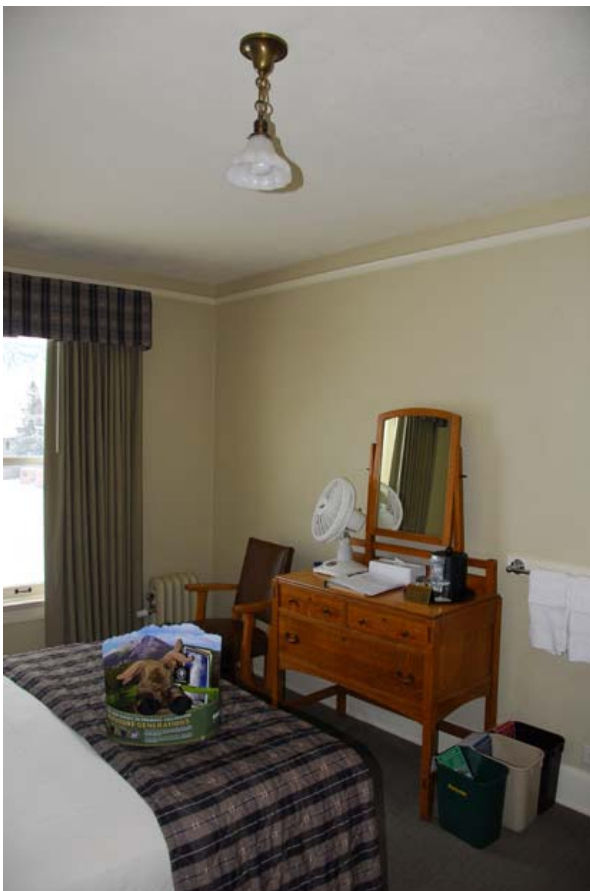
Figure 140: Looking southeast at the typical room materials and design that are original to the hotel.

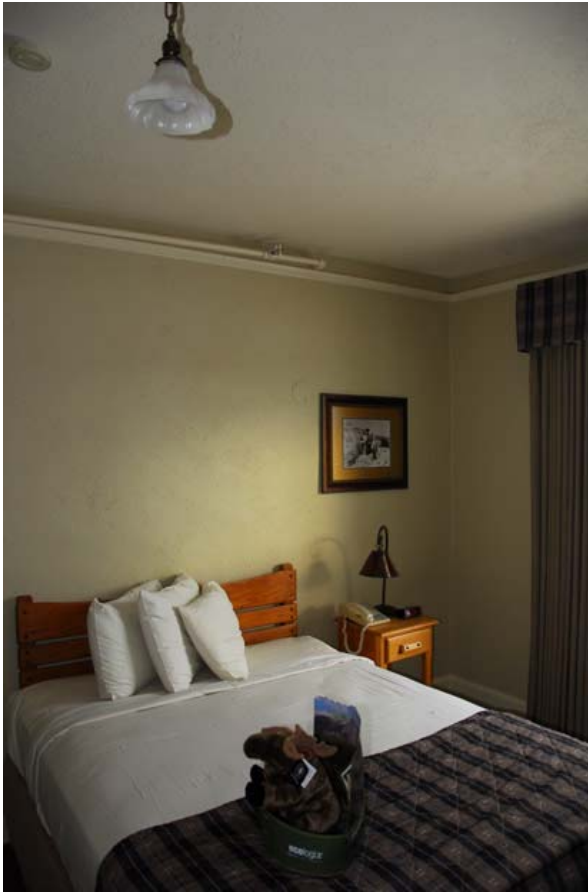
Figure 141: Looking northeast at the room. The room is in good condition and has been well maintained with few exceptions.

- Figure 141: Looking northeast at the room. The room is in good condition and has been well maintained with few exceptions.
- Figure 142: Looking west at the entrance door to the room and the bathroom wall that was extended into the space.

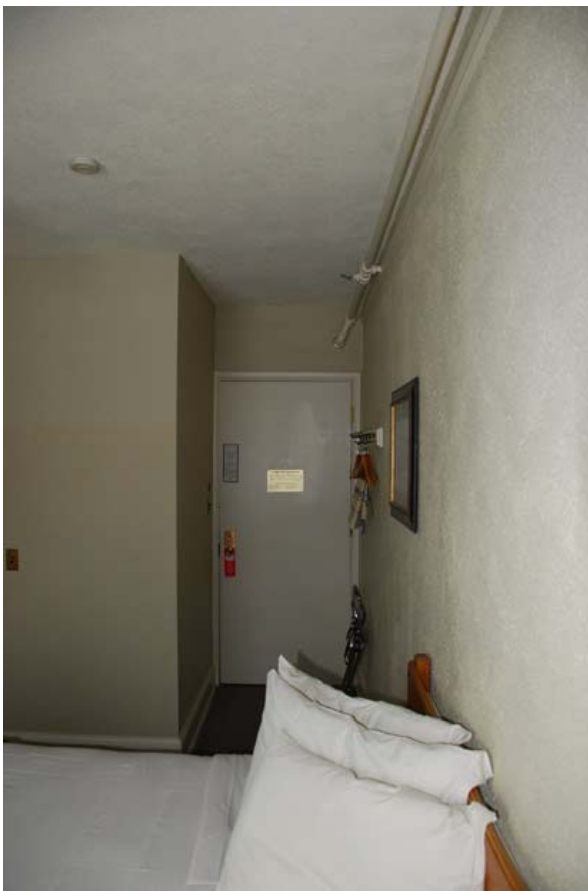
Figure 142: Looking west at the entrance door to the room and the bathroom wall that was extended into the space.

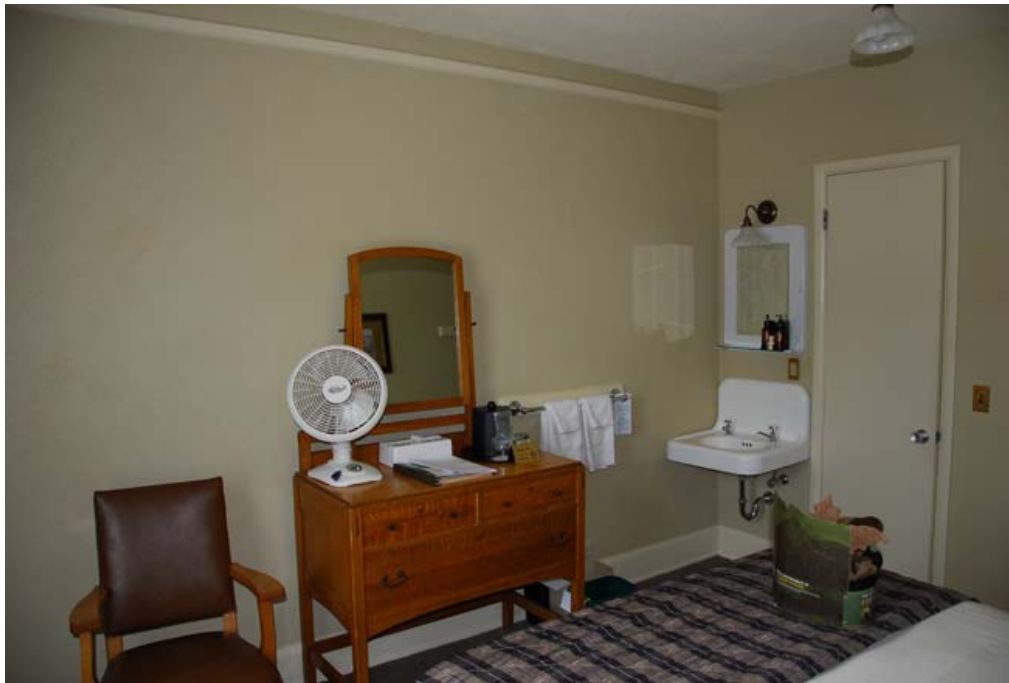
Figure 143: Looking southwest at the sink in the room and the door to the bathroom.

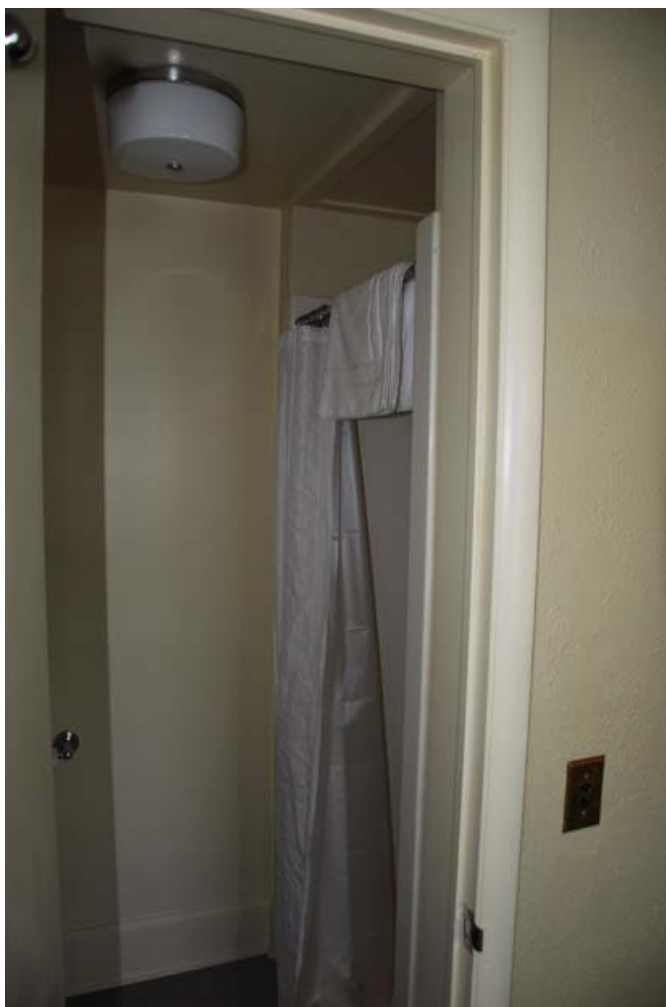
Figure 144: Looking west at the shower in the bathroom. The materials and fixtures are very modest and not necessarily compatible with the room.

- Figure 143: Looking southwest at the sink in the room and the door to the bathroom.
- Figure 144: Looking west at the shower in the bathroom. The materials and fixtures were very modest and not necessarily compatible with the room.

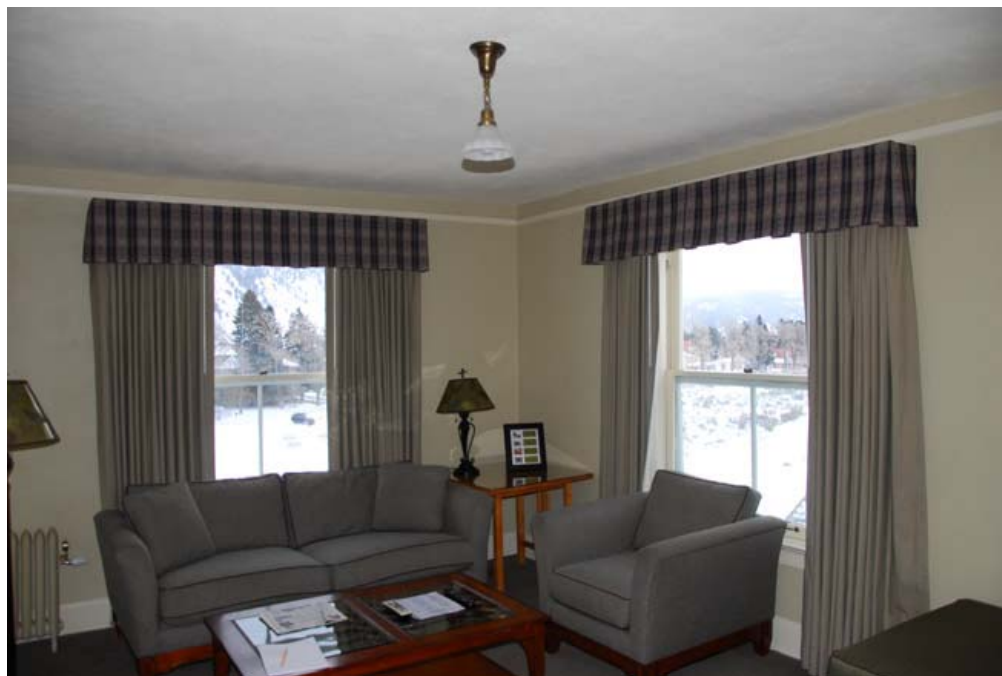
Figure 147: Looking east at the living room in the corner suite. The materials are very similar to other rooms but the suite is larger after it was remodeled from two rooms.

- Figure 146: Looking northeast at the entrance door to the room 401 suite.
- Figure 147: Looking east at the living room in the corner suite. The materials are very similar to other rooms but the suite is larger after it was remodeled from two room.

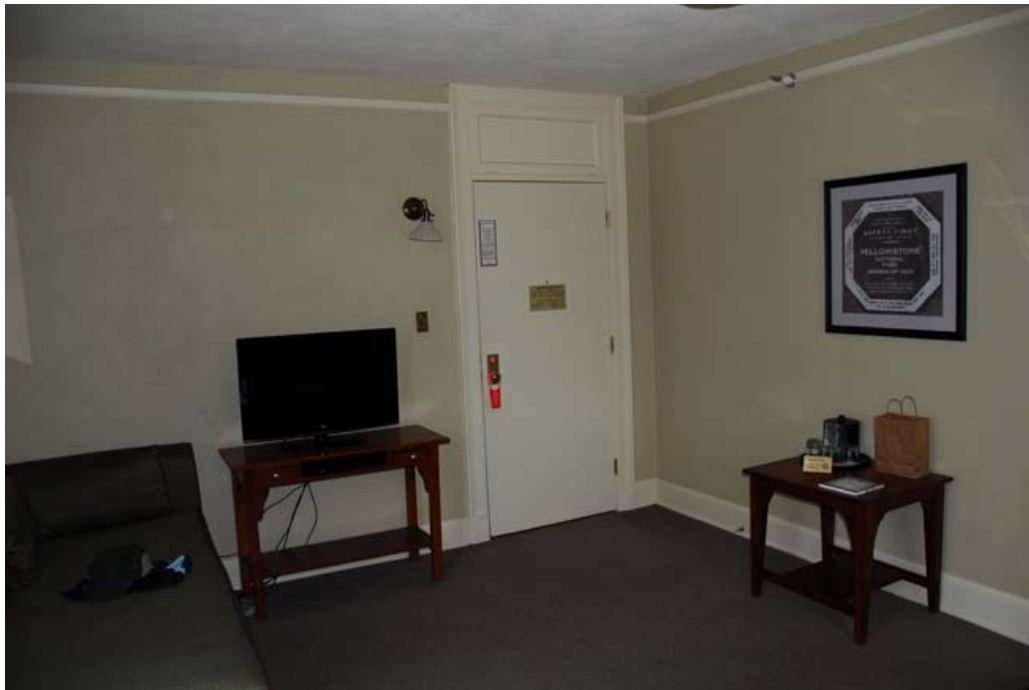
Figure 148: Looking northwest at the entrance door and plaster wall finishes and trim. They are in good condition.

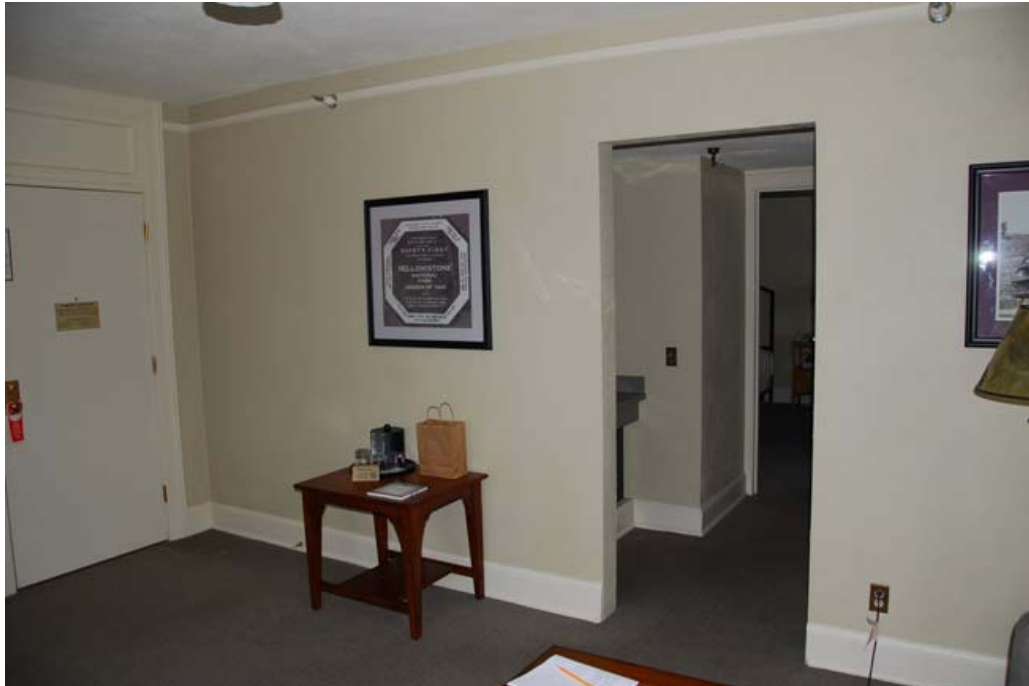
Figure 149: Looking northwest at the corridor from the living room to the bedroom area.

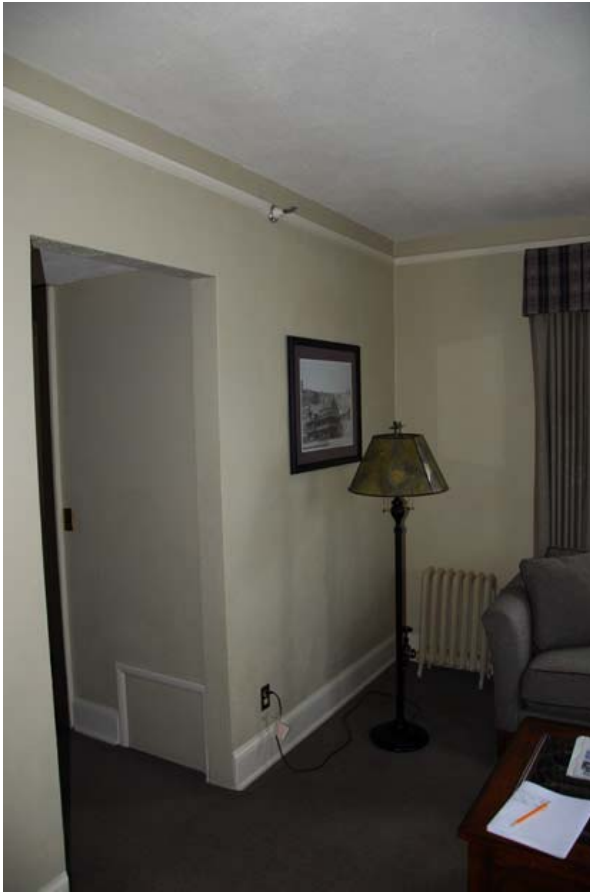
Figure 150: Looking northeast at the small cast iron steam radiator in the corner of the living room space.

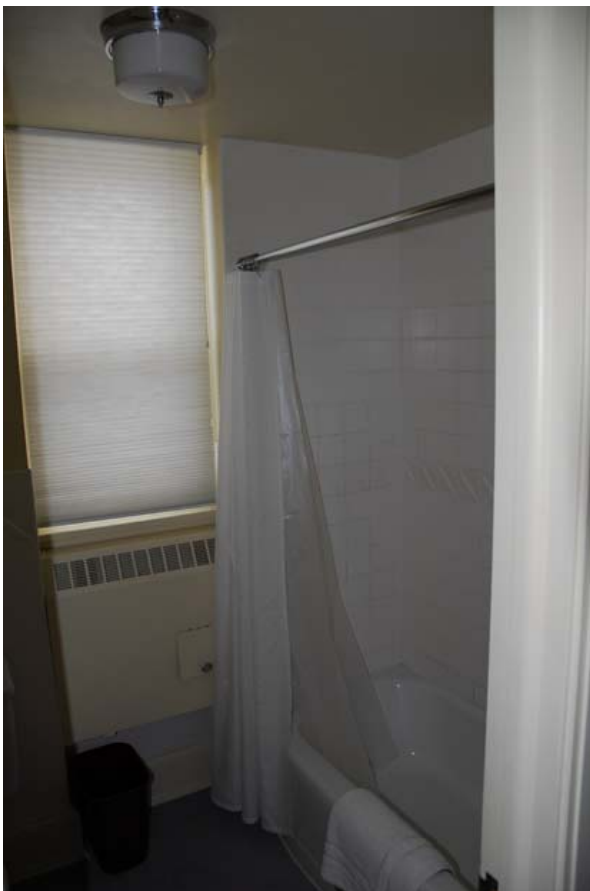
Figure 151: Looking east at the newer shower in the center room of the suite.

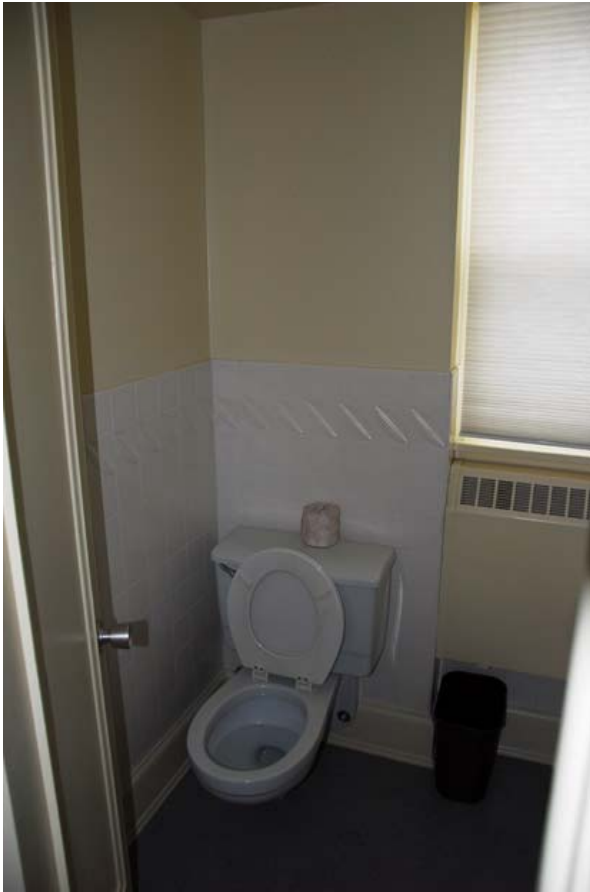
Figure 152: Looking east at the toilet in the shower room.

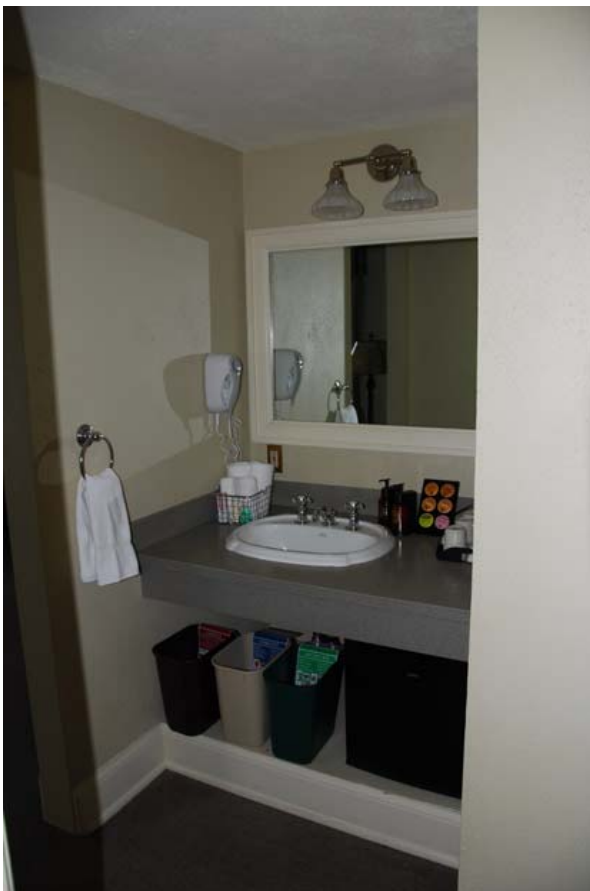
Figure 153: Looking west at the modern vanity and sink in the corridor between the living room and the bedroom.

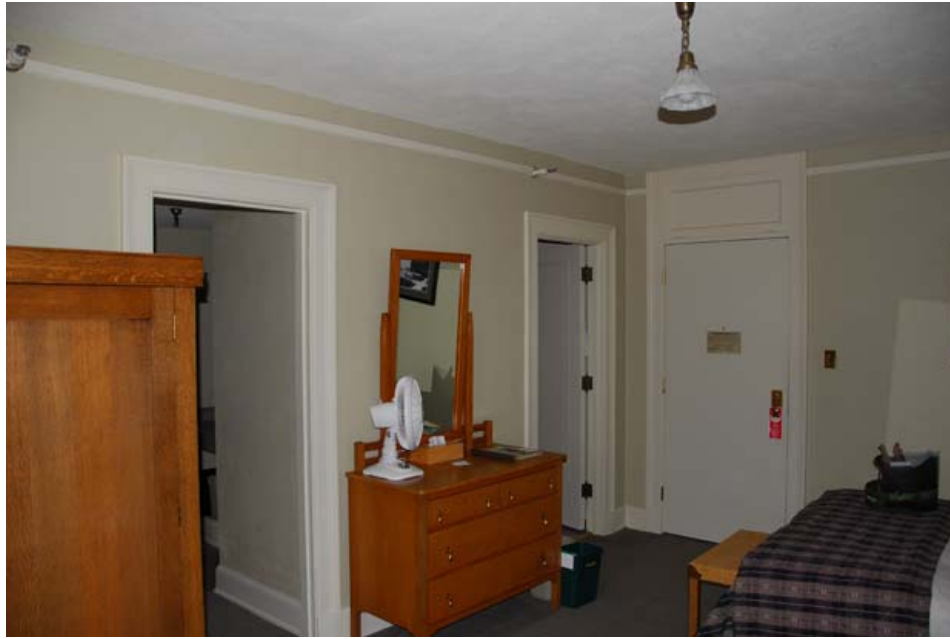
Figure 154: Looking southwest at the corridor opening, the second bathroom door, and another door to the main corridor in the bedroom space. The bathroom door is original to the building.

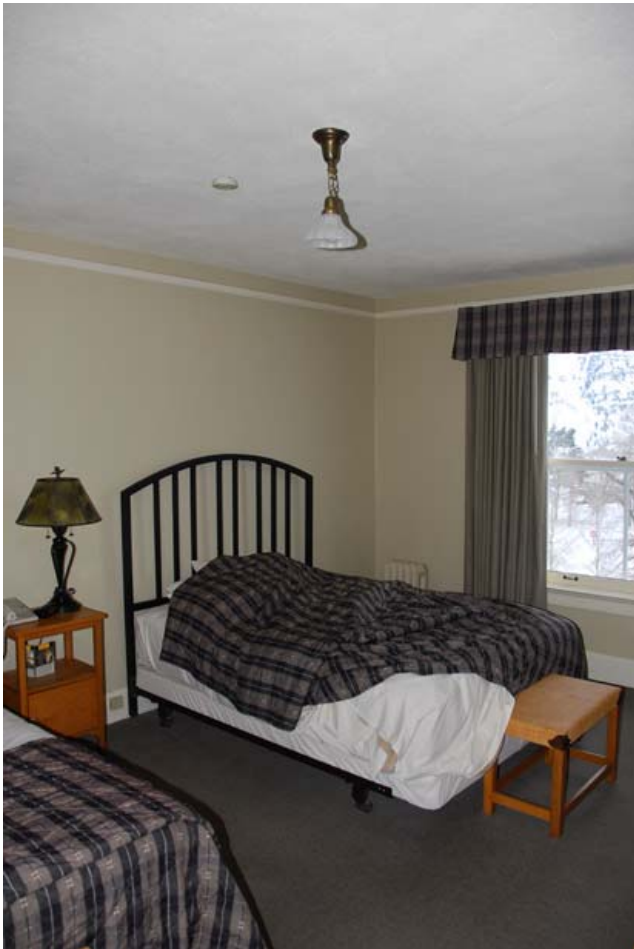
Figure 155: Looking northeast at the bedroom suite. Similar materials including original wood trim.

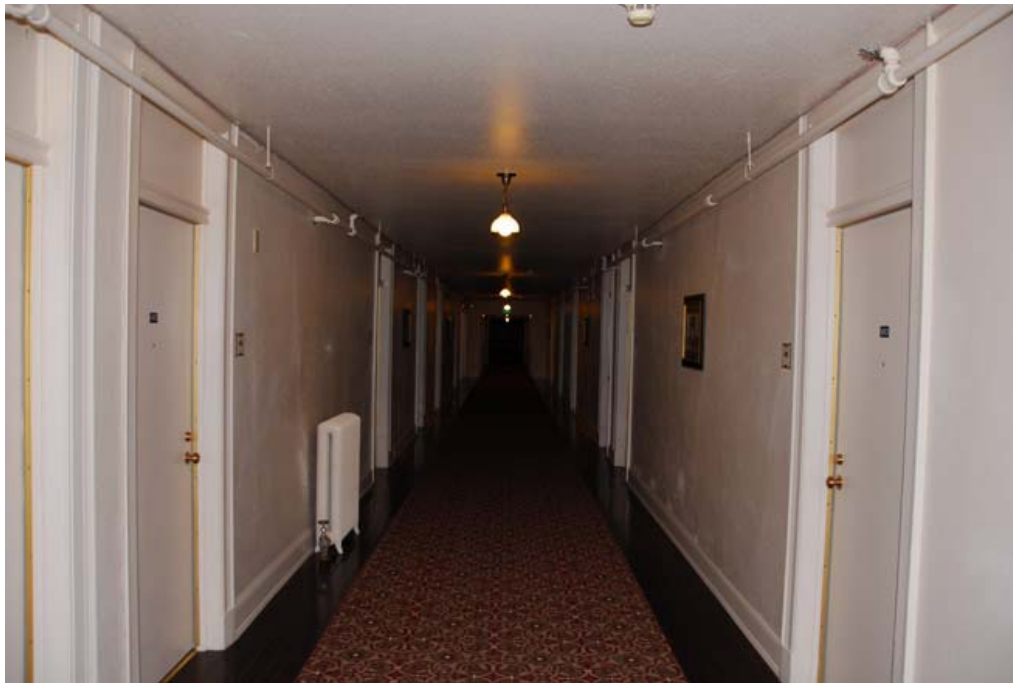
Figure 158: Looking north at the fourth floor corridor similar to the rest of the building.

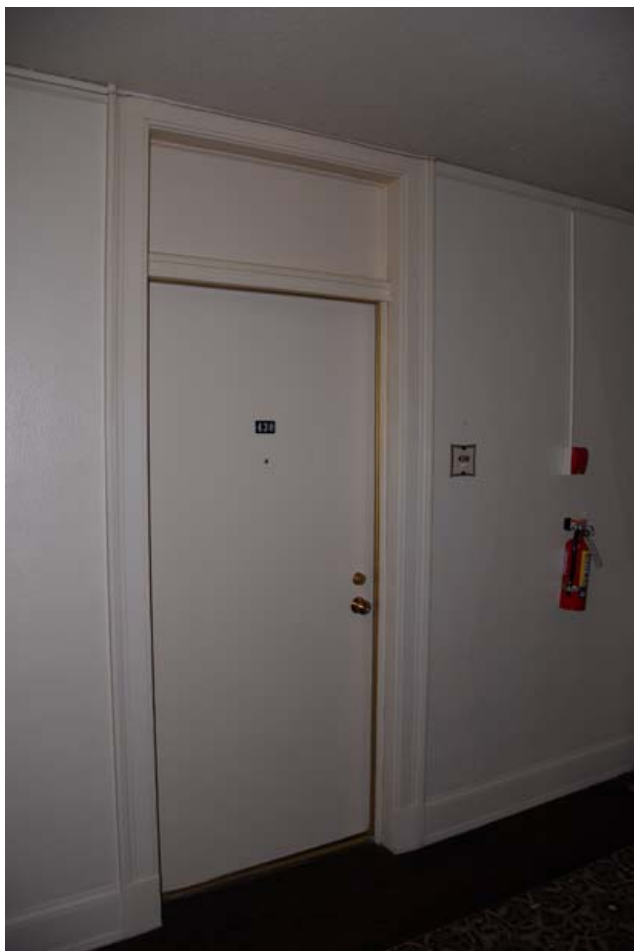
Figure 159: Looking northwest at the entrance door to Room 430, a corner room with an original bathroom.

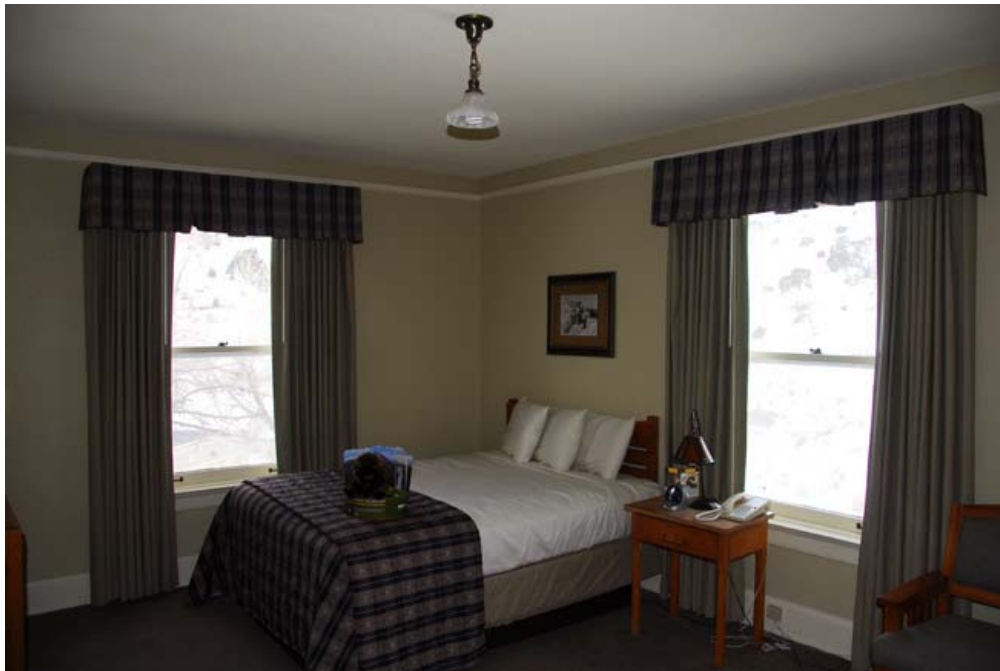
Figure 160: Looking northwest at the room with the corner windows that lets a lot of light into the space but only allows for the bed to be in the corner.

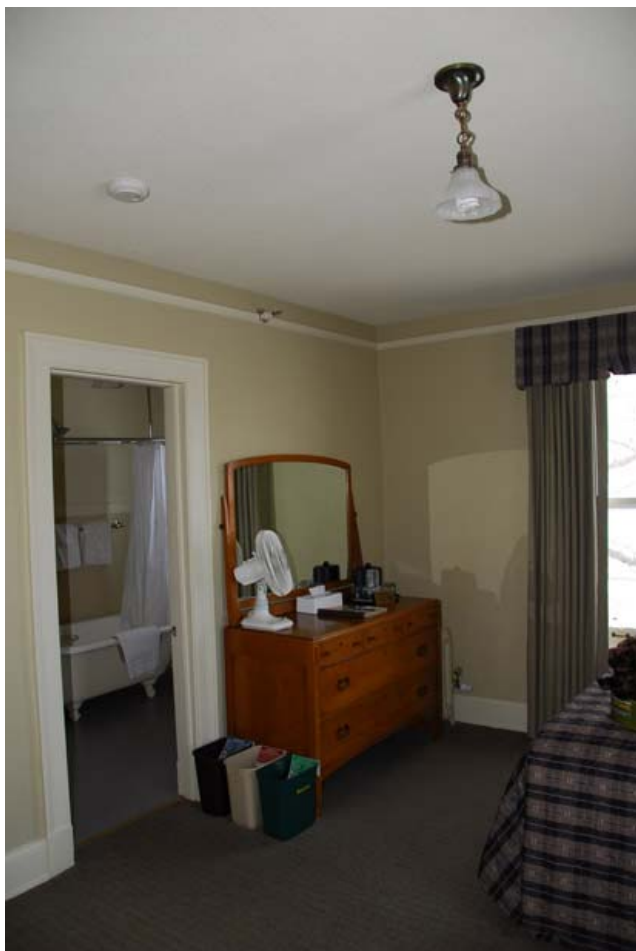
Figure 161: Looking southwest at the bathroom doorway and corner of the room.

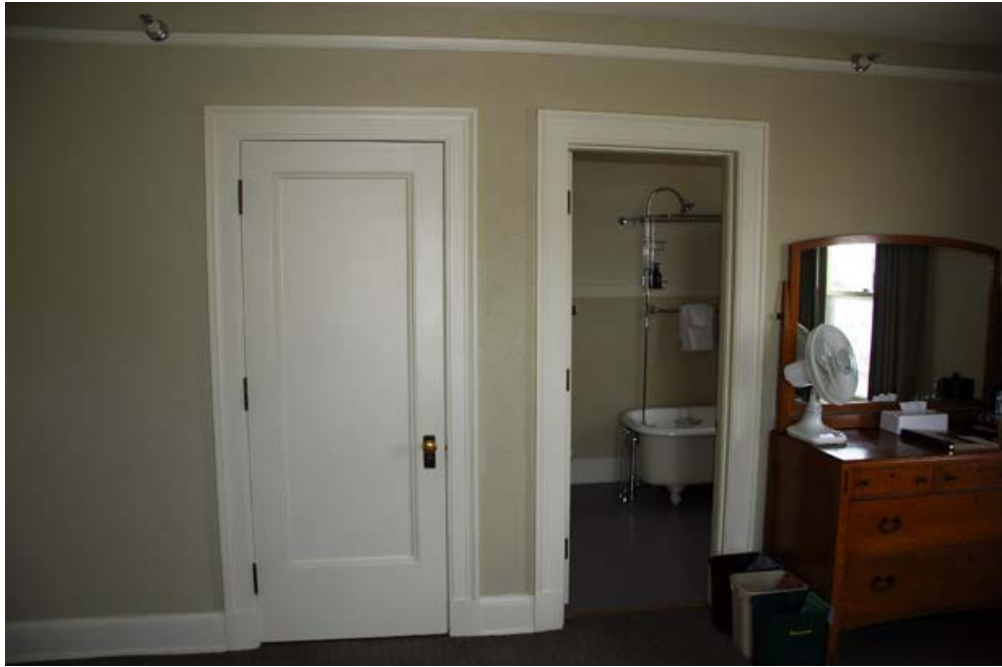
Figure 162: Looking south at the closet door and bathroom doorway. The wood paneled doors are original to the hotel.

- b. Retain the original door openings unless not needed. Replace the wood flush doors with wood paneled doors similar to what remains on the interior.

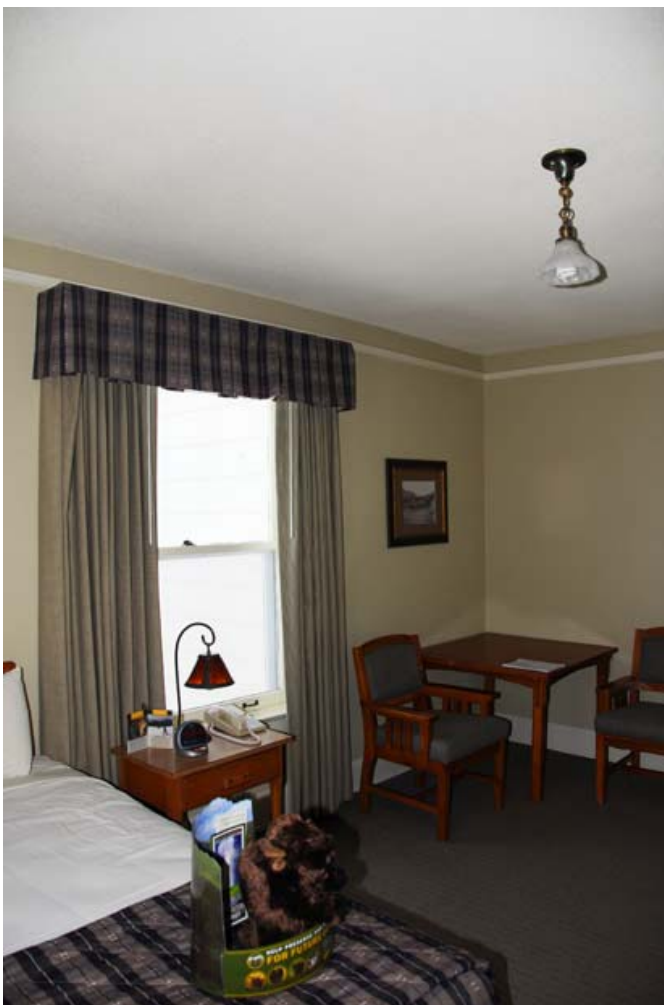
Figure 163: Looking northeast at the room. Lighting of the interior spaces in this room, as well as most rooms, is poor.

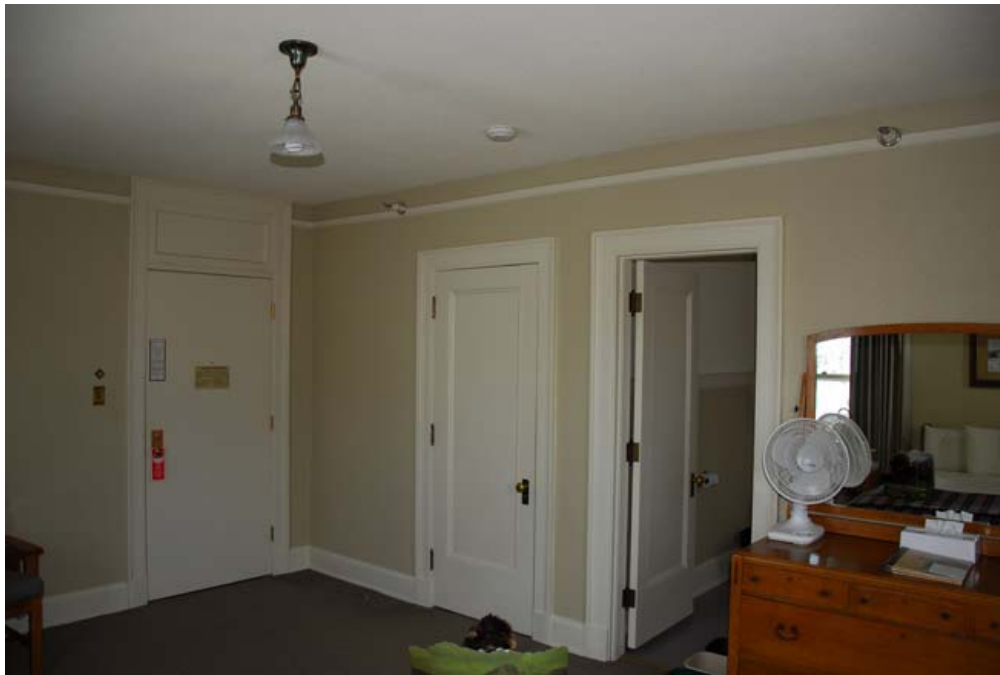
Figure 164: Looking southeast at the entrance door and the other doors on the south wall. Generally the materials are in good condition and have been well maintained.

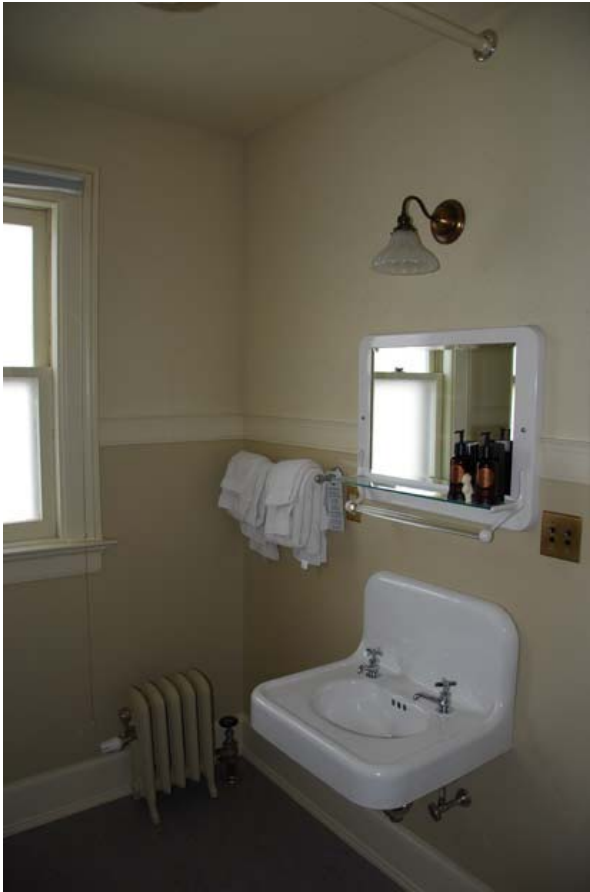
Figure 166: Looking northwest at the original sink, mirror, and light fixture. The fixtures are generally in good condition.

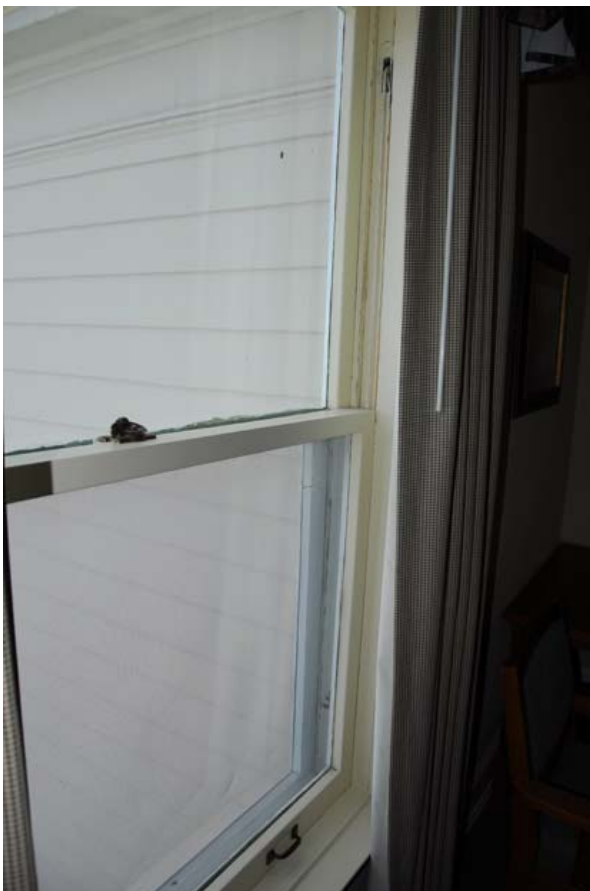
Figure 167: Looking east at a detail of one of the windows. The window is in fair condition. The windows are not very energy efficient.

- The deteriorated wood on the back dock area, as well as the stair and porch areas, need to be replaced as they are becoming a hazard.
- The windows are in fair condition. The double-hung wood windows should be replaced with energy efficient wood windows that match the existing windows in-kind. The current windows can't be restored with an insulated glass unit without totally rebuilding them. The windows in the Map Room have been restored and insulated low-E glass was installed to cut down on the ultraviolet which was causing problems with deterioration of the Map and mahogany paneling. The large fixed windows in the lobby and gift shop need to be restored for the same purposes.
