MAMMOTH HOT SPRINGS HOTEL

Historic Structures Report

Yellowstone National Park

March, 2015

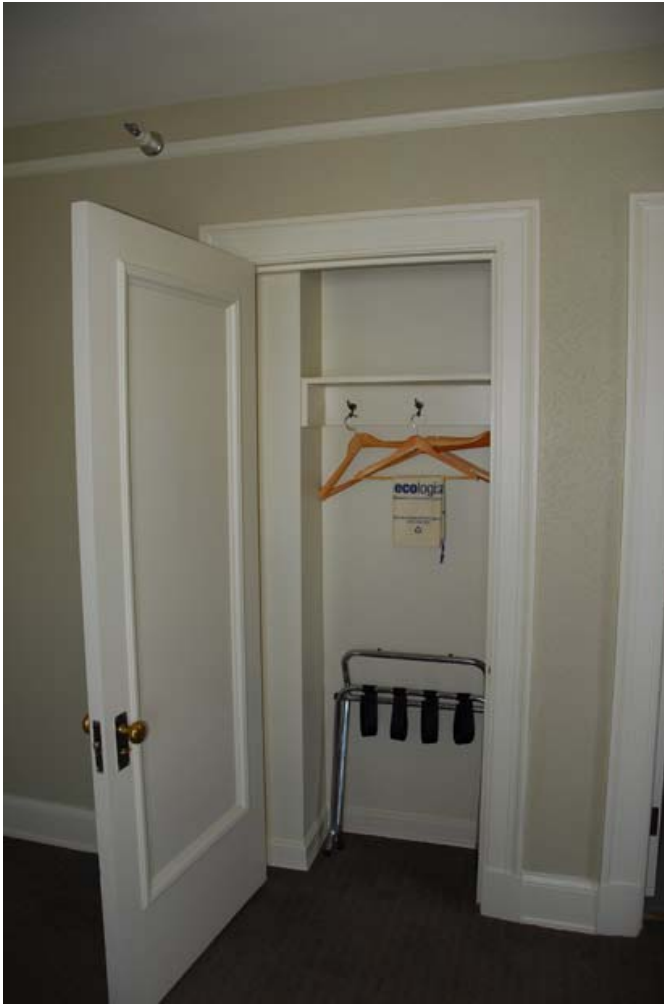
Figure 168: Looking south at the closet in the room.

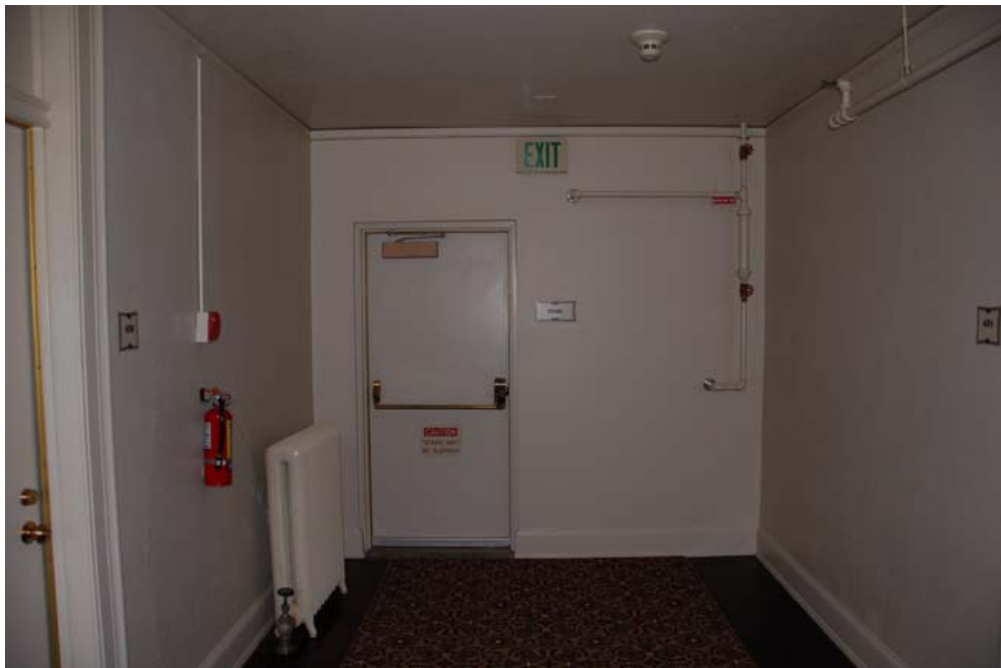
Figure 169: Looking north at the north exit door. This is normally a very dark area at the end of the hall.

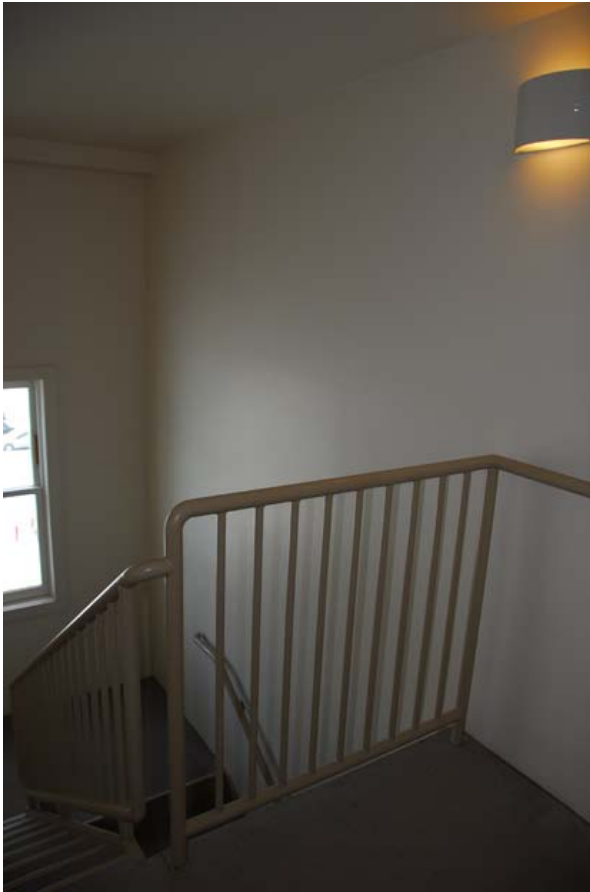
Figure 170: Looking north at the exit stair, railing, and lighting. This stair is in good condition.

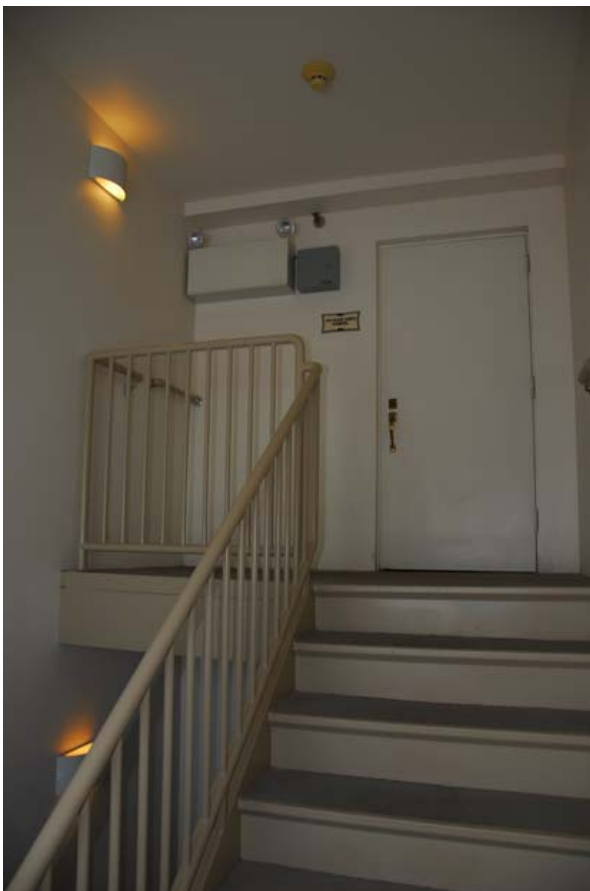
Figure 171: Looking south at the fourth floor landing.

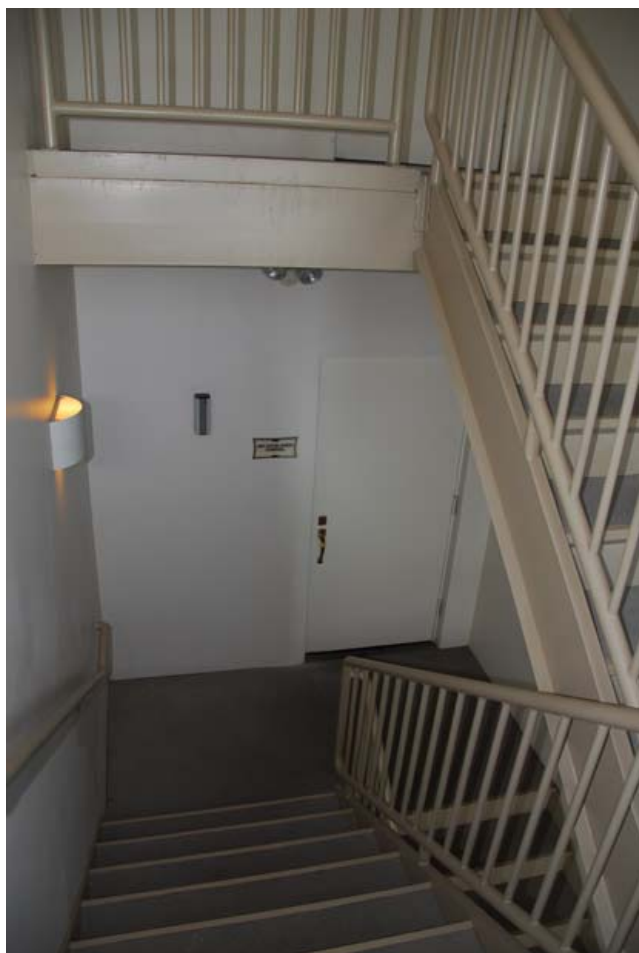
Figure 172: Looking south at the third floor landing.
