**SUMMARY MEMO:**

**ENCHANTED VALLEY CHALET  
SITE FLOOD HAZARDS**

Technical Assistance for **OLYM**.

Date: 4-26-18

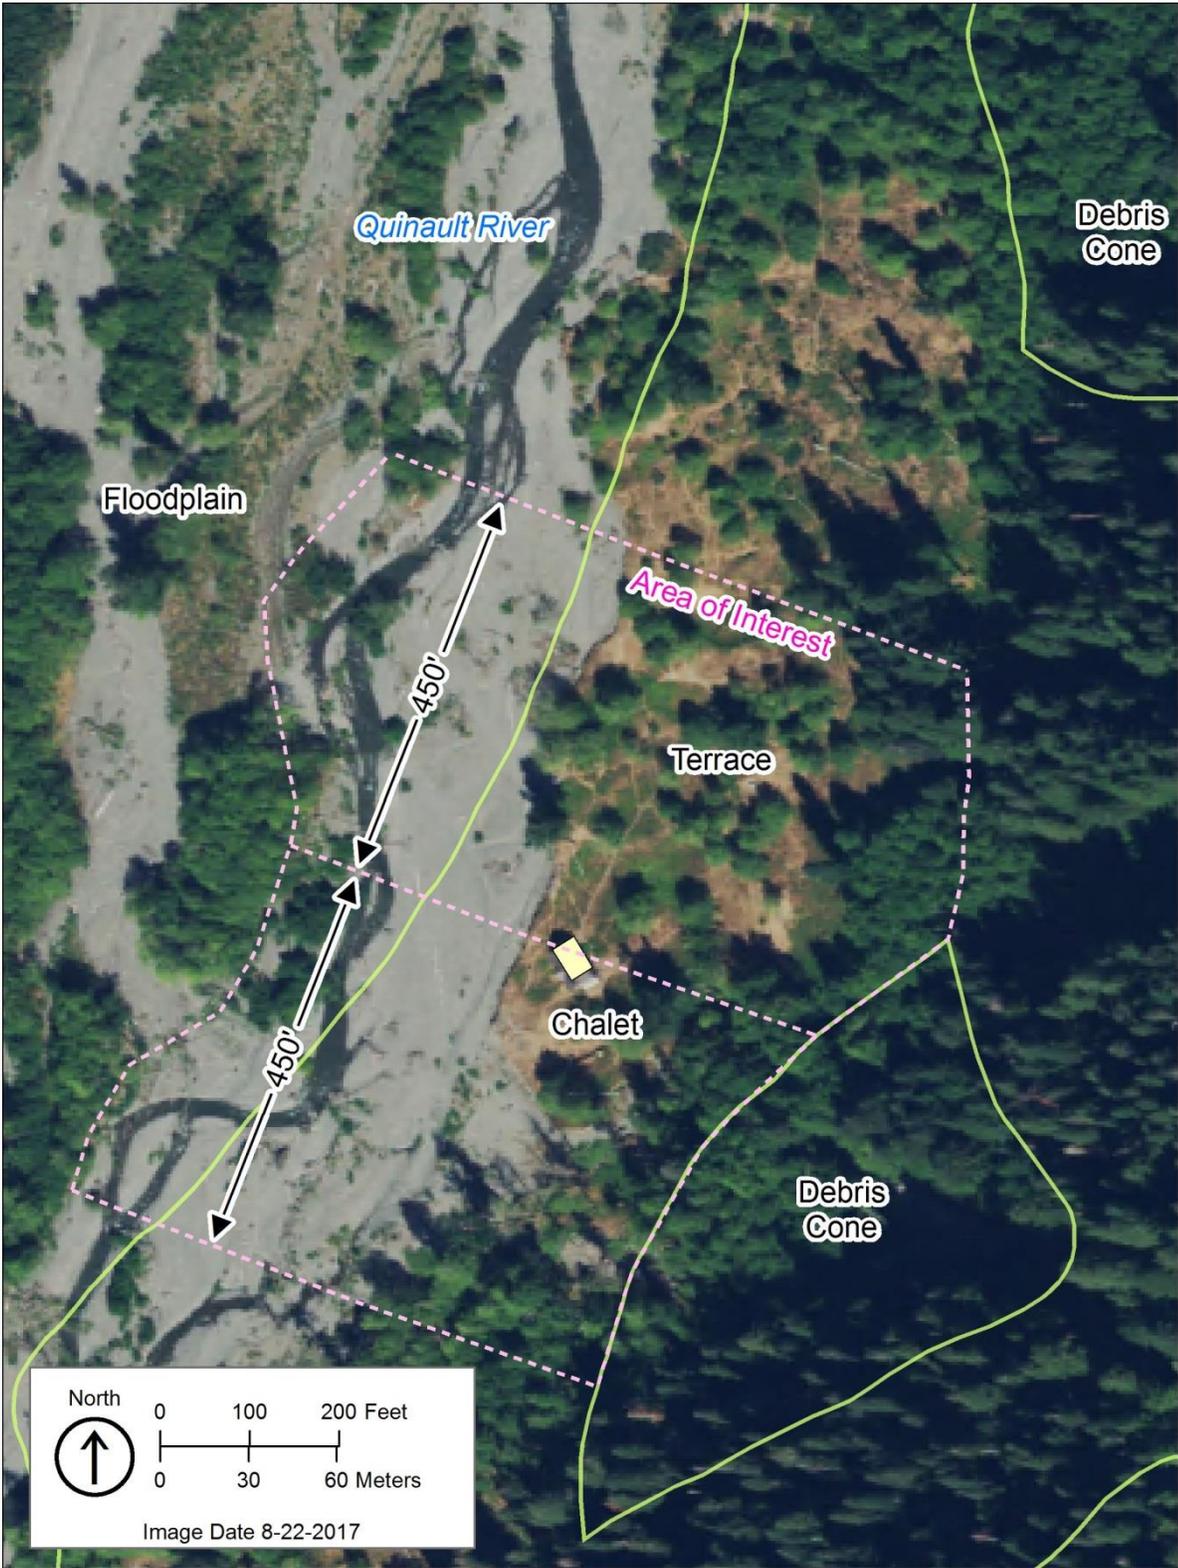
The specific region of interest (figure 1) is the area 137 meters (450 feet) up and downstream of the Chalet's current location on the alluvial terrace landform upon which the terrace is located. The average terrace width in this area is about 131 meters (430 feet). The terrace is mapped in Riedel and Dorsch (in prep.) and depicted in figure 3. A terrace is a relatively flat surface that grades gently downstream and represents the dissected remnants of a previous floodplain (Jarrett 1990).

**Figure 1.** Area of Interest Map. Area on terrace used for Chalet hazard evaluation — 137 meters (450 feet) up and downstream of current Chalet location.

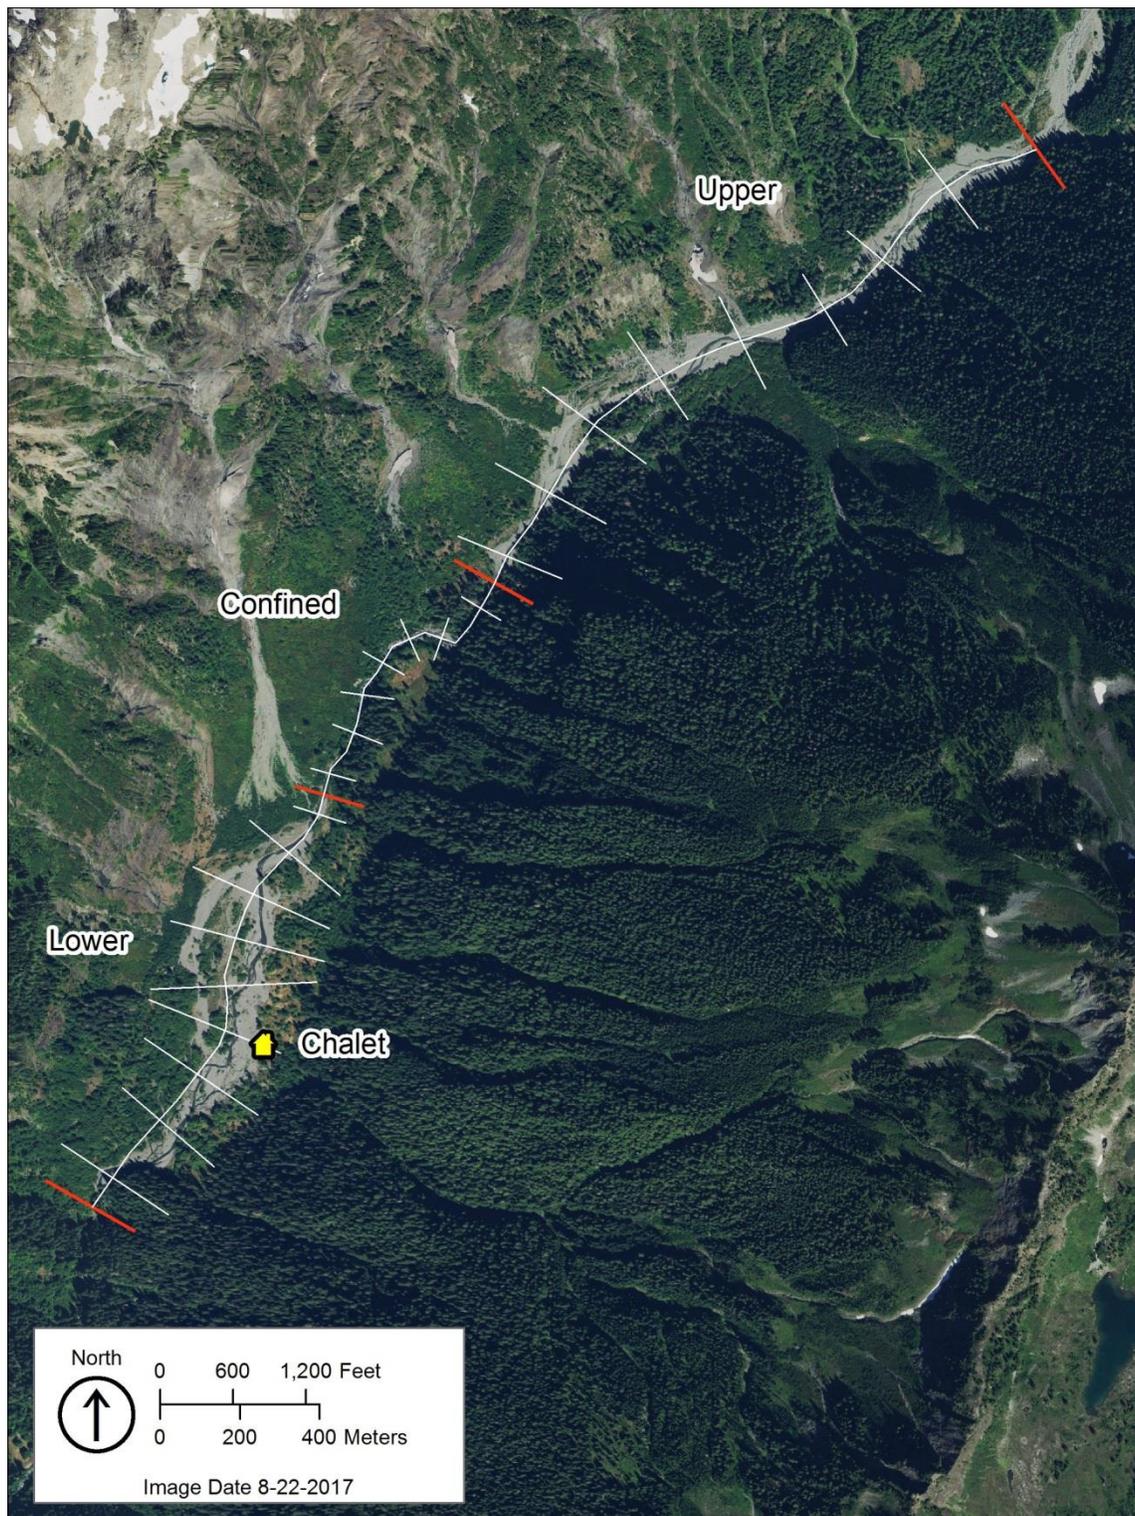
Channel bank erosion rates were calculated by quantifying river channel widening based on 1990, 2006, 2013, 2015, and 2016 aerial photography using Google Earth. The rates were calculated separately for the three channel segments (labeled Upper, Confined, and Lower; figure 4). Channel widening was calculated along a series of 24 cross sections drawn perpendicular to the main river flow (thalweg) as shown in figure 6. In the Upper, Confined, and Lower channel segments, there are 8, 7, and 9 cross sections, respectively.

**Figure 4.** Stream channel segment map, based on gradient and confinement. The red cross sections indicate the segment boundaries.

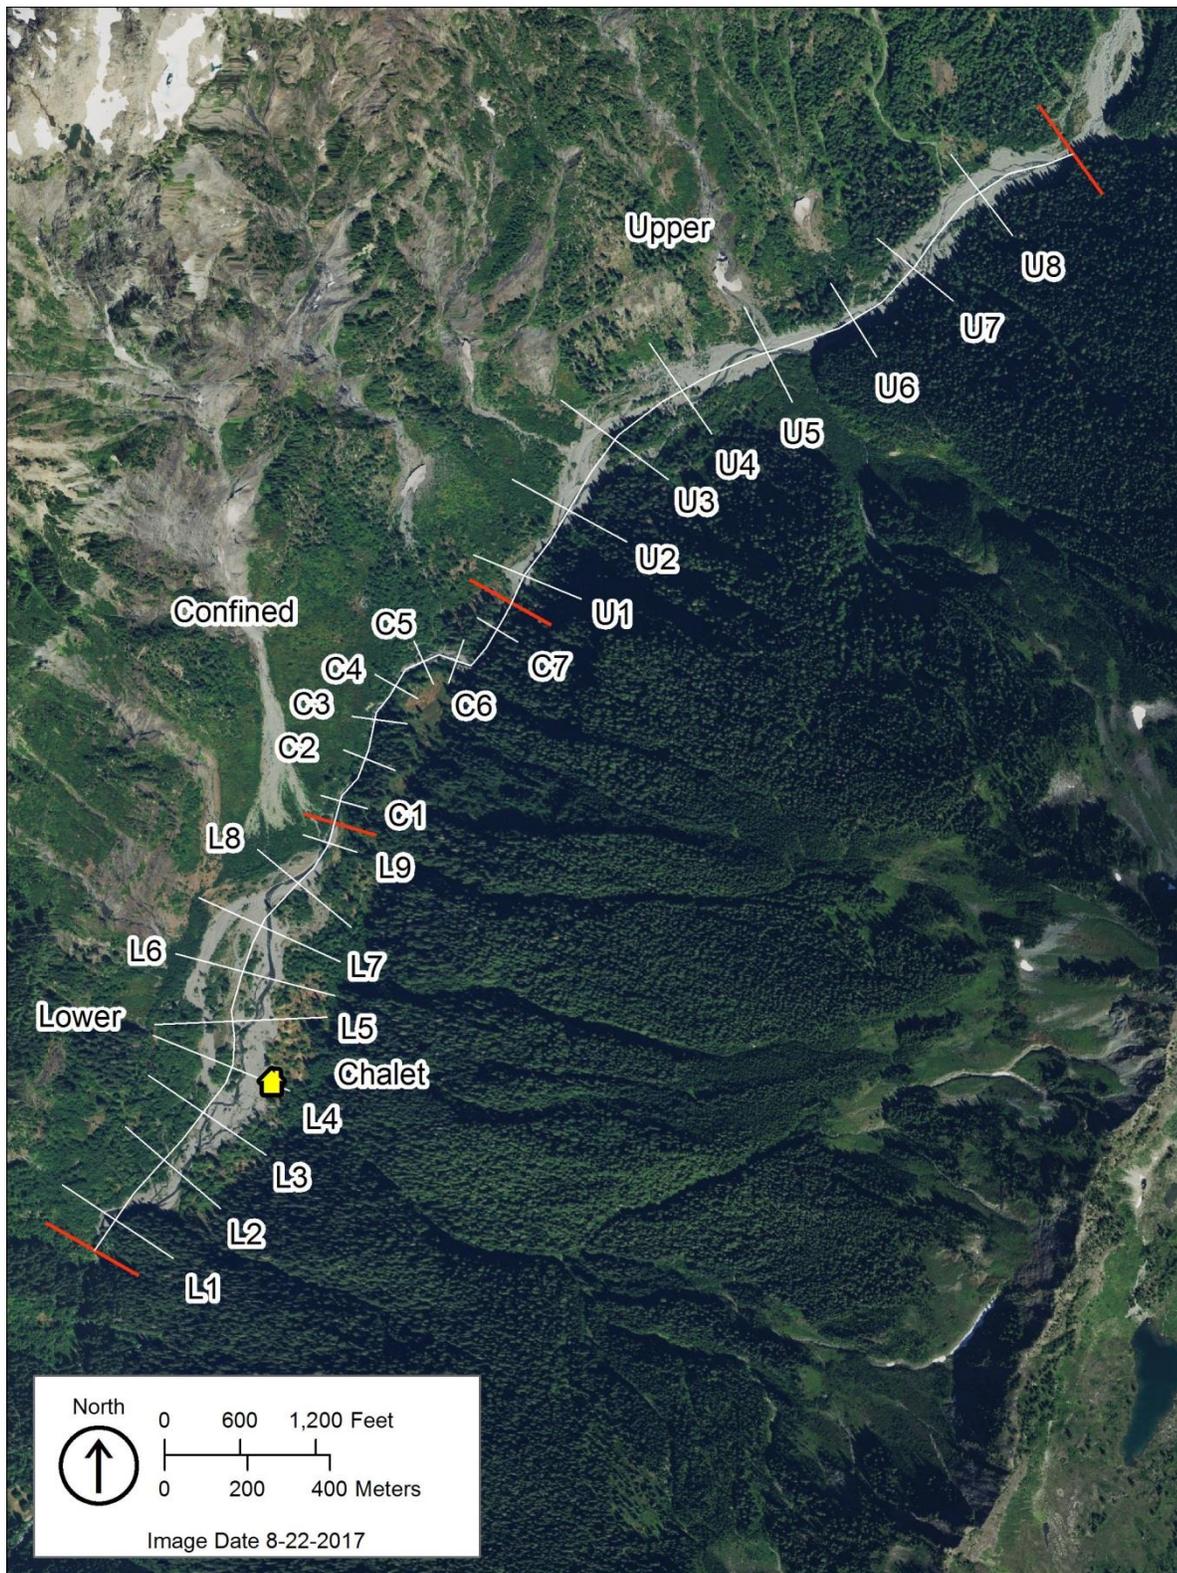
**Figure 6.** Cross sections used for bank erosion calculations. Red segments delineate channel segments (figure 4). Cross section labels correspond to those in table 2.

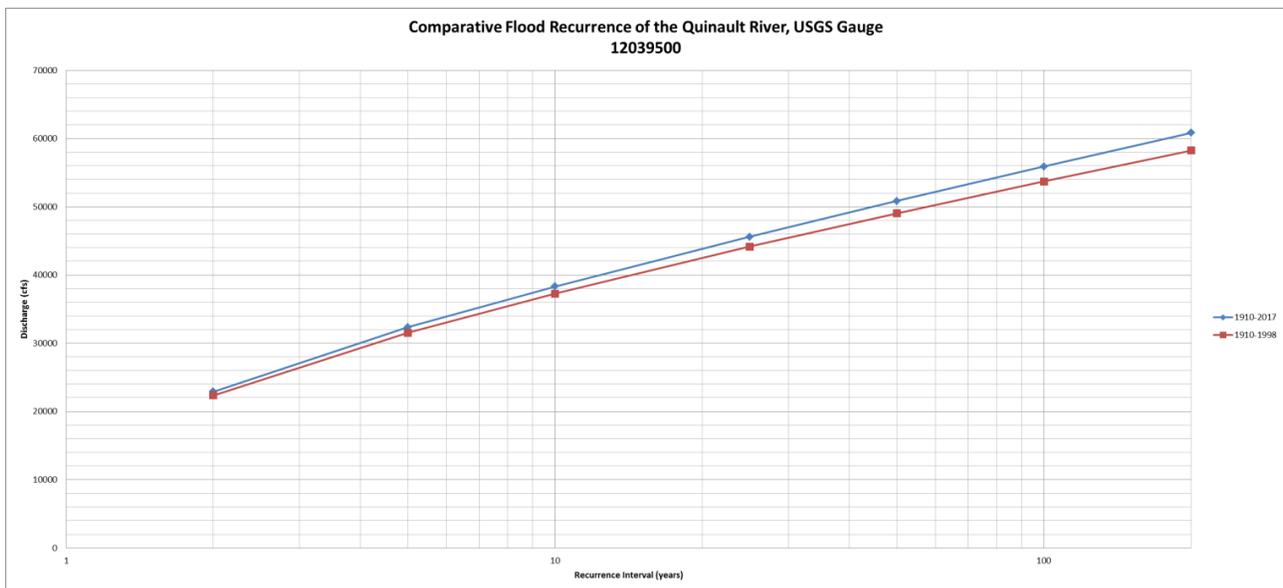
Figure 8 reveals that earlier characterized 100-year floods now occur about every 70 years and 10-year floods about every 9 years.

**Figure 8.** Comparison of flood recurrence intervals (1910-1998 with 1910-2017).

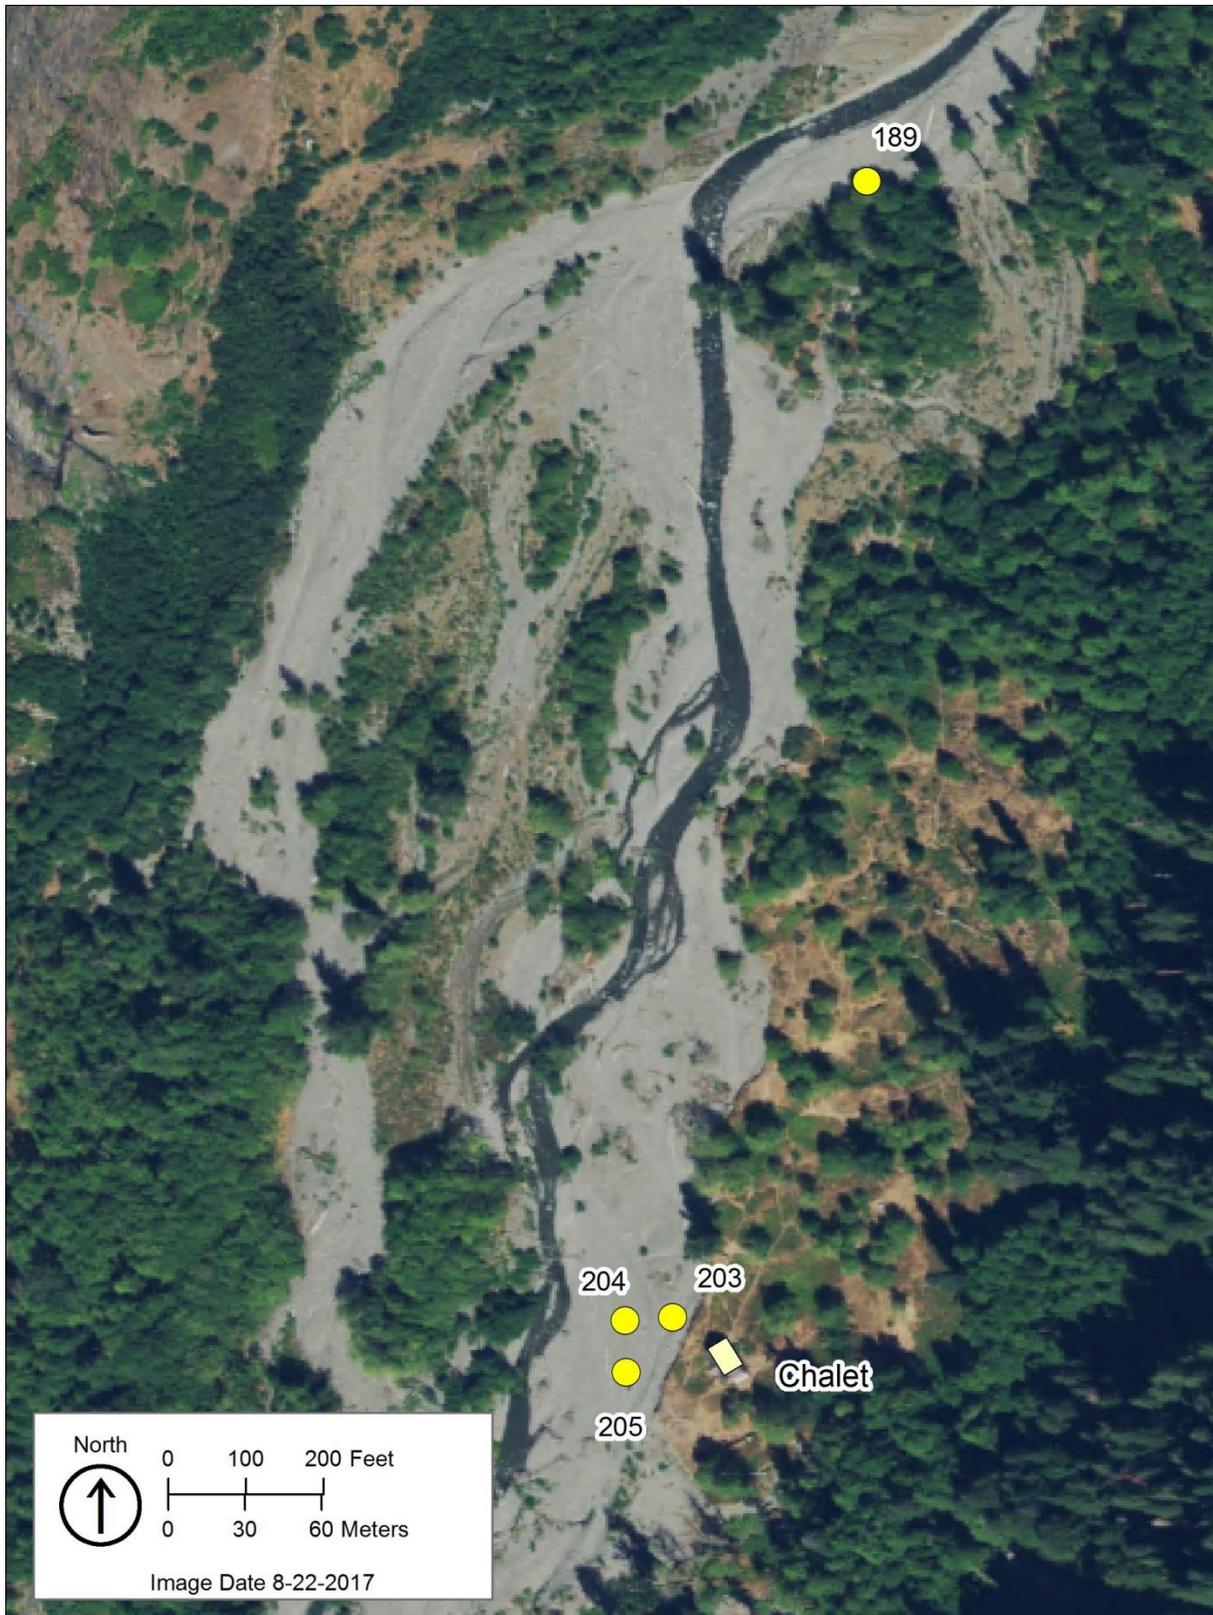
**Figure 10.** Location of Carbon 14 samples
