Existing Conditions

Introduction

This chapter describes through narrative text, contemporary photographs, labeled base mapping, and analytical diagrams, the current conditions and extant landscape features associated with the Vicksburg National Military Park landscape. The first section—Environmental and Cultural Context and Setting—describes the battlefield within a regional and local context, including hydrological, geographical, and geological features, as well as the demographics and other traits that characterize the park’s contemporary setting and surrounding community. The second section—Site Description—describes the primary organizing elements and features that characterize the Vicksburg National Military Park landscape, including former park lands quitclaimed to the City of Vicksburg and Warren County in the 1960s. The third section—Landscape Description by Characteristic—depicts the individual extant landscape features and resources that together compose the Vicksburg National Military Park battlefield landscape. (See Fig. 7 and Fig. 8 for site location and context and study area boundary maps.)

The physical condition of the primary features described herein has been

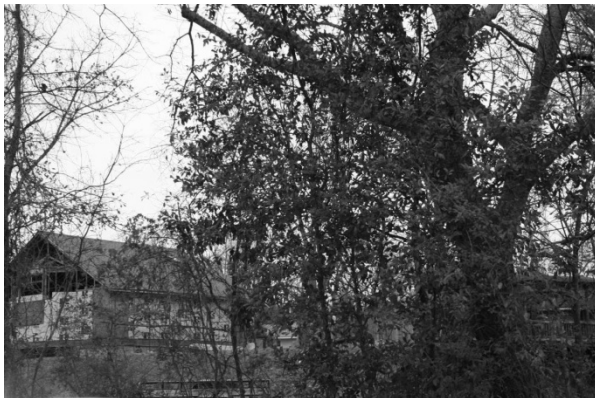
FIGURE 61. View of development encroaching on the park boundary, on the northwest portion of Confederate Avenue, west of Thayer's Approach, looking south.

along its eastern boundary where a large elementary school, numerous commercial ventures, and a new regional hospital have recently been built along the U.S. Highway 61 corridor. Commercial development along U.S. Highway 80 and the Interstate 20 frontage road occurs within close proximity to the park's boundaries and has impacted the park's viewsheds and water resources, and heightened incidences of vandalism (Fig. 61). This development is visible from the park's entrance area and the South Loop.

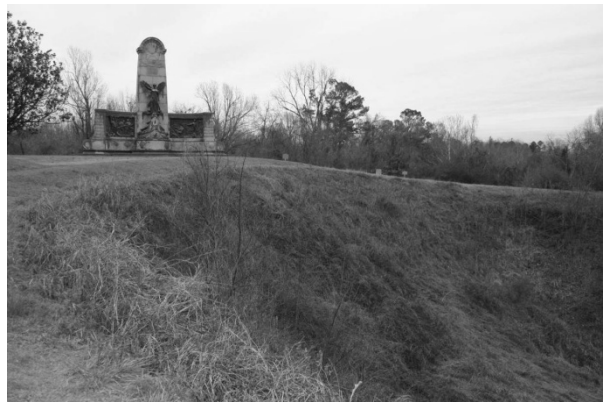
Many of the park's cleared slopes have been planted with Bermuda grass to hold the soil and prevent erosion while maintaining an open character for interpretation and viewing of Civil War-era and commemorative features (Fig. 70).

FIGURE 70. The highly erodible, steep slopes within the park are stabilized with vegetation. This view is of a slope east of Confederate Avenue, near the Missouri State Monument, looking east.

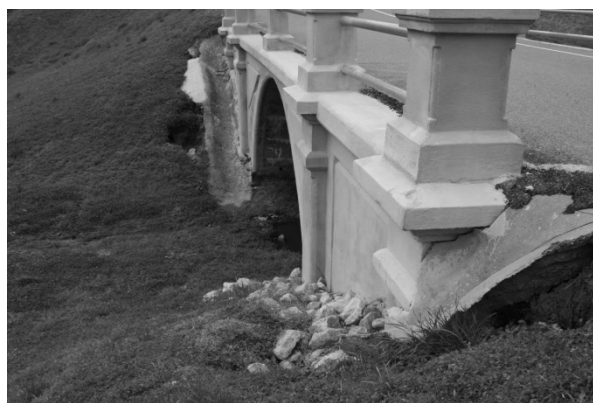
Today, the park continues to experience problems with sinkholes, cave-ins, and erosion (Fig. 73). A borrow pit behind the maintenance area is sometimes utilized to obtain material for repair of erosion problems (Fig. 74).

FIGURE 73. Erosion around the footings of historic Melan Arch Bridge No. 2 along Union Avenue north of Pemberton Avenue, looking southwest.

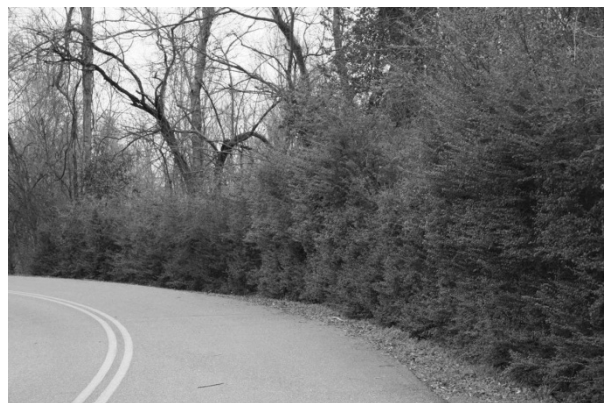
FIGURE 77. Privet forms a screen planting along the park boundary to the northeast of Grant Avenue.

Many of the park's boundaries are edged by contemporary development that is not consistent with the historic character of the site. Evergreen shrubs such as privet are used to screen views of features outside the park (Fig. 77). Woodland cover along park boundaries also serves as a defined edge to the open space areas of the park. The primary exception is the open view toward the Yazoo River Diversion Canal afforded from Connecting Avenue, the USS *Cairo* Museum, and Fort Hill. The elevated topography in the northwestern corner of the park overlooks the river and allows for long views toward and along the river. A ten-foot wide corridor of the park boundary is maintained clear of woody vegetation to reduce the fuel load and associated fire hazard as a fire break at the wildland/urban interface. The boundary clearing effort is an on-going process.

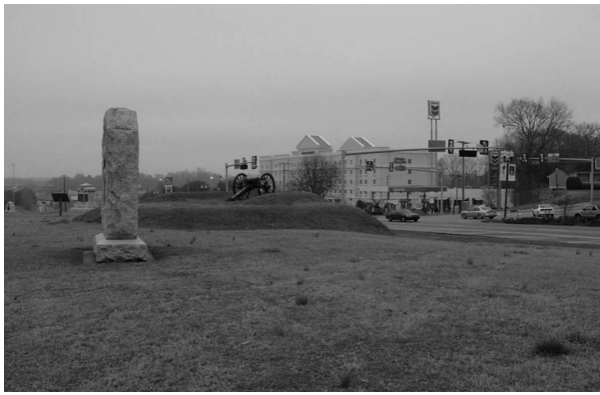
Clay Street (U.S. Highway 80) and the Park Entrance. Clay Street is state- and city-maintained forty- to fifty-foot-wide, four-lane, asphalt-paved road with a median and a grass shoulder that extends through the park landscape. Clay Street is a busy arterial corridor that conveys motorists between Interstate 20 and downtown Vicksburg. The road corridor, built on fill, is both physically and visually intrusive to the park's setting (Fig. 80).

FIGURE 80. Clay Street is a heavily utilized municipal road that bisects the park, and services its main entrance. Commercial development on this road is visually intrusive to the historic character of the park. An overpass conveys Clay Street over an internal park tour road. This view is from south of the visitor center parking lot, looking southeast.

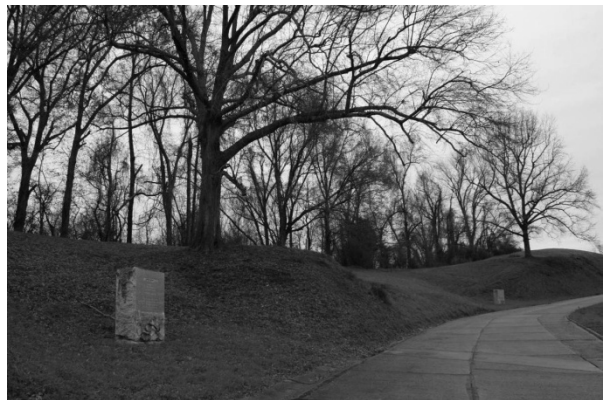
Confederate Avenue. Confederate Avenue generally runs along the western boundary of the park. The one-way road is twenty feet wide, has a single lane, and is primarily paved with concrete, although sections have been repaved or patched with asphalt. Concrete curbs, swales, and gutters edge the road corridor in places. A white stripe along the left side of the road designates a walking lane for pedestrians. As the concrete shows cracking and wear in many places, the road is considered to be in fair condition (Fig. 87).

FIGURE 87. Confederate Avenue follows the Confederate fortification siege lines along the southern and western halves of the park. It is twenty feet wide and paved mostly in concrete, in many places in only fair condition. This view is looking south, south of the bridge that crosses modern Jackson Road.

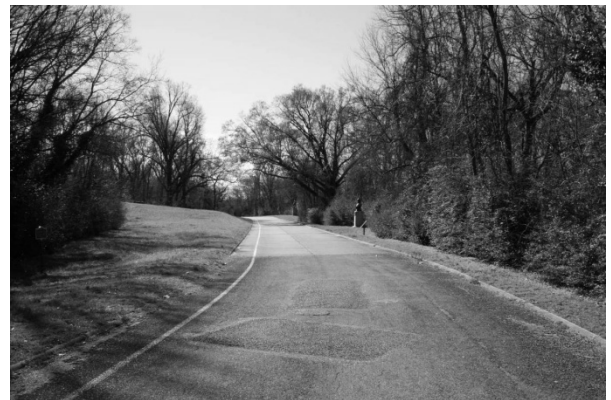
South Loop. The South Loop begins to the south of the visitor center. The road leading to the South Loop passes beneath a concrete overpass that conveys Clay Street past the park. It then passes over a bridge that spans the Kansas City Southern Railway line (Fig. 89) before splitting into the one-way loop that accesses the last three tour stops within the park. The one-way, single lane South Loop is approximately fifteen feet wide and paved with asphalt. A white stripe running along the left-hand side of the road designates a section as a pedestrian walking lane. The road is in fair condition due to cracking and patched sections of asphalt.

FIGURE 89. The South Loop is continuous one-way road that affords access to the tour stops south of the Visitor Center and Clay Street (Railroad Redoubt, Fort Garrott and Hovey's Approach). This view is west of the Texas State Monument, looking southwest.

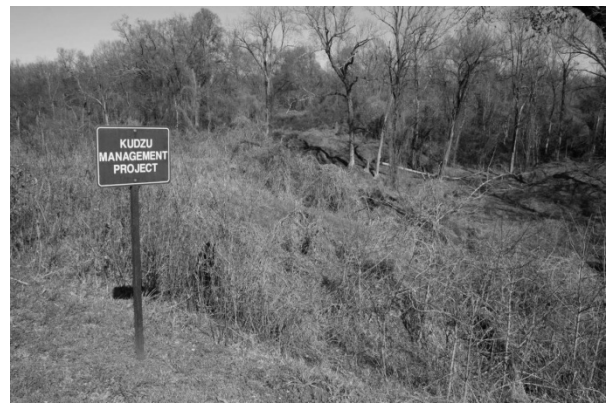
Vicksburg National Military Park's natural resource program focuses on managing invasive species, and on improving the park's ecological integrity, using an existing invasive plant management plan (Fig. 92).¹⁸⁷ In addition to monitoring activities, the park conducts active control programs. The kudzu population, for example, is being aggressively treated by the park at twelve locations totaling approximately forty acres (Fig. 93). Kudzu is a perennial, trailing, or climbing vine of the legume family. During the growing season, this prolific plant can grow at a rate of a foot per day, easily covering and shading out trees and understory vegetation. It is considered one of Mississippi's "Top Ten Worst Weeds."¹⁸⁸ The kudzu population is being managed by a long-term program of repeatedly treating the leaves and stems of the plants with approved herbicides in an attempt to eradicate the plant from the area.¹⁸⁹ At least two treatments per year over a five to ten year period is anticipated by the park's Natural Resources staff. Prescribed fire is another tool that is being used within the park to control kudzu as well as Johnson grass on Fort Hill. The park currently manages six burn units, including four acres at Logue's Meadow, ten acres along Graveyard Road, ten acres at Thayer's Approach, four acres at Fort Hill, eleven acres at Railroad Redoubt, and nineteen acres at Fort Garrott/Hovey's Approach (Fig. 94).

FIGURE 92. Looking northwest down into one of the park's kudzu management areas, off the South Loop, north of Fort Garrott. The NPS is waging a constant battle to protect native vegetation from invasive species.

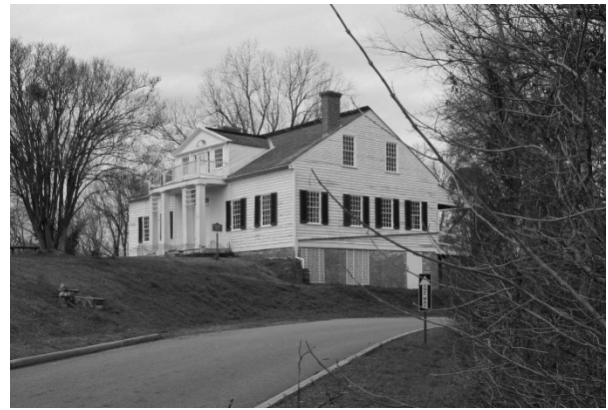
avoid artillery fire. The exterior walls are white-painted clapboard. The first floor windows are twelve-over-twelve double-hung units with green-painted wood shutters. The building has undergone several renovations and alterations since the Civil War. Prior to the completion of the Old Administration Building in 1936, the Shirley House was used as the park headquarters. The interior is currently in poor condition and the building is not currently open to the public.

FIGURE 96. Shirley House, view of the front and east side from Union Avenue.

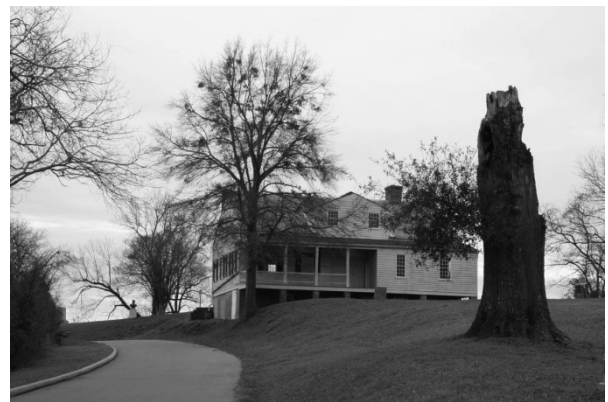
FIGURE 97. Shirley House, view of the back of the house from Union Avenue.

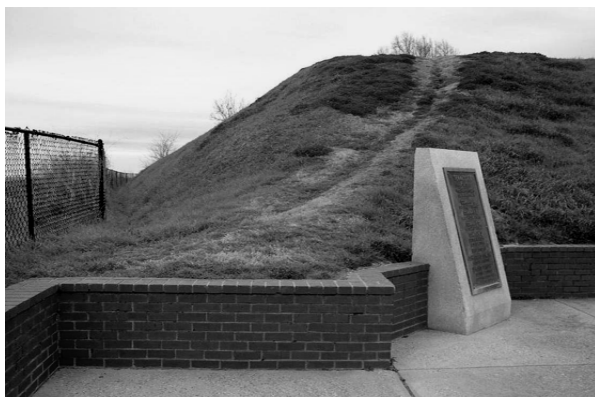
FIGURE 104. View from a parking area and interpretive plaza looking north toward Fort Hill. The earthwork was one of the major earthworks associated with the Confederate line established to defend Vicksburg. It was later used by Union soldiers occupying Vicksburg after the siege.

Fort Hill. LCS 001360. Fort Hill is a four-sided earthen fortification, with parapet walls between twelve and fifteen feet in height, sited atop a high bluff overlooking the Yazoo River Diversion Canal (Fig. 104). First established by the Confederates as part of their defense line, Fort Hill was later modified by the Union army during their occupation of Vicksburg after the siege. It was rehabilitated using CCC labor between 1934 and 1937 (Fig. 34 and Fig. 35). The earthwork is currently maintained under mown grass cover. A

parking area, stairs, and an asphalt-paved walk afford access to the fort. Chain-link fencing edges the margin of the parking area and stairs where the slope falls away steeply below to ensure the safety of visitors. Fort Hill was assessed in good condition by the List of Classified Structures (LCS) in 2006.

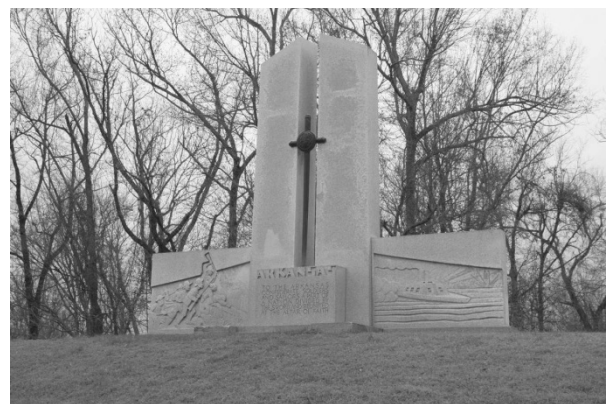
The Arkansas State Memorial was designed by William Henry Deacy. It depicts an upright bronze sword that divides two slabs of Mount Airy, North Carolina, granite (Fig. 108). This image is symbolic of a divided nation. The hilt bears the state seal of Arkansas. Relief panels to the left and right depict infantry in battle and the C.S.S. *Arkansas*. The memorial is located along Confederate Avenue, south of Graveyard Road. It bears the inscription “To the Arkansas Confederate Soldiers and Sailors, a part of a nation divided by the sword and reunited at the altar of faith.”

FIGURE 108. The monuments of Vicksburg National Military Park represent a range of sculptural styles. The Arkansas State Memorial, dedicated in 1954, has Art Deco stylistic detailing. It is situated along Confederate Avenue south of the Stockade Redan; this view is looking northwest.

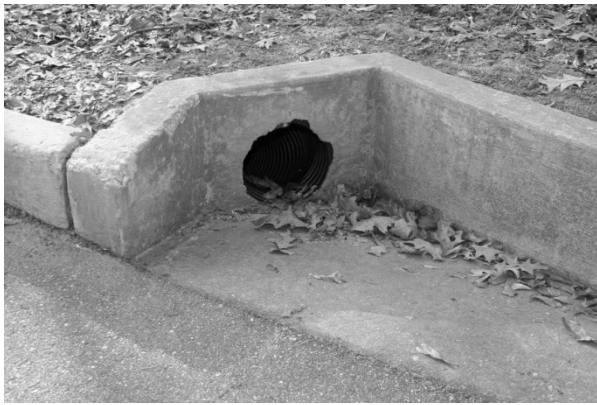
FIGURE 128. An elaborate system of curbs, gutters, and culverts control the overland flow of stormwater associated with roads and steep landforms within the park. Shown is a concrete swale along Union Avenue north of the Memorial Arch.

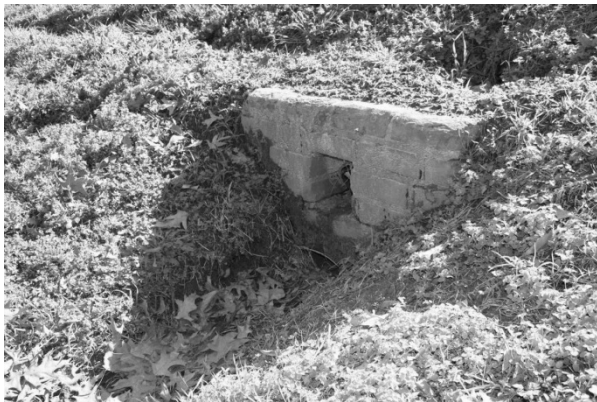
FIGURE 129. Another example of a drainage structure is a concrete culvert inlet, looking south on Union Avenue just past the first Melan Arch Bridge.

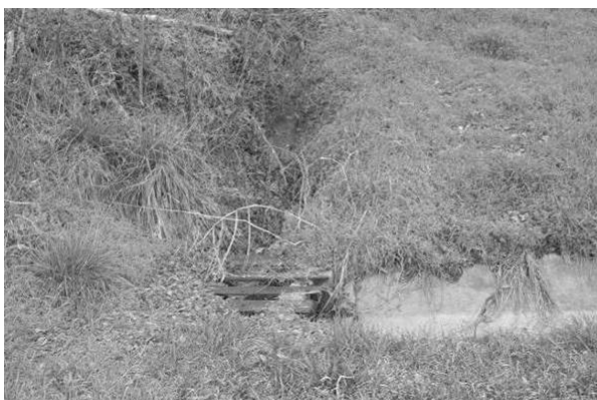
FIGURE 130. Other culverts within the park are made of brick, such as this outlet viewed looking east from the South Loop road near Fort Garrott.

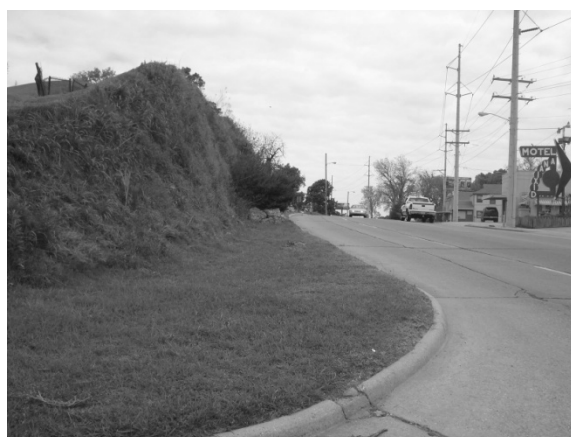
FIGURE 143. The landform at Louisiana Circle falls away gently towards the river and more steeply along Washington Street.

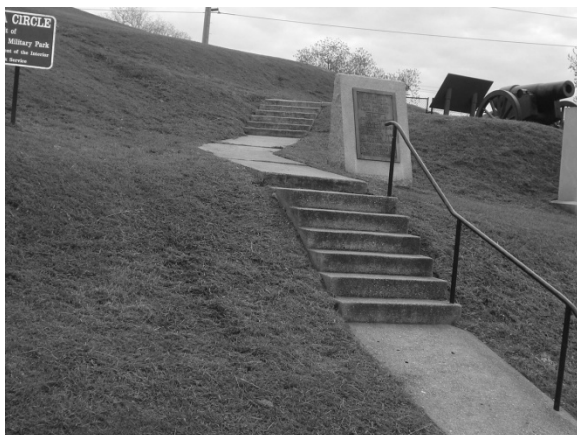
FIGURE 146. Pedestrians access the fortification at Louisiana Circle via a concrete stair and walk.

- The concrete paving is cracked and broken in some locations, and there is some minor surface wear. It has been patched with a black asphaltic material that contrasts with the color of the paving. (Fig. 151).
- Portions of the concrete walk constitute a trip hazard where the steps have risers of uneven heights, and settling has occurred between two slabs. The handrail does not extend the entire length of the stairs. The handrail needs painting. The upper walkway includes a trip hazard near the approach to the cannon (Fig. 152).

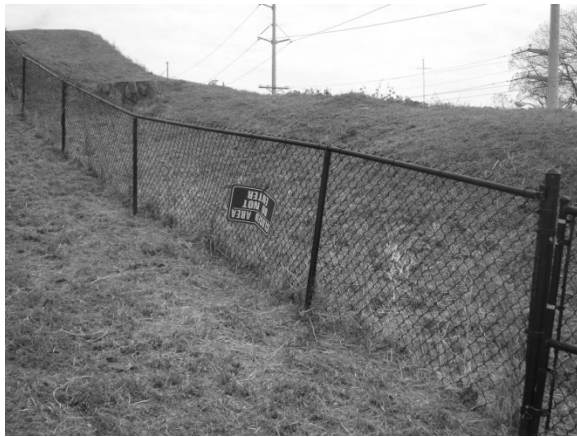
FIGURE 150. A black chain-link fence guards visitors to Louisiana Circle from the steep western slope of the knoll that parallels South Washington Street.

- Portions of the timber guard rail are damaged. Some of the timbers are cracked, split, or displaced. Some of the concrete piers lean outward.
- The black chain link fence is leaning in some locations.

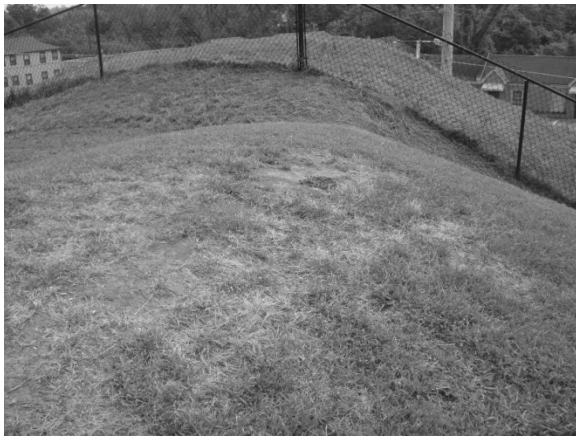
- There are bald spots in the turf grass on the earthen fortification that may lead to erosion. (Fig. 153).
- Social trails are worn in the turf grass where visitors are walking beyond the available path to reach the top of the knoll. (Fig. 152).

FIGURE 153. There are bald spots in the turf grass on the earthen fortification at Louisiana Circle that may lead to erosion.

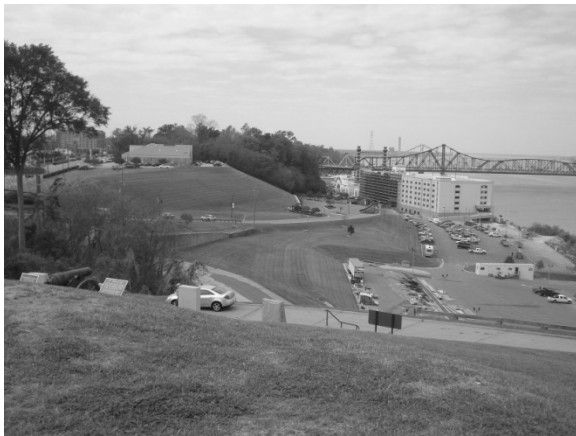
- Views from the fortification are affected by non-historic commercial developments including casinos, commercial buildings, and overhead electrical lines. (Fig. 155).

FIGURE 155. Views from the fortification at Louisiana Circle are affected by non-historic commercial developments.

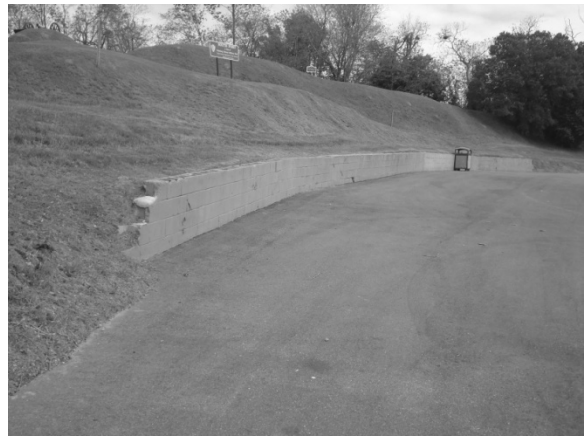
FIGURE 157. There is currently no public access to South Fort; however, the asphalt-paved road and parking pull-off associated with a former car wash edges the parcel to the east allowing access to the site for informal visitors.

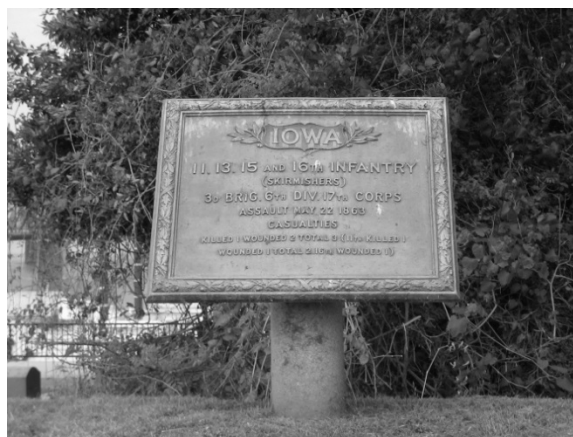
FIGURE 160. A bronze marker commemorating the role of Iowa brigades in the Civil War siege sits near the base of an electrical pole at South Fort.

- There is biological growth on the bronze tablet, which is also not very secure on its base and exhibits some corrosion and bowing of the tablet.
- There are bald spots in the turf grass on the earthen fortification that may lead to erosion. (Fig. 168)
- Social trails are worn in the turf grass where visitors are walking to reach the fortification.
- The concrete block retaining wall is leaning and bowing.
- The identity sign needs cleaning.
- Views of the river, important historically, are blocked.
- The cannon is set on concrete bases. One of these appears to be lifting up.
- One of the concrete USGS markers has the top edge broken off.
- There are many invasive exotic plants present within the parcel.

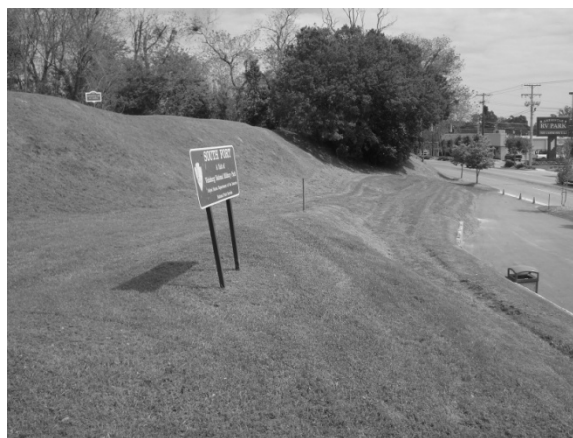
FIGURE 161. A social trail runs along the top of the rise at South Fort as there are no pedestrian paths leading into or around the fortification. An NPS identity sign is placed in the slope above the concrete block wall.

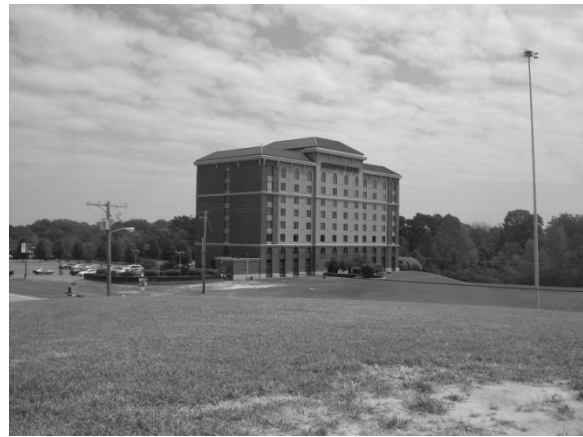
FIGURE 173. Commercial development along Washington Street is visible from Navy Circle.

- The deciduous tree along the circular drive that was damaged in a storm needs to be removed.
- Views from the fortification are affected by non-historic commercial developments including casinos and businesses and overhead electrical lines.

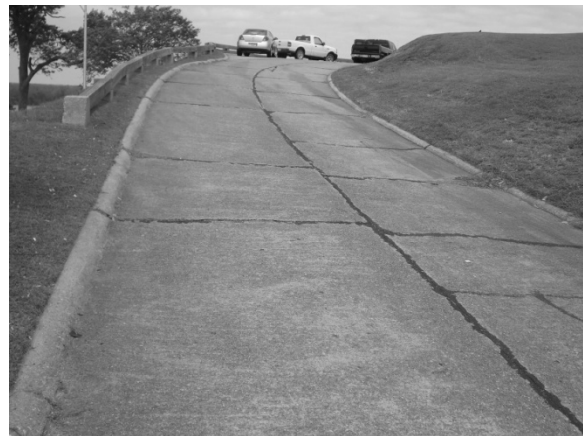
FIGURE 174. A concrete roadway encircles the knoll, providing visitor access to Navy Circle. Parking for approximately three cars is provided along the northern margin of the road. The road is edged by a low, rounded, mountable concrete curb and a concrete-post-and-wood-timber guard rail.

- The concrete paving and curbing are cracked and broken in some locations. The pavement is being patched with a black asphaltic material that contrasts with the color of the paving.

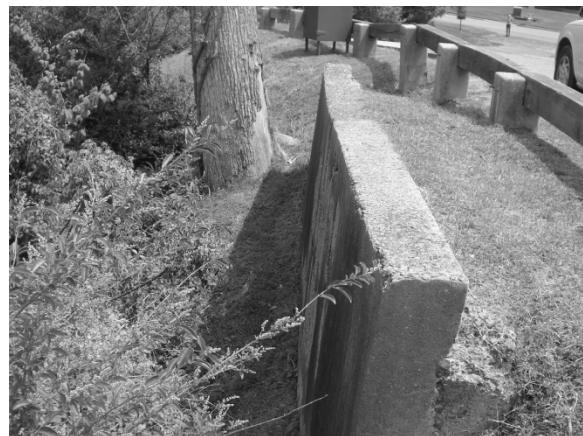
FIGURE 175. Below the guard rail along the Navy Circle access road to the north is a concrete retaining wall that extends for a portion of the embankment.

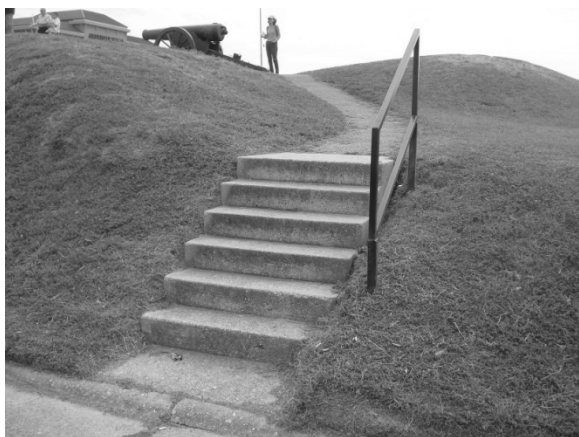
FIGURE 176. A flight of concrete steps leads up to the fort from the access road at Navy Circle. Erosion is undercutting the edge of the stairs.

- Portions of the timber guard rail have been damaged by cars, and one of the concrete piers is broken (Fig. 180).
- Erosion is undercutting the concrete stair (Fig. 176).

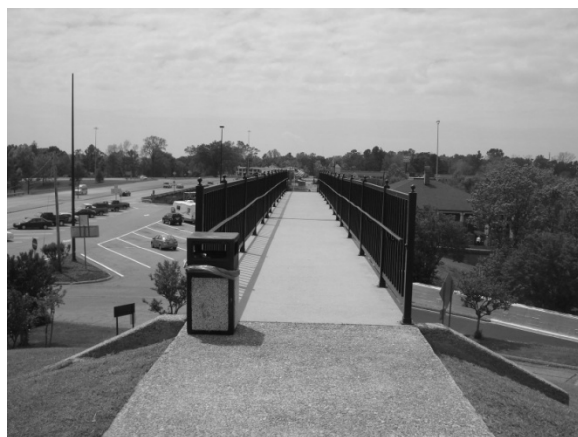
FIGURE 179. A trash receptacle sits at the end of the bridge leading to the welcome center from Navy Circle.

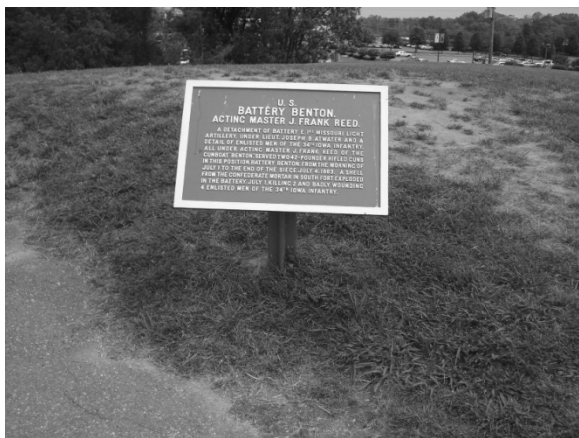
FIGURE 178. There is a metal War Department-era tablet located near the cannon at Navy Circle.
