## Replace Damaged Bench Slats with Composite Material Chancellorsville Visitor Center

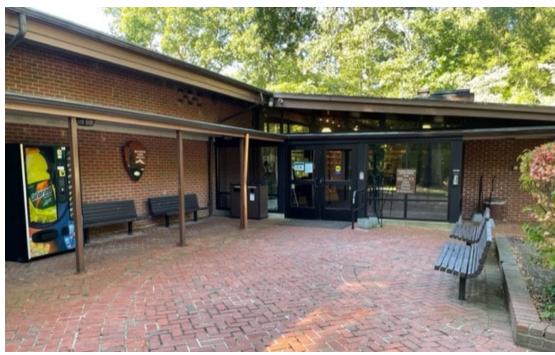
Entrance to the Chancellorsville Visitor Center showing four of the six benches.

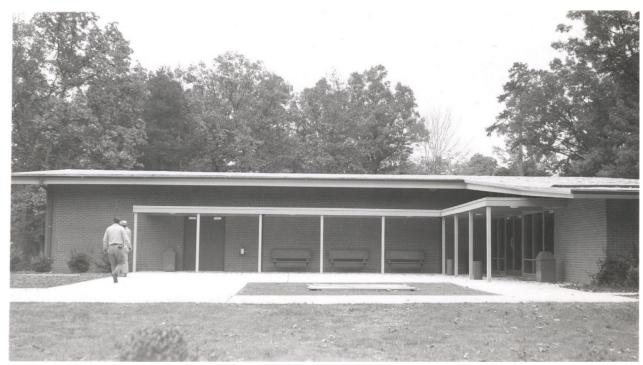
The north elevation of the Chancellorsville Visitor Center showing three original benches located under the porch overhang, circa 1963. One of the benches was later removed – date unknown – and only two remain at this location today (although of a different design).

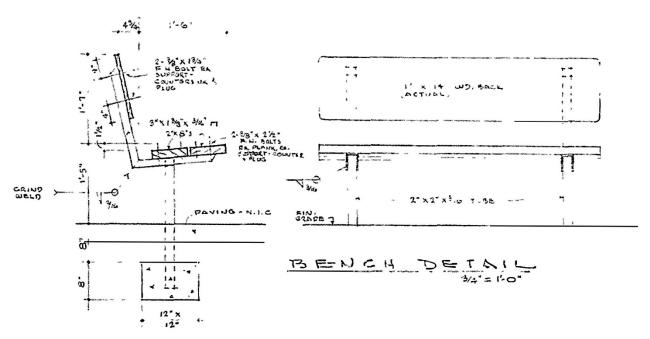
Original bench design from the 1961 construction plans.

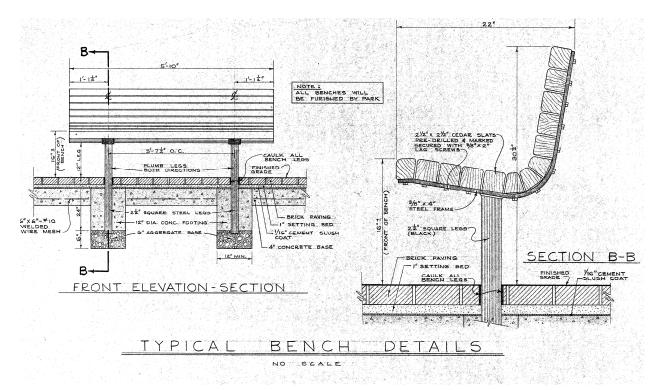
Detail from the 1979 visitor center brick plaza project showing a revised bench design using 2.5" x 2.5" wooden slats. The existing benches continue to utilize this design today.

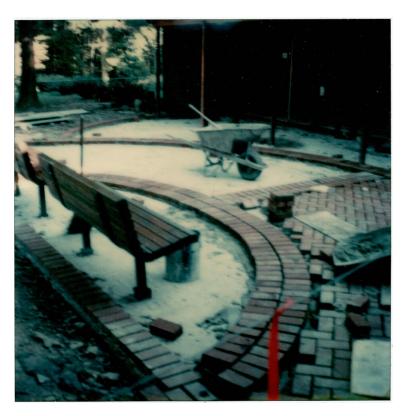
Installation of the brick plaza and new benches outside the entrance of the Visitor Center, 1979.

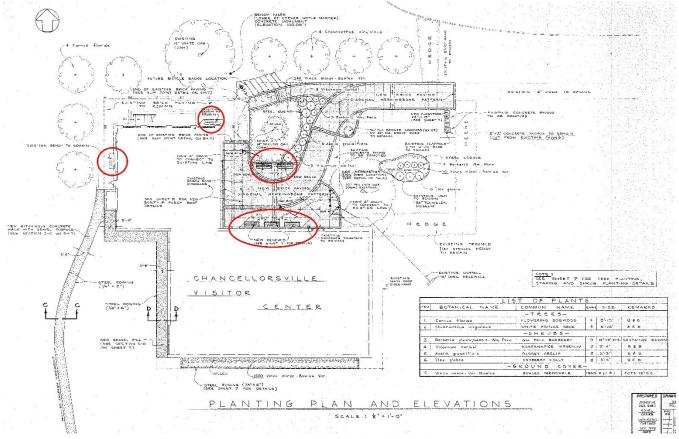
The 1979 planting plan for the Chancellorsville Visitor Center showing the location of seven exterior benches. One of the benches located under the porch overhang near the main entrance was later removed. Only six benches remain today.
