THOMAS BLACKSTONE HOUSE

HISTORIC STRUCTURES REPORT

SEIP EARTHWORKS UNIT – HOPEWELL
CULTURE NATIONAL HISTORICAL PARK
BAINBRIDGE, OHIO

APRIL 17, 2017
NPS PMIS # 218963

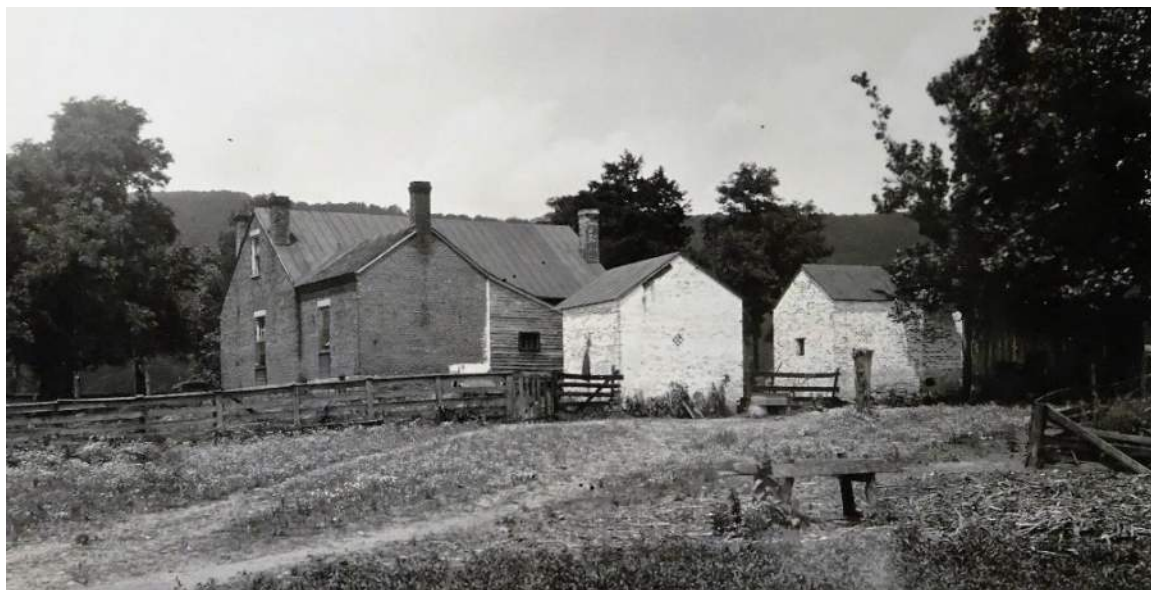
Figure 30. Blackstone House and Outbuildings, Photo by I. T. Frary. The back of the image has a handwritten label which reads "Old Seip Home, rear, August 1, 1927" and a stamp that reads "Photograph by I. T. Frary, Cleveland, Ohio." Note the frame addition in the shadows east of the smokehouse. (Photo Collection Number A0957, Folder 6, Ohio History Connection Archeological Collections Facility, Columbus, Ohio.)

- g. After abatement (if required), whitewash exposed masonry walls inside porch to match existing condition and as seen in the 1920s Figure 30 historic photograph.

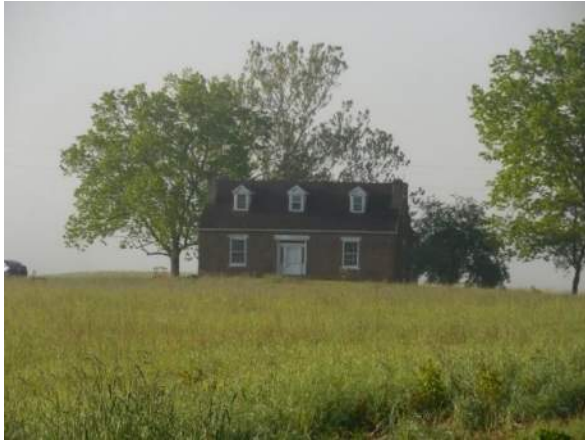
For the most part, the grade surrounding the house slopes positively away from the structure, with a slight crown in the grade centered on the house (Figure EX-12). There are some areas where the downspouts have been disconnected. The missing downspouts create a concentrated flow of water landing at the base of the wall, which in turn creates soil erosion and depressions that hold water. This standing water against the foundations migrates into the stone and brick walls causing mortar loss and masonry deterioration (Figure EX-17).

Figure EX-12. Home site, looking south.
(Strata 2016)

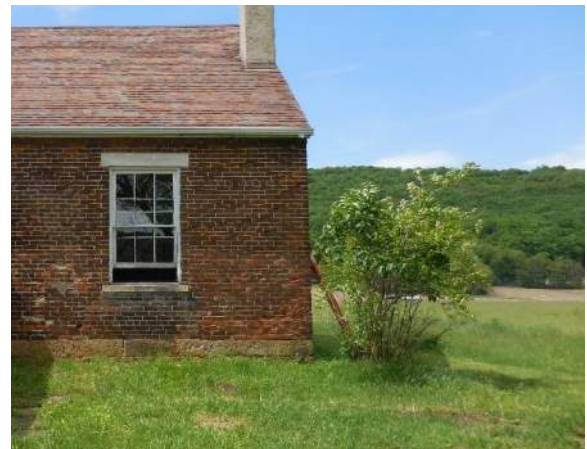
Figure EX-17. Deterioration, southeast corner,
due to missing downspout. (Strata 2016)

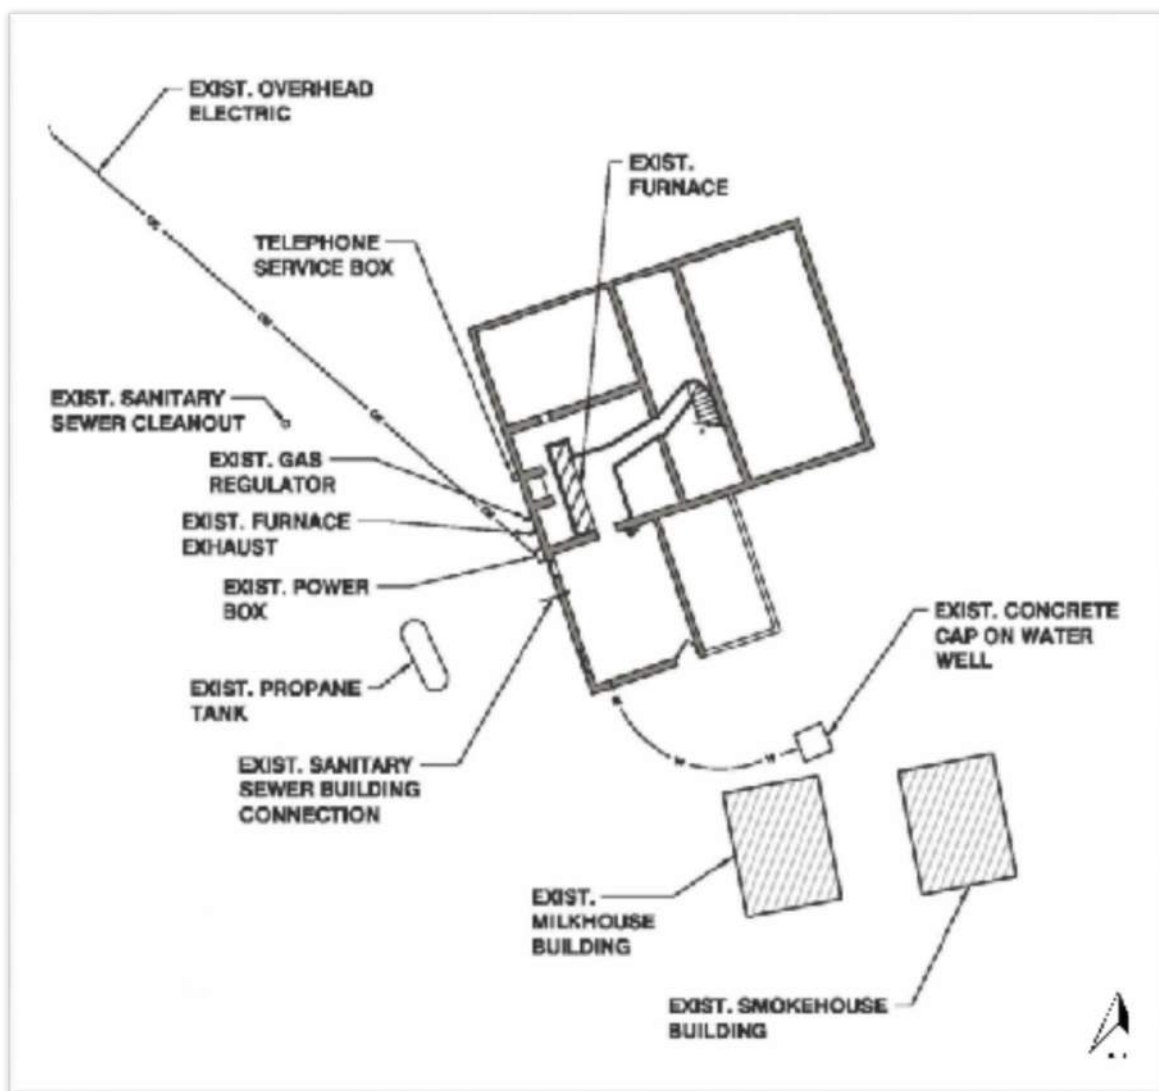
Figure EX-18. Utility Service Connections. (SKDG 2016)

The house currently has utility service connections for water, propane gas, sanitary sewer, telephone and electric. Overhead electric service is the only active utility service to the house. All utility service connections are located along the west face of the house (Figures EX-18 and EX-19) except for the water connection which enters the south basement wall below the kitchen.

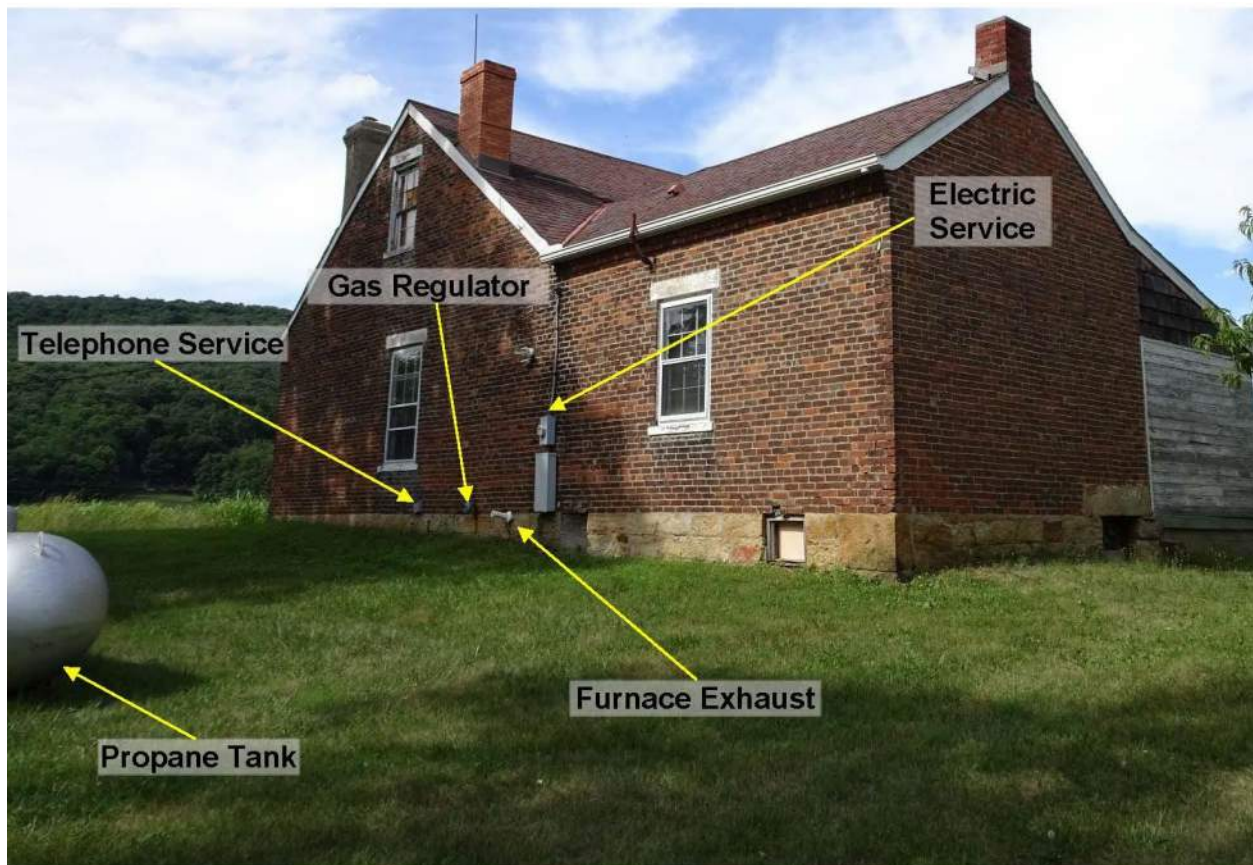
Figure EX-19. Utility service connections at west side of house. (SKDG 2016)

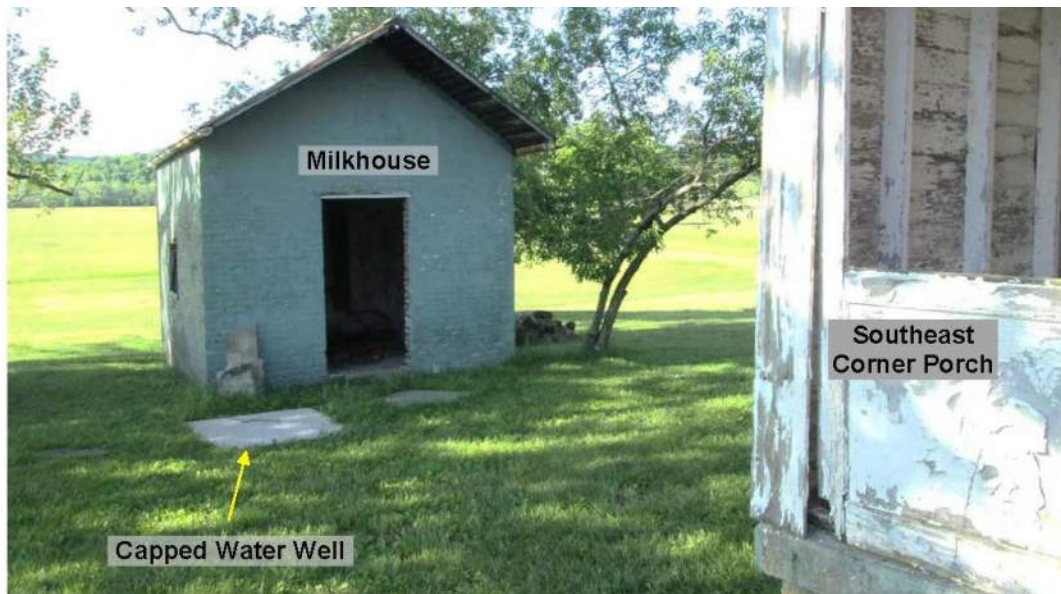
The water service to the house is no longer active. The service to the house was provided from the stone lined well located just north of the northeast corner of the milk house. The well was recently capped with a concrete slab and was not accessible for inspection (Figure EX-21). The former water service enters the house under the kitchen area in the basement area along the south wall approximately midway between the exterior access to the basement and the southwest corner of the house. The service entered below frost depth, ran across the basement floor and turned up to connect to the house plumbing below the kitchen floor (Figure EX-22).

Figure EX-21. Capped water well. (SKDG 2016)

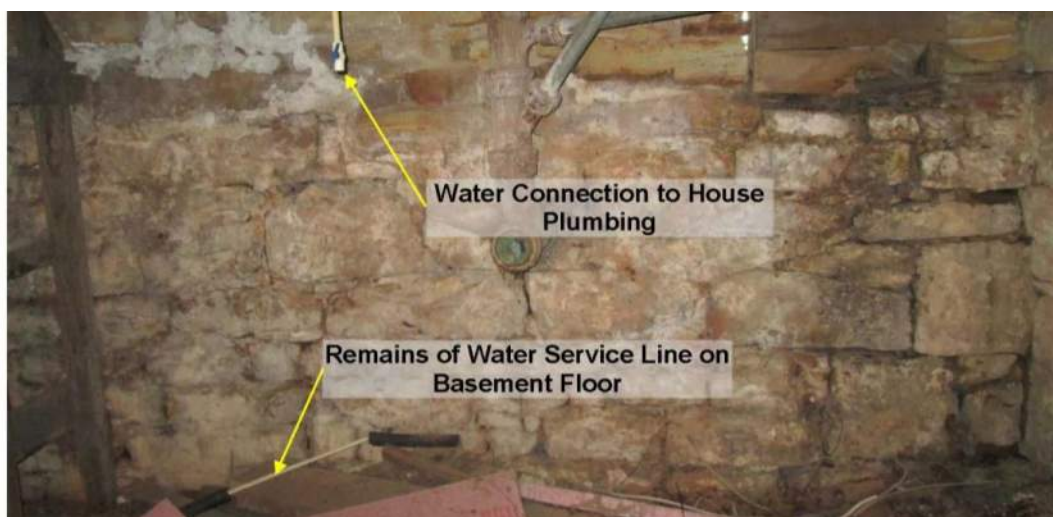
Figure EX-22. Water service line on floor, Room 005. (SKDG 2016)

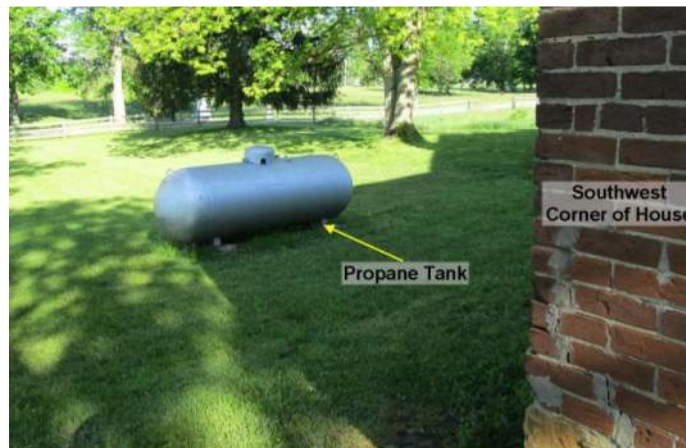
The house was heated with a gas fired forced air furnace located in basement Room 004 (Figure EX-24). The furnace is in disrepair and is not operational. Gas was supplied to the furnace from the propane tank located on the west side of the house (Figure EX-23). The routing of the propane service line from the tank to the house is underground and enters the west basement wall of Room 004. There is an old gas regulator located on the west face of the house that once served as the gas service connection.

Figure EX-23. Propane gas service, west of house. (SKDG 2016)

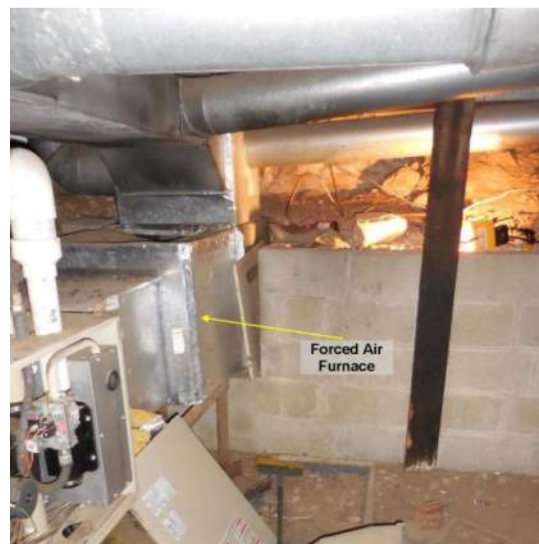
Figure EX-24. Forced Air Furnace Basement Room 004, looking north. (SKDG 2016)

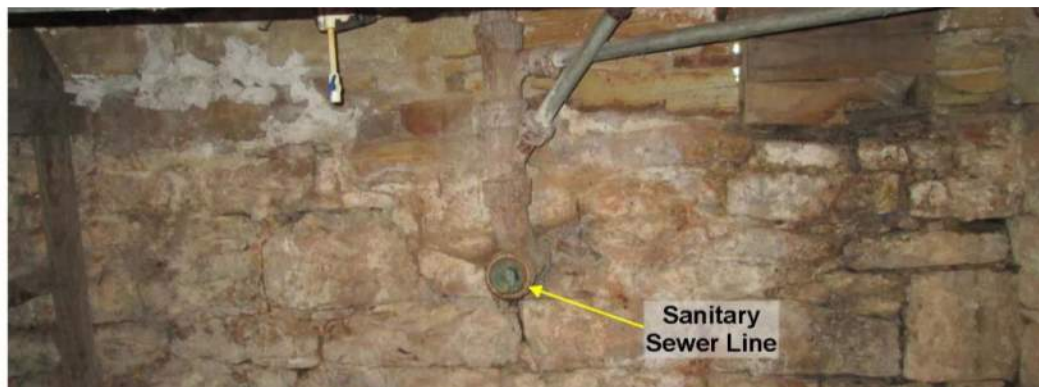
The sanitary service line exits through the west wall in basement Room 005 (Figure EX-25). A video of the existing line was performed to determine its routing. A ductile iron pipe exits the basement of the house and the pipe makes a 45-degree bend five feet outside the wall heading northwest to the existing cleanout. The pipe material changes from ductile iron to PVC at the 45-degree bend. The video indicates the entrance to the septic tank is located approximately three feet beyond the cleanout approximately 53 feet from the line location leaving the house. The PVC cleanout is located approximately 29 feet west and 5 feet south of the northwest corner of the house (Figure EX-26). The cleanout cap was removed to see if it was located over a septic tank. The cleanout line makes a 90-degree bend approximately 3 feet deep and provides service to the existing septic tank located adjacent to the cleanout. The top of the septic tank is around one foot below existing grade as determined with a probe rod. The location of the absorption field is assumed to be beyond the septic tank on the extension of the sewer line from the house to the tank. Ground penetrating radar is required to determine the exact size and location of the absorption field. SKDG met with the Ross County Health Department to obtain records on the design of the absorption field. The installation of the septic system at the Blackstone house pre-dated their record keeping and no information on the septic system is available.

Figure EX-25. Sanitary sewer service, west wall, Room 005. (SKDG 2016)

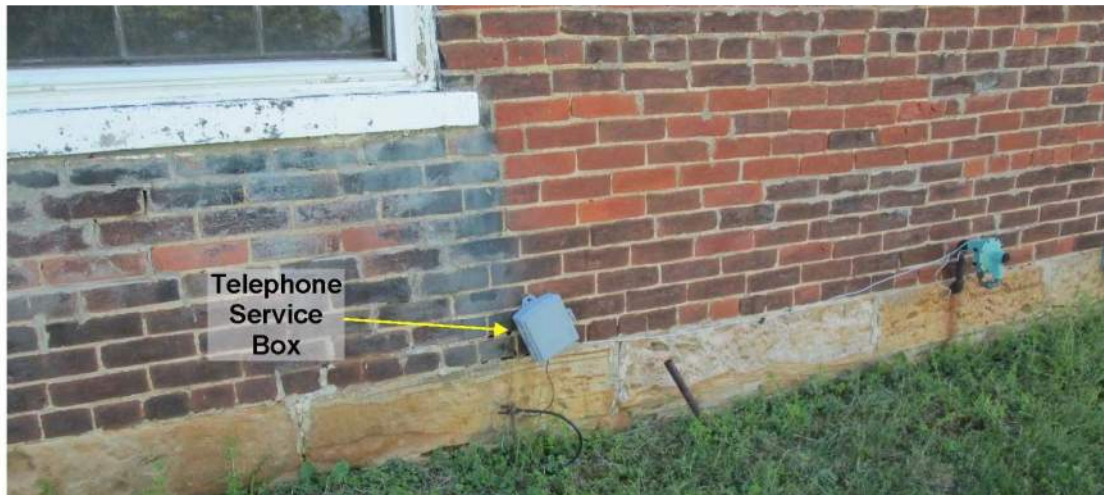
The telephone service to the house is inactive. There is a telephone service box located on the west wall of the house (Figure EX-17). The previous service to the house may have originated from a telephone service pedestal located approximately fifteen feet east of the entry drive to the Blackstone House and fifteen feet south of Highway 50 (Figure EX-18). The actual location of the service line from Highway 50 to the house is undetermined. The telephone service line to the house appears to be located along the east side of the driveway as shown in Figure EX-18.

Figure EX-27. Telephone service, west wall. (SKDG 2016)

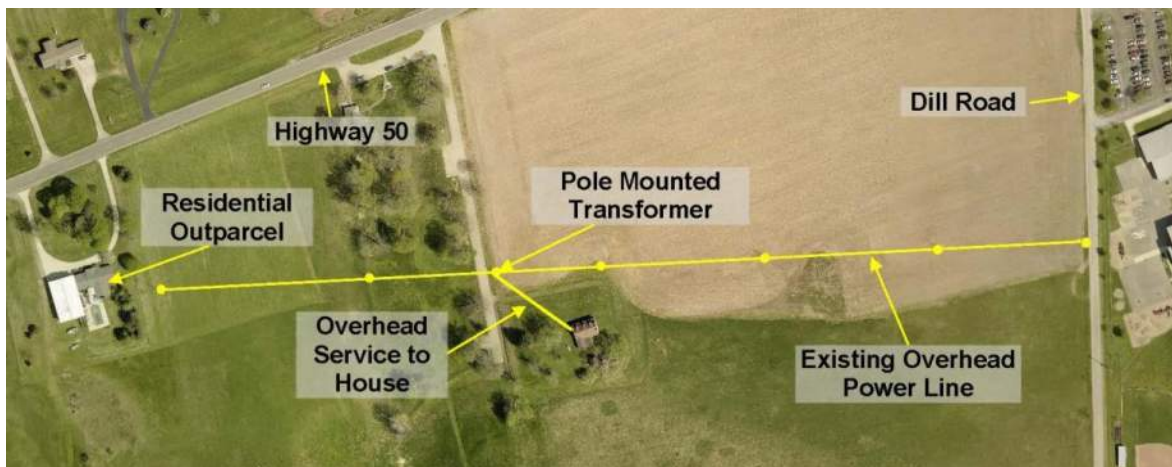
There are existing overhead power lines running east-west across the Seip Earthworks property from Dill Road on the east to a residential outparcel within the park property on the west (Figure EX-29). There is a pole mounted transformer located approximately 190 feet northwest of the NW corner of the house next to the east side of the driveway (Figure EX-30). Overhead electric service from the pole mounted transformer is provided to the house. The existing poles and overhead lines are considered to be intrusions on the historic landscape.

Figure EX-29. Electric system on site. (SKDG 2016)

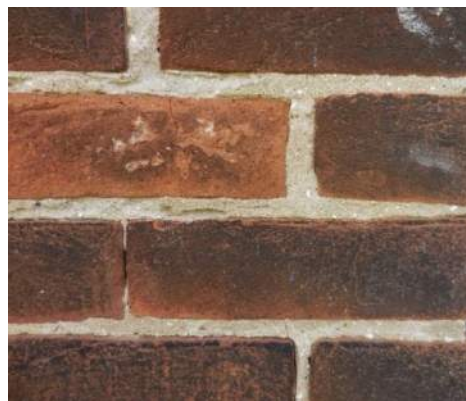
The mortar used for the brick and stone masonry walls is a lime based mortar utilizing a native aggregate material with lime inclusions (Figure EX-32). The mortar was not tested, but it is likely very soft and does not carry any great structural characteristics typical of contemporary Portland mortars.

Figure EX-32. Typical bricks, showing what appears to be original or early mortar with fine aggregate and lime inclusions. (Strata 2016)

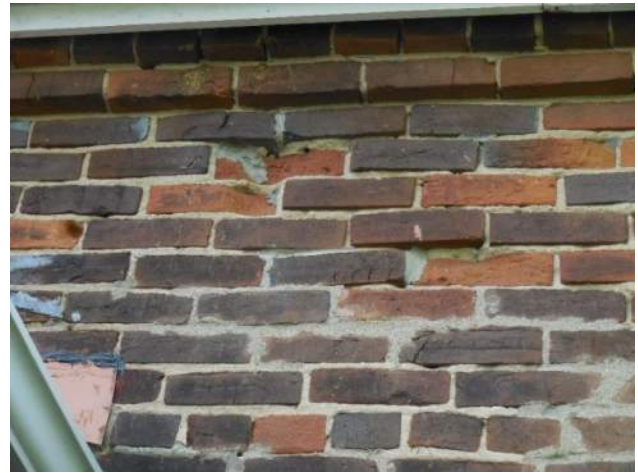
Figure EX-33. Typical bricks, showing the different colors of bricks and what appears to be original or early mortar. Note some of the softer bricks are deteriorated and areas have been patched and repointed with a Portland cement mortar that is too hard for the soft bricks. (Strata 2016)

The exterior brick masonry walls on the house and outbuildings are original and have witnessed very few changes since the original construction. The bricks walls of the house and milk house are in relatively good to fair condition with several of the softer bricks in very poor condition. The brick walls at the smokehouse are in poor condition, especially on the interior. The brick used for the construction of the smokehouse is a very soft brick.

There are signs of previous repointing campaigns throughout the exterior and interior of the masonry walls. Several campaigns of previous mortar repairs can be seen, including areas that appear to have been repointed with improper Portland mortar which is too hard for the soft bricks.

Cracks extend through the two wythes of bricks in the walls in several locations which indicates previous foundation settlement. There are several areas where daylight can be seen through the exterior walls from the inside of the house.

Where the downspouts are missing or the gutters overflow, the mortar is deteriorating from the joints. The house and outbuildings require spot repointing. The brick walls are soiled with concentrated areas under the window sills that are darker.

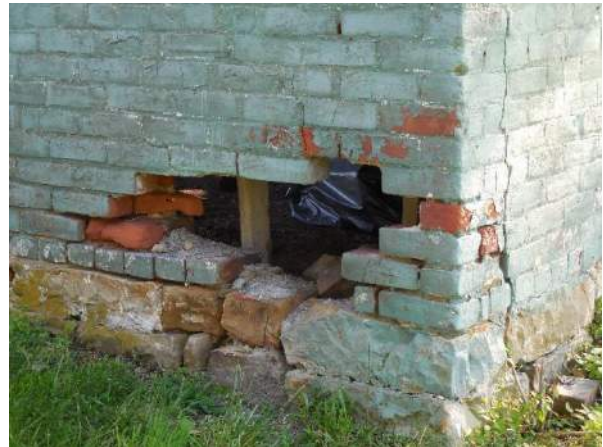
The exterior walls of the smokehouse and milk house are painted (Figure EX-34). The paint is latex and is trapping moisture in the brick walls. Historic photographs in the 1920s indicate that the outbuildings were painted or whitewashed.

Figure EX-34. Typical green painted walls at the brick smokehouse. (Strata 2016)

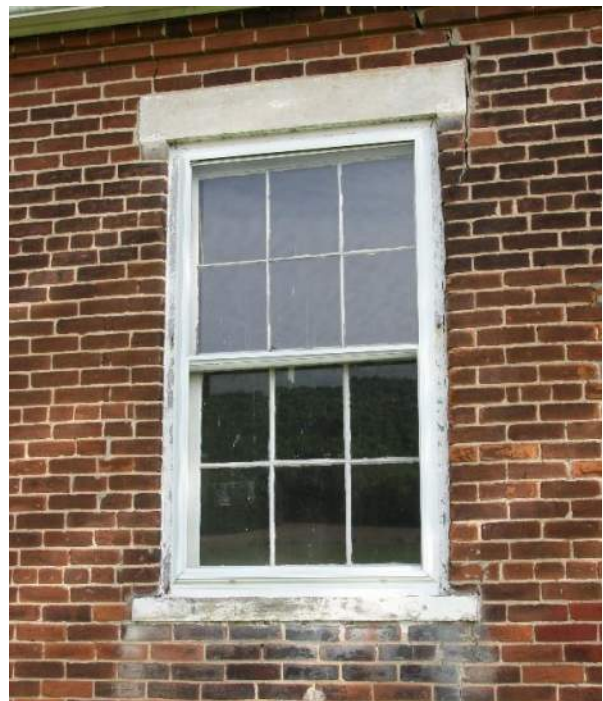
Cut stone lintels and sills are installed at windows and doors (Figure EX-35). The cut stone appears to be a native limestone and has been painted white. The lintels and sills have been painted white. The paint is deteriorated and flaking. The presence of the paint makes it difficult to assess the condition of the lintels and sills.

Figure EX-35. Cut stone lintel and sill, typical, Window 100. (Strata 2016)

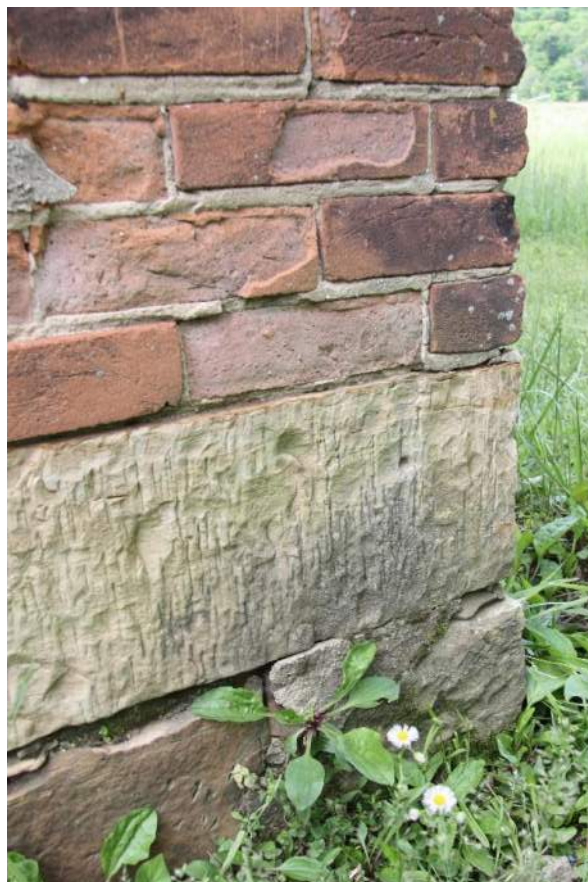
At the house, the brick walls rest on a native cut stone foundation which is exposed above grade for approximately five inches to thirteen inches at the perimeter (Figure EX-36). The cut stones are a veneer with back-up rubble stone walls. The stone appears to have a slight vertical tooled finish to even out the natural texturing. Signs of settlement occur at the northeast corner where the corner of the house has begun to rotate. This is further discussed in the Structural Existing Conditions section of this report. The foundation is in fair condition with some settlement cracks and is missing mortar throughout. The foundation is lightly soiled.

Figure EX-36. Typical stone and brick deterioration at southeast corner due to water infiltration. Note the vertical tooling on the stone foundation. (Strata 2016)

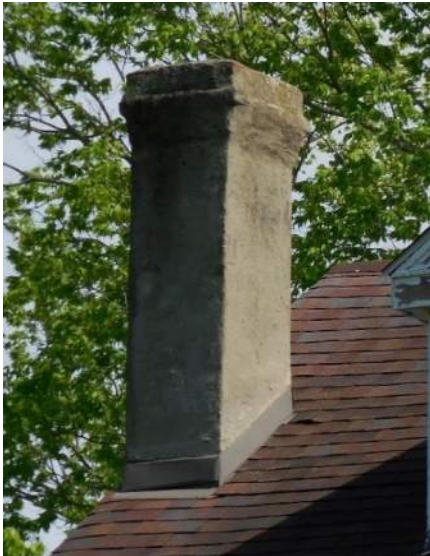
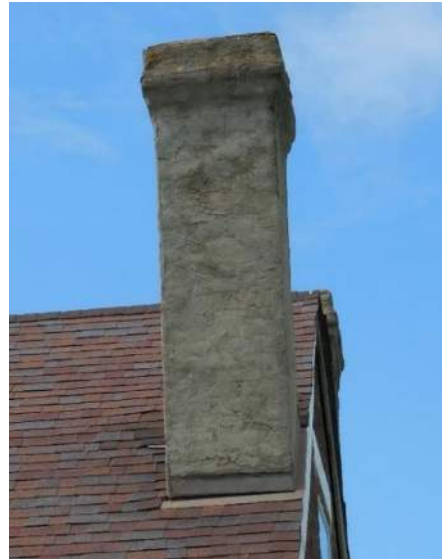
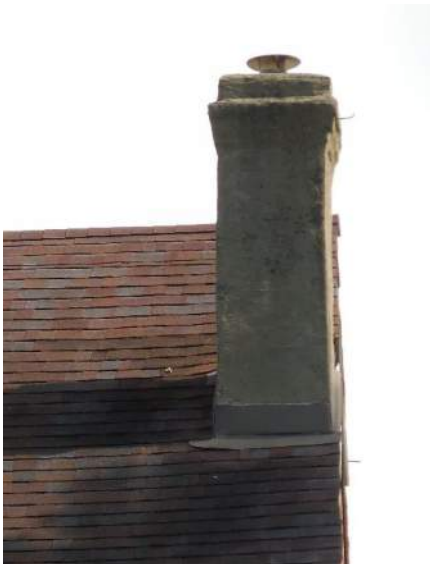
There are five brick chimneys at the main house. Three of the brick chimneys that are covered in stucco are in very poor condition (northwest, northeast and southeast chimneys – Figures EX-37, EX-38 and EX-39). It is likely they were covered in stucco due to advanced deterioration of the soft bricks. The stucco finish that was installed on the exterior has minor cracking which allows water infiltration. Hard, cementitious stucco also retains moisture within the bricks leading to further deterioration of the bricks. The flashing at the perimeter of the chimneys on the main part of the house is failing. The cap conditions are unknown for the northeast and southeast chimneys. Due to the amount of debris in the southeast chimney, it is assumed this chimney flue is open. The northwest chimney has a vent pipe and cover from a previous stove installation.

The chimneys are in overall poor condition. All four of the chimneys at the main house are failing at the perimeter flashing, causing significant interior damage to the second floor. These require immediate repair.

Figure EX-37. Northeast chimney. (Strata 2016)

Figure EX-39. Southeast chimney. (Strata 2016)

Figure EX-38. Northwest chimney. (Strata 2016)

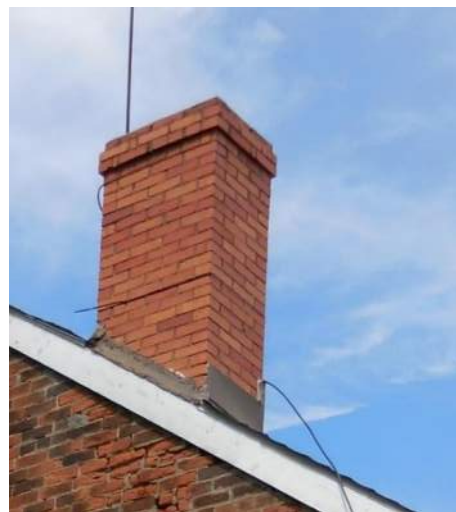
The southwest chimney has been reconstructed in the twentieth century (Figure EX-40) and the kitchen chimney has also been reconstructed and has a concrete cap (Figure EX-41). The two reconstructed chimneys were built of brick that does not match the historic handmade bricks. The southwest chimney has a vent pipe from an old furnace installation installed.

Figure EX-40. Southwest chimney. (Strata 2016)

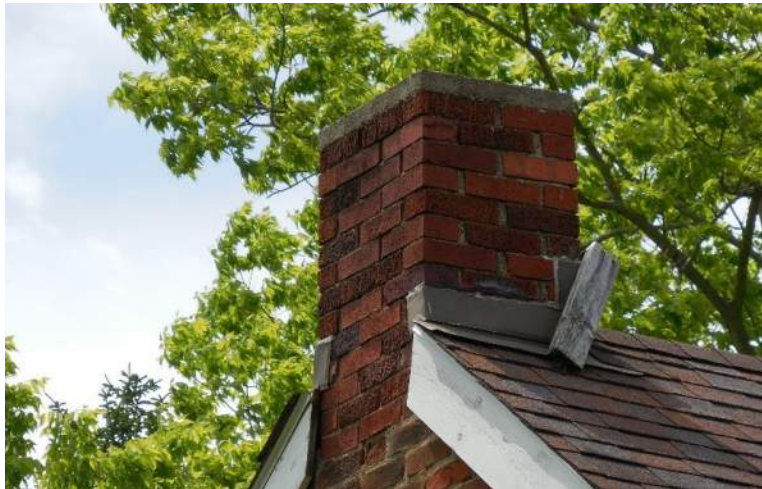
Figure EX-41. Kitchen chimney. (Strata 2016)

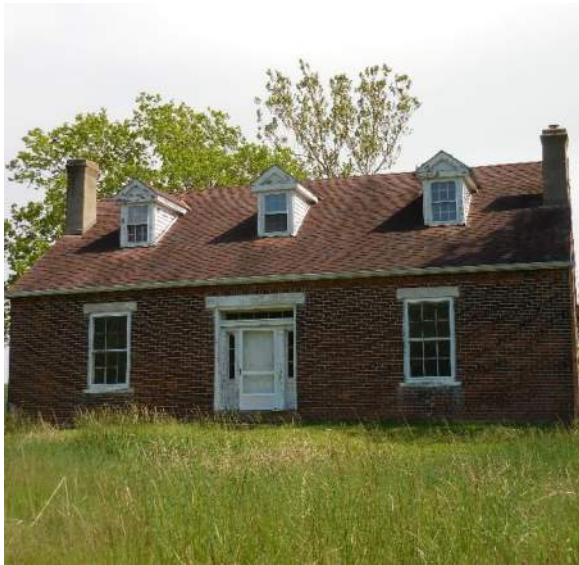
Three dormers are located on the north-facing roof. The dormers were last rehabilitated in 1995.²³⁰ The dormers are wood frame construction with wood trim, lap siding and a pedimented gable (Figures EX-42 – EX-45). The windows are wood 6/6 double hung. The wood trim and lap siding at the three dormers are in various states of deteriorated condition. The wood towards the tops of the dormers and side walls is in good condition, while the base of the trim and the wood window sills on the fronts of the dormers are in poor condition and require immediate replacement. The jambs of the central Window 202 require replacement, as well.

Figure EX-42. Dormers at north side of house.
(Strata 2016)

The three dormers require prepping, priming and painting of all wood surfaces. The metal exterior storm windows are in poor condition and need to be replaced. The space between the storm and wood windows are full of wasp nests. The wood double hung window sashes are in fair condition with deteriorated paint, deteriorated glazing putty and some wood rot.

The flashing at the side walls is unsightly and is not properly installed to shed water which will lead to water infiltration at this joint. When the roof is replaced, the siding needs to be removed and reinstalled to provide flashing behind the wood siding.

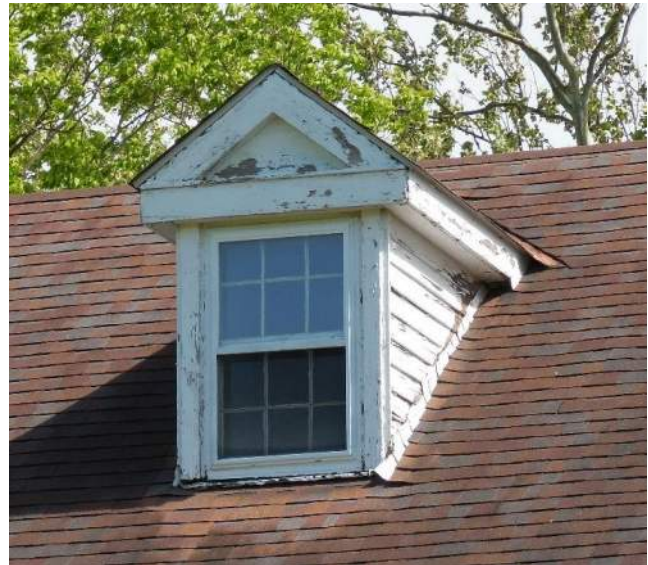
Figure EX-44. Detail of the center dormer and Window 202. The trim is deteriorated and the window requires restoration. Note the side wall flashing installation is unable to shed water effectively.
(Strata 2016)

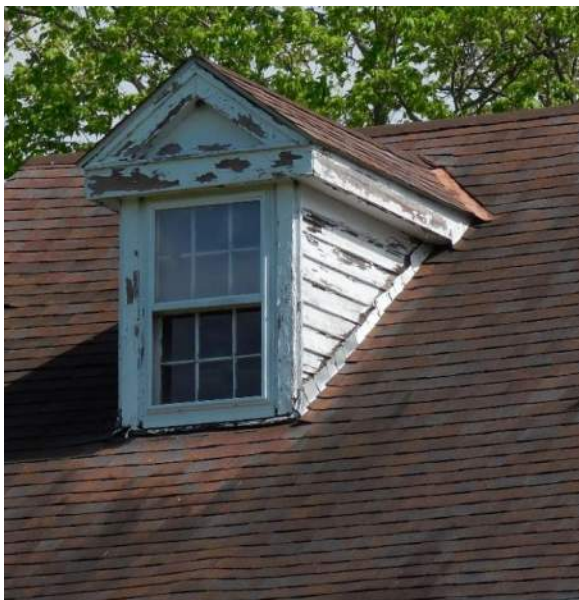
Figure EX-43. Detail of the eastern-most dormer and Window 203. The trim is deteriorated and the window requires restoration. Note the side wall flashing installation is unable to shed water effectively. (Strata 2016)

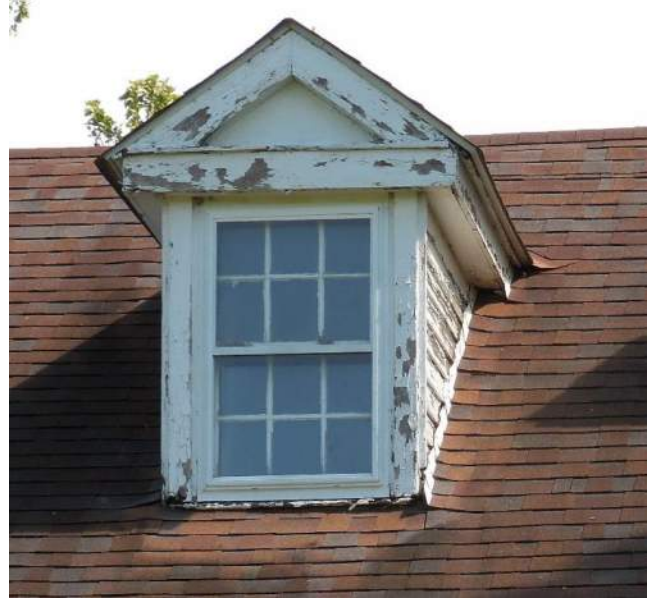
Figure EX-45. Detail of the western-most dormer and Window 201. The trim is deteriorated and the window requires restoration. Note the side wall flashing installation is unable to shed water effectively.
(Strata 2016)

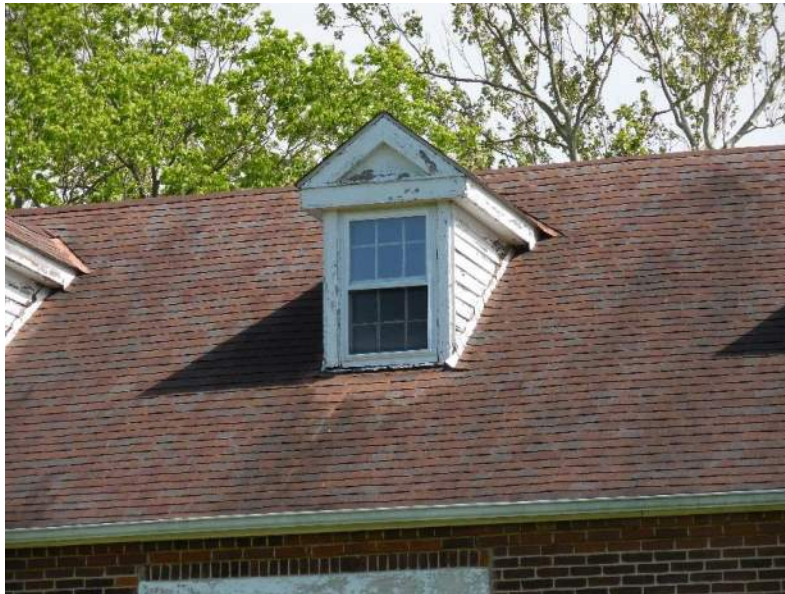
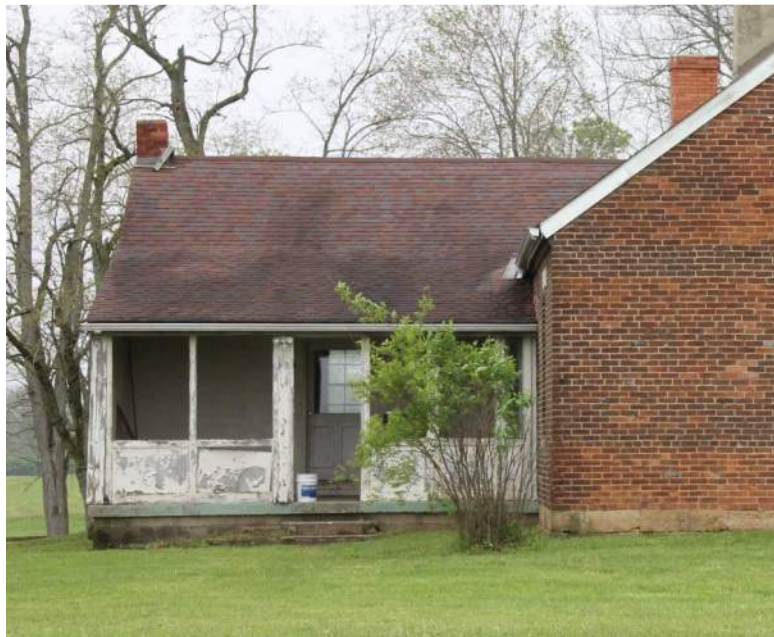
Contemporary pre-finished aluminum K-style gutters are installed on the house, but the downspouts are missing (Figures EX-46 – EX-51). The lack of downspouts results in water from the gutters streaming down the side of the building and collecting at grade. The soil below the gutters where the downspouts are missing is depressed, which allows the pooling of water. This pooling water infiltrates the surrounding soil slowly, and eventually migrates into the foundation walls. The water running down the brick walls pools and splashes back onto the building, keeping the walls damp. The consequence of missing downspouts can most significantly be seen at the northwest corner, where the foundation has settled, resulting in cracked masonry. This water infiltration can be seen at each corner where the downspouts are missing. New downspouts had been delivered to the site prior to the last site visit in August 2016, but they had not yet been installed.

Figure EX-46. Existing asphalt shingle roof on north side of the house. (Sheals 2016)

Figure EX-47. Existing asphalt shingle roof on rear ell of house. (Sheals 2016)

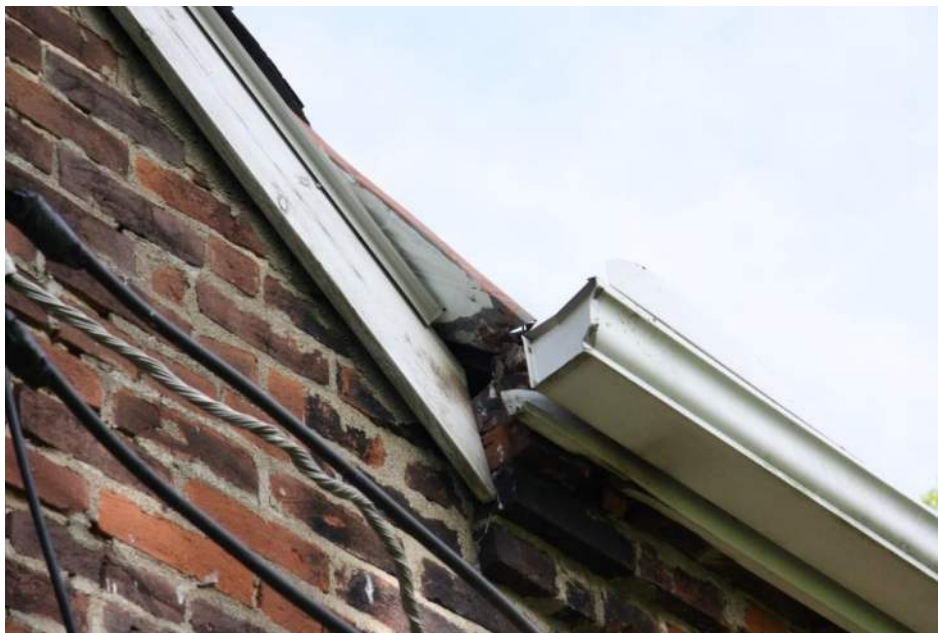
Figure EX-49. Detail of flashing transition at the west upper roof to the kitchen roof. This is an awkward transition and there is a resultant hole under the flashing which leads into the attic. This requires further inspection and new flashing detailing. (Strata 2016)

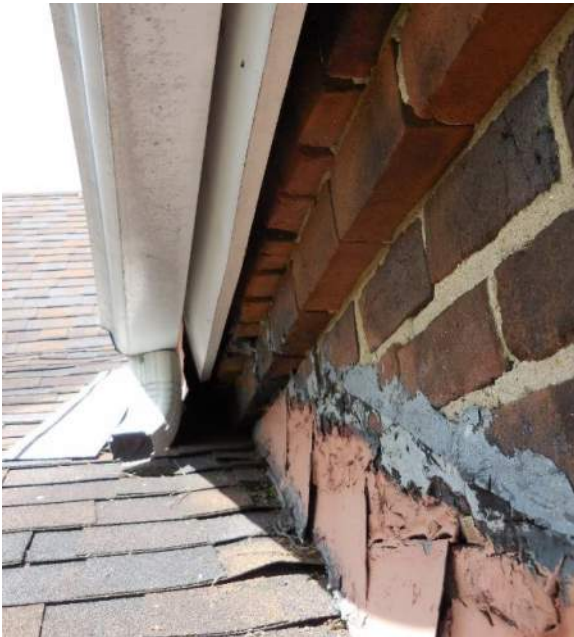
The roof was installed with open valleys at the rear ell and main roof connection. The roof itself is not leaking; however, the area where flashing is installed is leaking (Figure EX-52). The flashing installation does not meet Sheet Metal & Air Conditioning Contractors' National Association (SMACNA) recommendations for flashing and counterflashing installation details and in some cases, appears to funnel water into the structure rather than direct it away. Leaks are prevalent at the perimeter of the chimneys. This may be due to the lack of saddles or crickets behind the chimneys which would help direct water away, but it is more likely that the flashing and counterflashing at the mortar joints have failed. Sidewall flashing at the back porch roof is deteriorated and relies on sealant to keep water out of the joints (Figure EX-50).

Figure EX-50. Detail of rear porch roof connection to the main house. Note the flashing is pulling away from the building and has several layers of sealant installed. The downspout from the upper gutter is very short and does not direct the water far enough away from the side wall. (Strata 2016)

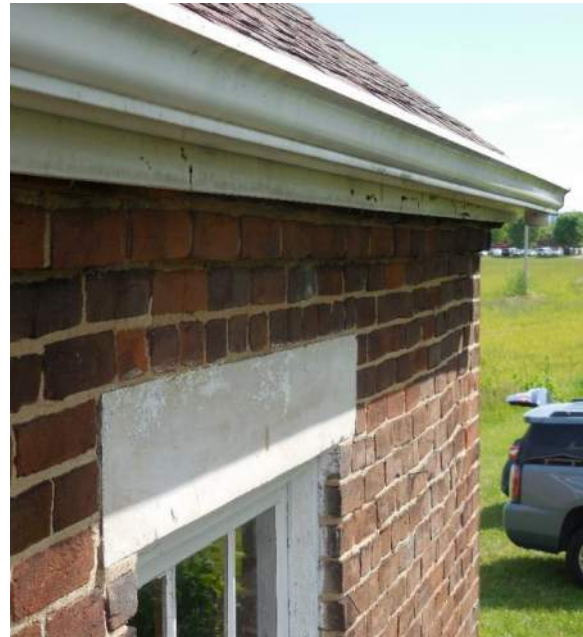
Figure EX-51. Detail of rear wood fascia and contemporary K-style gutter. Note, the downspout is missing. (Strata 2016)

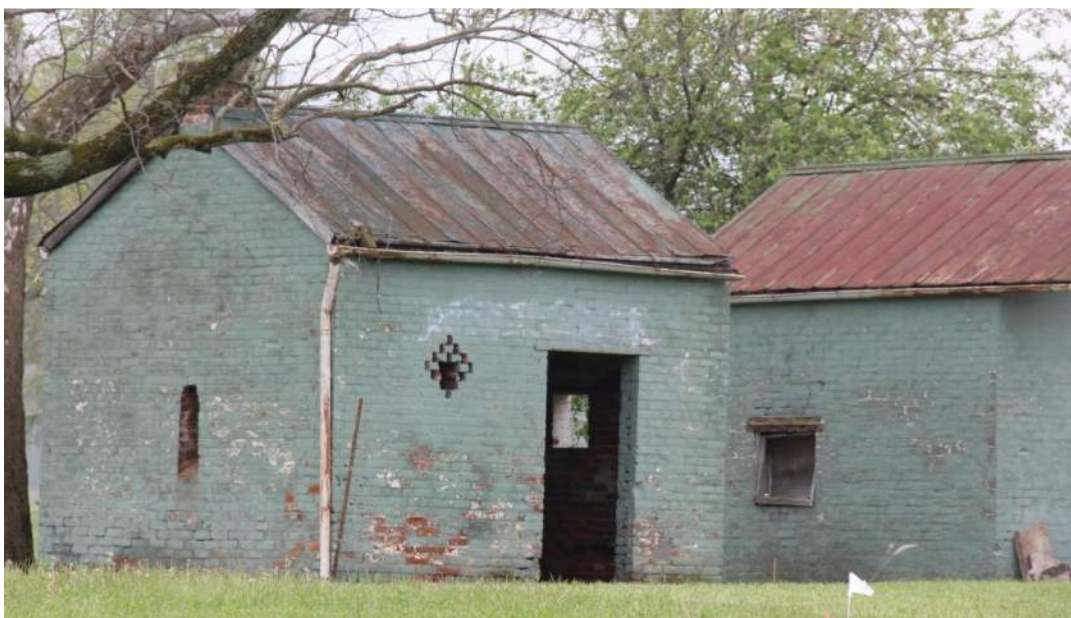
The metal roofs on the smokehouse and milk house may have been installed at the same time as the metal roof on the house (Figure EX-52). The exact date of installation is unknown, but these metal roofs are first seen in 1927 photographs. In these photographs (Figures 29 and 30), the roofs are well worn and showing signs of age. It is therefore very likely that these were installed prior to the 1920s. Both structures were most likely roofed with wood shingles to match the house, as evidenced by the wood skip sheathing. The metal roofs on these buildings are in poor condition. The smokehouse roof has holes through the roofing and is deteriorated at the edges. The existing gutters are painted steel, 4-inch diameter, half-round and the downspouts

are 4-inch round. They are hung with twisted steel wire hangers. The gutters and downspouts are deteriorated and partially missing and require complete replacement.

Figure EX-52. Metal roofing, half-round gutters and round downspouts at the smokehouse and milk house. (Strata 2016)

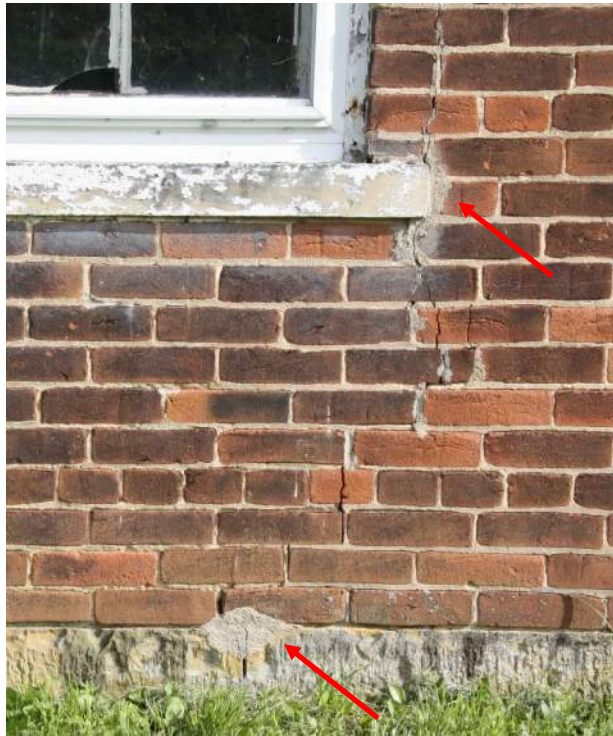
The cut stone lintels and sills are difficult to assess because they have been painted, but they appear to be in good condition (Figures EX-54, EX-55 and EX-57). The paint is flaking.

Figure EX-55. Examples of incompatible Portland cement-based mortar below Window 101, north elevation. (Strata 2016)

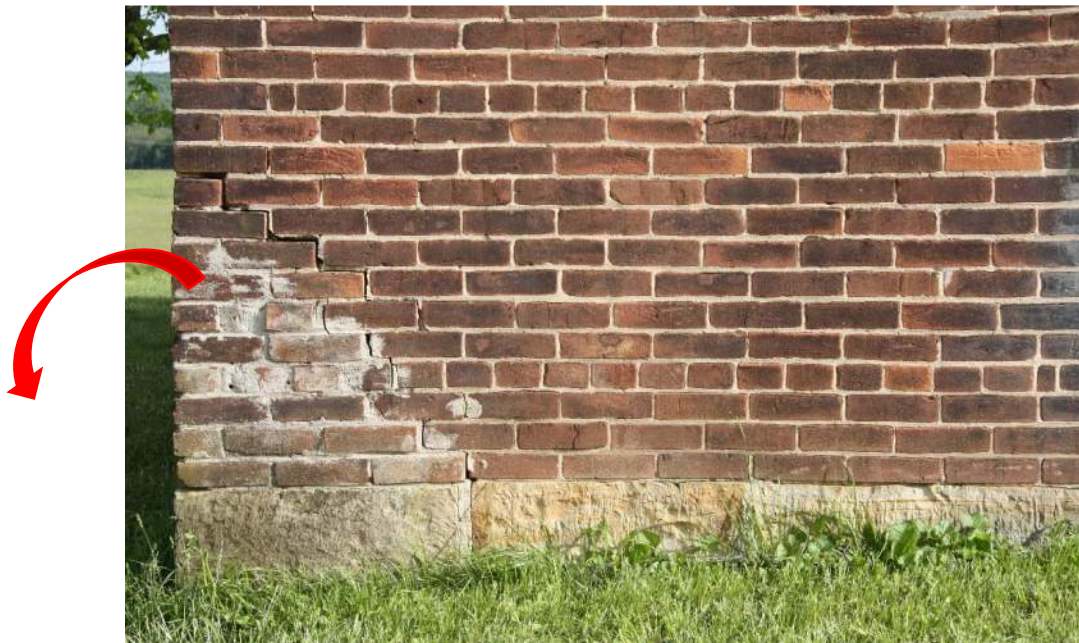
The condition of the chimneys, roofing, guttering and downspouts are discussed in the Exterior Materials section of this report. The downspouts are missing from each corner, causing significant water damage to the foundation and brick walls. The ground below the missing downspouts is eroded and holds water when it rains. This water is the cause of the settling foundations at the corners of the building.

Figure EX-56. Northeast corner settlement, north elevation. The foundation in this area has settled and the corner is rotating outward. (Strata 2016)

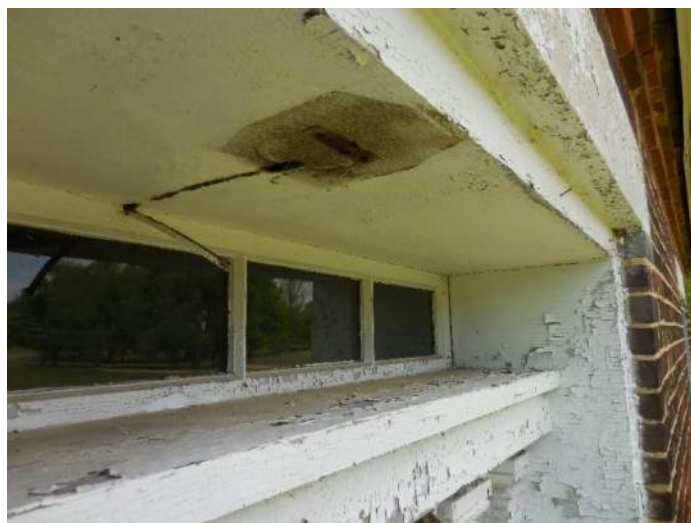
Figure EX-58. Detail of the transom at the front door surround. Note the exposed wiring from a previous light fixture installation. The transom glass appears to be original. (Strata 2016)

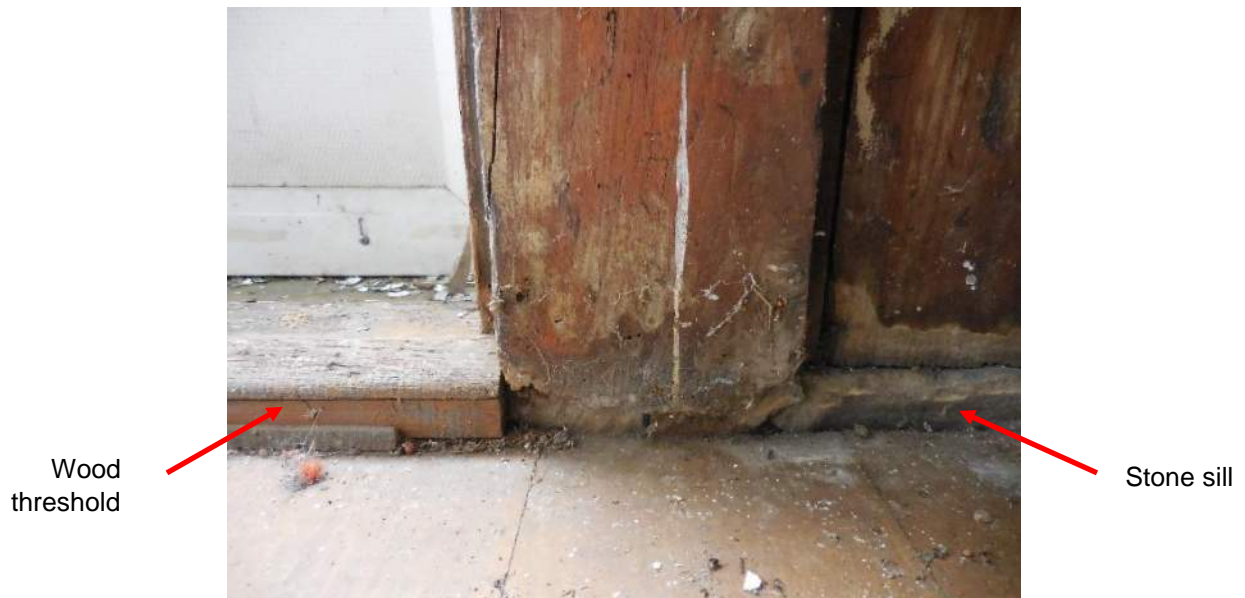
Figure EX-61. Interior detail of the front door trim resting on the stone sill. The base of the trim is deteriorated. The wood threshold is a replacement. (Strata 2016)

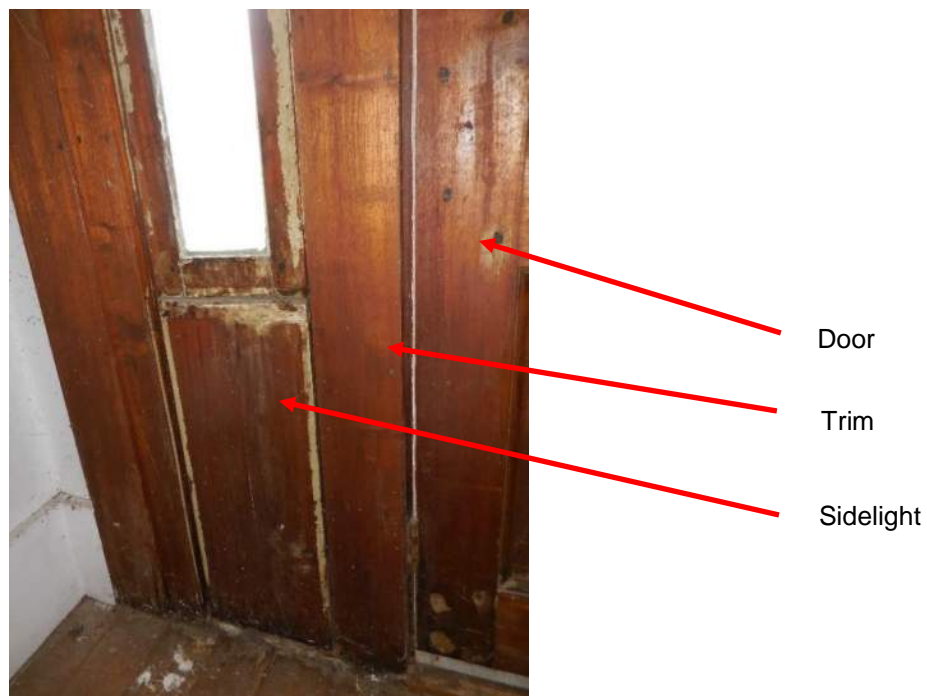
Figure EX-62. Interior detail of the water infiltration and deterioration at the front door sidelights. The residue on the wood is from some type of sealer tape, presumably used to stop drafts. The interior of the door surround is quite primitive and does not have any fine millwork detailing. It appears to be all original (Strata 2016)
