THOMAS BLACKSTONE HOUSE

HISTORIC STRUCTURES REPORT

SEIP EARTHWORKS UNIT – HOPEWELL
CULTURE NATIONAL HISTORICAL PARK
BAINBRIDGE, OHIO

APRIL 17, 2017
NPS PMIS # 218963

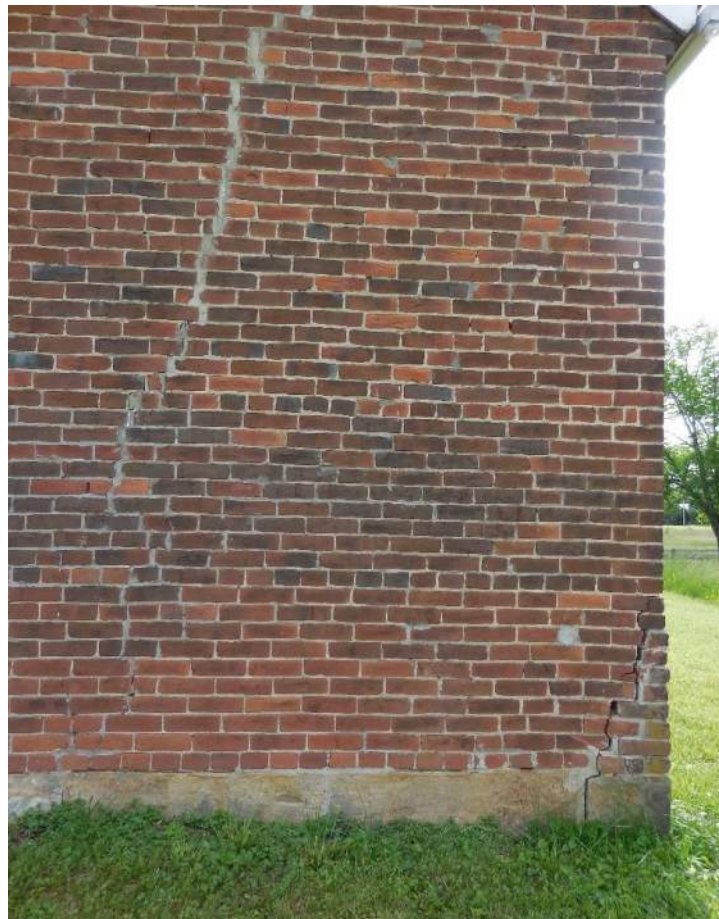
The most noticeable crack in the brick wall is located at the northeast corner (Figure EX-64). This was discussed in the North Elevation section above and is due to water infiltration and foundation settlement. A similar, but smaller crack is located at the southeast corner, also due to foundation settlement, brought on by a missing downspout (Figure EX-65). A large vertical crack is in the northern part of the first floor which has previously been repaired with incompatible mortar (Figure EX-64). A second crack with smaller cracks branching off is located below the window, stretching from the first floor to the underside of the window. Daylight can be seen through the wall from inside the fireplace chimney flue in the East Parlor 101. At the smoke shelf, the exterior brick wall is only a single wythe. This area requires both interior and exterior repointing. The masonry wall is in fair to good condition but is missing mortar throughout, containing deteriorated bricks and through-wall cracks.

Figure EX-64. East elevation cracks at north end of wall. (Strata 2016)

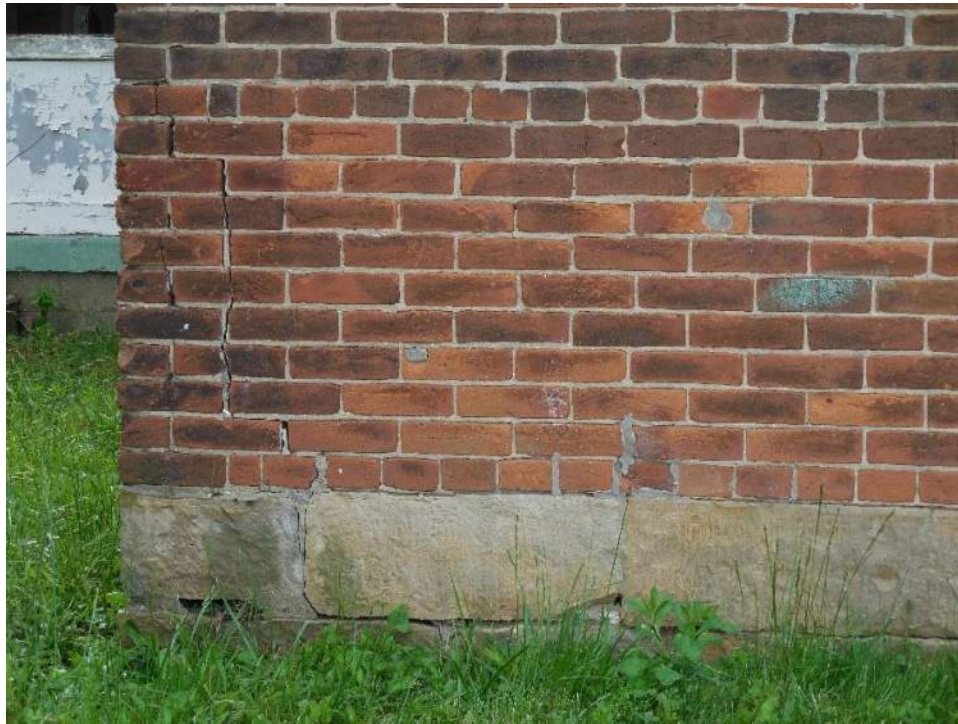
Figure EX-65. East elevation crack at south corner of wall. (Strata 2016)

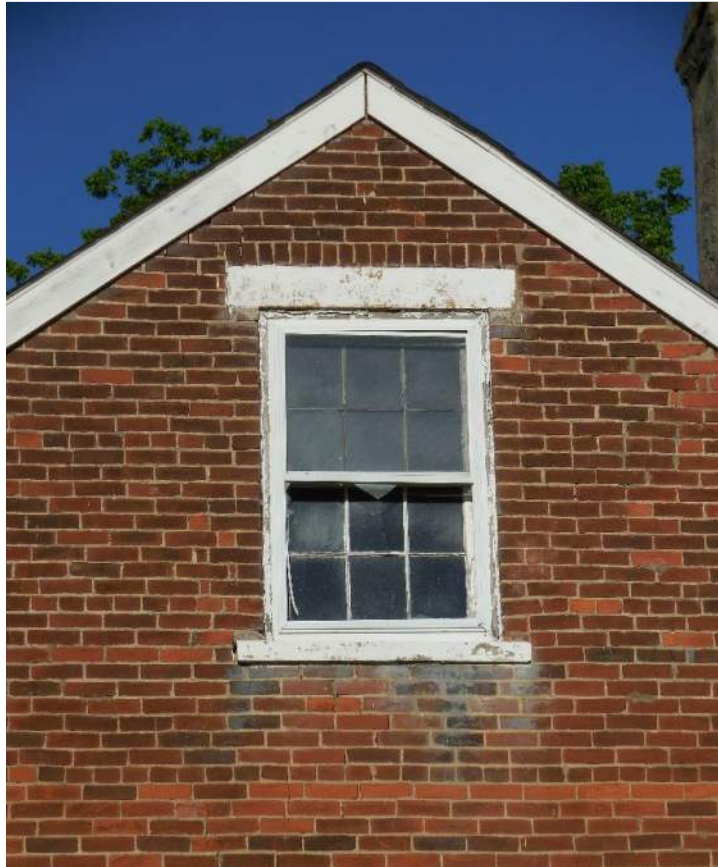
Window 204 at the second floor is covered with contemporary metal storm window which is broken and is not offering protection to the historic window, allowing water to enter the wall through the deteriorated wood sill and jambs (Figure EX-66). The window sill and frame have shifted for an unknown reason and have rotated to project outside of the wall at the lower left corner of the window sill. This rotation may be partially due to water infiltration and freezing and thawing, resulting in the expansion of the masonry and mortar within the wall. The window sashes, sill and jambs are deteriorated and have significant paint loss. The deterioration includes the glazing putty, wood rot and broken glass. The joints at the perimeter of the window frames in contact with masonry have deteriorated sealant. The window conditions are discussed in greater detail in the Materials section of this report and documented in the Window Schedule.

Figure EX-66. East elevation, detail Window 204. (Strata 2016)

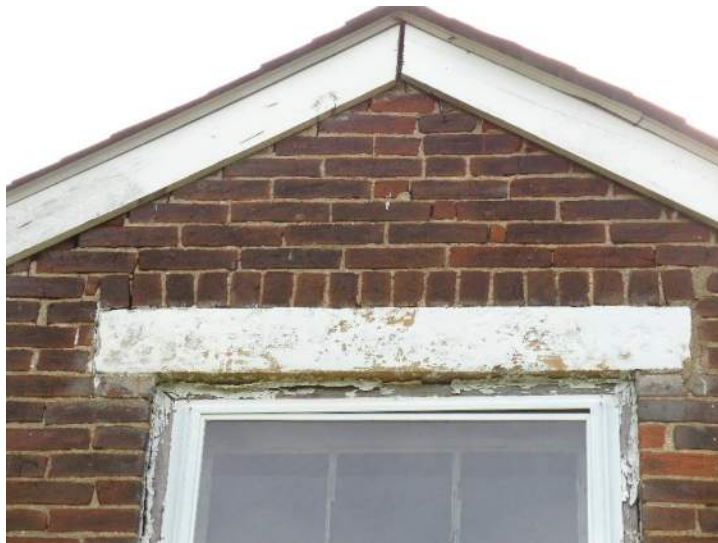
The brick masonry of the east wall is laid in a running bond pattern with header rows every tenth course. The top of the gabled wall is lined with a 1x wood barge board that is not original, but likely replaced in 2000 (Figure EX-67). The board does not meet at the ridge line and likely allows water into the brick wall at this location.²³² In general, the bricks are in fair condition with some of the softer bricks starting to deteriorate. The brick mortar appears to be a combination of

Figure EX-67. East elevation, detail above Window 204. Note that the barge board does not meet at the ridge line. (Strata 2016)

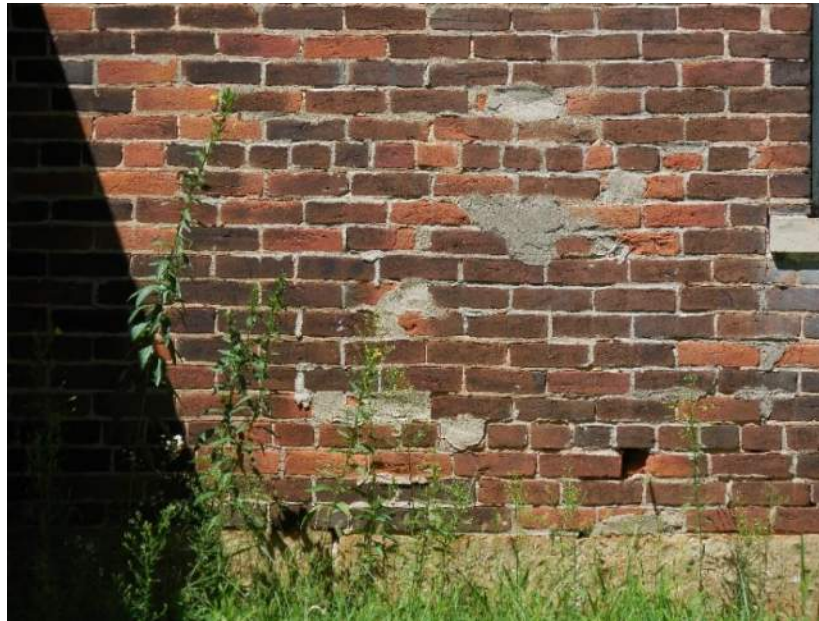
Figure EX-72. Deteriorated and patched bricks, south wall, adjacent to Window 102. (Strata 2016)

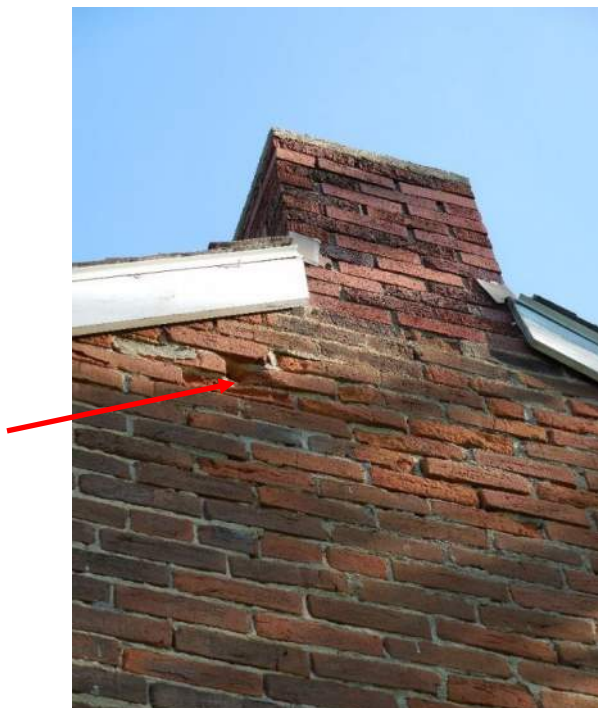
Figure EX-73. Kitchen (south) chimney. Note, the arrow points to a hole drilled through the wall. (Strata 2016)

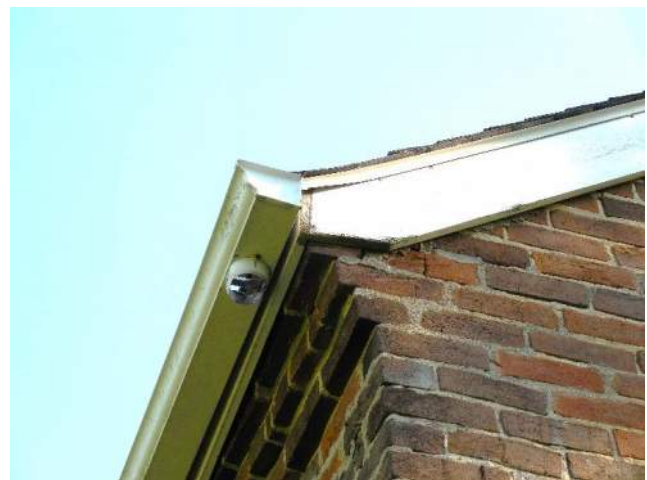
Figure EX-74. Southwest corner of the kitchen wing with corbeled brick cornice. (Strata 2016)

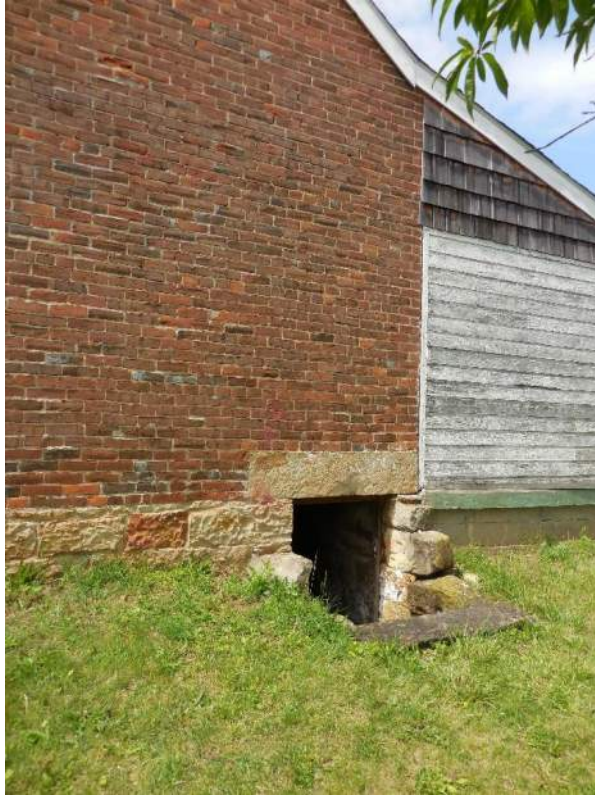
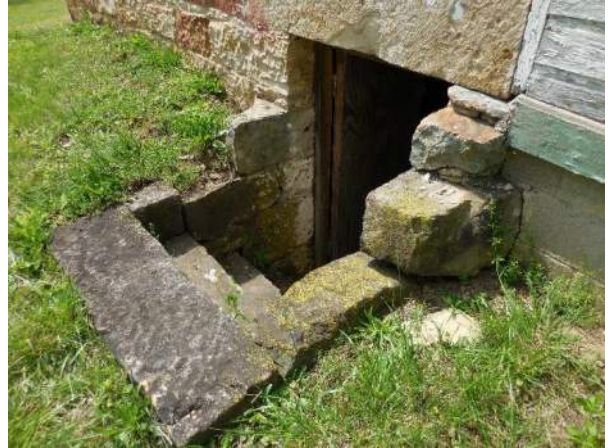
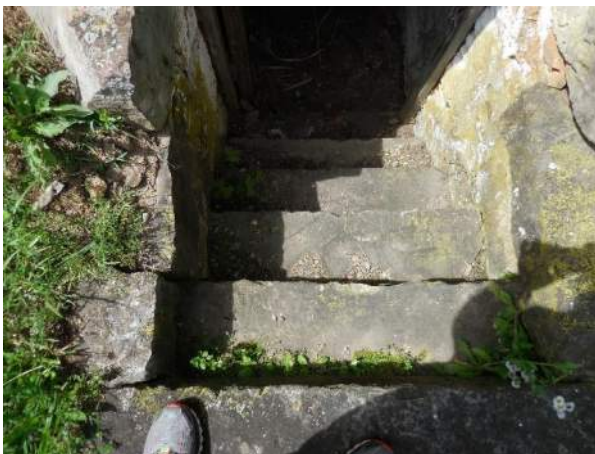
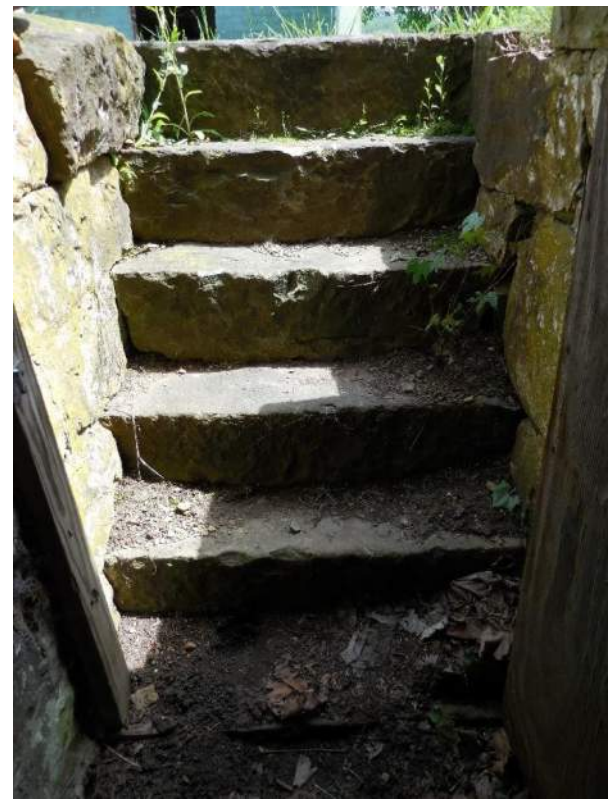
Figure EX-75. Basement stair. (Strata 2016)

The basement stairs are constructed of large cut stone blocks, matching the foundation (Figure EX-75). The six treads are set into grade with stacked stone retaining walls on either side. The side wall foundation stones are toothed into the house foundation walls. A very large stone lintel spans the door opening. The contemporary wood door frame is unfinished 2x4 construction. The door is a wood frame door clad with unfinished plywood. The basement door and frame are meant to be temporary. In the 1927 photograph of the rear of the house, (Figure 30) this exterior basement areaway appears to have been covered with a slanted wood bulkhead door.

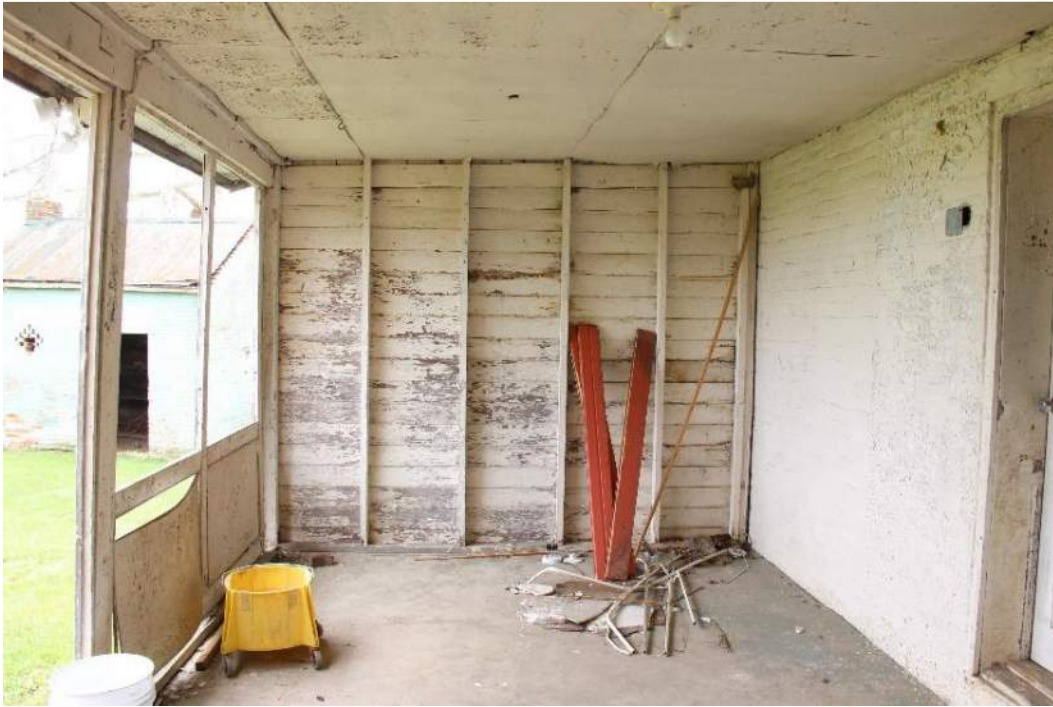
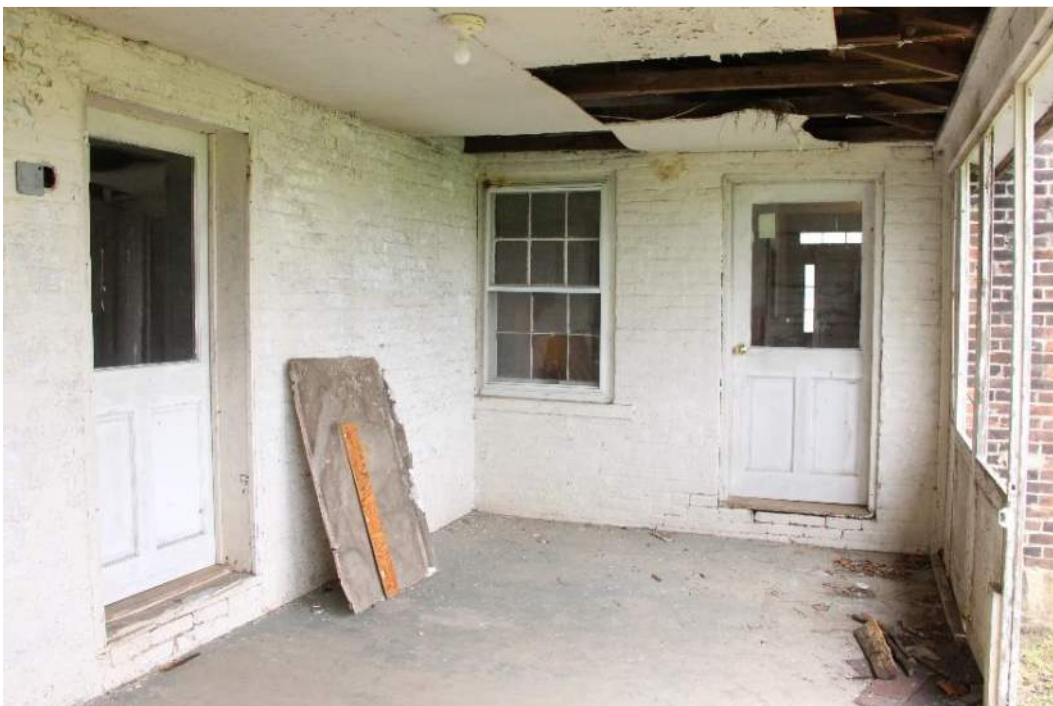
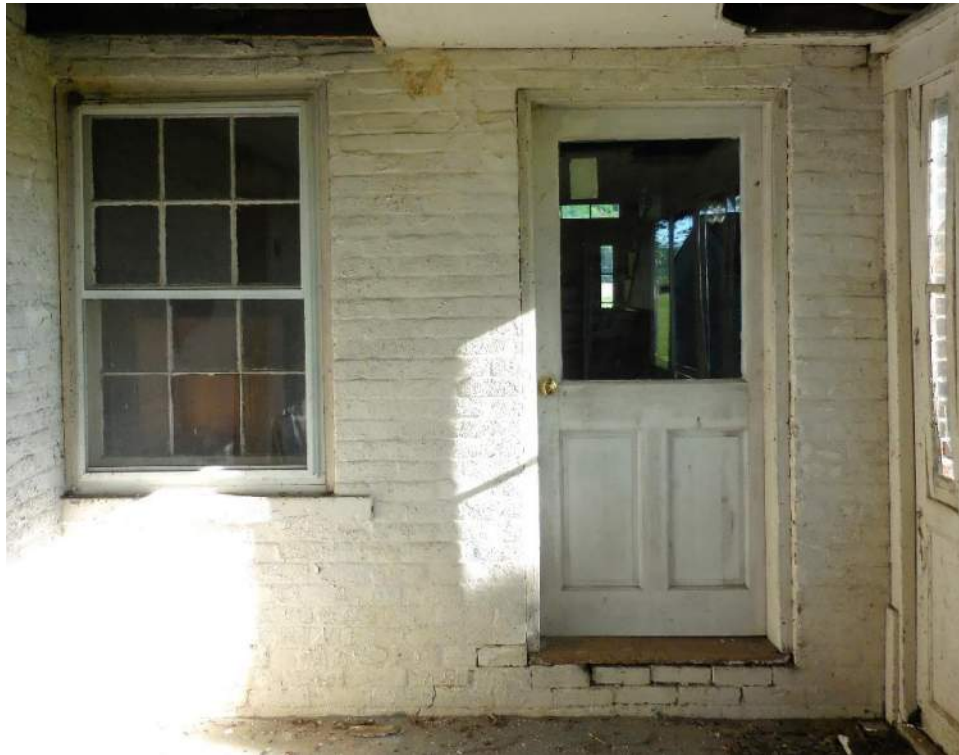
The existing wood frame porch walls and supports along the east wall are in deteriorated condition overall. The door and screening is missing, the wood panels are deteriorated and warping, and the base of the columns are rotten (Figures EX-80 and EX-81). This back porch wall requires stabilization and is further discussed in the Structural Existing Condition section of this report.

Figure EX-76. Back porch, looking south. (Strata 2016)

Figure EX-77. Back porch, looking northwest at Door 1/105, Window 103 and Door 2/100. (Strata 2016)

Figure EX-78. Back porch south exterior wall, looking at Window 103 and Door 1/200. (Strata 2016)

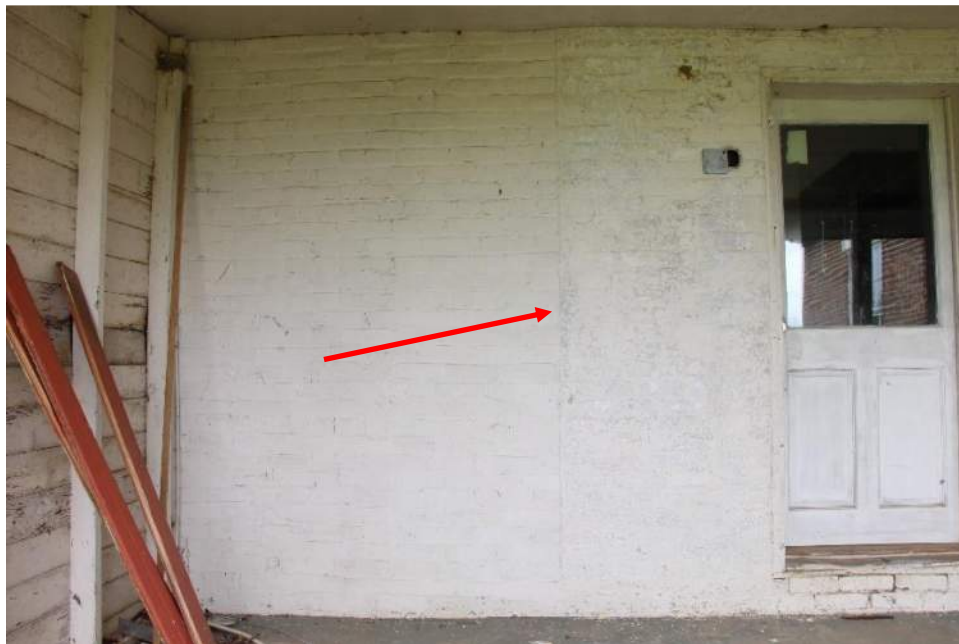
The south elevation and east elevation brick walls within the porch structure are painted white with several layers of paint. A defined line in the paint finish, located between the kitchen door and the south porch wall, indicates that there was likely a partition wall in this location, as the paint to the south of the line is very thick (Figure EX-79). The wall paint is peeling and in very poor condition. A previous wall light adjacent to the north door has been removed and a junction box remains.

Figure EX-79. Back porch, east exterior wall. The arrow points to the defined line in the paint, indicating a previous wall may have been present in this location. (Strata 2016)

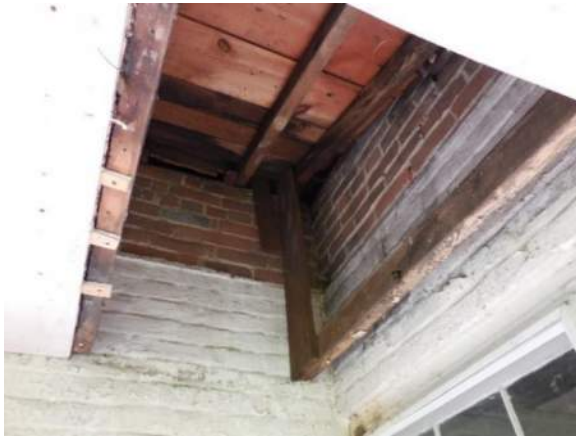
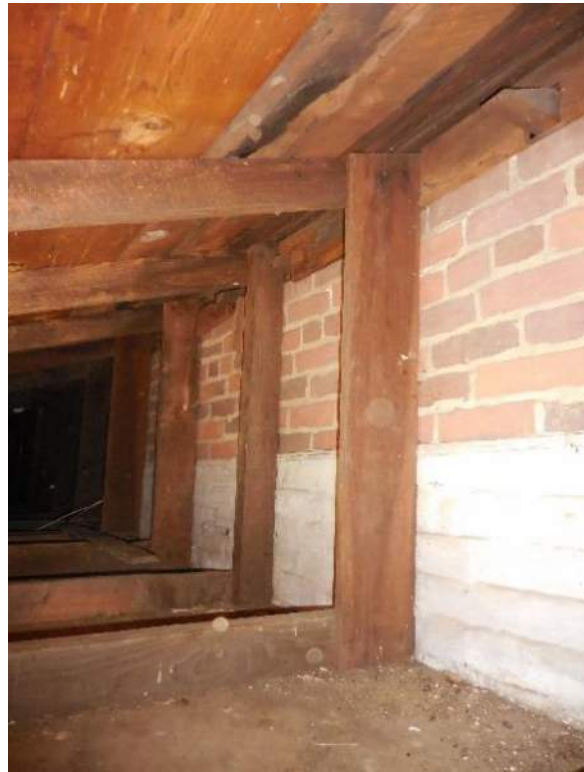
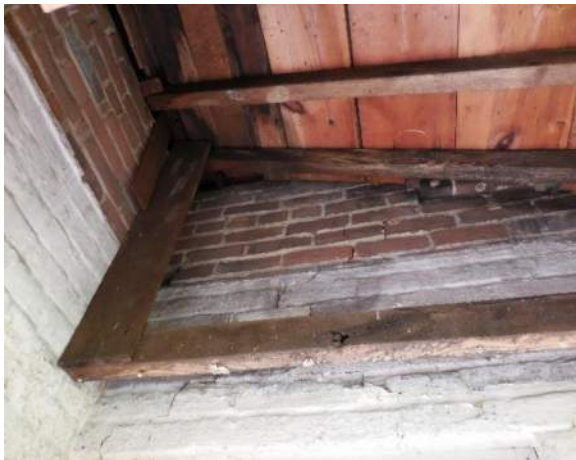
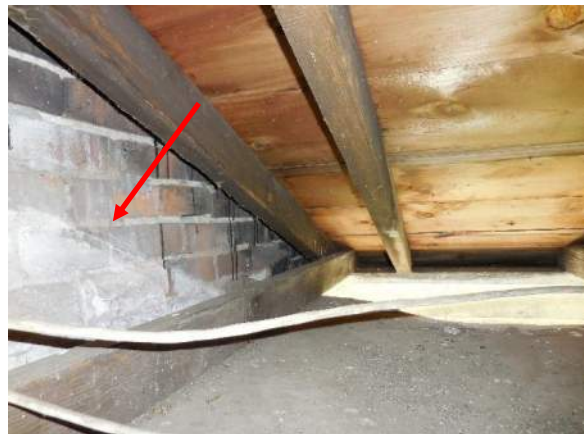
Figure EX-80. Back porch, opening in the ceiling to view porch roof framing. Note the defined lines of the white paint, which would have been the height of the previous porch ceiling. (Strata 2016)

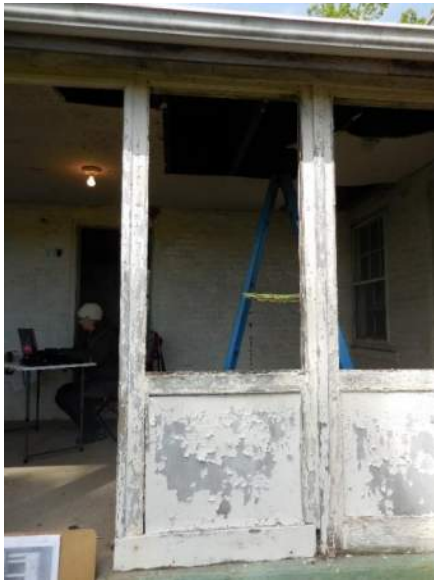
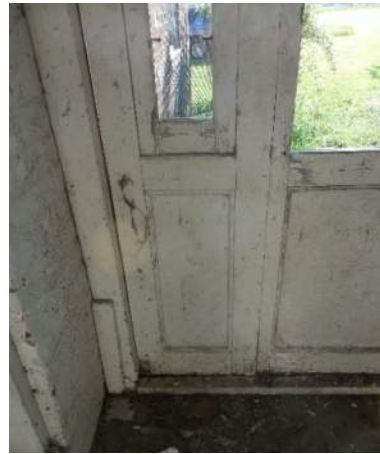
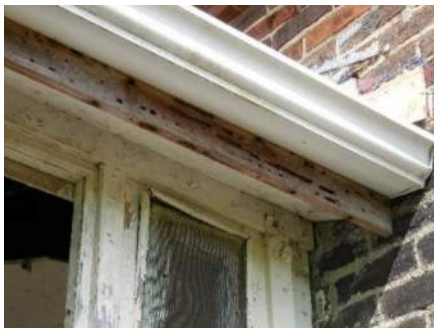
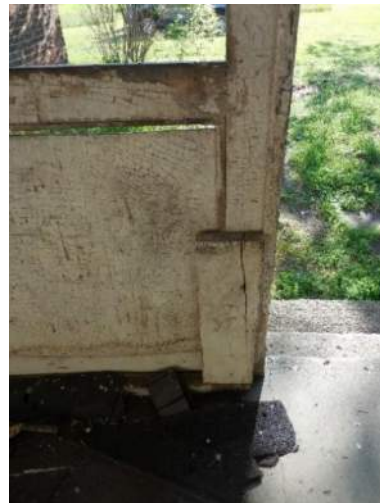
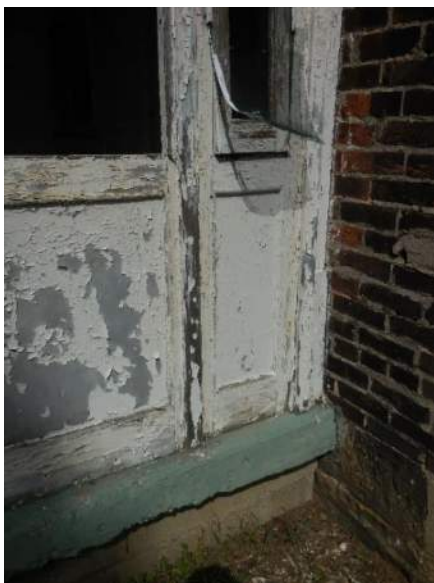
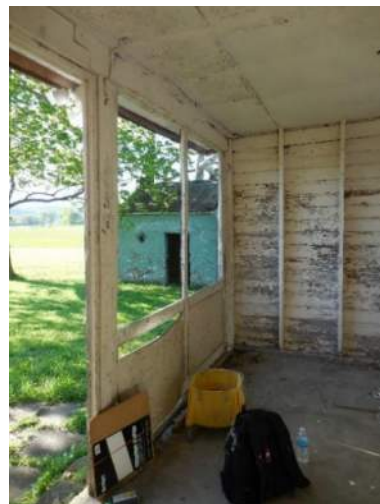
Figure EX-81. Details of deteriorated porch wall structure. (Strata 2016)

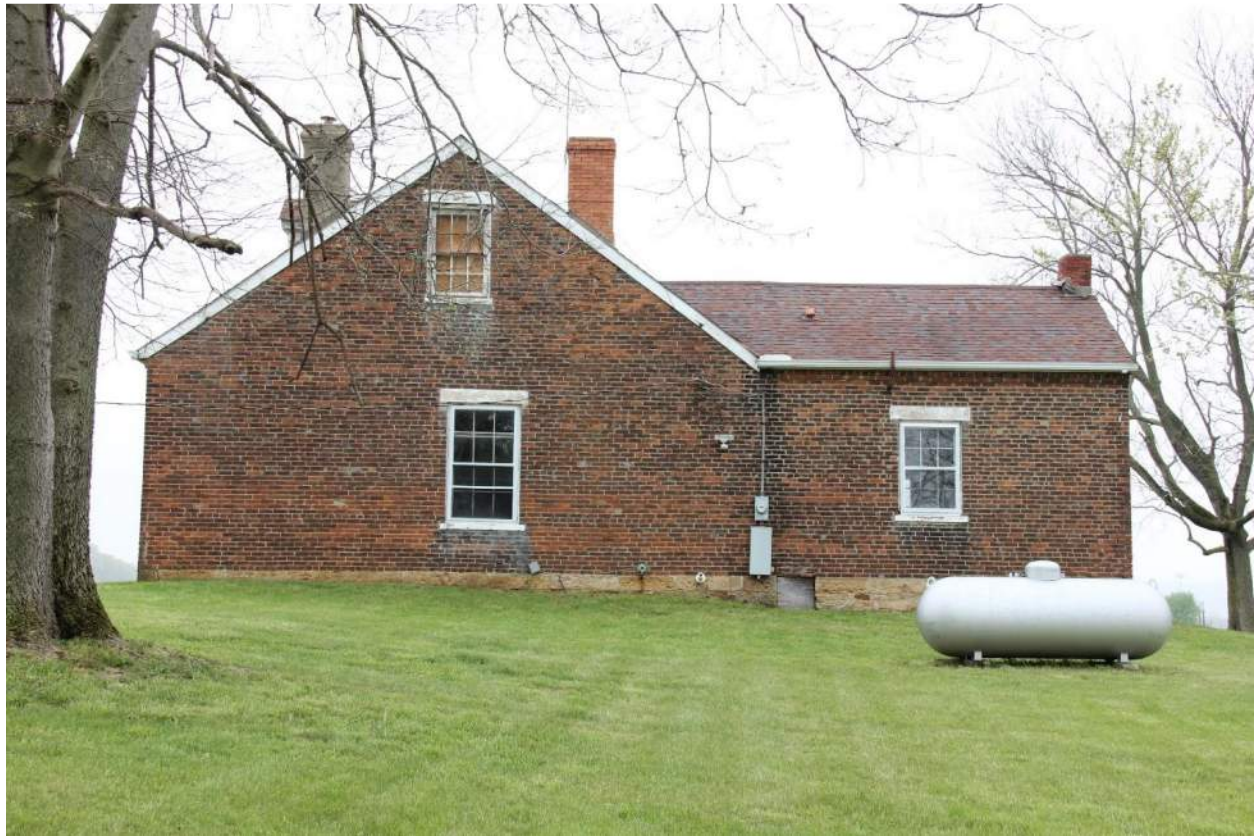
Figure EX-82. West elevation. (Sheals 2016)

There are several cracks throughout the west wall. The crack at the northwest corner is due to foundation settlement and shows signs of previous repairs. This was discussed in the North Elevation section above and is due to foundation settlement. A similar vertical crack is located several feet south of the corner crack. A crack below the second floor window extends almost to the lintel of the first floor window. Another small crack is located below the first floor Window 105. A small crack is also located at the upper right of the kitchen Window 104. The bricks exhibit similar masonry deterioration to the other exterior walls. Mortar is missing and bricks are deteriorated at the southwest corner where the downspout is missing. The bricks spanning the basement window openings are failing due to a lack of a lintels. Mortar is missing along the barge board at the gable end of the wall and in other select locations.

Daylight can be seen through the west wall where the West Parlor 103 fireplace is located. At the smoke shelf, the exterior brick wall is only a single wythe of brick. This area requires both interior and exterior repointing. A large section of deteriorated brick is located below the southwest chimney at the main gable wall.

The masonry wall is in fair to good condition but is missing mortar throughout, containing deteriorated bricks and through-wall cracks.

The condition of the chimneys, roofing, guttering and downspouts are discussed in the Exterior Materials section of this report. The downspouts are missing from each corner. These missing downspouts are causing significant water damage to the foundation and brick walls. The ground below the missing downspouts is eroded and holds water when it rains. This water is the cause of the settling foundations at the corners of the building.

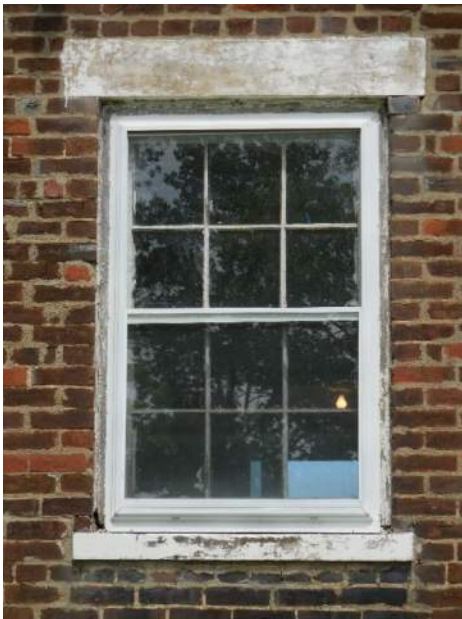
The three wood double hung windows on the west wall are in varying states of disrepair. The kitchen Window 104 is covered with a metal storm window (Figure EX-83). The jambs and sill are deteriorated and the sashes require restoration. The dining room Window 105 is also protected with a metal storm window, although it is open and does not close properly (Figure EX-84). The jambs are deteriorated and the sashes require replacement. Window 200 on the second floor is deteriorated and is not covered by a storm window. This window, jambs and sill are deteriorated. Evidence on the jambs indicate there were once shutters installed on the jambs. In general, the window surrounds (jambs and sills) and sashes on the west elevation have significant deterioration and paint loss. The perimeter joint between the window frame and brick wall is deteriorated. The windows are discussed in the Materials section of this report and documented in the Window Schedule.

Figure EX-83. Kitchen Window 104 deteriorated jambs, sill and sashes, west elevation. (Strata 2016)

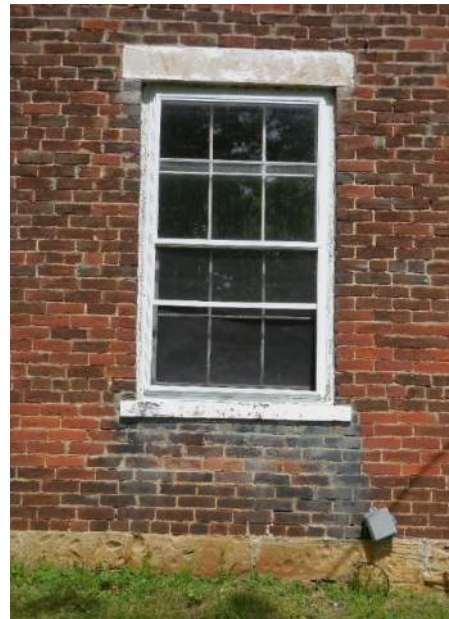
Figure EX-84. Dining room Window 105 deteriorated jambs, sill and sashes, west elevation. (Strata 2016)

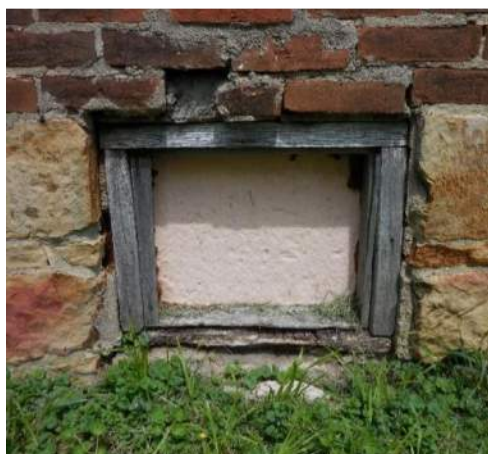
The basement Window 100 frame, sill and sash are deteriorated, missing glass and require replacement. The sash opening is covered on the interior by insulation board. The mortar jambs have been pointed with inappropriate mortar and the stone below the window is deteriorated and missing mortar. The adjacent Window 101 is boarded over from the exterior and the interior, so it is difficult to assess. It is assumed it is in similar condition to Window 100. This opening may have once been converted into a coal chute. The bricks spanning the window openings have failed.

Figure EX-87. Basement window opening, west elevation. Basement Window 100. (Strata 2016)

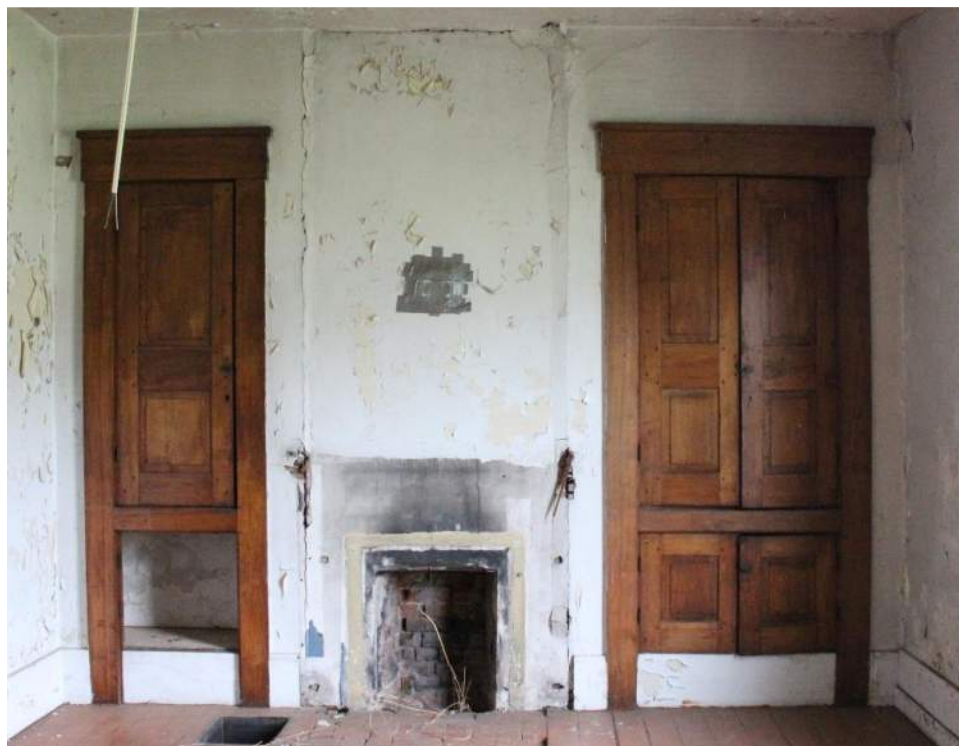
Figure EX-97. West Parlor 103, Built-in cabinetry. (Strata 2016)

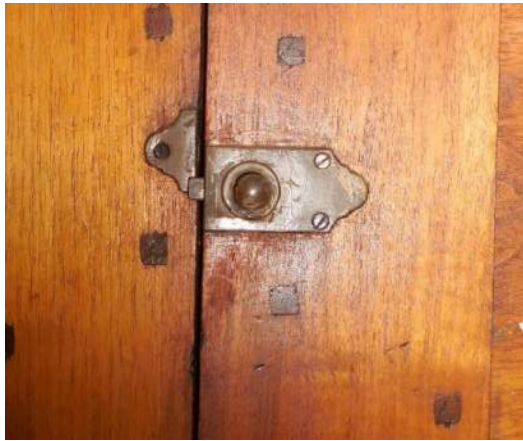
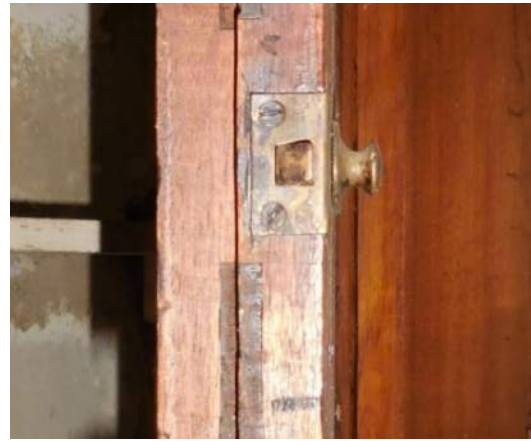
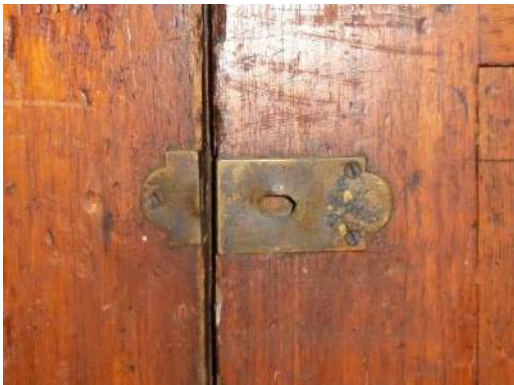
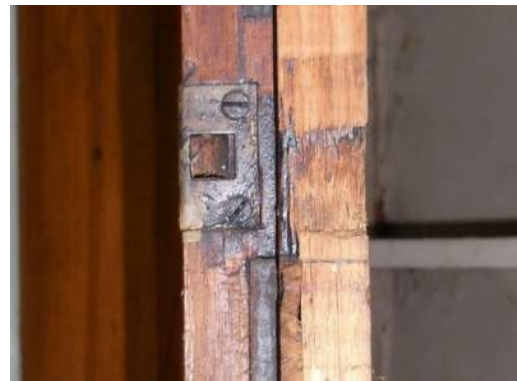
Figure EX-100. Typical brass spring latch details. (Strata 2016)

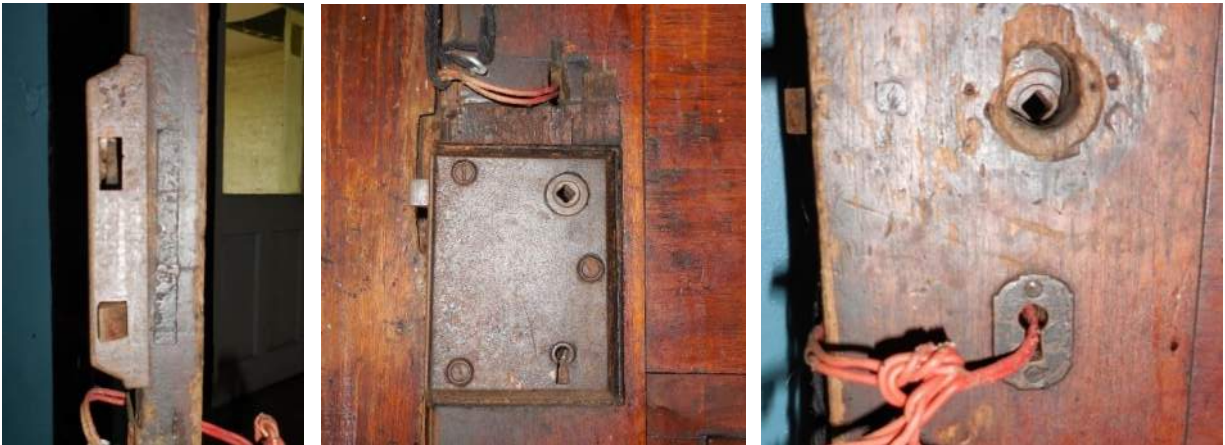
The original doors had cast iron rim locks and matching keepers, likely with cast iron, porcelain or brass knobs. One rim lock remains and is installed on the Bedroom Door 1/102 (Figure EX-106). The keepers appear to have been installed in the jambs prior to the installation of the door trim. Only one interior door jamb keeper remains installed at the East Parlor Door 1/101 (Figure EX-107). An example of an antique rim lock similar to those which have been removed from the Blackstone house is shown in Figure EX-110.

Figure EX-106. Portion of an original rim lock currently installed upside down on the Bedroom Door 1/102. This photograph was reversed for the report to turn the rim lock right side up. The original keeper at the jamb is missing. This is an original rim lock but installed in the incorrect location, upside down. Note the similarities between the keyhole style and the edge profile to the example antique rim lock shown in Figure EX-84 below. (Strata 2016)

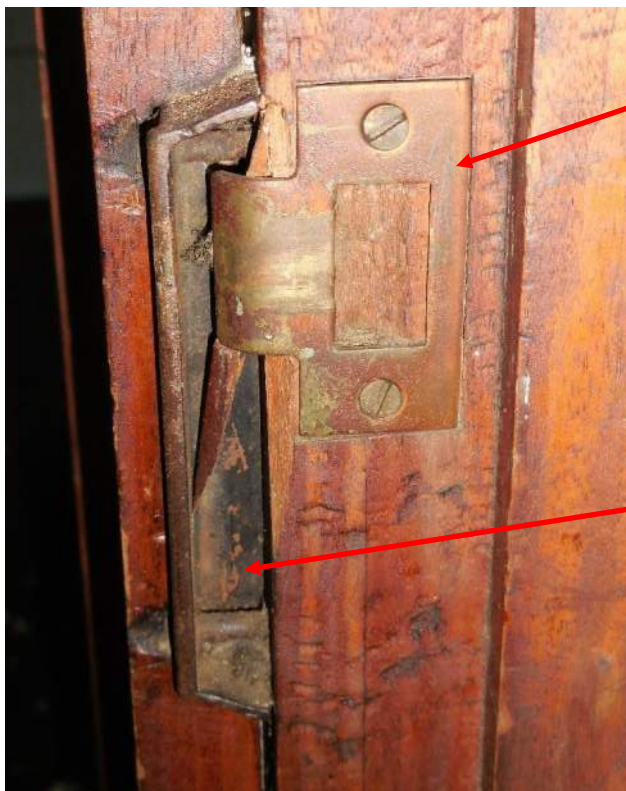
Mid-twentieth century door strike.

Original cast iron door keeper with trim mortised around the keeper. Note, the keeper was installed prior to the installation of the finish trim.

Figure EX-107. Door 1/101 to the East Parlor. This is the only remaining cast iron door keeper still installed in the house. The brass door strike plate is a more recent installation. (Strata 2016)

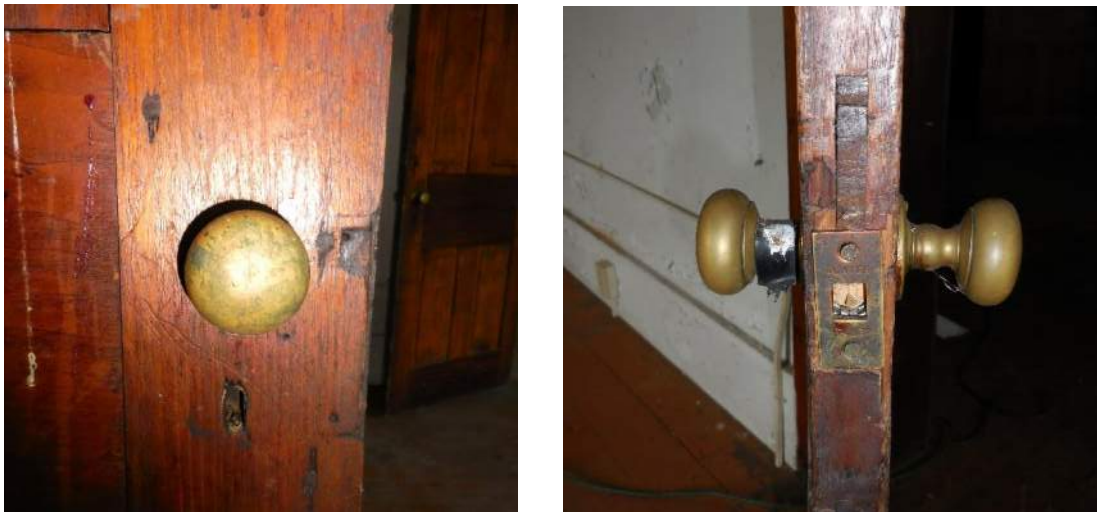
The interior door locksets have all been replaced with Dexter brand brass mortise locksets, of an unknown date, but most likely mid-twentieth century (Figures EX-108 and EX-109). The installation of the Dexter locksets on the doors and strike plates on the jambs has damaged the original historic doors by requiring drilled holes through the sides of the doors and chiseling to mortise in the strikes. Various other hardware has been installed on the doors through the years including bolts and locks.

Figure EX-108. Typical interior door existing with more recent mortise lockset. Note the scars on the door (left photograph) from the original rim lock. The keyhole through the door remains. (Strata 2016)

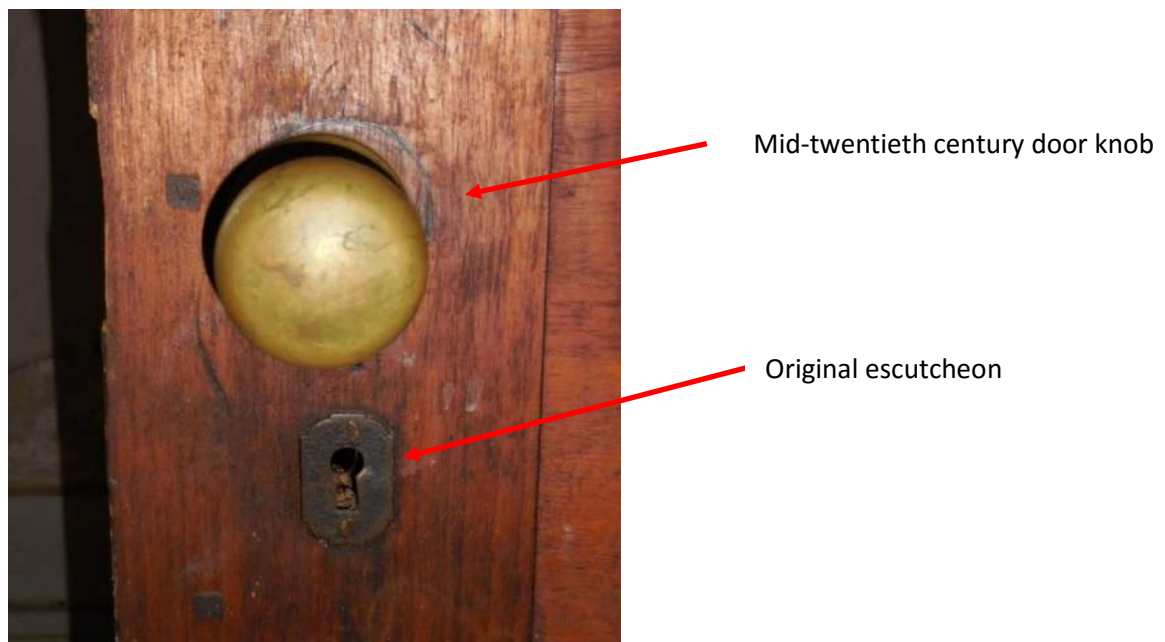
Figure EX-109. Typical interior door existing mortise lockset. This door 1/103 has an original escutcheon which was not removed but is no longer utilized for a key. (Strata 2016)

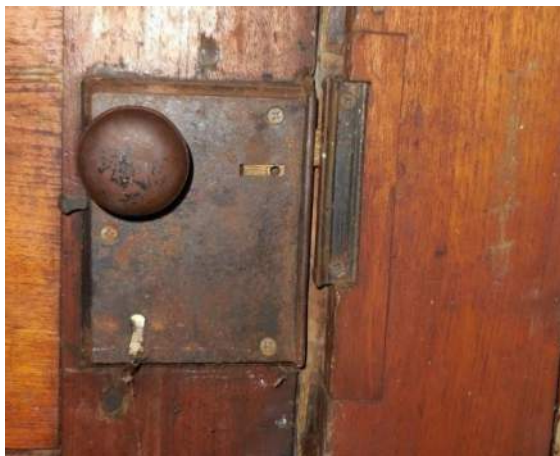
The front Door 1/100 currently has a rim lock installed with cast iron knobs, which appear to be original, although the keeper does not match and is likely reused from another location (Figures EX-111 and EX-112). An example of a period restored front door rim lock was found on the internet for sale, which shows what the original installation may have resembled (Figure EX-113).

Figure EX-111. Front Door 1/100 existing rim lock with non-matching keeper. Note, the brass slide bolt knob is missing (Strata 2016)

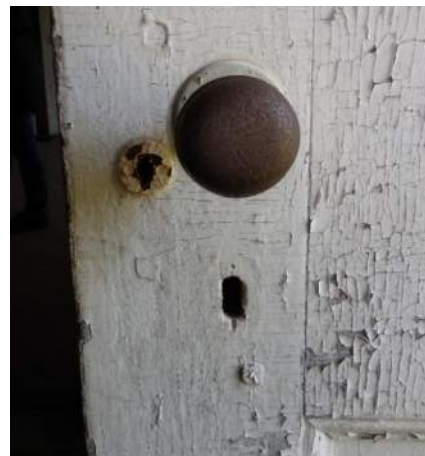
Figure EX-112. Front Door 1/100 existing front door knob from the exterior. Note the lower keyhole below the knob has a shadow of an escutcheon that is no longer installed. (Strata 2016)

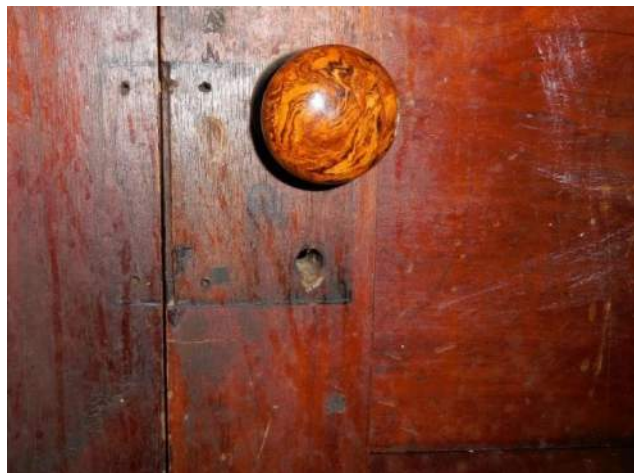
The rim lock on Door 3/100 to the basement is missing and has been replaced with a decorative glazed ceramic Bennington style ceramic knob. The origin of the knob is unknown (Figure EX-114).

Figure EX-114. Door 3/100 Bennington style ceramic swirl knob. Note, the scars are visible from the original rim lock installation. (Strata 2016)

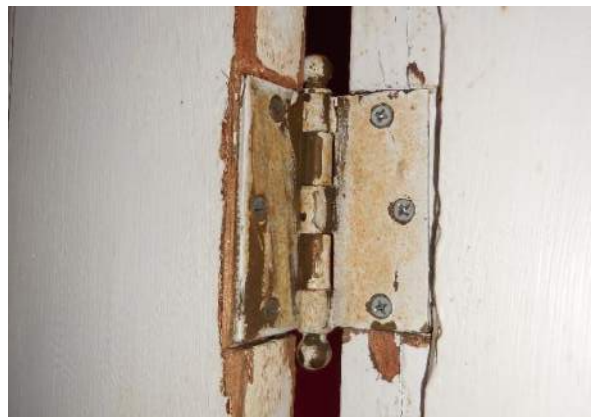
Figure EX-116. Door 1/201 Ball tip hinges. These are very likely replacement hinges from the later 19th century. (Strata 2016)

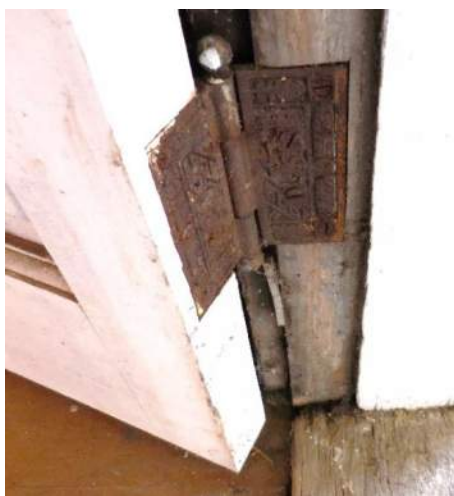
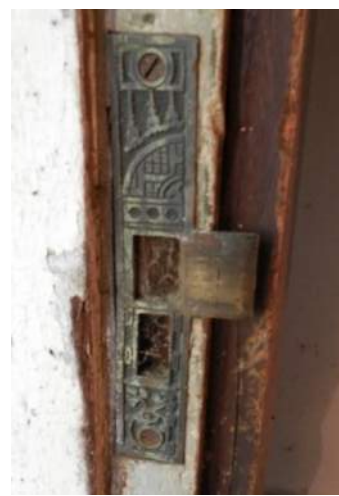
The back Door 2/100 has an original keeper installed, although the door swing has been reversed. The door also has Eastlake style ball tip hinges and a matching decorative door strike that likely date to the late nineteenth century (Figure EX-117).

Figure EX-117. Door 2/100 Eastlake style ball tip hinges and door strike. (Strata 2016)

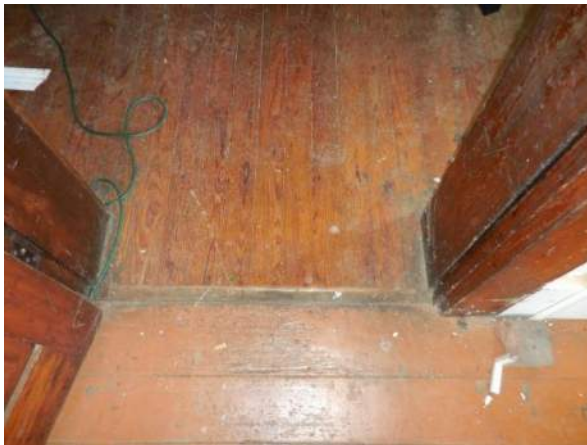
Figure EX-125. Wood flooring transition between the West Parlor 103 and the Dining Room 104 where the dining room floor has been overlaid with another layer of wood floor. Note, the wood flooring runs in opposite directions at this transition. (Strata 2016)

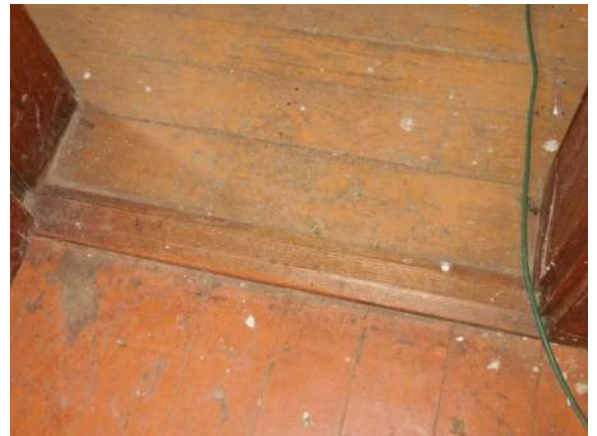
Wood thresholds are found between nearly every room (Figure EX-125). These are original to the construction of the house and cover the wood flooring transition between the rooms. The thresholds are nearly one-inch thick and are therefore not in compliance with ADAAG or IBC guidelines.

Figure EX-126. Typical wood threshold, Door 1/103 between West Parlor 103 and Hall 100. (Strata 2016)

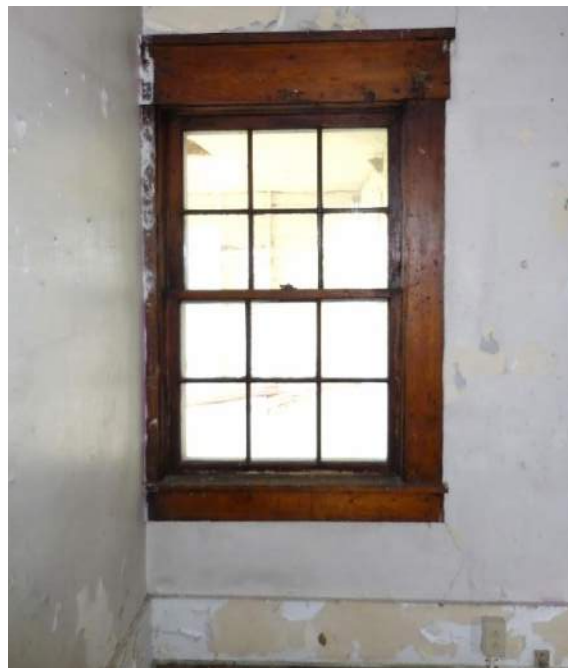
Figure EX-127. Typical interior Window 103 in the Dining Room 104. This is an original window with original sashes. (Strata 2016)

These sashes are in a variety of conditions and require complete restoration. Some sashes have had previous repairs. The original windows appear to have had a clear interior finish, while some repairs have been painted.
