THOMAS BLACKSTONE HOUSE

HISTORIC STRUCTURES REPORT

SEIP EARTHWORKS UNIT – HOPEWELL
CULTURE NATIONAL HISTORICAL PARK
BAINBRIDGE, OHIO

APRIL 17, 2017
NPS PMIS # 218963

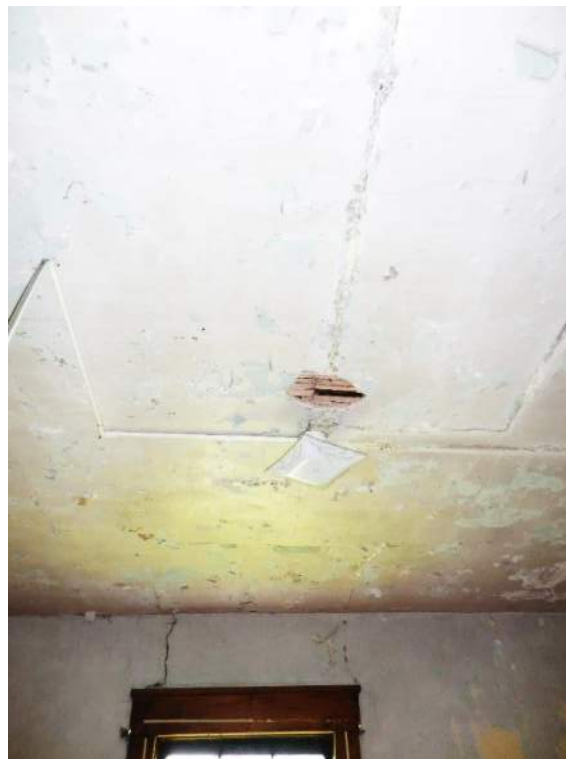
The plaster coatings on the walls are well adhered to the brick walls, but the plaster is in poor overall condition. The walls have significant cracking due to the shifting of the brick walls from uneven foundation settlement. There are through-wall cracks at the heads of many of the windows and doors and several within the walls in other locations. The plaster walls have many layers of paint which is peeling throughout the house.

The plaster on the ceilings is very thin, appearing to having been installed in a single coat. the ceilings are thin enough that a shadow of the ceiling joist framing is visible along some of the ceilings. The plaster ceilings are in very poor condition with cracking prevalent throughout. The ceilings have many layers of paint which is peeling throughout the house. The ceiling in the kitchen has been overlaid with a single layer of painted gypsum board.

Figure EX-130. Typical deteriorated lath and plaster ceiling in West Parlor 103. Note the through-wall cracks in the wall above the window. (Strata 2016)

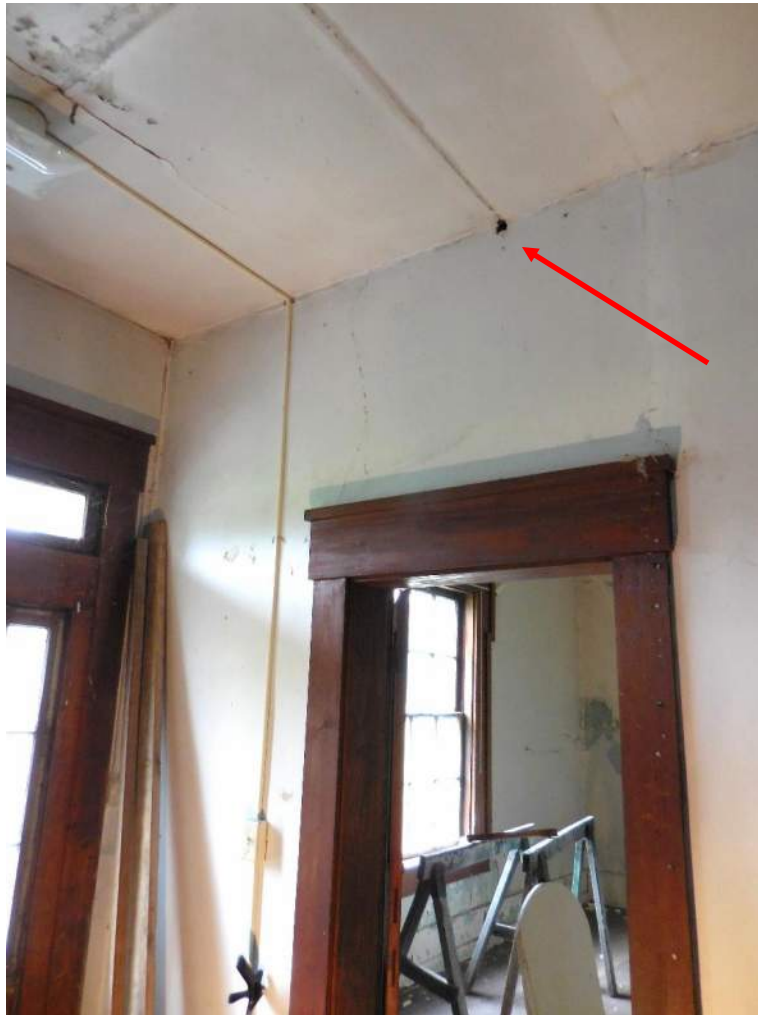
Plastic electrical conduit has been installed throughout the interior of the house, which has caused significant damage to the walls and ceilings (Figures EX-130 and EX-131). The conduit is no longer used.

Figure EX-131. Typical installation of conduit on walls and ceilings throughout the house. Note, some of the conduit has been removed, but once was installed from room to room through the hole in the top of the wall (arrow). (Strata 2016)

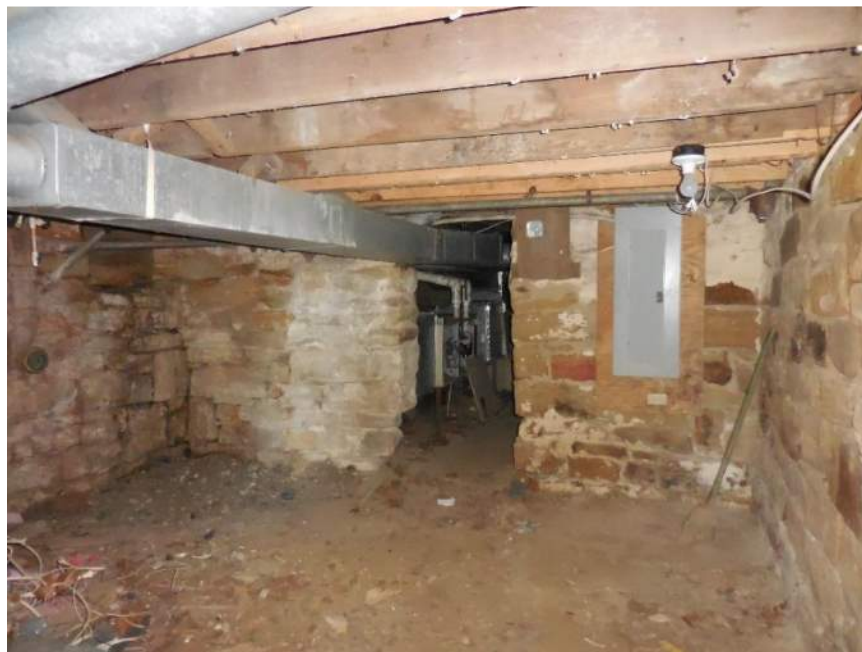
Room 005, which is located under the kitchen, was the original basement room (Figures B2 – B7). This room was originally accessed from the exterior through a small stair and door opening in the south wall which may have been covered with an exterior bulkhead door. This room measures approximately seventeen feet ten inches by thirteen feet nine inches. This room is currently accessed both from the original exterior door opening in the south wall and through an opening in the north wall that was created at an unknown date. The exposed foundation walls are native rubble limestone. The wall appears to have had what appears to be a lime-based whitewash finish, which has mostly worn away. The stone foundation walls transition to soft salmon bricks at the floor joist level. The foundation walls are tuckpointed with a soft lime putty mortar with varying sized aggregate and lime inclusions. This mortar is original to the construction of the house. The foundation wall in the northwest corner of the room requires repointing, as it appears this wall has been taking on water from the old covered coal chute. The remainder of the stone foundation walls are in good overall condition, requiring only spot repointing throughout. There are several deteriorated bricks in the east wall that require replacement at the joist level.

Figure B2. Looking north, Basement Room 005. (Strata 2016)

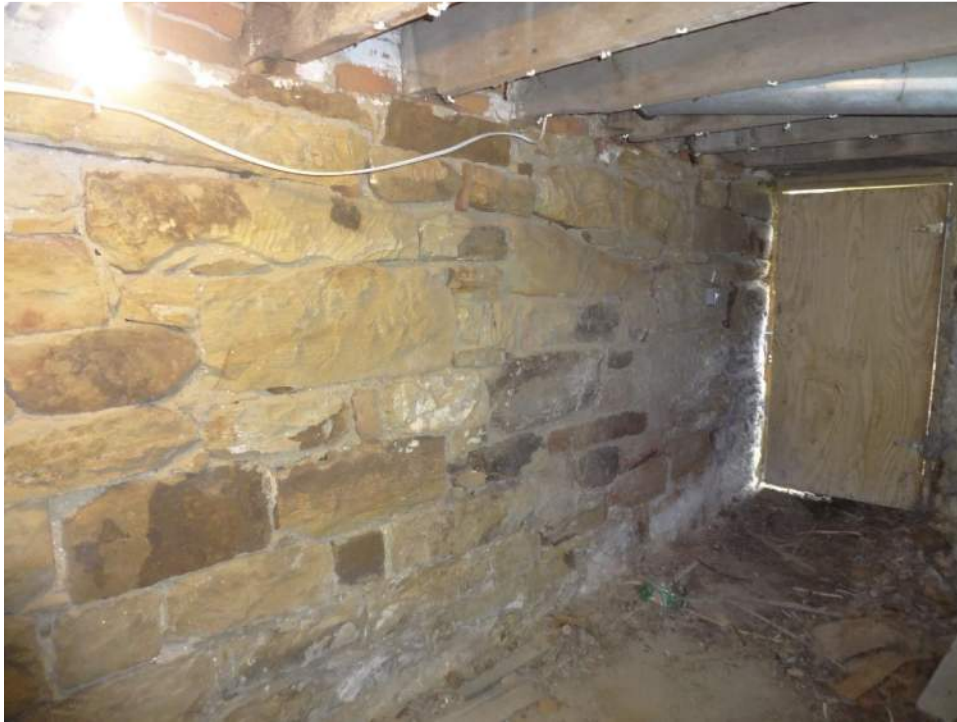
Figure B3. East wall, Basement Room 005. (DS 2016)

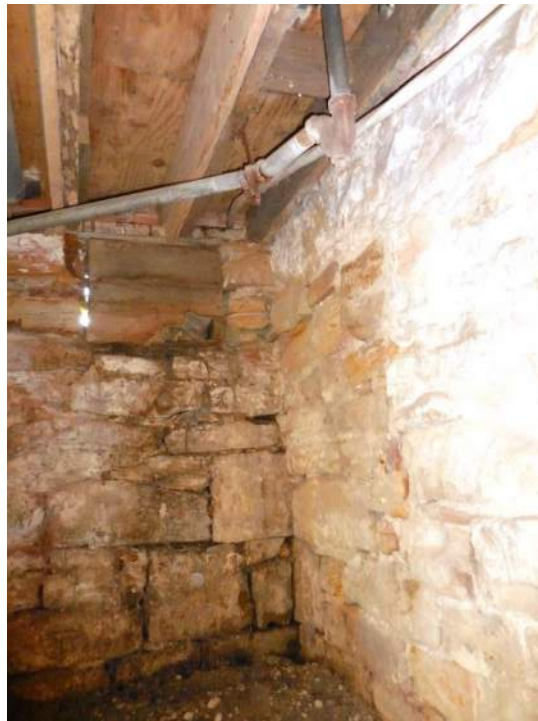
There are two openings in the foundation along the top of the west wall; both openings were likely windows originally. The southernmost opening Window 001 has a wood sash that is deteriorated and is covered with plywood. The entire opening is sealed with spray foam insulation. The northernmost opening Window 002 was likely an original window opening which was later converted into a coal chute (Figures B5 and B6). The wood covering is deteriorated, and the perimeter of the wood frame is not sealed. Several inches of coal were found within the dirt floor directly below this window during an archaeological excavation in this area.

Figure B6. Detail at old coal chute, west wall, Basement Room 005. Note the wood covering is deteriorated and daylight can be seen through the stone wall at the wood frame. (Strata 2016)

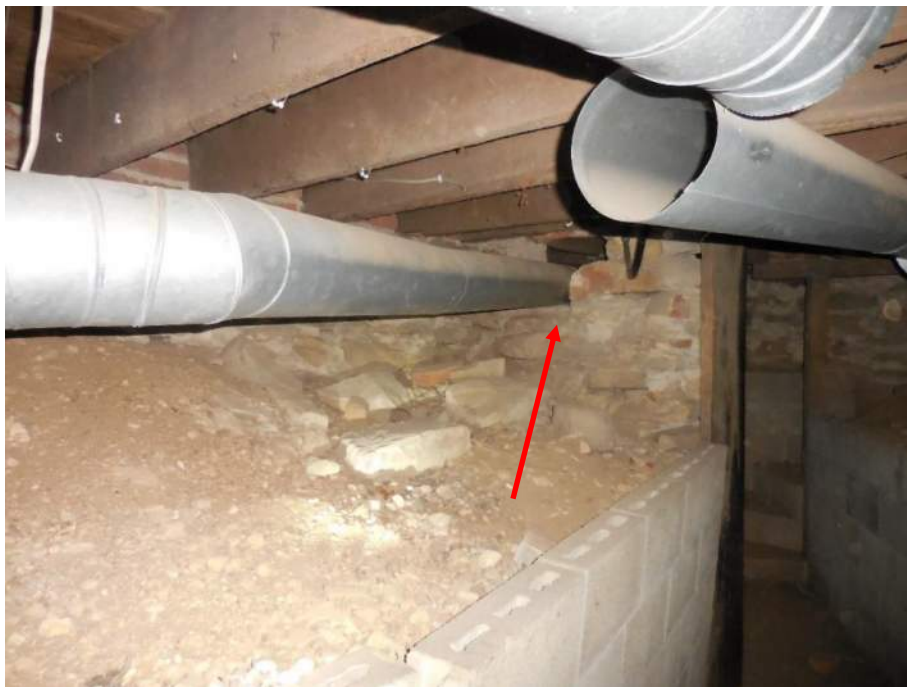
Ductwork is run into adjacent crawl space areas, through the original stone foundation walls. no lintels were installed where the penetrations in the walls occur. A wood door frame that leads into the Room 000 was installed in the east wall to brace the first floor framing. The condition and structural integrity of these alterations is further discussed in the Structural Existing Conditions Section of this report.

Figure B9. Looking northeast, towards the east dividing wall between Rooms 004 and 000. Note the hole through the foundation wall for the duct to pass into Room 004. (Strata 2016)

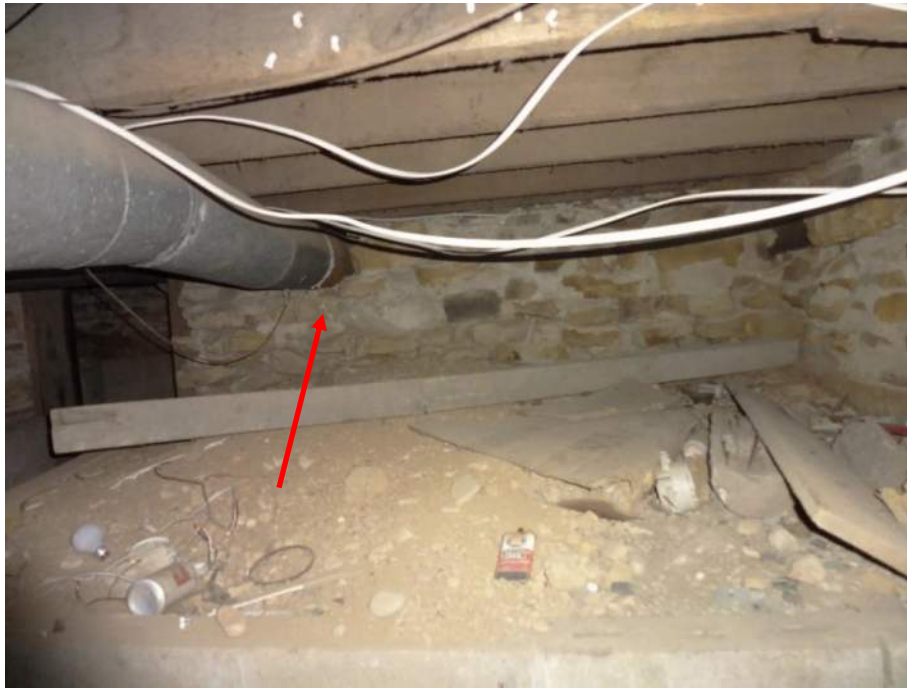
Figure B10. Looking east, Basement Room 004, southeast corner. Note the hole through the east wall for a duct to pass into Room 000 beyond. (DS 2016)

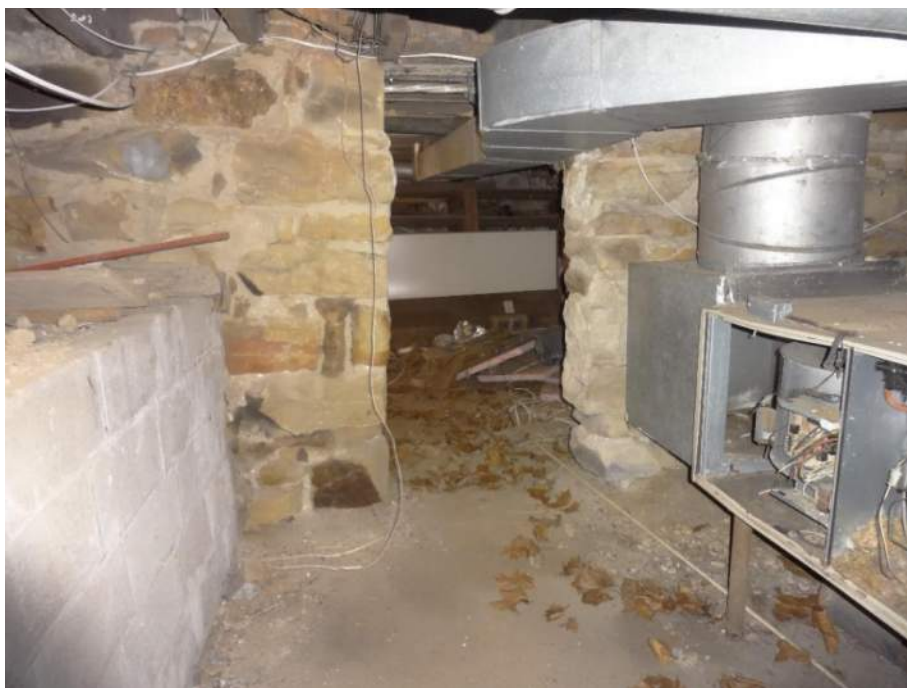
Figure B11. Looking south, Basement Room 004. Room 005 beyond. Note the lower right stone jamb is not flush. Note, the south wall is a full height stone wall, because Room 005 (beyond) was originally a basement room. (DS 2016)

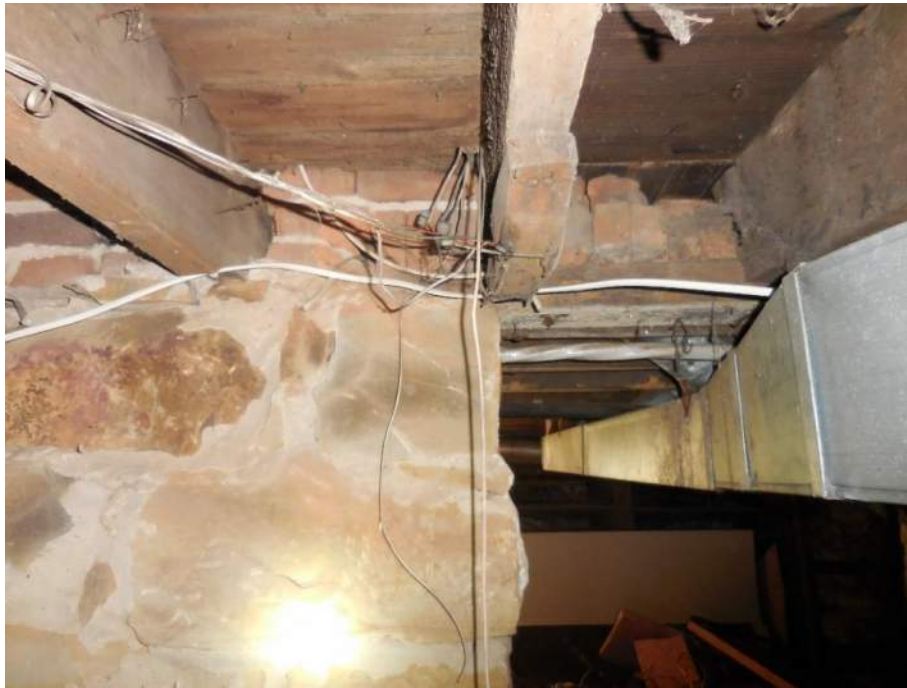
Figure B12. Detail of opening between Room 004 and Room 005 beyond. Note the wood and brick spanning the opening with no formal lintel. (DS 2016)

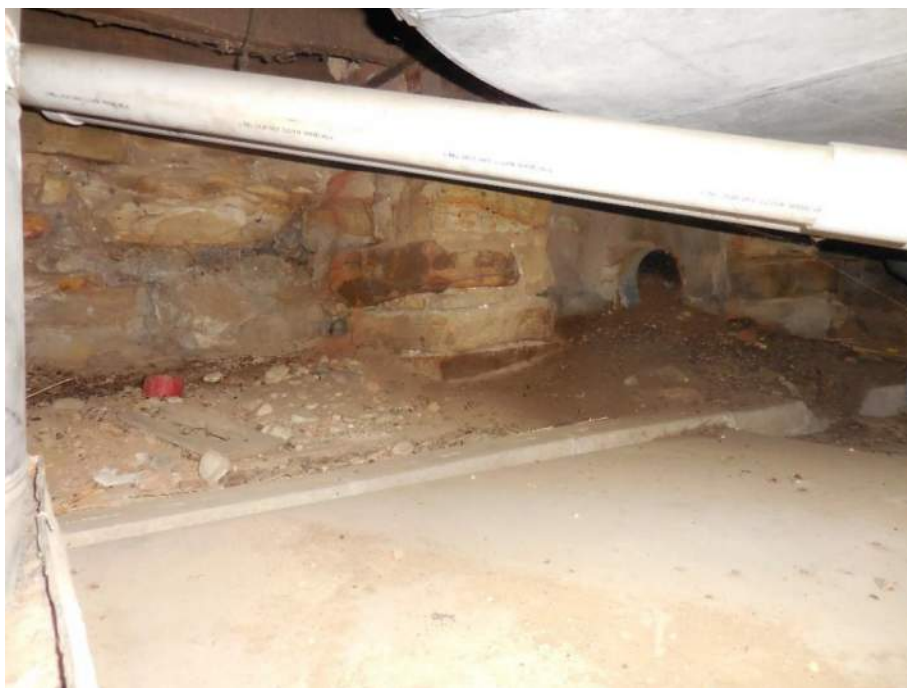
The contemporary air handling unit sits along the west side of this space and is not in working condition. Ductwork, servicing the first and second floor, lines the ceiling. The PVC vent piping associated with the air handling unit are installed to exhaust through the west wall (Figure B13).

Figure B13. Looking west towards foundation wall and fireplace foundations, Basement Room 004. The pipe between the fireplace foundations, once vented a larger coal burning furnace. (Strata 2016)

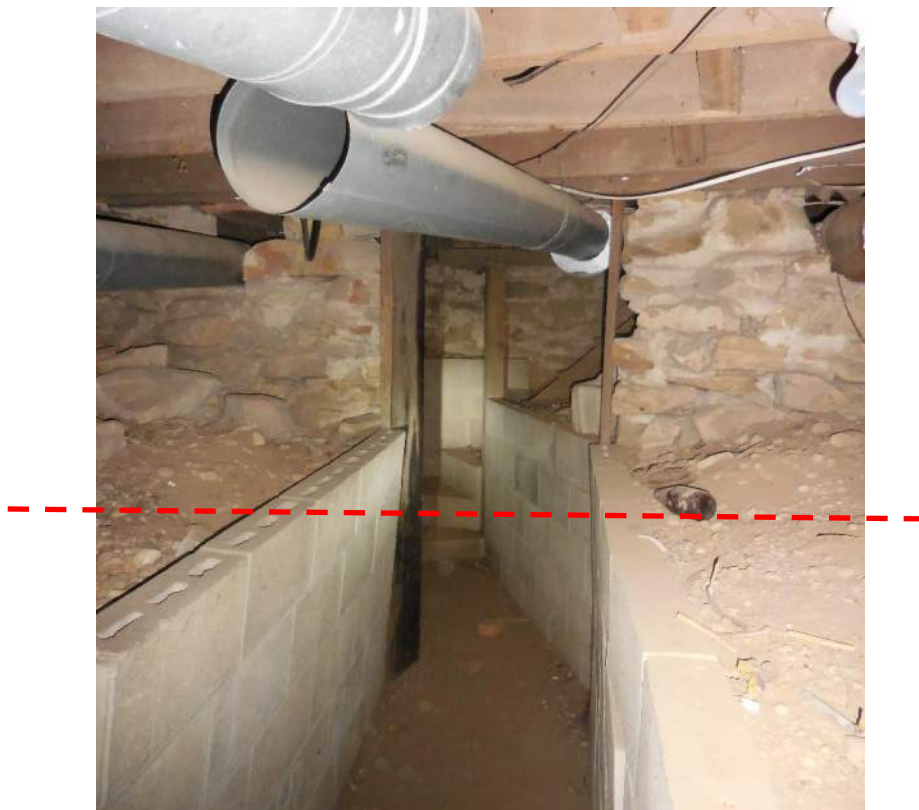
Figure B15. Looking east, Basement Room 004. Room 000 beyond. The dashed red line indicates the approximate bottom of the north/south interior crawl space stone foundation wall before the door opening was cut through and the path excavated. (DS 2016)

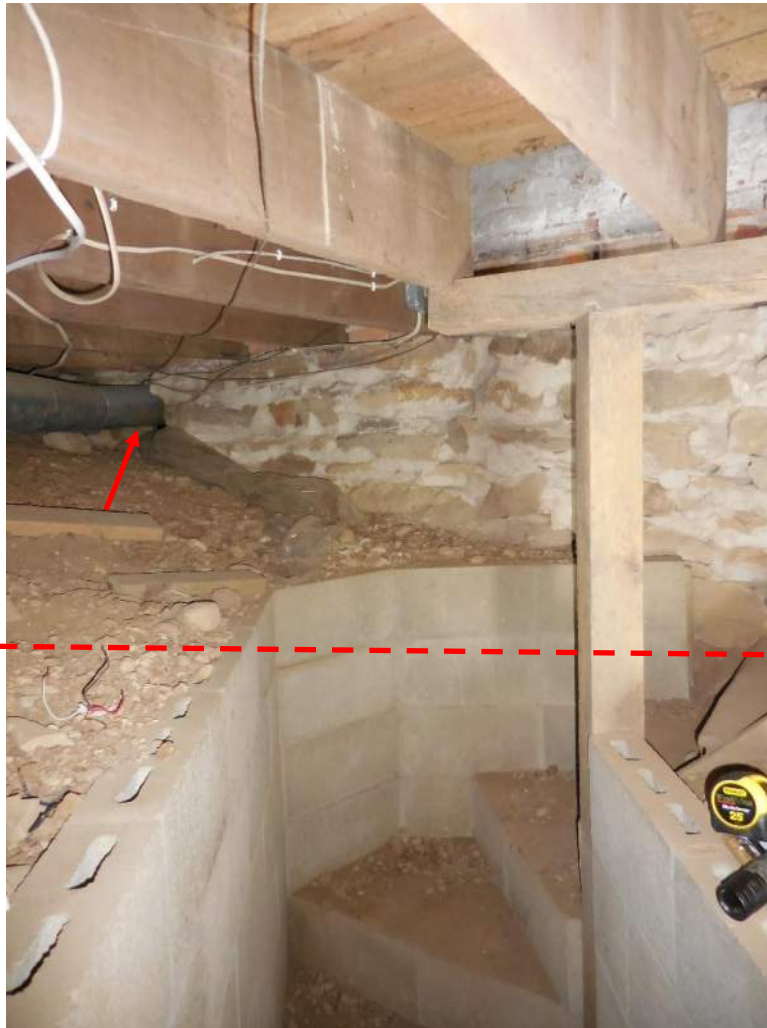
Ductwork is installed north and south of the stair. This ductwork penetrates the east foundation wall in two locations to access the crawl spaces below Rooms 101 and 102 on the first floor. There are no lintels installed above these penetrations (Figures B116 and B18). Ductwork is also installed through the wall between Room 000 and Room 04, again with no lintels to support the brick walls above (Figure B20).

Figure B16. Looking east at the stair, Room 000. The dashed red line indicated the bottom of the stone foundation wall beyond. The arrow is pointing towards the duct that is penetrating the east wall and serving Room 101 on the first floor, Room 000. (Strata 2016)

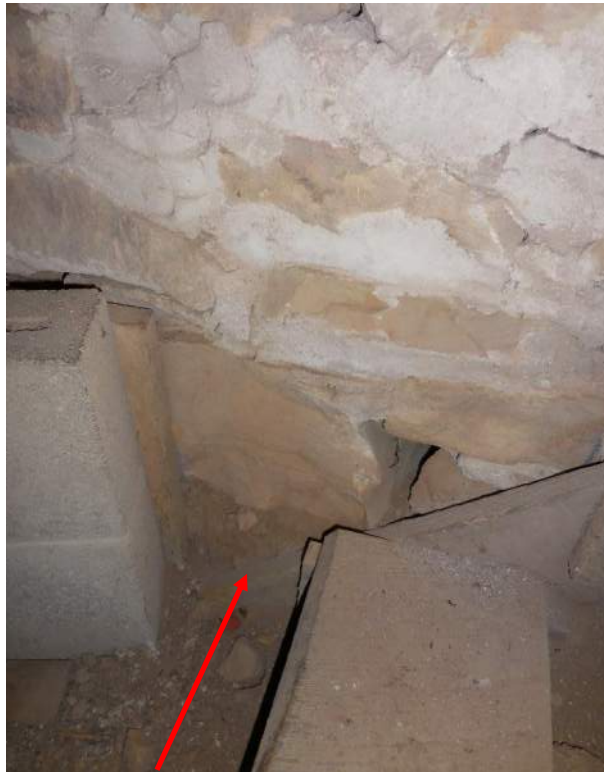
Figure B17. Detail of east stone foundation wall. The bottom of the stone is the bottom of the interior foundation wall, Room 000. (Strata 2016)

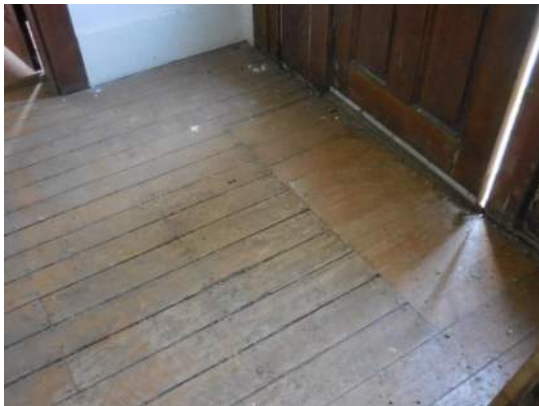
Figure 1.10. Patch in floor at front door, Hall 100. (Sheals 2006)

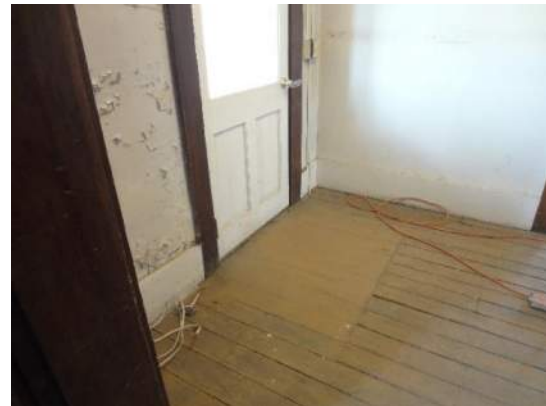
Figure 1.11. Patch in floor at back door, Hall 100. (Sheals 2016)

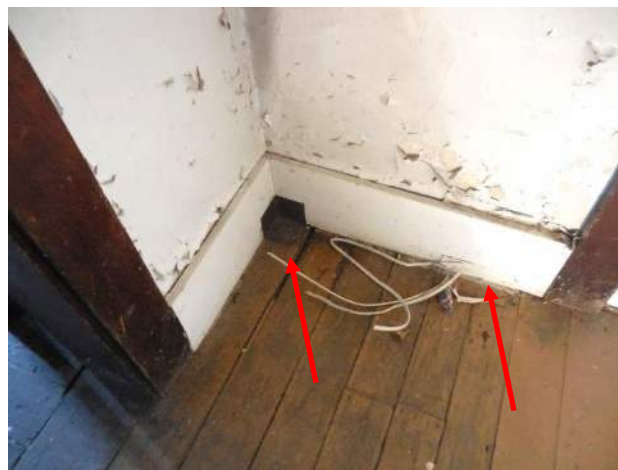
The baseboard is original to the construction of the house and has been painted. Two small sections of the baseboard in the southeast corner are patched with painted sheet metal (Figure 1.12). The door trim is all original and is clear finish, as is typical throughout the first floor of the house. A majority of the wood trim is in good condition, but there are significant amounts of staples and tacks installed on the face of the door trim.

Figure 1.12. Floor/baseboard sheet metal patches in southeast corner, Hall 100. (Strata 2016)

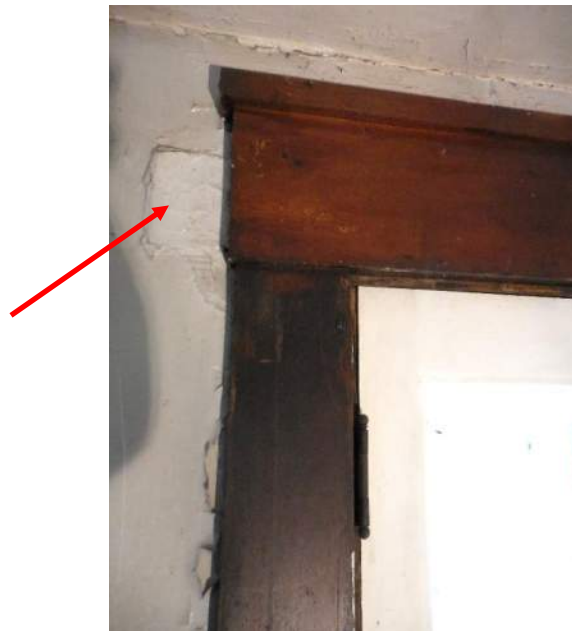
The back Door 2/100 is a recent replacement door with two panels below and a single pane of glass on top (Figure 1.6). The door swing has been reversed from the original door configuration. The door now swings on Eastlake style hinges and has a matching door strike. The original rim lock keeper is still installed on the west jamb but is no longer used. The door trim on the back door is damaged and there are at least two contemporary slide bolts attached to the west door trim. The wood lintel that spans the back Door 2/100 is visible through the

Figure 1.13. Detail of visible painted wood lintel above the back Door 2/100. (Strata 2016)

plaster and is painted (Figure 1.13). This lintel was likely originally covered in plaster. Further investigation should be conducted to determine if this wood lintel is deteriorated.

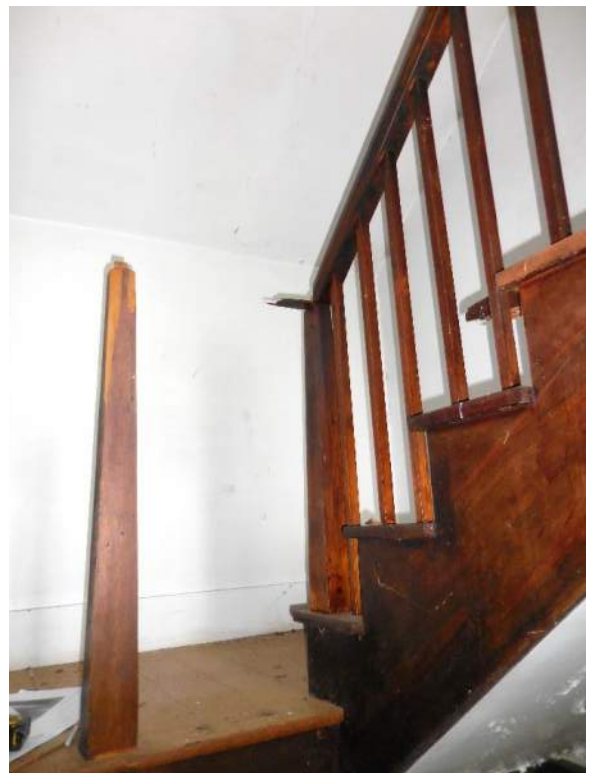
The balusters and handrail are butternut.²³⁸ All of the balusters and handrail are missing from the first floor section of the stairs. The newels are present at the intermediate landing, although the eastern-most newel is significantly damaged, and the balusters and handrail are missing. The balusters and handrail comprising the top section of stairs and at the top landing are extant and are in fair condition, although the handrail at the western-most newel at the landing was slightly damaged when the landing handrail was removed. A small section of the handrail from the landing balustrade is loose and stored on the second floor landing. This can be utilized as a pattern to create a new handrail. A missing baluster is used as a nailer board in the second floor Window 200 and should be salvaged and reinstalled. Two balusters at the landing are replacement pieces. They appear to be pine and are unstained. The baluster spacing at the second floor is 5 ½-inches, which is wider than allowed by code. The balustrade height is thirty-

Figure 1.15. Stair landing, Hall 100. Note, the east newel is damaged and the handrail and balusters are missing. (Strata 2016)

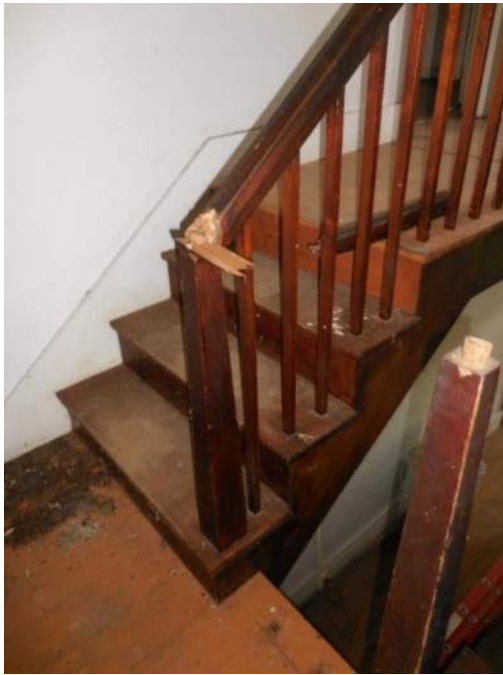
Figure 1.16. Stair landing, Hall 100. Note, the east newel is damaged and the handrail and balusters are missing. (Strata 2016)

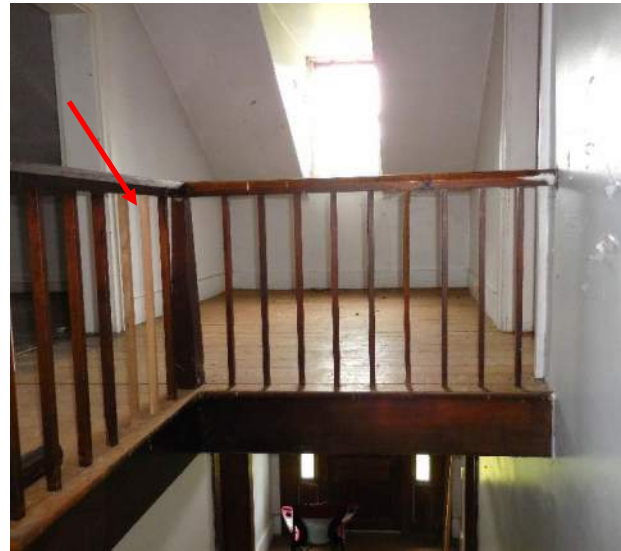
Figure 1.17. Stair landing, Hall 200. Note, the arrow points to the two replacement balusters. (Strata 2016)

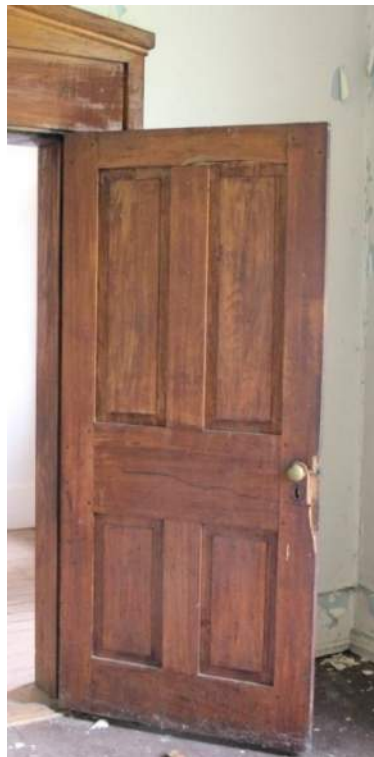
Figure 1.22. Door 1/101 which is damaged at the stile, East Parlor 101. (Strata 2016)

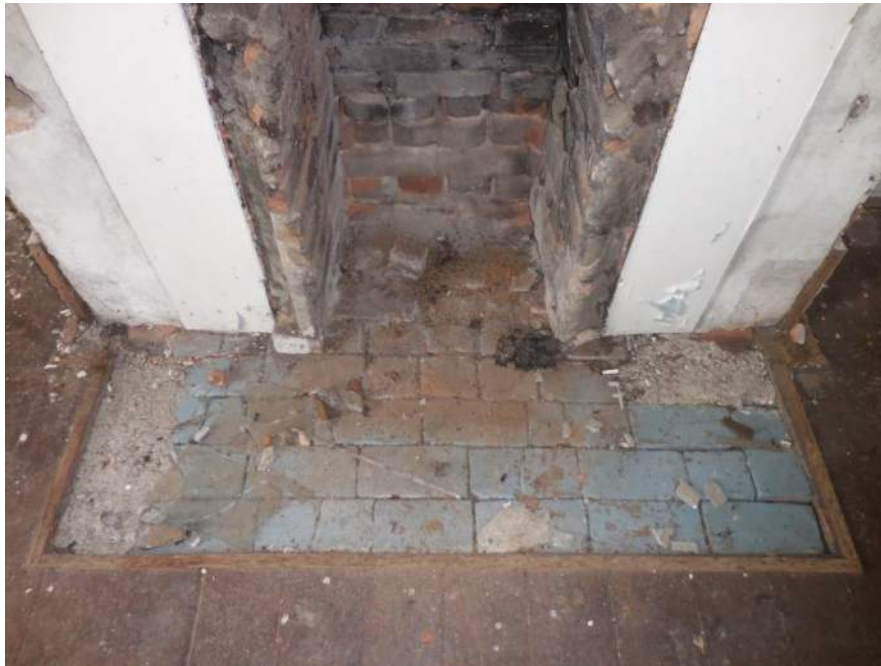
The brick hearth is painted and is in poor condition. Several bricks are missing and have been infilled with concrete, and a large void in the southeast corner is open to the crawlspace below. The bricks appear to have been installed over dirt and are not mortared. The brick hearth requires inspection from below in order to determine a stabilization strategy. A vertical crack in the plaster face of the brick fireplace wall extends through a patched thimble where a stove pipe was once installed near the top of the wall. The back wall of the firebox, which is the exterior east wall, is only a single wythe of brick, and daylight can be seen through the back wall.

Figure 1.25. Painted brick hearth and firebox, East Parlor 101. Note the ends of the baseboards flanking the walls are unfinished. There are concrete patches on both side of the hearth. (Strata 2016)

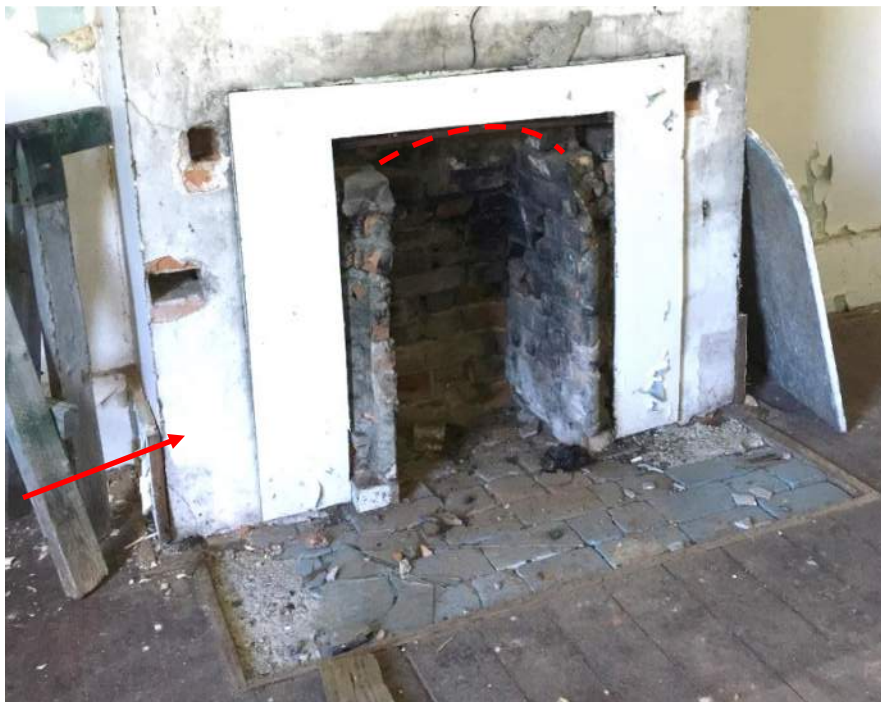
The original brick firebox opening is spanned by a rolled iron lintel that is slightly arched (Figures 1.26 – 1.28). The firebox appears to have been modified to receive a decorative cast iron insert with an arched top by installing additional brick side walls and arched top. Bricks on the top arch are missing. The iron insert is missing, but the imprint of the profile of the insert in the mortar is very clear. The narrowness of the firebox indicates this was a coal burning insert. The date this was installed and removed is unknown. A photograph of an example cast iron firebox insert is shown in Figure 1.29 below. The firebox, shelf and chimney interior are missing mortar and the bricks are deteriorated.

Figure 1.26. Hearth and firebox, East Parlor 101. Note, the ends of the baseboards flanking the fireplace mass are unfinished. The dashed line indicates the arched opening that has fallen. (Strata 2016)

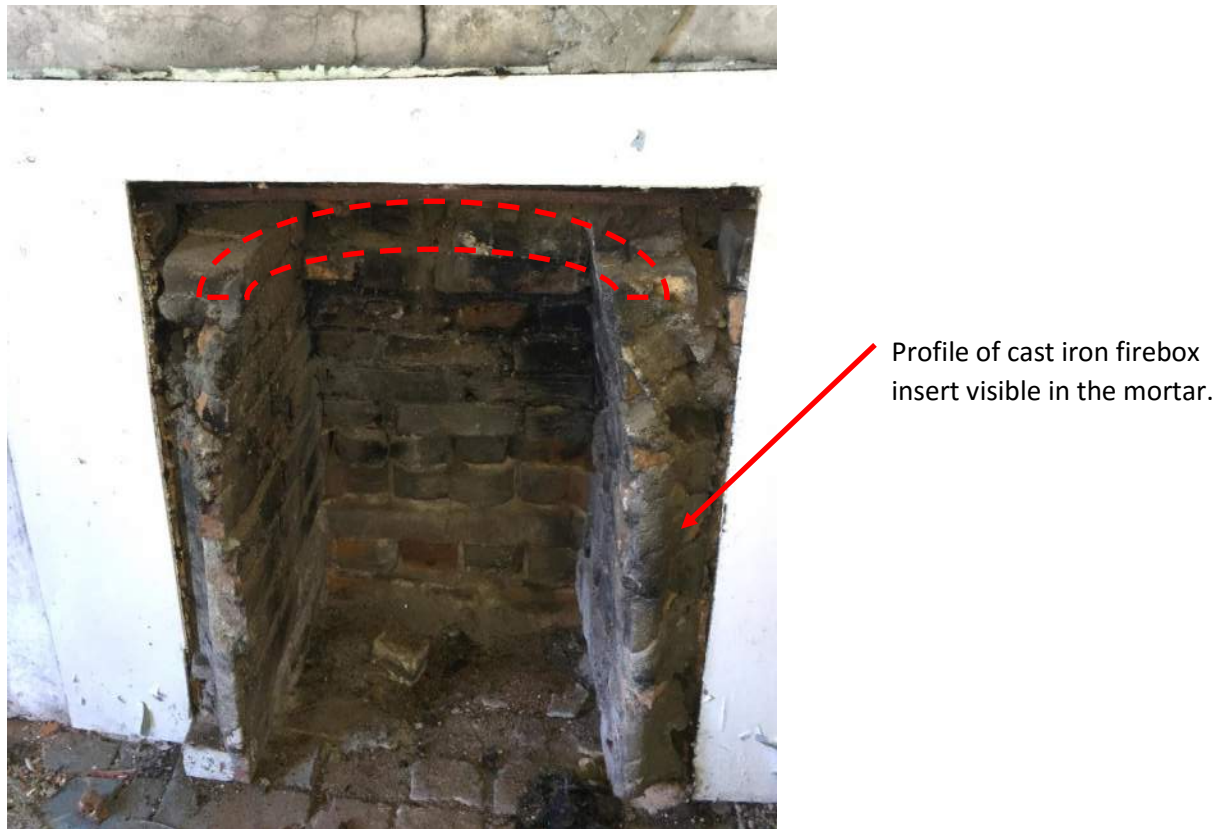
Figure 1.27. Hearth and firebox, East Parlor 101. (Strata 2016)

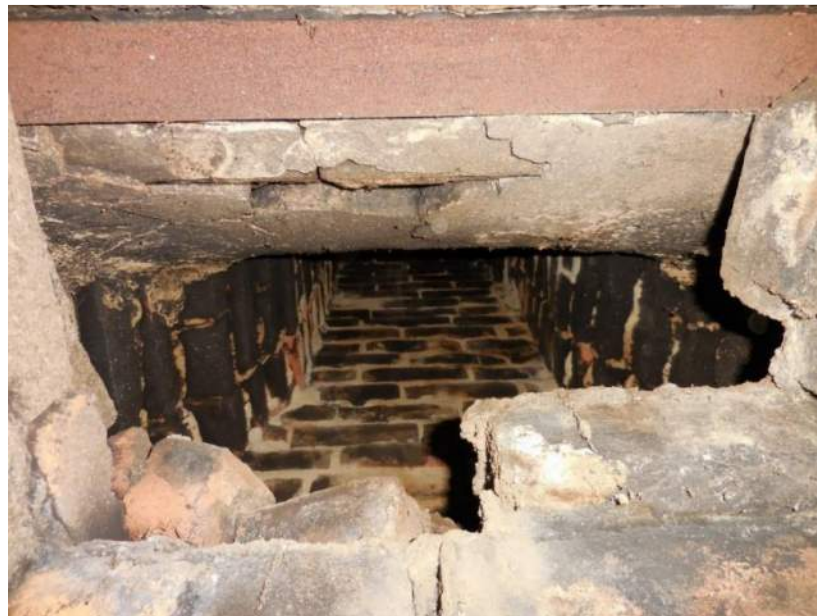
Figure 1.28. Inside of deteriorated firebox, looking up into the smoke shelf and the chimney, East Parlor 101. Note, the back wall is only a single wythe of brick thick and daylight can be seen through the wall. (Strata 2016)

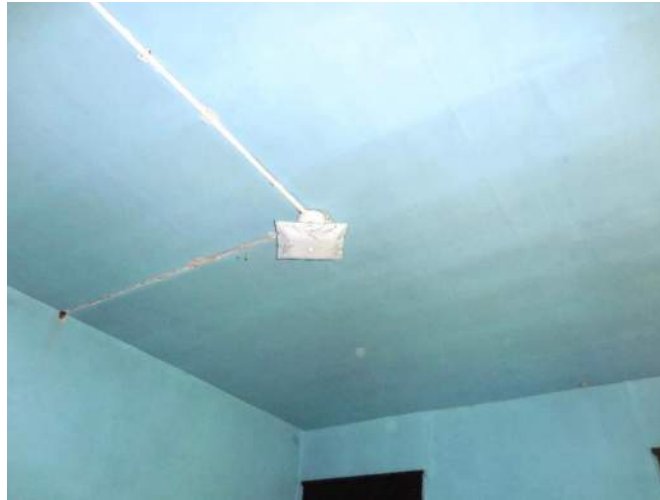
All four walls are brick load bearing walls with plaster installed directly to the brick. The brick walls are cracked in many locations which have projected through the plaster. The cracks indicate signs of previous footing settlement, as all of these walls rest on shallow stone foundations. There is a hole through the top/center of the north wall for conduit installation (Figure 1.34). The plaster ceiling is in fair condition and is cracked throughout. The walls and ceiling are painted. The paint is in fair to poor condition.

Figure 1.34. Ceiling, Bedroom 102. (Strata 2016)

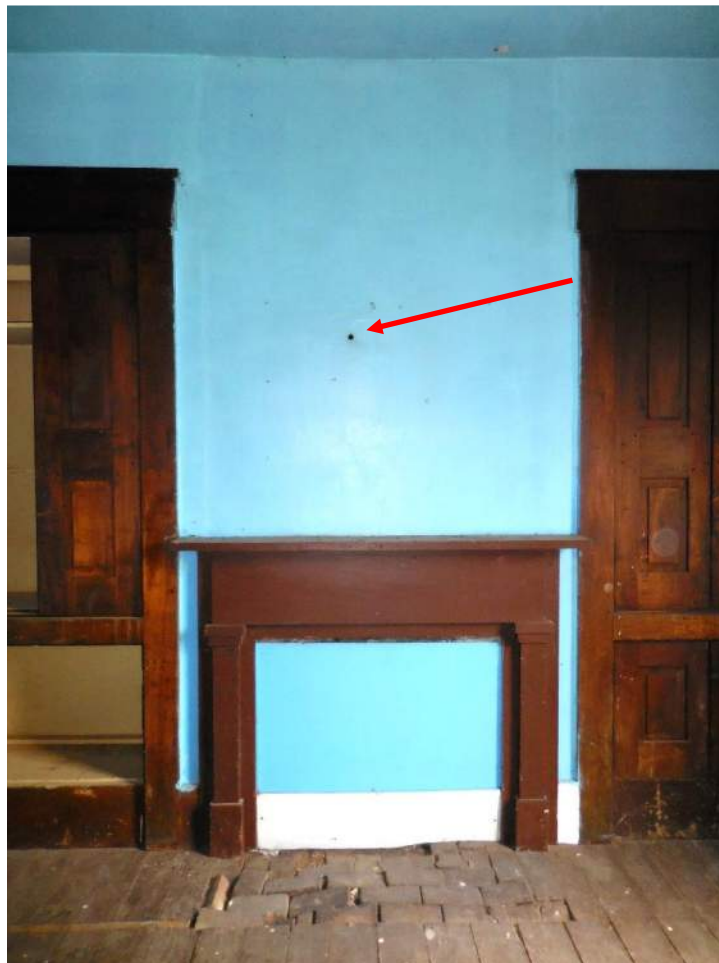
The east fireplace wall retains much of the original historic fabric, including the original wood mantelpiece (Figures 1.36 and 1.37). The mantelpiece has been painted a dark brown color and has a lot of holes and dents but is relatively intact. The fireplace box has been covered with a wood board. A section of the wood board was removed during the assessment which revealed a firebox full of bird nests and debris. The firebox appears to be original and is spanned by a rolled iron lintel that is slightly arched. The firebox surround is plastered on the room face. The firebox itself is in fair condition. Several bricks in the back of the firebox are missing or deteriorated and mortar is missing throughout. A mark in the plaster indicates there may have been a thimble for a stove installed into the chimney flue above the fireplace mantel (Figure 1.36)

Figure 1.36. Fireplace and hearth, Bedroom 102. Arrow points to infilled thimble. (Strata 2016)

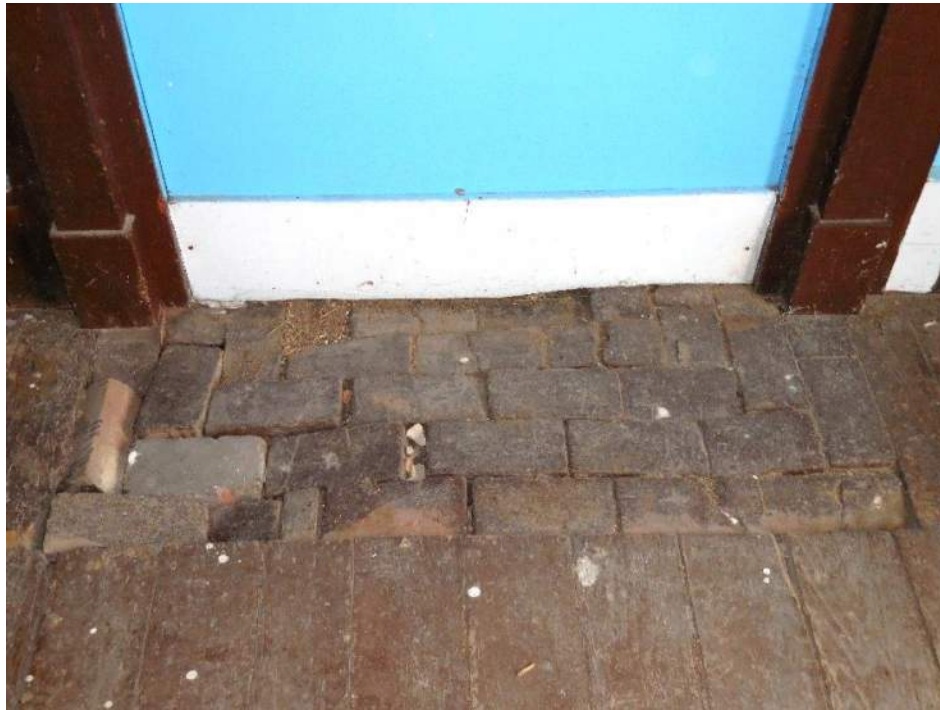
The brick hearth is comprised of a series of dry laid bricks that are laid directly over dirt and are not mortared into place (Figure 1.37). The brick hearth has shifted and is in poor condition. Several bricks were removed during the assessment, and contemporary objects, such as an asthma inhaler and 1990s coins were found below the loose bricks. The integrity of this hearth extension is in question, and the hearth within the firebox was unable to be assessed due to the debris. This hearth requires further invasive inspection to determine its foundation from the inaccessible crawl space below in order to determine a stabilization methodology.

Figure 1.37. Deteriorated brick hearth, Bedroom 102. (Strata 2016)

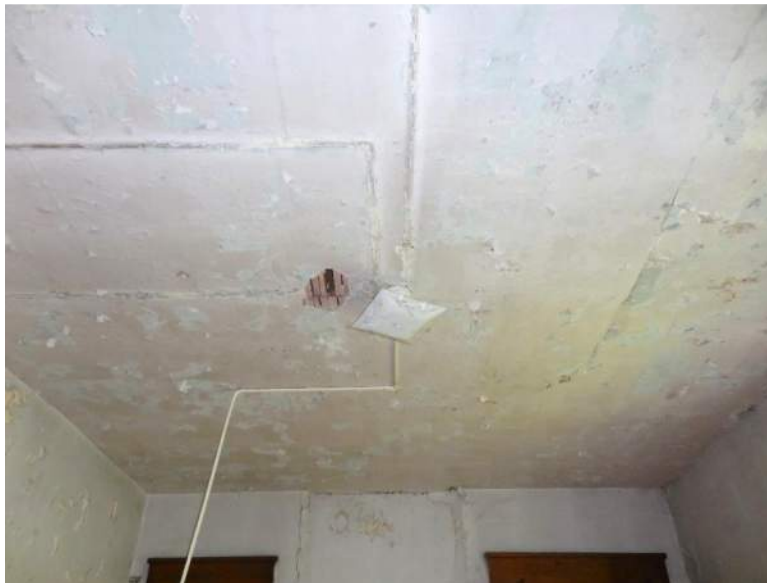
The four walls are brick load bearing walls with plaster installed directly to the brick. North and south sections of the west wall are lath and plaster, where they surround the built-in cabinets. The plaster at the wood lath shows some deterioration. The brick walls are cracked in many locations which have projected through the plaster. The cracks indicate signs of previous footing settlement, as all of these walls rest on shallow stone foundations. The plaster ceiling is in poor condition and is cracked and deteriorated throughout (Figure 1.42). A small section in the center of the ceiling is missing, exposing the wood lath. The ceiling and walls are painted with several layers of paint which is peeling and is in poor condition. There are holes through the south and east walls, near the ceiling, where conduit was installed between the rooms. Daylight can be seen through the north wall at the upper left section of the window.

Figure 1.42. Deteriorated ceiling, West Parlor 103, looking west. (Strata 2016)

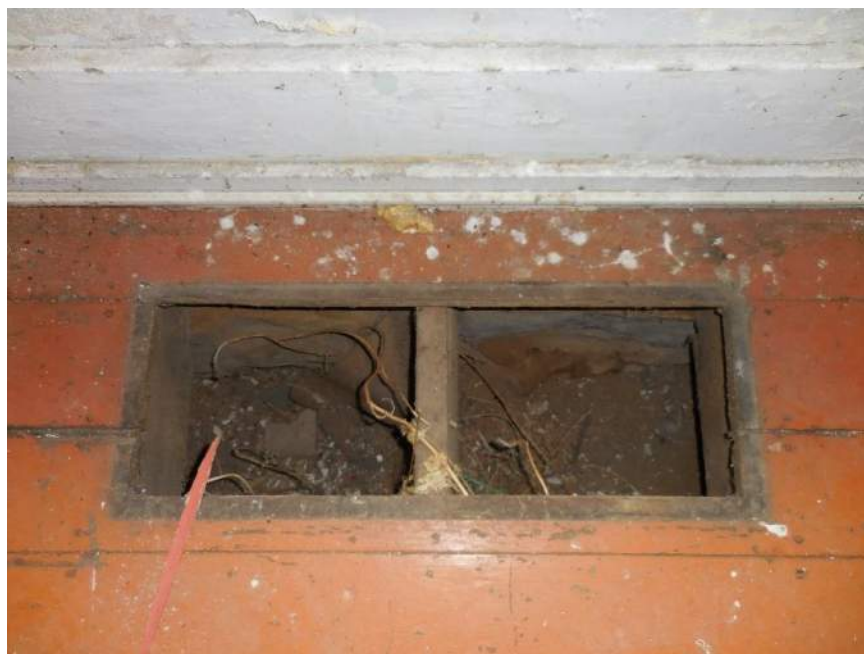
Figure 1.44. Vent through floor along north wall, exposing floor joists, foundation and crawl space, West Parlor 103. (Strata 2016)

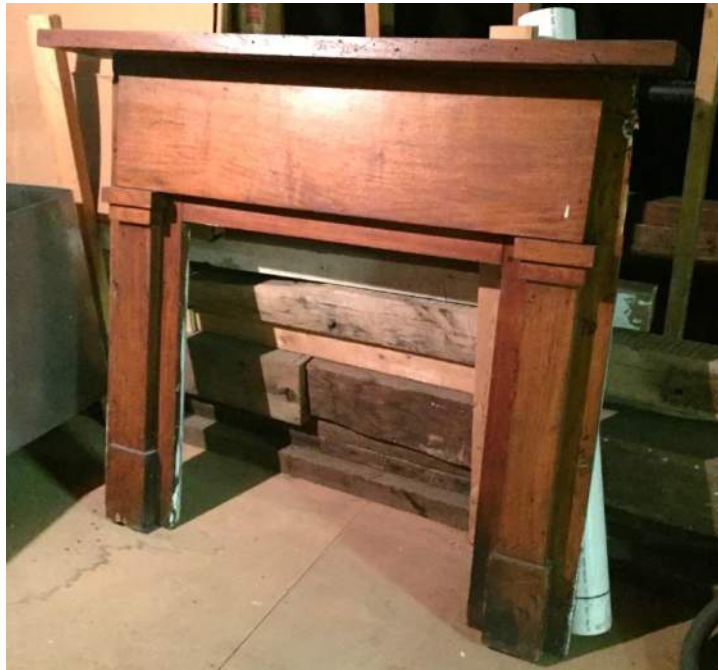
The fireplace was once the central feature of this room, but the wood mantelpiece is no longer installed. The mantelpiece was reportedly removed by vandals, and only a small remnant of the back of the wood surround remains attached to the wall. The wood species matches the other millwork throughout the house and was tested to be butternut.²³⁹ The mantelpiece was salvaged by the park staff before it was stolen, and it is now in park storage (Figure 1.45). Based on photographs taken by the park staff, it appears to be very similar in design to the mantelpiece in Bedroom 102. There are two small sections of wood baseboard which are still installed on the fireplace wall, which would have flanked the wood mantelpiece. These are the only profiled baseboard in the house, with an ogee design along the top edge (Figure 1.46).

Figure 1.45. Missing mantelpiece from Parlor 103, which is in off-site park storage. (Photograph provided by Brett Ruby, HOCU staff)

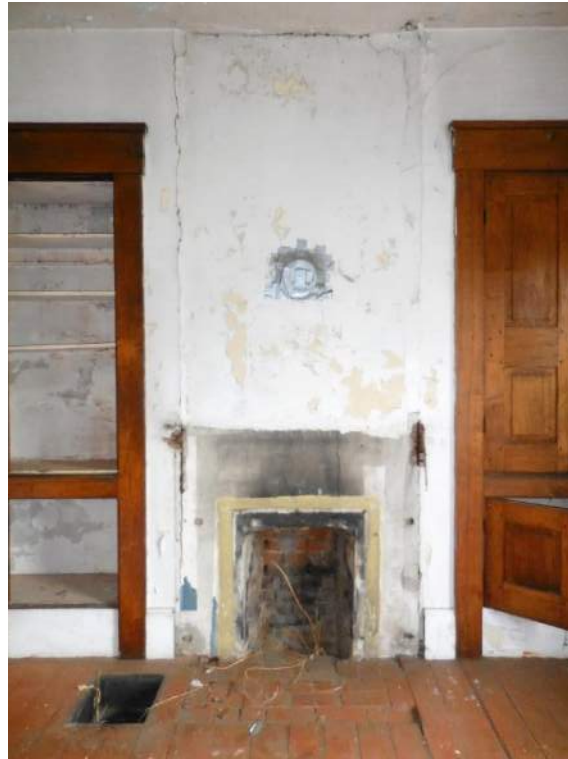
The firebox is original and is spanned by a rolled iron lintel that is slightly arched (Figures 1.47). The brick firebox is narrow and is beveled towards the back. The interior of the firebox, the smoke shelf and the chimney bricks and mortar are deteriorated. Daylight can be seen through the west wall inside the fireplace at the smoke shelf level. The brick wall at this location is only a single wythe thick (four-inches).

Figure 1.47. Fireplace wall, West Parlor 103. (Strata 2016)

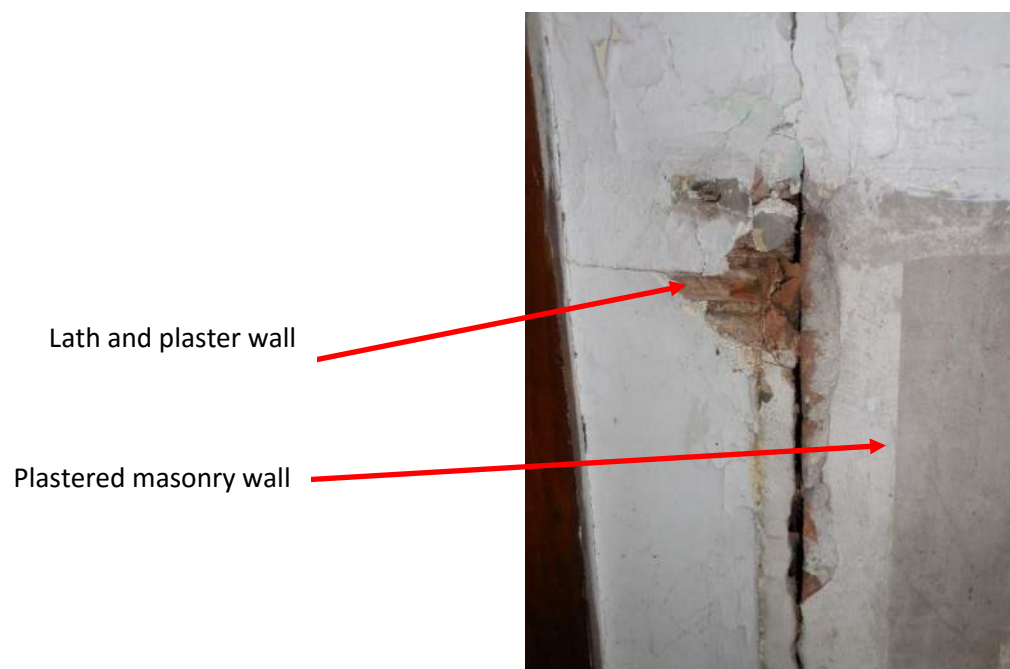
The central section of the west wall at the fireplace is brick masonry construction and is plastered, while the flanking built-in cabinets have surrounding walls of wood frame, lath and plaster. The plaster wall finish at the transition between the masonry and the wood and lath wall system is slightly recessed and the joint is cracked, as the differing base materials expand and contract differently (Figures 1.48). An old stove pipe thimble is located about mid-way up the wall above the fireplace. This has been covered by a metal plate and duct tape. Remnants of the stovepipe, surrounded by insulation, can be seen part-way up the chimney flue (Figure 1.50).

Figure 1.48. Crack at the transition between lath and plaster and masonry walls, West Parlor 103. (Strata 2016)
