THOMAS BLACKSTONE HOUSE

HISTORIC STRUCTURES REPORT

SEIP EARTHWORKS UNIT – HOPEWELL
CULTURE NATIONAL HISTORICAL PARK
BAINBRIDGE, OHIO

APRIL 17, 2017
NPS PMIS # 218963

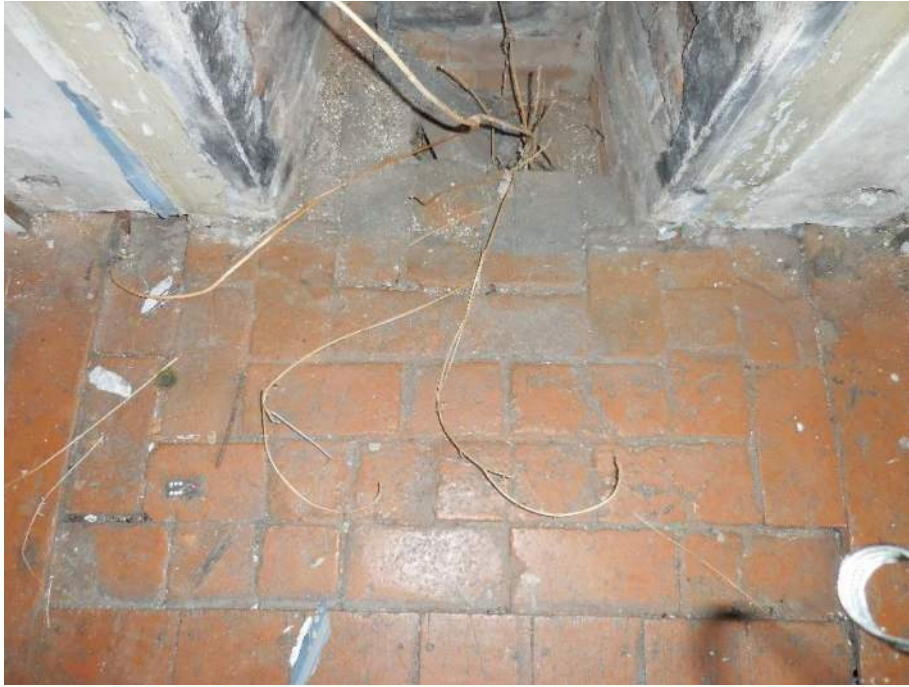
The brick firebox hearth and extension is painted and has collapsed (Figure 1.49). The bricks appear to be laid directly over dirt and are not mortared into place. Weeds are growing in the hearth. This hearth requires further invasive inspection from the inaccessible crawl space below in order to determine a stabilization methodology.

Figure 1.49. Fireplace painted brick hearth, West Parlor 103. (Strata 2016)

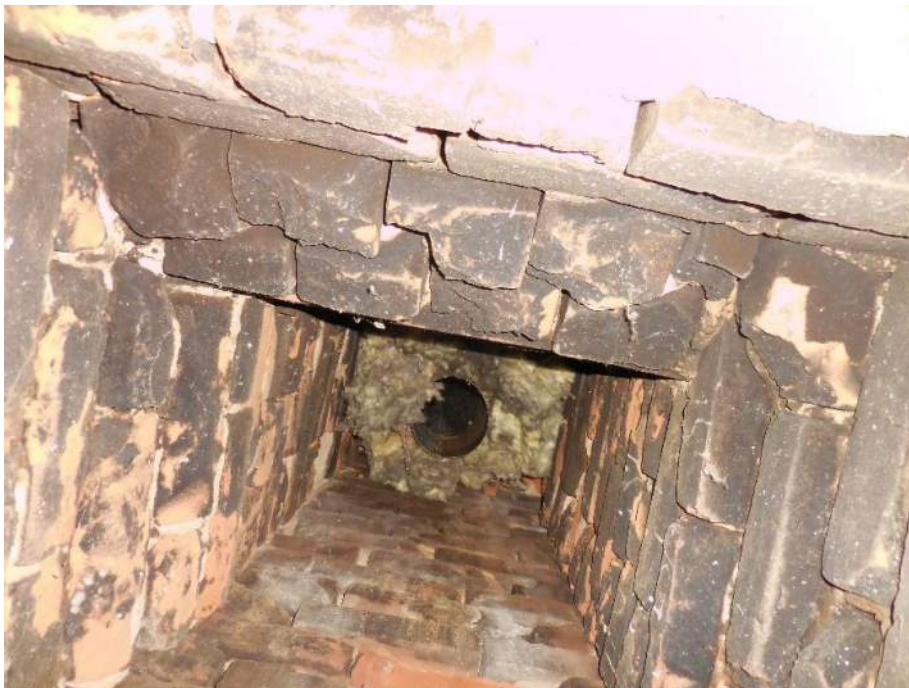
Figure 1.50. Old stovepipe, part way up the chimney, surrounded by insulation, West Parlor 103. (Strata 2016)

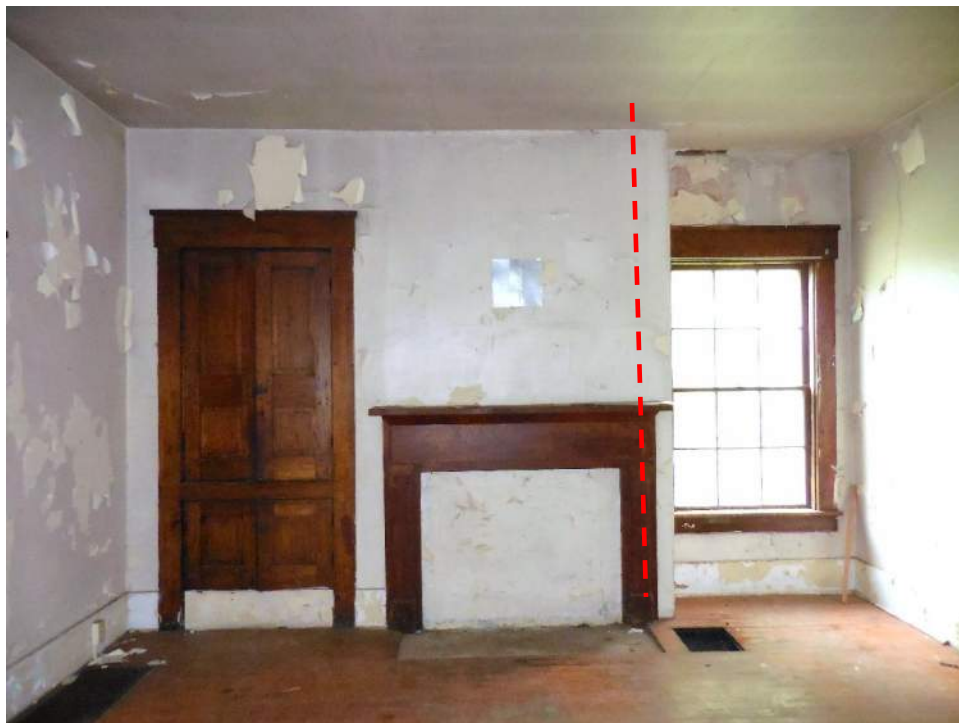
Figure 1.56. West wall, Dining Room 104. The dashed line indicates the furred out duct that leads from the basement to the second floor, which was added in the 1950s. (Strata 2016)

The exterior west wall is slightly bowed under Window 105 and a very large crack occurs in the south wall near the west wall. This section of the west wall and adjacent ceiling is deteriorated and shows signs of previous water infiltration. Where the wall has pulled away from the ceiling, newspapers from the 1950s were found in the crack.

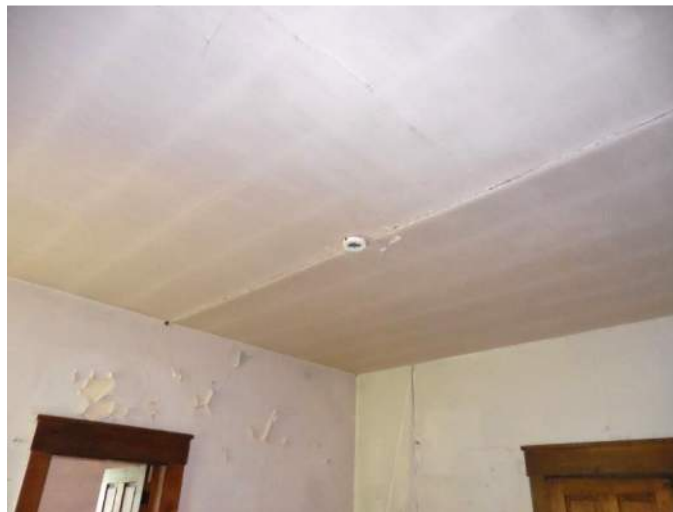
Figure 1.57. Ceiling with 'ghosting' of ceiling joists visible, Dining Room 104. (Strata 2016)

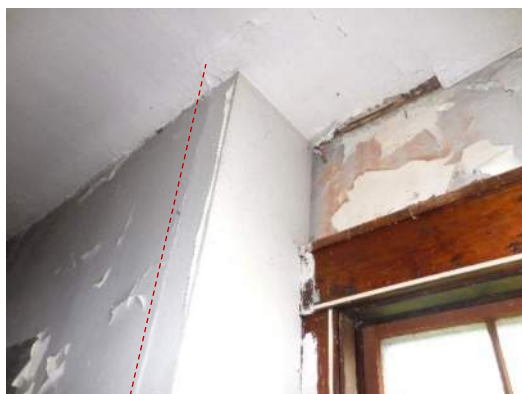
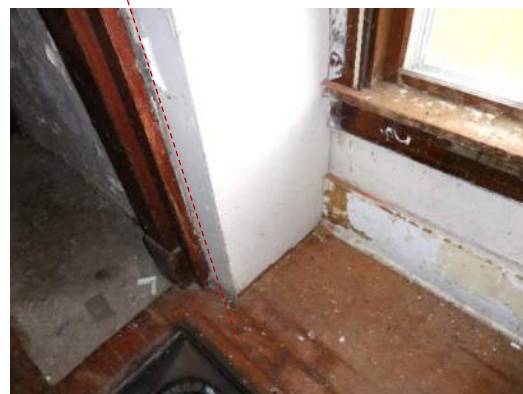
Figure 1.58. Detail of furred duct chase adjacent to the fireplace. Note, the gypsum wallboard is installed around the baseboard. The plaster ceiling and west wall are deteriorated.
Dining Room 104. (Strata 2016)

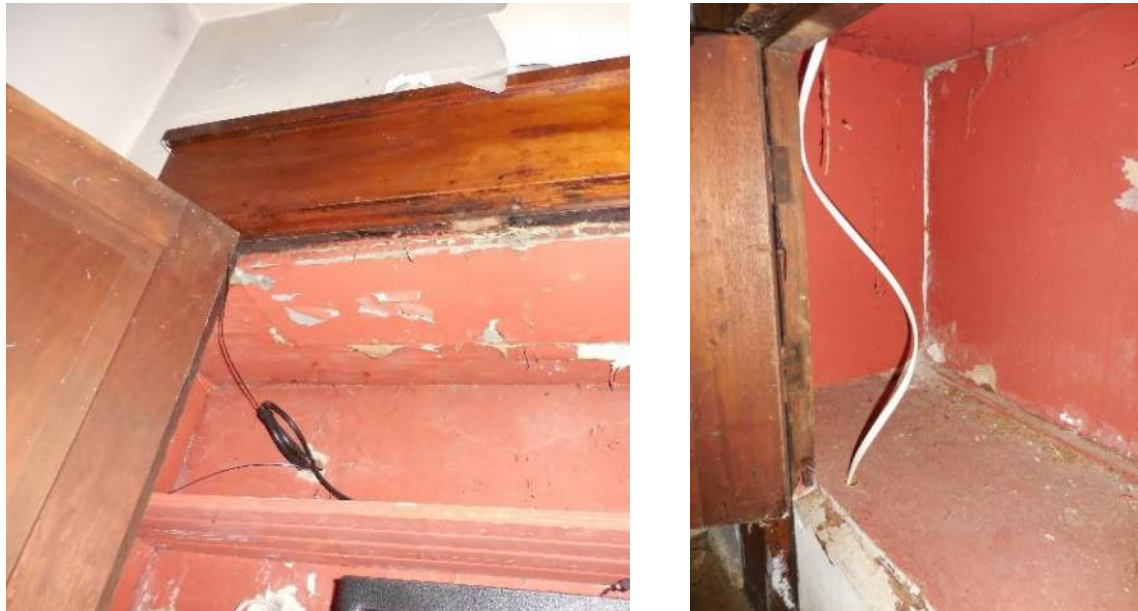
Figure 1.61. Metal plate at top of cabinet. Electrical wiring drilled through cabinet, Dining Room 104. (Strata 2016)

Exposed conduit is installed throughout the room. It is attached on the south and east walls to serve switches and to provide service to the adjacent hall, and it was also attached to the ceiling, although it has been removed. Receptacles are installed on the baseboards with conduit drilled through the wood floor to the basement on the south, north and east walls. All electrical conduit, receptacles and switches likely date to the 1950s renovation or later. A telephone jack is installed on the south wall near the receptacle. The baseboard is drilled where the conduit served light switches.

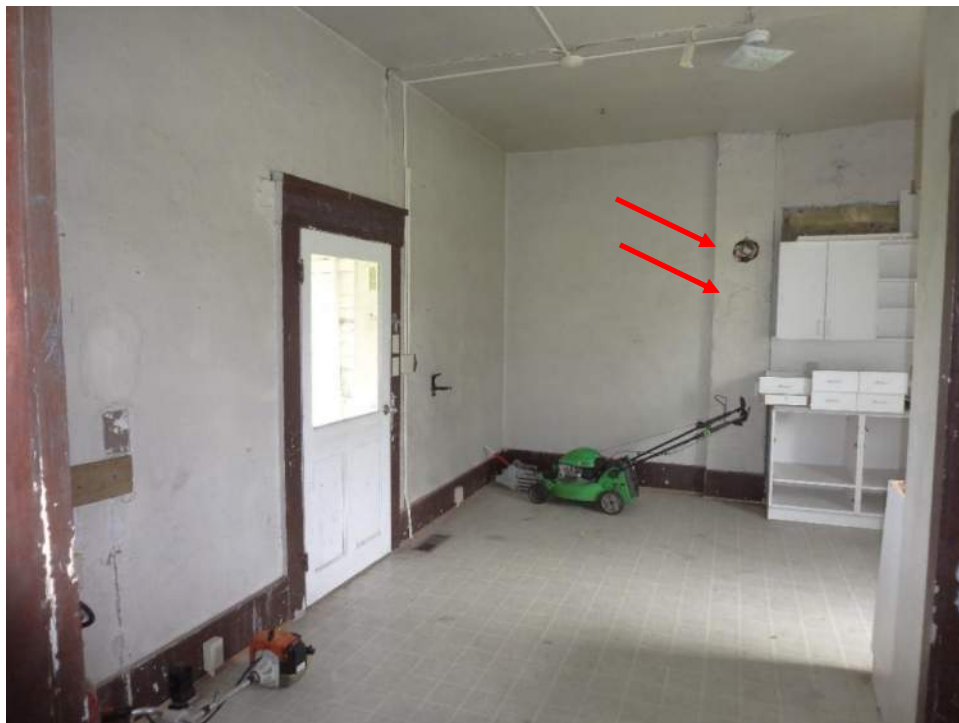
Figure 1.63. Looking south and east, Door 1/105 in east wall, Kitchen 105. Arrows point to two thimbles in chimney flue. (Sheals 2016)

The south wall contains a projecting brick chimney flue and two thimbles from old cook stoves (one which has been infilled). The window and door trim and baseboard in this room matches those of the other first floor rooms and are in fair condition. The millwork, window, doors and hardware are discussed further in the Materials Section of this report.

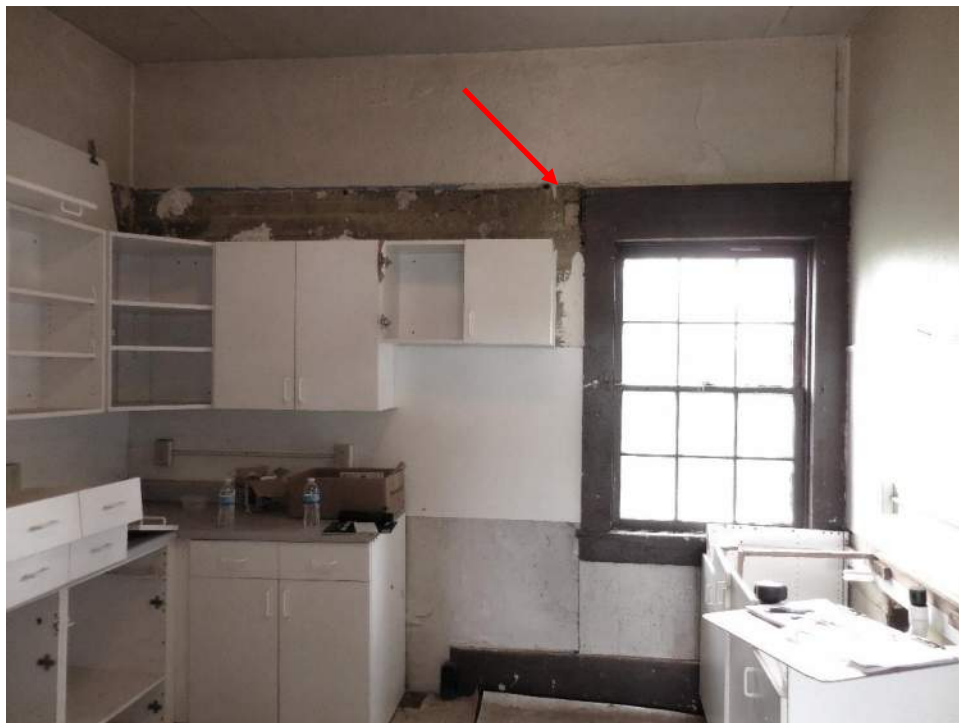
Figure 1.65. West wall and Window 104, Kitchen 105. The arrow is pointing to the exposed wood lintel. (Sheals 2016)

The west wall has a large 6/6 divided lite Window 104 (Figure 1.65). This is an original window opening with replacement sashes that appear to date to the 1950s renovation and are in good condition. The wood lintel above the window is deteriorated and is exposed on the interior. The lintel is typical, in that it is installed only on the interior wythe of brick to span the window opening. This appears to be typical of the construction throughout the house, although only this lintel and the one installed above the east Door 1/105 are visibly deteriorated and the plaster has fallen to expose the lintel.

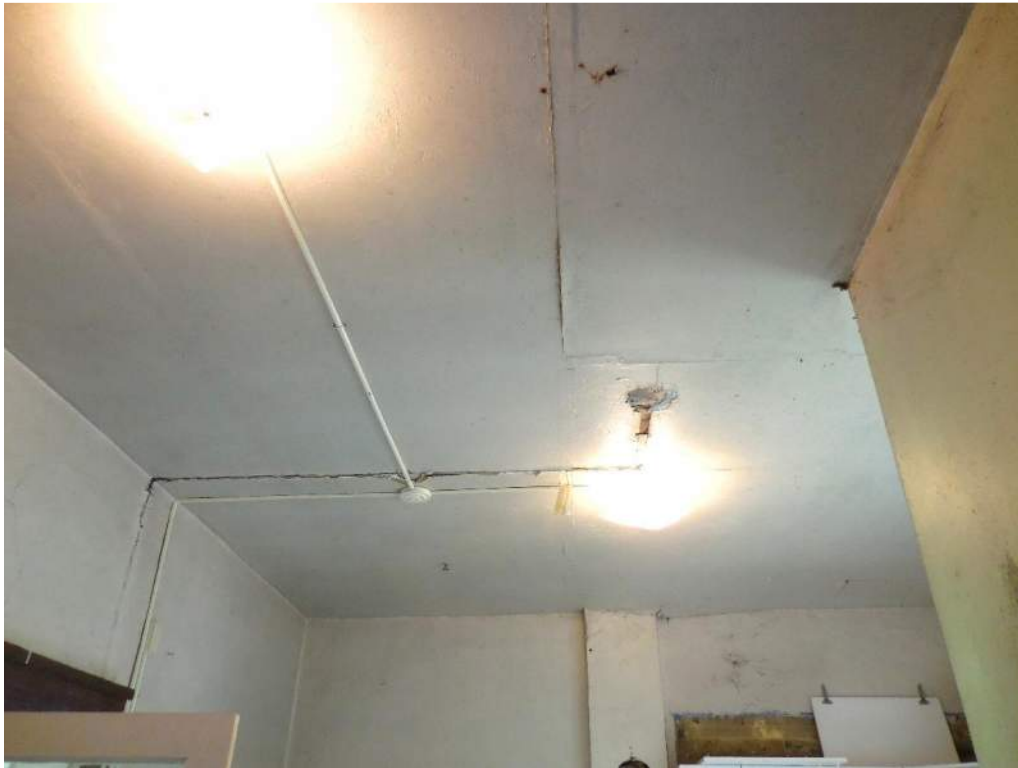
All four outside walls are brick load bearing walls with plaster installed directly to the brick. The brick walls are cracked in many locations, which have projected through the plaster. The cracks indicate signs of previous footing settlement, as all of these walls rest on shallow stone foundations. The plaster ceiling has been overlaid with thin gypsum board and has a textured finish (Figure 1.66). The paint on the walls and ceiling is in fair to poor condition.

Figure 1.66. Ceiling, Kitchen 105. (Strata 2016)

Exposed conduit is installed throughout the room (Figure 1.66). It is attached to the east and north walls and the ceiling to serve switches and the ceiling lighting. There are two ceiling light fixtures that appear to date to the 1950s renovation or later. Receptacles are installed on the baseboards with conduit drilled through the wood floor to the basement on the south and east walls. Washer and dryer hookups, including electrical and a drain are located on the east wall in the north corner of the room. The plumbing service piping is removed. A telephone jack is installed on the north wall, just east of the door to the dining room. A stove receptacle is installed along the west wall.

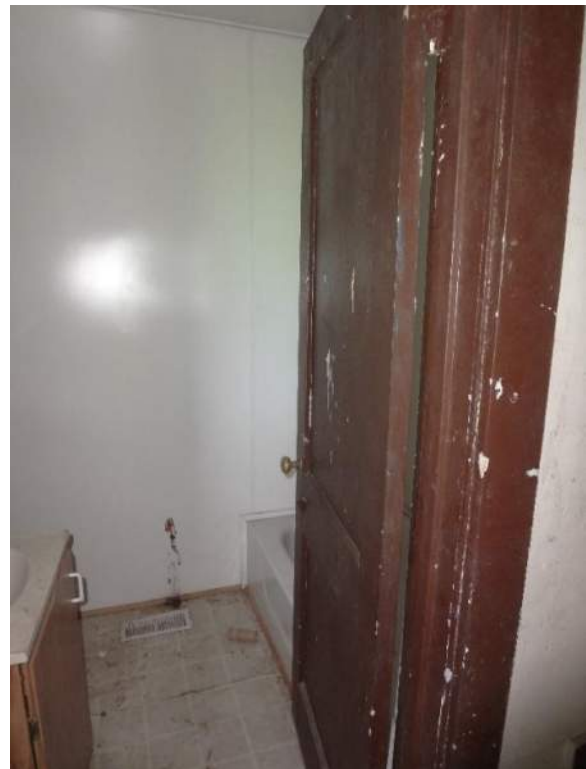
The Bathroom 106 is constructed in the northwest corner of the rear kitchen ell and is approximately six and one-half feet by five feet with a dropped ceiling height of seven feet ten inches (Figure 1.67). This room was constructed in the late 1950s and remodeled again in the 1990s. The bathroom is no longer functional and contains no historic finishes. The south and east walls are modern construction.

Figure 1.67. Bathroom 106. (Strata 2016)

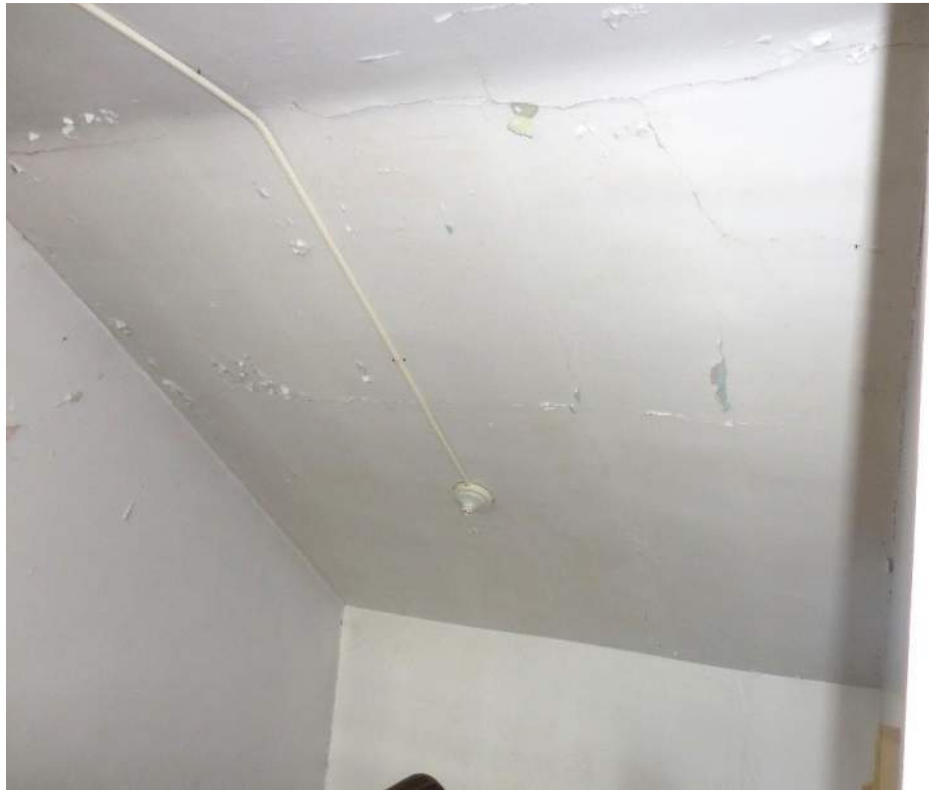
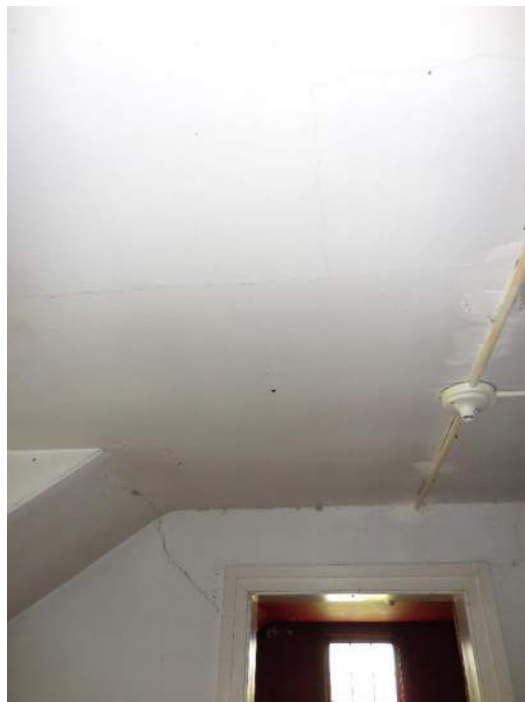
The east and west hall walls are load bearing brick walls that have a plaster finish. These walls align directly with the center hall walls below on the first floor. The walls are in good condition with a few through-wall cracks. The north and south walls, as well as the ceiling structure are wood frame with wood lath and plaster finish (Figures 2.6 and 2.7). The paint on the walls and ceiling is in fair to poor condition.

Figure 2.6. Ceiling, looking south, Hall 200. (Strata 2016)

Figure 2.7. Ceiling, looking east, Hall 200. (Strata 2016)

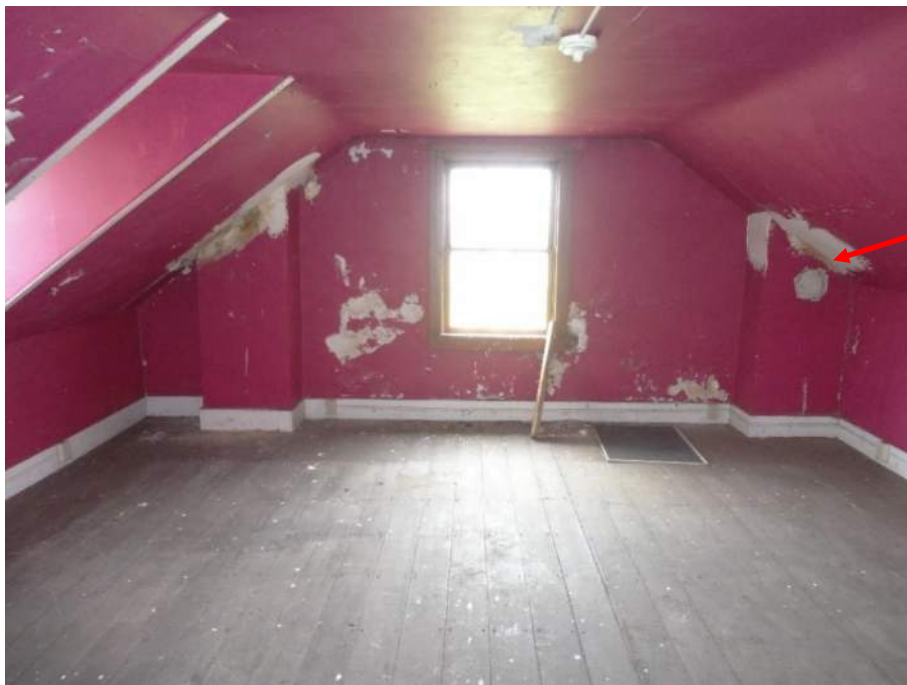
Figure 2.10. East wall and Window 204, East Bedroom 201. The arrow points to a stove pipe thimble covered with a tin plate. (Sheals 2016)

Two brick flues project into this room along the east wall and are plastered – a chimney in the northeast corner and one in the southeast corner of the room. The flue in the southeast corner has a thimble from an old heating stove installed. The plaster on the east wall is in very poor condition, showing signs of cracking and crumbling, as well as bubbling paint in the area surrounding the window and the southeast chimney, where there are signs of water infiltration. Water infiltration at the northeast chimney is also prevalent (Figure 2.15).

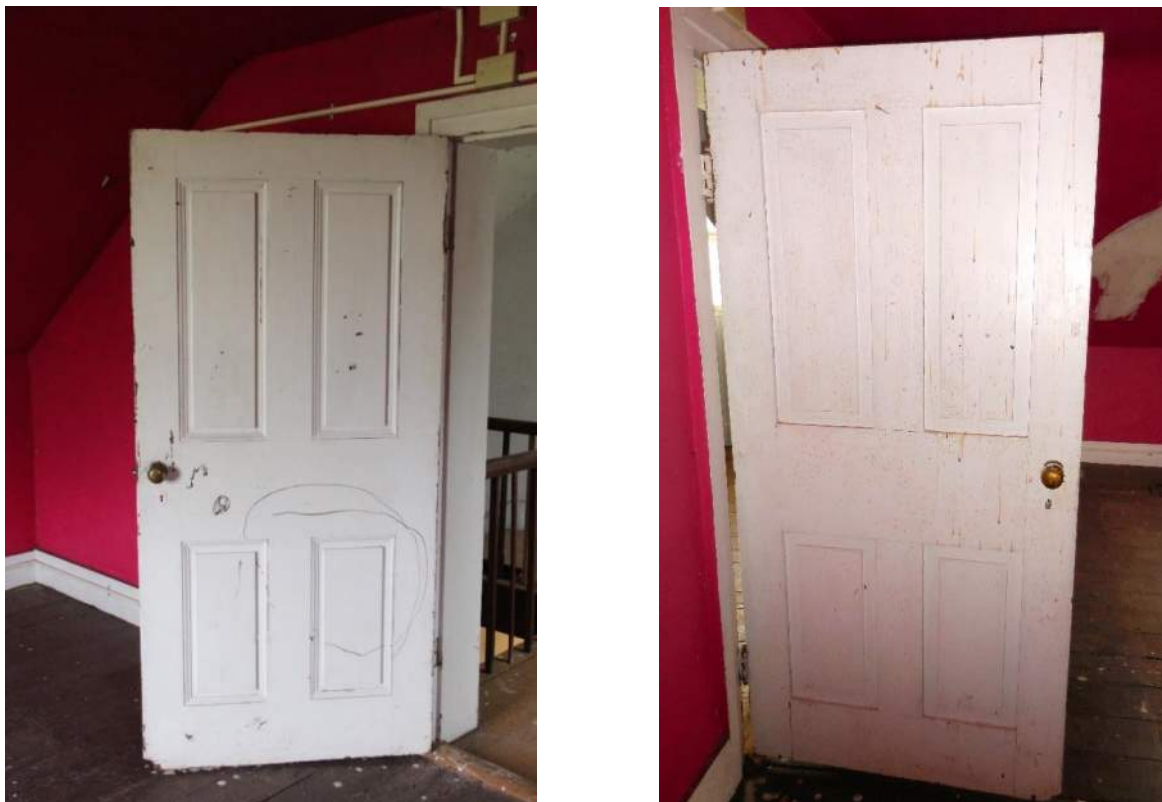
bottom outside corner (Figure 2.13). The design and condition of the millwork, windows, doors and hardware are discussed further in the Materials Section of this report.

Figure 2.13. Door 1/201, East Bedroom 201. (Sheals and Strata 2016)

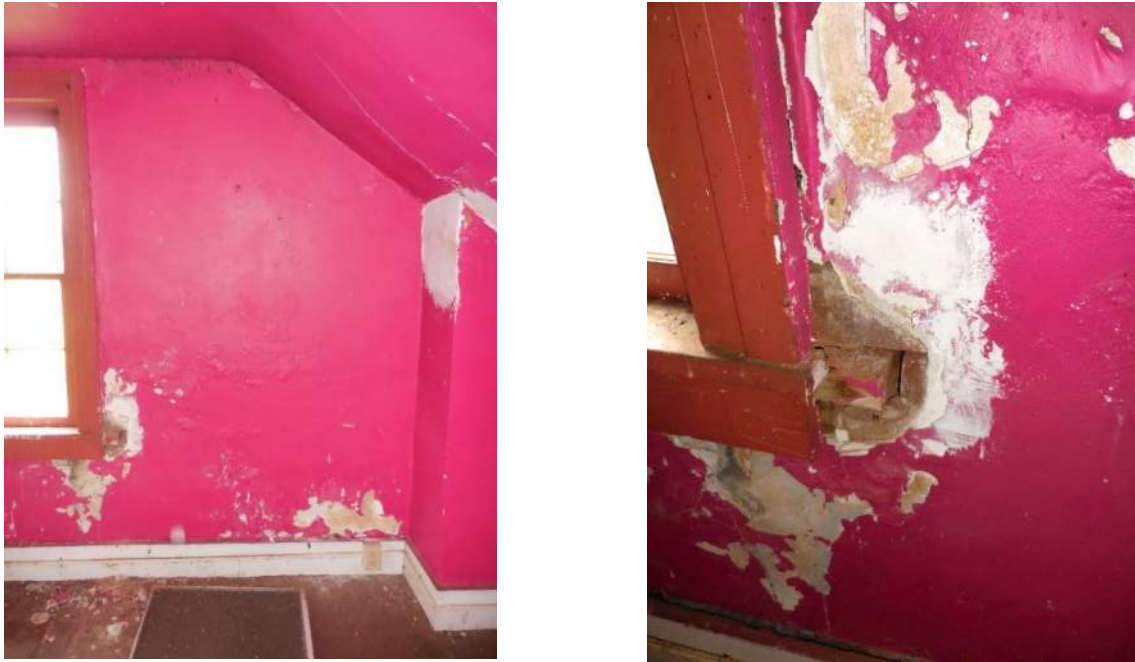
The exterior east wall and the west partition wall are brick load bearing walls with plaster installed directly to the brick. The north and south walls are wood frame with lath and plaster. The walls are cracked in many locations, which have projected through the plaster. The cracks and crumbling plaster and bubbles in the wall paint indicate signs of settlement and water infiltration (Figure 2.14).

Figure 2.14. East wall, plaster and paint deterioration and detail of racked window frame projecting from the wall at Window 204, East Bedroom 201. (Strata 2016)

A dormer on the north wall contains Window 203, which is an original window frame, with replacement double-hung 6/6 sashes. The exterior window trim and sill are deteriorated. Window 204 on the east wall is a 6/6 double-hung configuration and appears to be original or early to the construction of the house. The window frame is racked within the wall, as the sill and window frame are projecting into the room.

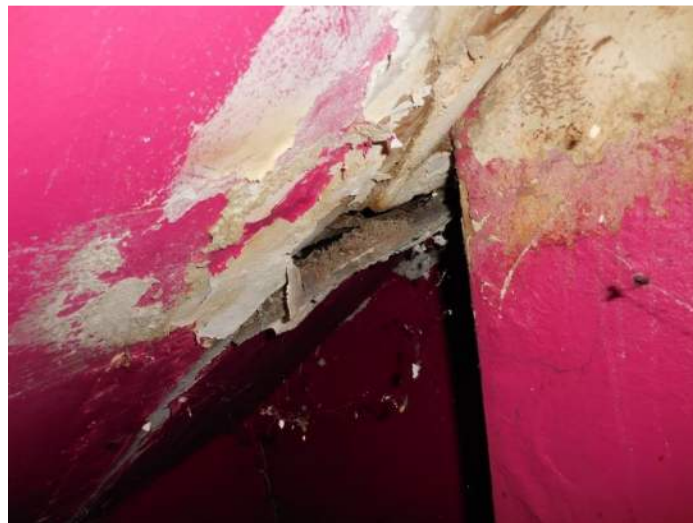
The plaster ceiling is in fair condition with cracking throughout. The walls and ceiling are painted. Both the walls and ceilings have plaster repairs, which have been inappropriately repaired with drywall joint tape. The wall and ceiling paint is in fair to poor condition. A hole in the northeast sloped ceiling provides access to measure the roof rafters, view the original wood roof skip sheathing and to also view the lath and plaster ceiling construction (Figure 2.15).

Figure 2.15. Hole in northeast corner ceiling. Note the deterioration is due to water infiltration at the chimney/roof connection, East Bedroom 201. (Strata 2016)

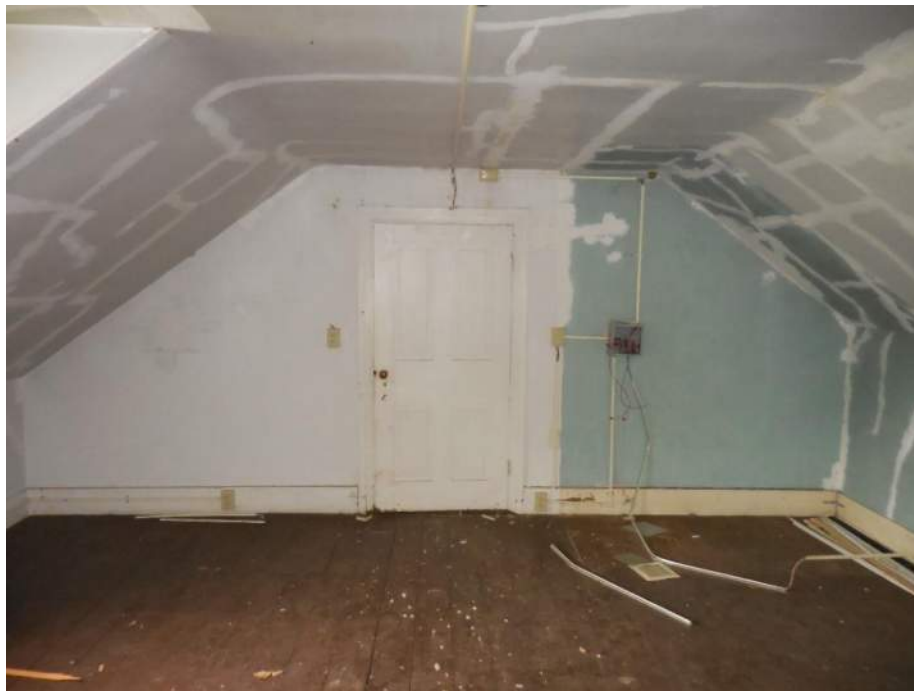
Figure 2.17. East wall and Door 1/202, Bedroom 202. (Strata 2016)

An electrical junction box is drilled through the east wall to serve a switch in the adjacent hall (Figure 2.17). Exposed conduit to the center ceiling porcelain socket light fixture and switch were installed in the mid-twentieth century. Additional conduit runs along the baseboards, supplying receptacles throughout the room.

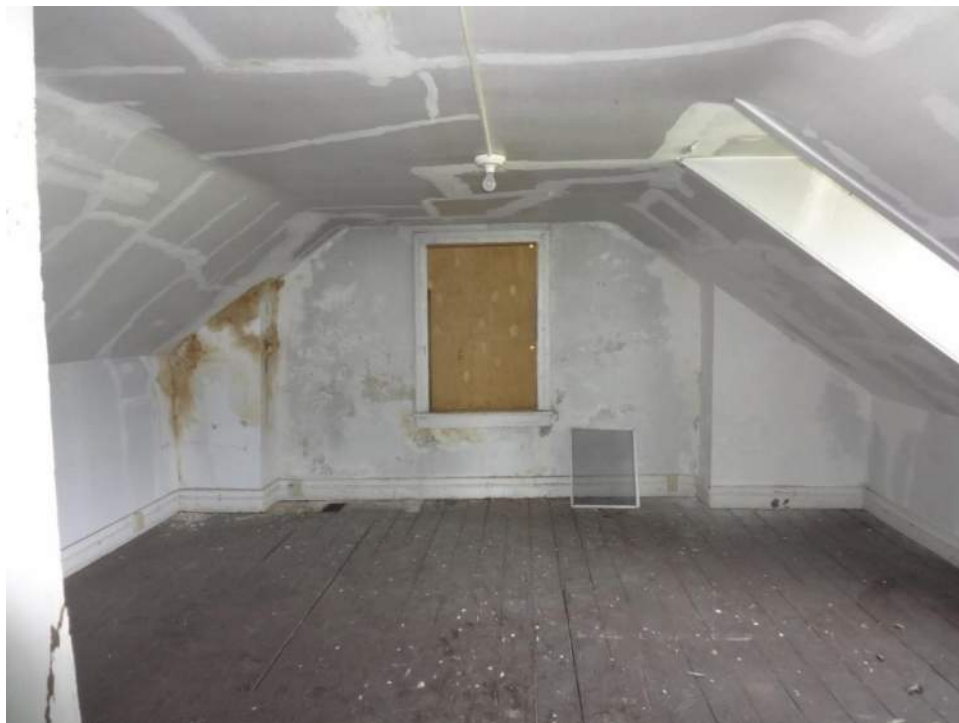
Two brick flues project into this space and are plastered (Figure 2.19). One chimney is located in the southwest corner and the second in the northwest corner of the room. The flue in the southeast corner has a thimble from a former heating stove. The plaster on the east wall is in very poor conditions surrounding the window and the southeast chimney, where there are signs of water infiltration. Water infiltration at the northeast chimney is also prevalent.

Window 200 on the west wall is a 6/6 double-hung configuration. The window is currently covered with plywood from the interior and was not able to be closely inspected, but appears to be very deteriorated from the exterior. The window opening appears to be taking on water, as the window frame in the wall and the plaster surrounding the bottom right side of the window are deteriorated and projecting into the room (Figure 2.23). A dormer on the north wall contains Window 201, which is an original window frame, with replacement 6/6 double-hung sashes and is in good condition (Figure 2.21).

Figure 2.19. West wall and Window 200, Bedroom 202. (Sheals 2016)

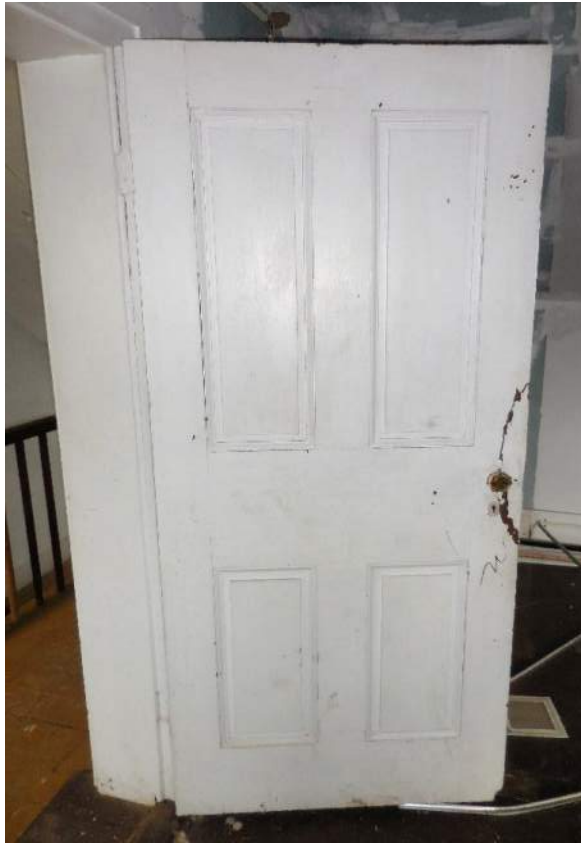
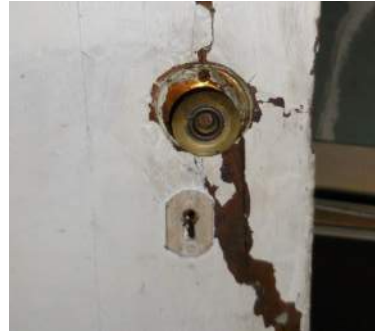
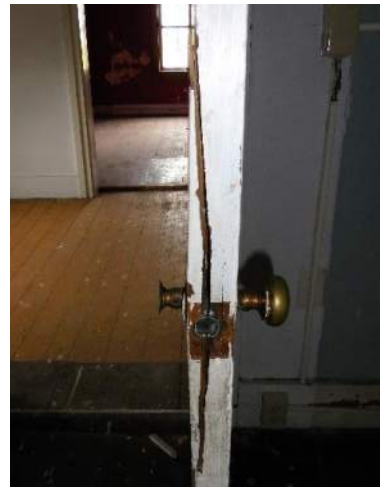
corner and is split at the mortise lock (Figure 2.22). The millwork, windows, doors and hardware are discussed further in the Materials Section of this report.

Figure 2.22. Door 1/202, Bedroom 202. Note the door is split at the mortise lock. (Strata 2016)

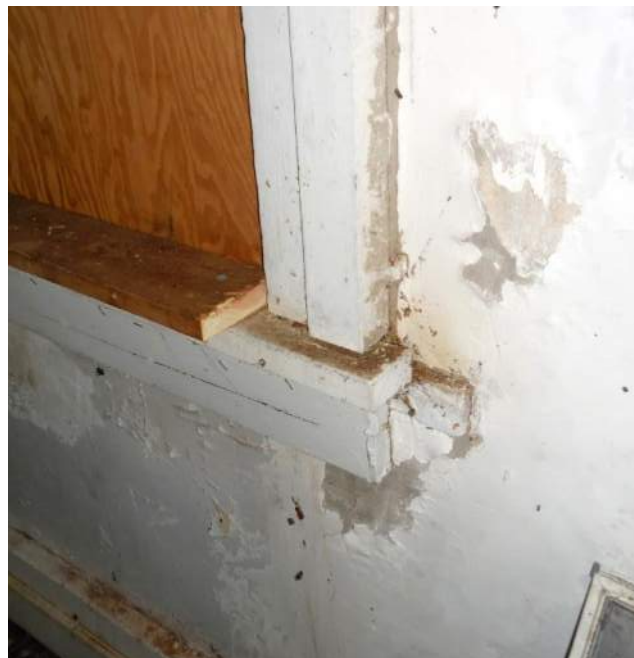
Figure 2.23. Window 200, Bedroom 202. Note the plaster wall deterioration around the lower wood frame. (Strata 2016)

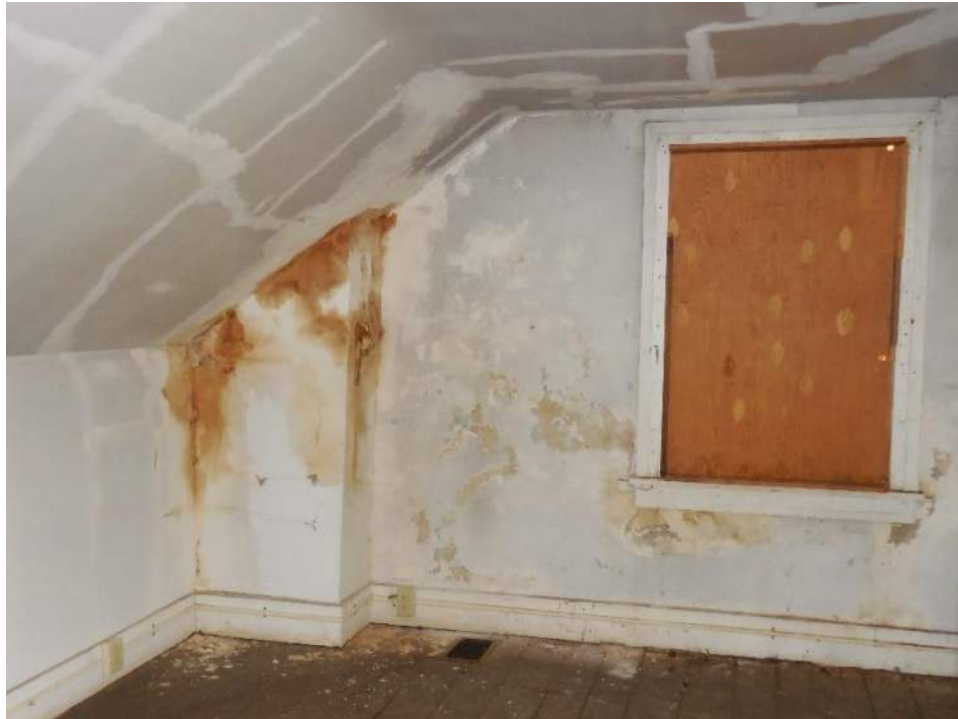
The original tongue and groove wood floors are laid in the east/west direction and are painted a brown color. They are between six and seven inches wide. Again, the species of the wood flooring is unknown, but it appears to be pine or another wood with similar characteristics. The wood floor is in good overall condition. There is one mechanical vent installed in the floor in the southwest corner of the room (Figure 2.24). This is the only vent on the second floor.

Figure 2.24. Detail of water infiltration at the southwest chimney, Bedroom 202. Note, the floor vent along the west wall is the only mechanical vent in the second floor. (Strata 2016)

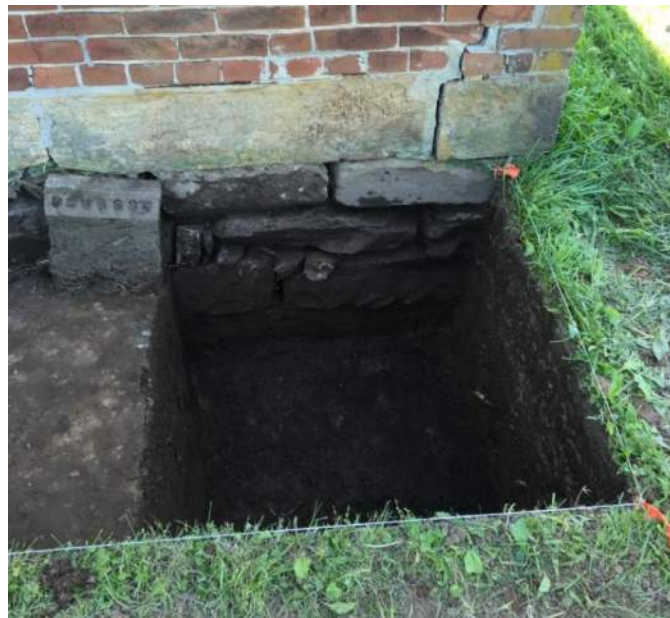
The north portion of the structure is constructed on a shallow masonry foundation. At an exterior excavation near the northeast corner of the house, the masonry foundation measured 36-inches deep from the bottom of the brick (Figure S3). With 12-inches of exposed stone foundation, this results in 24-inches of foundation below grade. No spread footings were observed. Room 000 was originally a crawl space. A portion was excavated at some point to provide a partial basement area and to provide access to basement Rooms 004 and 005. The excavated portion is defined by Concrete Masonry Unit (CMU) walls. Near the bottom of the interior central stair, there is an area where the bottom of the original stone masonry foundation is exposed at the area of excavation. In Room 000 the depth of the original stone foundation measured 36-inches (Figure S4). The basement rooms provide some visibility to the interior of the foundation walls below the north portion of the house. This visibility is limited, however, and there was no physical access to the crawl spaces beneath first floor Rooms 101, 102, and 103. The interior stone foundation walls have penetrations for contemporary ductwork, which allow for direct measurements of thickness. Walls measured between 11-inches and 16-inches wide, with variation due to the nature of the rubblework pattern of the masonry. It is assumed that the depth of footing is consistent throughout the north portion.

Figure S3. Exterior excavation at the east wall, near the north corner of the foundation wall. (SEA 2016)

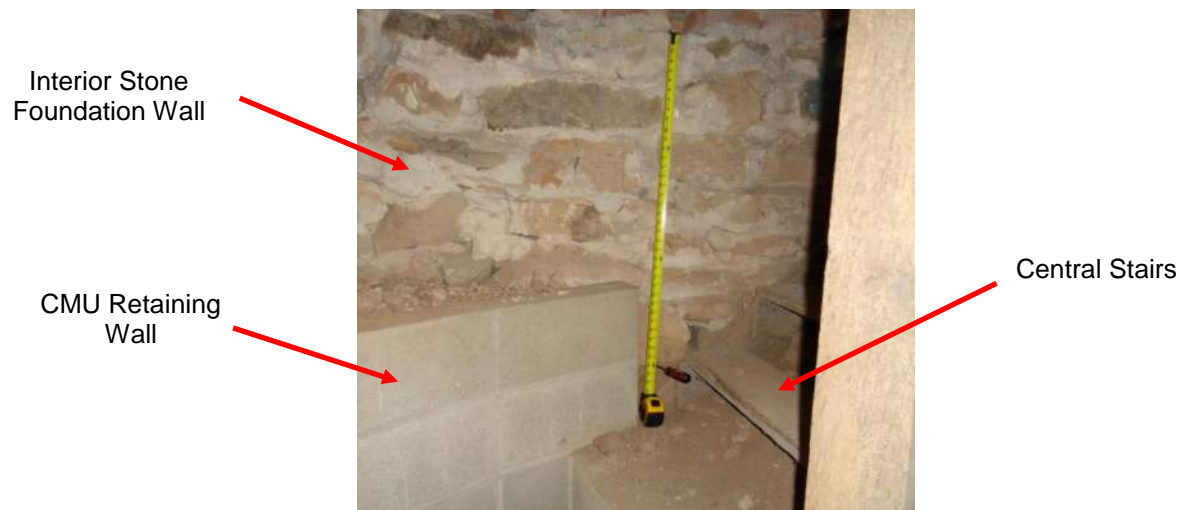
Figure S4. Interior foundation wall at basement stairs, Room 000, looking east. (SEA 2016)

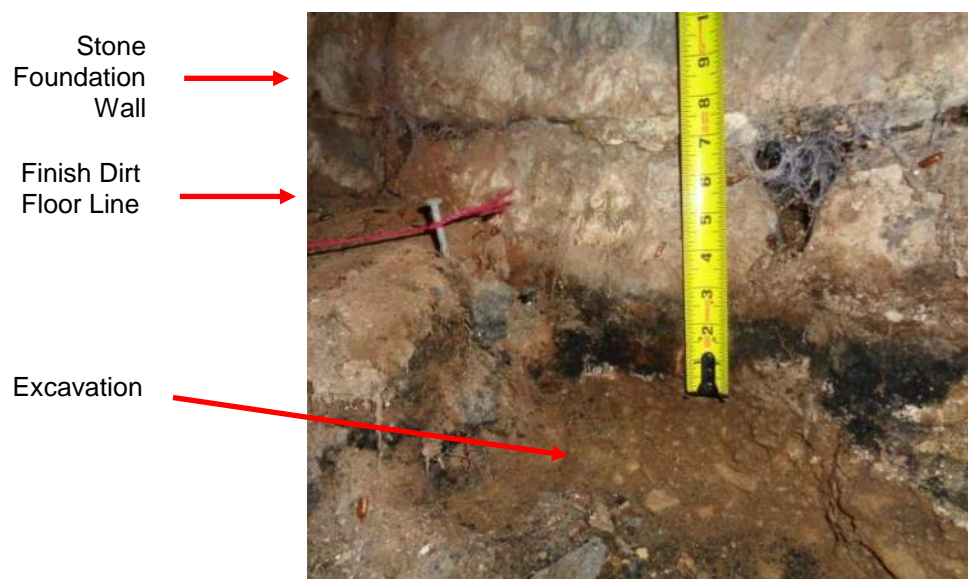
The walls of Room 005 are deeper than the foundation of the rest of the structure, resulting in an original full height basement room. The height of masonry from the floor to the bottom of the joists measures 6-feet 2-inches to 6-feet 4-inches; the variation is due to the uneven dirt floor. The masonry wall extends approximately 3-inches below the existing dirt floor, observed directly at the interior excavation in the northwest corner (Figure S5).

Figure S5. Depth of foundation below basement dirt floor, Room 005. (SEA 2016)

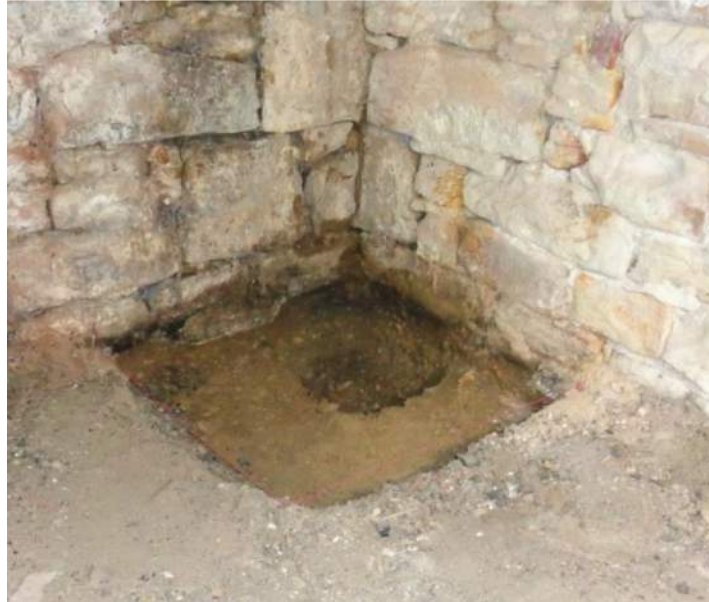
The thickness of the south wall measured 11½-inches at the south exterior door. The thickness of the west wall measured 11½-inches at the infilled coal chute. The interior north wall thickness varies from 10-inches to 14-inches, measured at the door to Room 004. The east wall thickness could not be directly measured. Absence of mortar in places on the face of the masonry

indicates deterioration and/or water intrusion and erosion, especially on the west basement wall (Figure S6).

Figure S6. Interior excavation at the northwest corner foundation wall, Room 005. (SEA 2016)

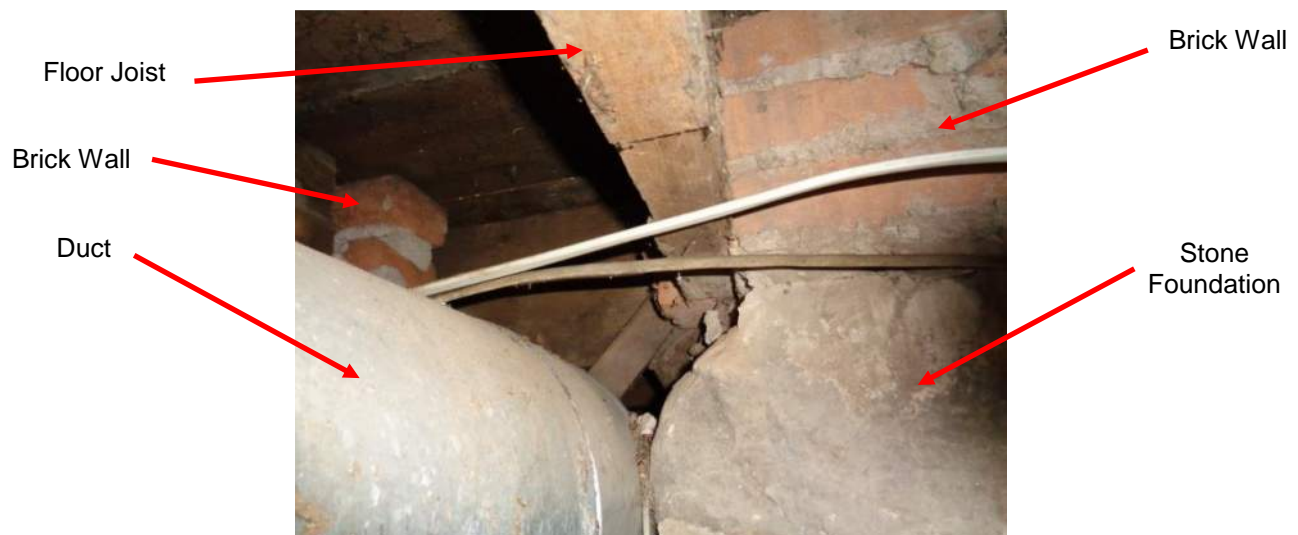
The interior brick load-bearing walls and wood floor joists bear directly on the stone foundation walls, but at wall penetrations they have insufficient bearing. Where non-original wall penetrations and doors were created through the original stone foundation walls, some problematic connections exist. At the ductwork penetrations, no lintels were installed (Figure S7). The doorways do have wood jambs and lintels, but at the opening between Rooms 000 and 004, the bearing connection is poor (Figure S8) and the jamb is unbraced.

Figure S7. Wall penetration with no lintel to support the floor joist. (SEA 2016)

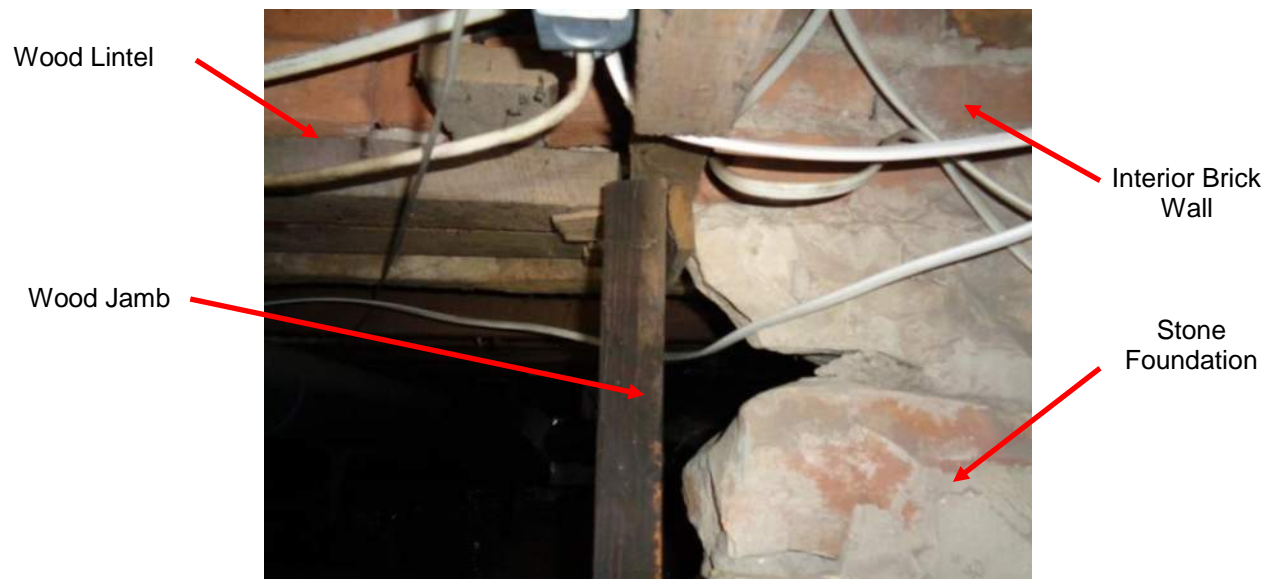
Figure S8. Lintel detail at opening between Room 000 and Room 004. (SEA 2016)

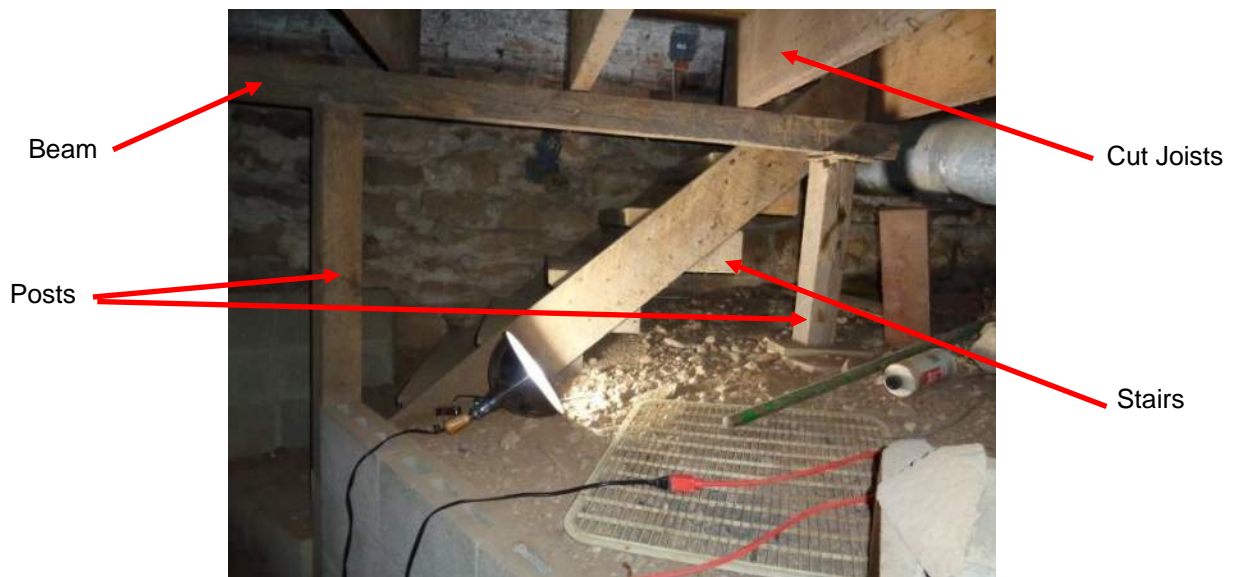
Construction of the non-original central interior stairs required alteration of four floor joists. They are now supported by two posts and a beam (Figure S9). One of the posts shows signs of deterioration at the base (Figure S10).

Figure S9. Joist support at stairs, Room 000, looking east. (SEA 2016)

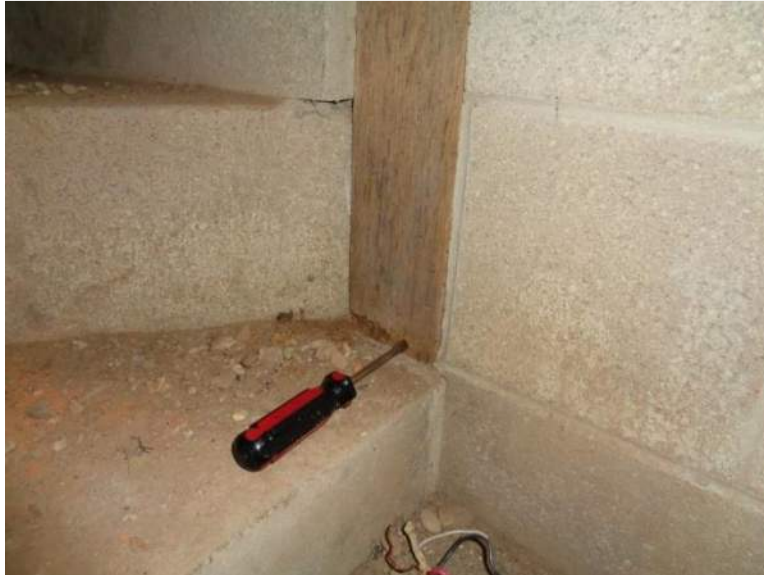
Figure S10. Detail of deteriorated post, Room 000, at the stairs. (SEA 2016)

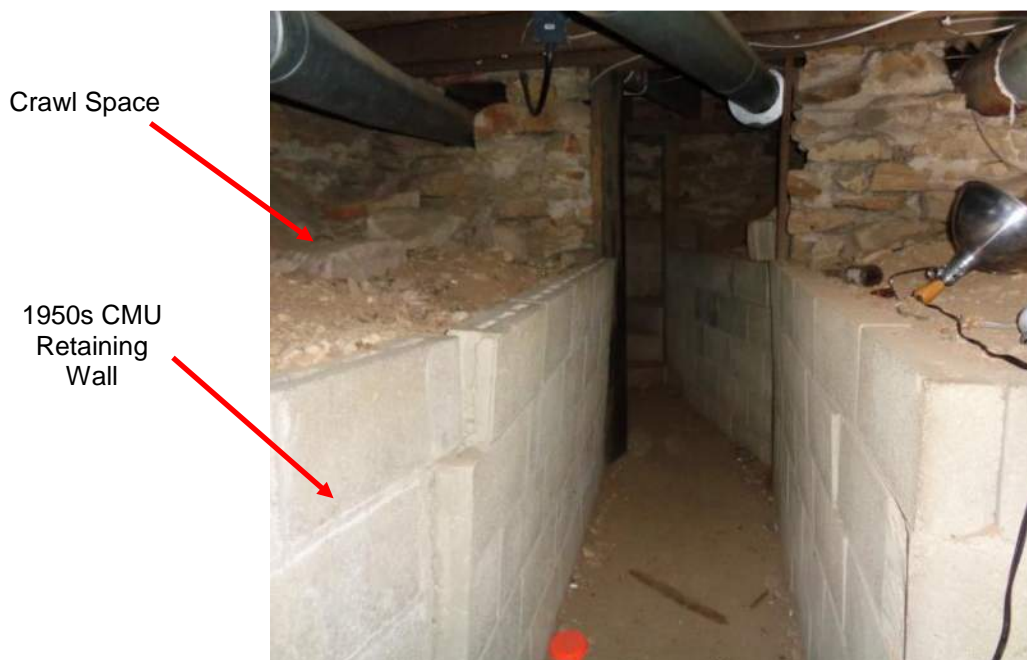
The basement walkway in Rooms 000 and 004 is bounded by stub walls, constructed for retaining the pressure of the soil under the adjacent crawlspace areas. These walls are constructed using unreinforced CMU and measure from 38-inches to 45-inches tall (Figure S11). Certain portions of the wall are between five and ten degrees out of plumb (Figure S12). The rotation of the walls has occurred since they were originally constructed in the 1950s.

Figure S11. CMU basement walls, Room 004 looking east into Room 000. (SEA 2016)
