THOMAS BLACKSTONE HOUSE

HISTORIC STRUCTURES REPORT

SEIP EARTHWORKS UNIT – HOPEWELL
CULTURE NATIONAL HISTORICAL PARK
BAINBRIDGE, OHIO

APRIL 17, 2017
NPS PMIS # 218963

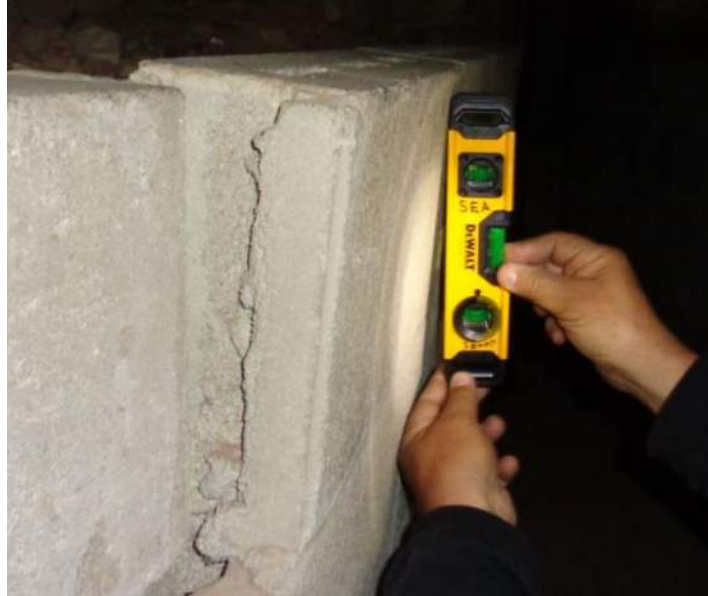
The basement walkway in Rooms 000 and 004 is bounded by stub walls, constructed for retaining the pressure of the soil under the adjacent crawlspace areas. These walls are constructed using unreinforced CMU and measure from 38-inches to 45-inches tall (Figure S11). Certain portions of the wall are between five and ten degrees out of plumb (Figure S12). The rotation of the walls has occurred since they were originally constructed in the 1950s.

Figure S12. Rotated CMU wall, Room 004. (SEA 2016)

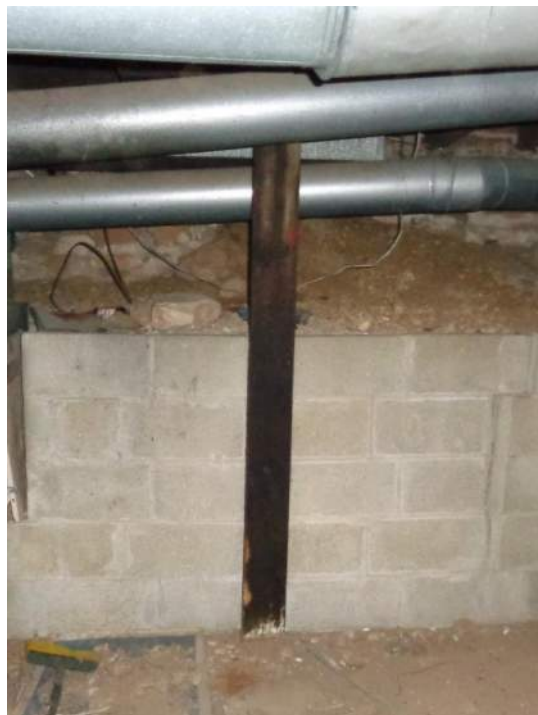
In Room 004, a wood post has been installed near the center of the room (Figure S13). The post does not appear to be structural and may only keep a duct in place. However, the joist that the post attaches to cannot be seen due to ductwork installation, and the post is taking load, so further investigation would be needed to determine the condition of the joist (Figure S13 and S14).

Figure S13. Wood post, Room 004 looking north. (SEA 2016)

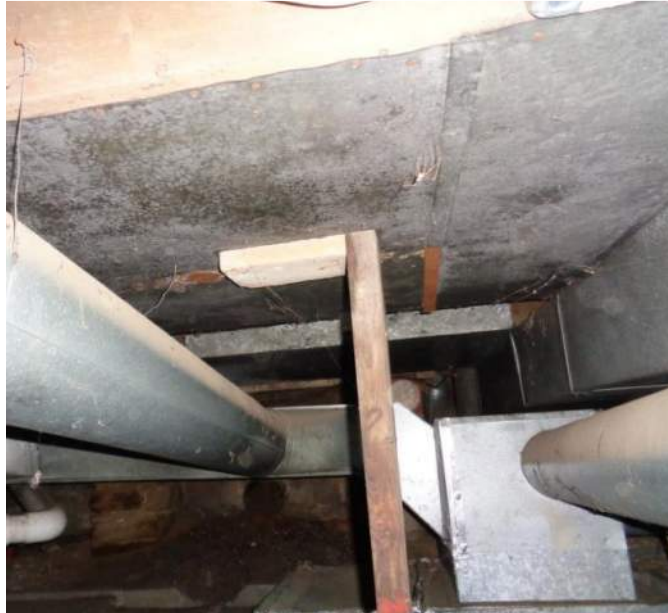
Figure S14. Wood post connection detail in Room 004 through duct at ceiling. (SEA 2016)

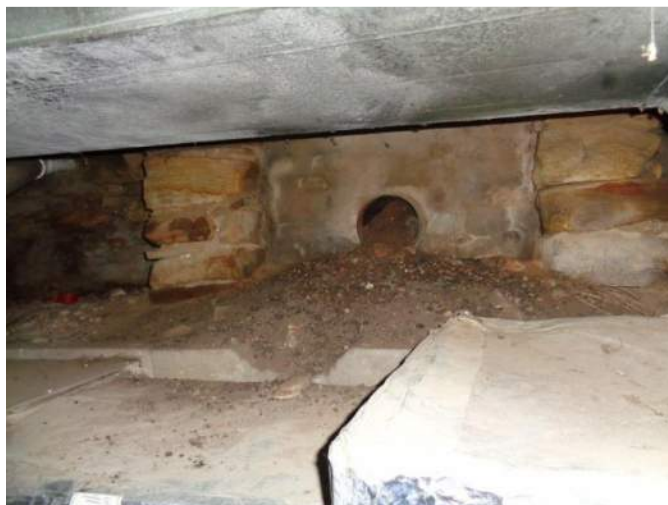
In Room 004, a fireplace foundation can be seen which supports the fireplace along the west exterior wall in the first floor (Figure S15). The chimney has been modified to accommodate exhaust for a previous furnace. This does not allow for adequate comparisons to the other fireplace foundations that cannot be seen. In Bedroom 102, the hearth extension pad is uneven and shows signs of possible failure of the support system (Figure S16). Additional investigation is needed to understand the cause and magnitude of the problem, as this area is inaccessible for assessment from the basement.

Figure S15. Chimney foundation. (SEA 2016)

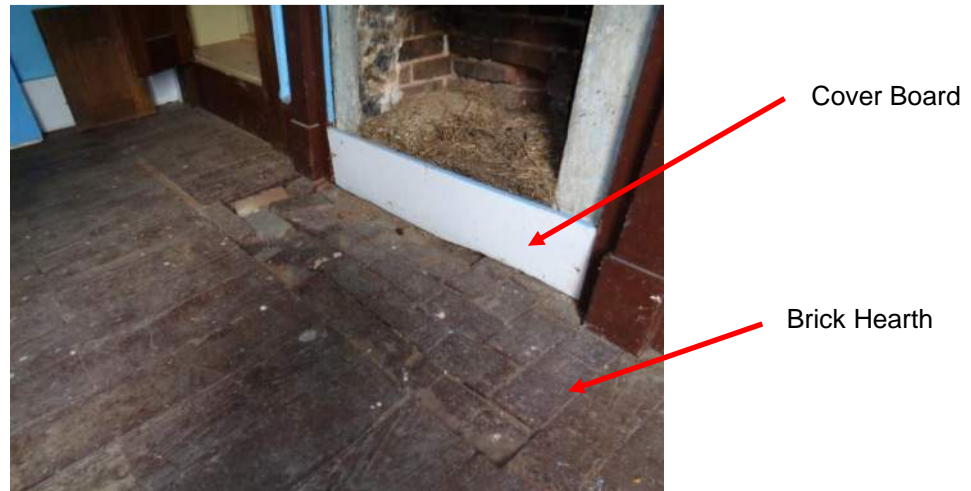
Figure S16. Hearth extension pad appears to be failing under the brick hearth in Room 102. (SEA 2016)

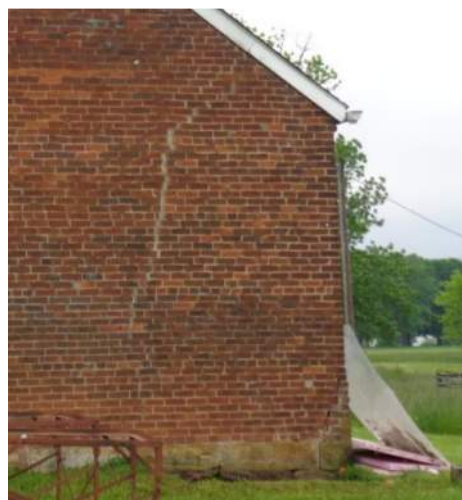
Each exterior wall of the house shows cracks running along mortar joints and through bricks. The most apparent signs are on the east wall near the north corner of the structure, where previous repairs have highlighted the movement of the brick (Figure S17).

Figure S17. Repaired crack in the east wall near the north corner. (SEA 2016)

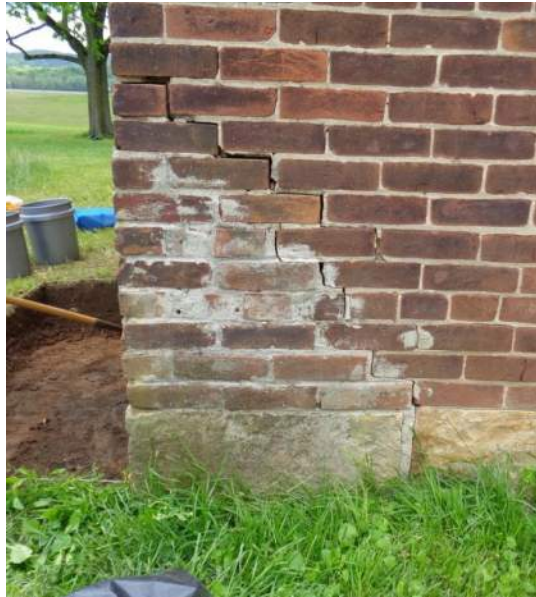
The cracks appear to get wider as they move up the structure (Figure S18). While the true measure of the cracks do widen, the movement of the brick is not as pronounced as it may first appear, because more mortar is missing higher in the crack.

Figure S18. Northeast corner. (SEA 2016)

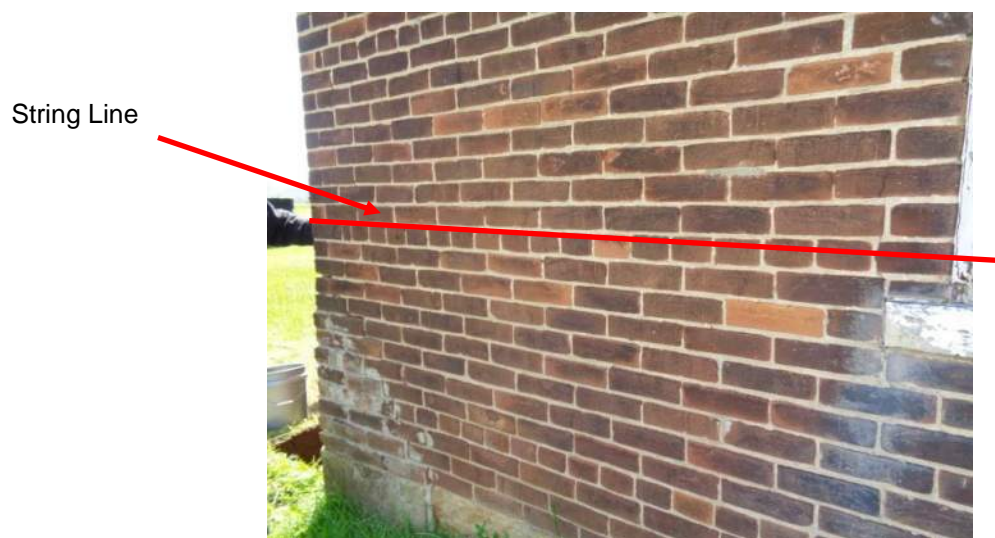
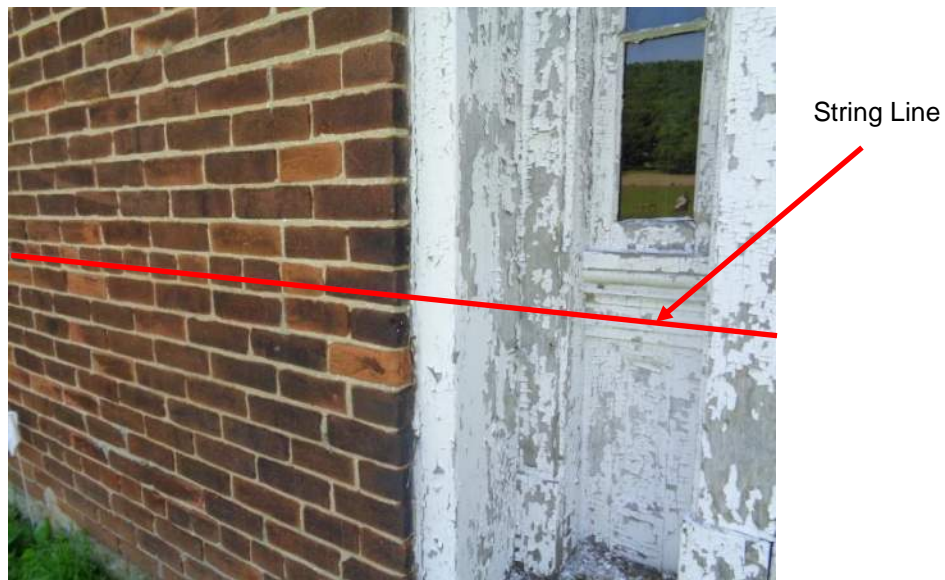
Overall, the cracks on the exterior indicate rotation of the structure, rather than only horizontal or vertical movement. Rotation is caused by corners settling at a more advanced rate than the wall center. This was confirmed with a string line on the north elevation. The string line was placed at the same bed joint at the northeast and northwest corner. When level, the line shows the bed joint approximately 1½-inches higher at the center of the wall than at the corners (Figures S19 and S20).

Figure S19. String line at north wall near east corner. (SEA 2016)

Figure S20. String line at front door, north wall. (SEA 2016)

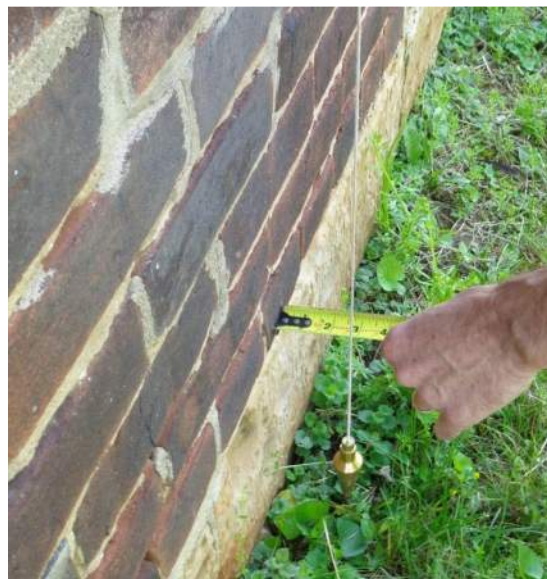
The east and west exterior walls also tilt, demonstrated by a plumb line dropped from the second level windows at the east and west elevation. The east elevation plumb line was 1-inch further from the face of brick than the edge of sill, or 0.4° from plumb. The west elevation plumb line was $2\frac{1}{4}$ -inches further from the face of brick than the sill, or 0.8° from plumb (Figure S21).

Figure S21. Plumb line, west wall. (SEA 2016)

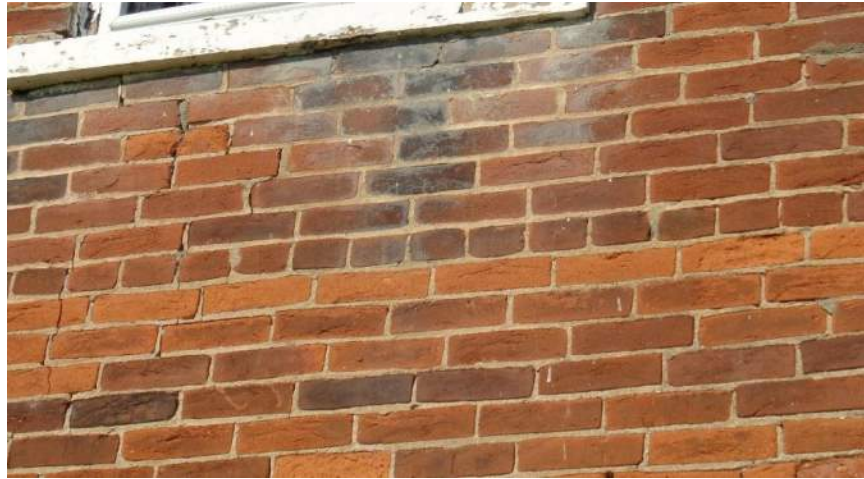
Some exterior bricks have deteriorated in place (Figure S22). The cause is likely from variation in quality of brick. Bricks of the time period were fired in a batch process; bricks at the bottom or outer layer of the kiln (salmon brick) would not achieve the same strength properties as those at

the top of the kiln. Hard-burned brick is darker in color. Masons were aware of this variance and used higher quality bricks for exterior applications. Brick deterioration is present on each face of the structure.

Figure S22. Typical deteriorated brick. (SEA 2016)

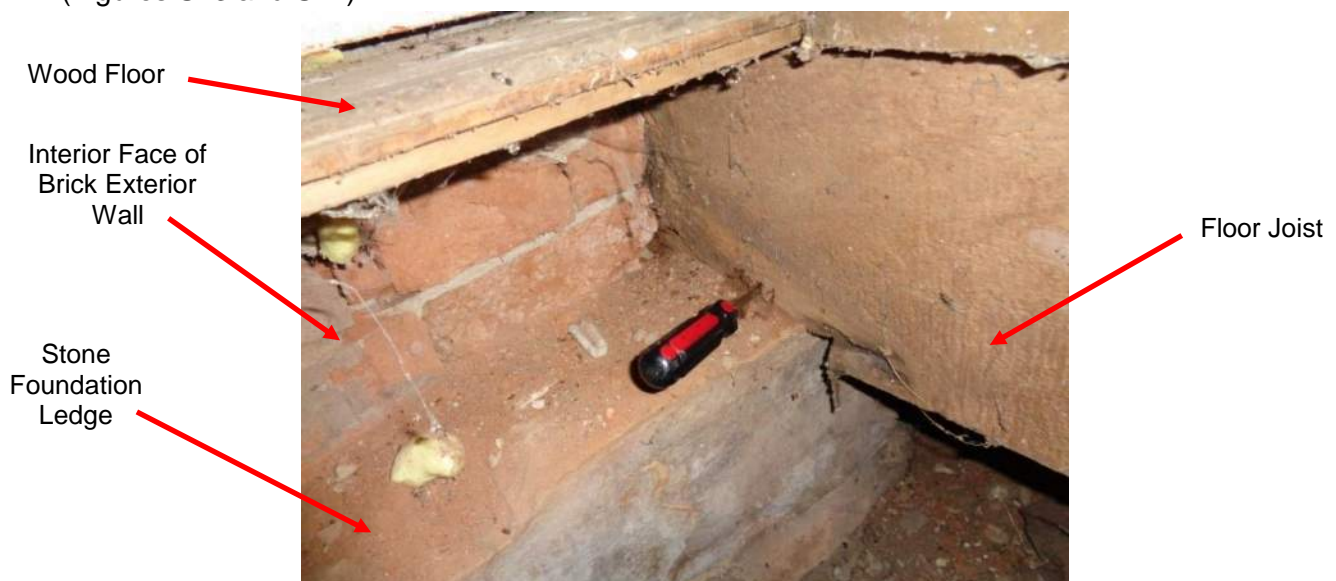
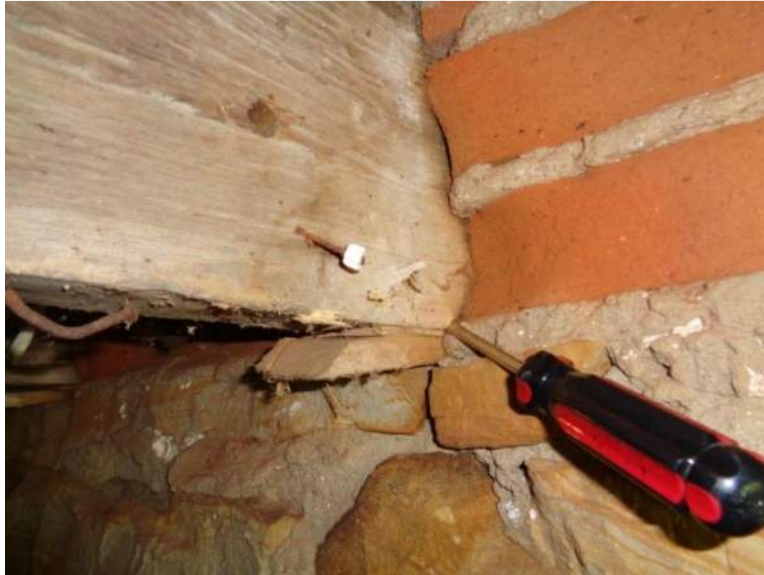
The interior wythe was likely constructed using lower quality bricks, as they are not subjected to the elements. Over time moisture has intruded and deteriorated the interior wythe in places (Figures S23 and S24).

Figure S23. Detail of rotted joist and interior wythe of brick, below the West Parlor 103 at old return air register location, north wall. (SEA 2016)

Figure S24. Detail of rotted joist and interior wythe of brick, Room 005, west wall. (SEA 2016)

First floor joists with bearing at exterior walls show rot due to moisture (Figures S23 and S24).

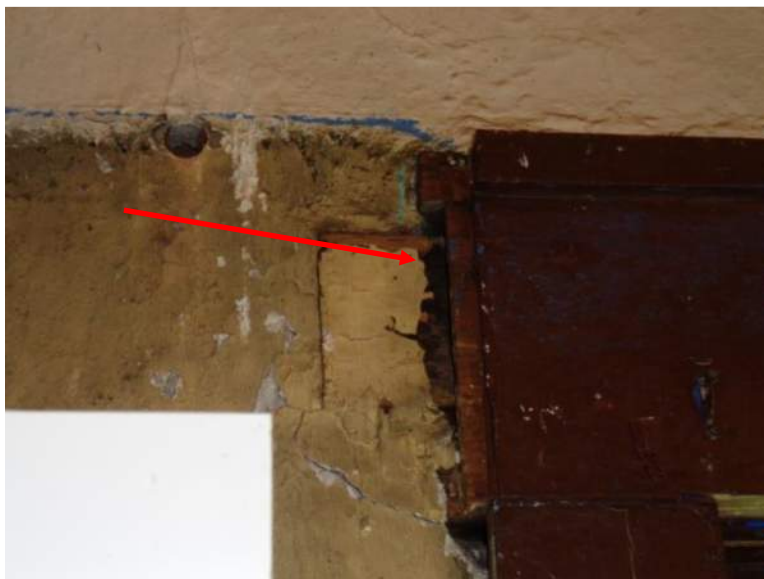
Above the first finish floor, the interior wythe of brick is plastered over, so a full study of the brick condition could not be performed. In Kitchen 105, however, the rotted wood window lintel at Window 104 in the brick is visible (Figure S25). This condition is likely present throughout the house.

Figure S25. Rotted wood lintel, Window 104. (SEA 2016)

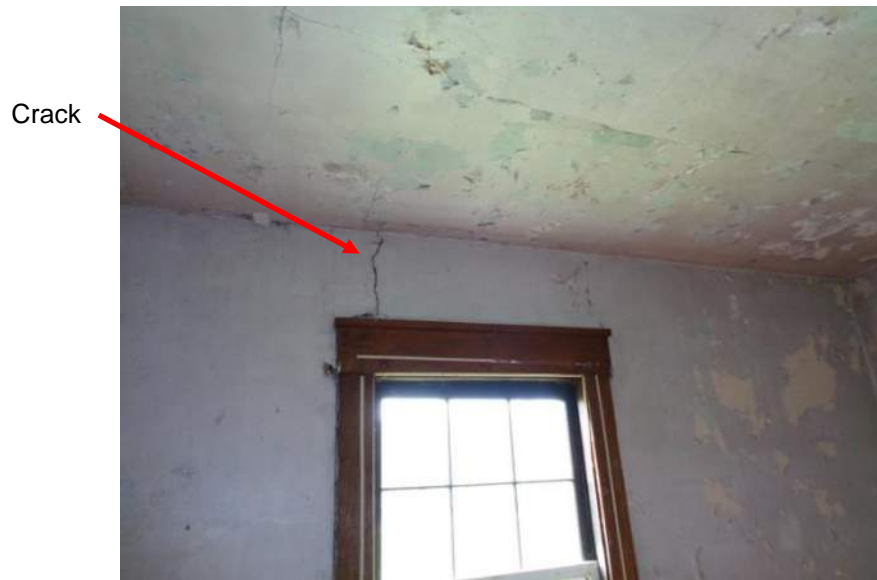
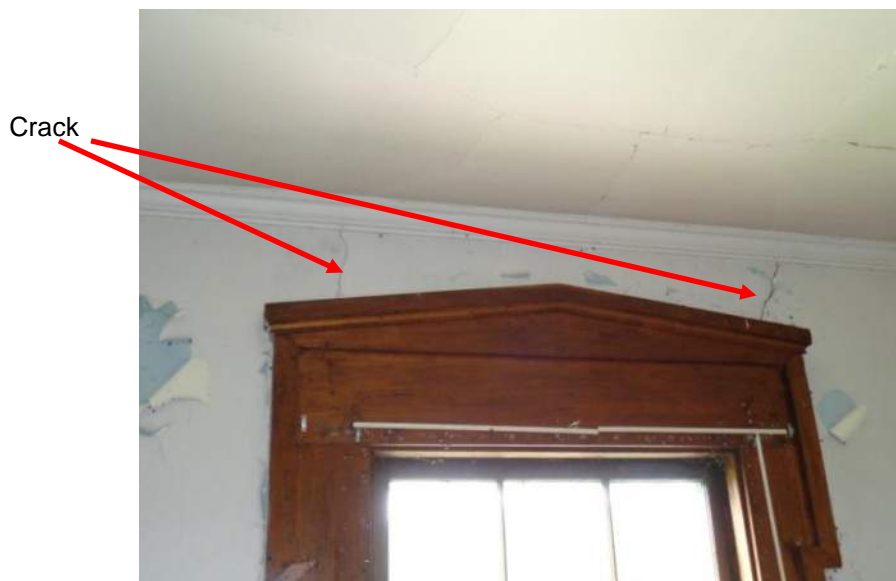
The plaster throughout the house has cracked, especially at windows and doors (Figures S26 and S27). The cracks observed mirror exterior cracks (through-wall cracks) and are consistent with rotational settlement at many of the locations.

Figure S26. Cracks through plaster and the exterior wall at Window 100, looking north. (SEA 2016)

Figure S27. Cracks through plaster and exterior wall at Window 101, looking north. (SEA 2016)

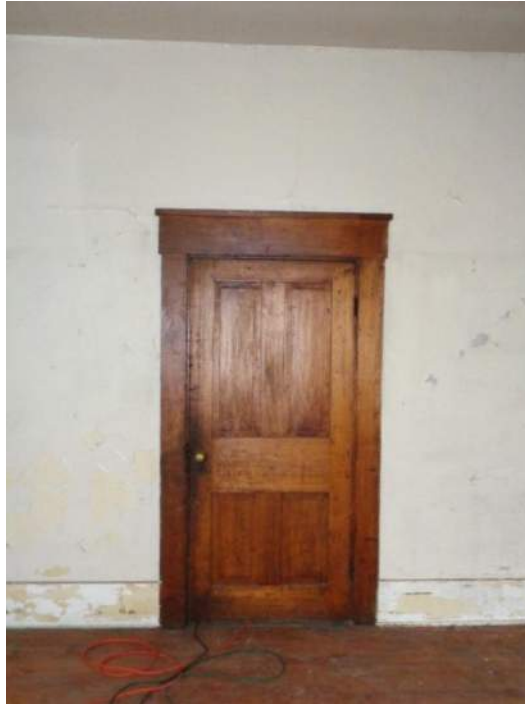
The door frames and windows were observed. The doors are all operable, indicating that the walls have not settled differently at these locations. The door frames are square and are consistently a rather tight fit (Figure S28).

Figure S28. Door 1/104 in Dining Room 104. (SEA 2016)

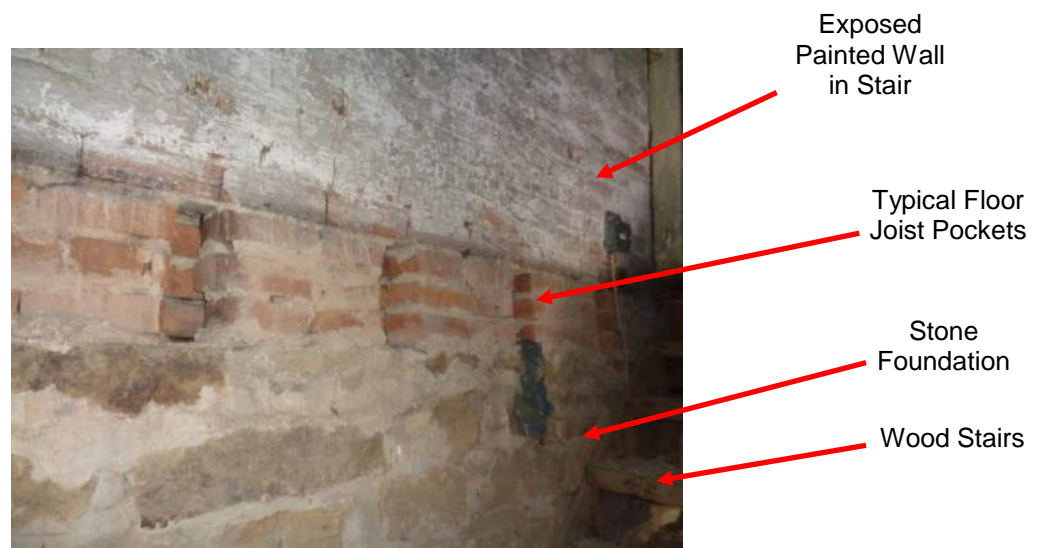
The interior walls are double wythe brick coated in plaster. At the masonry footing, the brick is pocketed for first level floor joists. The brick bond pattern is assumed to be the same as the exterior walls. Lower quality brick is likely used throughout, as salmon brick is seen at the pockets (Figure S29).

Figure S29. Pocketed brick at stairs where joists were removed, Room 000. (SEA 2016)

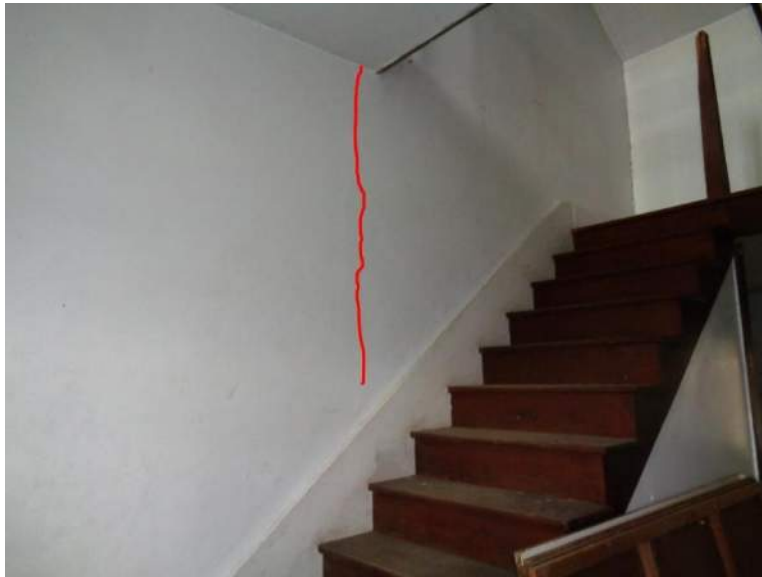
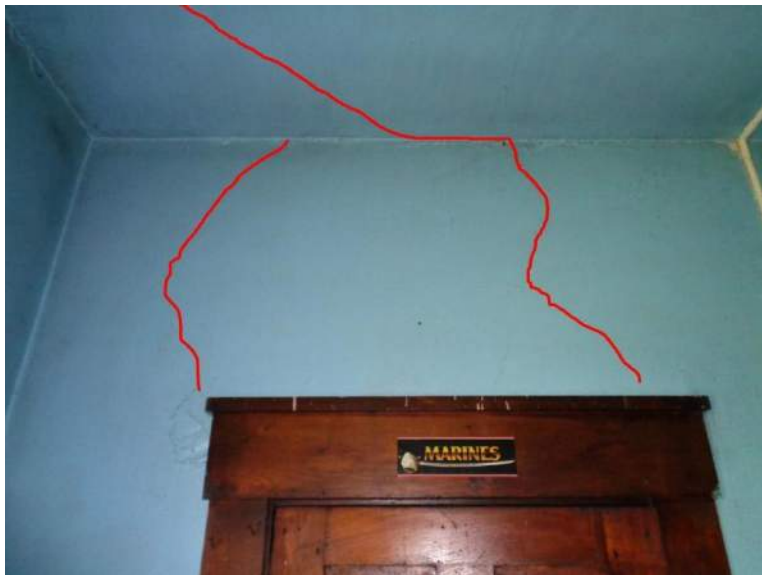
The plaster in the first and second levels is cracked at door openings and wall transitions (Figures S30 and S31).

Figure S30. Crack through plaster, interior wall Hall 100. (SEA 2016)

Figure S31. Cracks through plaster, interior wall Bedroom 102. (SEA 2016)

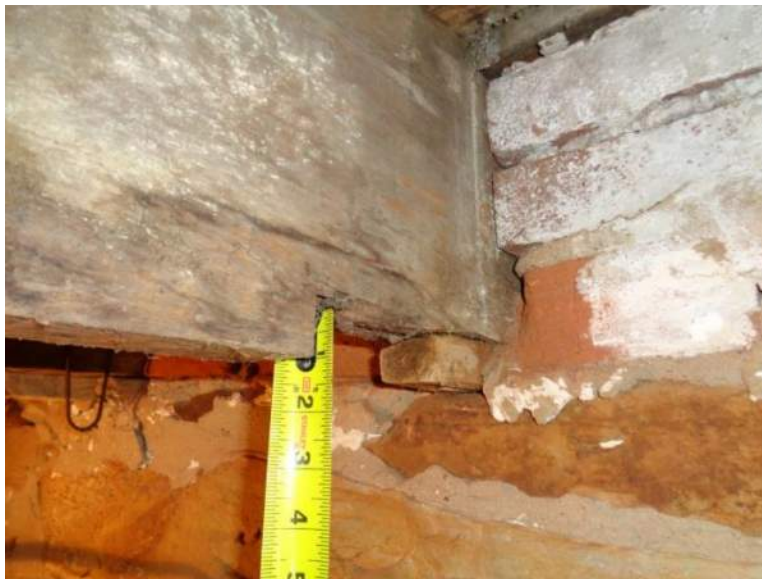
At bearing, all joists have been notched and shimmed (Figure S32). This technique is uncommon; full joists are typically pocketed into the masonry foundation. Here notches were likely used so the joist would fit into three courses of brick. The shim was then used to level the joist on the uneven masonry. Notches were measured from ½-inch to 1-inch deep. The first two joists at the south entrance to Room 005 have been notched/carved to 7 ½-inches deep for headroom (Figure S33).

Figure S32. Typical notched and shimmed joist at east wall. (SEA 2016)

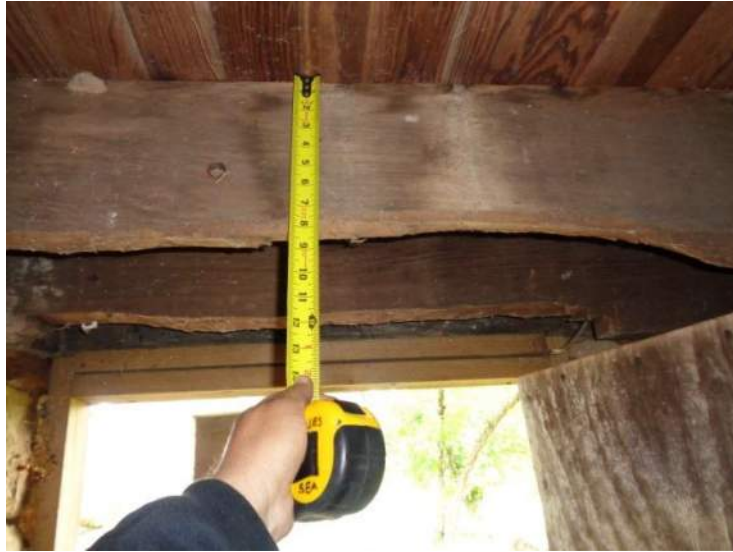
Figure S33. Joists at basement door, notched for headroom. (SEA 2016)

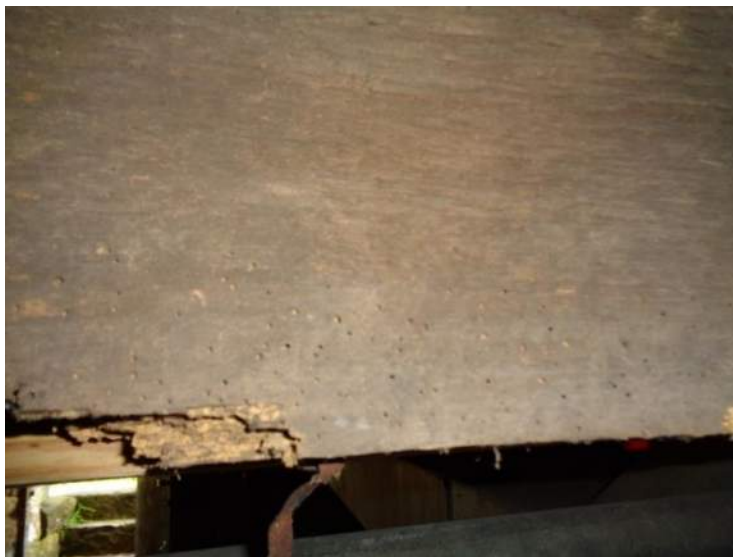
Throughout the basement floor joists, there is evidence of bore holes, very likely from a powder post beetle (Figure S34). The extent of the joist damage is unknown in the inaccessible crawlspaces, although it is very likely the damage is extensive in these spaces. The infestation may or may not still be active. Four joists in Room 005 show considerable beetle damage and have been sistered with 1 ½-inches by 9 ½-inches net dimensional modern lumber (Figure S35). The infestation is assumed to extend to all joists in the other crawl spaces which were inaccessible.

Figure S34. Typical beetle damage. (SEA 2016)

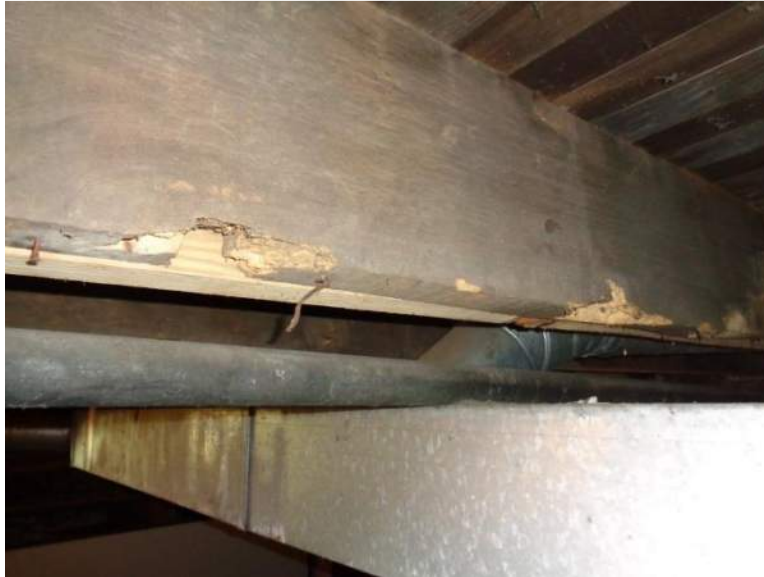
Figure S35. Beetle damaged joist with sister joist in Room 005, looking south. (SEA 2016)

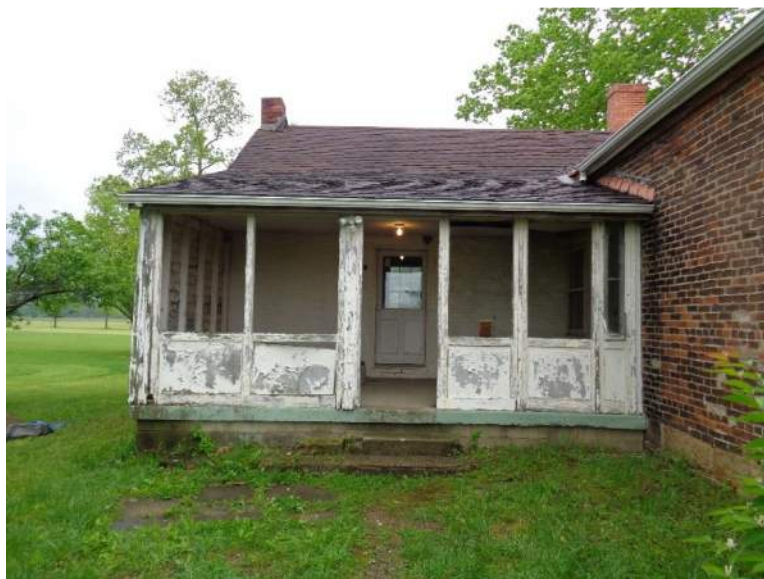
The porch is a wooden lean-to type structure over a deteriorated and unreinforced CMU wall foundation and concrete slab. This structure was built in the 1950s. The south wall is wood framed with wood shingle siding. The east wall has wood posts and short wood panels below screen openings. The condition of the east wall is extremely poor. The posts are deteriorated and/or not connected at the concrete slab (Figure S41). The porch roof has a shallower slope than the rest of the structure. The sloped wooden framing for the roof is 2-feet on center and connects to the rest of the structure only at the wooden joists for Room 105. No extensive investigations or calculations on the porch structure were performed.

Figure S41. Porch at south of house. (SEA 2016)

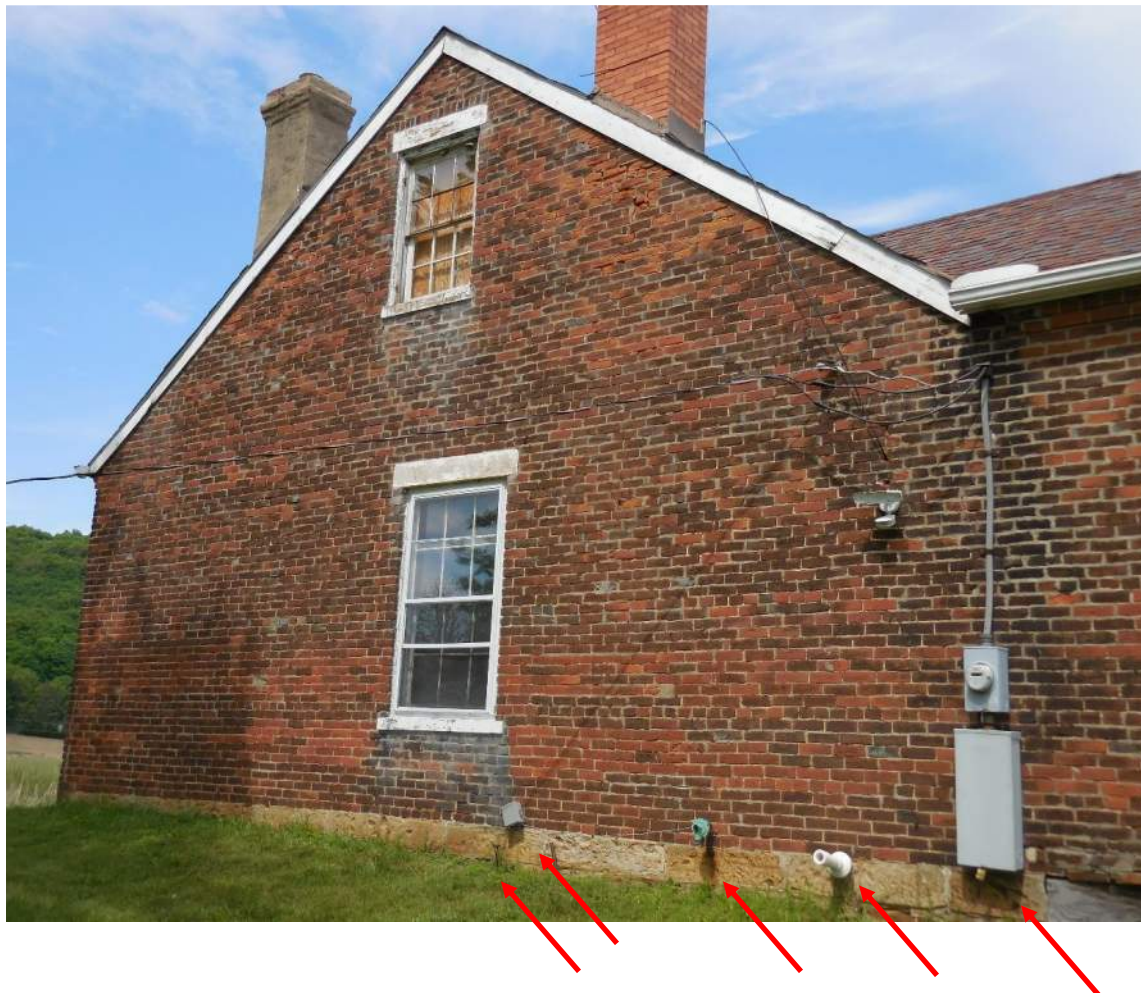
Figure M1. West side of house. In order from left to right: Ground rod; Telephone connection; Propane gas connection; Furnace concentric intake and exhaust; electrical meter and service. (Strata 2016)

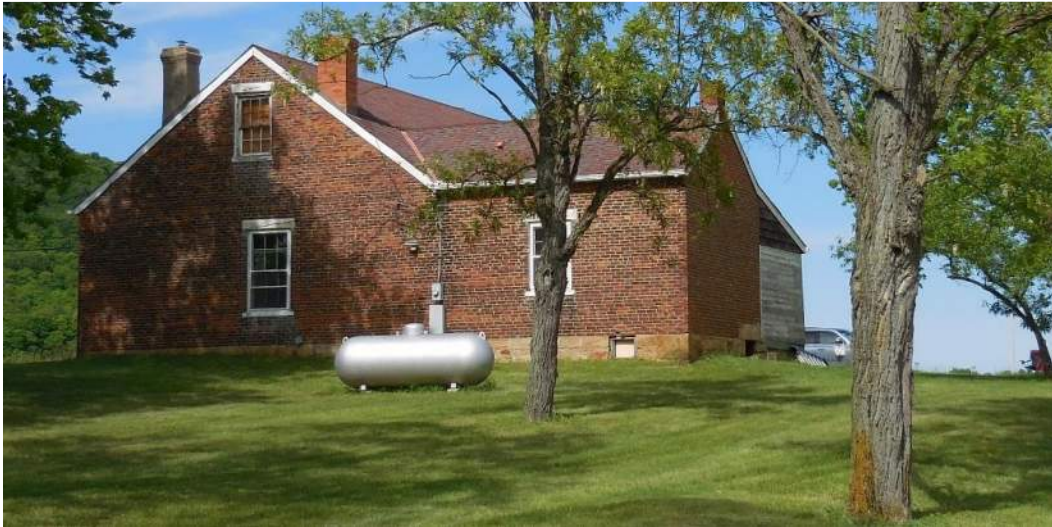
Figure M2. Propane tank, west of house. (Strata 2016)

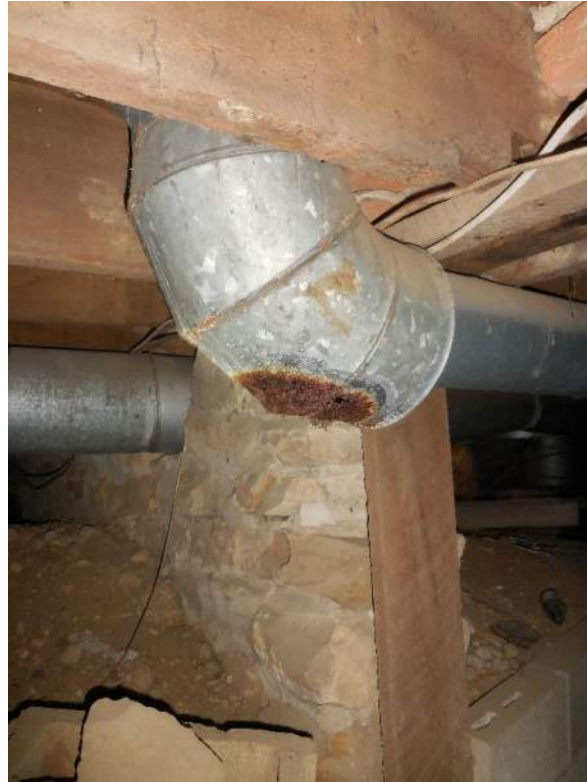
Figure M7. Ductwork deterioration, Basement Room 000. (Strata 2016)

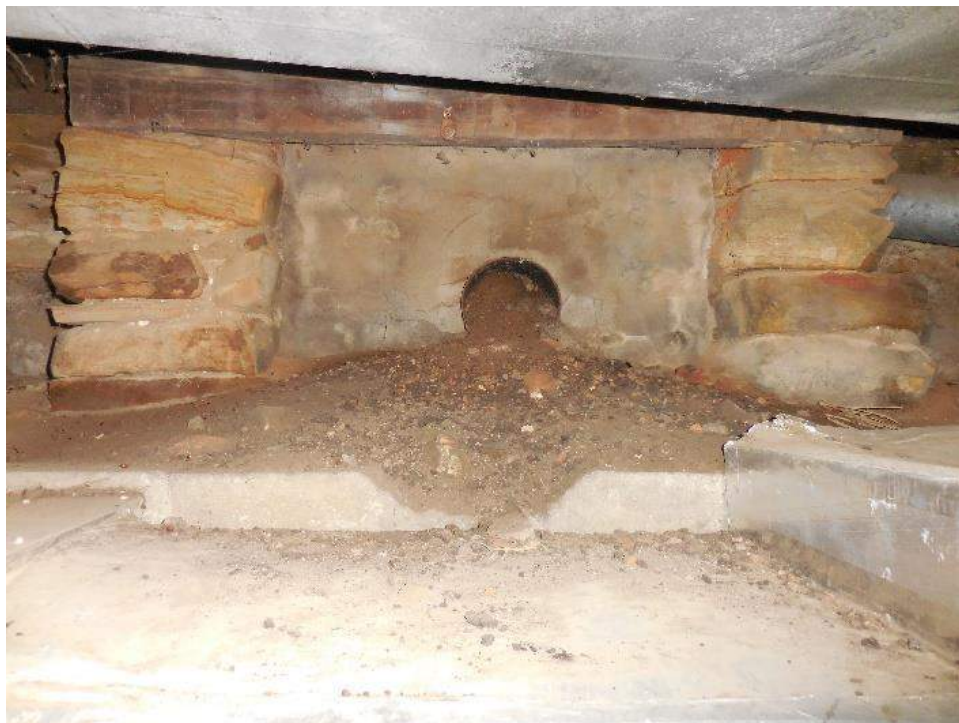
Remnants of previous furnaces are found throughout the basement. This furnace likely dated to the 1950s renovation. The exhaust flue remains installed between the stone fireplace

foundations along the west wall of basement Room 004 (Figure M9). This flue vents through the original historic chimney. In order to install the exhaust, the firebox at the Dining Room 104 fireplace was closed off and plastered over. It is likely that the vent is not capped at the chimney, considering the amount of debris at the bottom of the flue in the basement. Coal remnants found within the dirt floor in Room 005, also suggest that perhaps an even earlier furnace was coal-fired. Other remnants of a previous ventilation system include the pulleys installed on the first floor joists, which are visible from the basement (Figure M10). These were likely used to operate dampers on floor vents.

Figure M9. Old furnace flue installed between dining room fireplace foundations, Basement Room 004, looking west. (Strata 2016)

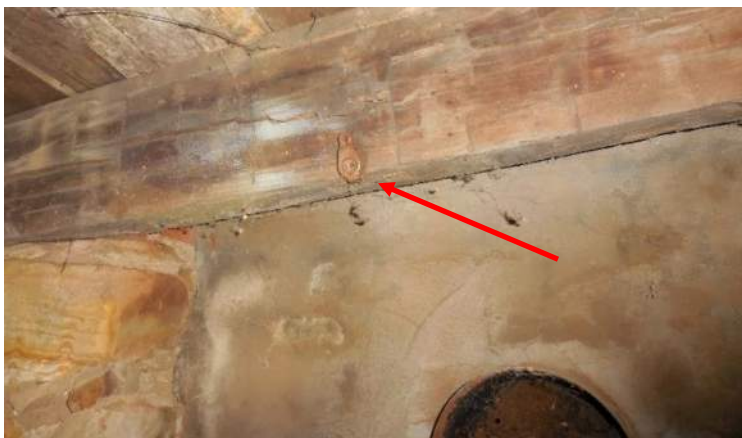
Figure M10. Pulley, remnant of previous ventilation system, Basement Room 004. (Strata 2016)

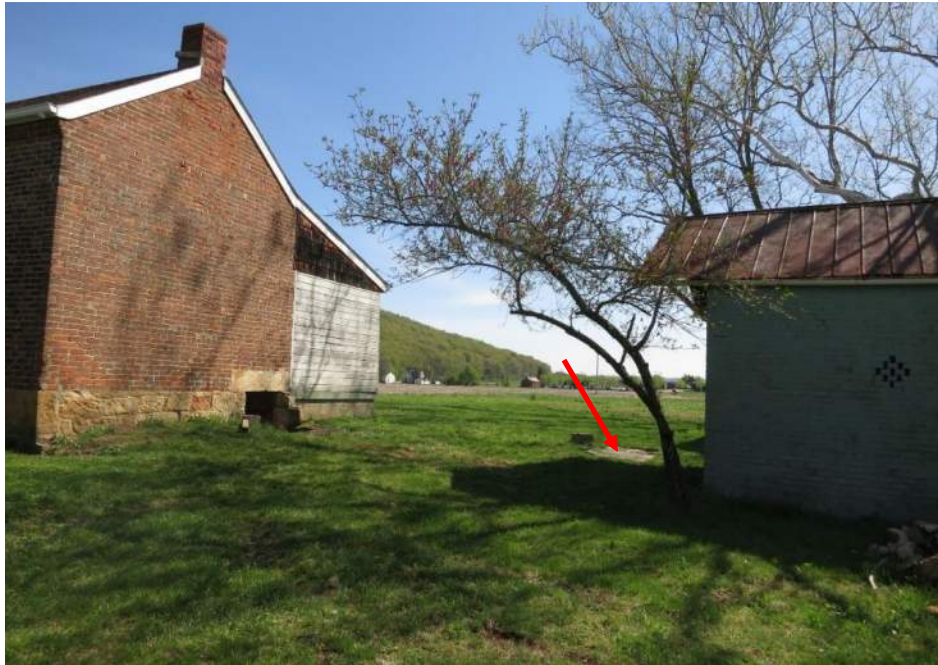
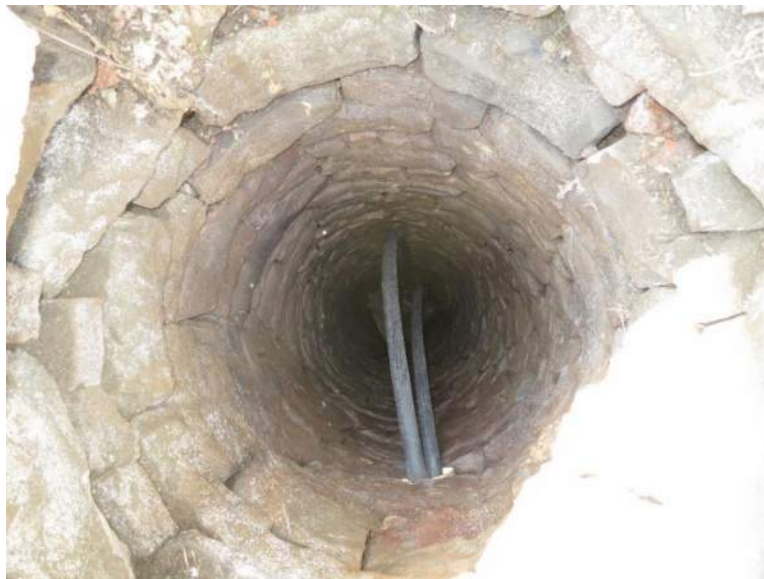
The water was supplied to the house by the well, (Figures P1 and P2), which is located south and east of the kitchen wing. The well is hand-dug, stone lined, and may be original to the house. The well was capped with concrete by park staff as a safety precaution. The well water was piped underground to the house at some point, and entered the house along the south wall of basement Room 005. Remnants of PVC piping are still found in this location. None of the well pump equipment or tank in the basement remains. The well is no longer serviceable.

Figure P1. Original stone well location. (Photograph provided by the park, 2013)

Figure P2. Original stone well location. (Photograph provided by the park, 2013)

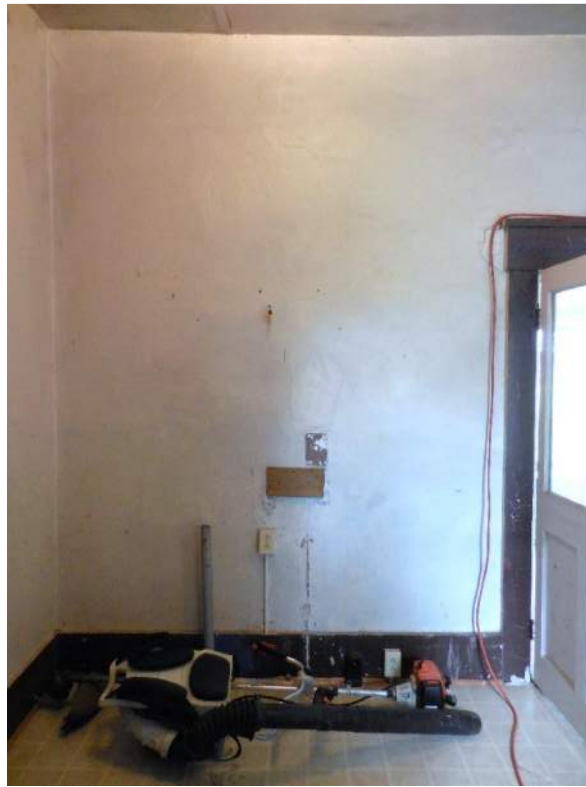
Figure P6. Washer and dryer hook-ups. Water service has been removed, but the drain and electrical services remain, east wall, Kitchen 105. (Strata 2016)

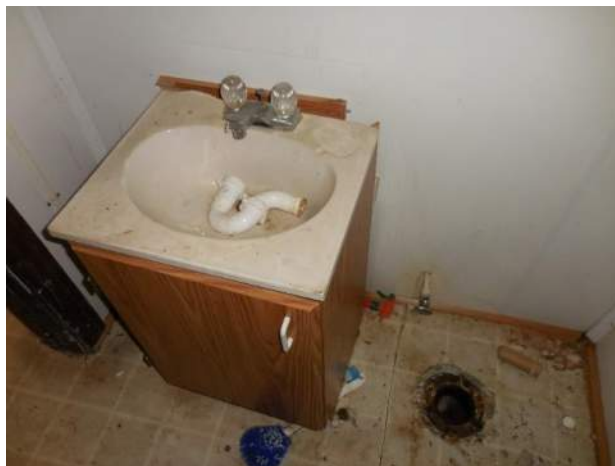
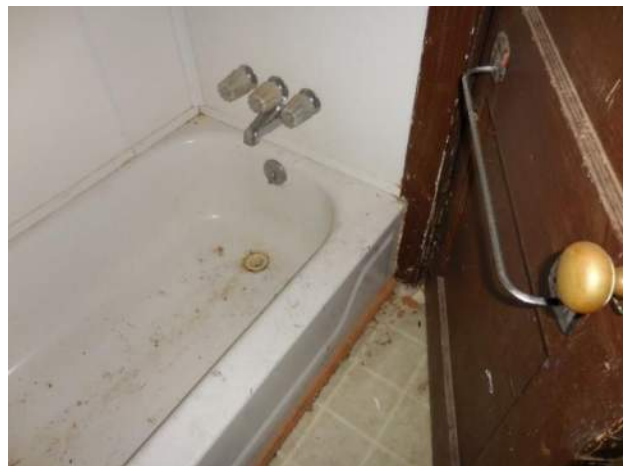
(Figures P7-P8). The water closet has been removed, but the vanity sink and tub/shower are still installed but are not functioning.

Figure P7. Vanity and water closet location, Bathroom 106. (Strata 2016)

Figure P8. Tub/shower, Bathroom 106. (Strata 2016)

The plumbing equipment and distribution systems associated with the house are not functional, nor reusable. Renovation of the house will require installation of all new systems.

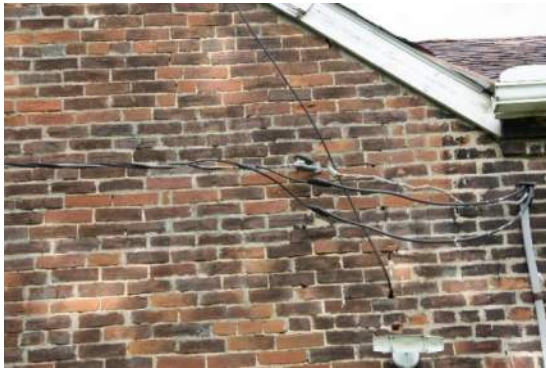
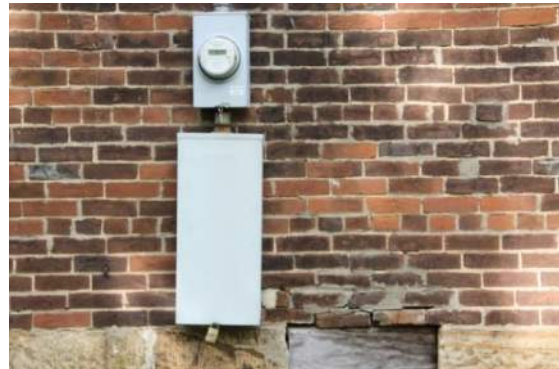
Figure E1. Electrical meter and pull box, west side of the house. A ground wiring does exit the box, but it is unknown what it is attached to. (Strata 2016)

It is not recommended to reuse any of the electrical service or distribution system, all service and equipment should be replaced and installed per current code during a future renovation project.

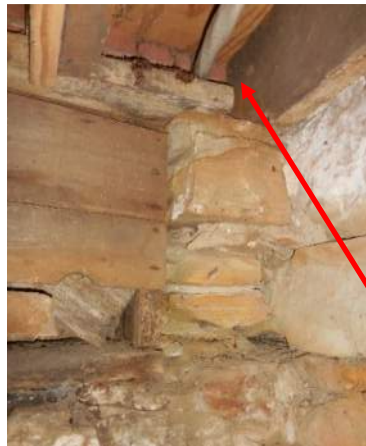
Figure E2. Electrical feed from the service panel enters the house along the west wall. It is installed through a hole in the brick wall. (Strata 2016)

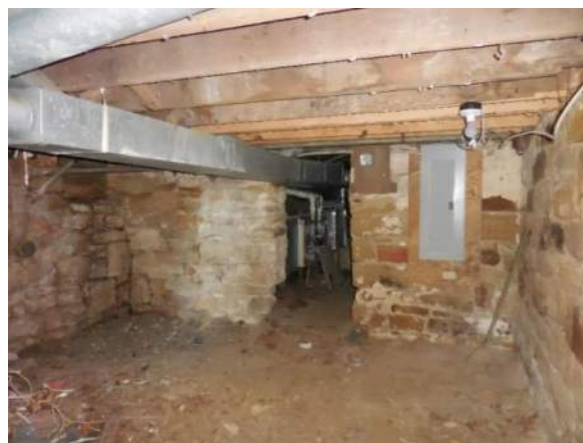
Figure E3. Electrical panel, north wall, basement Room 005. Note, this is the only known working outlet (below the panel) installed in the house at this time. (Strata 2016)

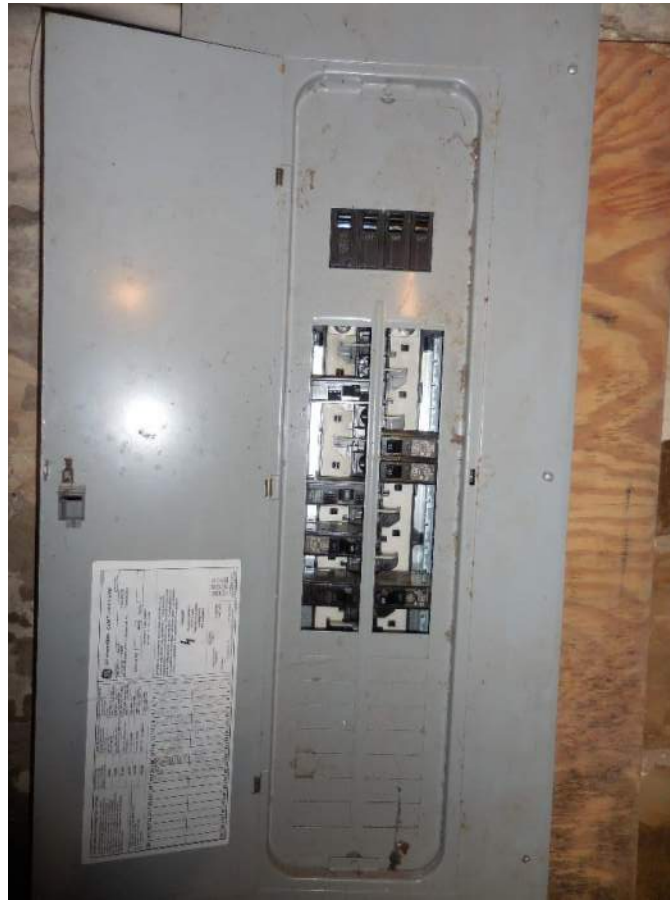
Figure E4. Circuit breakers are missing from panel. (Strata 2016)

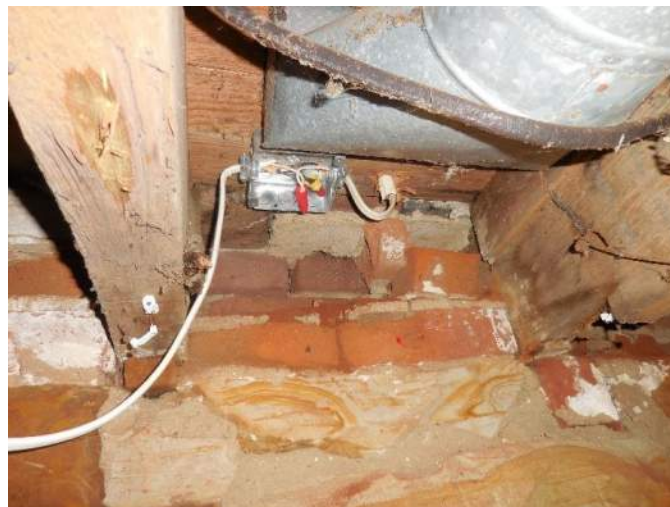
Figure E5. Uncovered junction box in basement Room 004. (Strata 2016)

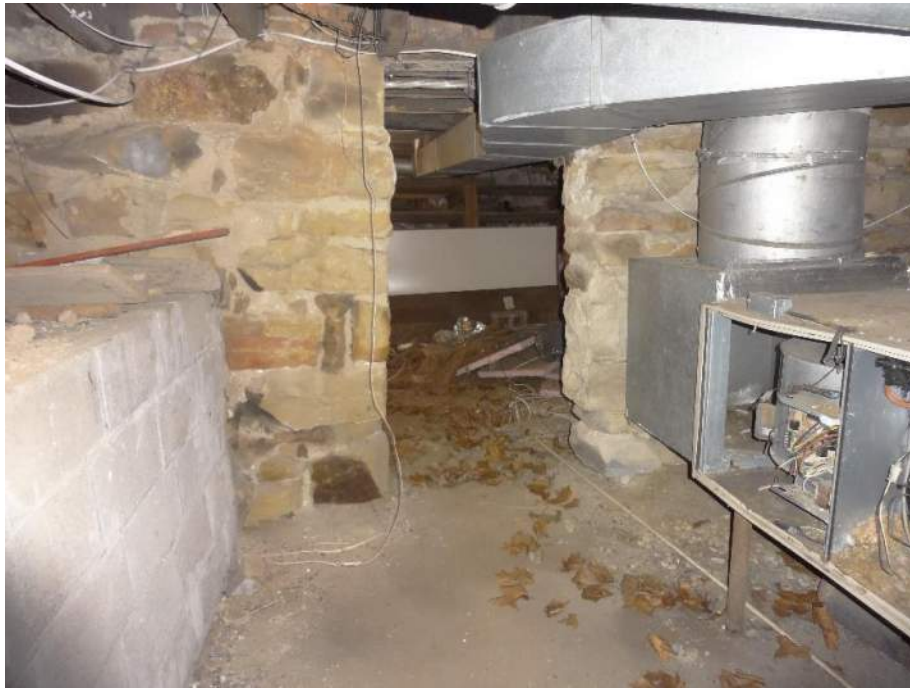
Figure E6. View south in basement Room 004. Note the unsupported wiring strewn throughout the space. (Strata 2016)

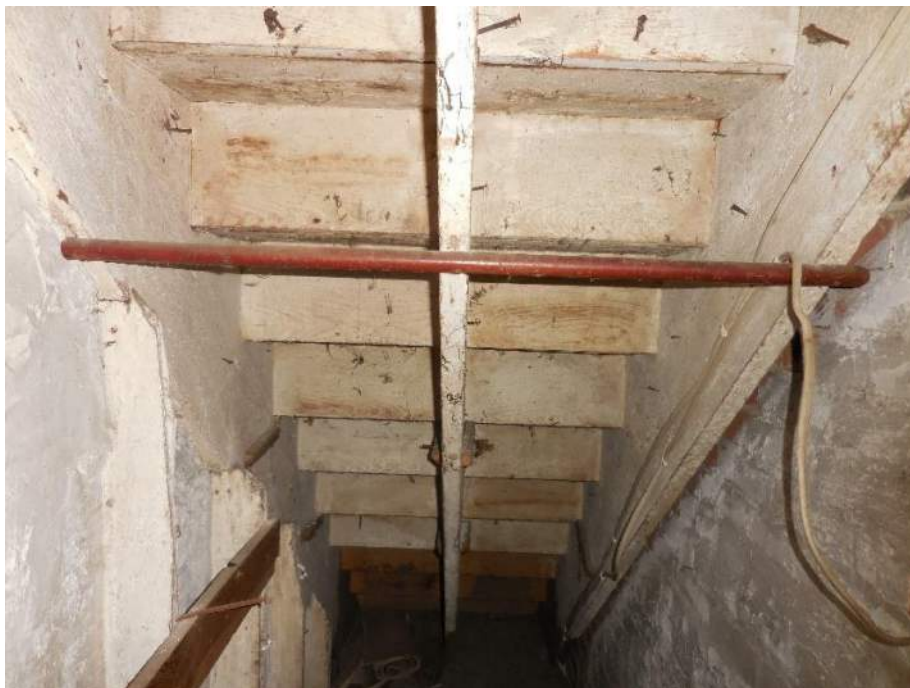
Figure E7. Wiring supported by clothes rod in the basement stair. (Strata 2016)
