THOMAS BLACKSTONE HOUSE

HISTORIC STRUCTURES REPORT

SEIP EARTHWORKS UNIT – HOPEWELL
CULTURE NATIONAL HISTORICAL PARK
BAINBRIDGE, OHIO

APRIL 17, 2017
NPS PMIS # 218963

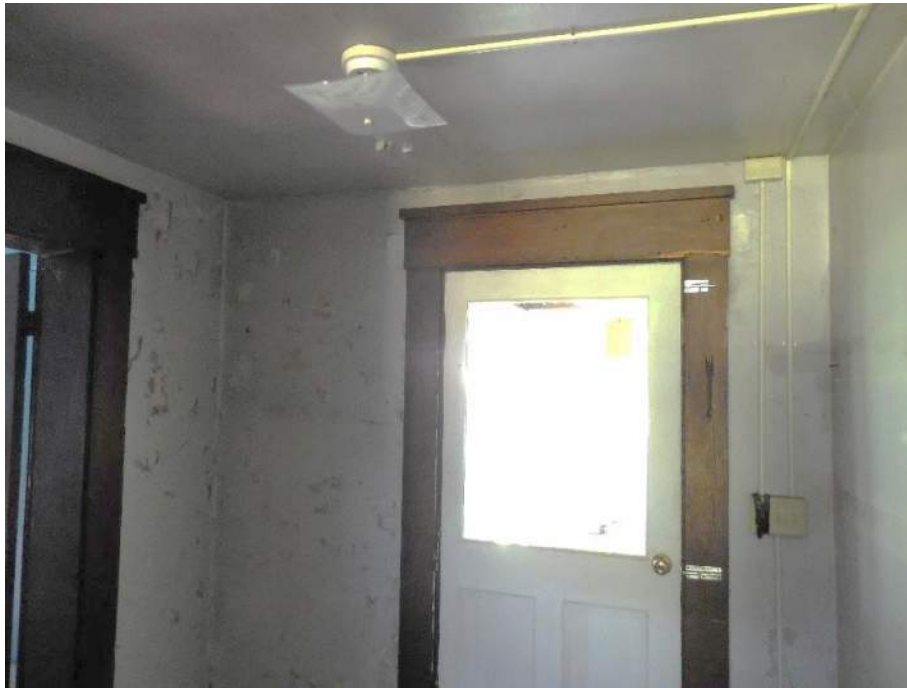
Figure E8. Typical conduit installation on walls and ceilings. Typical midcentury surface mount ceiling light fixture. (Strata 2016)

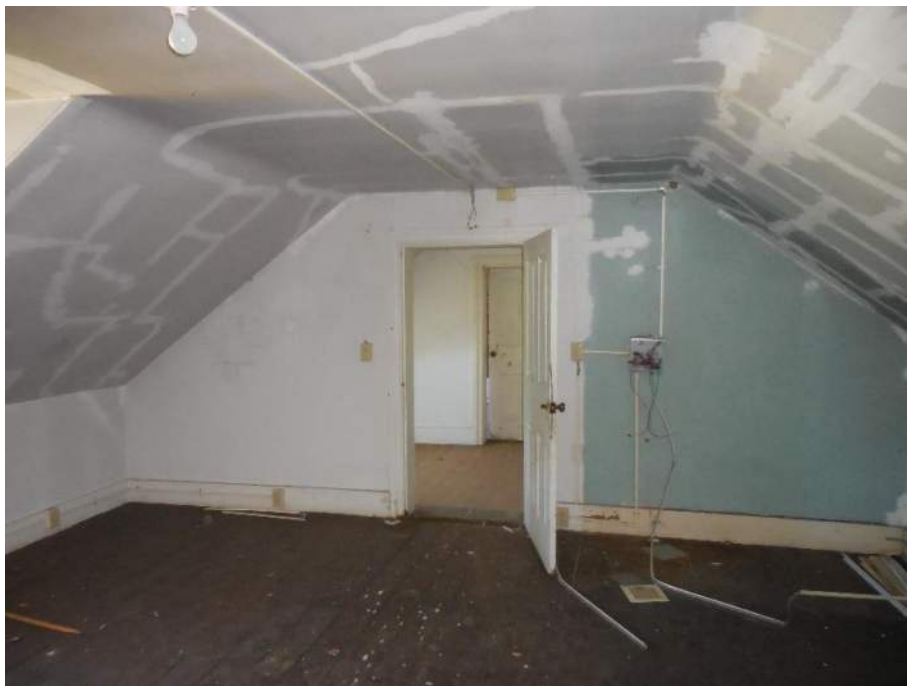
Figure E9. Typical conduit installation on walls and ceilings at the second floor. The lighting is provided by porcelain sockets with exposed incandescent lamps. Note the open junction box on the east wall. (Strata 2016)

It is not recommended to reuse any of the electrical service or distribution system, all service and equipment should be replaced and installed per current code during a future renovation project.

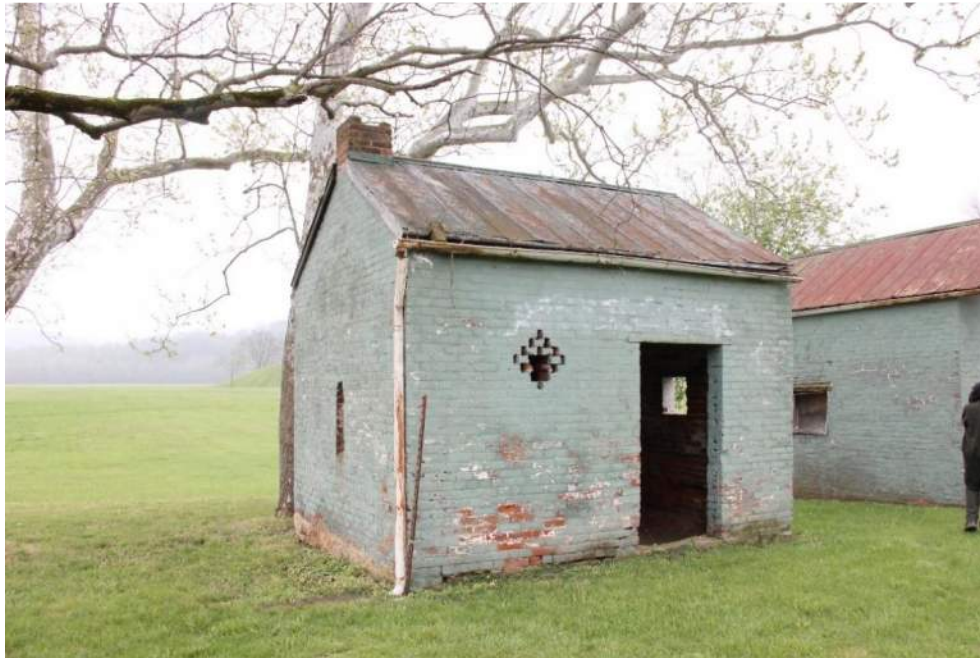
Figure SH.1. Smokehouse, looking southwest. (Sheals 2016)

The Smokehouse is a masonry structure resting on a shallow stone foundation (Figure SH.1). This structure was constructed circa 1857 and is located south of the main house and oriented with the north face of the building facing more northeast.

The exterior of the building is in fair to poor condition. The brick exterior walls require 35% - 40% repointing and the southwest corner of the brick wall is cracked and settling. On the interior of the structure 25%-30% of the bricks are missing and deteriorated and are structural compromised due to exposure. The historic wood door frame and door are missing as well as the historic window. The half-round gutters have significant amounts of rust and a majority of the downspouts have deteriorated and are missing. The existing metal roof has no protective paint finish. Several of the bricks on the chimney are missing or have been displaced.

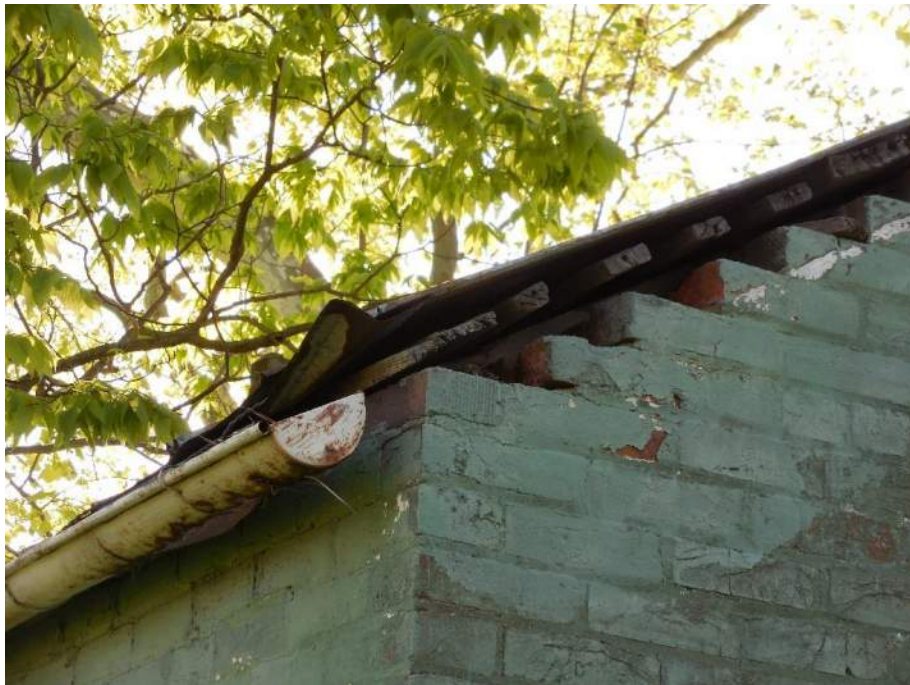
Wood rafters span north/south creating a gabled roof that is covered in 3-inch wide skip sheathing and topped with a standing seam metal roof (Figure SH.1). There is no overhang at the roof edge. On the east elevation at the roof ridge is a masonry chimney that measures approximately 16 inches by 16 inches. The roof is in poor condition with a majority of the deterioration developing from the roof metal being exposed to the elements causing rust and holes throughout the roof. The existing wood skip sheathing suggests that the roof at one time was covered in wood shingles. There are no wood shingles remaining. On the east end of the roof the standing seam metal roof wraps down one-inch, partially covering a wood rake board (Figure SH.7). On the west end of the roof the standing seam metal roof stops and does not wrap the edge. The rake board is missing on the west side (Figure SH.4).

Figure SH.4. West Elevation, looking up at the soffit and the exposed skip sheathing. (Strata 2015)

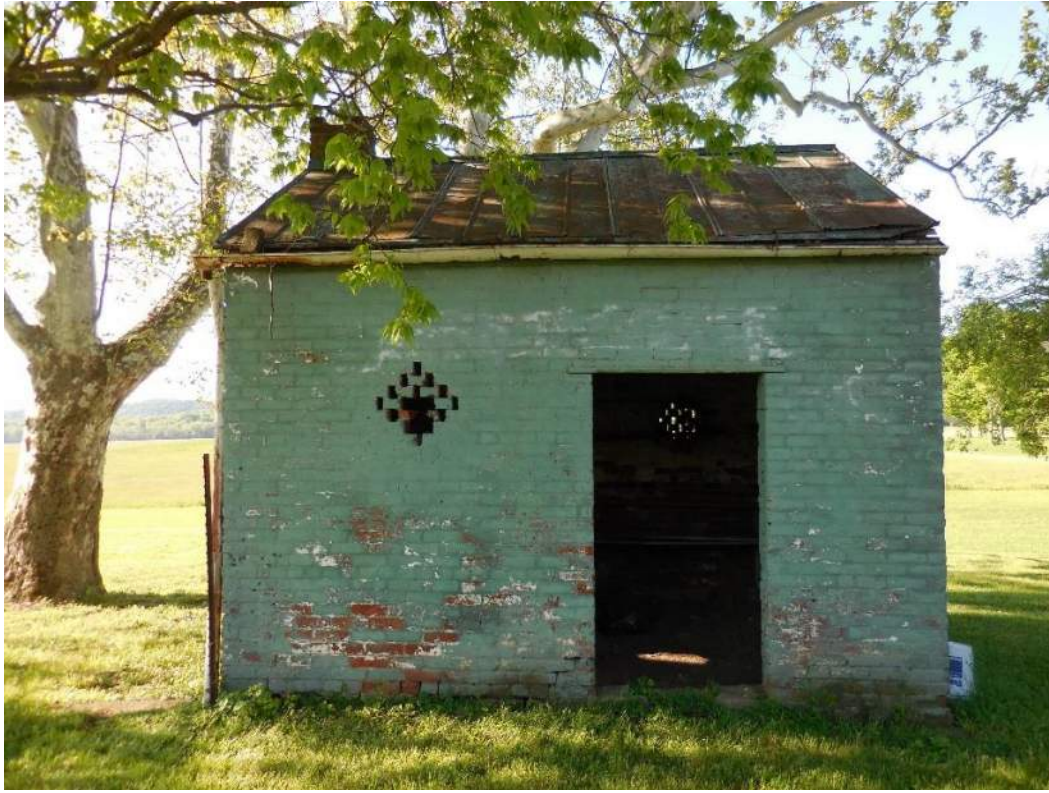
Figure SH.5. Smokehouse, north elevation. (Strata 2016)

The North Elevation is visible from the main house and contains the entrance (Figure SH.5). The elevation is in fair condition with a majority of the deterioration at the mortar joints near the base of the wall. The grade is relatively consistent across this wall with a slight slope on the east and west corners. The door opening is located west of center and is missing the wood door frame and door (Figure SH.7). The door threshold is constructed out of stone and concrete that is partially below grade (Figure SH.8). One of the stones within the threshold is cracked.

Throughout the masonry wall there are areas of missing or deteriorated lime mortar and cracks in the walls. Along the base of the wall, a significant amount of the mortar is missing and several of the bricks are deteriorated. Approximately 20% of the mortar joints need repointing and 8-10 bricks need replaced.

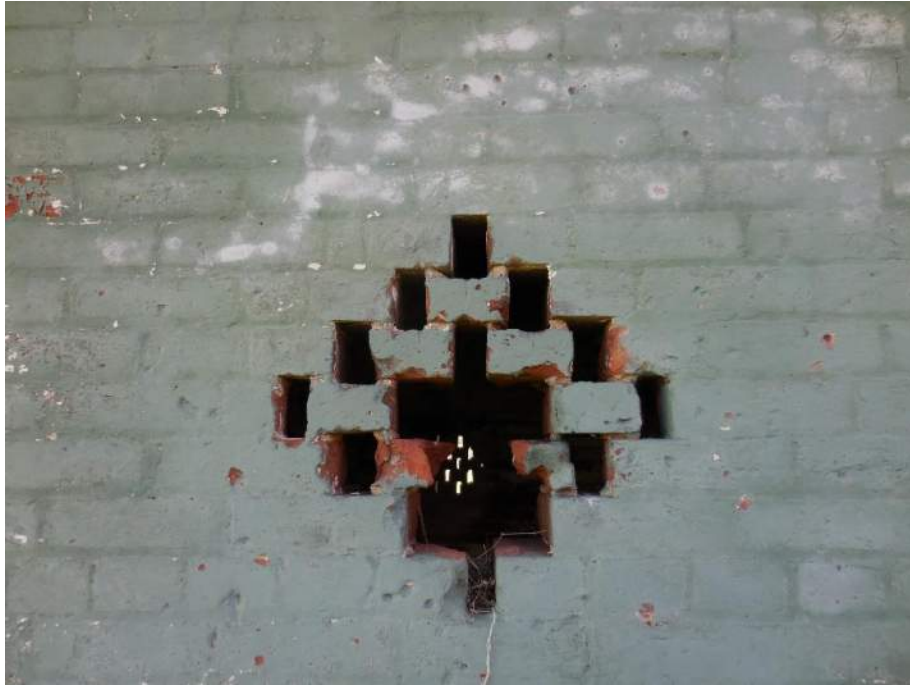
A steel angle iron spans the door opening and bears on three inches of masonry at each jamb. This lintel was likely added when the wood door jamb was removed or deteriorated. Located east of the door opening, roughly 6'-0" off the grade, are sixteen single ventilation holes that are arranged in a diamond shaped pattern. The holes are created by leaving an approximately 2-inch gap in the masonry pattern. Due to the bricks being soft, two of the bricks that define the vent openings have significant deterioration and two of the bricks are missing (Figure SH.6).

Figure SH.6. North elevation, detail of ventilation holes. (Strata 2016)

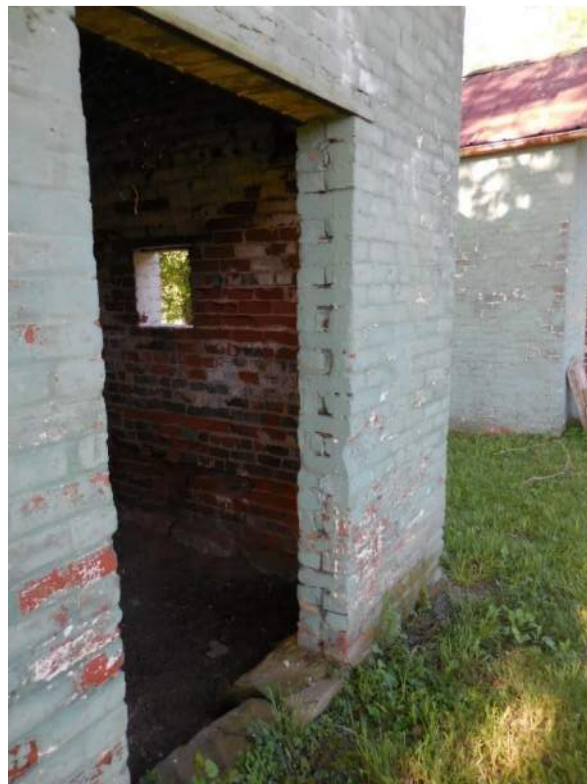
The wood rafters set on the north and south side walls, while the wood skip sheathing sets directly on the gabled east/west masonry walls. Half-round gutters are attached to the roof on the north and south, with twisted metal wire that wrap around the gutter acting as a hanger. The wire hangers are secured back to the roof with nails, penetrating the metal roof (Figure SH.5 and Figure SH.6). The western side of the south gutter is detached from the wall and has significant deterioration. The south downspout is completely missing (Figure SH.7).

Figure SH.7. North elevation, detail at door opening. (Strata 2016)

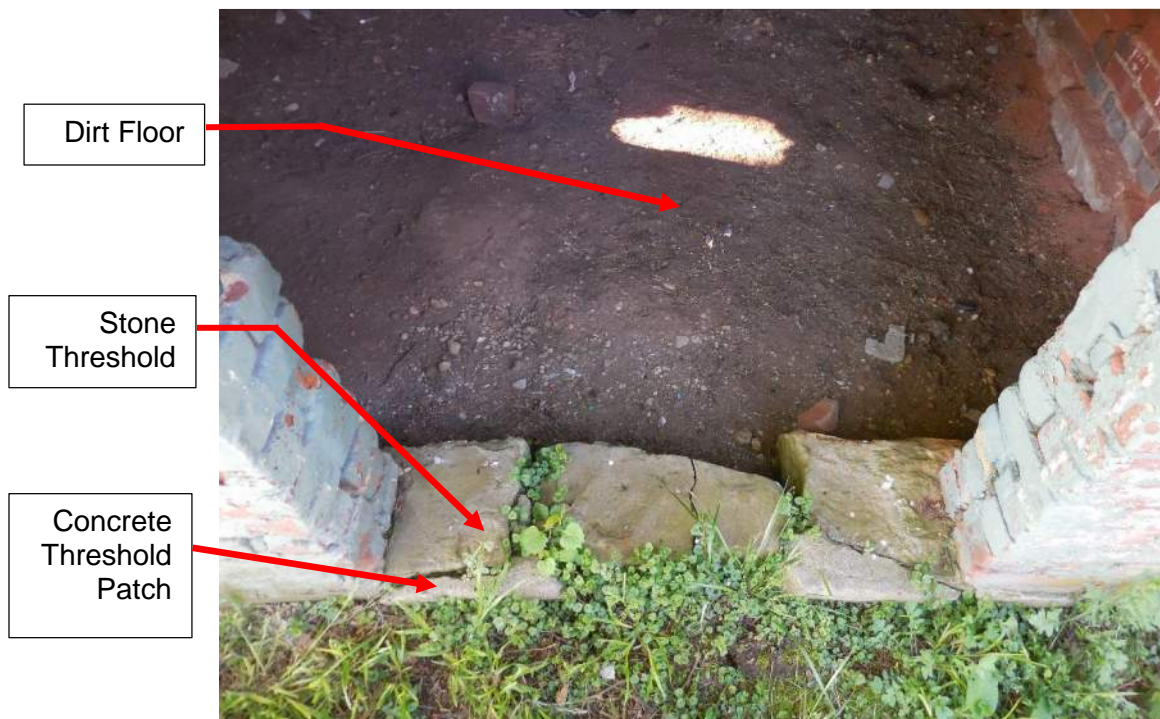
Figure SH.8. North elevation, detail at door threshold. (Strata 2016)

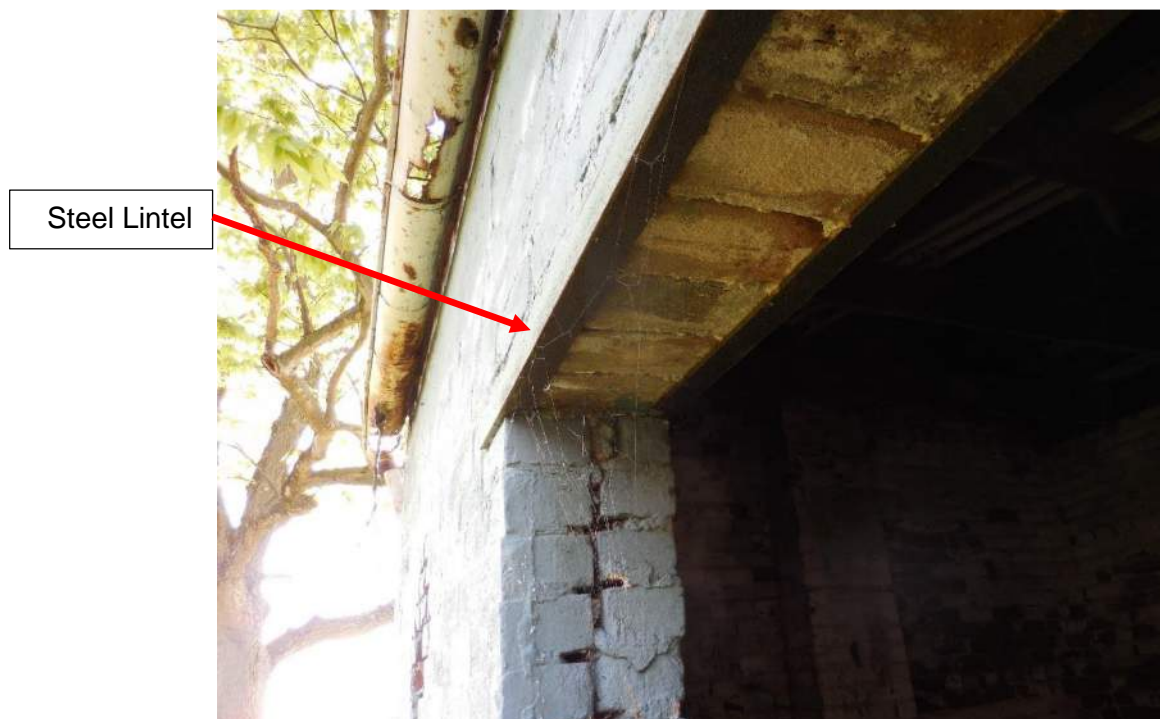
Figure SH.9. North elevation, detail at door lintel. (Strata 2016)

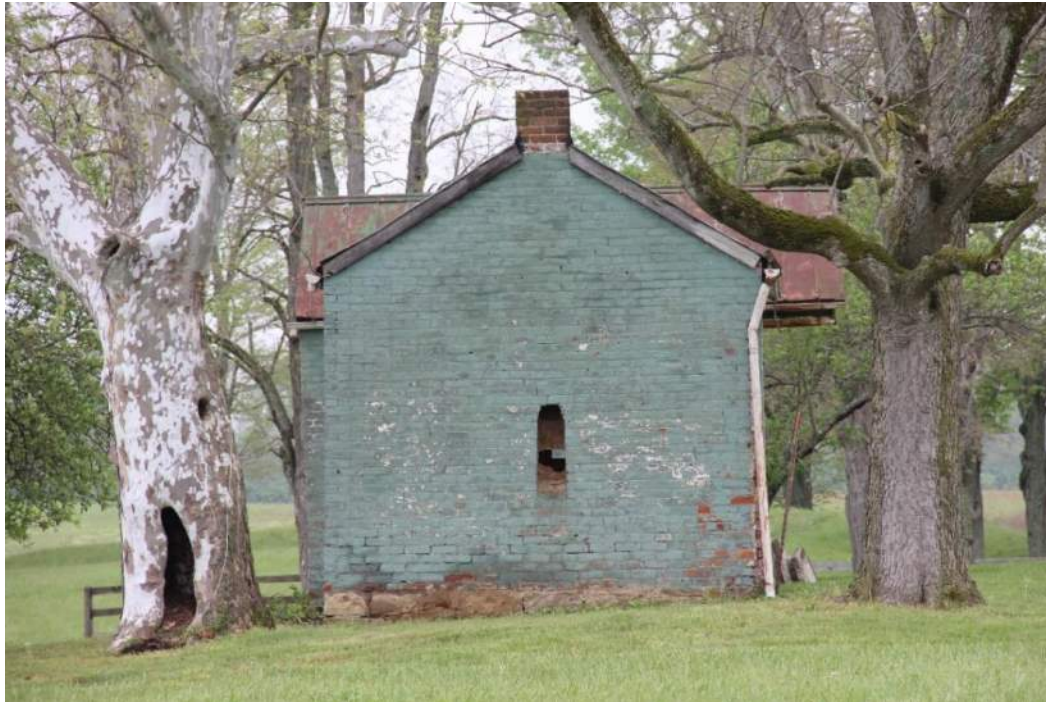
Figure SH.10. East elevation. (Sheals 2016)

The East Elevation of the smokehouse is not visible from the main house (Figure SH.10). This wall is in fair to good condition with most the deterioration developing at the base of the wall where a significant amount of mortar is missing. The masonry wall is painted, excluding the stone foundation and chimney, and the painted masonry has minor chipping and flaking throughout the elevation. Throughout the masonry wall there are areas of missing mortar and cracks in the wall. At least four of the bricks are deteriorated beyond repair. Approximately 20% of the wall requires repointing.

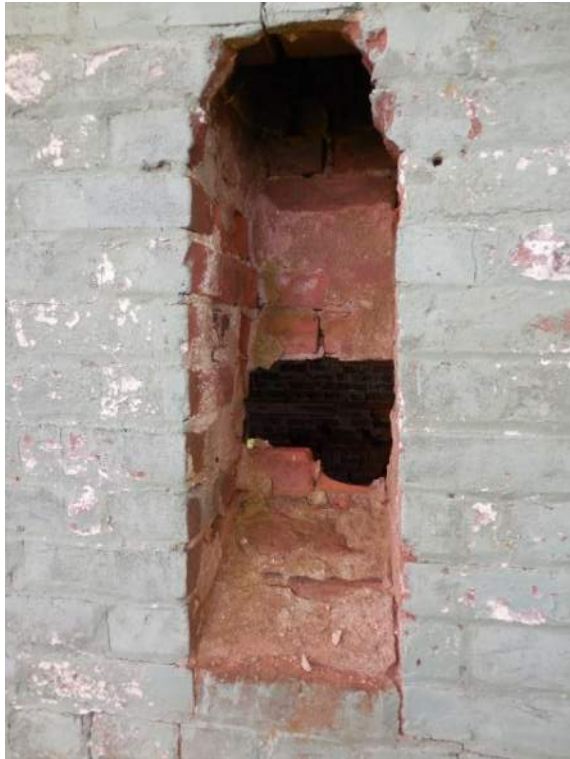
At the top of the wall, on either side of the chimney is a wood 4-inch rake board that is exposed to the elements with no protective finish (Figure SH.13). Along the north edge of the wall is a metal downspout with the lower half detached from the wall (Figure SH.12). The grade gradually slopes to the south, with the lowest elevation at the south corner of the structure (Figure SH.10). A flue opening for the masonry chimney is located centrally in the wall, roughly 3'-0" off the grade (Figure SH.11).

Figure SH.11. East elevation, detail at chimney flue. (Strata 2016)

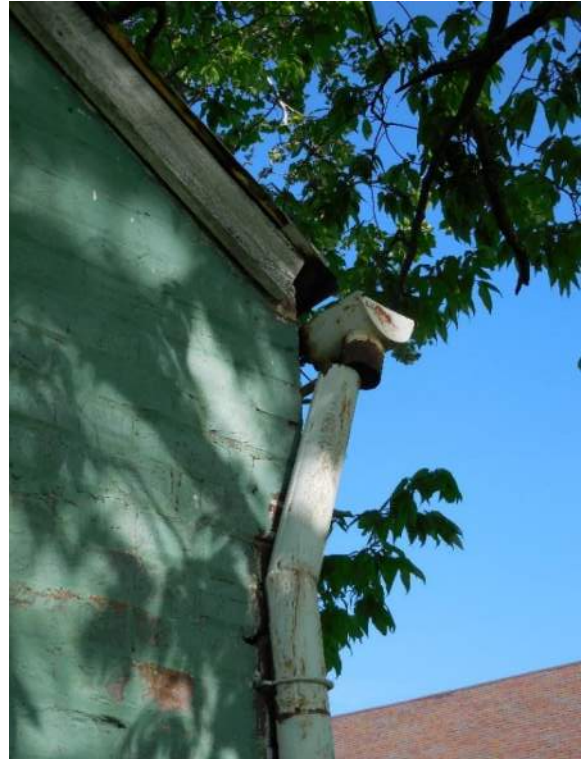
Figure SH.12. East elevation, detail at downspout. (Strata 2016)

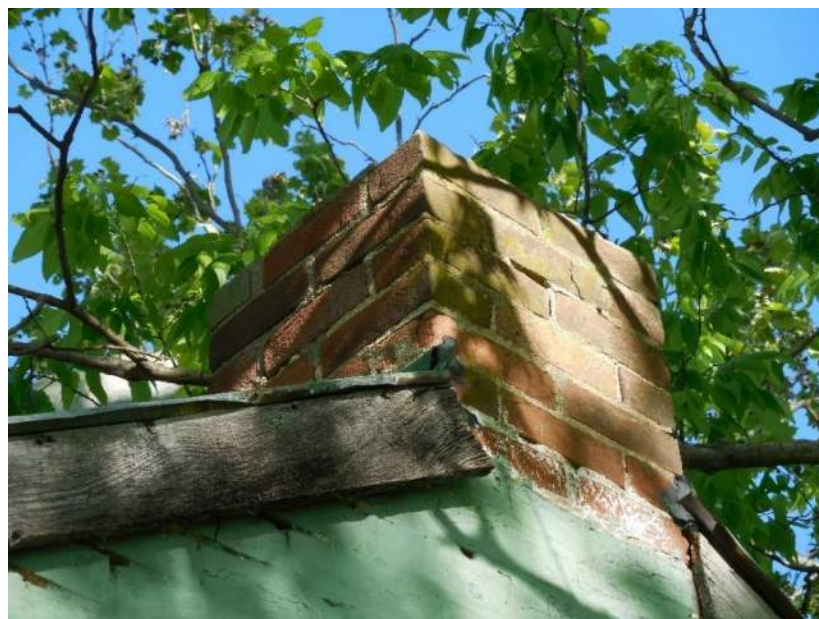
Figure SH.13. East elevation, detail chimney. (Strata 2016)

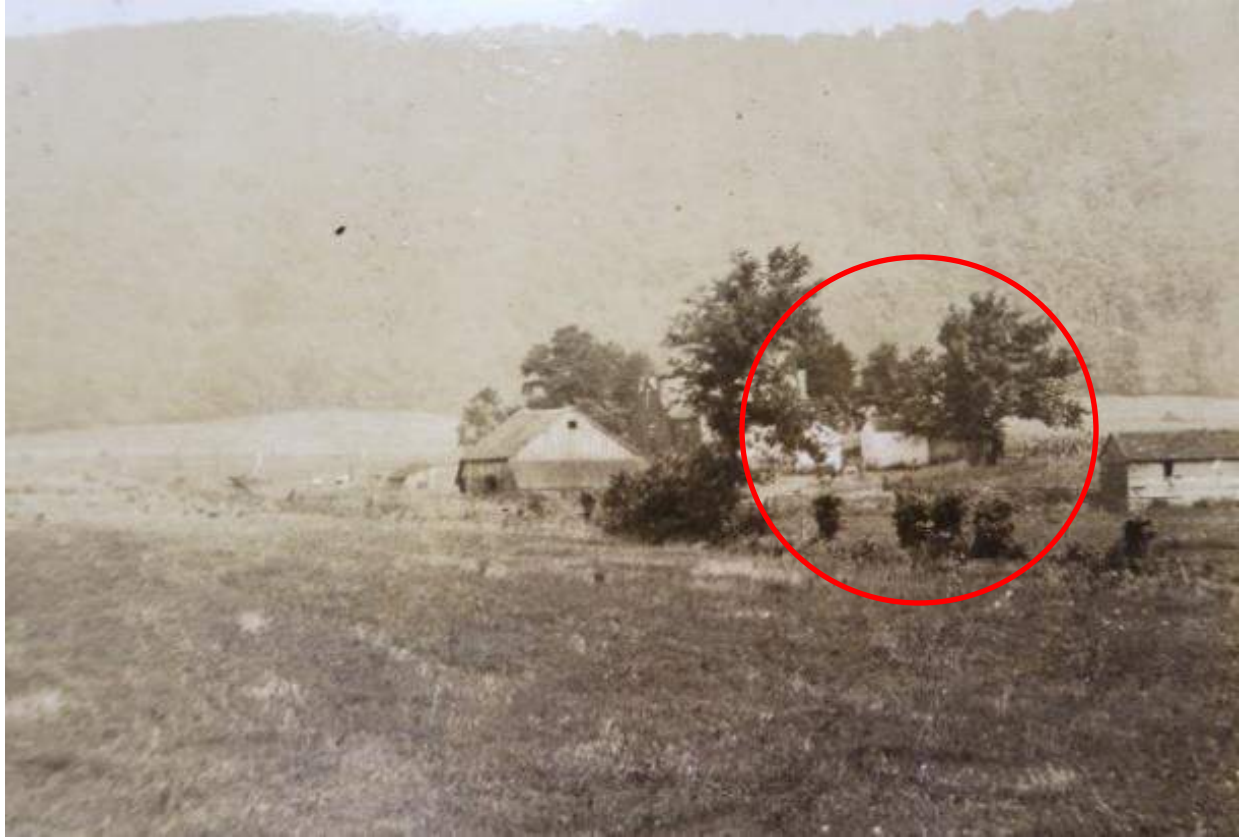
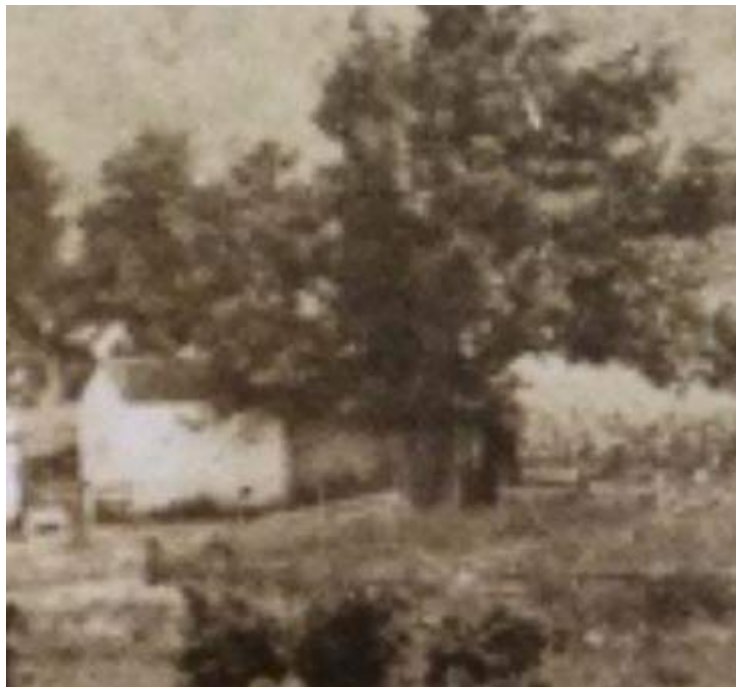
Historic photographs of the smokehouse from the 1920s indicate there may have been a wood frame addition to the east side of the smokehouse (Figure 30 and Figure SH.14). This addition may have served as a wood shed for the wood burning smoker. The evidence of the flue opening through the east exterior walls suggests that some type of apparatus was connected from this side of the structure.

Figure SH.14. East elevation addition, 1927. (Photo Collection Number A0957, Folder 6, Ohio History Connection Archeological Collections Facility, Columbus, Ohio.)

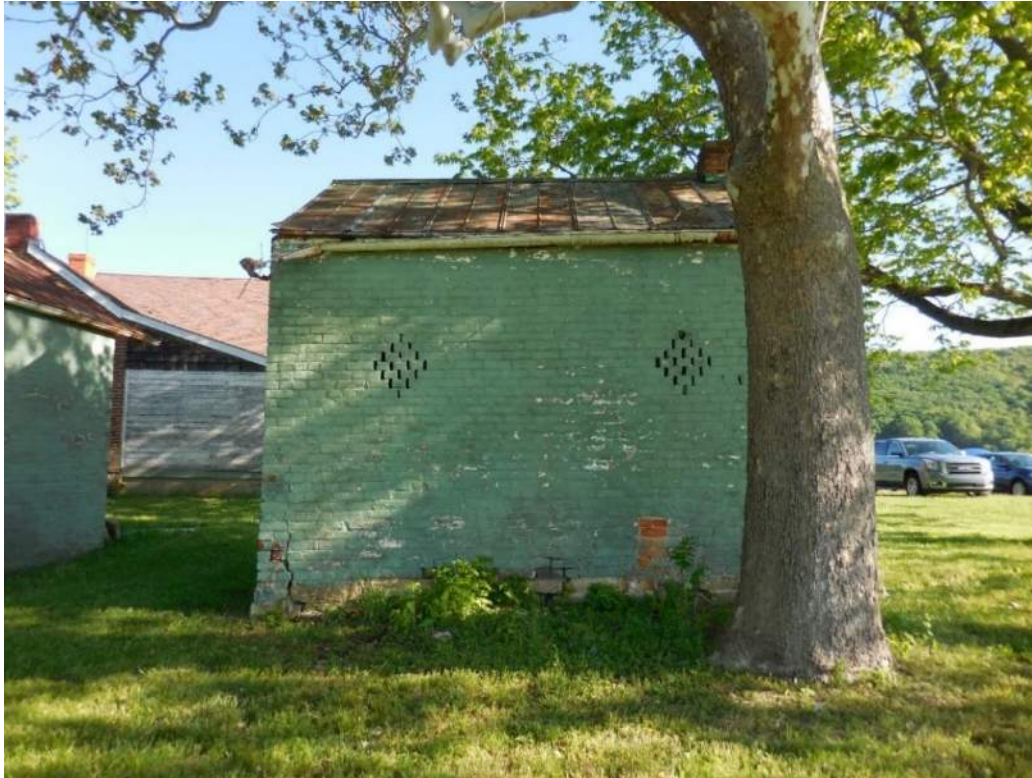
Figure SH.15. South elevation. (Strata 2016)

The South elevation is the back of the building and is not visible from the main house. This back wall contains two diamond-shaped vent openings (Figure SH.15). The elevation is in fair condition with a majority of the deterioration at the mortar joints near the base of the wall. The brick masonry has been painted and has minor chipped paint throughout the elevation. The grade is relatively consistent across the south elevation with a slight slope towards the west corner.

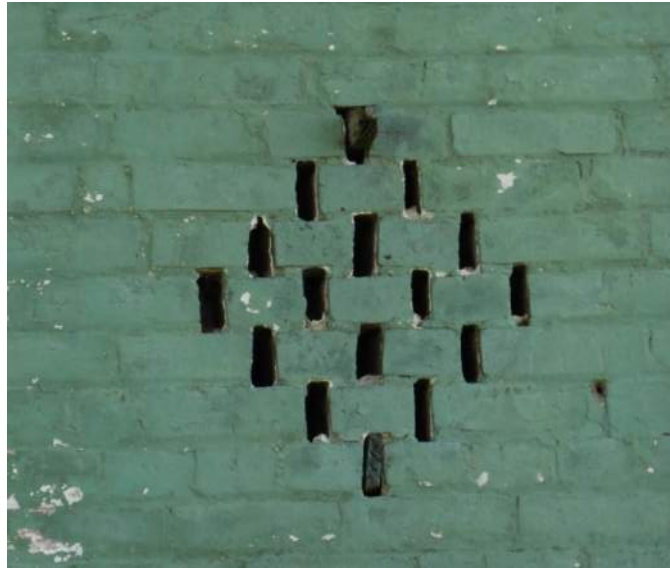
Two diamond-shaped vents are located in the south wall, one at either end of the wall. These are located approximately 6'-0" above finish grade. The holes are created by leaving an approximately 2-inch to 1-inch gap in the masonry pattern (Figure SH.16). The diamond shape vents on the South Elevation are in good condition, with none of the bricks missing or deteriorated.

Figure SH.16. South elevation, detail at vent. (Strata 2016)

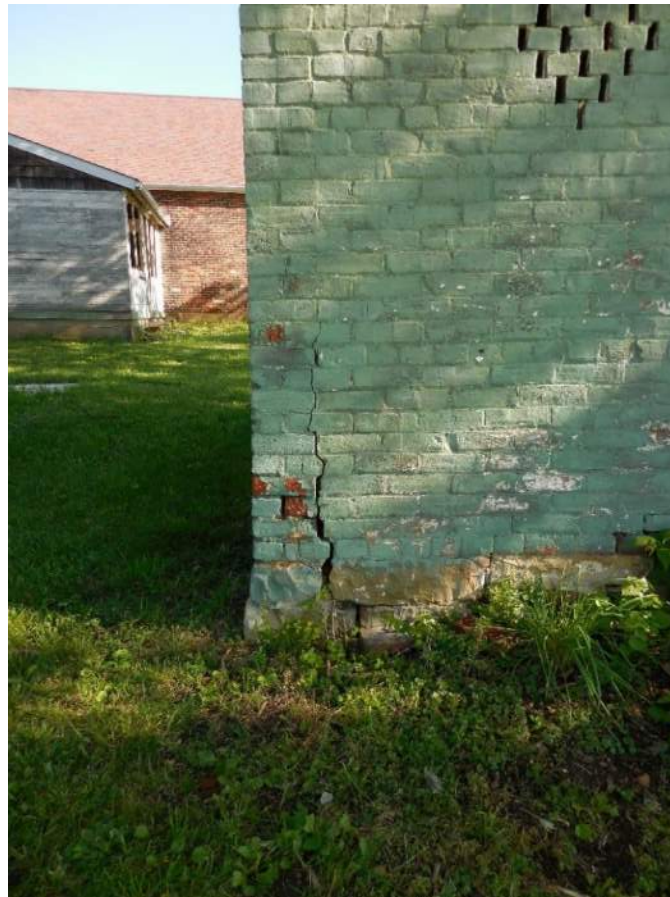
Throughout the masonry wall there are areas of missing or deteriorated mortar and cracks through the wall. At the southwest corner is a large vertical crack that extends from the stone foundation through two feet of the masonry wall (Figures SH.17 and 18). The crack indicates signs of settlement issues and is mostly likely caused by the masonry walls resting on a shallow stone foundation, which has rotated. Along the base of the wall, a significant amount of the lime mortar is missing and several of the bricks are deteriorated. Approximately 20% of the mortar joints need repointing and 15 bricks need replaced.

Figure SH.17. South elevation, detail at southwest corner. (Strata 2016)

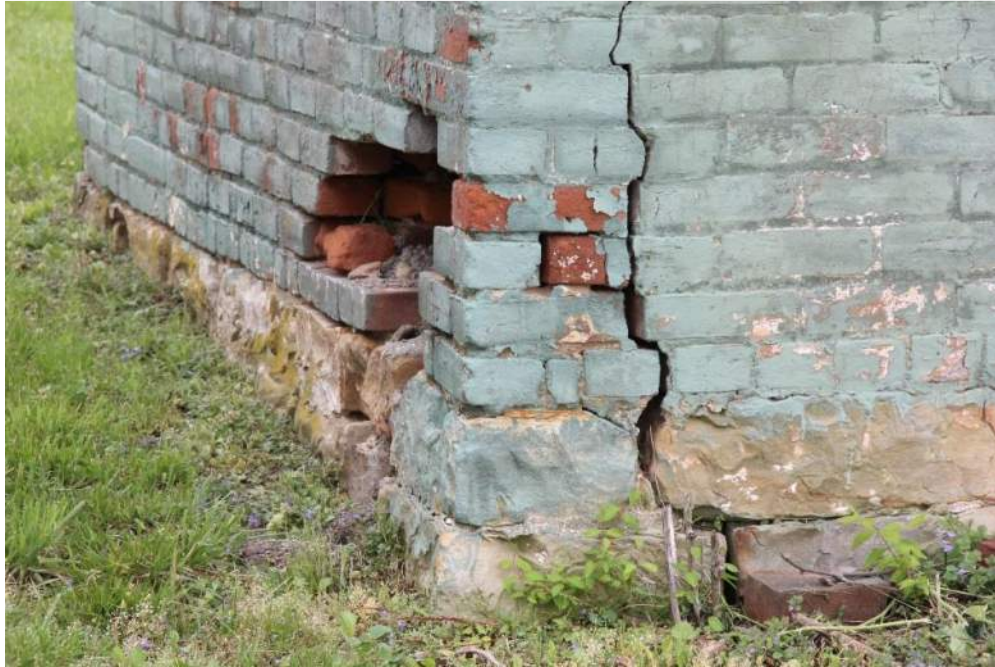
Figure SH.18. South and west elevations, detail at southwest corner. (Sheals 2016)

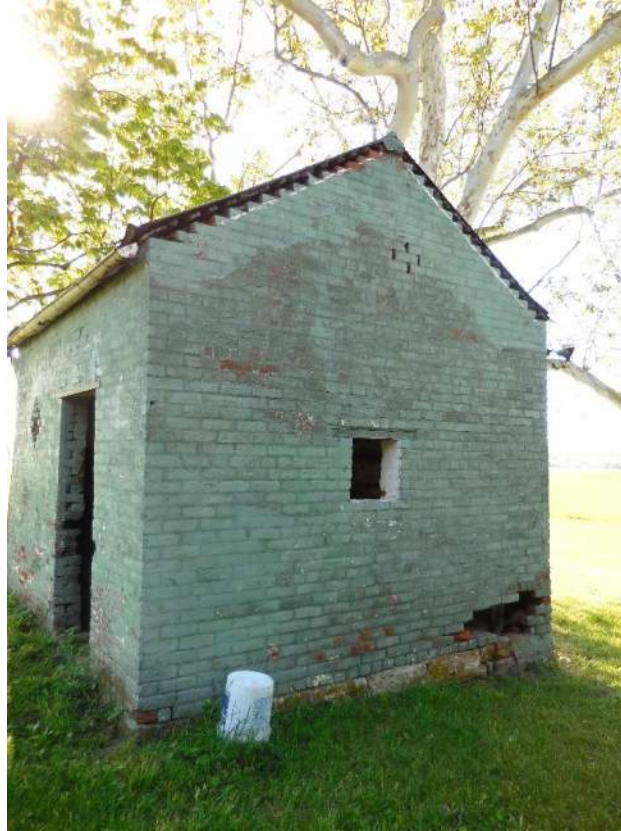
The west elevation is the end gabled wall and is visible from the main house (Figure SH.19). This wall is in fair to poor condition with most the deterioration developing at the base of the wall where roughly twenty bricks have fallen out of the wall creating a large hole. A majority of the missing bricks can be located on the interior of the smokehouse at the base of the hole. The masonry wall is painted, excluding the stone foundation, and the painted masonry has minor chipping and flaking throughout the elevation.

Figure SH.19. West elevation. (Strata 2016)

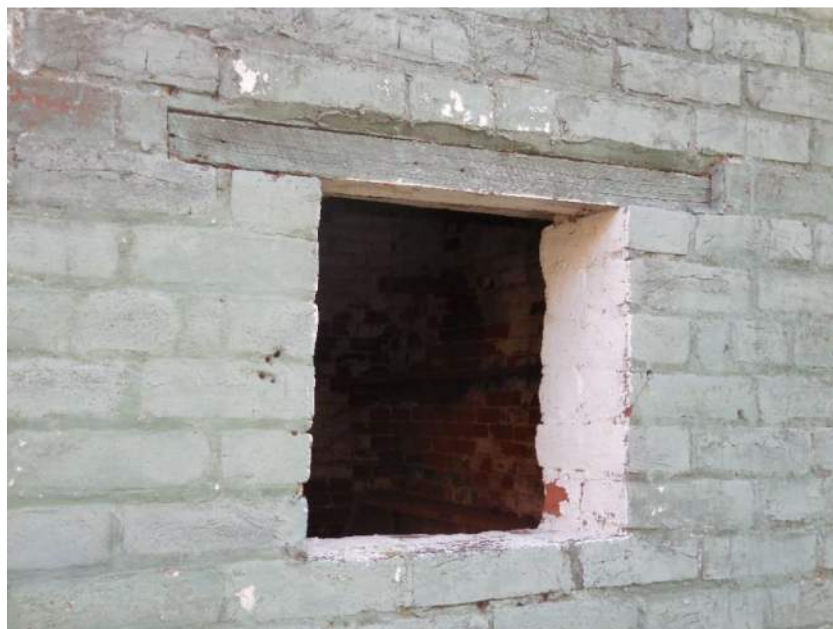
The grade gradually slopes to the south, with the lowest elevation at the south corner of the structure. A window opening is centered in the wall and is approximately one foot six-inches squared (Figure SH.20). The window opening sets roughly four feet five-inches off of grade. Framed by brick and topped with a wood lintel pocketed into the masonry wall, the opening no longer has a wood frame or sash.

Figure SH.20. West elevation, detail at window. (Strata 2016)

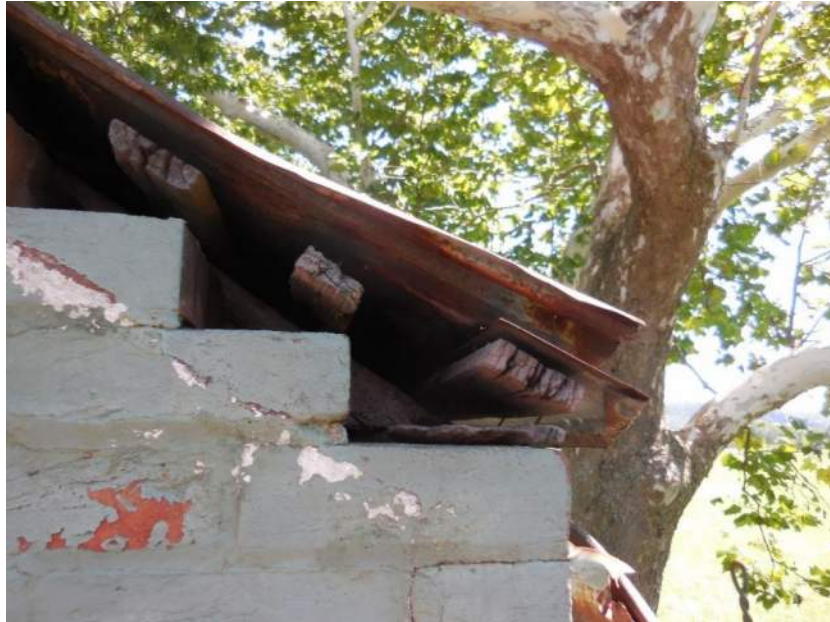
At the top of the wall the rake board is missing, exposing the top of the stepped masonry wall. A white ghost line roughly four-inches down from the top of the roof, suggests the outline of where the rake board was originally located (Figure SH.21). Just south of the roof center, two feet eight-inches down from the roof gable, are (4) single ventilation holes that are arranged in a diamond shape pattern. Throughout the masonry wall there are areas of missing or deteriorated mortar, cracks through the bricks, and twenty-five (25) of the brick are deteriorated, missing or cracked. Approximately 20% of the wall requires repointing.

Figure SH.21. West elevation, detail at roof. (Strata 2016)

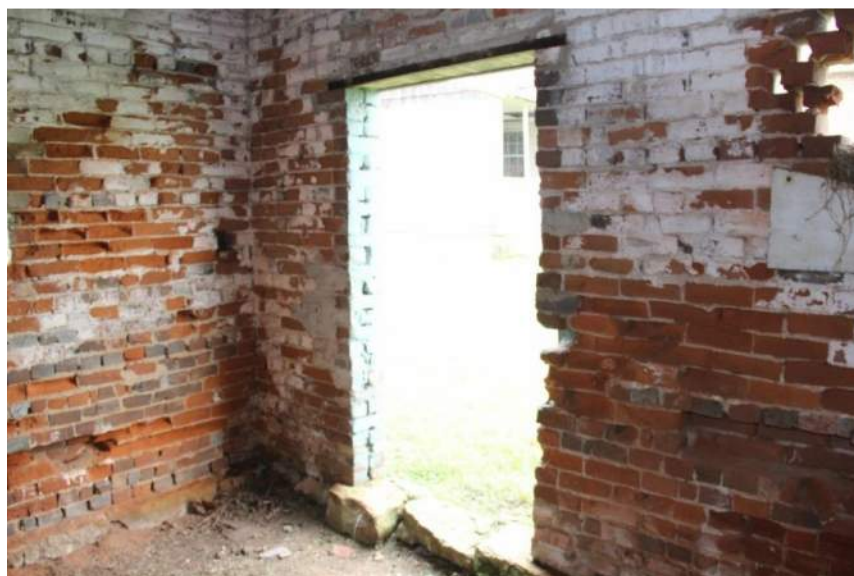
The north interior wall is in poor condition with major deterioration to more than 30% of the bricks (Figure SH.22). A majority of the brick deterioration is occurring on the lower three-quarters of the wall. Door Opening 1/100 is located in the west side of the north wall. A non-original steel angle has been installed at the head of the door opening most likely to help stabilize the settlement issues that were occurring above the door. The bricks above the door opening have been repointed with incompatible mortar. A through-wall crack extends from the top east corner of the door opening to the top of the masonry wall. Daylight can be seen through the crack. The stone foundation crosses the door opening, creating a threshold with a height of approximately four- to six-inches above the dirt floor. The wood frame and door to the smokehouse is missing, but at the brick jambs, there are nails that once connected the door jambs to the structure (Figure SH.24).

Figure SH.22. Interior North Elevation, looking northwest. (Sheals 2016)

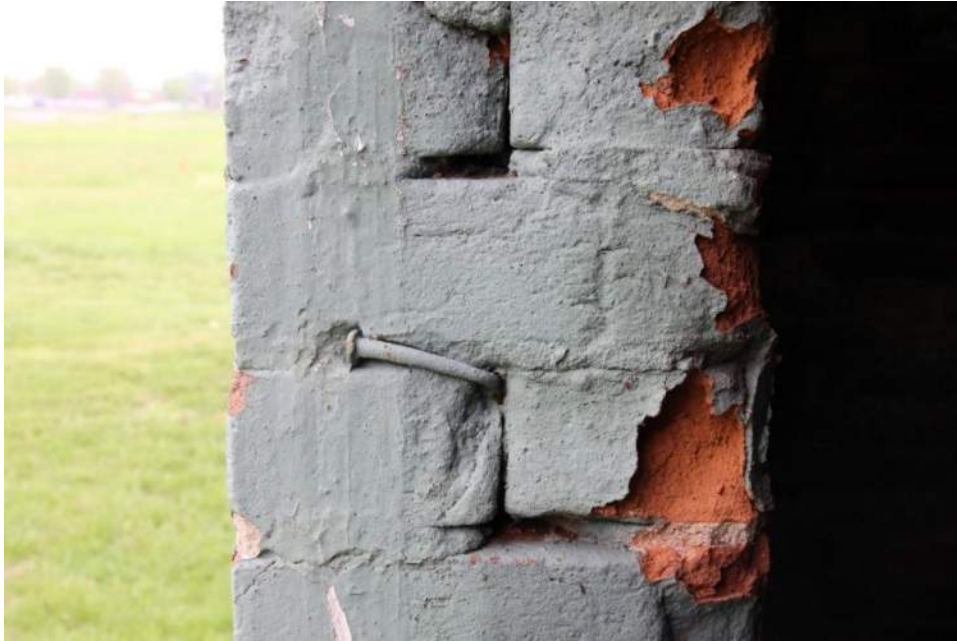
Figure SH.23. Door Opening, detail at east jamb. (Sheals 2016)

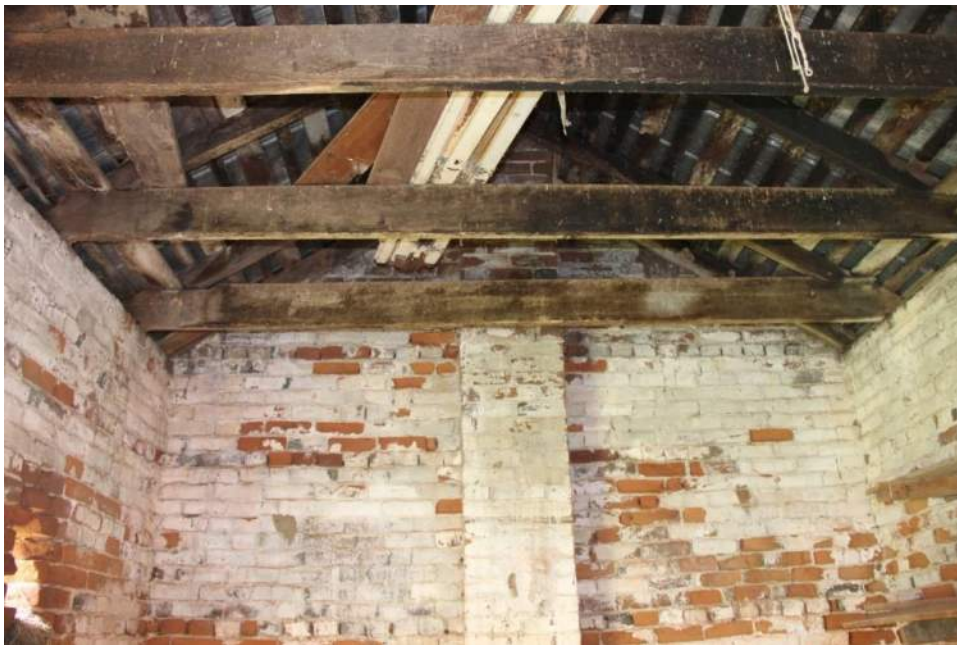
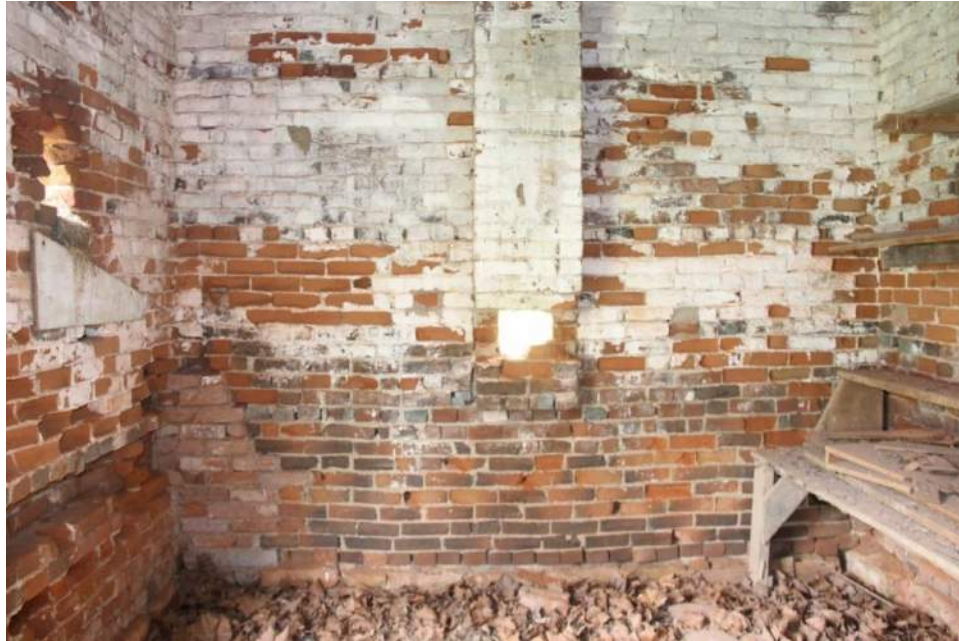
The east interior wall is in poor condition with major deterioration to more than 25% of the bricks (Figure SH.24 and SH.25). Deterioration to the bricks appears to be from the bricks being too soft, combined with water infiltration. In the north corner of the east elevation the lower corner has been reconstructed. The reconstruction is assumed to be from stabilization issues caused by water infiltration and a shallow stone foundation. Centered on the wall, roughly three feet off

the floor, a brick flue extends into the interior space. The flue is one foot six inches wide and has a depth of nine inches from the interior face of the east wall (Figures SH.24 and SH.25). The base of the flue is corbeled to help support the structure above. After the third row of corbeling, three rows of masonry are deteriorated or missing from the flue creating a large hole that opens to the exterior. There was likely some type of hole that vented smoke into the room from the flue, but it is no longer well defined. The flue is also open to the east exterior side of the wall. The flue extends up the full length of the wall and daylight at the roof.

Figure SH.24. Interior East Elevation. (Sheals 2016)

Figure SH.25. Interior East Elevation. (Sheals 2016)

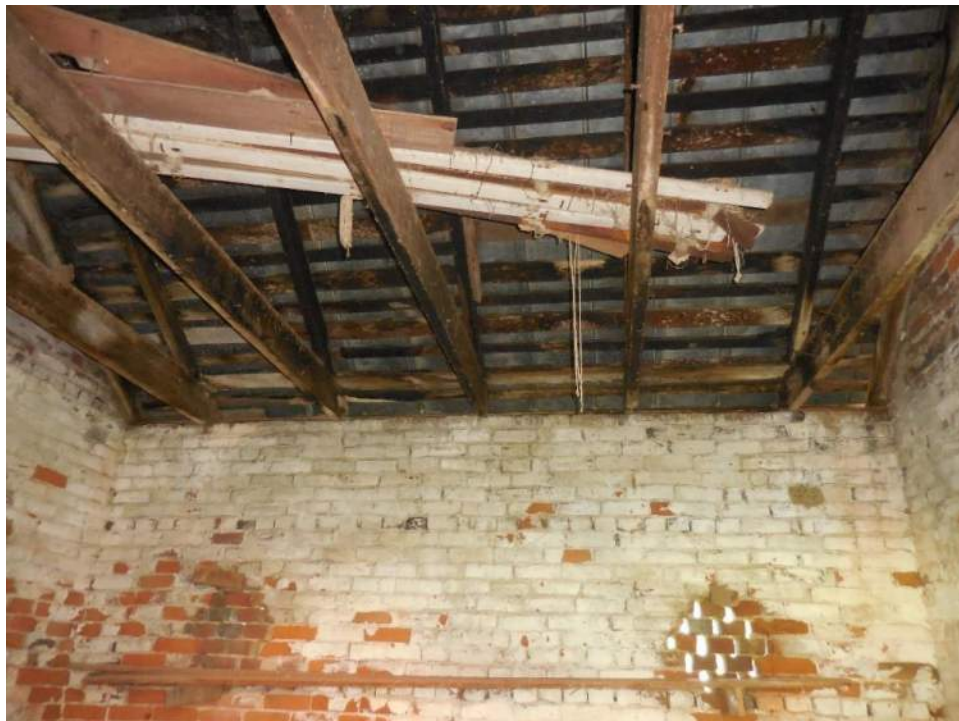
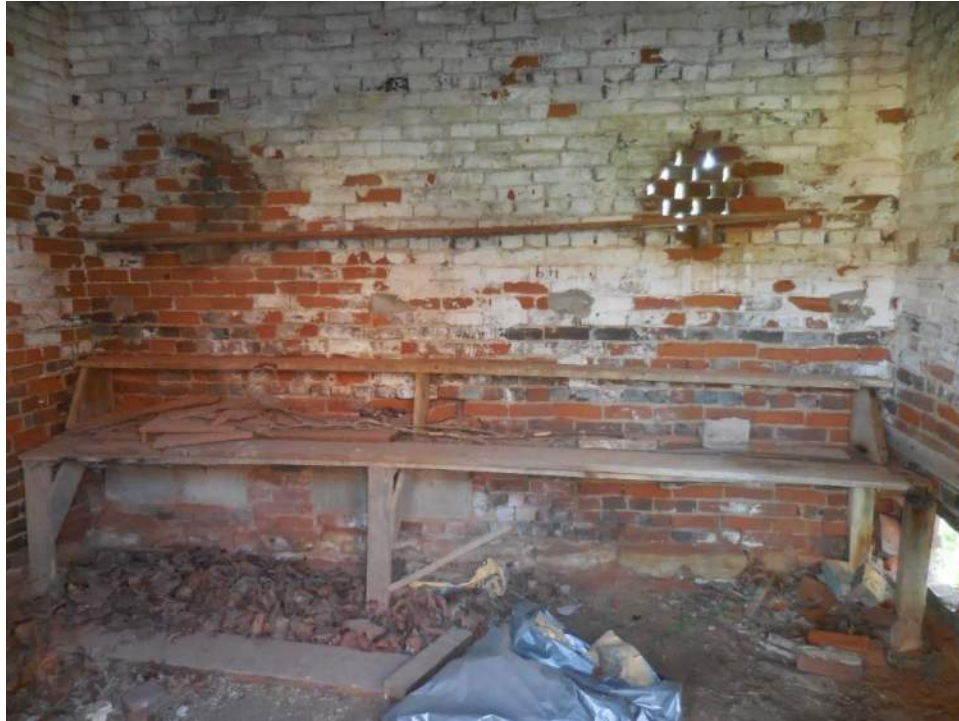
The south interior wall is in poor condition with major deterioration to more than 50% of the interior bricks (Figures SH.26 and SH.27). A majority of the brick deterioration is occurring on the lower half of the wall and a portion of the lower wall has been infilled with concrete blocks filling in where major brick loss or previous holes in the wall were once open. These concrete blocks cannot be seen from the exterior, as they are covered with an outer veneer of brick. A majority of the mortar is missing and what mortar remains is deteriorated. A wood shelf hangs half-way up the wall is supported by two wood boards that are wedged into the lowest brick opening at either of the diamond shaped vents that are built into the wall. Just below the wood shelf is a tiered, free standing wood work table that spans the entire length of the wall.

Figure SH.26. Interior South Elevation. (Strata 2016)

Figure SH.27. Interior South Elevation. (Strata 2016)
