THOMAS BLACKSTONE HOUSE

HISTORIC STRUCTURES REPORT

SEIP EARTHWORKS UNIT – HOPEWELL
CULTURE NATIONAL HISTORICAL PARK
BAINBRIDGE, OHIO

APRIL 17, 2017
NPS PMIS # 218963

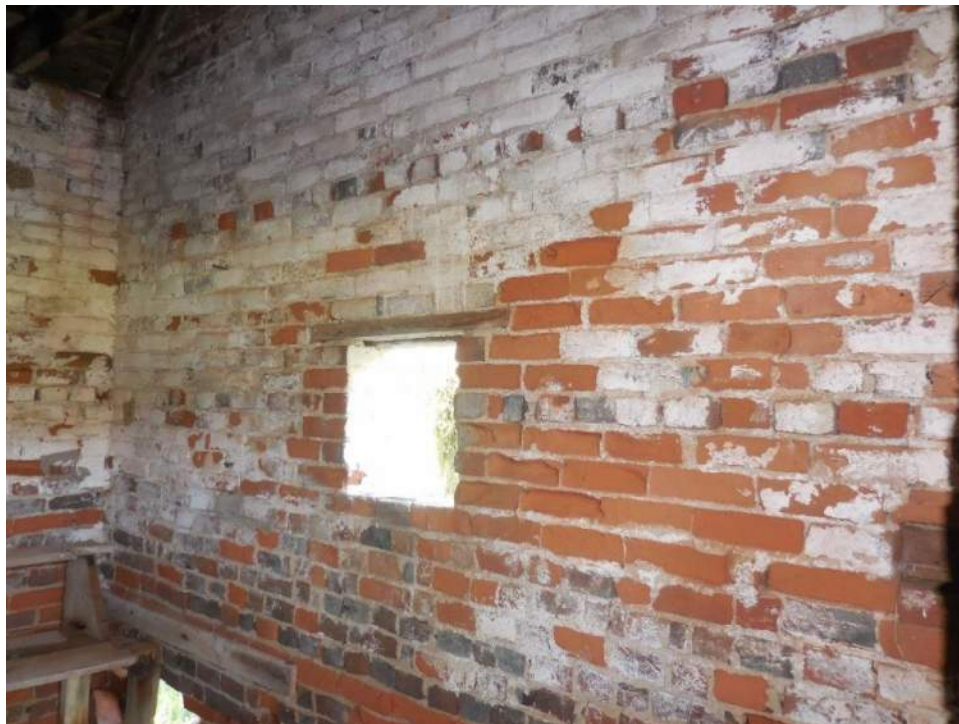
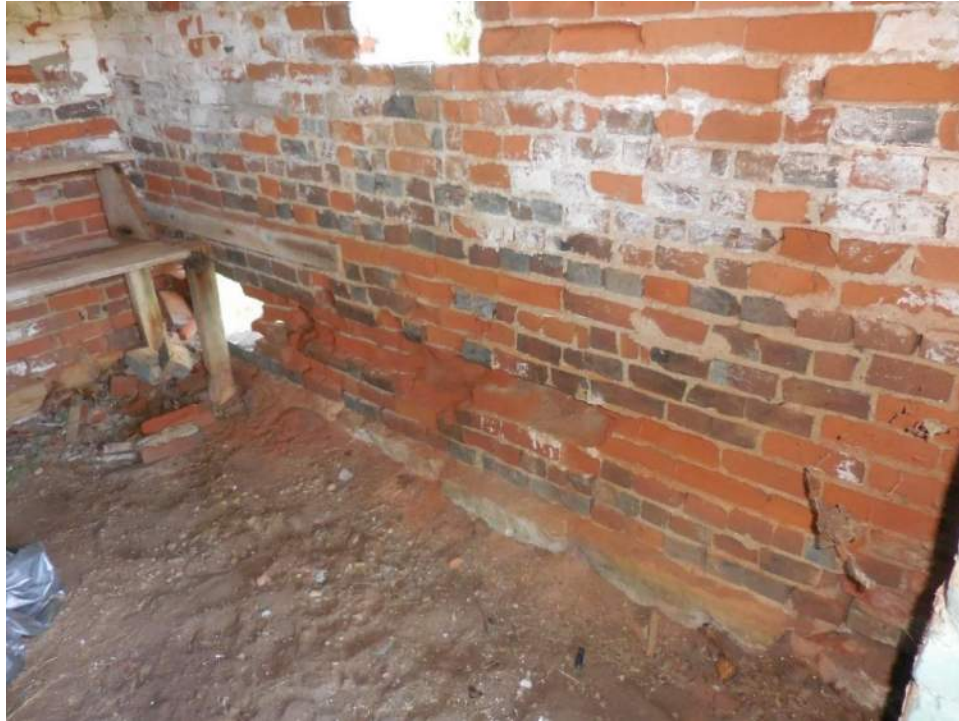
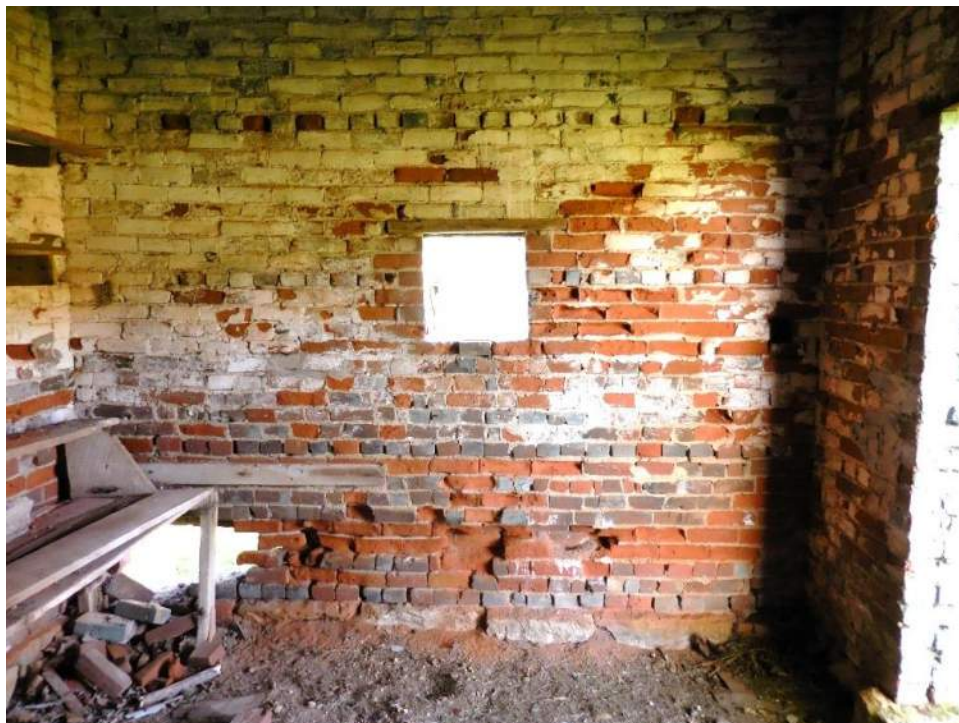
The west interior wall is in fair to poor condition with major deterioration to more than 50% of the interior bricks (Figures SH.28 – SH.30). A majority of the brick deterioration is occurring on the lower half of the wall with some deterioration extending higher on the north side of the wall. As mentioned on the exterior assessment, in the southwest corner, a large hole has developed with roughly twenty bricks missing from the wall. There are several other locations throughout the lower half of the wall where bricks are missing or where 80% or more of a brick has deteriorated.

Figure SH.28. Interior West Elevation. (Strata 2016)

Figure SH.29. Interior West Elevation. (Strata 2016)

Figure SH.30. Interior West Elevation. (Strata 2016)

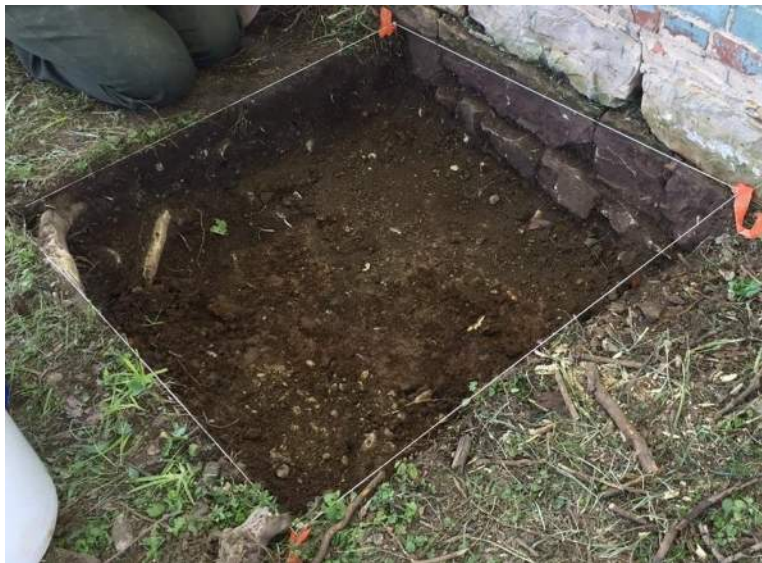
The smokehouse has a stone masonry foundation. From the bottom of the lowest brick to the bottom of the stone foundation is 28.9-inches as measured by the National Park Service. The foundation depth was visible through an exterior excavation at the east wall (Figure SH.31). The top of the stone masonry foundation wall is visible above grade around the perimeter of the structure. The top of masonry also acts as the threshold for the door.

Figure SH.31. Foundation excavation at smokehouse, east side. (SEA 2016)

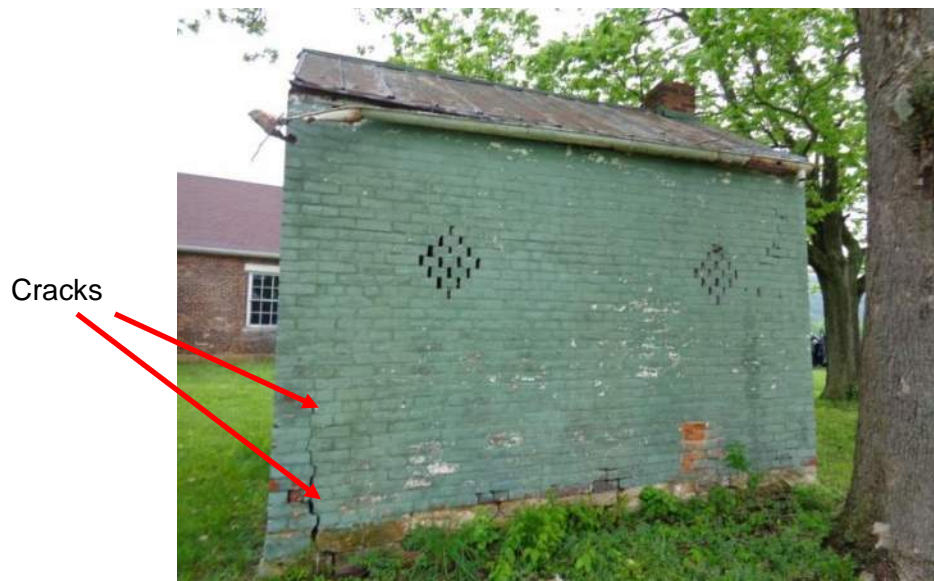
The exterior wythe has been painted. Several through-wall cracks are visible through the coat of paint. The cracks indicate lateral movement of the foundation at the corners. The largest crack is at the southwest corner of the structure (Figure SH.32). It is considered inactive since paint is in the crack. There is also evidence of selective tuck pointing work on the exterior. The south gutter is damaged and has no downspout.

Figure SH.32. South wall of smokehouse. (SEA 2016)

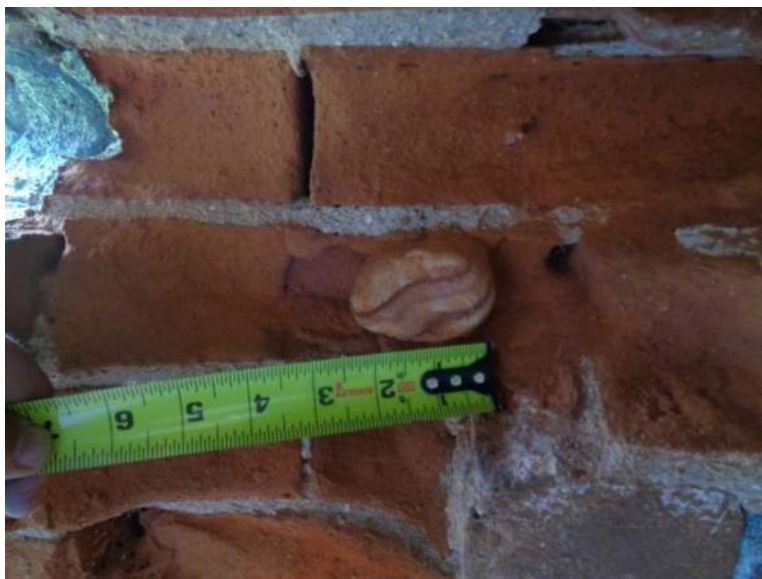
A small percentage of the bricks on the exterior show some deterioration. A large percent of the interior bricks show deterioration. Some partially deteriorated bricks exhibit large inclusions (Figure SH.33). Several bricks have completely deteriorated (Figure SH.34). Brick or CMU has been used to fill in a few places where the original interior wythe is gone.

Figure SH.33. Foreign object, interior wythe of brick, north wall. (SEA 2016)

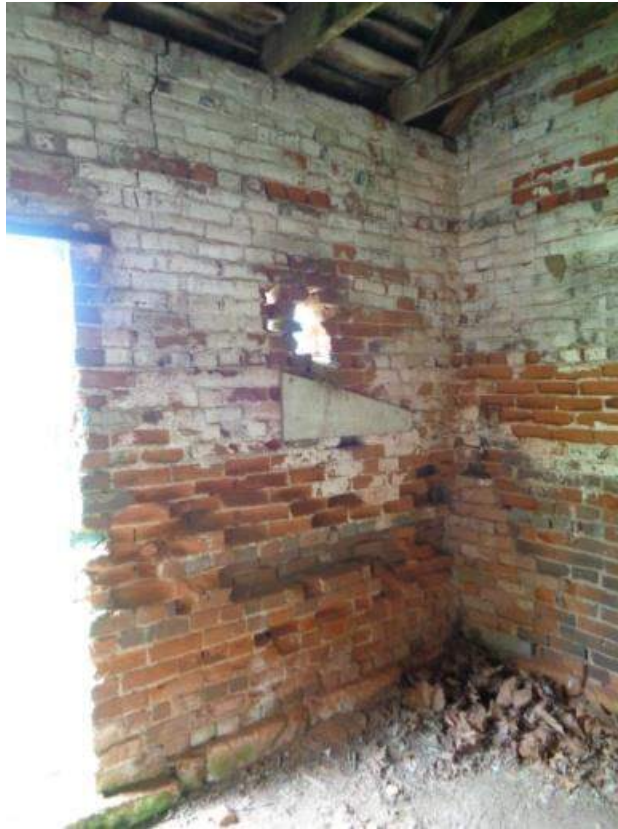
Figure SH.34. Interior wythe brick wall deterioration. (SEA 2016)

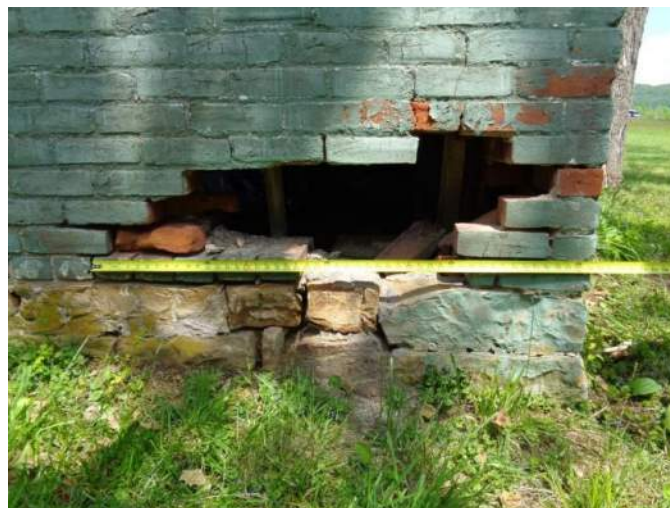
There is a large hole through the west wall just above the masonry foundation (Figure SH.35). It extends through both wythes of brick. There is also a hole through the east wall where the bottom courses of the chimney are missing (Figure SH.36).

Figure SH.35. Hole through west wall. (SEA 2016).

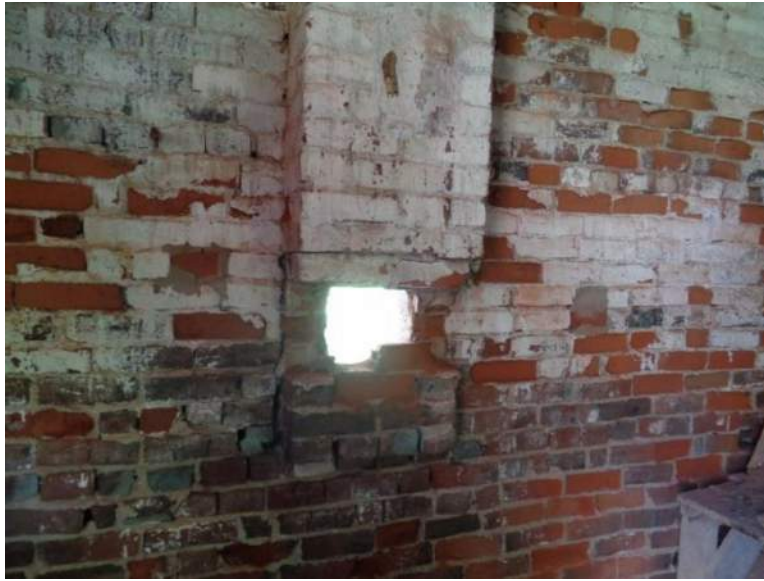
Figure SH.36. Hole in east wall. (SEA 2016)

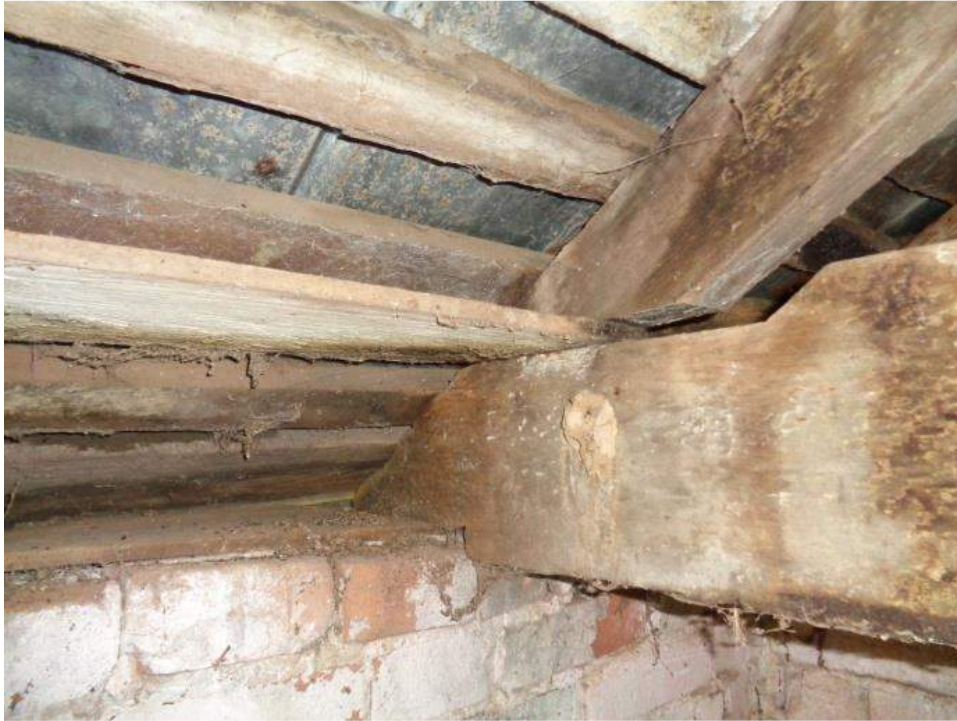
The roof frame construction style looks similar to the limited roof framing that was visible in the main house (Figure SH.37). The timber framing is deteriorating in several places. The westernmost joist is particularly deteriorated at the north bearing (Figure SH.38). There is also a rafter that has rotted completely through (Figure SH.39).

Figure SH.37. Detail at joist bearing. (SEA 2016)

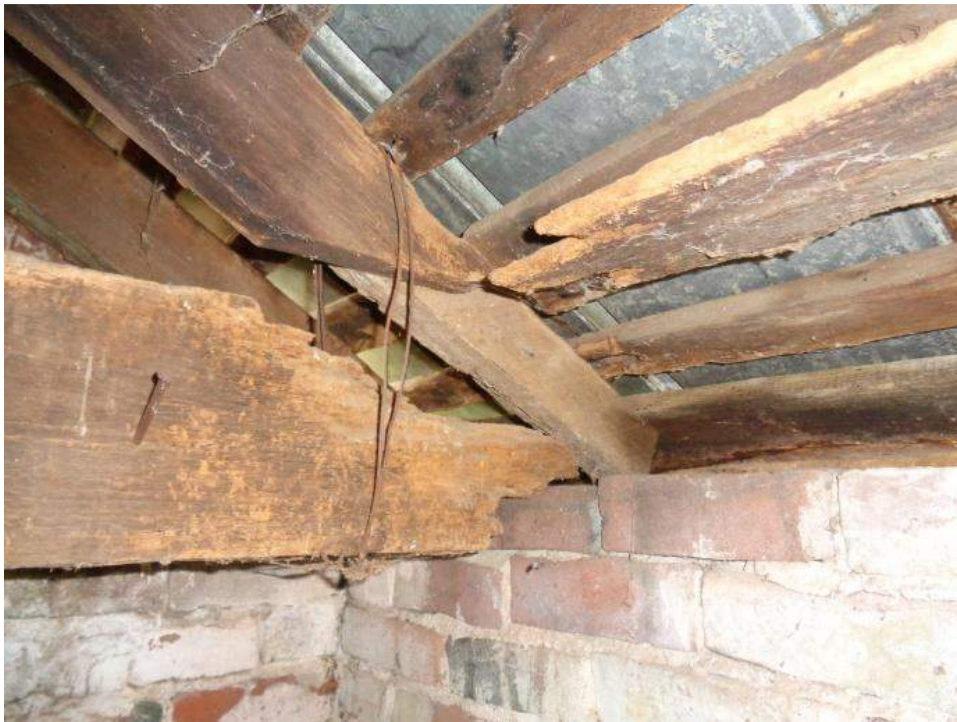
Figure SH.38. Rotted joist, looking northwest. (SEA 2016)

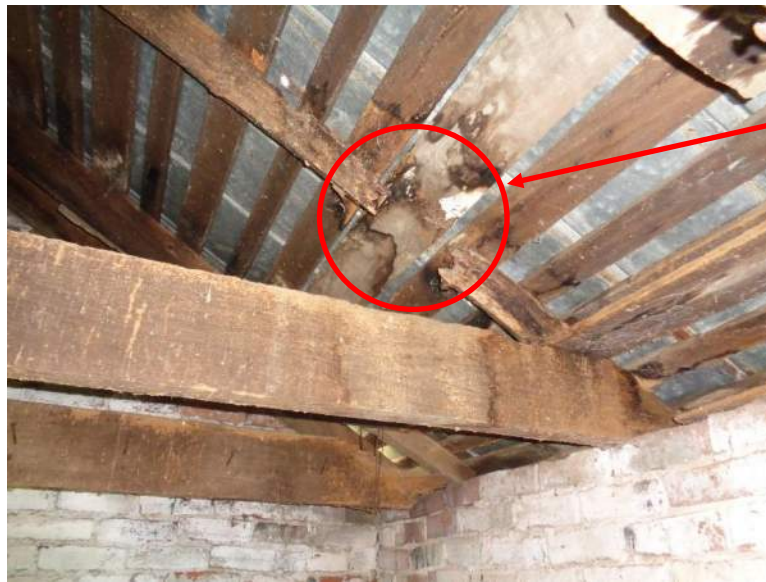
Rafter Rotted
Completely
Through

Figure SH.39. Rotted rafter, looking northwest. (SEA 2016)

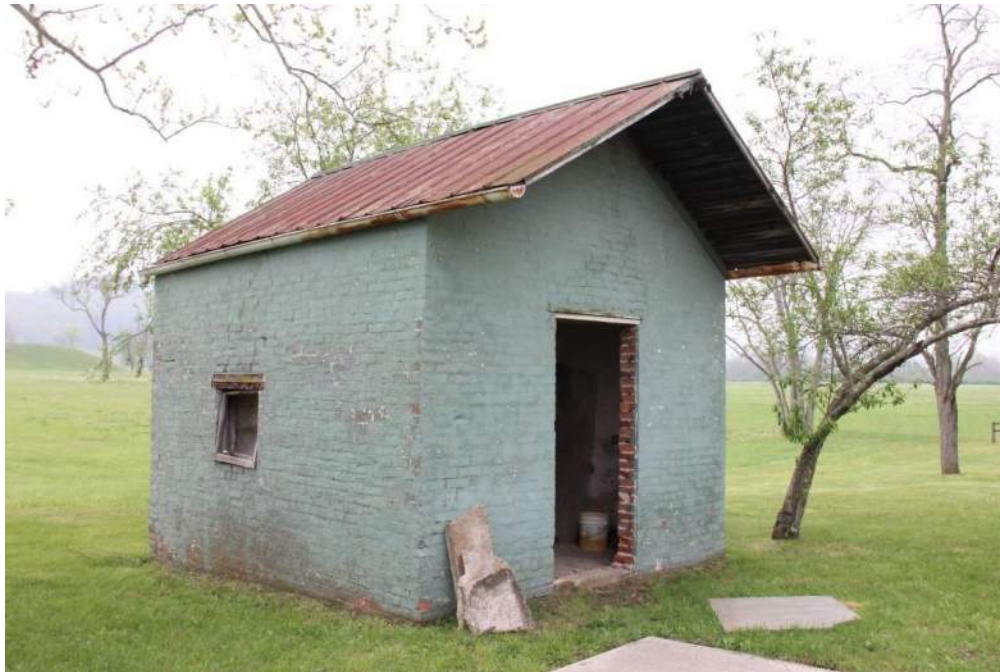
Figure MH.1. Milk House. (Sheals 2016)

The exterior of the building is currently painted green and is in overall good to fair condition. The brick walls require approximately 30% repointing and a small portion of the brick walls require reconstruction and brick replacement. At the southwest corner biological growth is covering the bricks, just below the deteriorated downspout. The historic wood door frame no longer exists and the wood door and a portion of the frame are currently being stored inside the building. The historic window sash in the east wall is missing. The half-round gutters have significant amounts

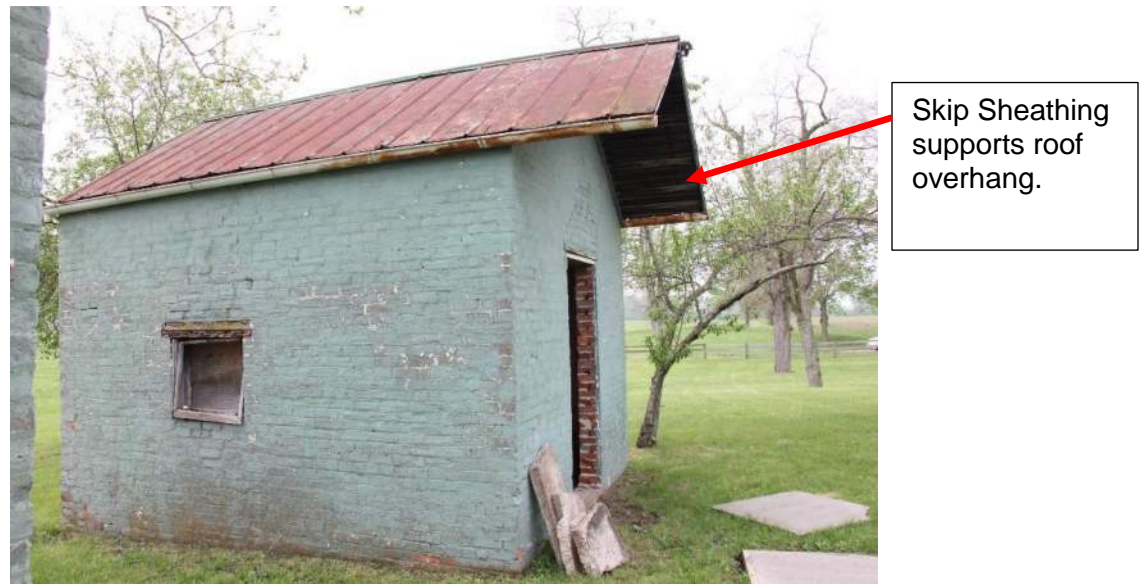
Wood rafters span east/west creating a gabled roof that is covered in three-inch wide skip sheathing and topped with a standing seam metal roof (Figures MH.4). The roof is in fair condition with a majority of the deterioration developing from the roof metal being exposed to the elements, causing rust throughout the roof. The existing wood skip sheathing suggests that the roof at one time was covered in wood shingles (Figures MH.23, MH.26 and MH.27). There are no wood shingles remaining. There are sections of the roof skip sheathing that are deteriorated, as well as one roof rafter. On the north end of the roof the standing seam metal roof turns down one inch, partially covering a wood rake board (Figure MH.7). On the south end of the roof the standing seam metal roof wraps down one inch, partially covering a metal rake board (Figures MH.3 and MH.5).

Figure MH.4. East elevation and roof, looking southwest. (Strata 2016)

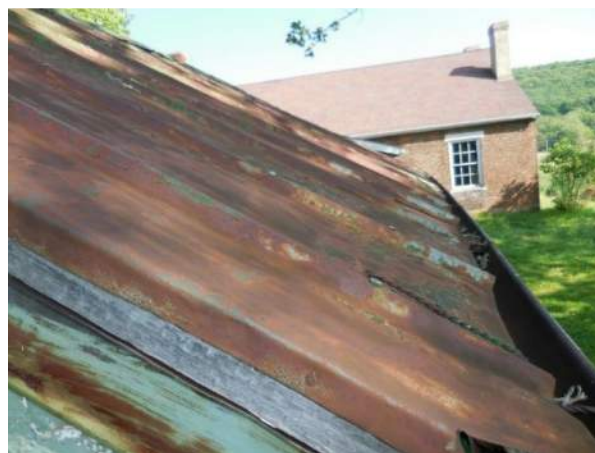
Figure MH.5. Roof, detail looking north towards main house. (Strata 2016)

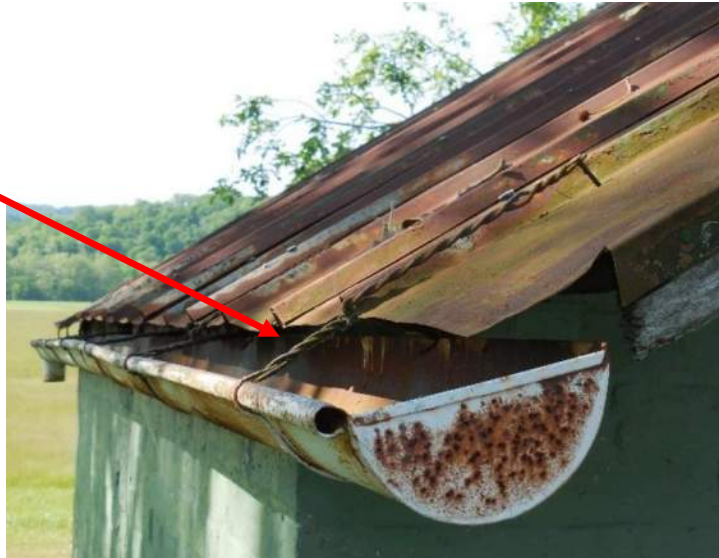
Twisted Metal Wire
Gutter Hangers

The wood rafters set on the east/west side walls, while the wood skip sheathing sets directly on the gabled north/south masonry walls. The roof overhangs the north elevation, with the wood skip sheathing extending three feet past the north exterior wall to support the roof overhang. Half-round gutters are attached to the roof with twisted metal wire that wrap around the gutter acting as a hanger. The wire hangers are secured into the metal roof with box nails (Figures MH.5 and MH.6). A deteriorated remnant of a metal downspout is located at the southwest corner. The southeast corner downspout is completely missing (Figure MH.4). A metal light fixture has been abandoned on the north elevation at the roof ridge (Figure MH.7). An old ceramic electrical insulator that holds electrical wiring has been abandoned east of the light figure.

Figure MH.6. Roof, detail of gutter looking south. (Strata 2016)

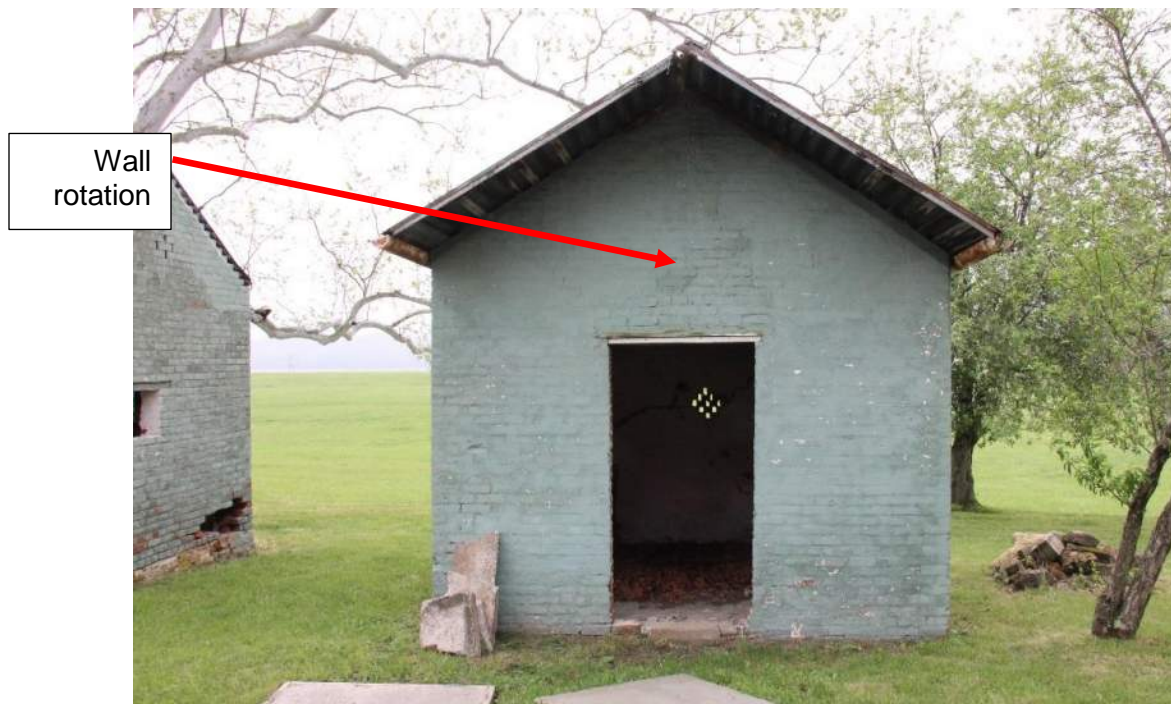
Figure MH.8. North elevation. (Strata 2016)

The north elevation is the gable end of the building and is visible from the main house with a deep roof overhang (Figure MH.8). The door opening is centered in the wall and is missing the wood door frame and door (Figures MH.8 and MH.9). The wood door was stored inside the building during the May 2016 site visit but was gone by August (Figure MH.11). The raised threshold is constructed with brick, which has been patched with concrete. This brick threshold would have been covered with a thick wood door sill that has since deteriorated. The west edge of the concrete threshold patch is cracked (Figure MH.10). The north elevation is in fair condition with a majority of the deterioration at and around the door opening.

The grade is relatively consistent across the north elevation with a slight slope from the west to the east side of the structure, with the lowest elevation being the east corner of the structure (Figure MH.8). The masonry wall is painted and has minor chipping and flaking throughout the elevation. Mortar is missing along the base of the wall. (Figures MH.10).

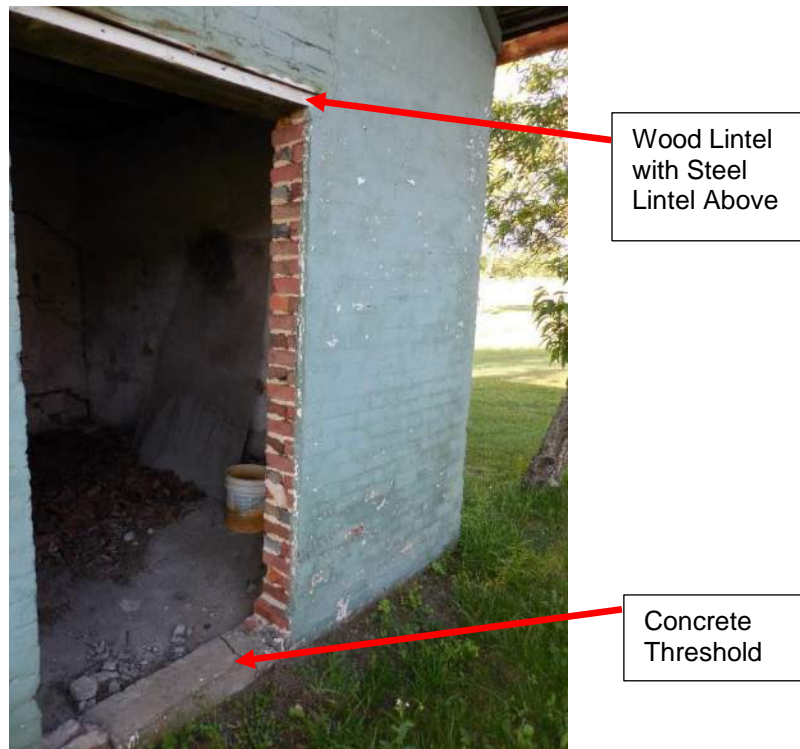
Figure MH.9. East elevation, detail of raised grade at door entry. (Strata 2016)

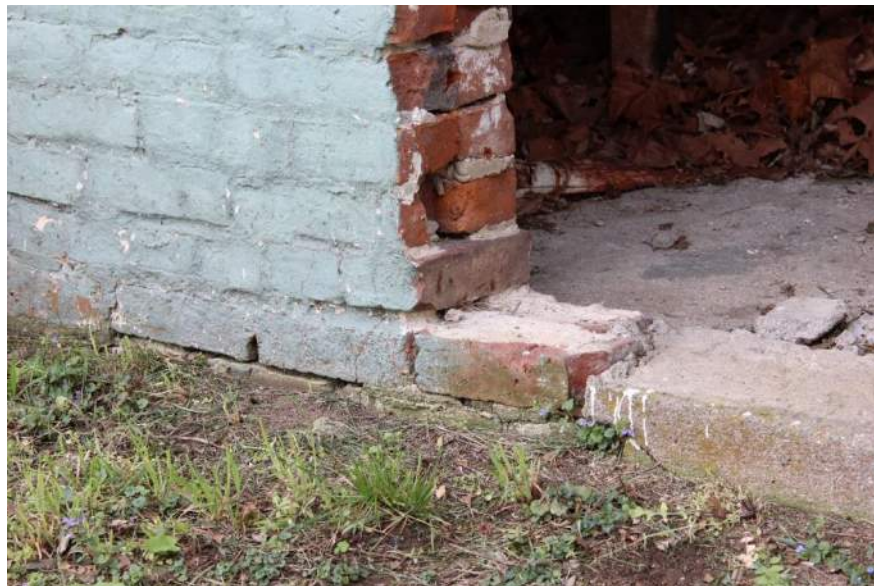
Figure MH.10. Door opening, detail of threshold. (Strata 2016)

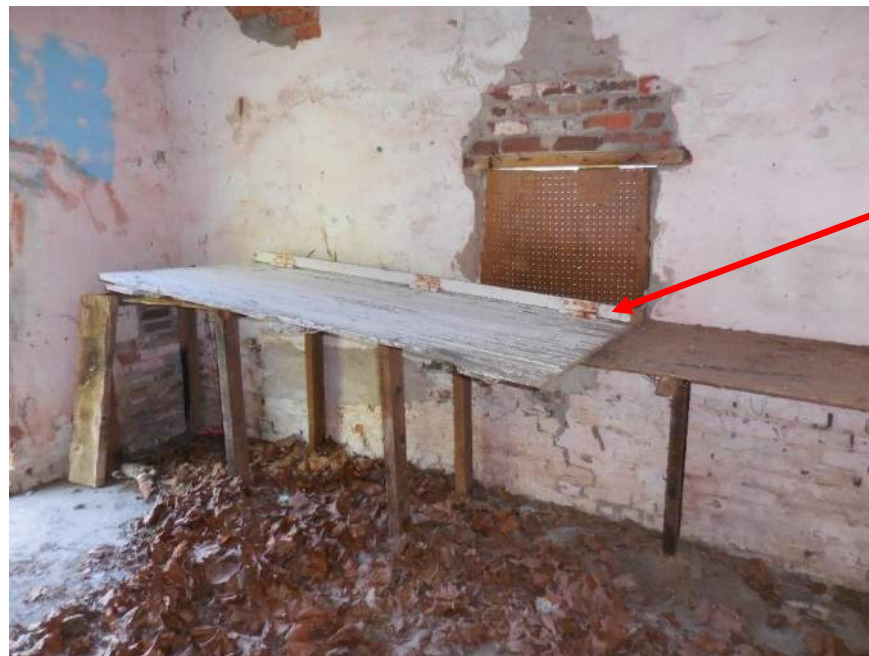
Figure MH.11. Interior, detail looking northeast. (Strata 2016)

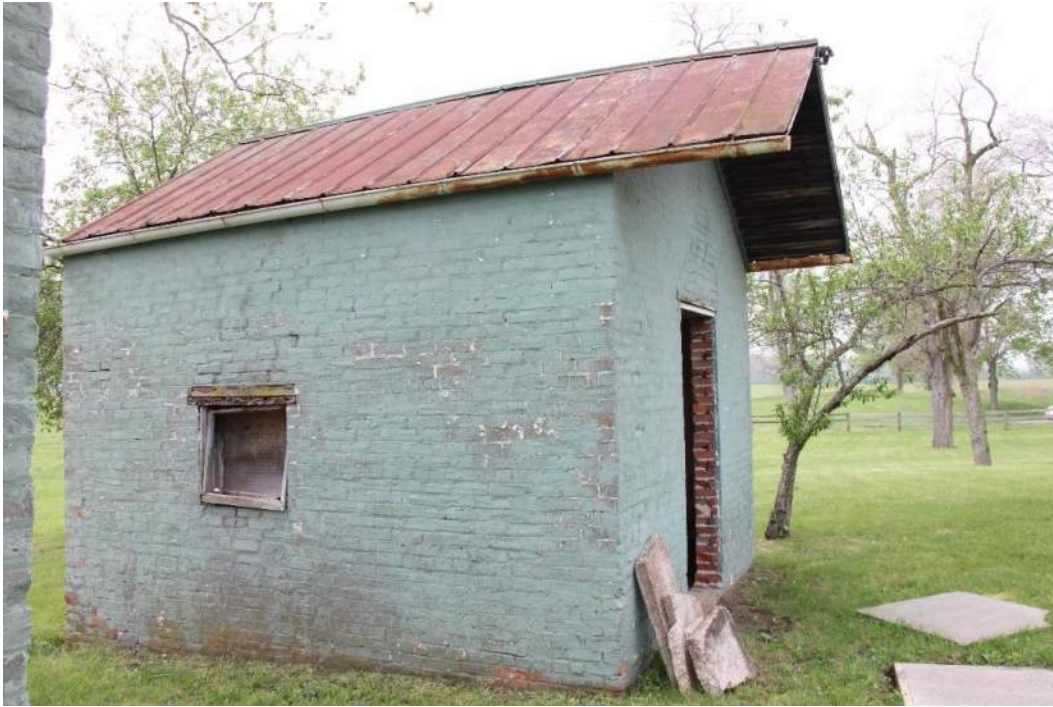
Figure MH.12. East elevation. (Sheals 2016)

The east elevation faces the smokehouse (Figure MH.12). Just south of the center of the wall is a window opening that measures approximately 2'-6" x 2'-2". The window jambs and sill are deteriorated and partially missing. The wood frame has substantial deterioration and is shifted within the wall, tilting inward (Figures MH.13 – MH.14). There are gaps in the upper rail of the sash that suggest two vertical muntins are missing. The sash has been filled with high-density perforated fiberboard or peg board. It is not clear if the sash is original to the window opening. Further investigation should be completed to examine if the window opening was filled with glazing. Directly above the window opening is a rough-sawn 2x8 wood lintel that shows signs of significant deterioration. The lime mortar is missing just above the wood lintel and the masonry has been repointed with inappropriate Portland mortar. The elevation is in fair condition with a majority of the deterioration surrounding the window opening.

The grade is gradually sloping to the south, with the lowest elevation at the south corner (Figure MH.12). The masonry wall is painted and has minor chipping and flaking throughout the elevation, with a majority of the paint deterioration occurring at the base of the wall. All along the base of the wall mortar is missing (Figures MH.10). Throughout the masonry wall there are a few areas of missing lime mortar, approximately 15% of the mortar joints. In several locations the brick is spalling.

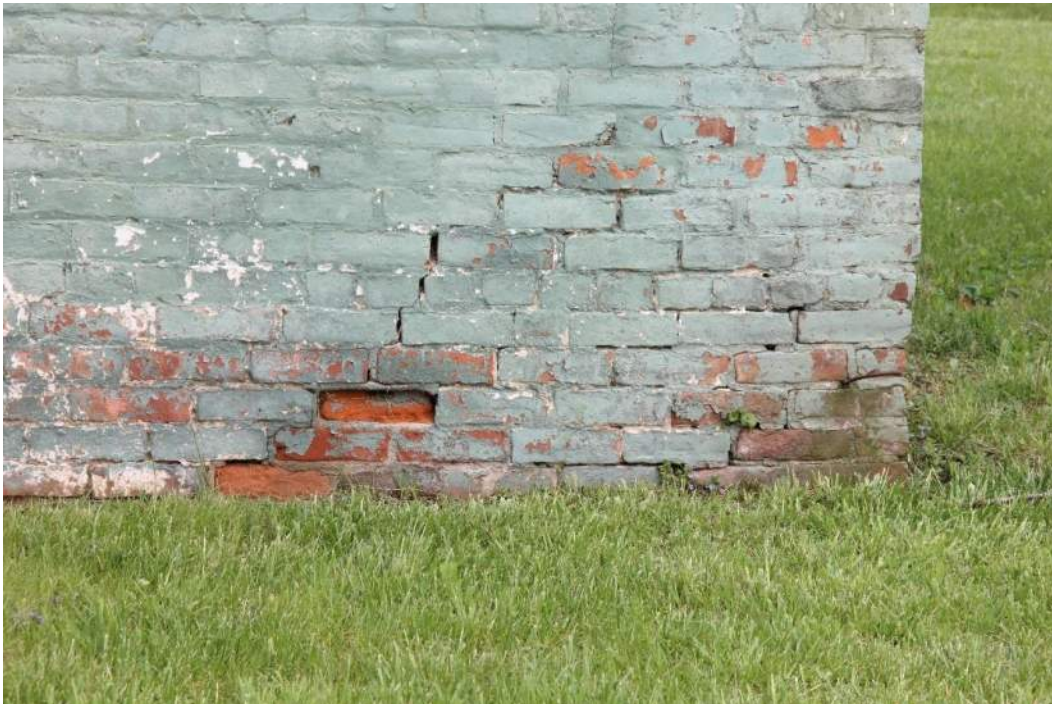
The south elevation is the back of the building and is not visible from the main house (Figures MH.3, MH.16 – MH.18). The elevation is in fair to poor condition with a majority of the deterioration developing at the base of the wall where the deteriorated downspouts directed water onto the masonry. Three-quarters of the masonry wall is painted and has minor chipping and flaking, with major deterioration along the base and at the corners (Figures MH.16 and MH.17). The top quarter of the wall has not been painted with the green paint. Throughout the upper three-quarters of the masonry wall there are areas of missing or cracked lime mortar, approximately 15% of the mortar joints. Along the base of the wall lime mortar is missing and several of the bricks have been displaced at the west corner (Figures MH.10). Heavy biological growth is occurring along the west corner. Approximately 10 bricks in the bottom quarter of the wall are significantly damaged due to spalling.

Figure MH.16. South elevation, detail of spalling brick, southeast corner. (Strata 2016)

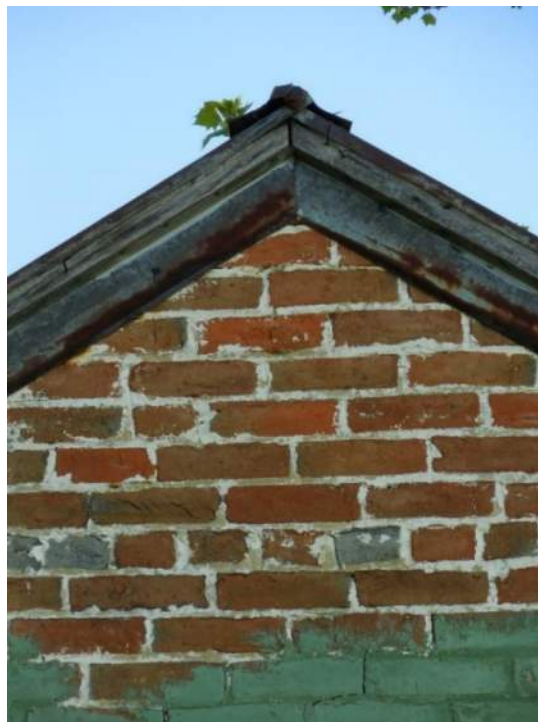
Figure MH.18. South elevation, detail of gable wall ridge. Note, there are remnants of old white wash finish that has worn away. (Strata 2016)

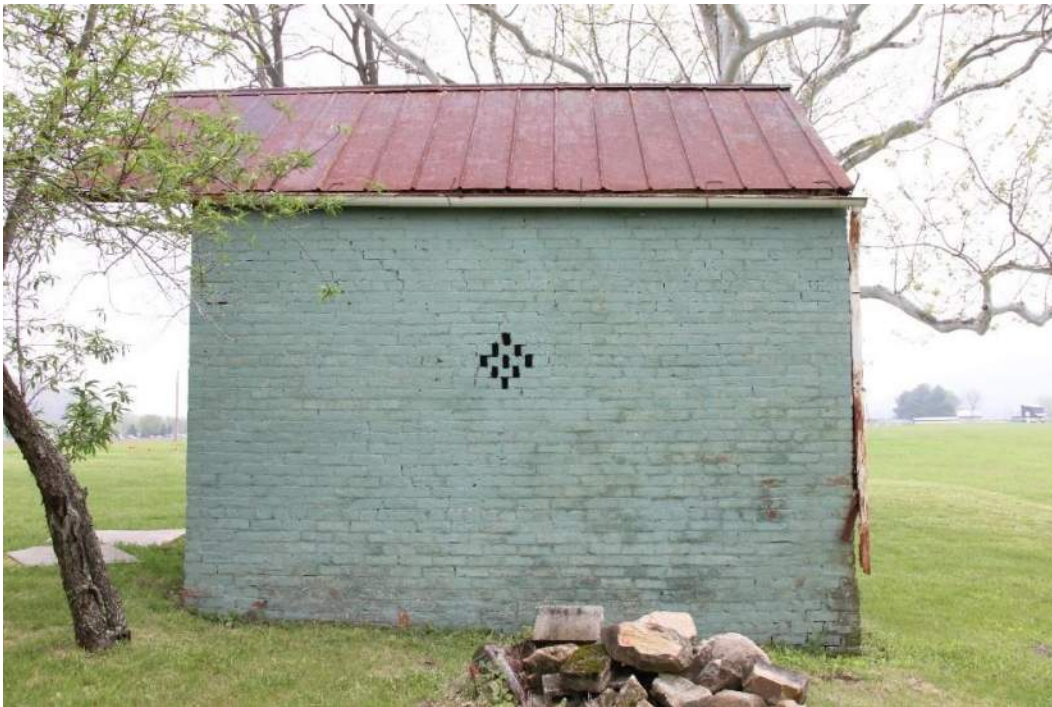
Figure MH.19. West elevation. (Sheals 2016)

The West Elevation is not visible from the main house (Figure MH.19). The elevation is in fair condition with a majority of the deterioration developing due to missing mortar or cracks. The masonry wall is painted and has minor chipping and flaking throughout the elevation. Approximately 20% of the mortar joints are deteriorated in this wall. The lower portions of the north and south corners have several bricks displaced due to settlement and moisture damage from deteriorated downspouts. Light biological growth is occurring along the south corner. Approximately two to four bricks in the wall are significantly damaged due to spalling.

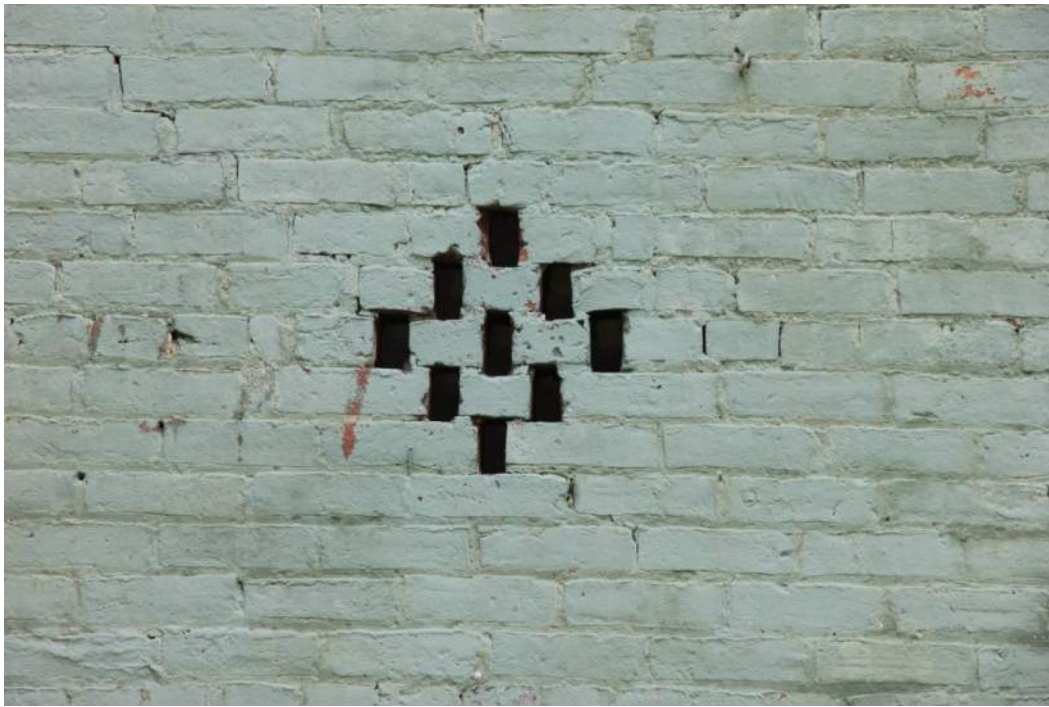
Figure MH.20. West elevation, detail of ventilation holes. (Strata 2016)

The grade is sloping to the south, with the lowest elevation at the south corner of the structure. Ventilation holes that are arranged in a diamond-shaped pattern are located centrally in the wall, roughly 5'-6" above grade (Figure MH.20). The holes are created by leaving a two-inch gap in the masonry pattern.

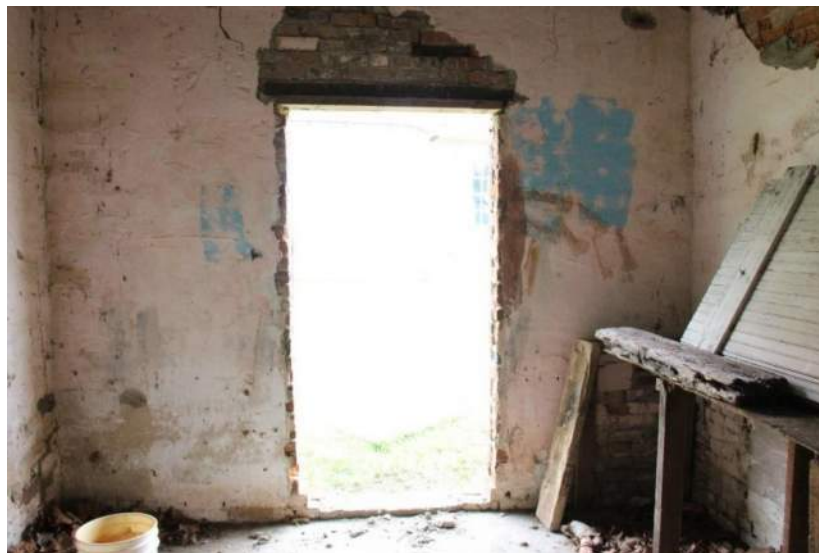
Figure MH.21. Interior, looking north. (Strata 2016)

The north interior wall is in fair to poor condition with minor damage to the parge coating (Figure MH.21). A large section of finish coating is missing, exposing the deteriorated bricks, just above the door opening. There is cracking in the remaining coating above the door and the wall is rotated slightly above the door. A single brick is missing on the left side, above the door opening. A wood lintel is pocketed into the brick and a rusted steel angle that matches the exterior angle, has been installed just above the wood lintel to help stabilize the settlement issues that were occurring above the door.

The south interior wall is in poor condition with significant parge coating deterioration and masonry wall cracks throughout the wall (Figure MH.21 and Figure MH.24). A large portion of the finish coating is missing in the east corner of the wall. The finish is also missing within the diamond shape of the ventilation holes and just below and to the west of the ventilation holes. Just above the wood rafter tie, the masonry wall is not covered with parge coating, but it is white washed.

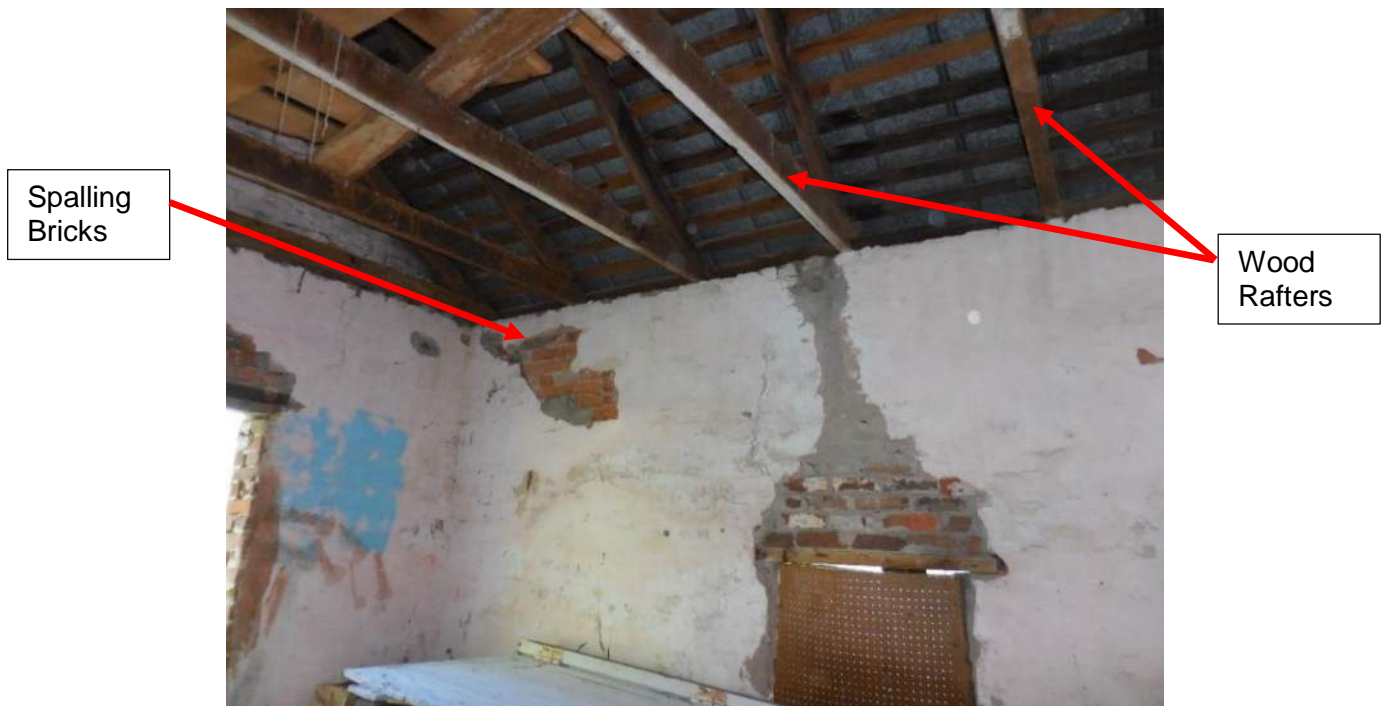
Figure MH.23. Interior, looking east. (Strata 2016)

The east elevation is in poor condition with a large portion of parge coating deteriorated, brick spalling and incompatible mortar patching (Figures MH.22 – MH.24). The parge coating is

thicker on the top three-quarters of the wall, with the bottom quarter being significantly thin allowing more of the brick profile to be seen. There is significant damage to the coating around the window opening with large portions of finish missing just above and below the window opening (Figures MH.22 – MH.24). The area directly above the window has been reconstructed with original bricks and a Portland mortar. In the north lower corner of the elevation the coating has been patched with a cementitious Portland material and the patch has not been white washed. In the north upper corner of the wall a large portion of coating is missing and the exposed bricks are deteriorated. The ceiling wood rafters set directly on top of the masonry wall (Figures MH.23 and MH.27).

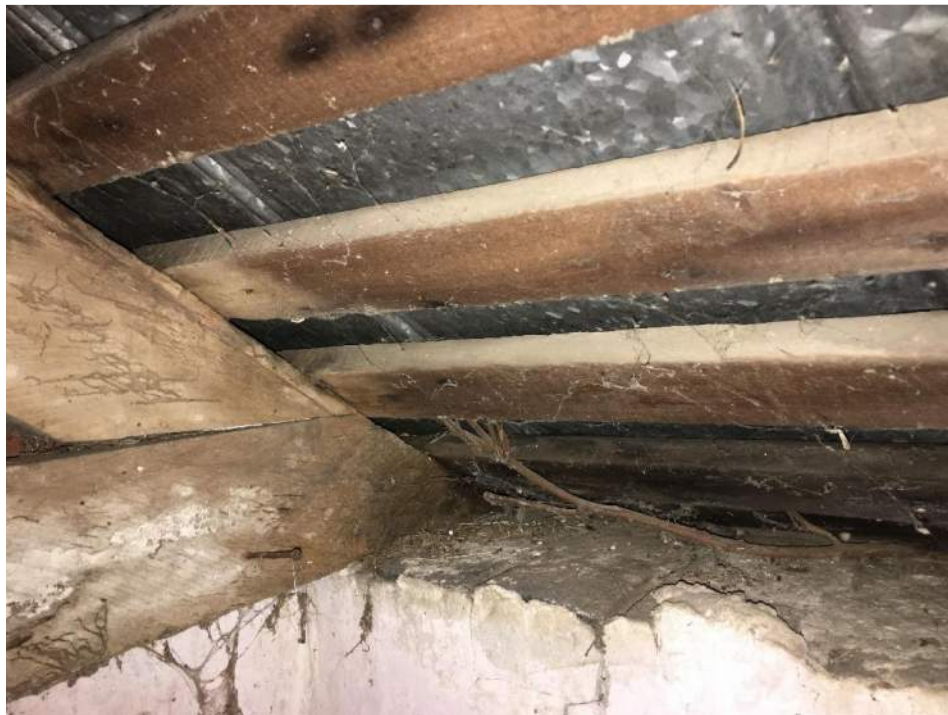
Figure MH.27. Typical rafter detail at top of brick wall. (Strata 2016)

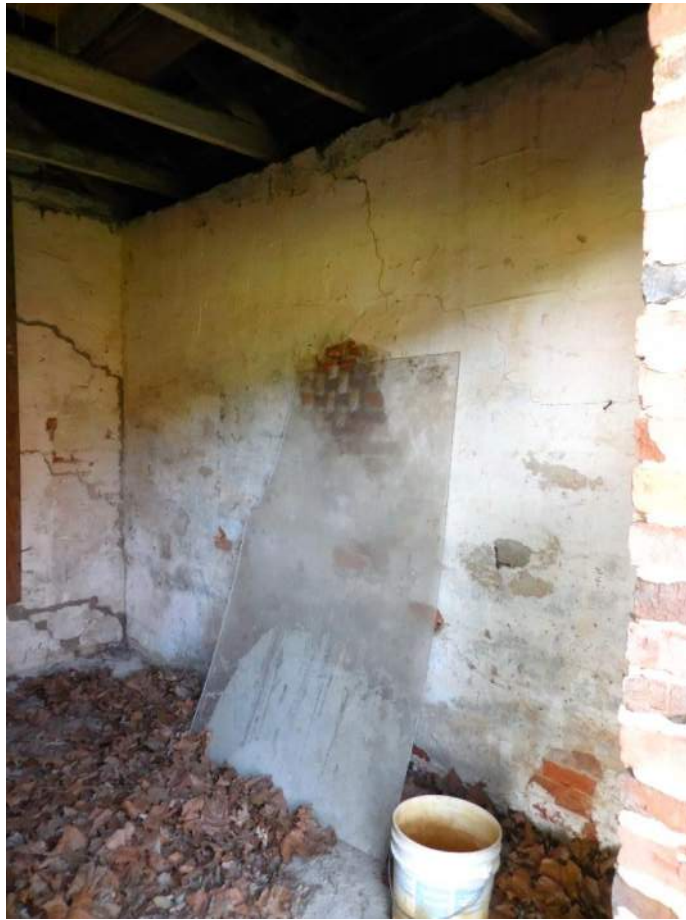
Figure MH.28. Interior, looking west. (Strata 2016)

The west elevation is in fair condition with minor parge coating deterioration and some brick deterioration (Figure MH.28). Throughout the upper wall there is cracking, with minor flaking occurring all along the upper edge of the wall. In the lower north corner there is a small portion of coating missing and the exposed bricks are deteriorated. The finish coating is also missing within the diamond shape of the ventilation holes. Like the east wall the wood rafters are set directly on top of the masonry wall.

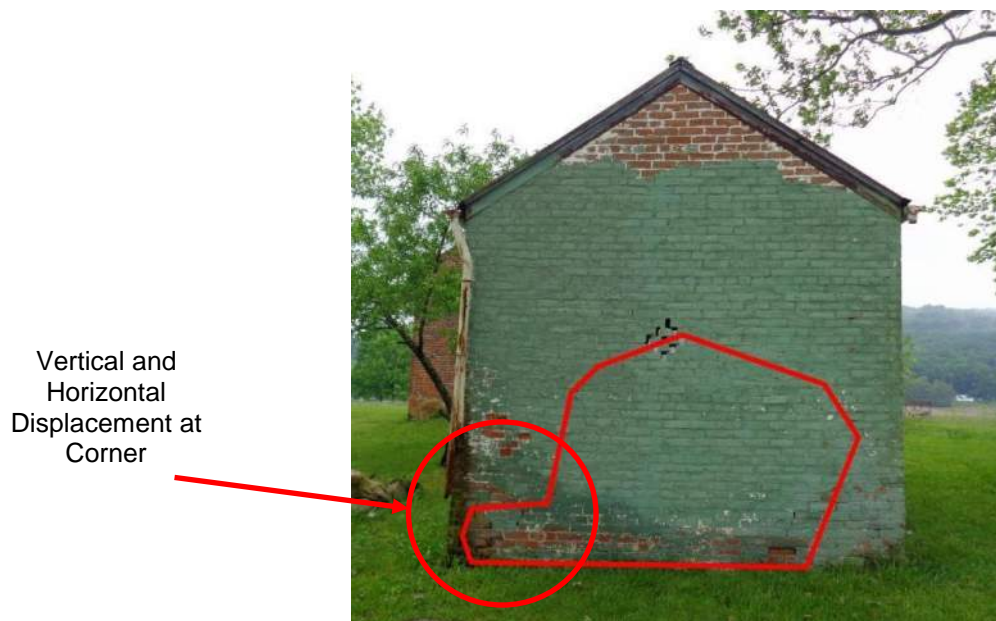
The exterior wythe has been painted almost completely. Several through-wall cracks are visible through the coat of paint. There is also evidence of selective tuck pointing. The base of the southwest corner shows vertical and horizontal displacement. Most of the bottom half of the south wall has an out of plane bulge (Figure MH. 29). A few exterior bricks show some deterioration. One downspout is mostly rusted away and the other is missing (Figure MH. 29).

Figure MH. 29. South elevation of milk house bulge. (SEA 2016)

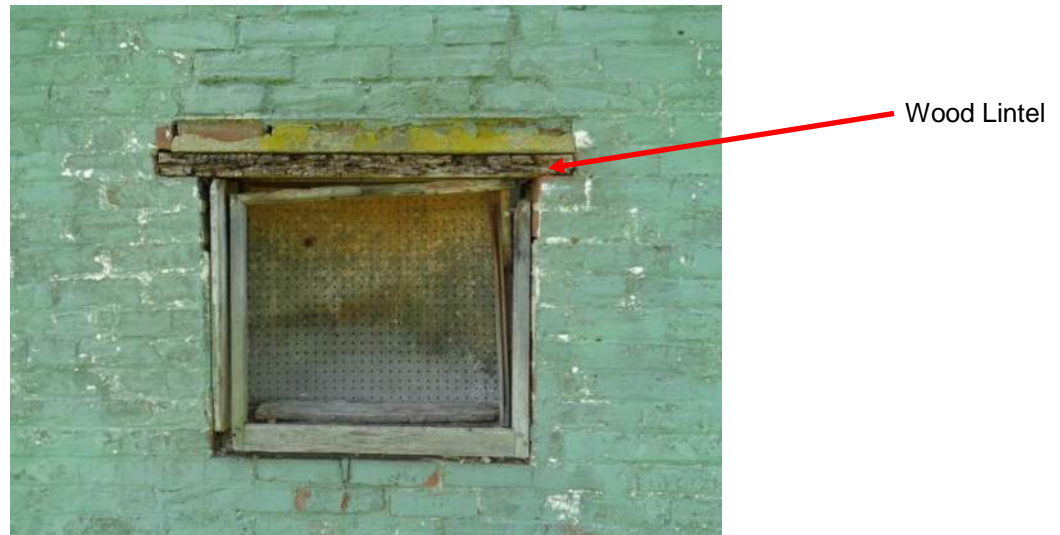
Figure MH. 30. East window opening. (SEA 2016)

The door lintel is composed of two non-original steel L2x2x¼ angle members over a 1 ½-inch by 8 ¼-inch wood lintel. There is a wood lintel over the east window that is rotted considerably (Figure MH. 30).

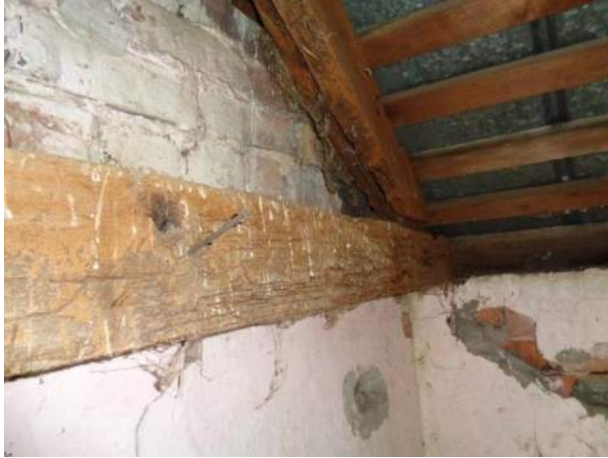
The light wood roof framing has six frames; one at each end with four evenly spaced. There is surface decay on the joists. The northernmost joist is especially affected (Figure MH. 31). The frames support skip sheathing and sheet metal roofing. The sheathing is 1-inch by 3-inch pieces spaced approximately 5½-inches on center. The purlins and roofing cantilever beyond the north wall (Figure MH. 32). The overhang is approximately 3-feet ½-inch from the face of brick.

Figure MH. 31. Northernmost roof frame with surface decay. (SEA 2016)
