THOMAS BLACKSTONE HOUSE

HISTORIC STRUCTURES REPORT

SEIP EARTHWORKS UNIT – HOPEWELL
CULTURE NATIONAL HISTORICAL PARK
BAINBRIDGE, OHIO

APRIL 17, 2017
NPS PMIS # 218963

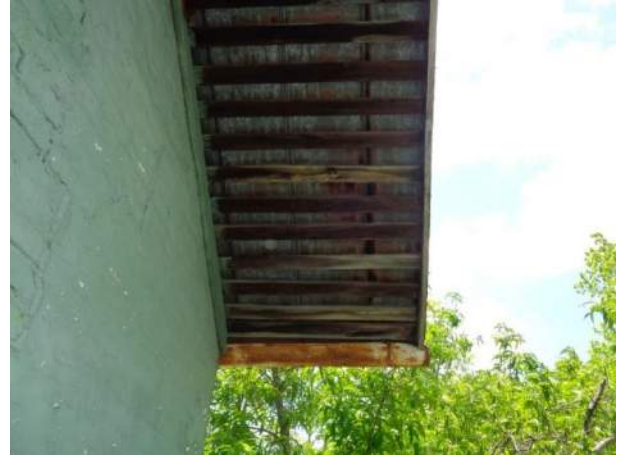
Figure MH. 32. Roof overhang. (SEA 2016)

The light wood roof framing has six frames; one at each end with four evenly spaced. There is surface decay on the joists. The northernmost joist is especially affected (Figure MH. 31). The frames support skip sheathing and sheet metal roofing. The sheathing is 1-inch by 3-inch pieces spaced approximately 5½-inches on center. The purlins and roofing cantilever beyond the north wall (Figure MH. 32). The overhang is approximately 3-feet ½-inch from the face of brick.

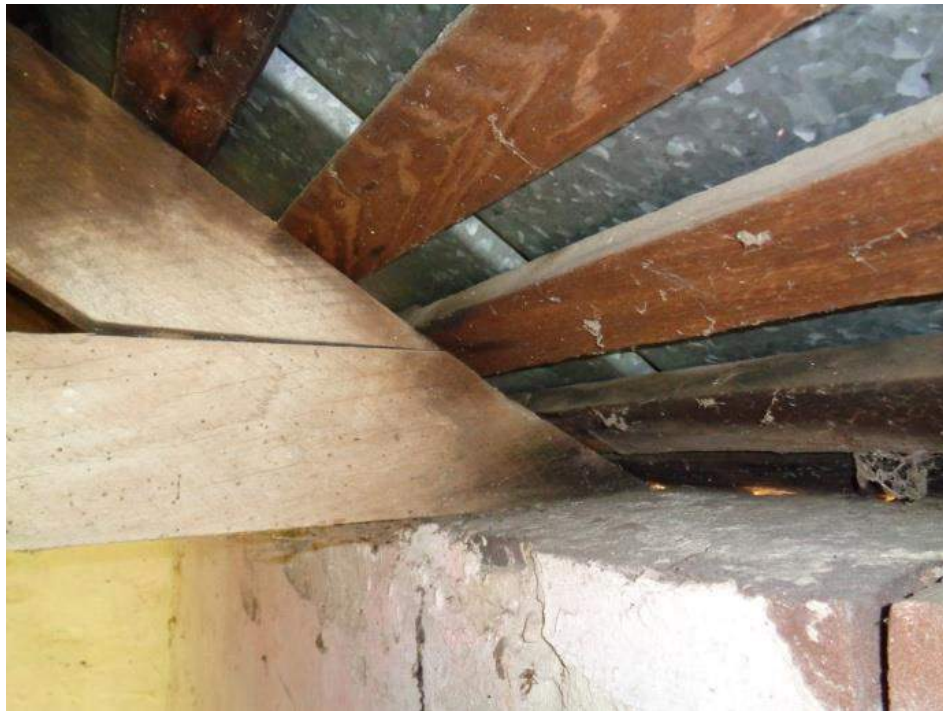
The connection detail at joist bearing differs in comparison to the smokehouse. There are no wood plates between the brick and joist or joist and rafter. There is also no notching in the joist members. The timber frames are not visibly tied down to the brick wall (Figure MH. 33).

Figure MH. 33. Detail at joist bearing with no wood plate. (SEA 2016)

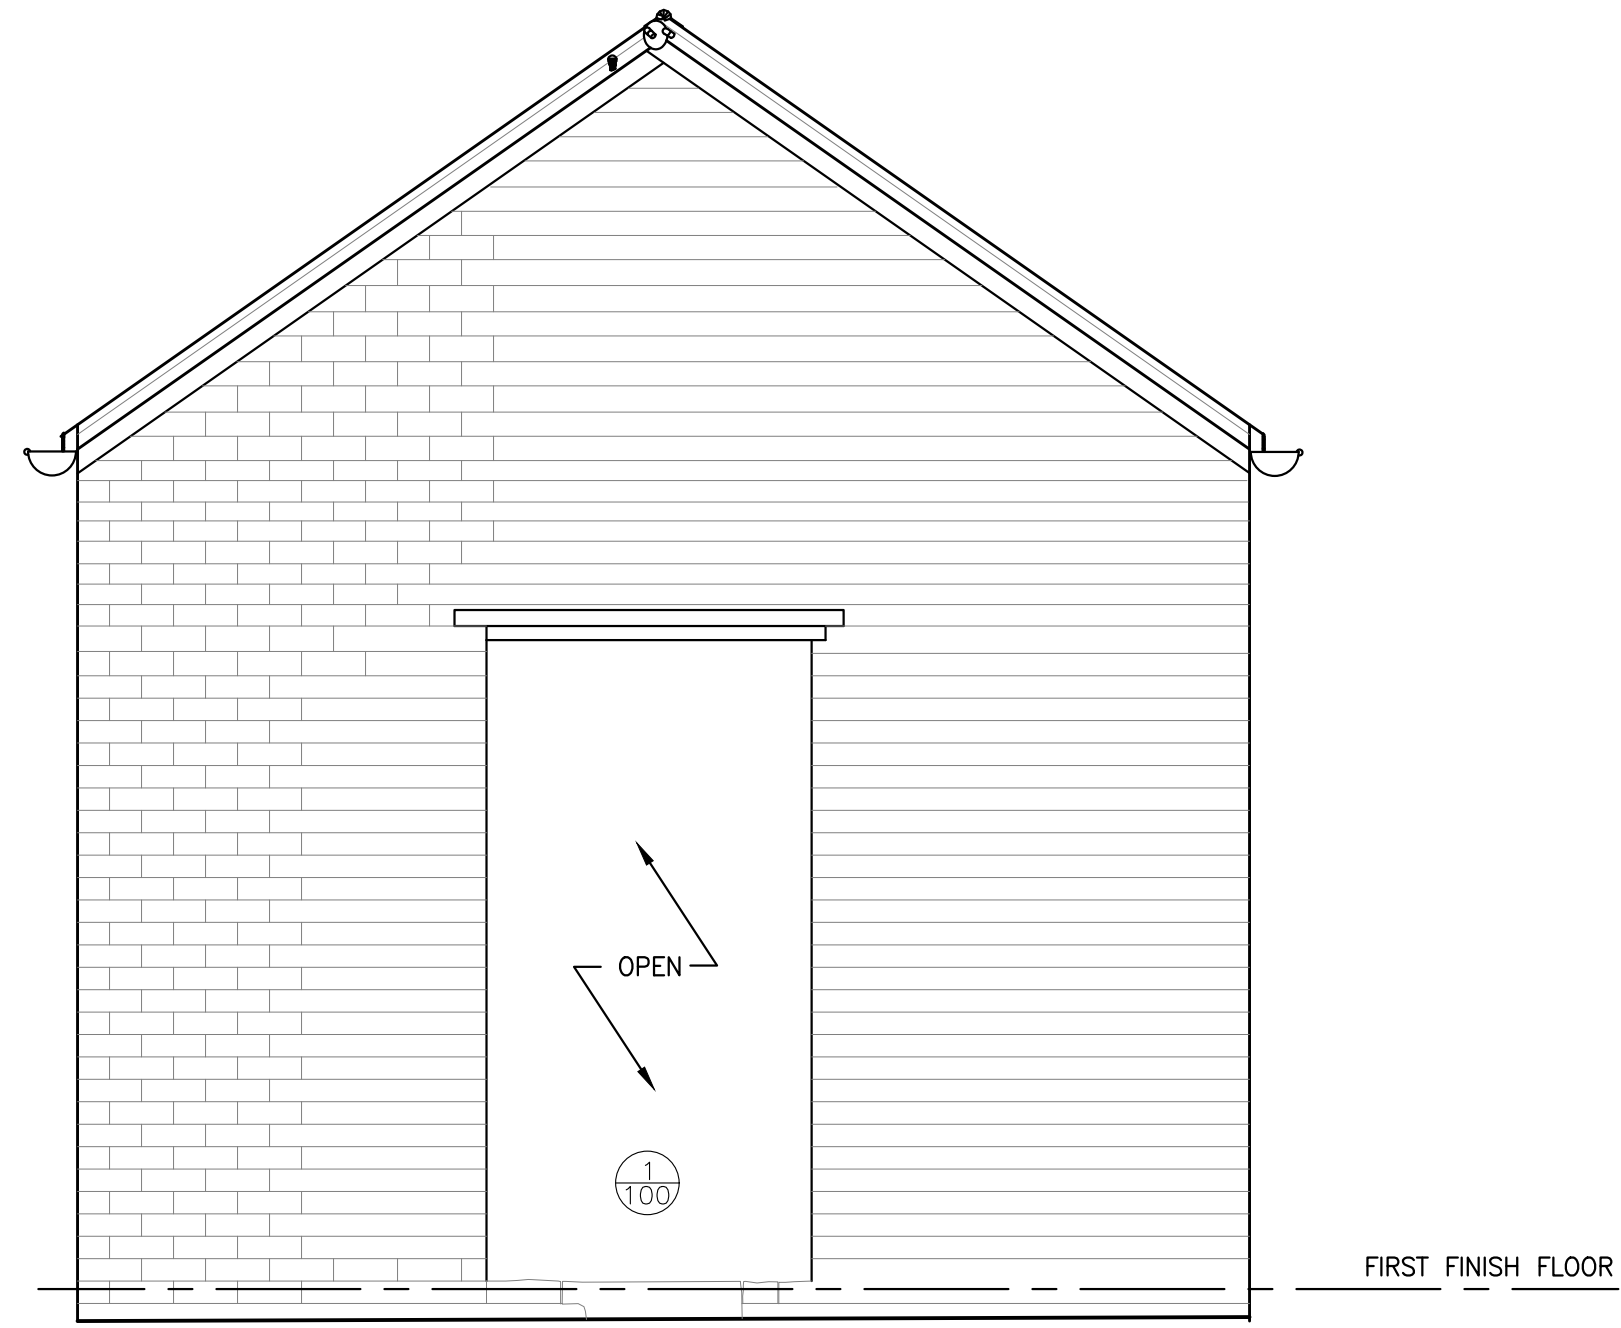
1 EXISTING NORTH ELEVATION
A11 1/2" = 1'-0"

THE FOUNDATION DEPTH
WAS NOT UNCOVERED
DURING THE ARCHEOLOGICAL
DIG IN AUGUST OF 2016.

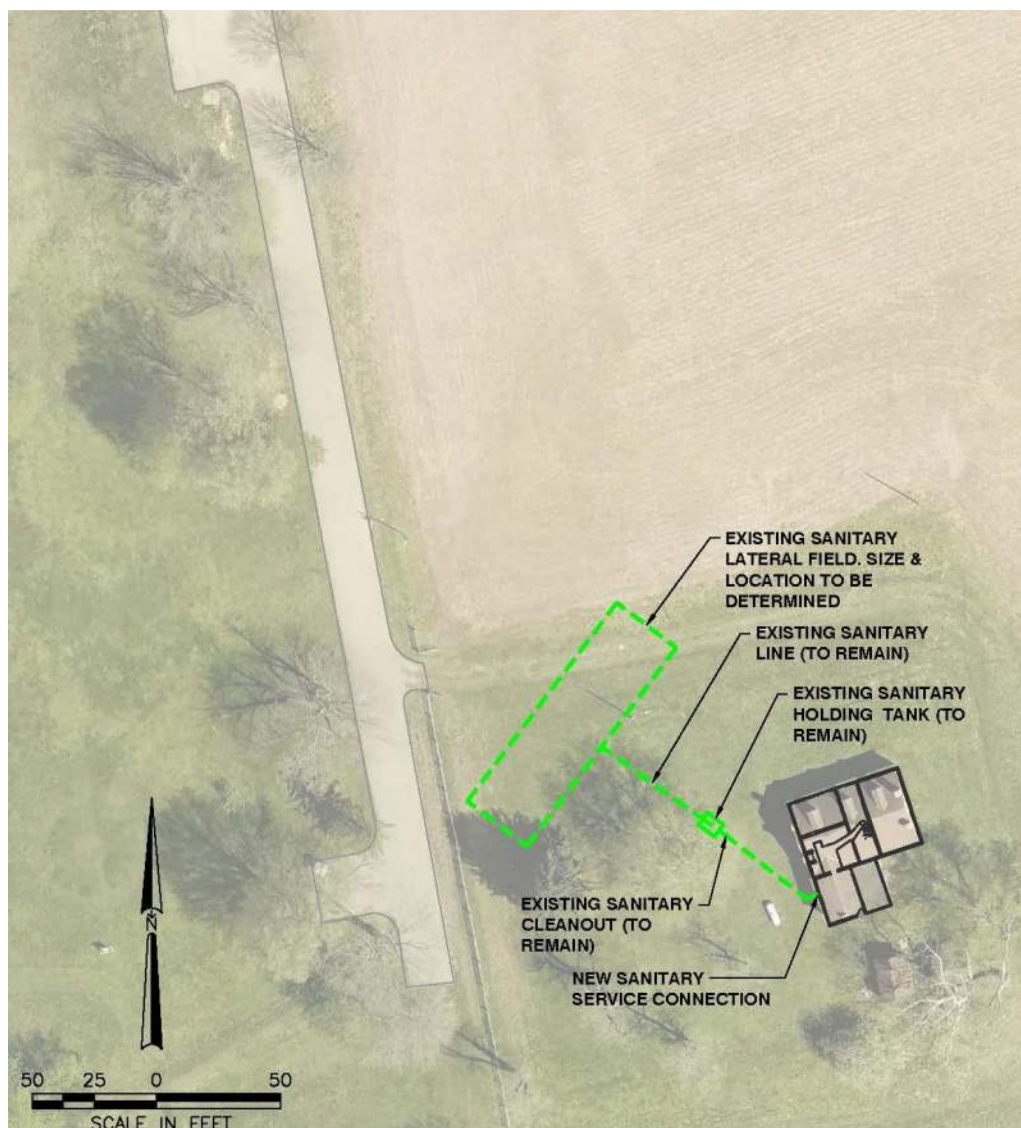
Figure T1. Sanitary Option 1. (SKDG 2016)

- a. Obtain an onsite soil evaluation from a professional soil scientist.
- b. Based on the soils report the designer or registered installer will prepare a design plan.
- c. Submit the design plan and soils report to RCHD for review.
- d. Layout the system in the field where it is reviewed by RCHD staff.
- e. Site review is approved and is valid for 5 years
- f. Applicant purchases the installation permit and operation permit. The system must be installed by a registered installer.

- RCHD permits residential sanitary systems only and all other sanitary systems are reviewed and permitted by the EPA. The Ohio EPA contact for the Southeast District is Dan Messerly; Ph. (740) 380-5218; email Daniel.Messerly@epa.ohio.gov
- The RCHD is willing to review and permit a sanitary sewer system for the Blackstone House even though it technically does not fall into a residential use.
- The reuse of the existing tank system and field is not a desired solution. There are many issues associated with the utilization of a tank and field within an archeologically sensitive area.

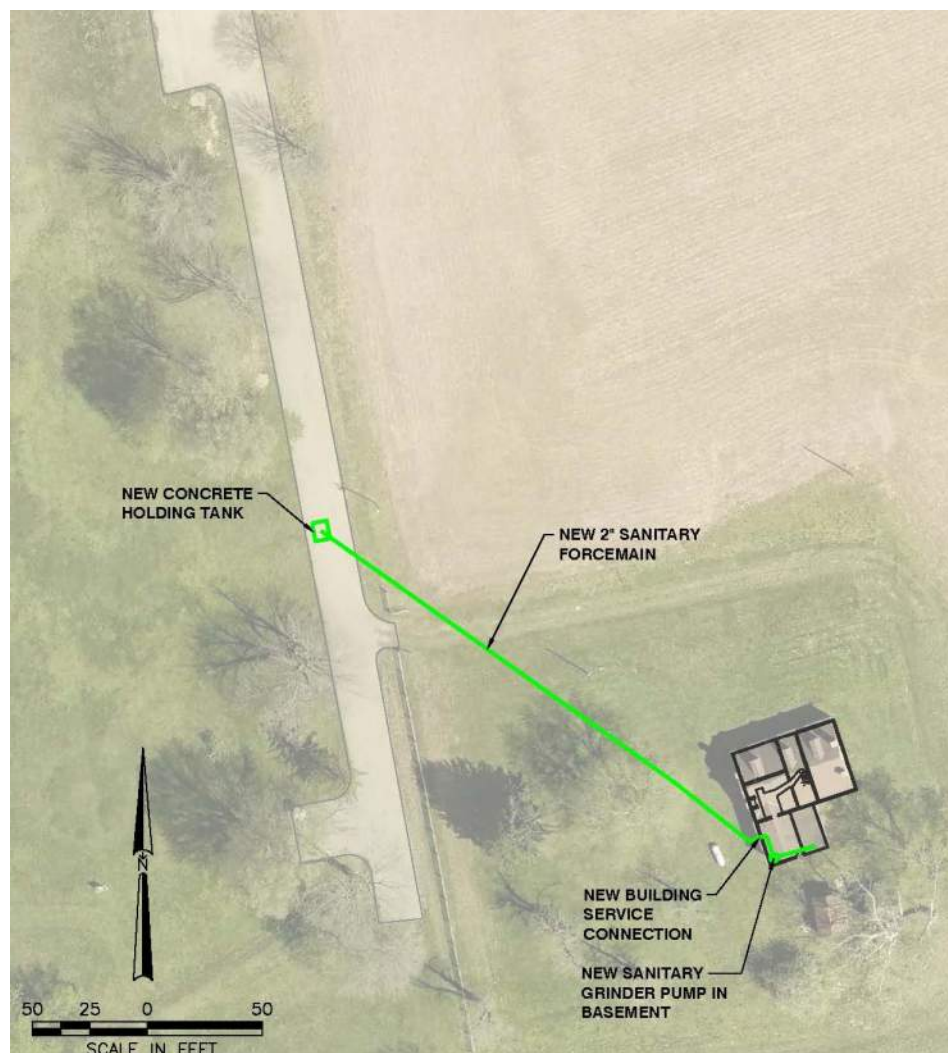
Figure T2. Sanitary Option 2. (SKDG 2016)

Option Two (Preferred Option) – Install a 1/2 horsepower grinder pump system with small holding tank in the basement of the House. The 1-1/2" discharge force main line leaving the house could follow the alignment of the existing sanitary service line, tank and field in order to be installed in previously disturbed areas. The force main might be pulled through some of the existing service line further minimizing site disturbance. A new concrete holding tank could be installed in the existing asphalt drive on the extension of the existing sanitary service line. The holding tank location provides easy access for pumping out the tank and would be located in an area previously disturbed by driveway construction (Figure T2). The holding tank needs to be concrete due to its location in a drive area. The tank can be equipped with a fill alarm for notification of required servicing. Along with this recommendation, would be the complete removal of the existing tank and piping.

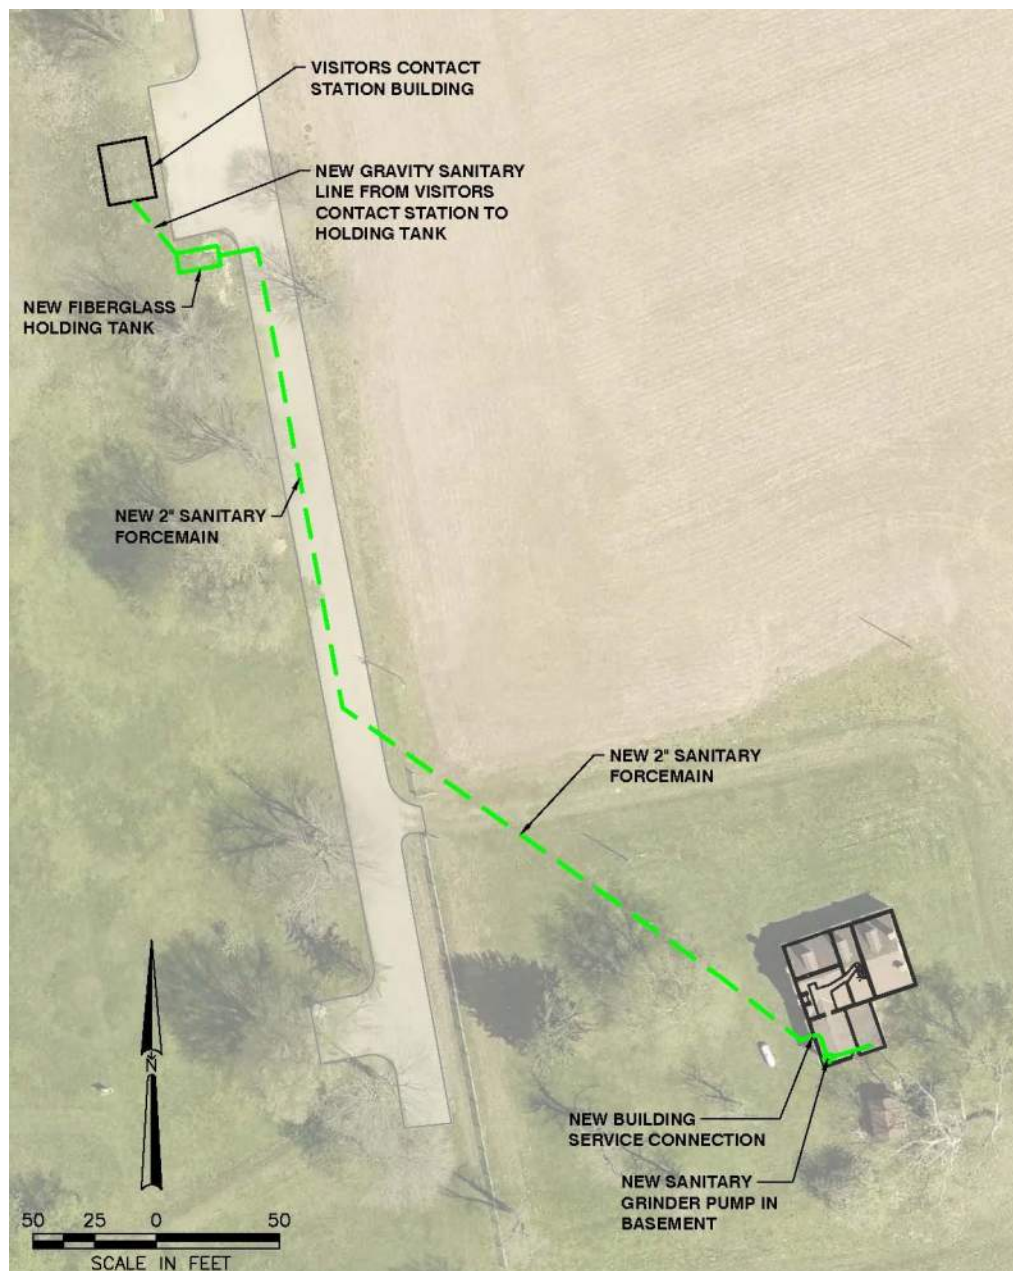
Figure T3. Sanitary Option 3. (SKDG 2016)

Option Three – If a Visitors Contact Station is desired the grinder pump system described in option two would be used to pump to a holding tank next to the Contact Station (Figure T3). The tank would need to be sized to accommodate the flows from the House and Contact Station. The Contact Station would be slab on grade construction and the service line to the tank would be a gravity service line. The holding tank could be fiberglass due to its location outside of a pavement area.

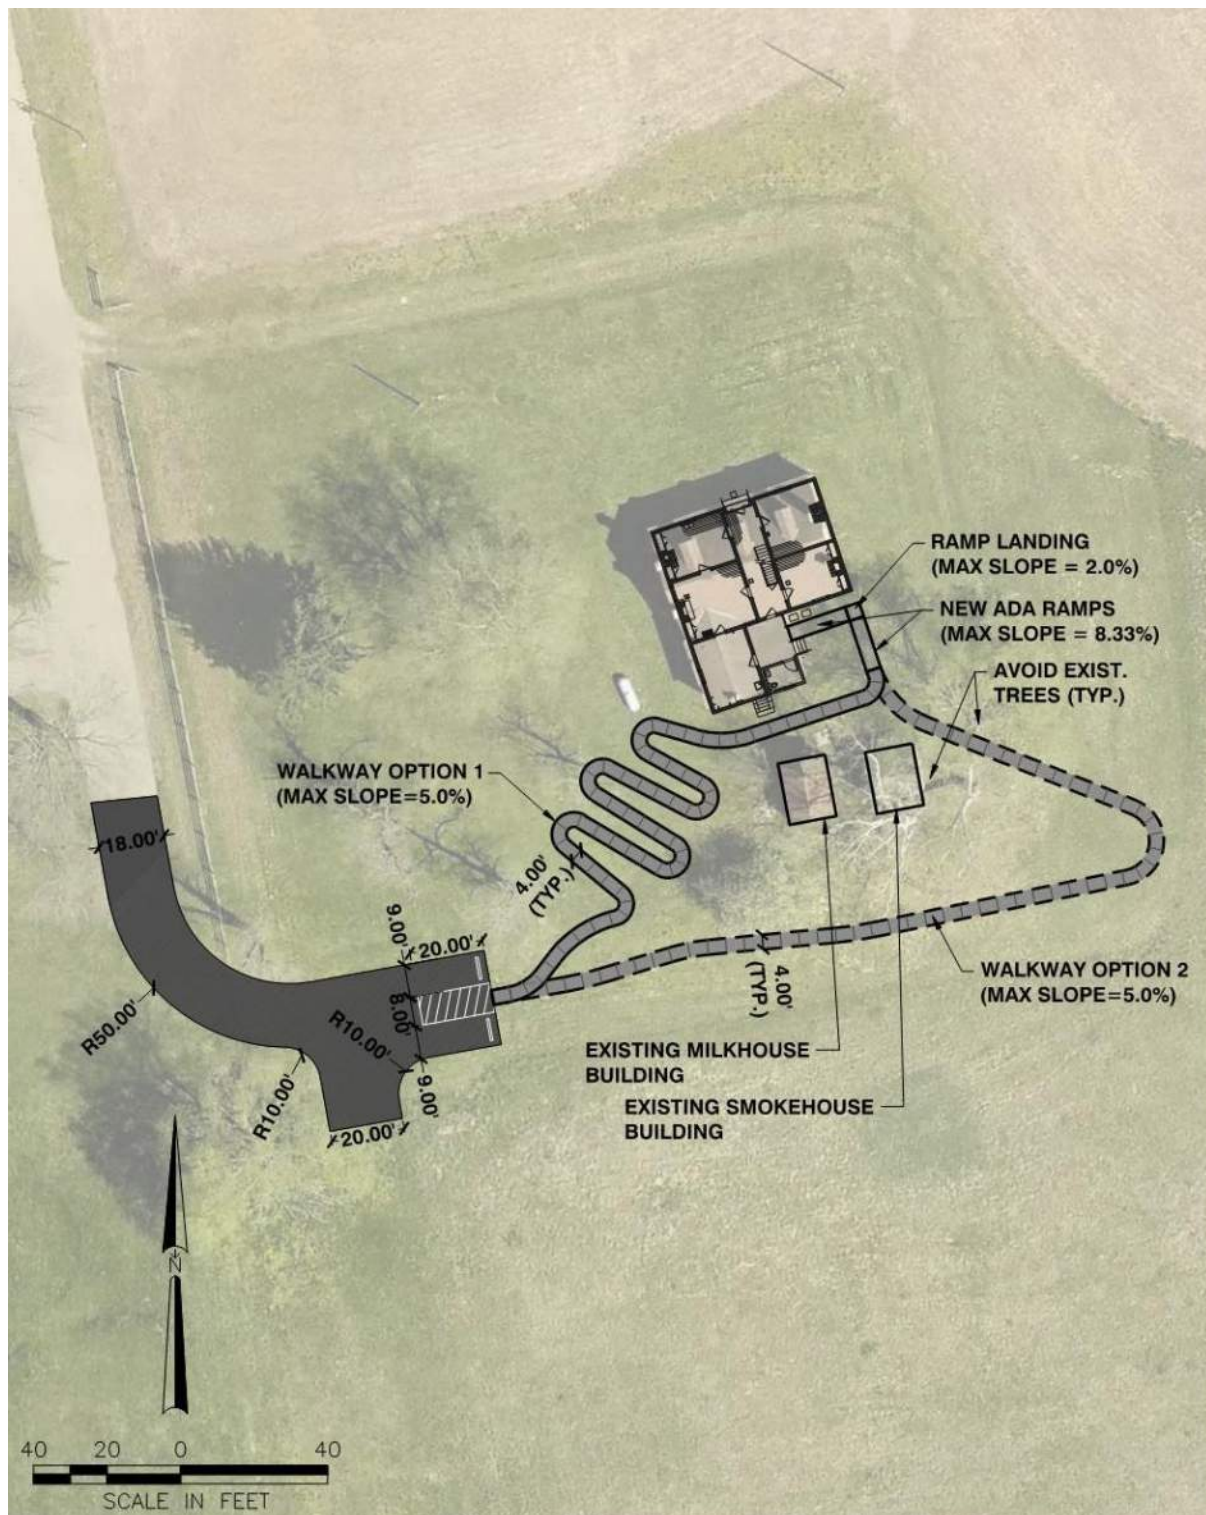
Figure T4. Site Handicapped Access – Options 1 and 2. (SKDG 2017)

- Options 1 and 2 (Figure T4) – Hiding the parking on the 'back' side of the of the earthwork wall, so it is not visible from the road.
 - Pros: Not visible from the road
 - Cons: Highly visible from the center of the earthworks and from the mound; Back side parking is set lower than the house, requiring extensive walkways; significant impact to the site.
- Option 3 (Figure T5) – Road follows exiting mown path. Parking at top of earthwork wall, east of the house and outbuildings.
 - Pros: Accommodates easy and nearby access to the house
 - Cons: Highly visible from the road; requires installation of a road in front of the house.

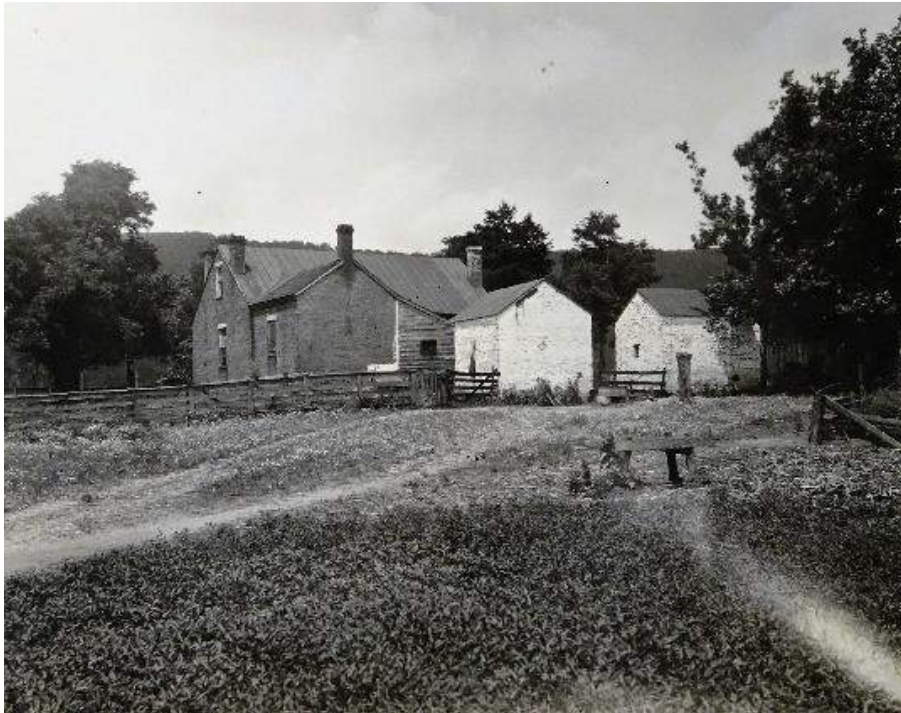
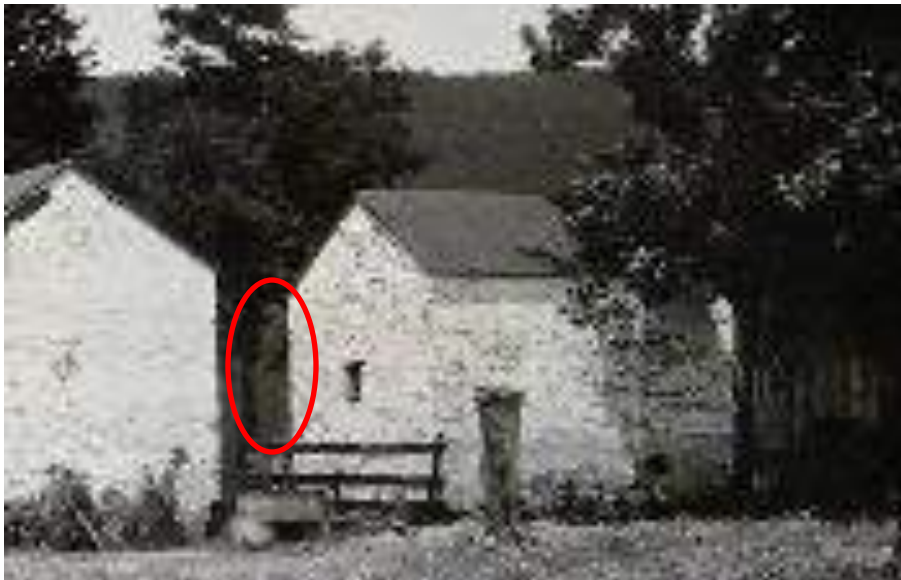
Figure T6. Blackstone House and Outbuildings. Note there appears to be a potential gable in the distance, beyond the smokehouse, east and south of the main house. This also shows in other photographs taken from the back of the house. This may be worthy of archeological investigation, as the outhouse location has not been determined. Photo by I. T. Frary. The back of the image has a handwritten label which reads "Old Seip Home, rear, August 1, 1927" and a stamp that reads "Photograph by I. T. Frary, Cleveland, Ohio." (Photo Collection Number A0957, Folder 6, Ohio History Connection Archeological Collections Facility, Columbus, Ohio.)

- 9) Archeological investigation of the extent and features associated with the non-extant wood frame addition to the east of the brick smokehouse.
- 10) Archeological investigation of potential addition structure east and north of the smokehouse. What appears to be a gable board of a structure can be seen in the historic photograph below. This may be an outhouse.

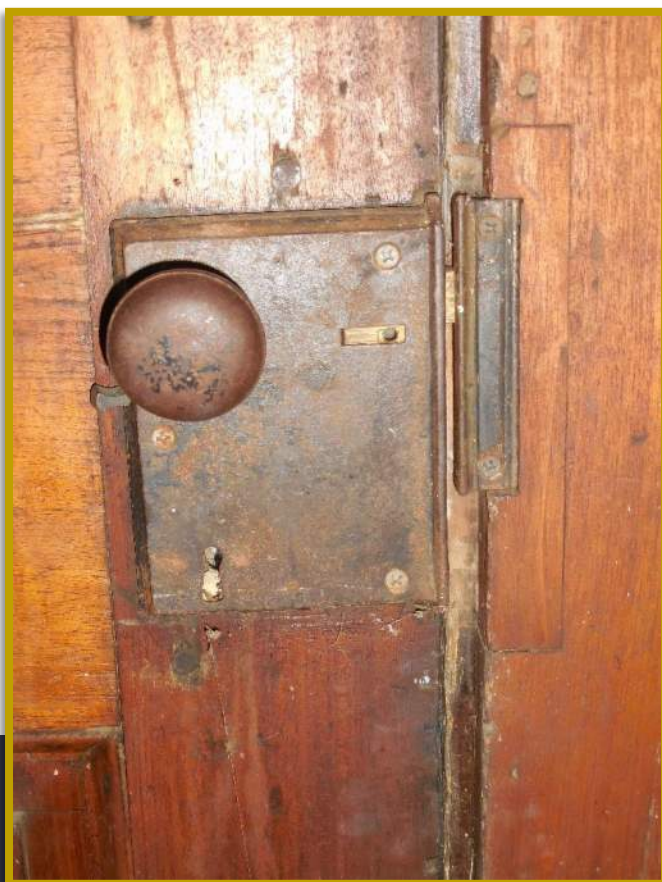
Front Door 1/100 existing rim lock with non-matching keeper. (STRATA 2016)

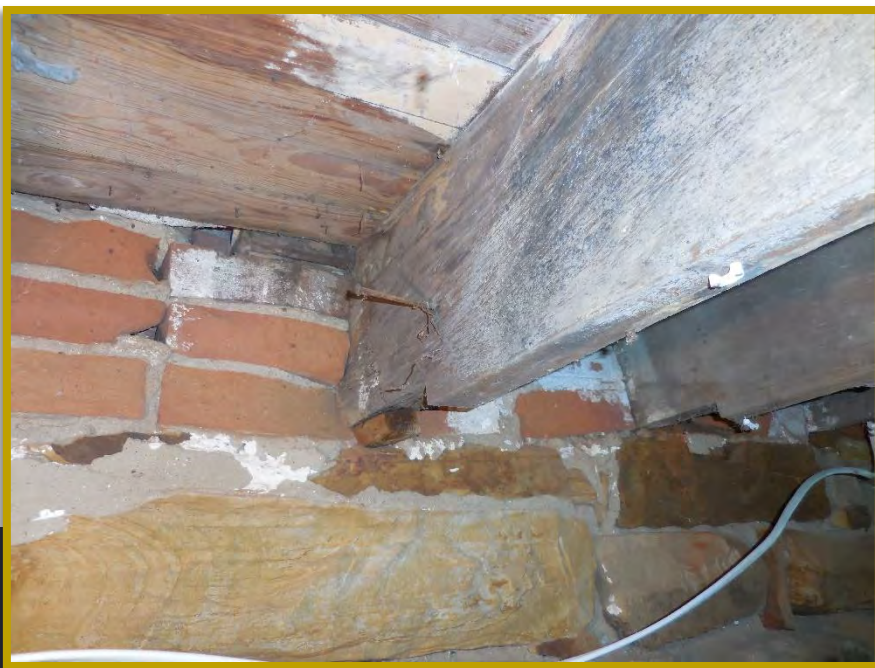
Typical notched and shimmed floor joists. (SEA 2016)

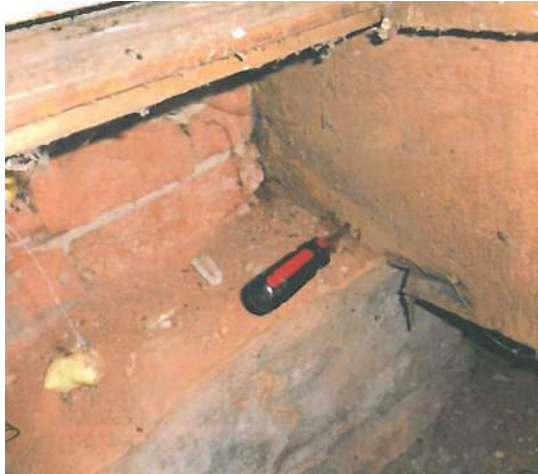
Detail of rotted joist and interior wythe of brick,
below Room 103

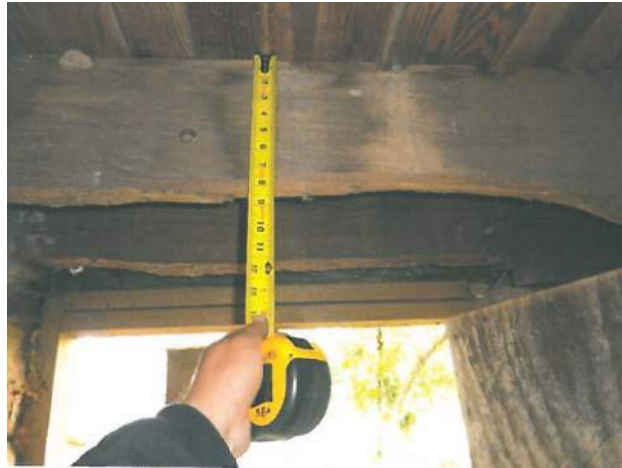
Joists at basement door.

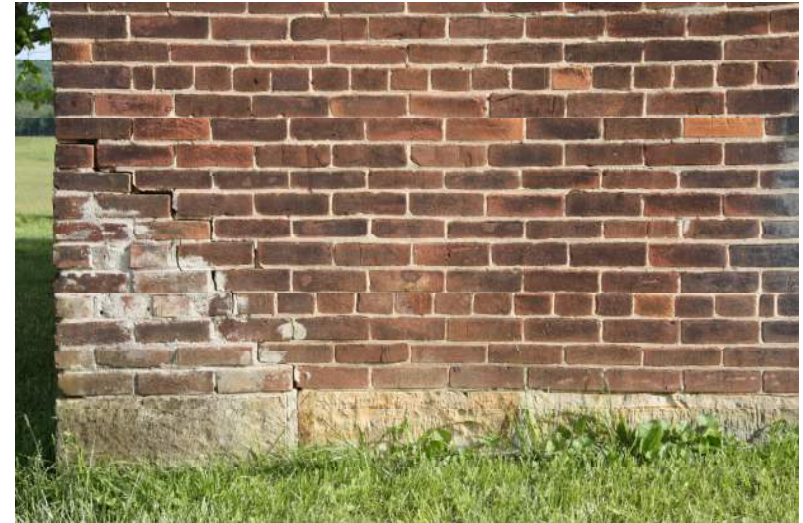
Crack at northeast corner of North Elevation.
