# **MOUNT RAINIER NATIONAL PARK**

## **SITE ASSESSMENT AND DESIGN OF ROCK BARBS, CHECK DAMS AND OTHER FLOOD DAMAGE REDUCTION MEASURES**

## **THE CARBON RIVER ROAD**

**30% DESIGN- CARBON RIVER ROAD  
FLOOD DAMAGE REDUCTION MEASURES**

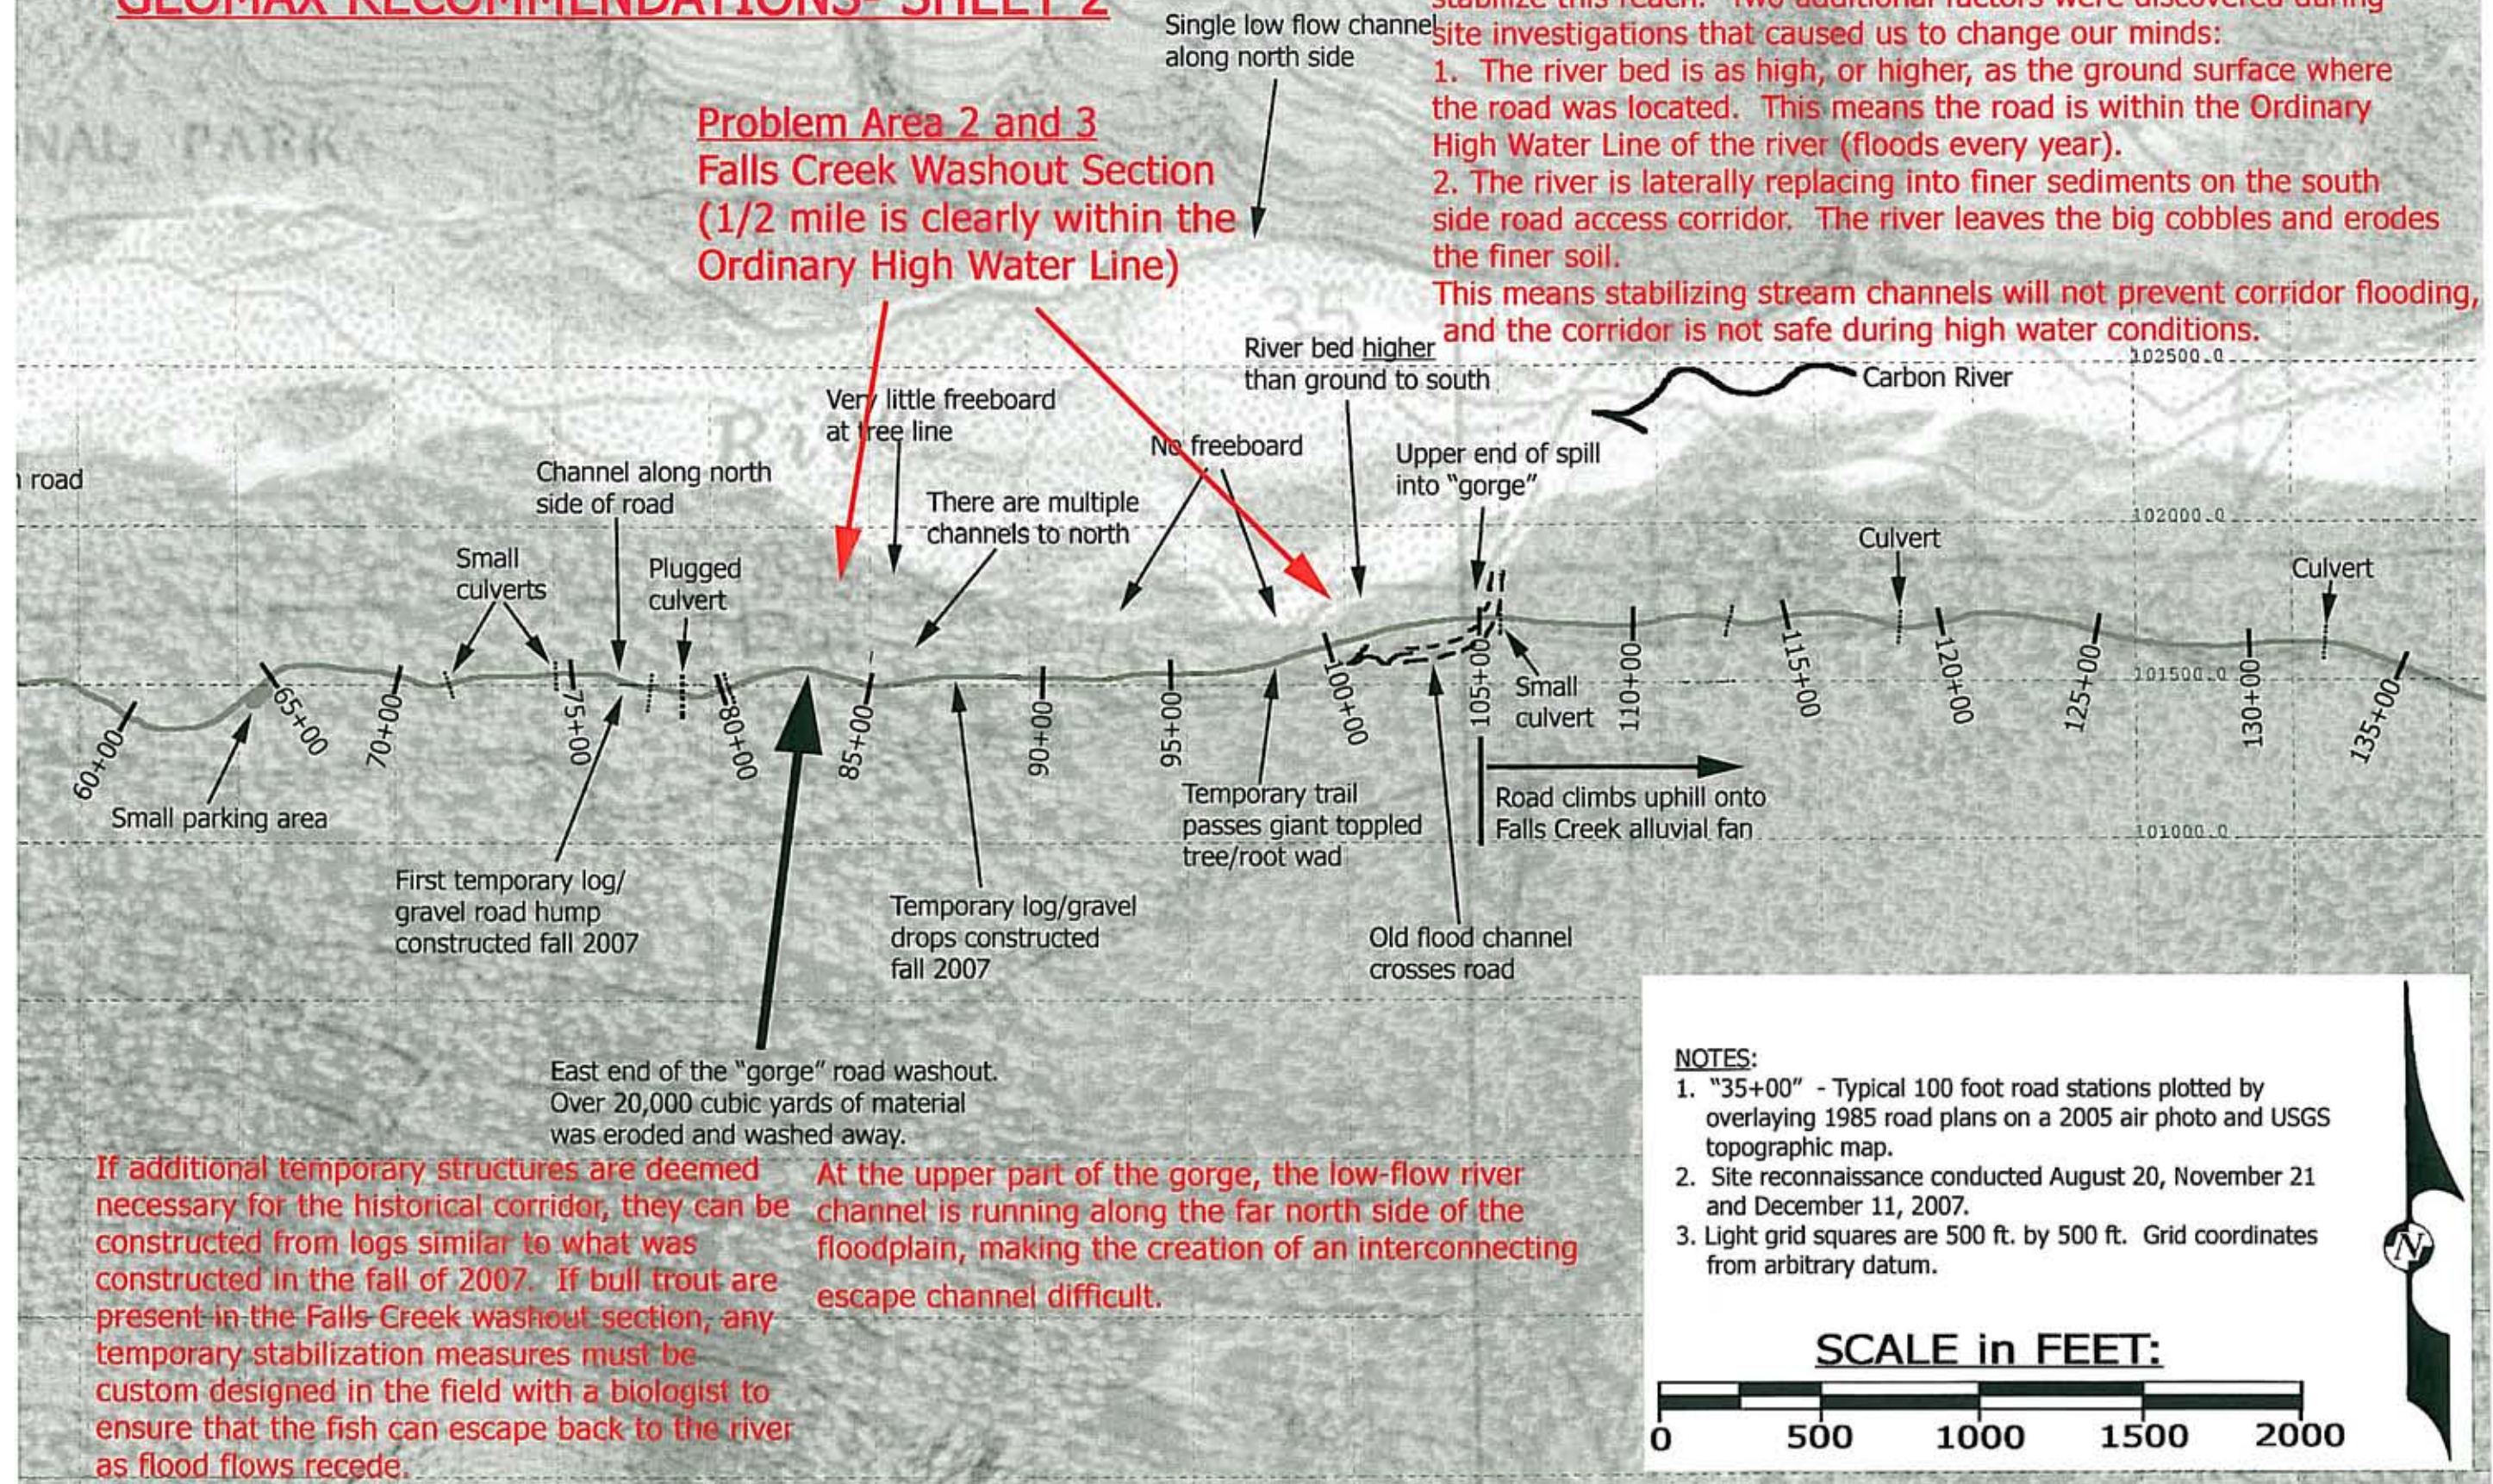
# GEOMAX RECOMMENDATIONS- SHEET 2

Geomax had originally thought it would be possible to permanently stabilize this reach. Two additional factors were discovered during site investigations that caused us to change our minds:

1. The river bed is as high, or higher, as the ground surface where the road was located. This means the road is within the Ordinary High Water Line of the river (floods every year).
2. The river is laterally replacing into finer sediments on the south side road access corridor. The river leaves the big cobbles and erodes the finer soil.

This means stabilizing stream channels will not prevent corridor flooding, and the corridor is not safe during high water conditions.

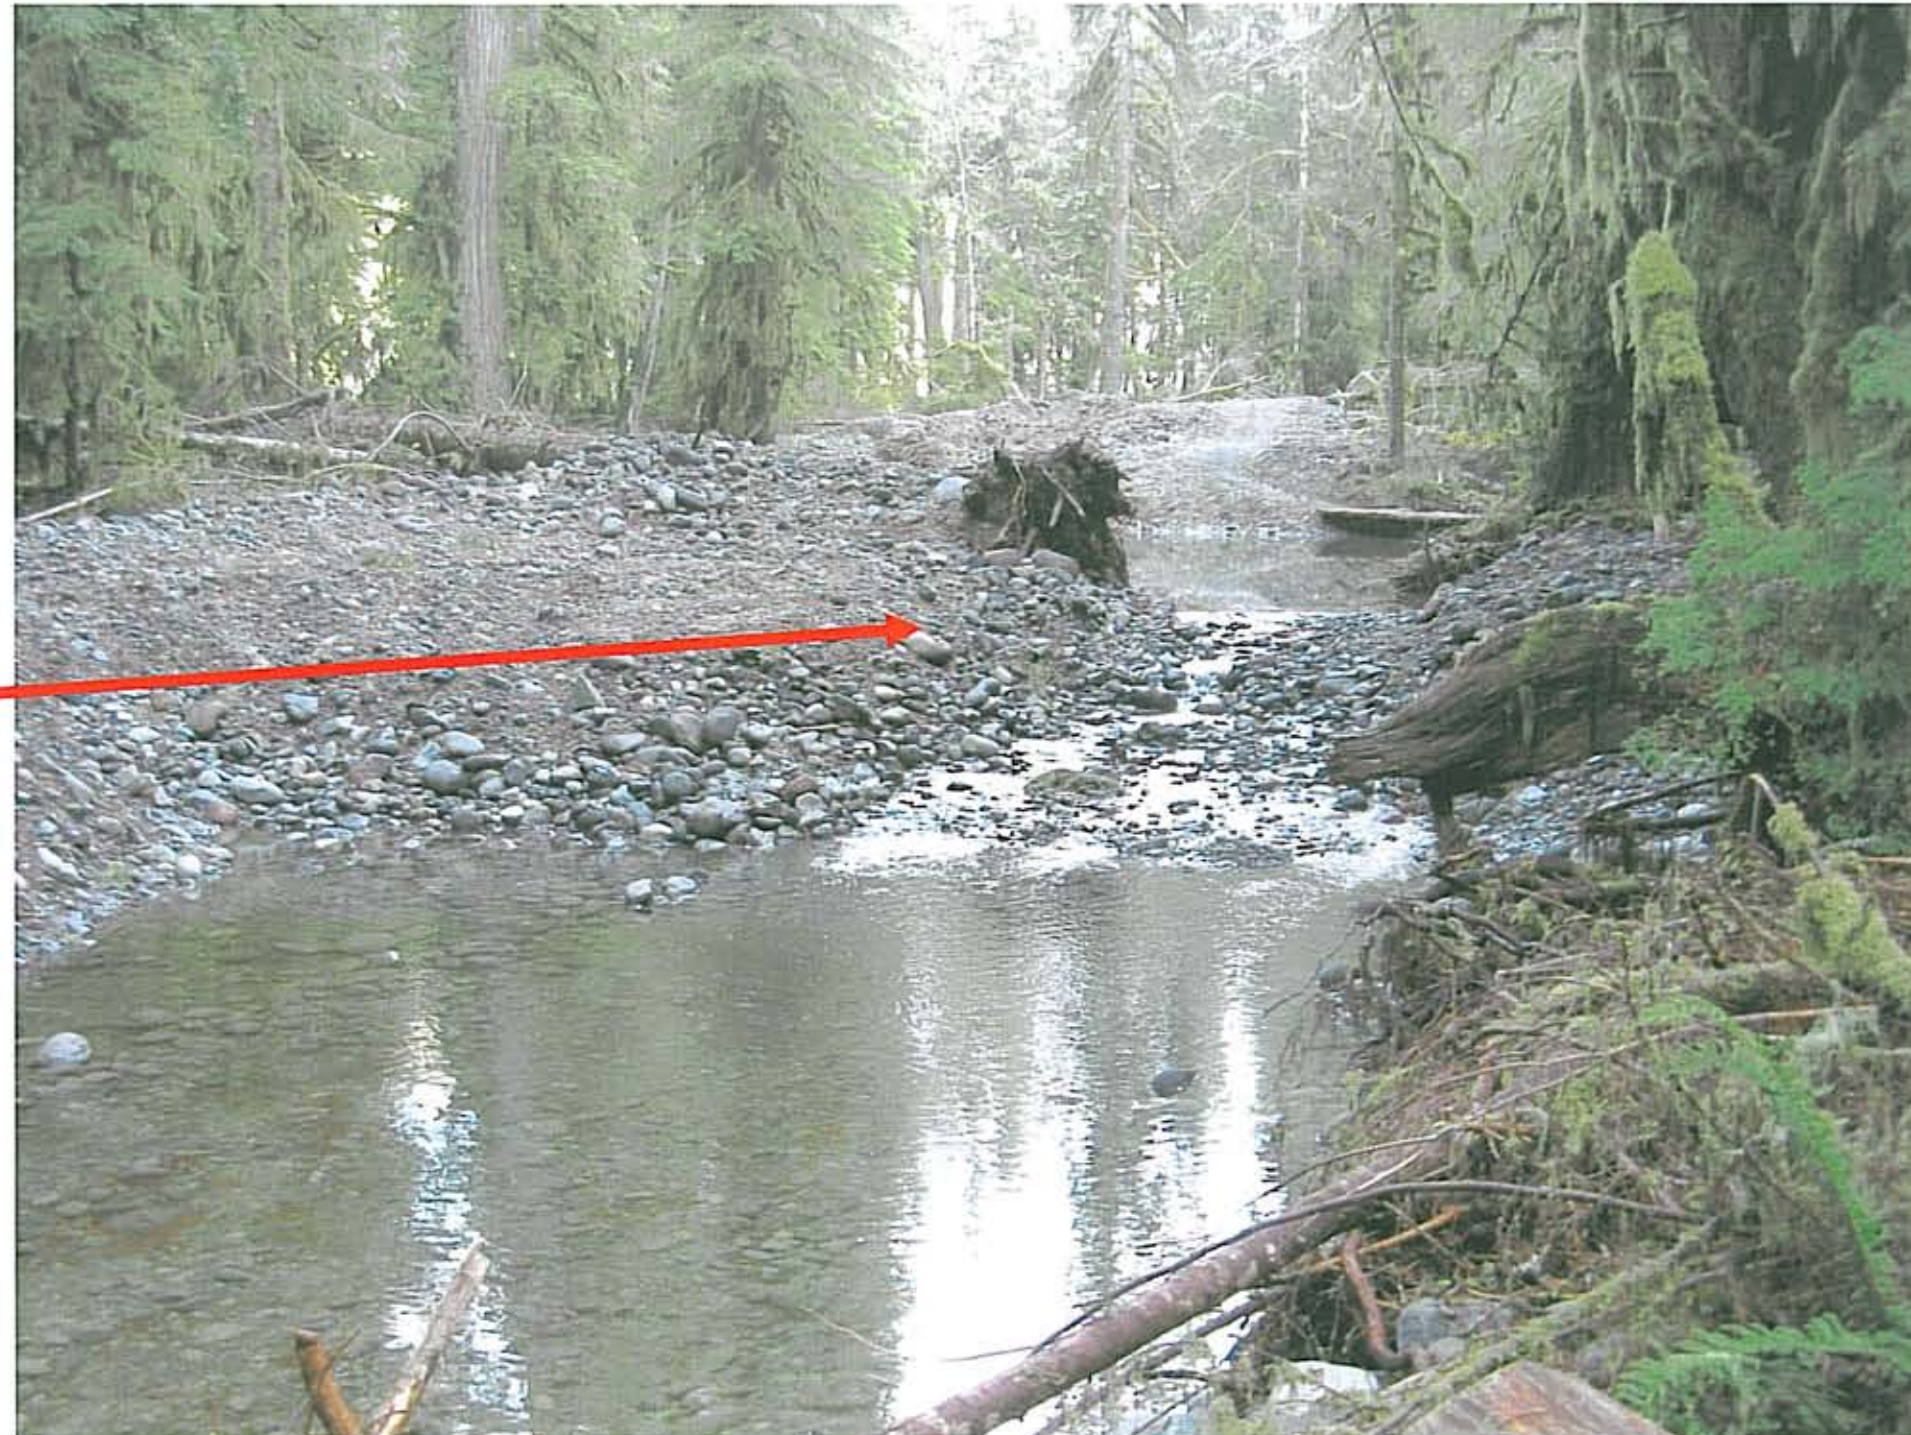
## Station 88+00- Two Temporary Log Check Structures Fall 2007

Previous Road Location

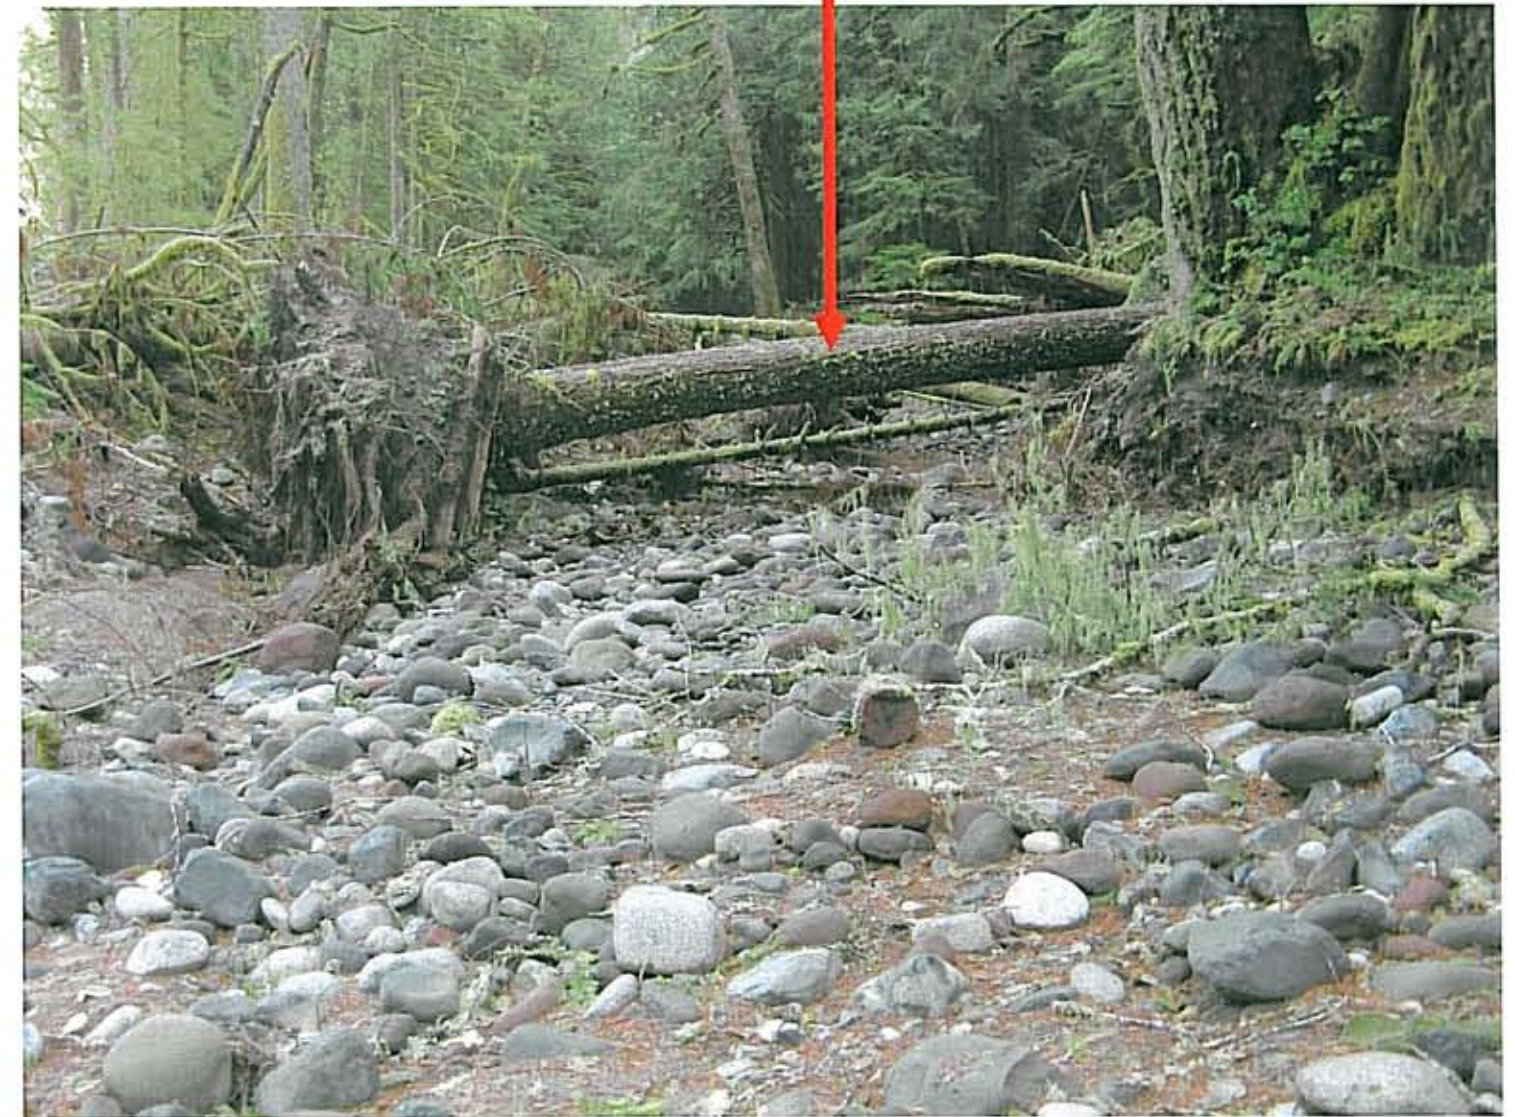
## Station 102+00

### Previous Road Location

If additional temporary structures are deemed necessary, use existing downed trees to construct checks similar to those constructed in the fall of 2007. Any temporary structures must be custom designed in the field, with the assistance of a fish biologist, to ensure that bull trout can escape back to the river.

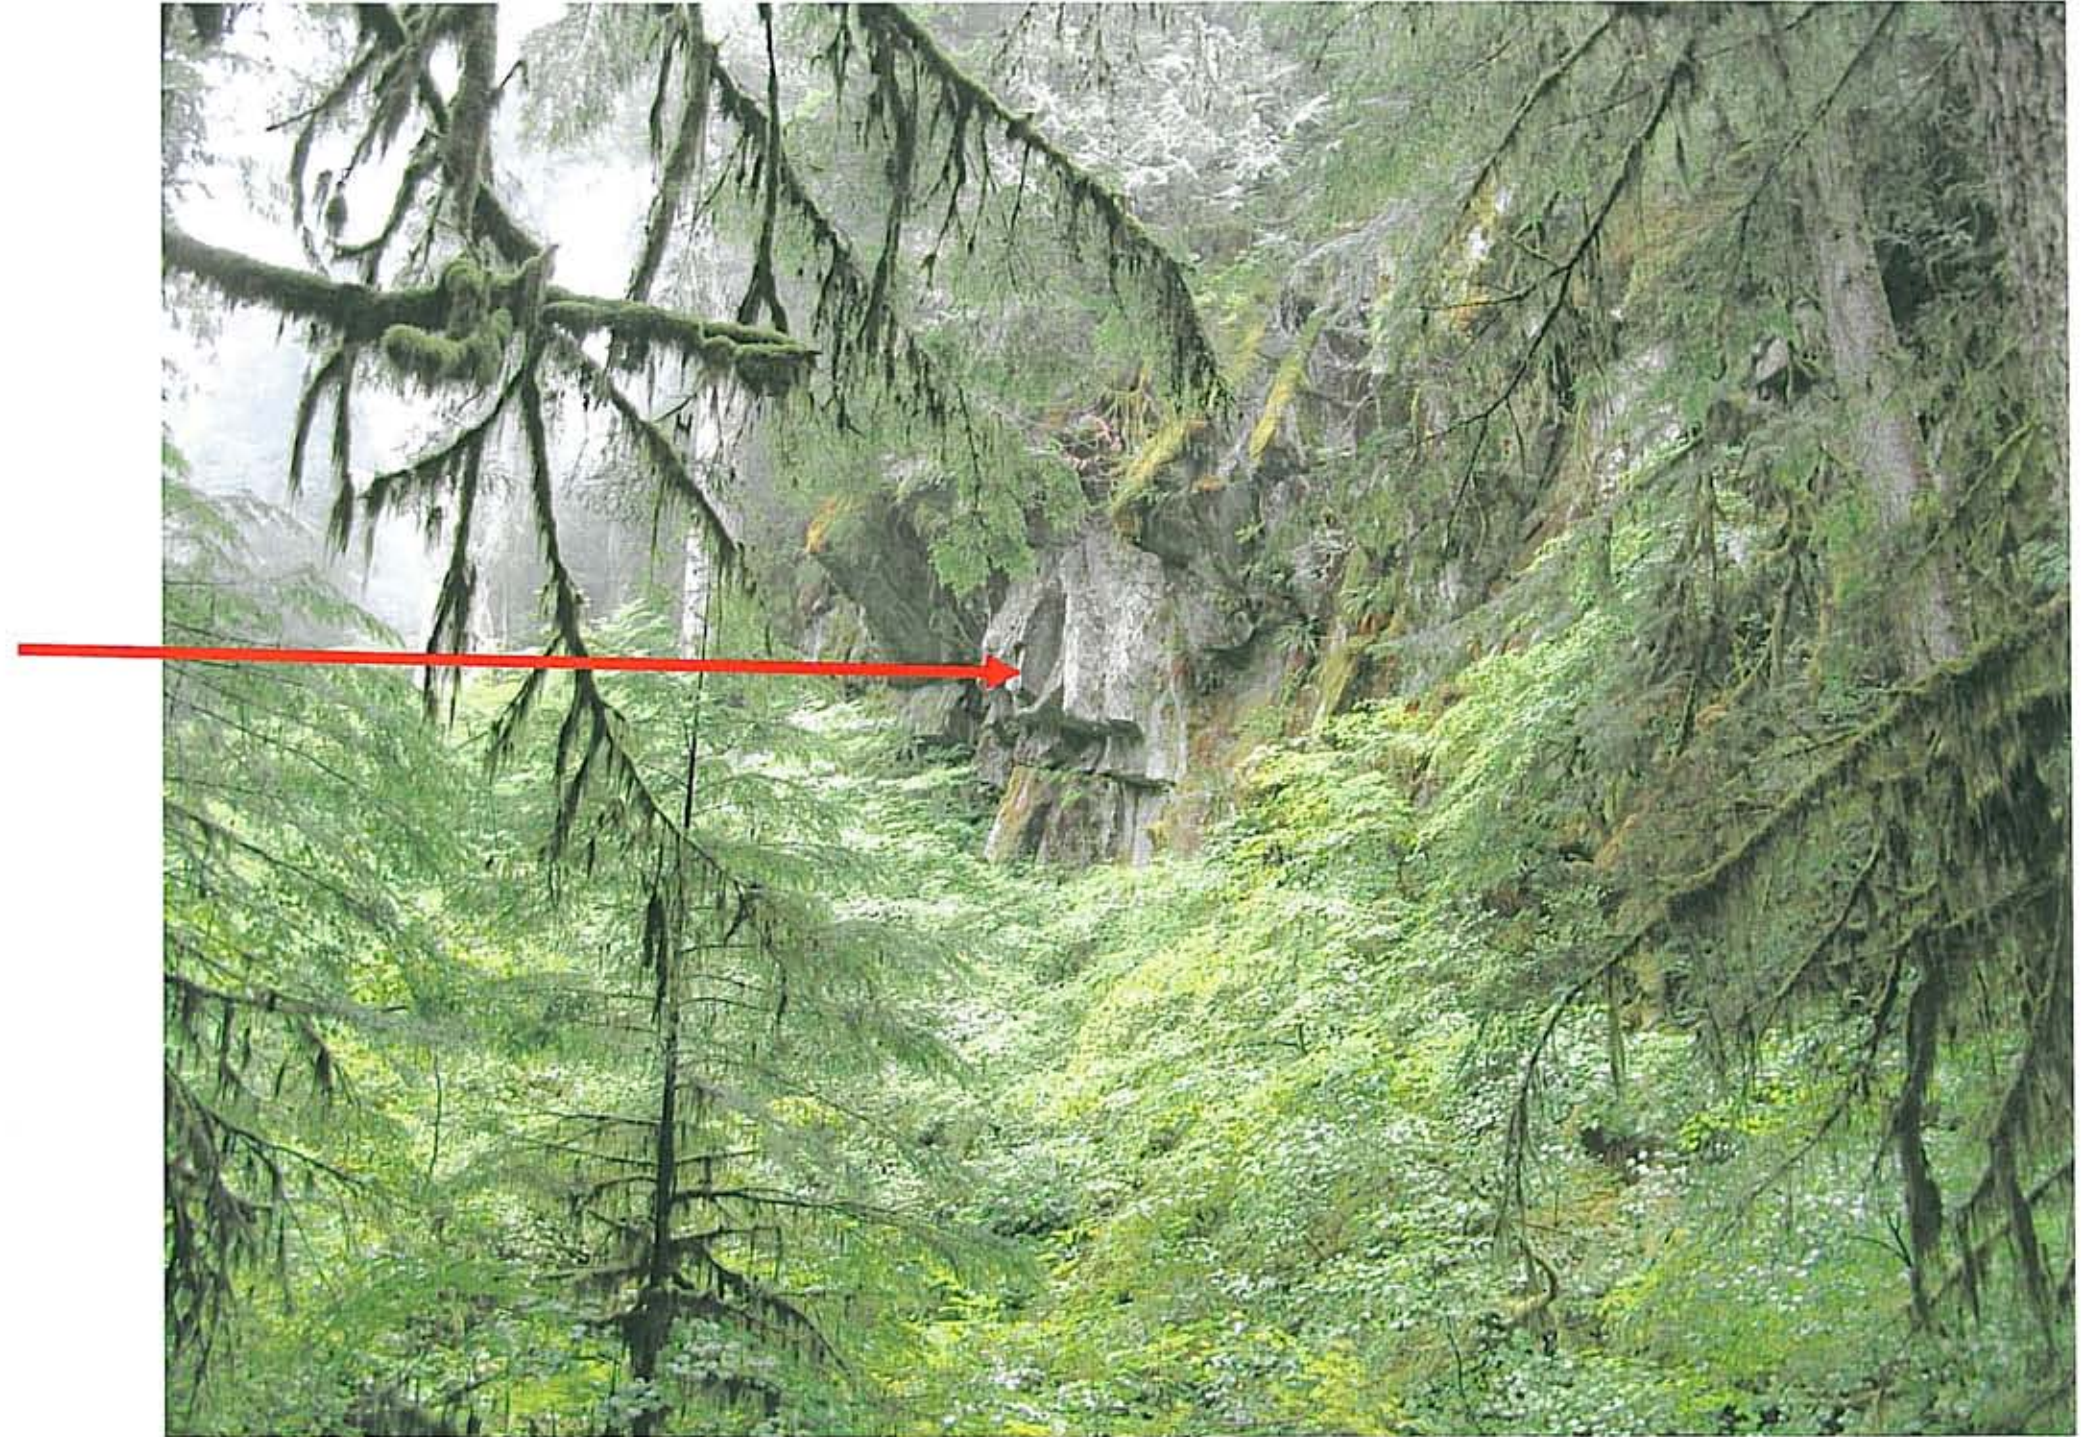
## Station 152+00

Outcrop of Granodiorite rock  
that would make a good quarry  
source for structural rock

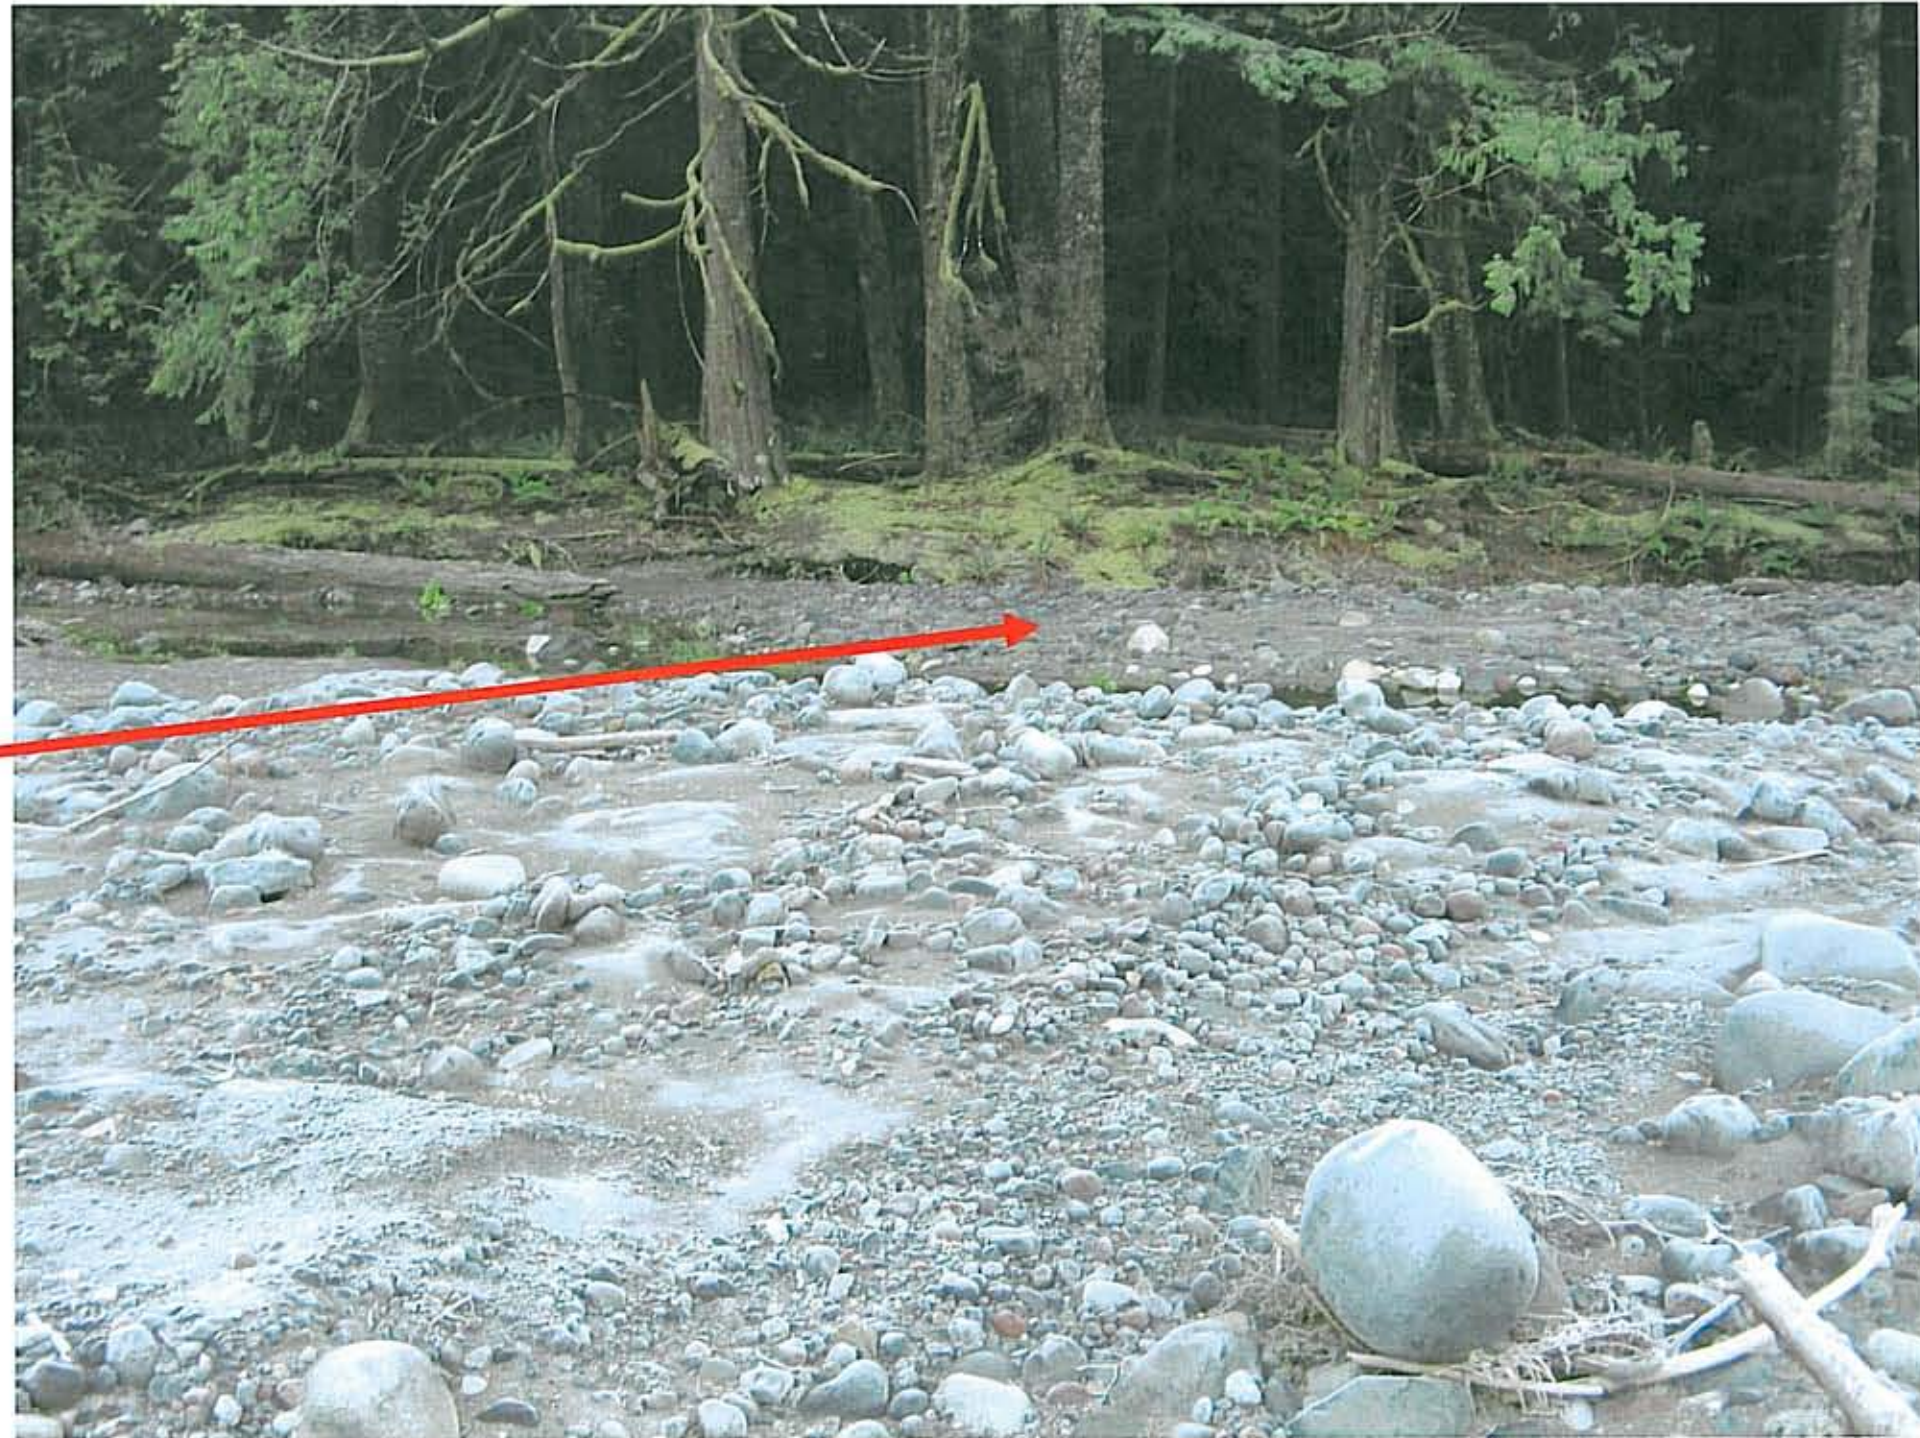
## Station 173+00, from River Bed Looking South at Bank Line

Note that river bed is near the top of the bank on the south side.

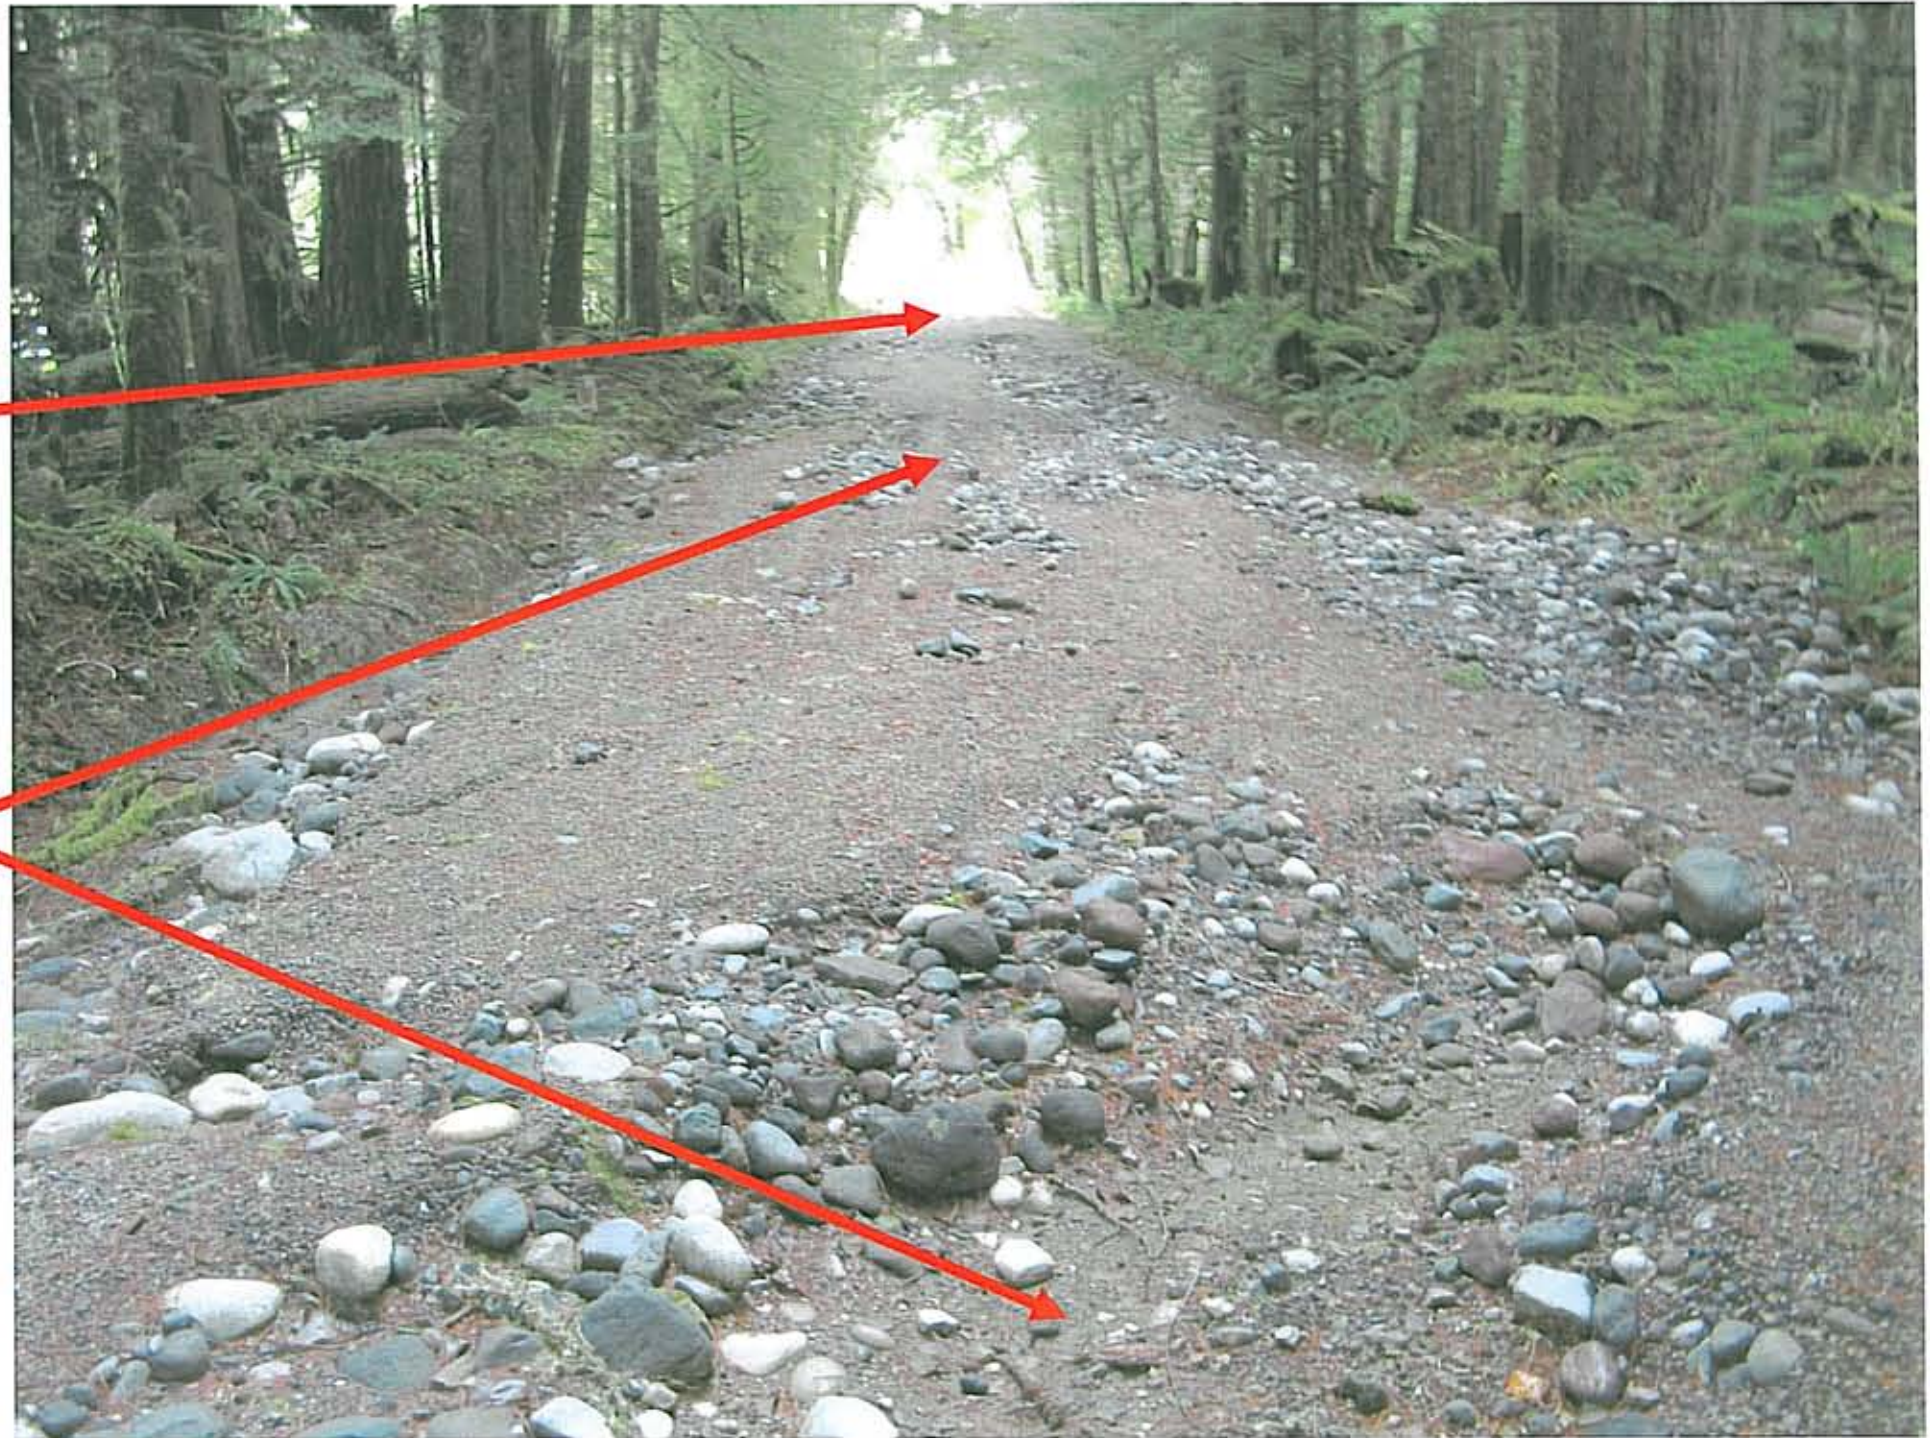
## Station 181+50, Looking East

Water spills out here and flows down the road corridor, towards the bottom of the photo. This section of road is within the Ordinary High Water Line of the river.

Construct two road hump/x-valley dikes to prevent flood overflow from concentrating in the road corridor.

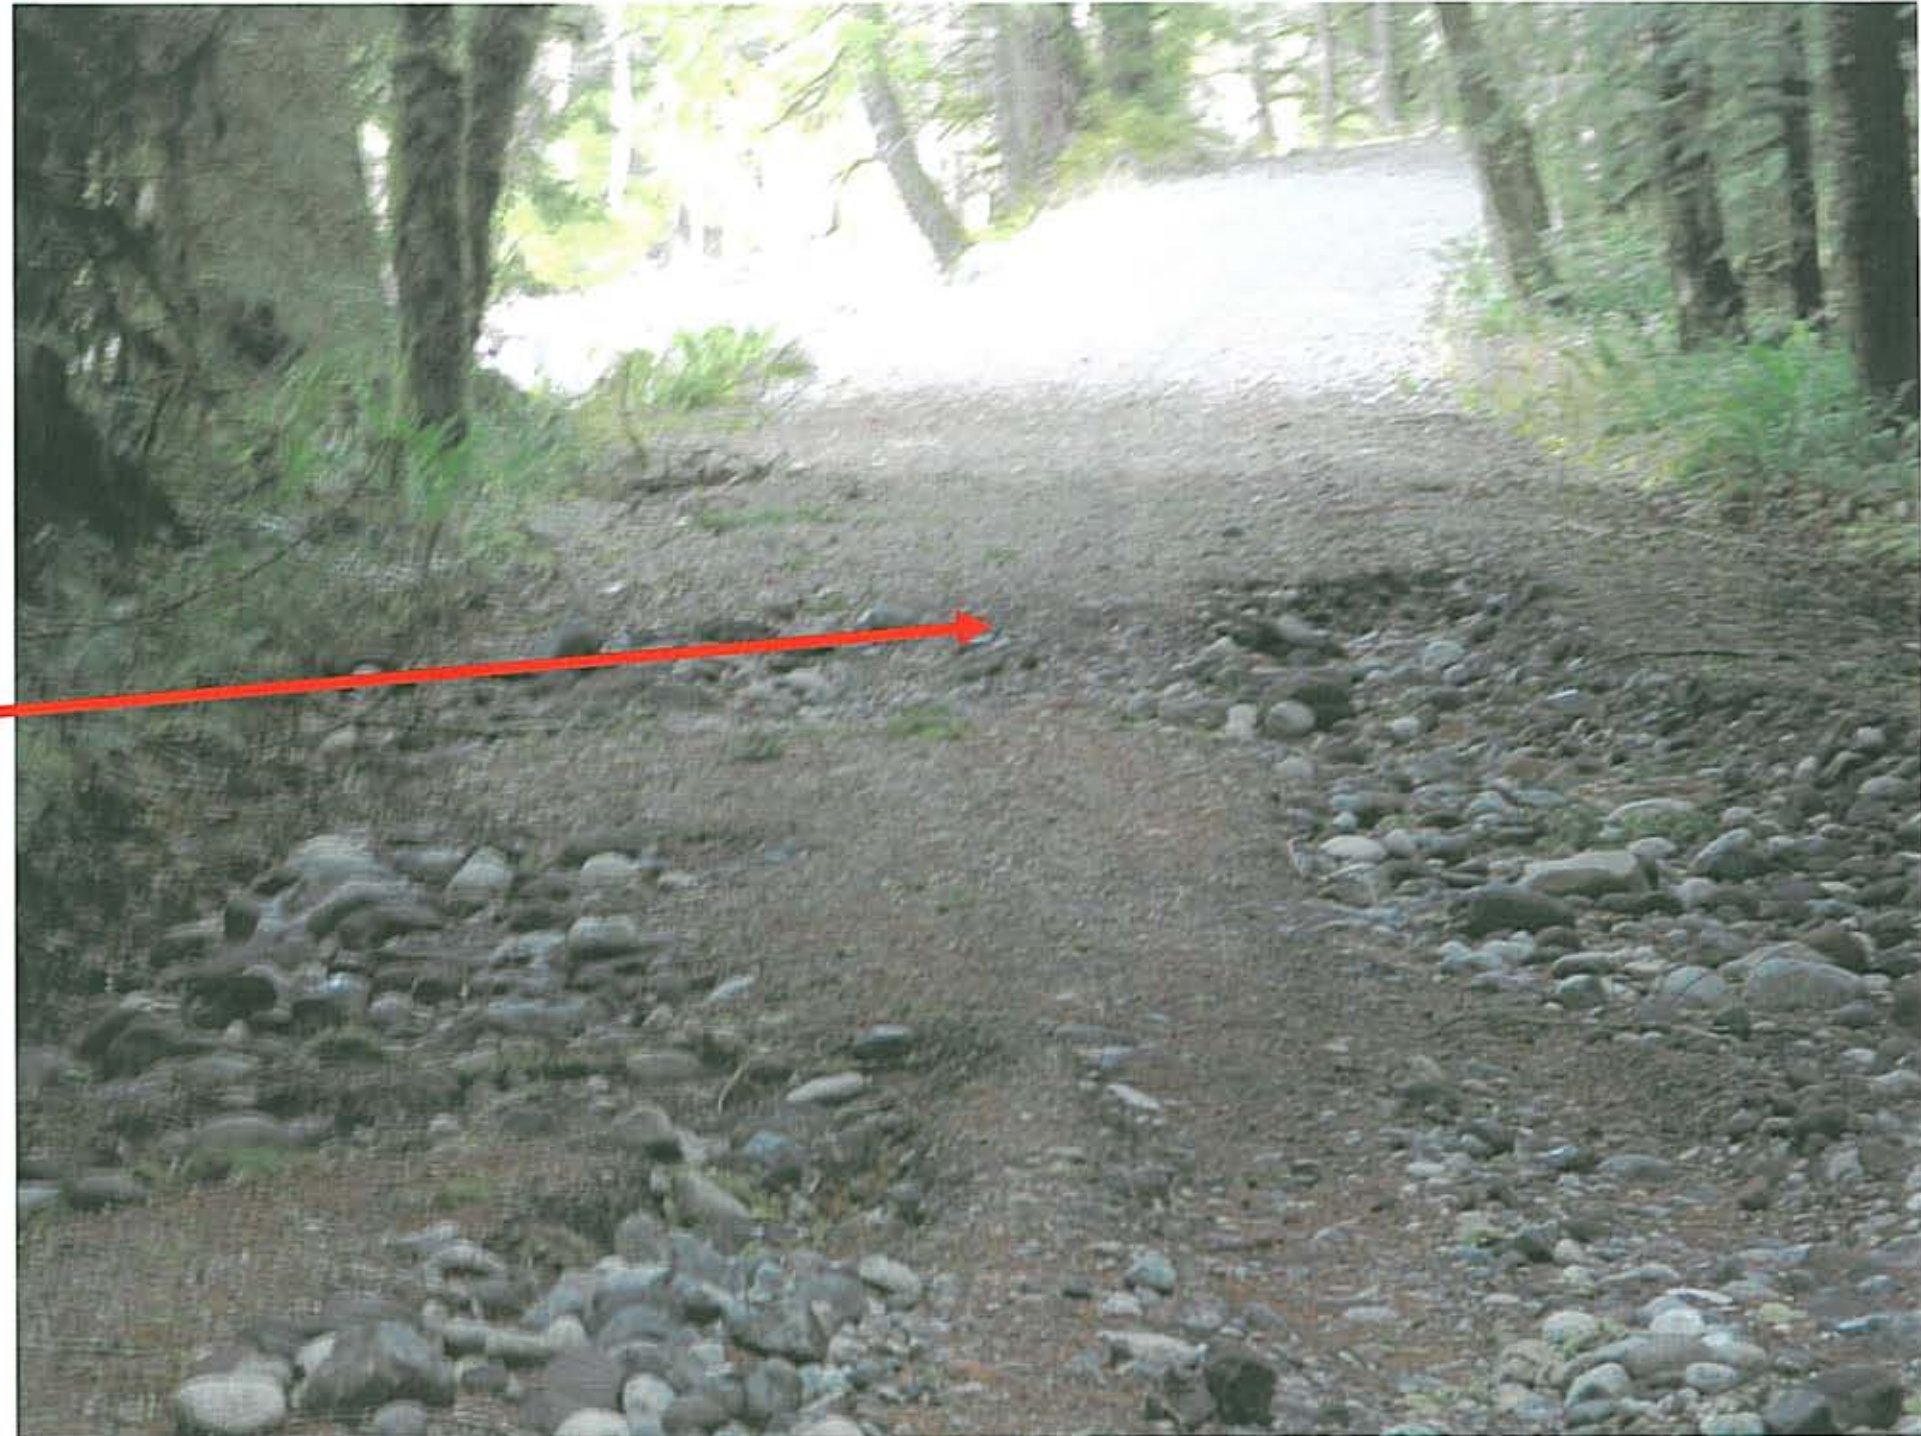
## Station 181+50

Close-up of the location where flood water spills out, shown in the previous photo.

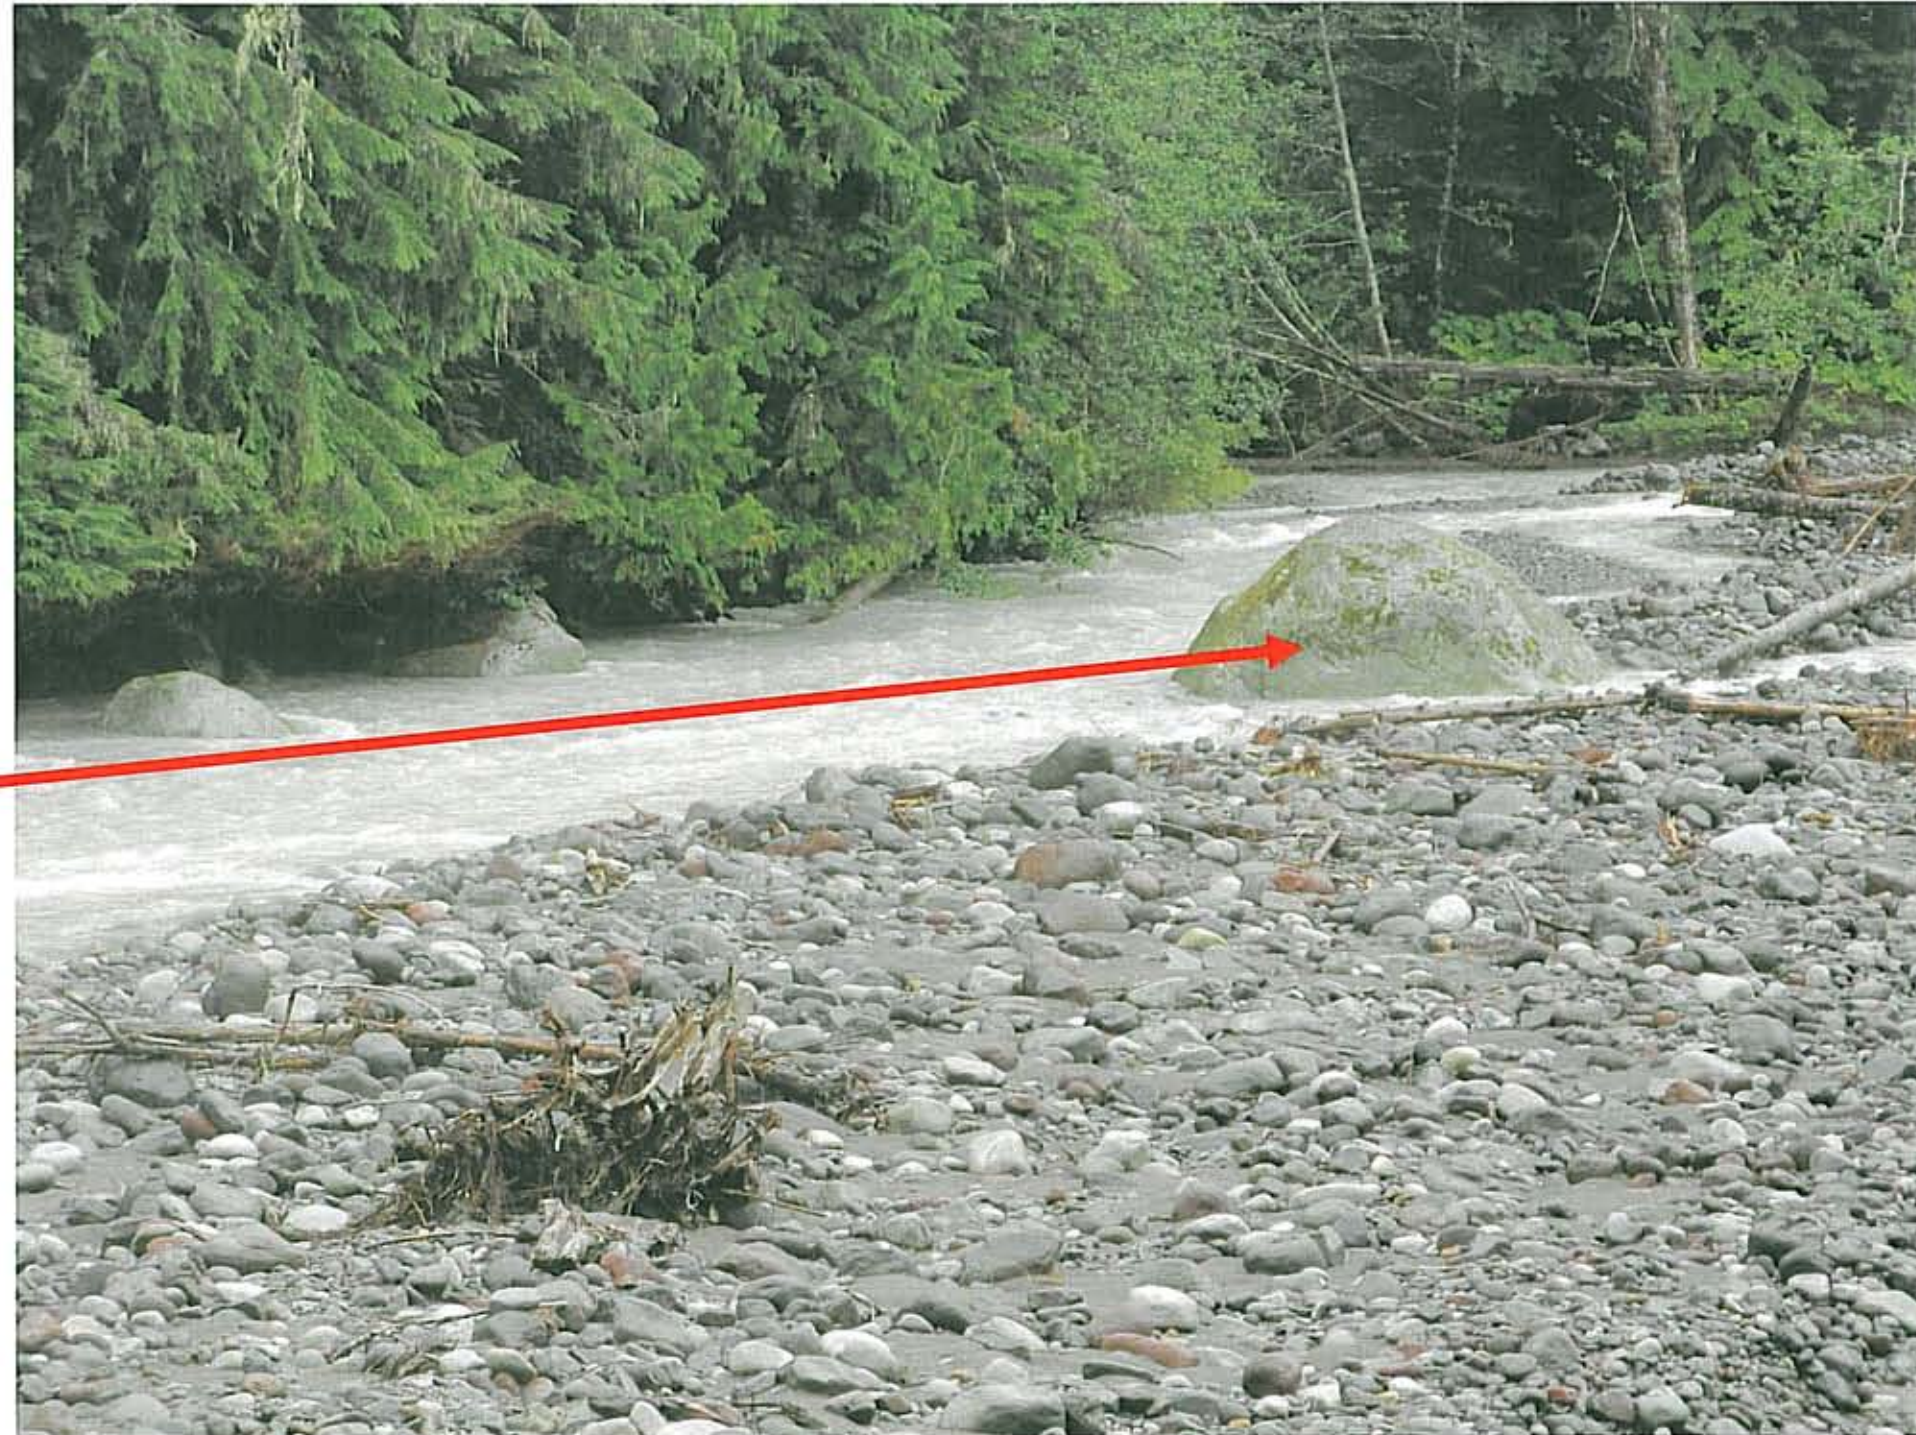
## Station 190+00, Looking North

Glacial boulders on north side of river bed, across from Chenuis Falls picnic area. The floodplain is narrowed here, which triggers increased deposition immediately upstream.
