# **MOUNT RAINIER NATIONAL PARK**

## **SITE ASSESSMENT AND DESIGN OF ROCK BARBS, CHECK DAMS AND OTHER FLOOD DAMAGE REDUCTION MEASURES**

## **THE CARBON RIVER ROAD**

**30% DESIGN- CARBON RIVER ROAD  
FLOOD DAMAGE REDUCTION MEASURES**

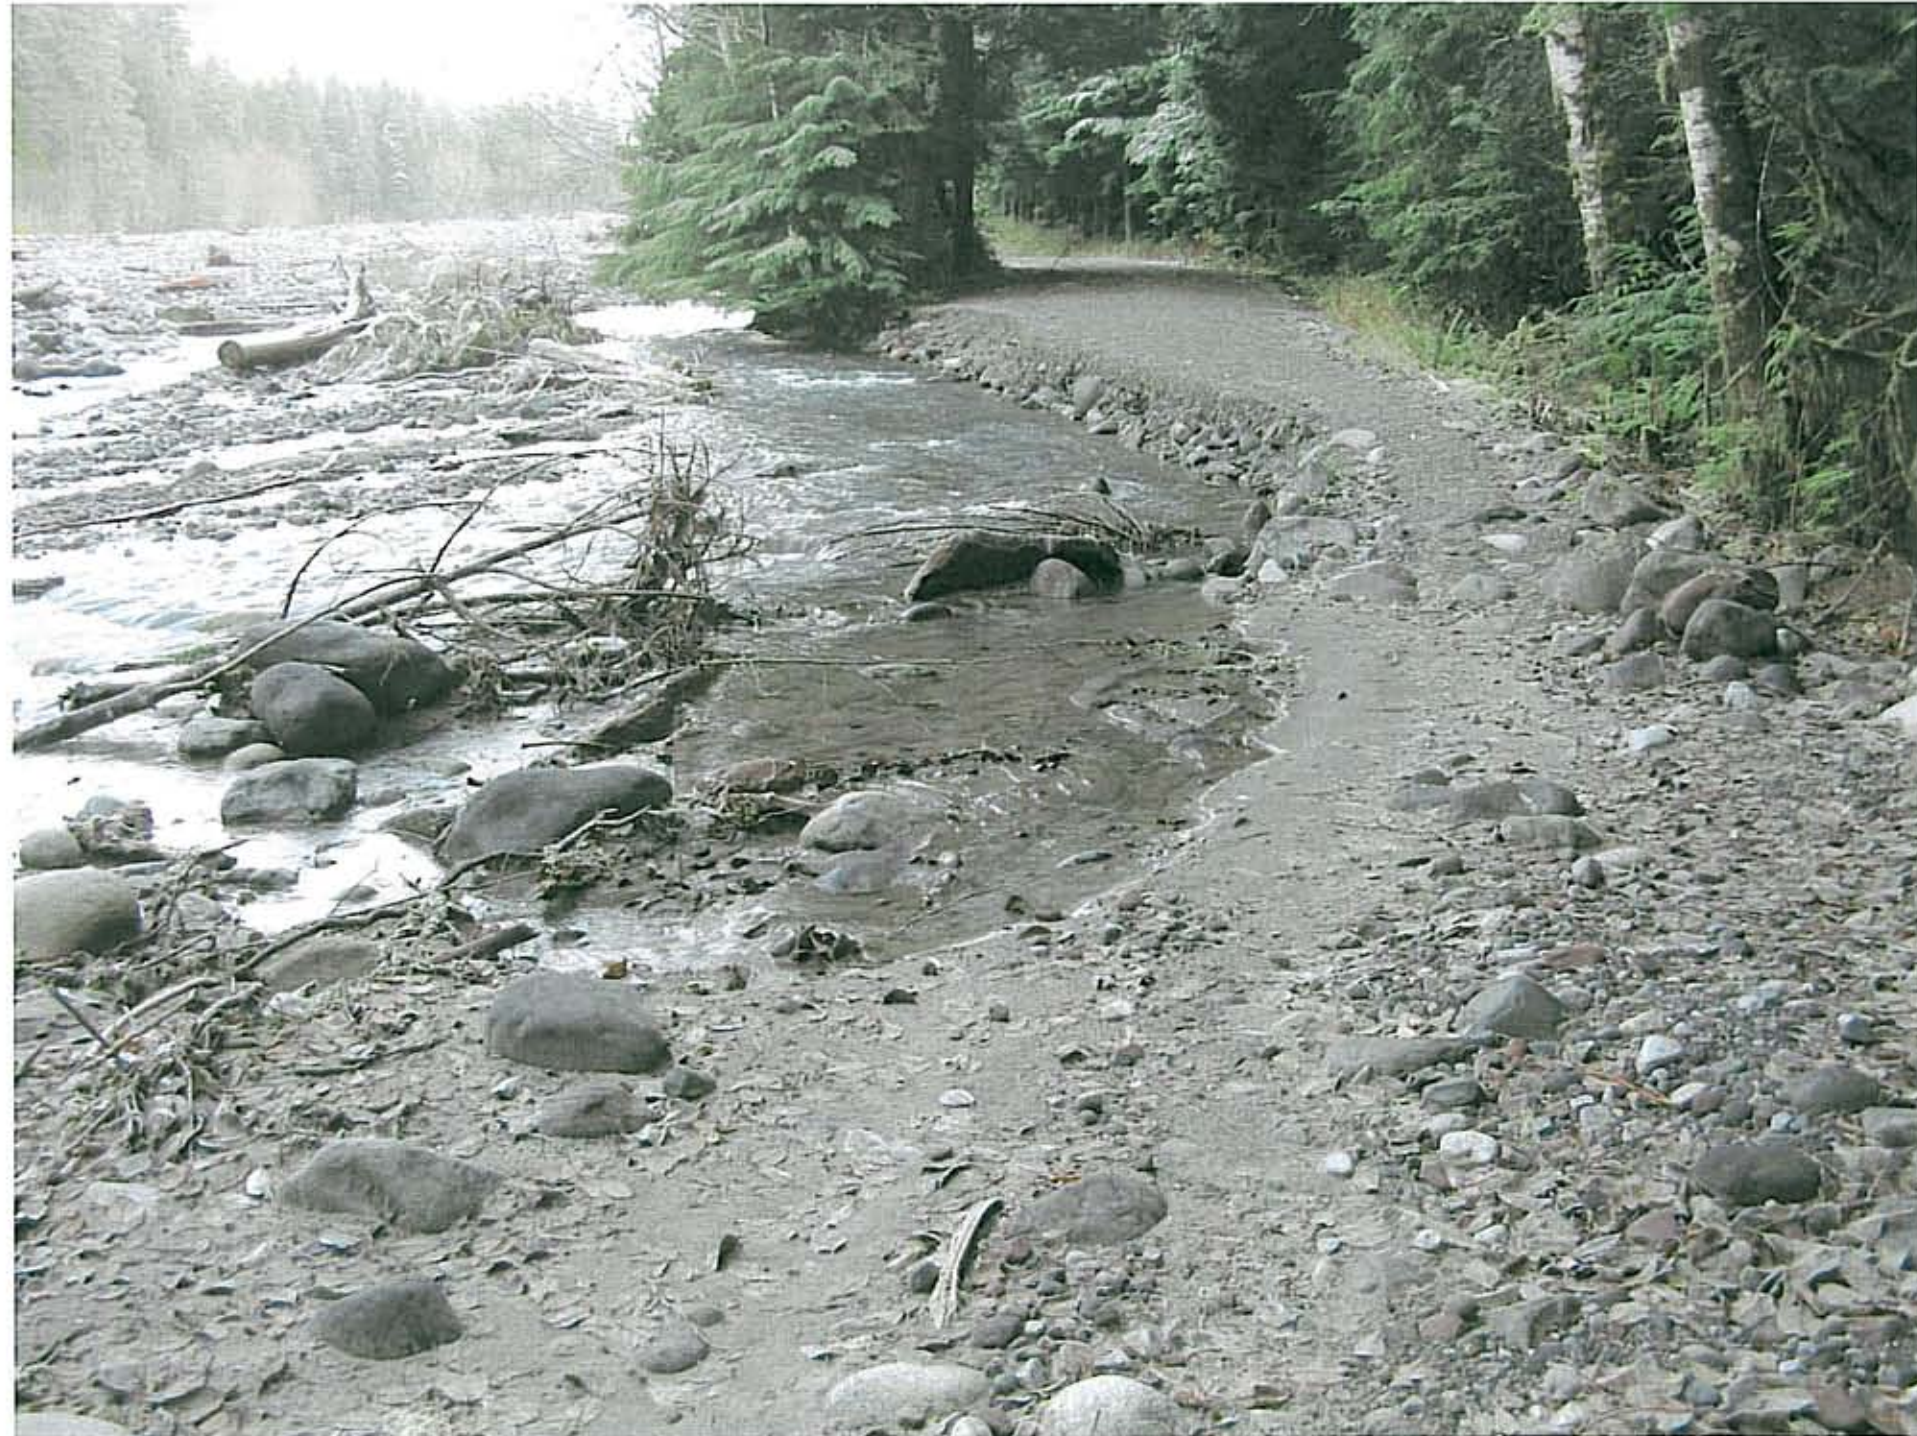
## Station 204+00, Looking Southeast

The riverbed is near the level of the road. The flow to the northwest for several hundred feet is within the Ordinary High Water Line of the river.

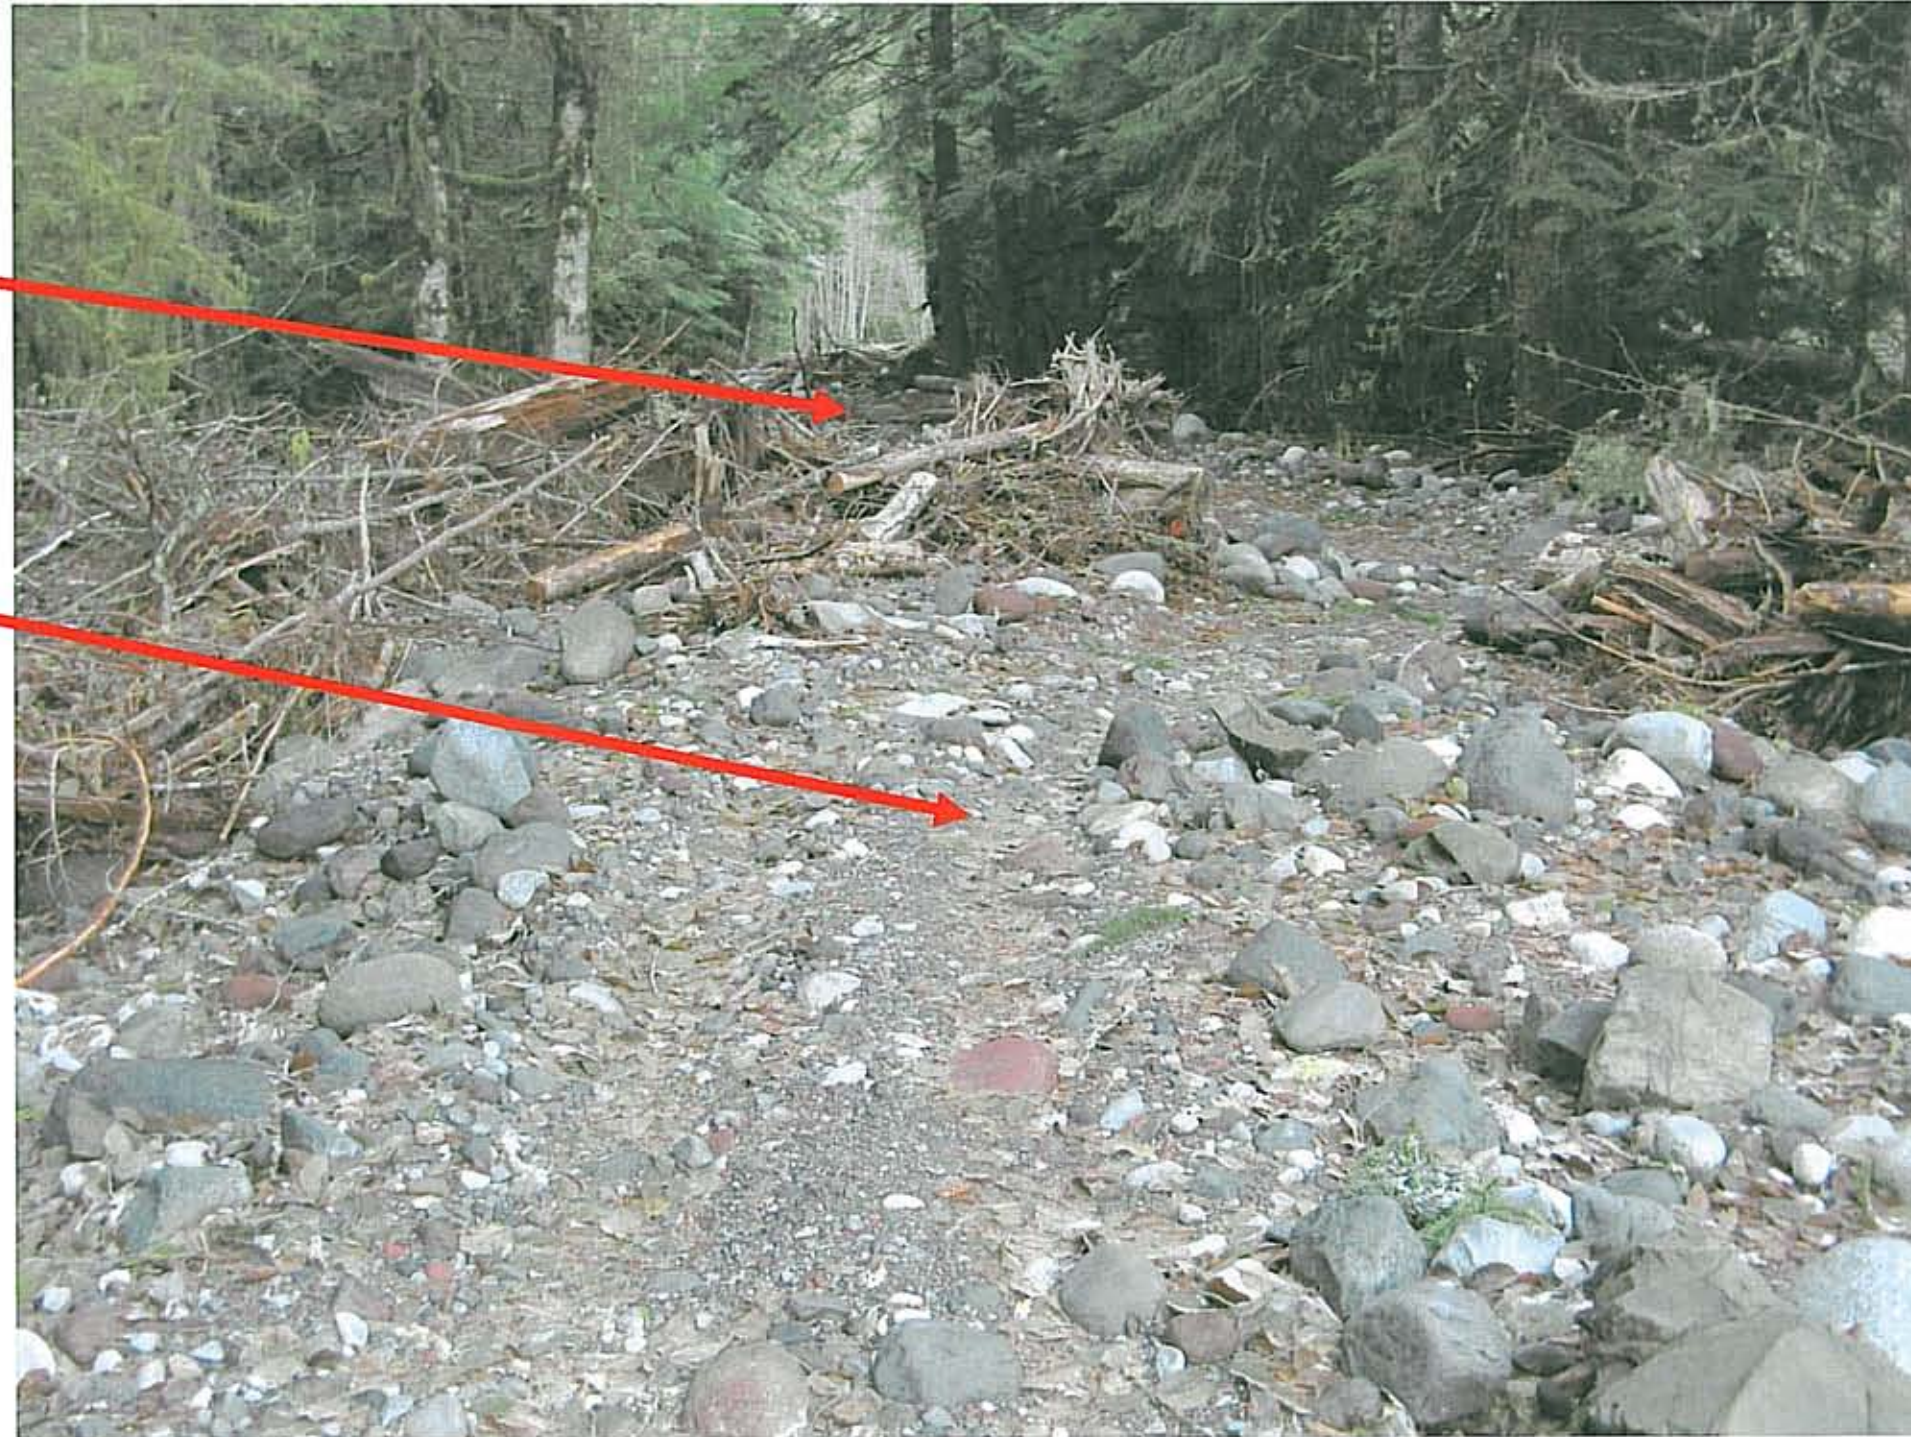
## Station 204+00, Looking Northwest

Looking downstream from the location of the previous photo. Water spills out and flows down the road corridor. The road is now a gravel/cobble deposition area within the Ordinary High Water Line of the river.

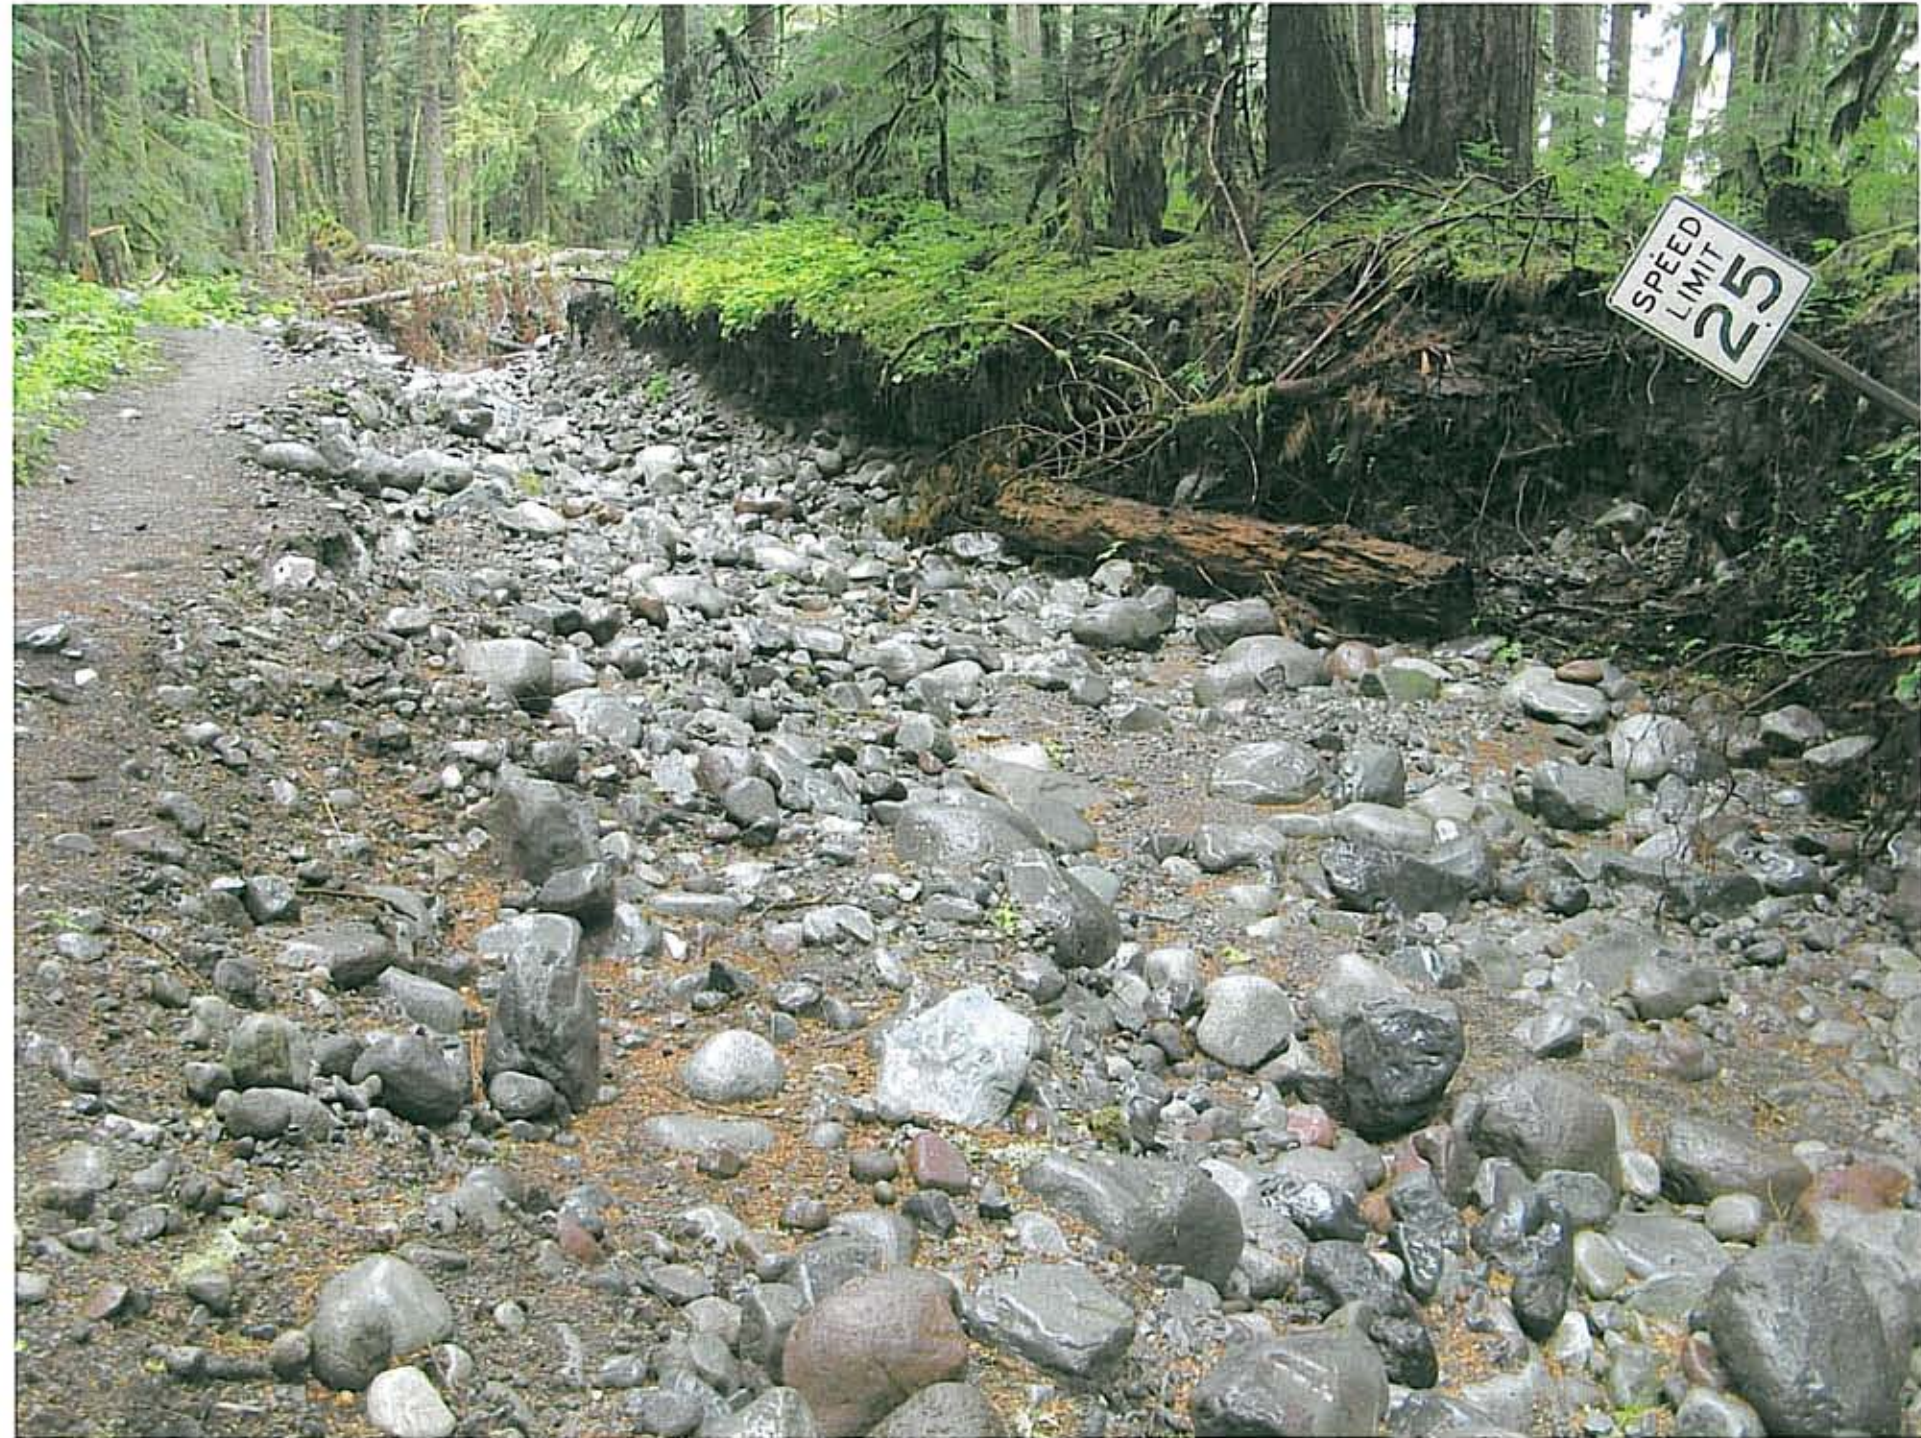
## Ipsut Washout Section

Road washout west of Ipsut  
Campground

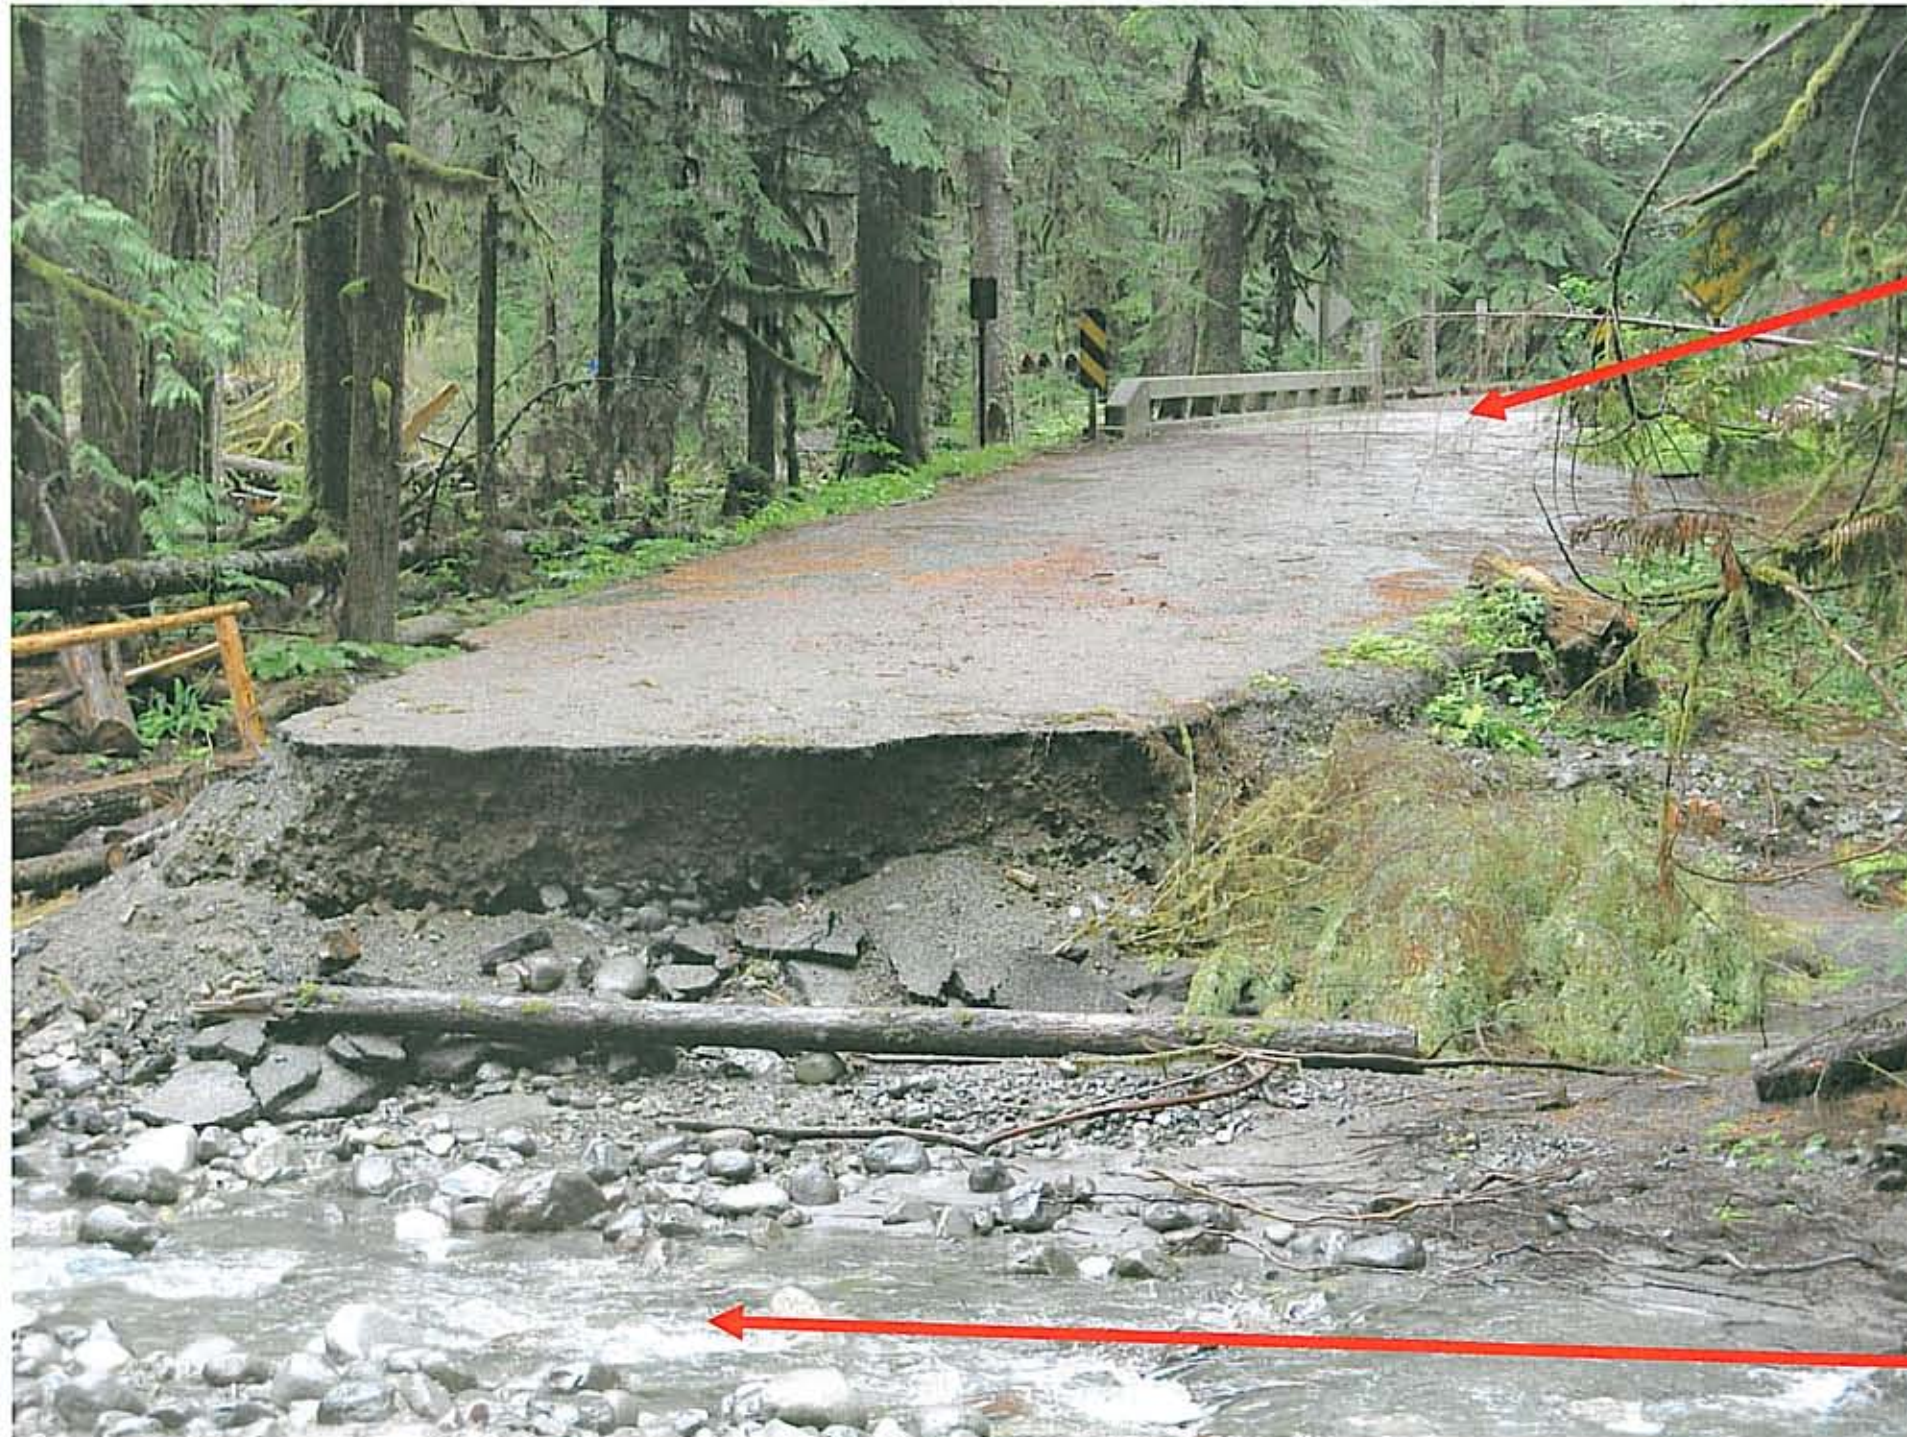
## Ipsut Campground Bridge Plugged and Road Breached

Road breached after log jam formed above bridge opening and water spilled over road.

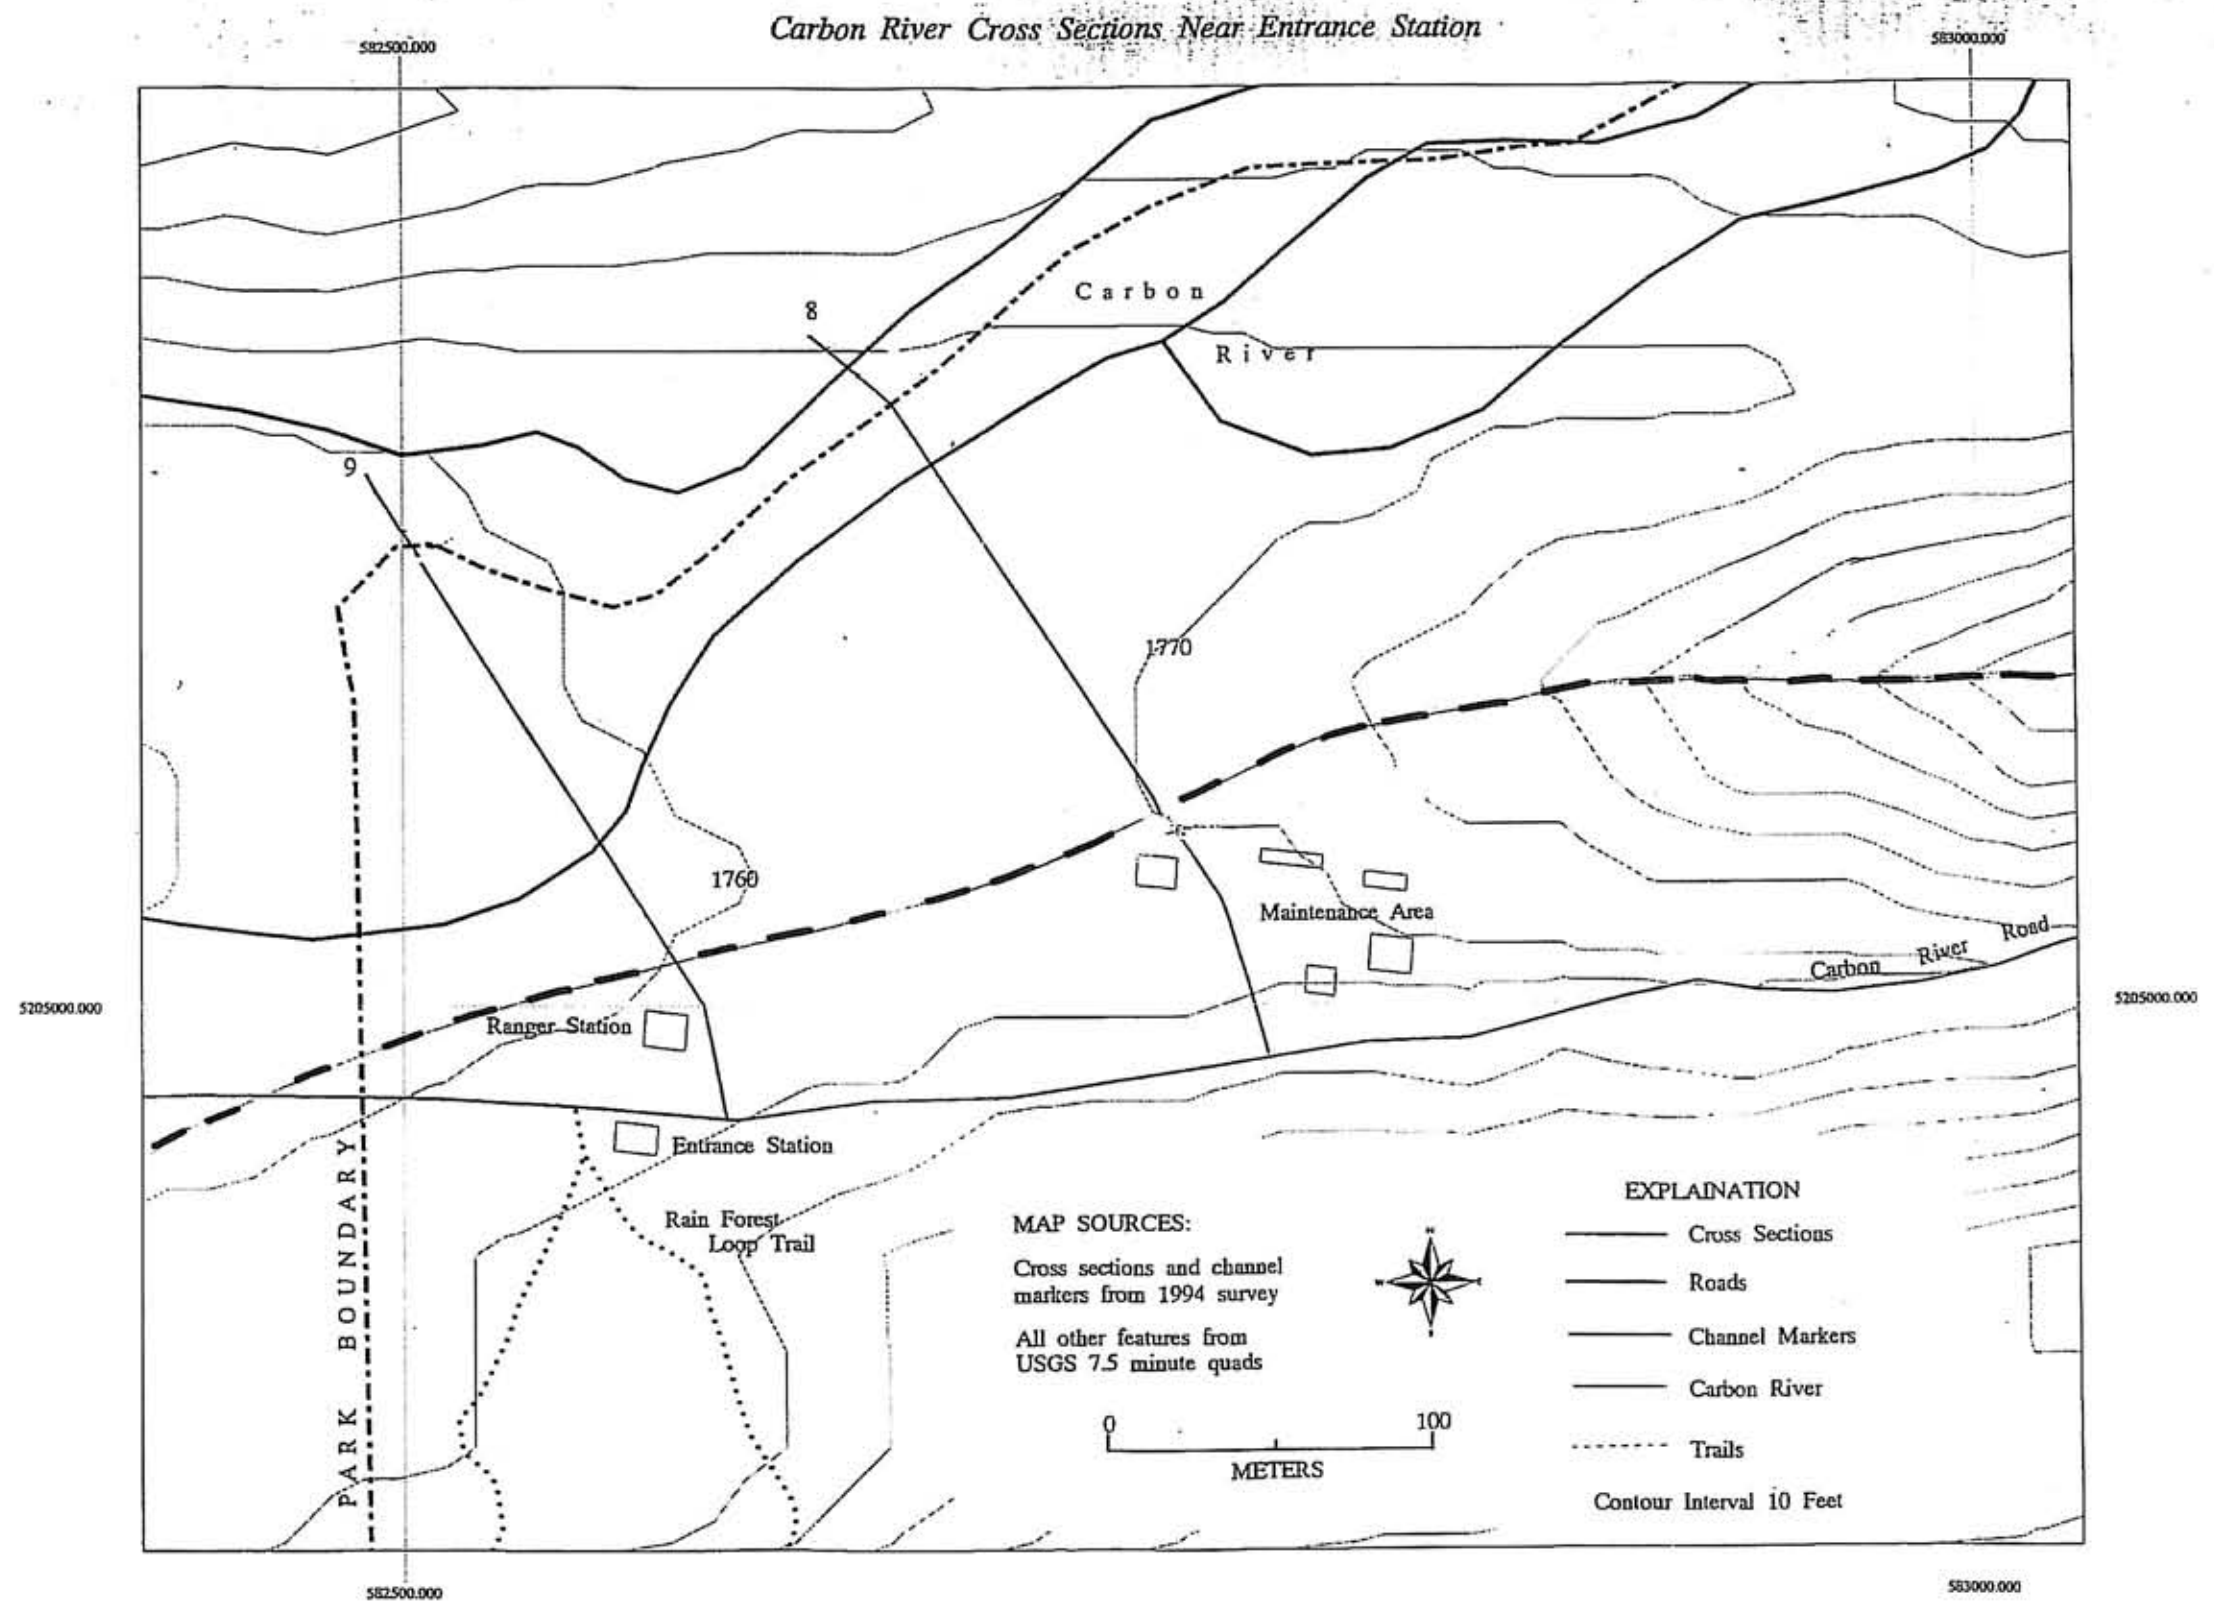
The hydraulic model results indicate that all of the facilities are presently outside their regulatory floodplains (Figures 7 and 8). Historic flooding at the entrance station has been observed, however. The channel of June Creek has shifted to the west since publication of the USGS 7.5 minute map in 1971, and is believed to be the source of flood waters at the entrance.

Figure 8. Floodplain map for the Carbon River near the Carbon River Entrance Station. Approximate floodplain boundary shown by dashed line.

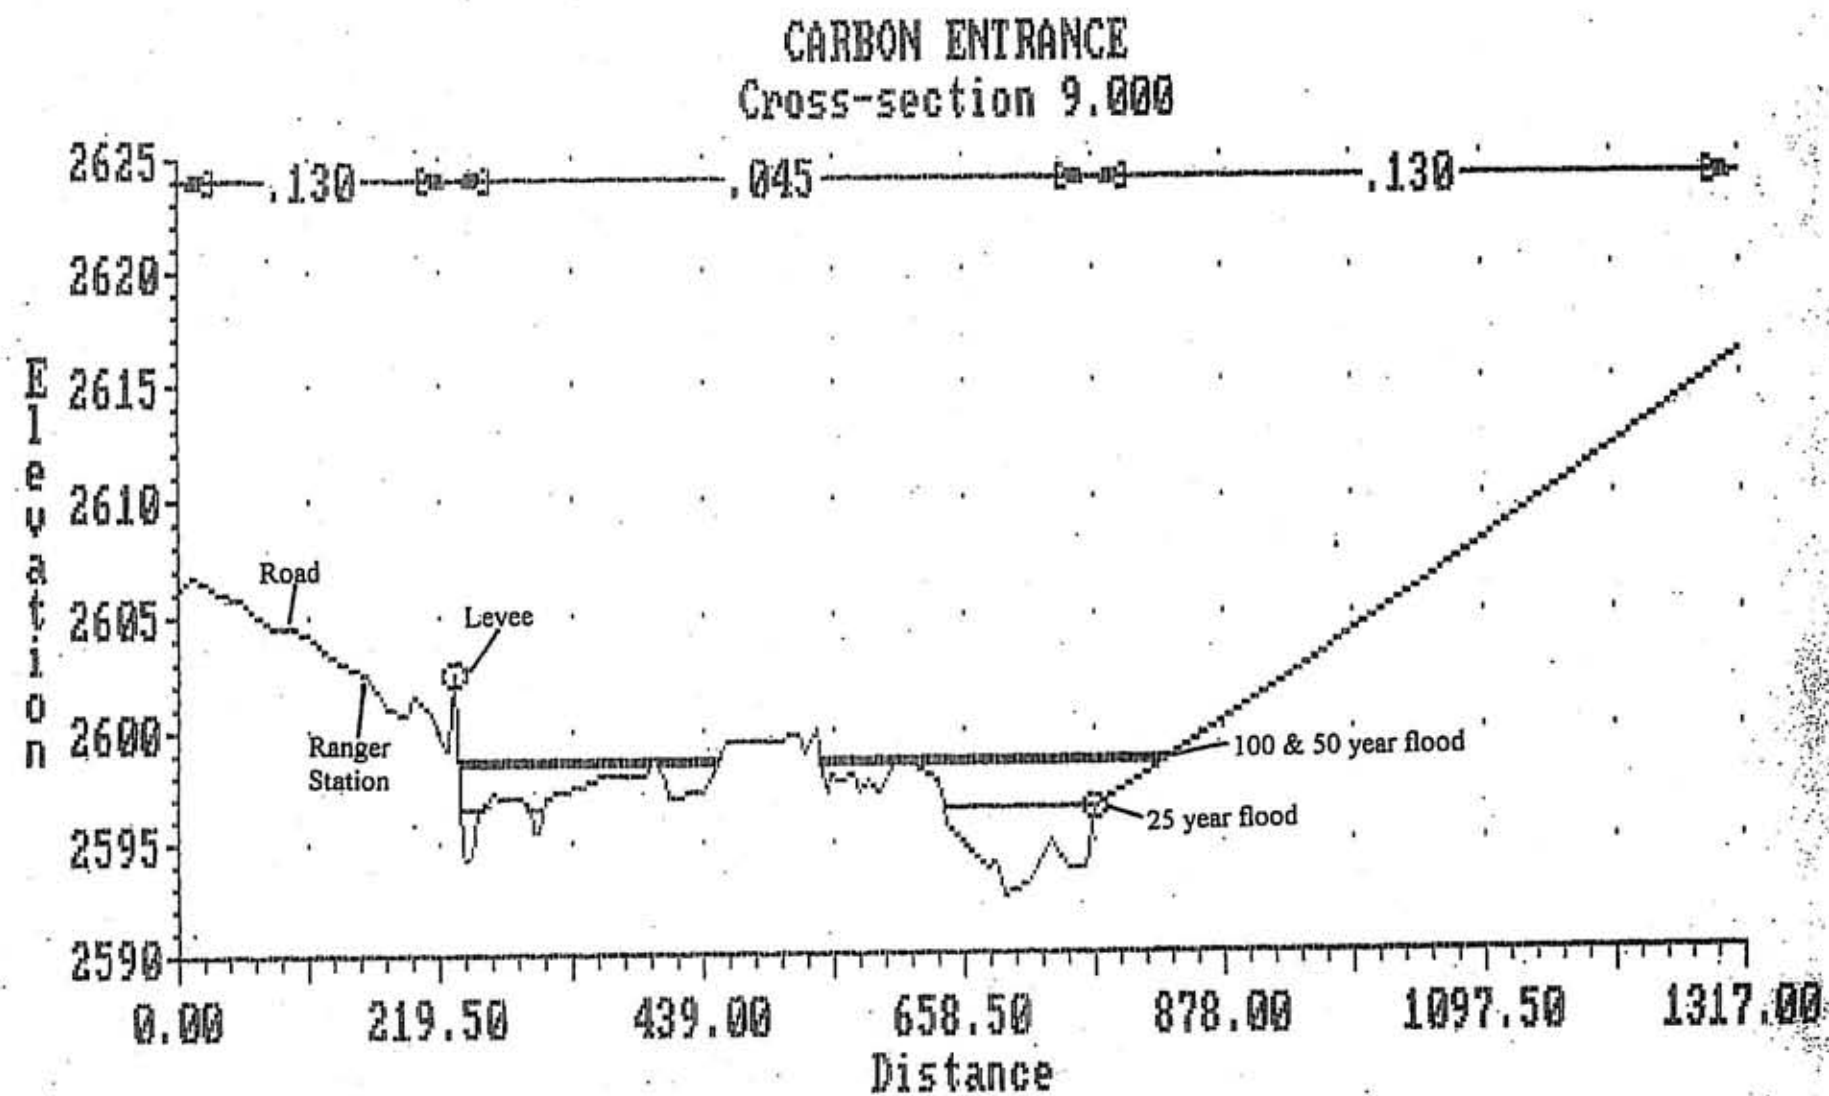
Figure 7. Floodplain cross section at Carbon River Entrance from floodplain model HEC2. View looking downstream.

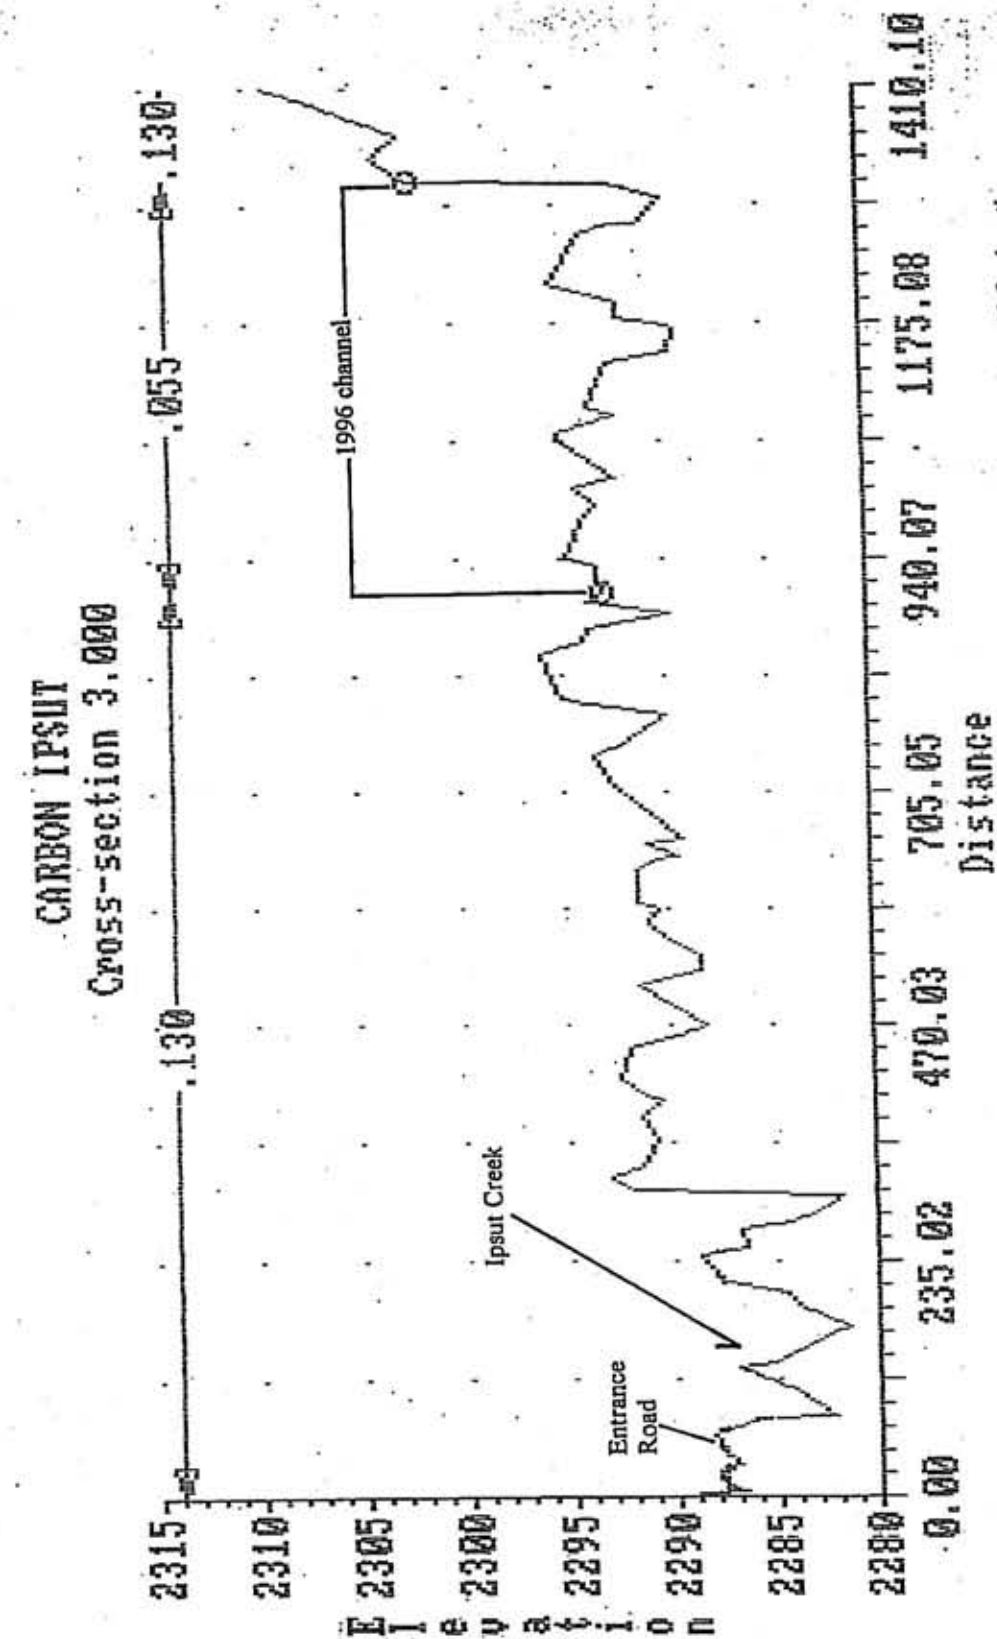
Surveyed cross sections shown in Figures 10 and 11 illustrate that parts of the campground, walk in sites and entrance road occupy very low parts of the floodplain. The majority of the campground rests on a low terrace, 5-6 ft (1.5-1.8m) above the modern channel. The walk in sites are isolated by swift water in a side-channel during even smaller flood events. High flood hazard occurs at discharges of 1,000 cfs or greater.

Hydraulic model output indicates that most of the camp is outside the existing 100 year floodplain (Figures 10 and 11). However, the unstable nature of braided channels and the fact that parts of the campground are at lower elevations than the active channel suggest that the 100 year floodplain boundaries from the model may not be accurate for very long. Therefore, the 100 year floodplain boundary lines are conservatively drawn to include the low-elevation flood channels on the southwest end of the valley (Figure 12). This places the campground within the 100 year floodplain.

Figure 10. Floodplain cross section at Ipsut Campground from floodplain model HEC2. Cross section #3, see Figure 12 for location. View looking downstream.

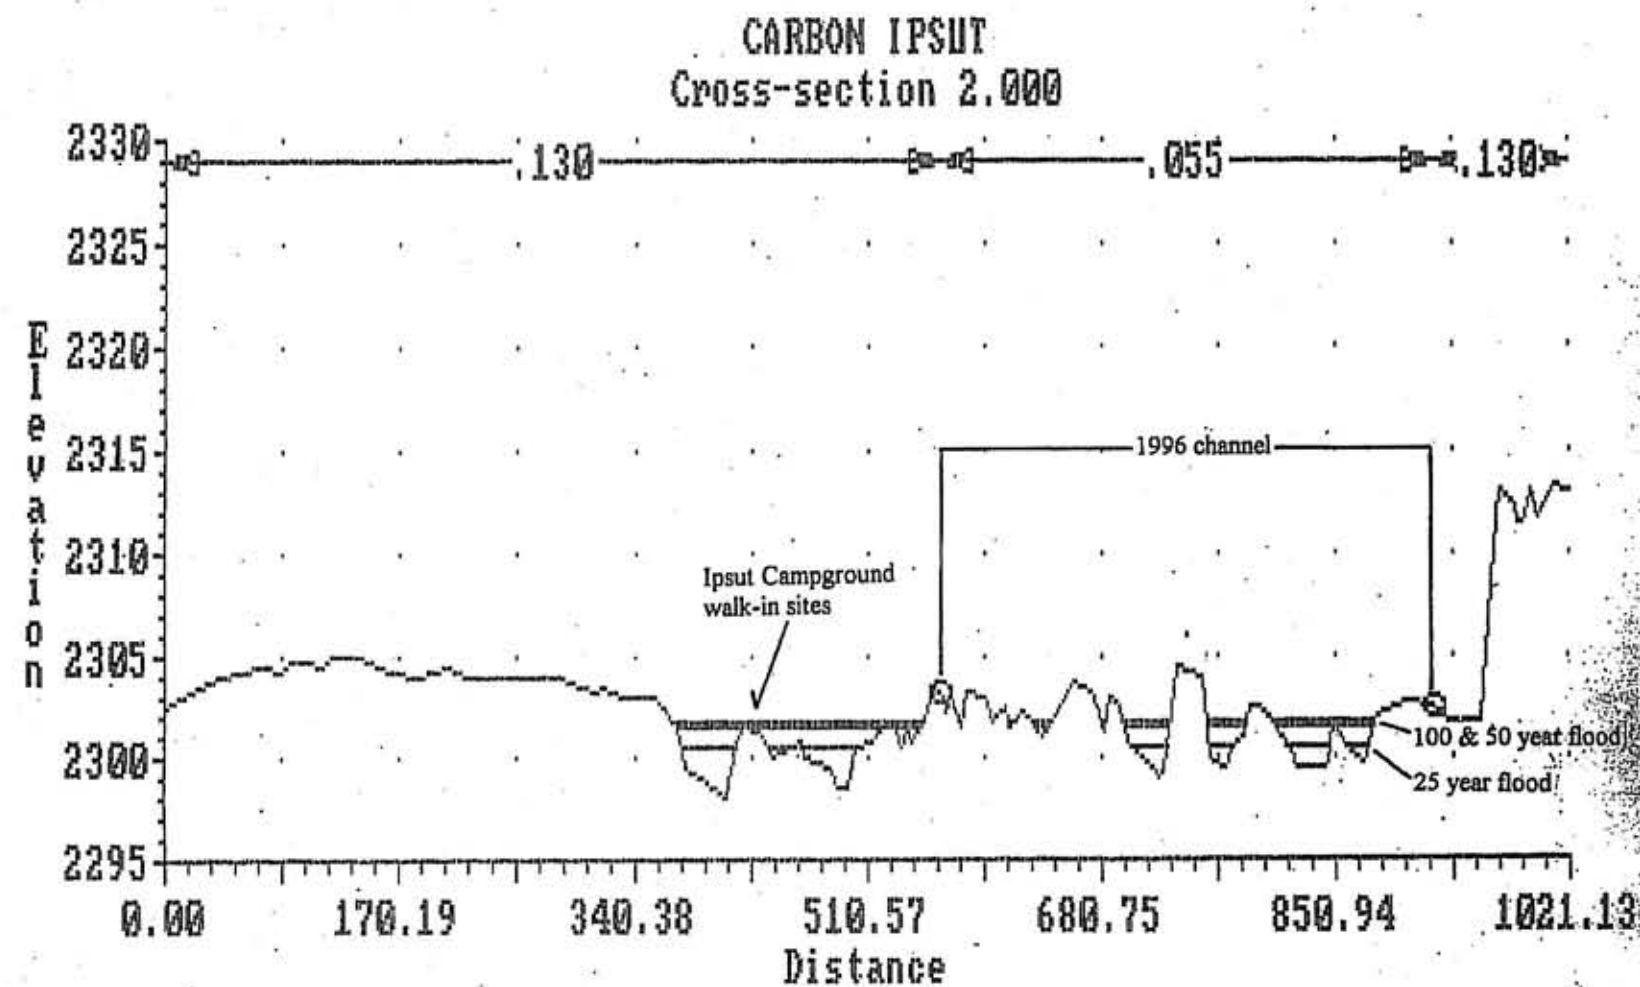
Figure 11. Floodplain cross section at Ipsut Campground from floodplain model HEC2. Cross section #2, see Figure12 for location.  
View looking downstream.
