3.4 DAINGERFIELD ISLAND SITE

3.4.2 Conceptual Site Plan

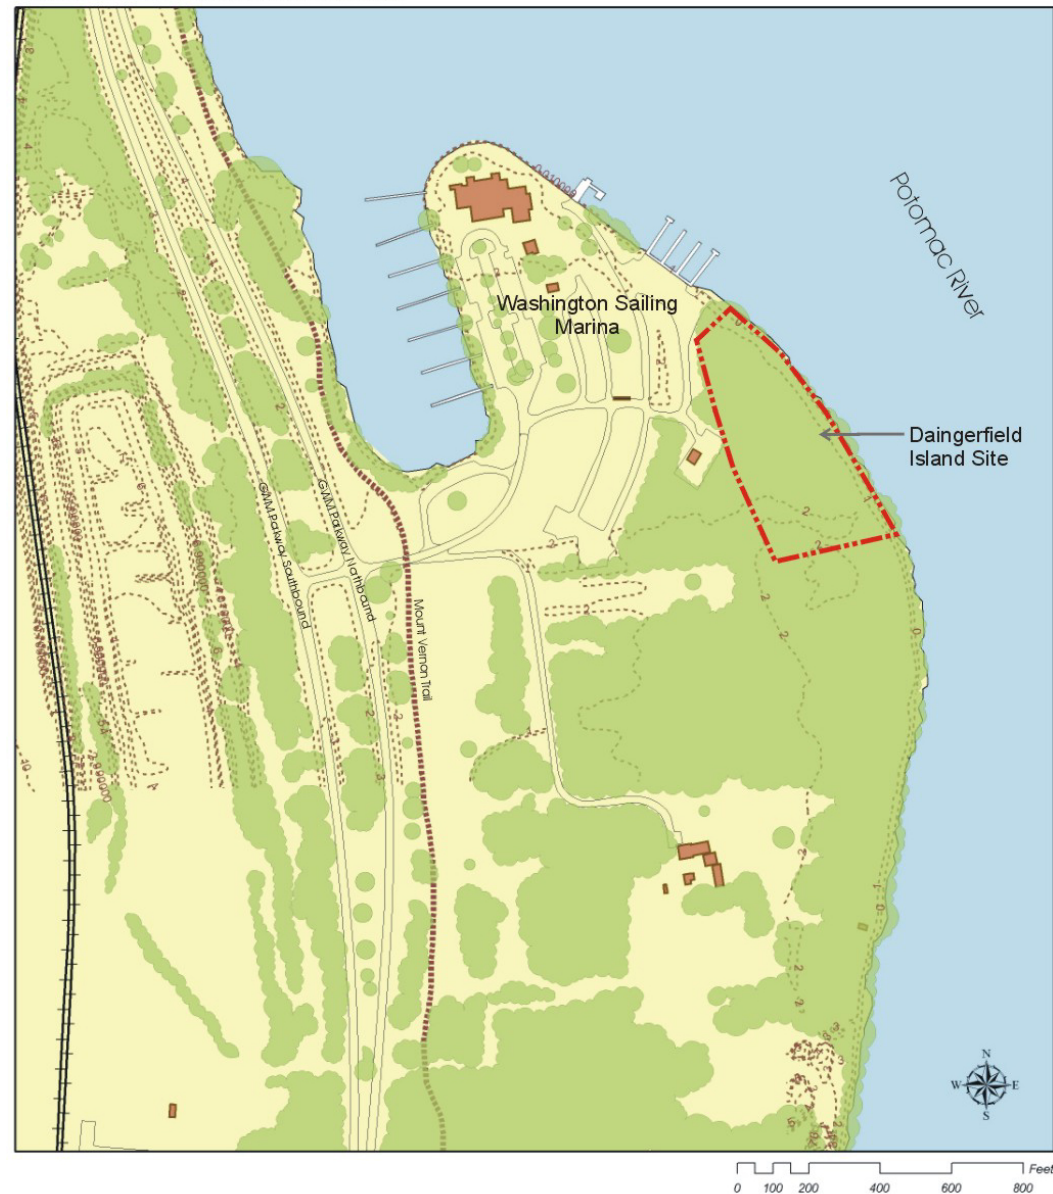
Figure 3.53: Existing Conditions, Daingerfield Island Site

The site is located at the eastern end of Daingerfield Island, to the south of the existing Washington Sailing Marina. See Figure 3.53. The site is a recreational/open space area under the ownership of the NPS.

- **Water:** An existing water system enters the property from the GWMP and services the site. An 8-inch ductile iron water main was recently installed adjacent to Marina Drive. The 8-inch water connects to an existing 6-inch water line that serves the marina facilities. A new 4-inch water main also extends to the nursery and greenhouse areas from the new 8-inch main.
- **Sanitary Sewer:** Record drawings indicate that a 6-inch sanitary sewer force main exists on site to serve the marina facilities. Further analysis would be required to determine the capacity of the existing force main.
- **Electric/Telephone:** The marina is served by electric and telephone systems. Further investigation with the utility owners will be required to determine the capacities in these systems.

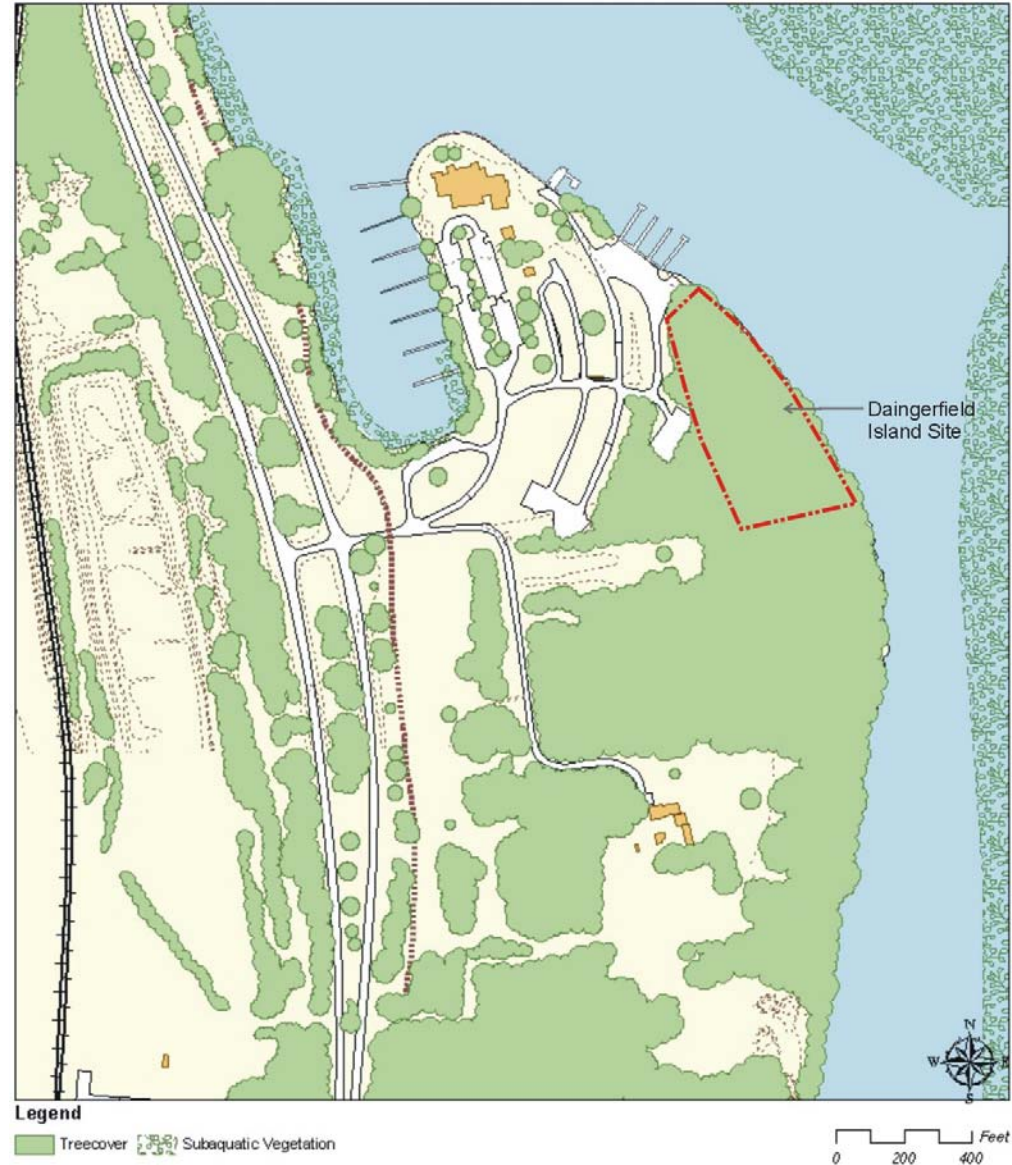
Figure 3.55: Existing Vegetation, Daingerfield Island Site

suitable for supporting rarities than do the more altered Upper Rosslyn and 14th Street Bridge sites for the boathouse, and recommends an inventory of suitable habitat on the Daingerfield Island site (see Figure 3.55).

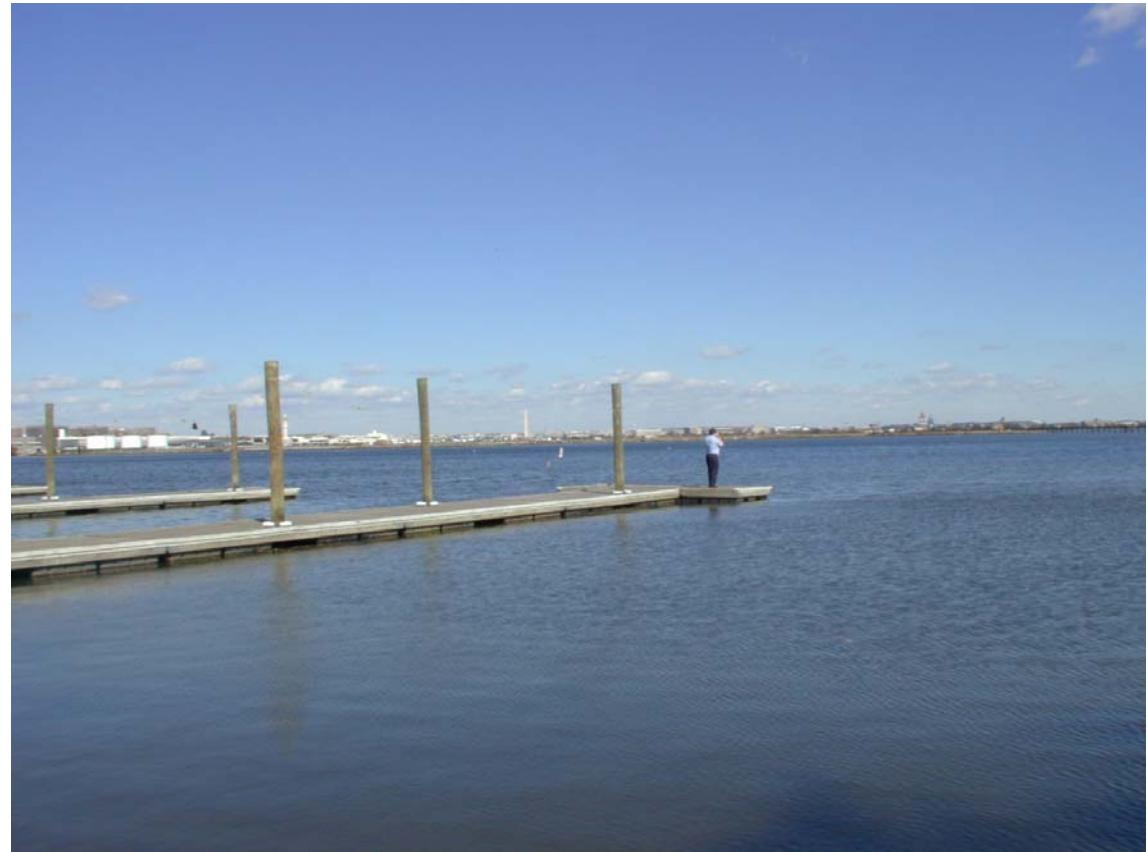
Figure 3.56: Potential Conflicting Uses Include Sail Boats that Launch off the Washington Sailing Marina Docks

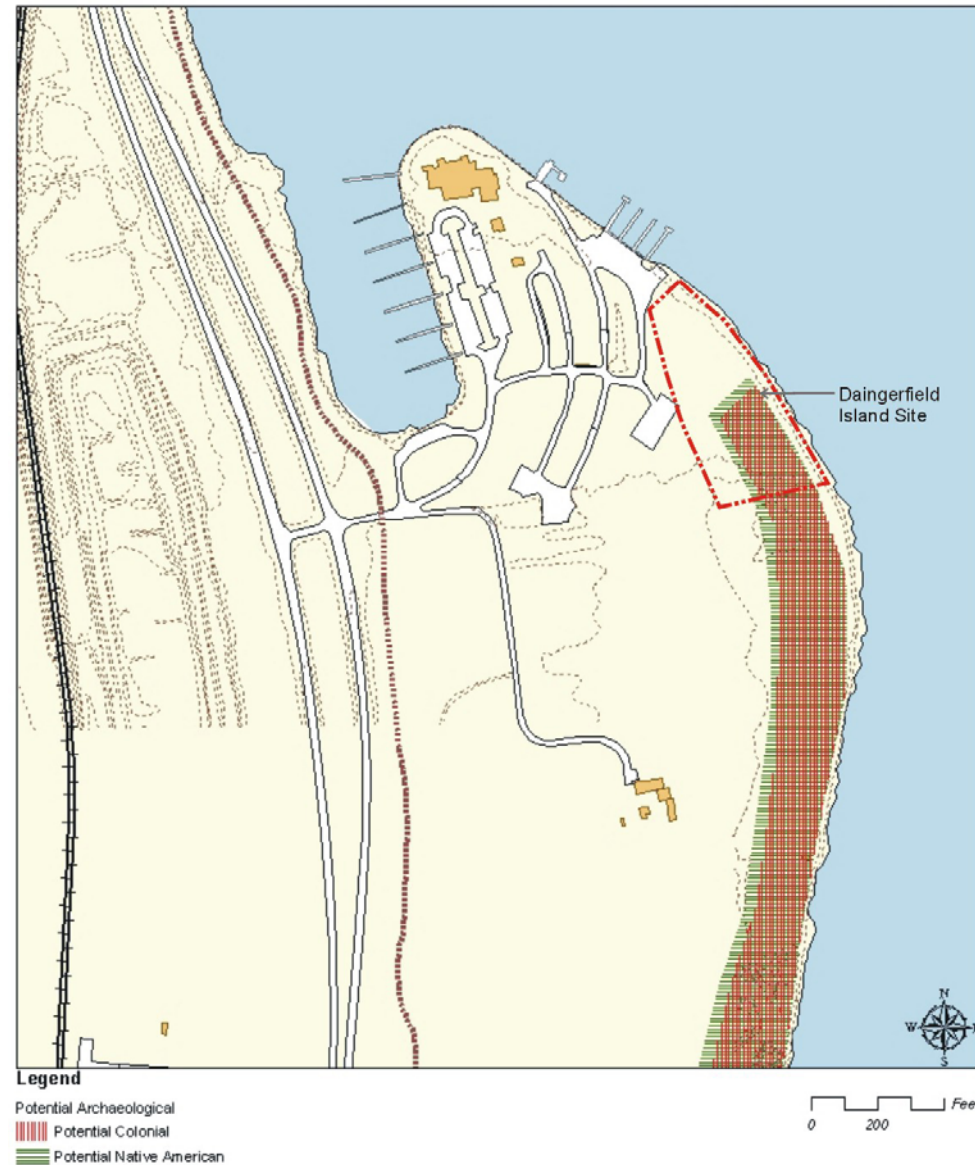
Figure 3.57: Potential Existing Historical/Cultural Resources, Daingerfield Island Site

In undisturbed areas of Daingerfield Island, potential archeological resources include possible locations for artifacts from prehistoric Native American settlements. There are also potential colonial period artifacts from initial clearing and settlement on the island (Arlington County 1993). The GWMP is a National Historic Register property that is near the project site.

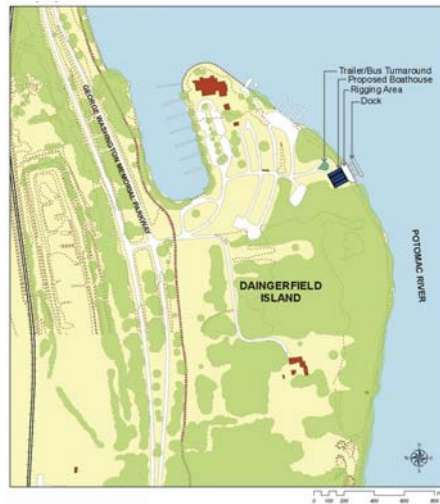
Figure 3.58: Conceptual Site Plan

Two conceptual plans were prepared to test the potential of locating a boathouse at this site. Figures 3.58 and 3.59 illustrate a smaller boathouse with a footprint of 10,000 SF. Figure 3.60 illustrates a larger boathouse with a footprint of 14,000 SF. In both plans, a new access road with a drop-off area, off the existing road network, is proposed. The boathouse and docks are proposed slightly

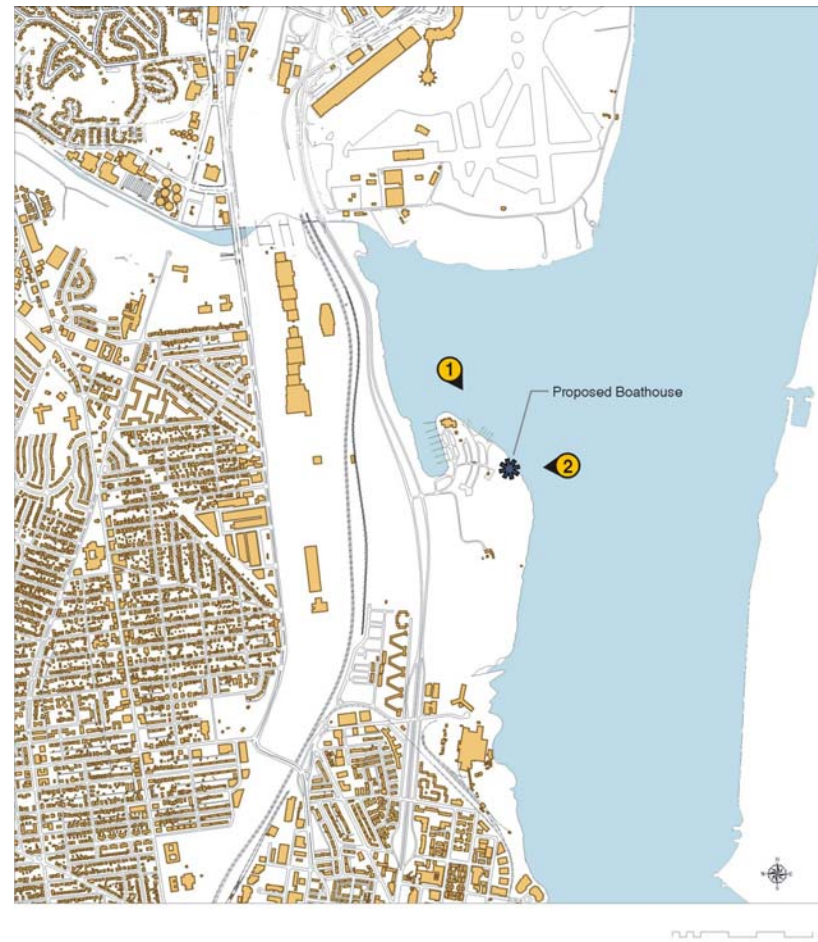
Figure 3.61: Location of Visual Simulations

To assess potential visual impacts of the proposed boathouse, simulations of the boathouse were prepared and overlapped with existing images. The locations of the images were determined based on their level of visibility from public places (see Figure

3.61). The existing boathouse at Alexandria was used as a model for the simulated architectural style of the proposed boathouse.

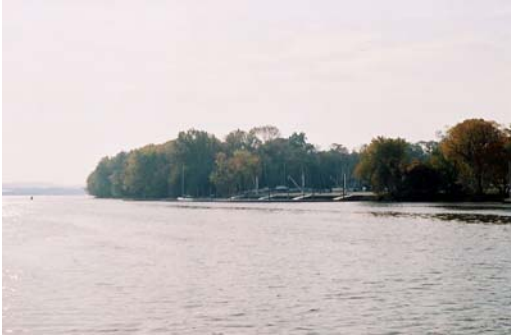
Figure 3.62: Existing View from Upstream along the Potomac River

The site is part of a wooded area located at the edge of the Potomac River (see Figures 3.62 and 3.64). To the immediate north is the Washington Sailing Marina, an area that includes outdoor boat storage and boat launching facilities. The site is only visible from the river.

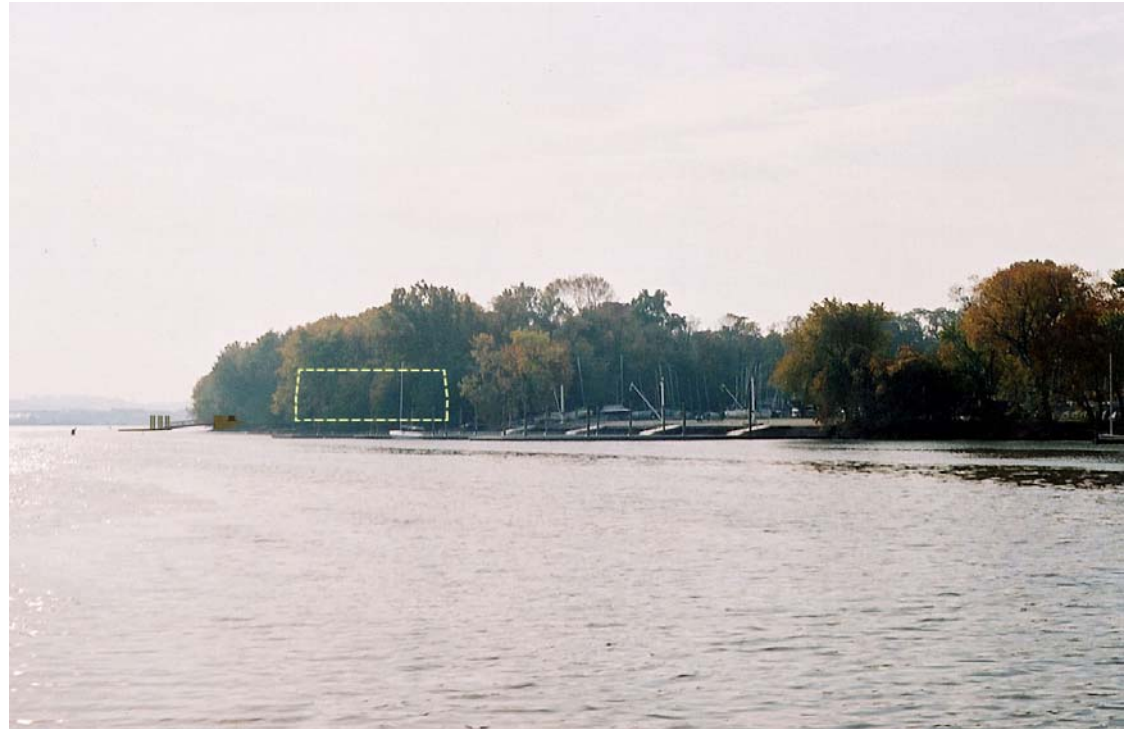
View 1: From the Potomac River, north of the Daingerfield Island, the boathouse would not be visible (see Figure 3.63). However, the docks would be visible. The boathouse would be located just beyond an existing stand of trees (shown here by an outline).

Figure 3.63: Simulation of Proposed Smaller Boathouse – View from Upstream along the Potomac River

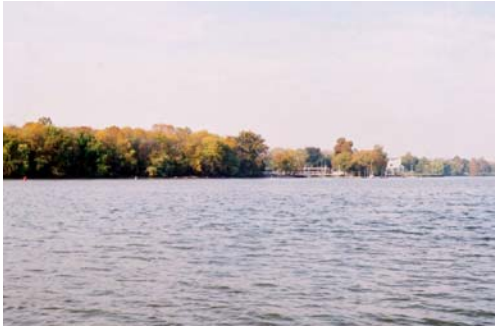
Figure 3.64: Existing View from Downstream along the Potomac River

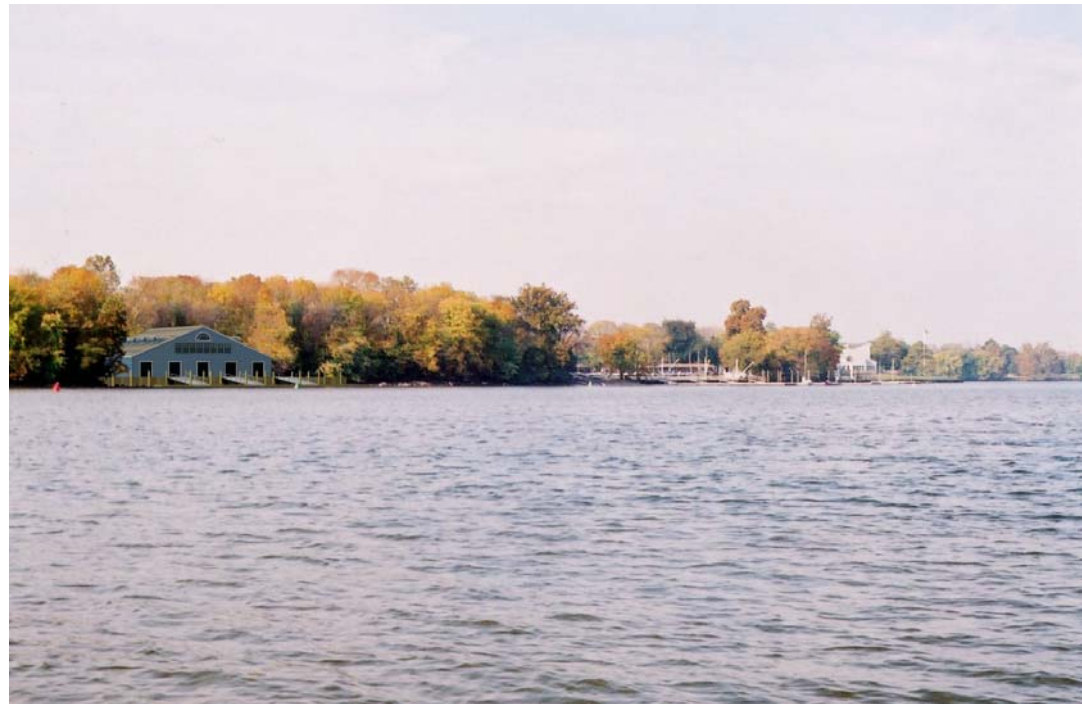
View 2: From the Potomac River, south of the Daingerfield Island, the boathouse and the docks would be visible within the strand of existing trees (see Figure 3.65). The simulation illustrates the relationship of the proposed boathouse to the existing piers for Washington Sailing Marina.

Figure 3.65: Simulation of Proposed Smaller Boathouse – View from Downstream along the Potomac River

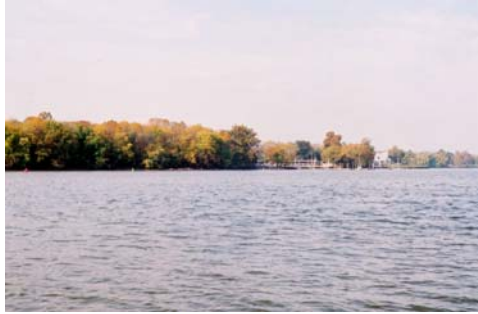
Figure 3.66: Existing View from Downstream along the Potomac River

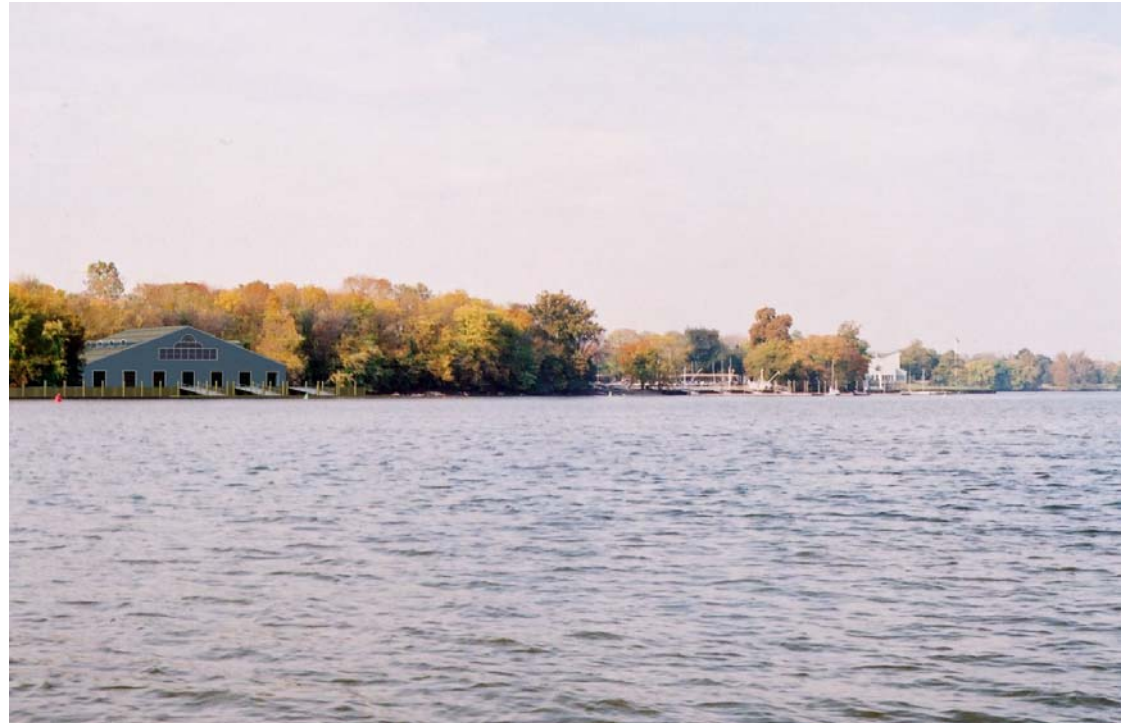
Figure 3.67: Simulation of Proposed Larger Boathouse – View from Downstream along the Potomac River

View 3: From the Potomac River, south of the Daingerfield Island, the larger boathouse and the docks would be visible within the strand of existing trees (see Figure 3.67). The larger boathouse would have a greater potential impact due to its larger size.
