## **TREATMENT ALTERNATIVES**

UNITED STATES DEPARTMENT OF THE INTERIOR APOSTLE ISLANDS NATIONAL LAKESHORE		FIGURE 14 TITLE OF PROJECT HISTORIC STRUCTURE REPORT, CULTURAL LANDSCAPE REPORT & ENVIRONMENTAL ASSESSMENT TREATMENT ALTERNATIVES TITLE OF DRAWING MICHIGAN ISLAND - RESERVATION BOUNDARY NAME OF PARK APOSTLE ISLANDS NATIONAL LAKESHORE REGION COUNTY STATE MIDWEST ASHLAND WISCONSIN
100% 3/18/11

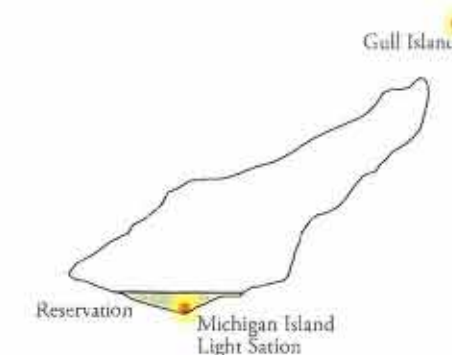
# Michigan Island Reservation Treatment Alternative 3

Treatment recommendations for Michigan Island Light Station generally include the following measures (Figures 38 and 39).

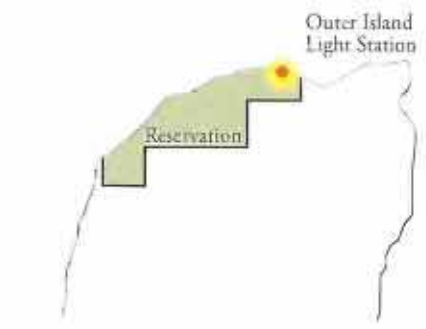
# Outer Island Treatment Alternative 3

Treatment recommendations for Outer Island Light Station generally include the following measures (Figures 40 and 41).

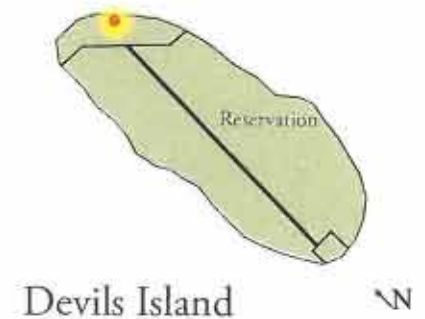
# Devils Island Treatment Alternative 3

Treatment recommendations for Devils Island Light Station generally include the following measures (Figures 42 and 43).

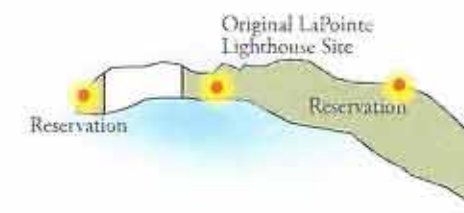
# Long Island Original LaPointe Lighthouse Treatment Alternative 3

Treatment recommendations for Long Island Light Station generally include the following measures (Figures 44 to 47).

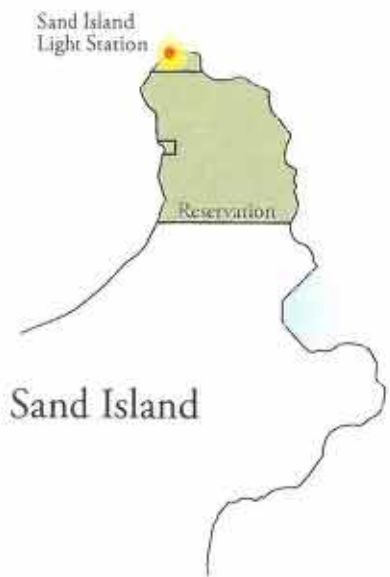
# Sand Island Reservation Treatment Alternative 3

Treatment recommendations for Sand Island Light Station generally include the following measures (Figures 48 and 49).
