# ***Installation of Egress Windows in Housing Area Apartment Building #51 (HEA-00469)***

### **Description of Undertaking**

Denali National Park and Preserve (DNA) is planning to replace 6 single and 36 pair single pane windows with more thermally efficient multi-pane windows in the Employee Six Unit Housing (Building #51) (HEA-00469). Building #51 contains six housing units and the park's primary conference and training room. Replacing windows with modern thermally efficient windows will reduce building energy use and improve resident comfort by eliminating condensation on the windows and sills.

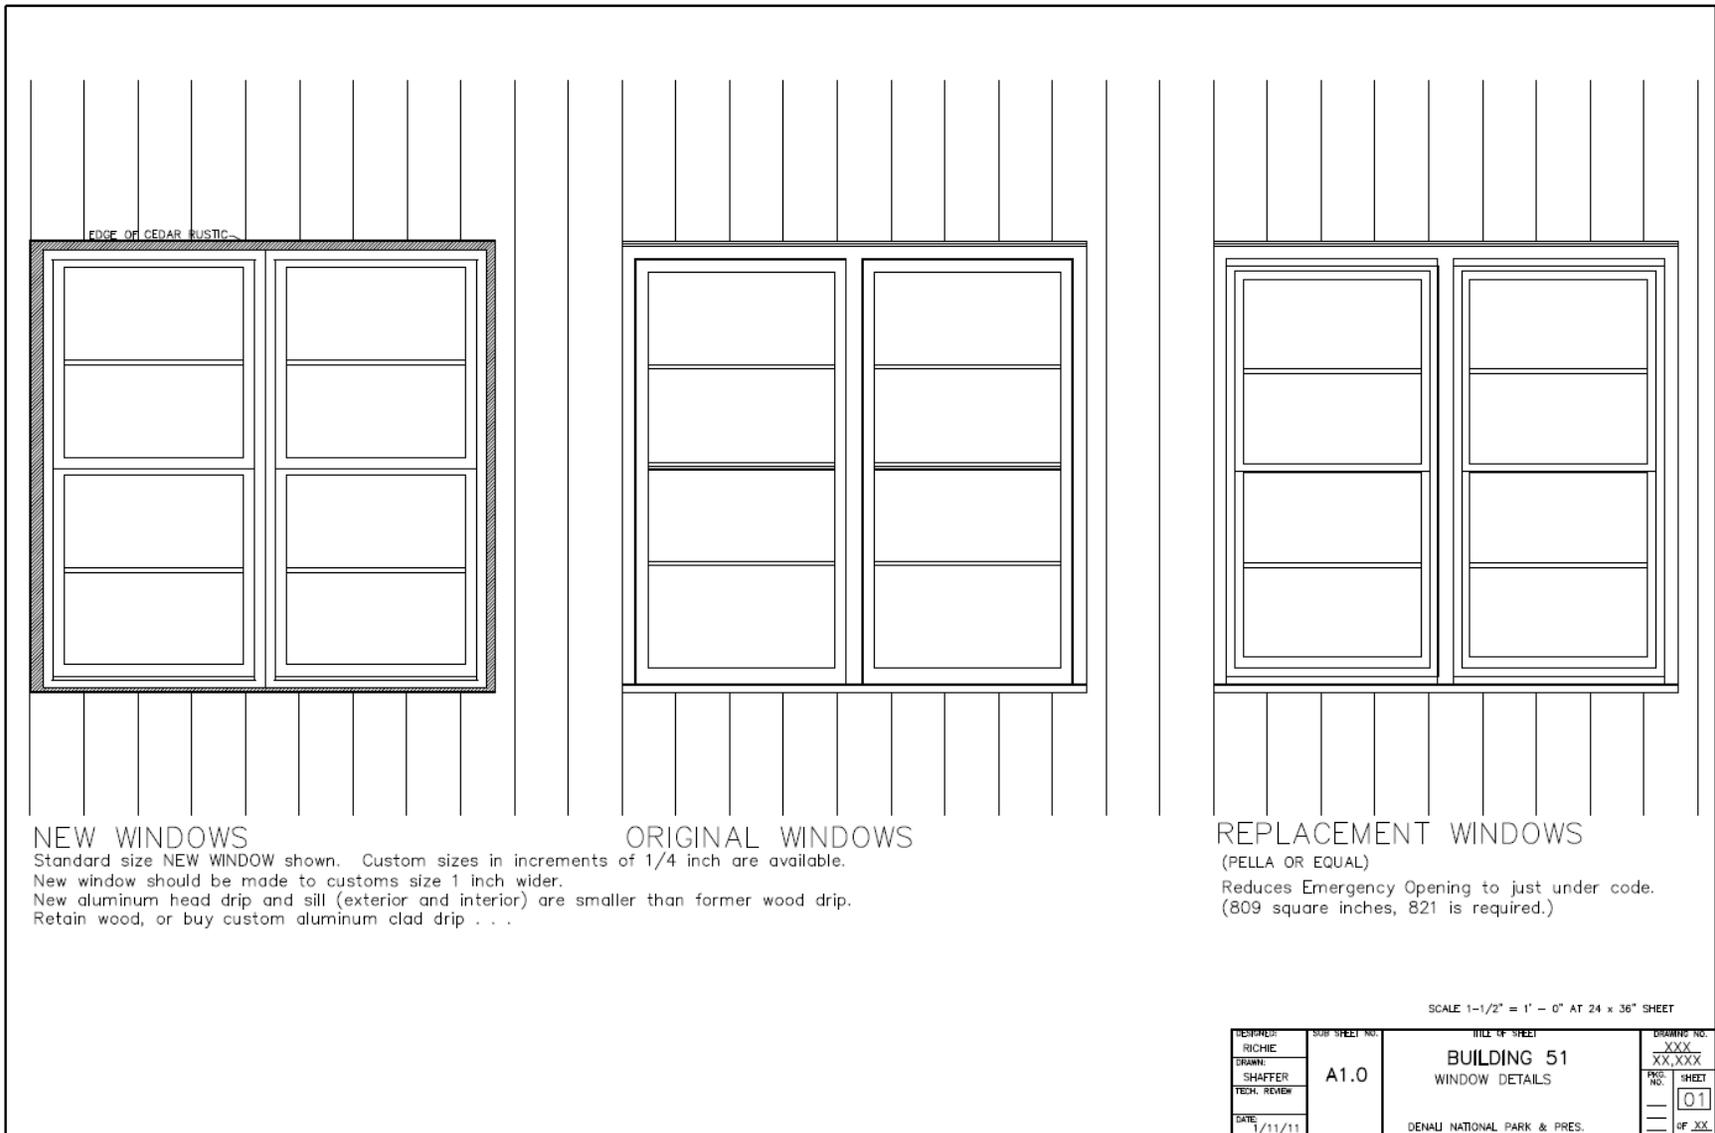
**Figure 8: Comparison of Original and Replacement Windows**

Existing	Proposed
Exterior clad casing: 1-5/16" wide. Marvin profile A898 or equivalent. Profile is to be brick mold or equivalent. Field applied.

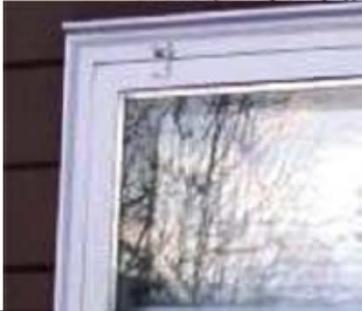
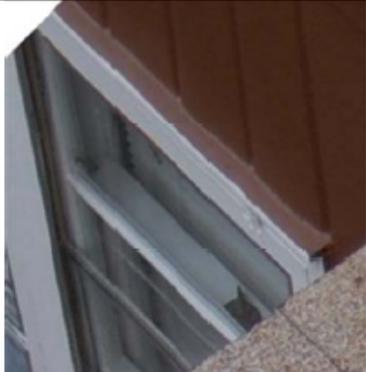
<p><b>Clad Brick Mould Casing*</b> Used to simulate a wood Brick Mould Casing for Clad units.</p>
With Aluminum Drip Cap, Marvin A100 or equivalent. White.

<p><b>Drip Cap - Aluminum</b> A100 - For use at Head Jamb. For use with wood or clad units including Brick Mould Casing Available in Bronze, Brown, Evergreen, Pebble Gray and White</p>

**Figure 9: Comparison of Original and Replacement Clad Casing**

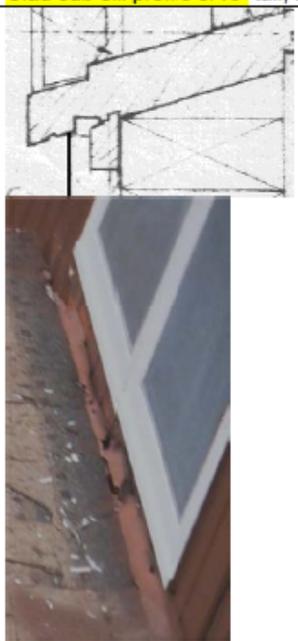
<p><b>Clad sub-sill profile 9/16" tall, Marvin Accessory #A246 or equivalent.</b></p>

<p>Hardware: Bronze sash lock and keeper.</p>

<p>Sash lifts: Quantity, (2) two, type: mortised, recessed or flush mount preferred, handles or pulls acceptable alternative, installed symmetrically on the lower sash rail. Color: white.</p>

**Figure 10: Comparison of Clad Sub-Sill Profile, Hardware, and Sash Lifts**

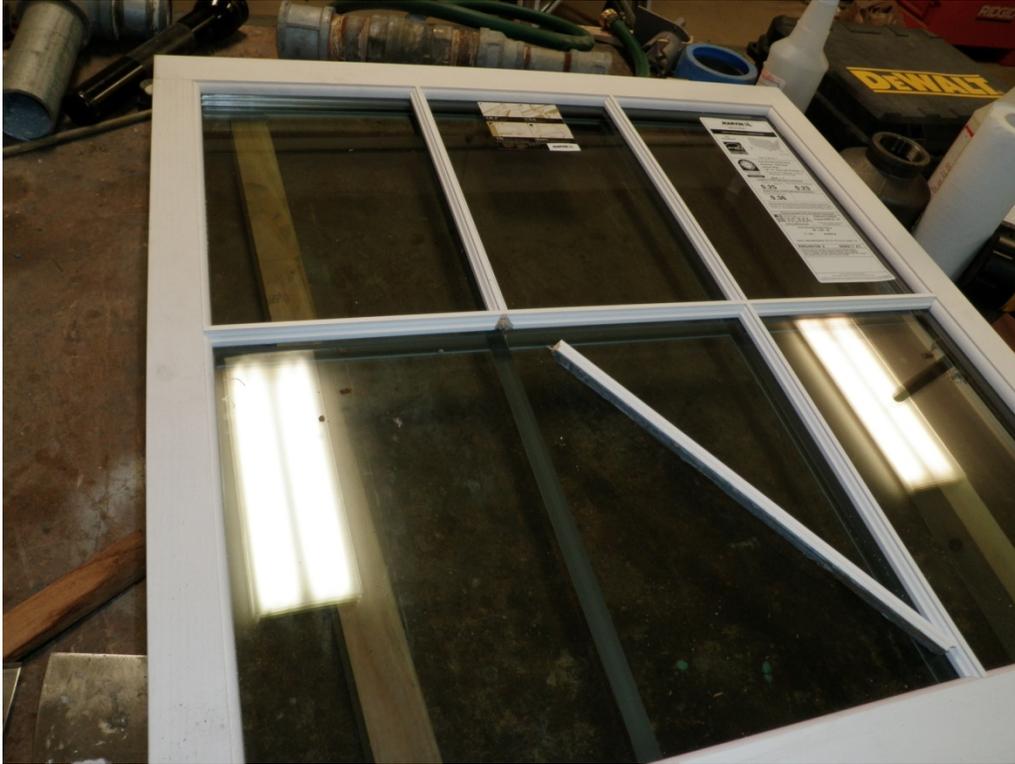
**Figure 14: Removal of Vertical Mullions in Replacement Windows**

**Figure 13: Comparison of Replacement Window (A), and Original Window (B).** The replacement windows that were ordered were not those that were delivered and installed. The vertical mullions should not be present. This will be mitigated by removing by hand the vertical mullions (Figure's 14 and 15) and replacing the horizontal mullions with ones that are not notched.
