Project Summary:

Project 2014-07; Block 200: Replace Second Bank Block Hazardous Walkways and Repair Underground Drains (PEPC 53272)

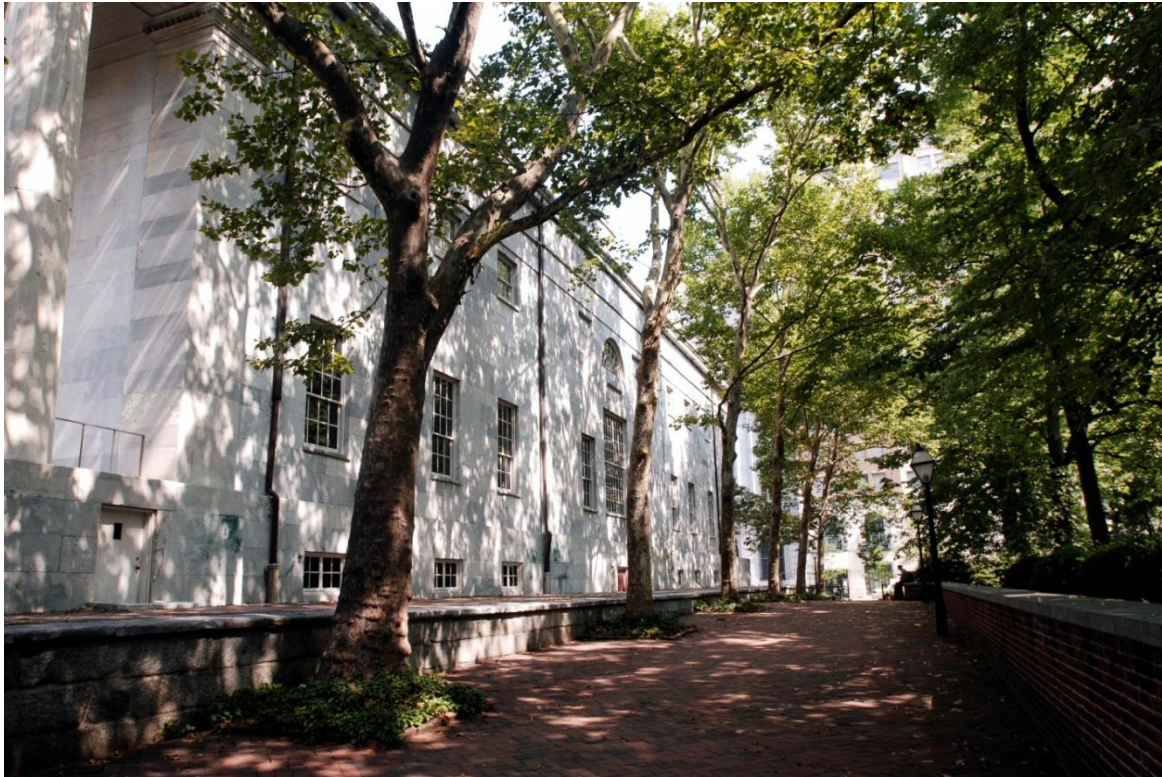
Figure 2: London planetrees, east side of Second Bank building, looking northwest.

The paved walkway on the west side of the Second Bank has both significant pavement heave due to tree roots, and drainage problems as a result of these tree plantings that negatively impact the Bank as a cultural resource, and create hazardous conditions in the walkway. The leaf, bark and fruit from the London planetrees continually clog gutters and surface drains; the inaccessibility of the roof gutters without large-high reach equipment as well as the unpredictability of surface flow from rain events, coupled with the tree litter, are a challenge for resource protection of both the Bank and the adjacent American Philosophical Society buildings. Root heave from the water-loving trees has created pavement heave, which results in an uneven and rippling brick surface for walkers. To correct both the resource protection and life/safety issues, this project has included regrading, installing new drainpipe and drains, and the installation of a new concrete walkway subbase for the east and west walkways. This work will also affect the viability of the existing trees.

Park and contractor staff conducted research on the type of vegetation planted in the tree pits on both east and west sides of the Second Bank during its construction in between 1804-1820s. Historic illustration show generic canopy trees that cannot be identified in terms of specific locations or species. The London planetrees currently on side were planted in 1966 as part of the current design. The park and contractor staff consulted with arborists from the Morris Arboretum on the long-term solutions to the problems caused by the existing trees. Although expanded tree pits were discussed, they were dismissed as an option because they were only a temporary solution. In addition, the expanded tree pits were not part of the 1960s landscape design, thus creating an impact there.
