**ASAN SPRING RESERVOIR
(Asan Spring Cistern)
Santa Ana Lane near Nino Perdido Street
Asan
Guam County
Guam**

HAER No. GU-10

**HISTORIC AMERICAN ENGINEERING RECORD
U.S. Department of the Interior
National Park Service
Oakland, California**

Project Information: This report was written in advance of work to re-open the Asan Spring Reservoir and place it back in service. Although this re-activation is expected to include the rehabilitation of the existing reservoir, its complete replacement also remains an option. Field work was undertaken in October 2015 and this report was researched and written by Dee Ruzicka of Mason Architects, Inc., Honolulu, Hawaii. Archival photographs were taken in October 2015 by Victor Consaga of Consaga Visual Arts, Tamuning, Guam.

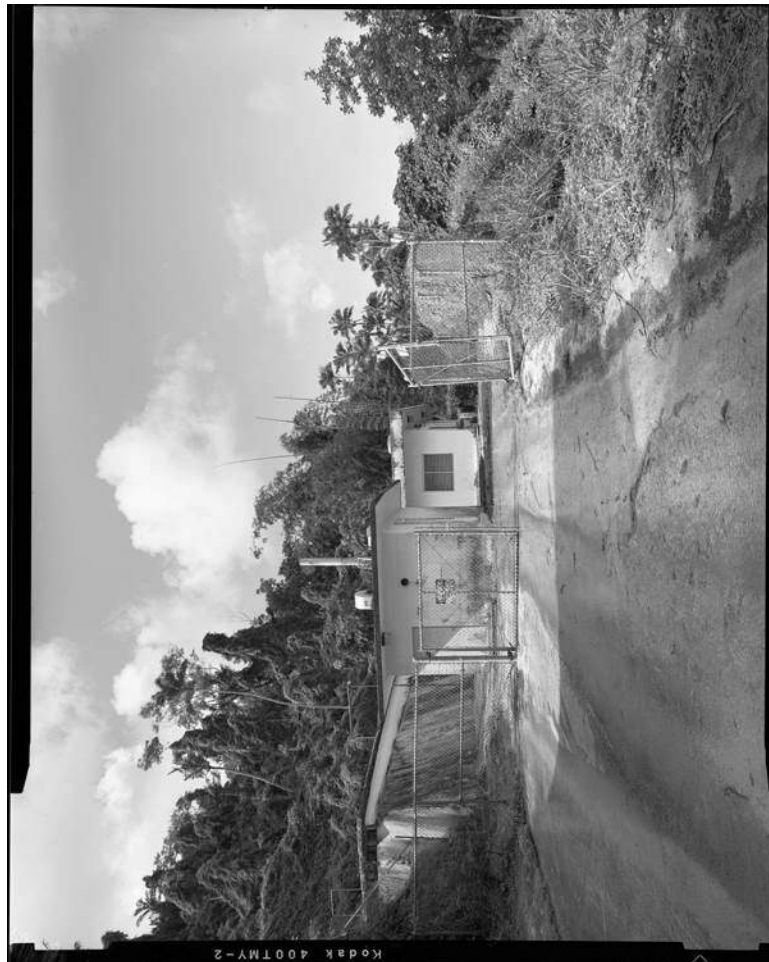
HAER No. GU-10-1

| GU-10-1 | OVERALL VIEW OF THE COMPLEX WITH THE RESERVOIR ON THE LEFT. ALSO SHOWING THE CHLORINATOR ROOM IN THE FOREGROUND OF THE COMPOUND AND THE PUMP HOUSE AT THE REAR OF THE COMPOUND. VIEW FACING SOUTHWEST. |

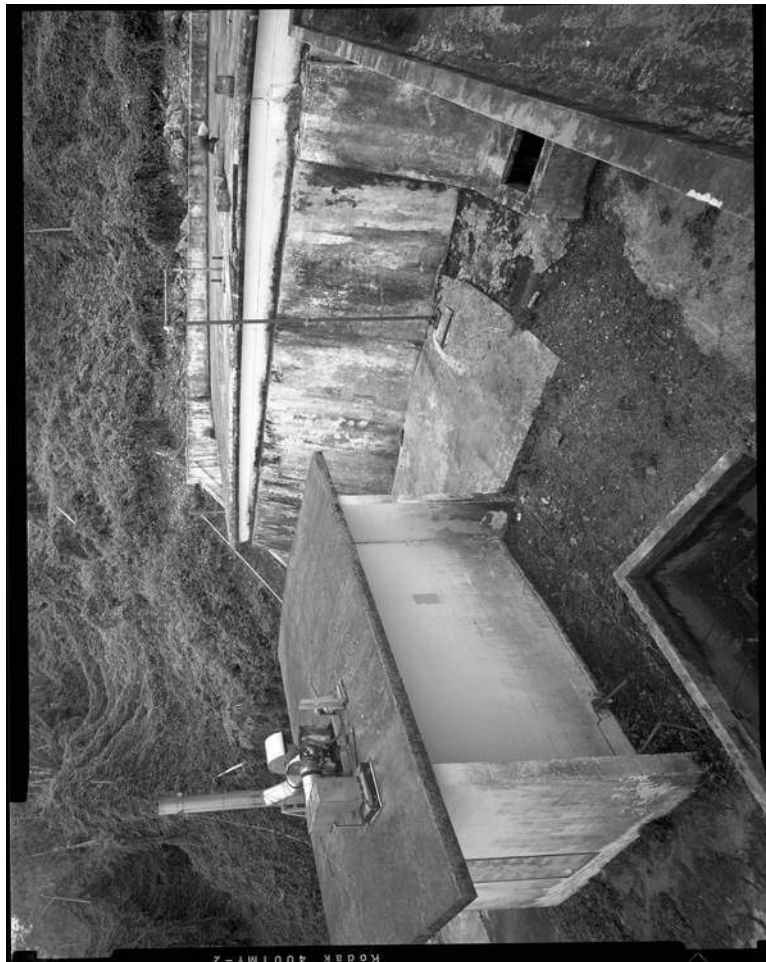
HAER No. GU-10-2

| GU-10-2 | VIEW OF THE NORTHEAST END OF THE RESERVOIR, TAKEN FROM THE ROOF OF THE PUMP HOUSE. SHOWING THE FRONT RETAINING WALL AND THE ROOF. CHLORINATOR ROOM AT LEFT. NOTE THE PORTION OF THE WATER-FILLED PIT IN THE LOWER FOREGROUND. VIEW FACING EAST. |

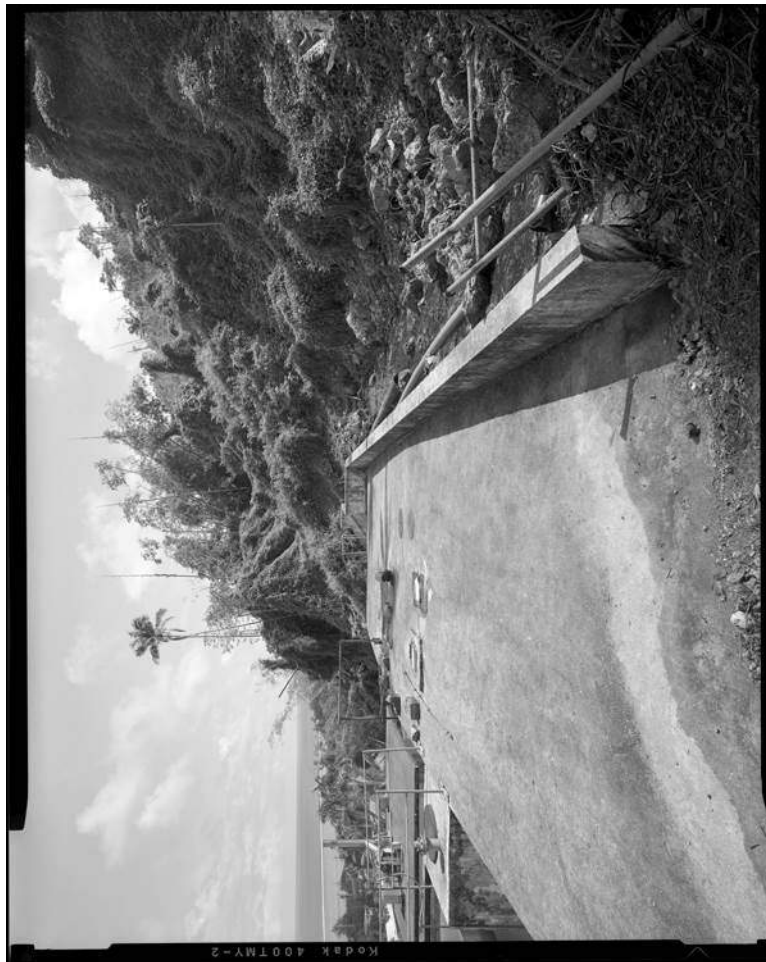
HAER No. GU-10-5

| GU-10-5 | OVERVIEW OF THE SOUTHWEST END OF THE RESERVOIR ROOF SHOWING THE REAR RETAINING WALL ON RIGHT. VIEW FACING NORTHEAST. |

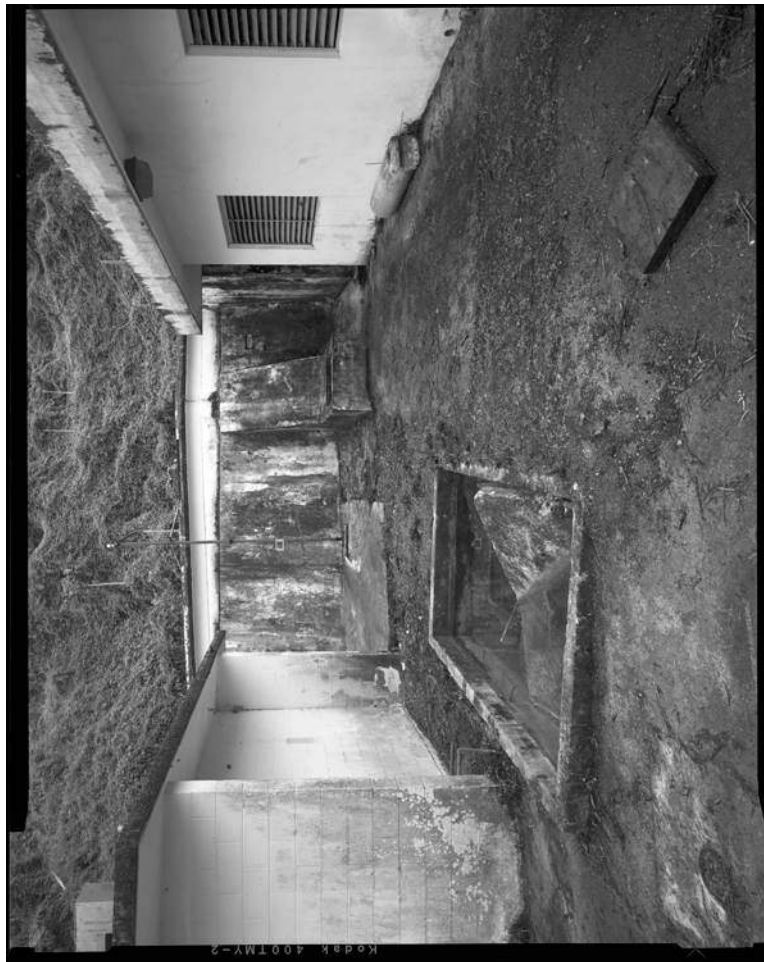
HAER No. GU-10-8

- GU-10-8 VIEW OF THE CENTER PORTION OF THE FRONT RETAINING WALL BETWEEN THE CHLORINATOR ROOM AND PUMP HOUSE SHOWING THE LOW-SLOPE GABLE ROOF OF THE RESERVOIR, THE SLOPING OVERFLOW SPILLWAY ON THE FRONT RETAINING WALL, AND THE WATER FILLED PIT IN FOREGROUND. NOTE THE SMALL BRASS PLAQUE (10" X 5") IS TO THE RIGHT OF THE OVERFLOW SPILLWAY. VIEW FACING SOUTHEAST.
- GU-10-9 DETAIL OF SMALL BRASS PLAQUE. VIEW FACING SOUTHEAST.
- GU-10-10 OBLIQUE VIEW OF THE FRONT RETAINING WALL OF THE RESERVOIR, BEHIND THE PUMP HOUSE WITH THE PYLON AND 9" DIAMETER WATER SUPPLY PIPE IN BACKGROUND. NOTE THAT EXCESS WATER FLOWS DOWN THE HILLSIDE AROUND THE RESERVOIR IN THE FOREGROUND. VIEW FACING NORTHEAST.

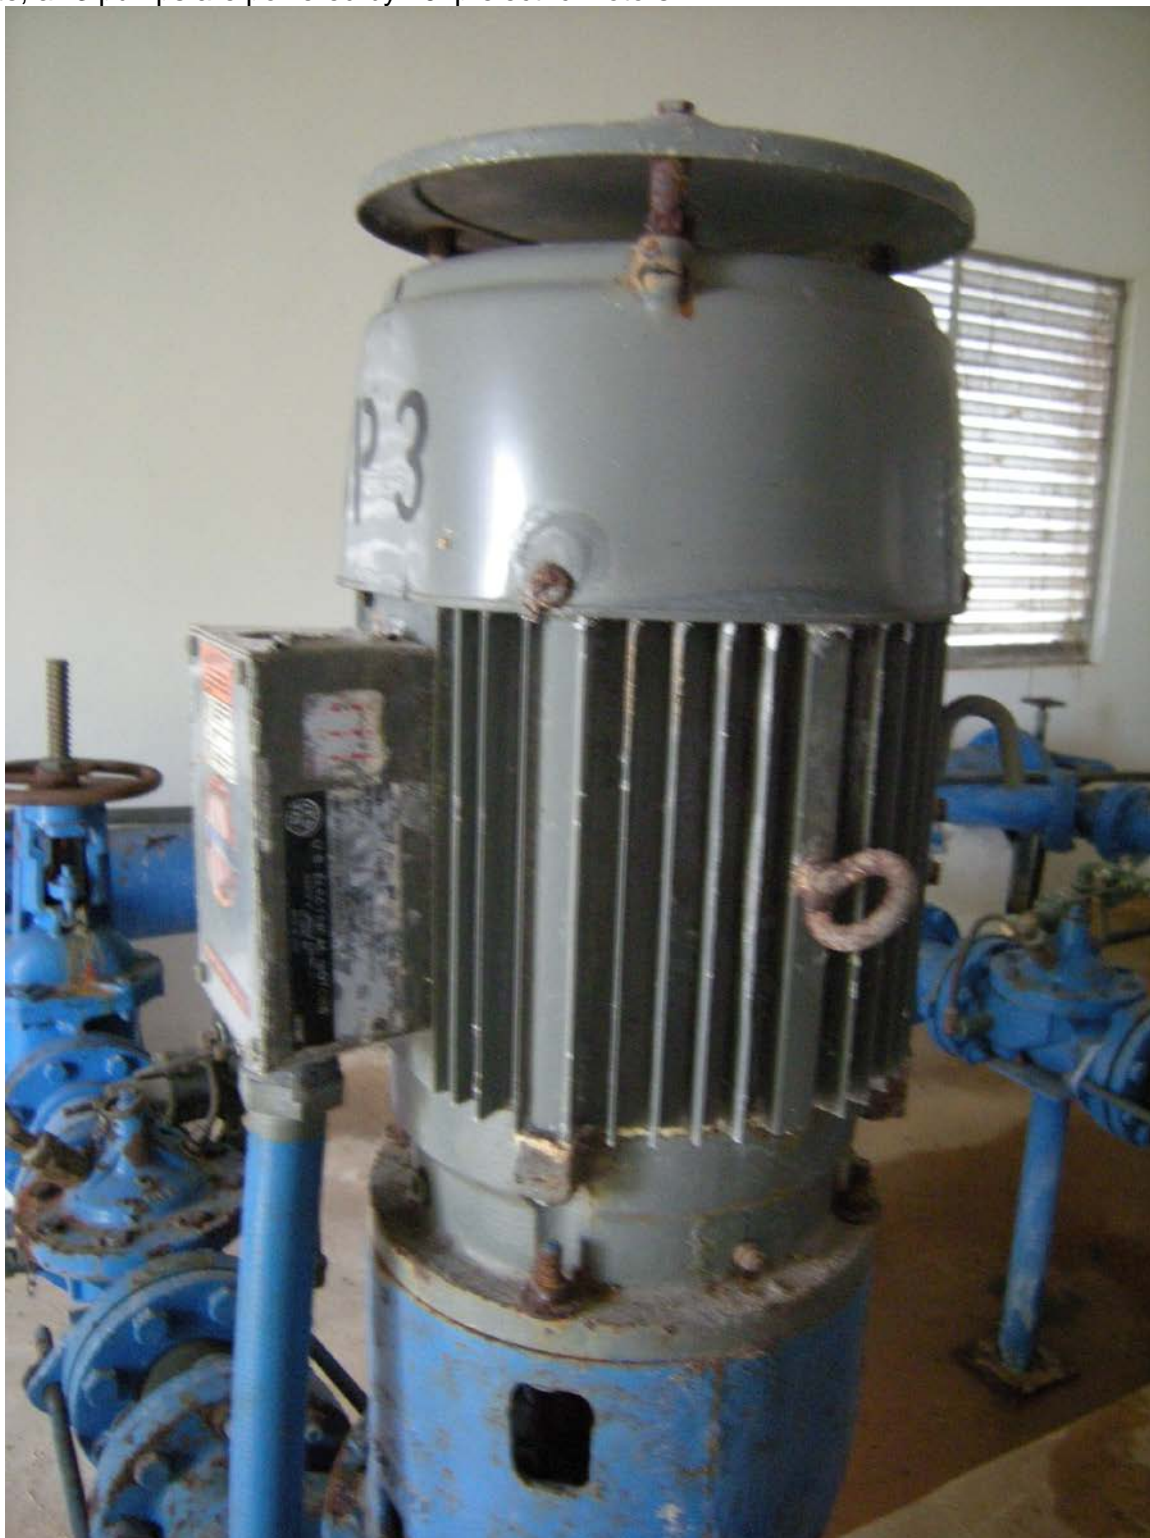
Field photo taken October 21, 2015. Pump House interior.
Note, all 3 pumps are powered by 10hp electric motors.

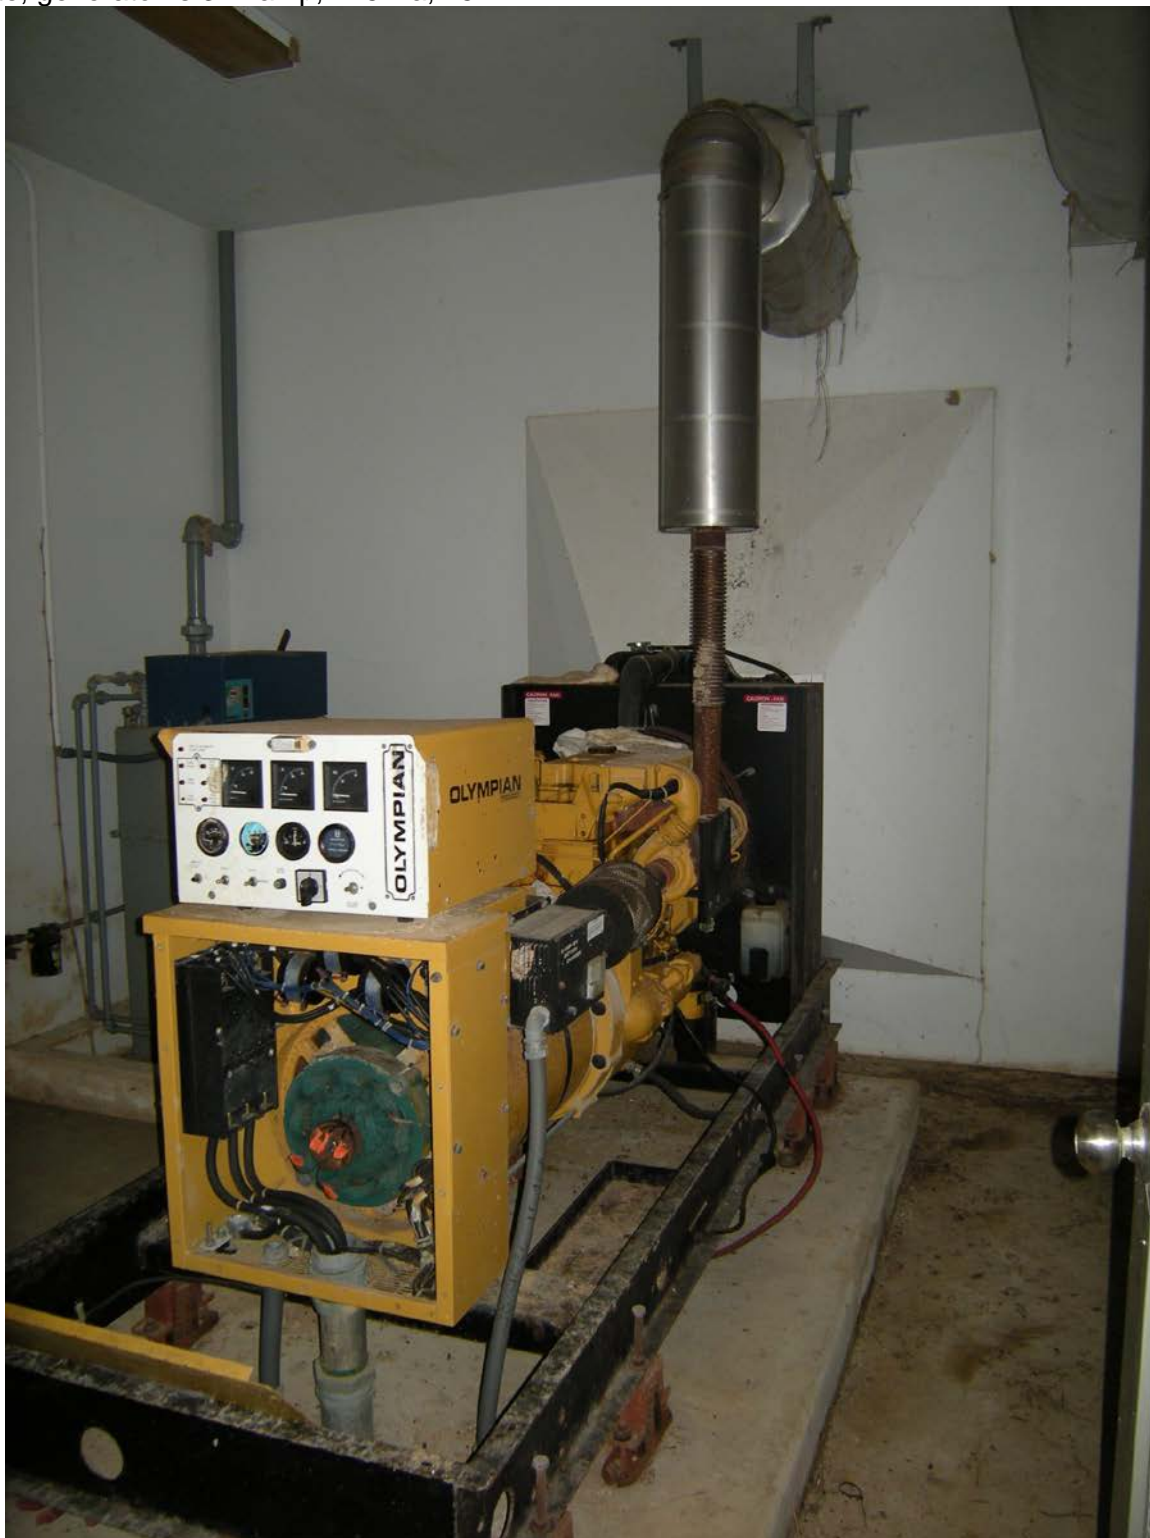
Field photo taken October 21, 2015. Pump House interior.
Note, generator is 347 amp, 125kva, 75kw.
