CULTURAL LANDSCAPE REPORT • HISTORIC STRUCTURE REPORT

APOSTLE ISLANDS NATIONAL LAKESHORE LIGHT STATIONS OF MICHIGAN ISLAND, OUTER ISLAND, DEVILS ISLAND, LONG ISLAND AND SAND ISLAND VOLUME II

100% DRAFT
MARCH 2011

VOLUME II OF VI: MICHIGAN ISLAND CLR/HSR

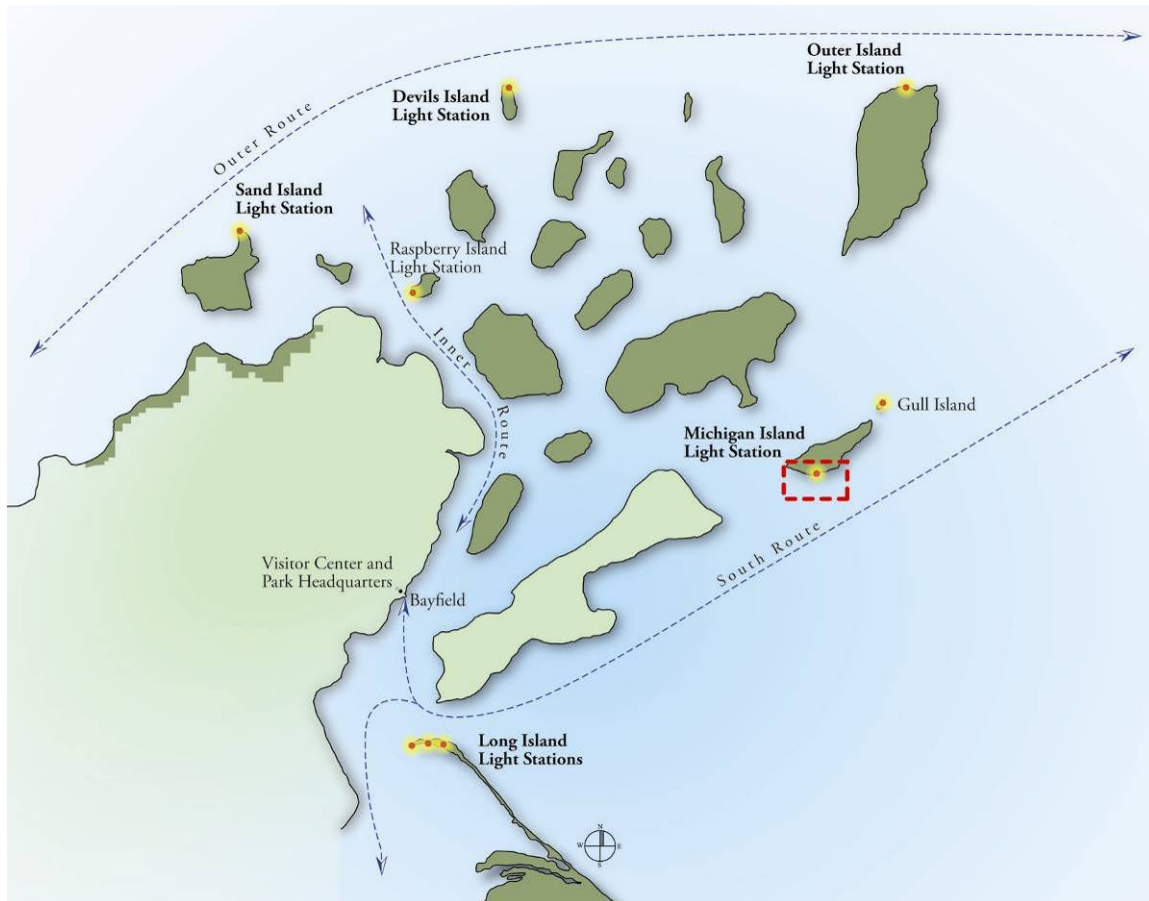
Michigan Island Light Station Context (Source: MBD 2010)

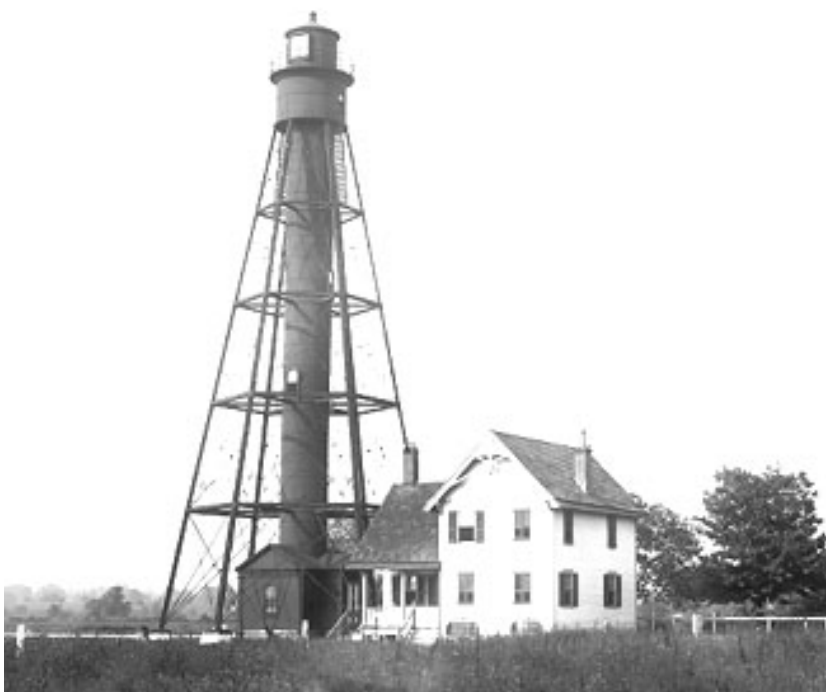
The Schooner Ledge Tower as it looked on the Delaware River (Source: Coast Guard archives – accessed at http://www.uscg.mil/history/CG_Photo_Index.asp). Photo date unknown.

The Lighthouse Board modified the Michigan Island plan by eliminating a proposed diaphone fog signal and installing a combination of navigational aids including the Schooner Ledge Tower, a new radio beacon on Michigan Island and an unmanned acetylene powered light on Gull Island. The recycled 112-foot-tall Schooner Ledge Tower would be the tallest in the Apostle Islands. The revised estimated costs came to \$85,000 for the light tower, beacons and support buildings for the light station.
