1 **MICHIGAN ISLAND CLR TREATMENT**

2 **Introduction**

3 The treatment section of the CLR in conjunction with the HSR describes a strategy for the long-term
4 management of the cultural landscape and historic structures of the Michigan Island Light Station. The
5 strategy is based on the analysis of the cultural landscape’s characteristics, the history and period of
6 significance for the light station, the existing condition of the historic features, and contemporary use of the
7 light station. A general management philosophy of rehabilitation has been identified as the most
8 appropriate approach for the cultural landscape. Rehabilitation will allow for repairs, alterations, and
9 additions that will be necessary for the compatible use of the light station, and will preserve the
10 characteristics and features that convey the light station’s historical, cultural and architectural values.⁴⁰
11 These actions will enable the park to preserve the contributing resources of the cultural landscape, while

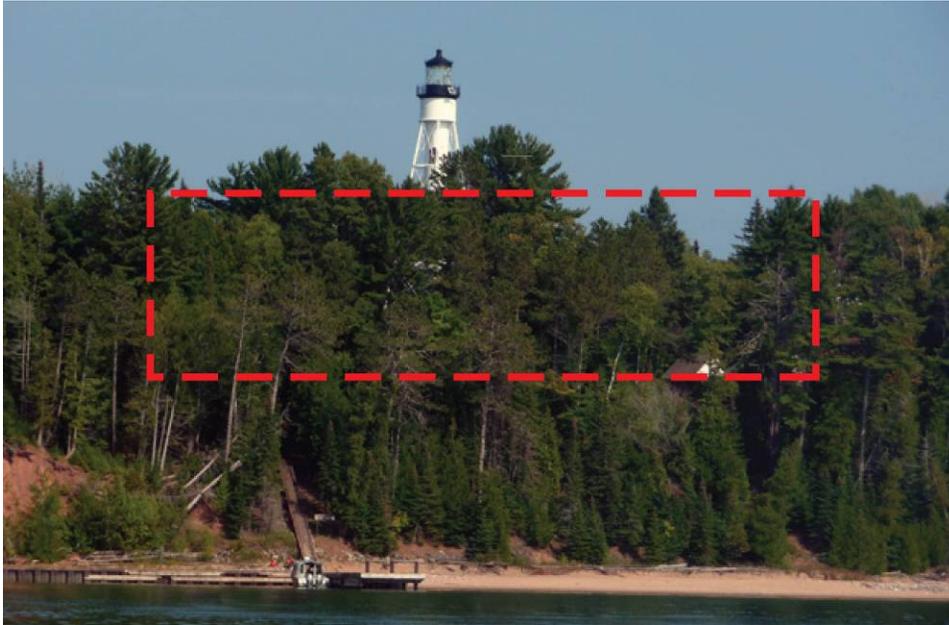
2
3 *Site Image MI-82: Area of selective clearing for the restoration of views to the light station from Lake Superior, 2010*
4 *(Source: MBD P1010811_annotated.JPG)*

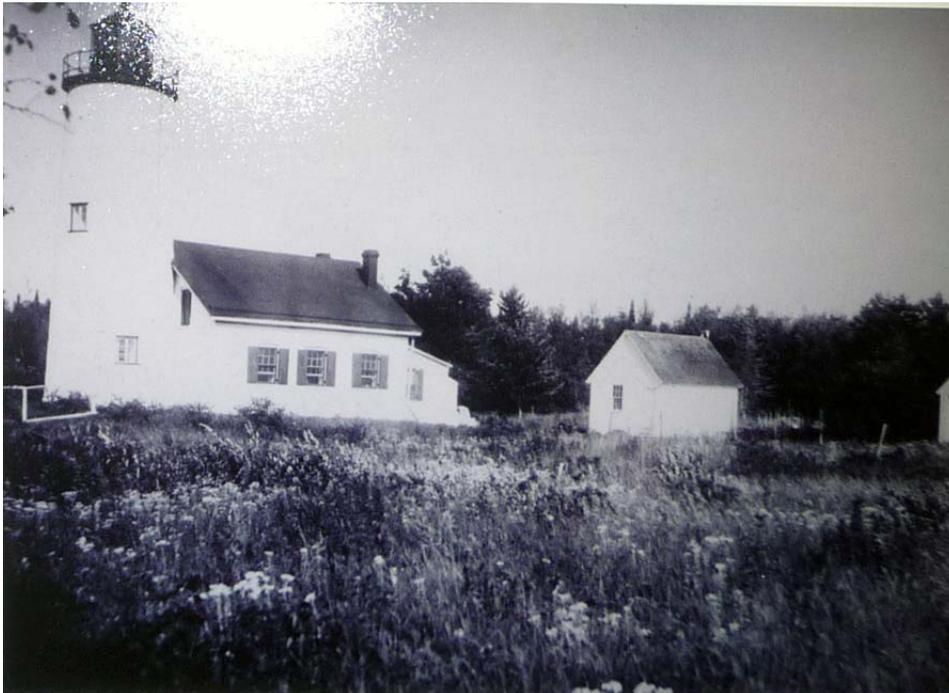
6
7 *Site Image MI-83: Historic condition of cleared area east of the Old Michigan Island Lighthouse, c. 1913; (Source: NPS*
8 *APIS Archives)*

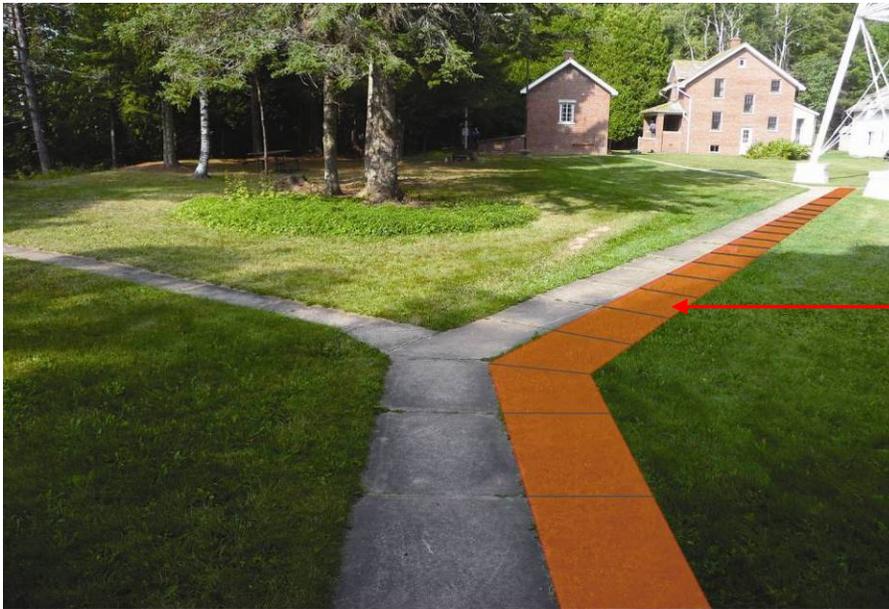
Precast Concrete
Stones

Site Image MI-84: Widen walks by retaining existing historic walks in place and installing new precast concrete material to achieve an accessible width, 2010 (Source: MBD P1010741_annotated.JPG)

Repair and maintain all concrete walks in the current, historic locations. Repair includes the removal and replacement of several severely cracked sections. Maintenance includes vegetation removal and minor leveling to eliminate trip hazards. Replacement of damaged sections shall be completed with precast units matching the various dimensions of the existing concrete slabs, poured and finished prior to installation. The finish of the replacement sections should match the finish of the historic material including aggregate size and tooling.

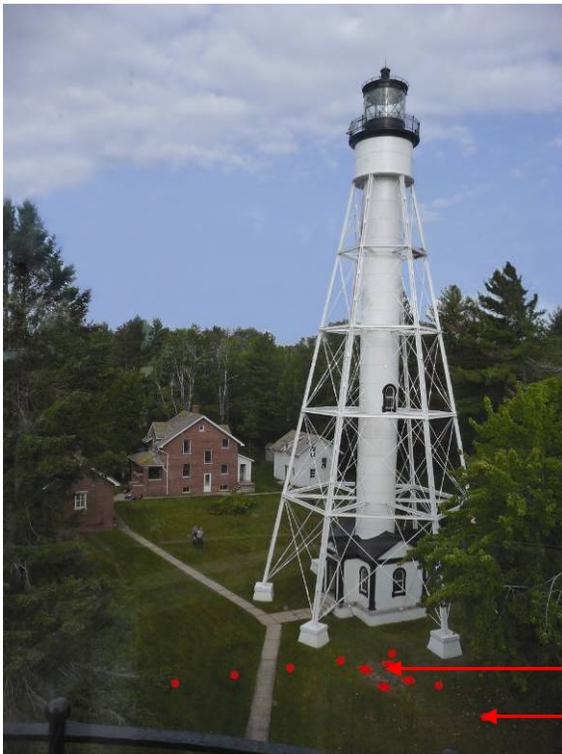
Location of Nonextant Oil Building

Location of Nonextant Fence
