1 OUTER ISLAND CLR TREATMENT

Outer Island Reservation Preferred Treatment Alternative

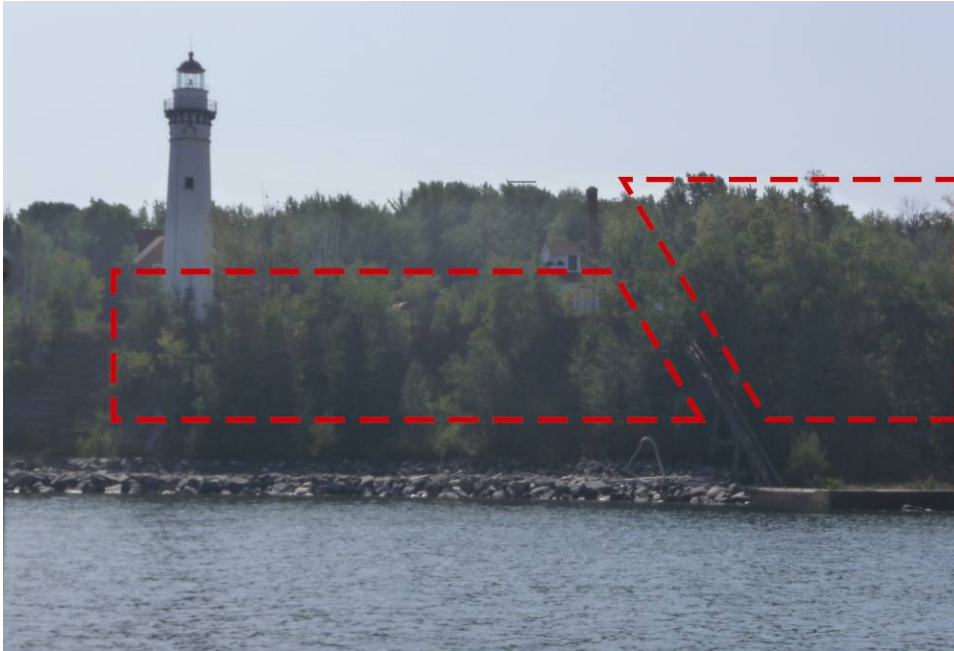
2
3 *Site Image OI-77: Area of selective clearing for the restoration of views to the light station from Lake Superior, 2010*
4 *(Source: MBD P1010831_annotated.JPG)*

As previously discussed under Spatial Organization, the cleared area of the light station reservation and the light station grounds has been substantially reduced from the period of significance. Historic photographs, drawings and correspondence from this period indicate the area outside and adjacent to the current light station grounds was cleared of forest trees and shrubs and vegetated with grasses and wildflowers. The treatment recommendation to address the light station clearing includes the removal of forest vegetation (approximately 1.2 acres) that has encroached into the historic cleared area of the light station, and the establishment of a meadow-like vegetation to reestablish the spatial qualities of the light station. This would reestablish approximately 43% of the clearing present during the period of significance. The meadow may contain native grasses, forbs, wildflowers, ground covers and compatible nonnative species. Additional study will be needed to develop a method of revegetation and a list of species that will be suitable and noninvasive as meadow species native to the island are limited. Clearing should also be done to maintain adequate fire protection from historic structures. For purposes of this study a general rule of a 50' break has been used. Further discussion on means and methods of clearing are discussed in Volume I, Chapter 5: Management Issues. Maintain newly cleared areas as meadow vegetation at a 12" to 24" height by mowing on a regular basis.

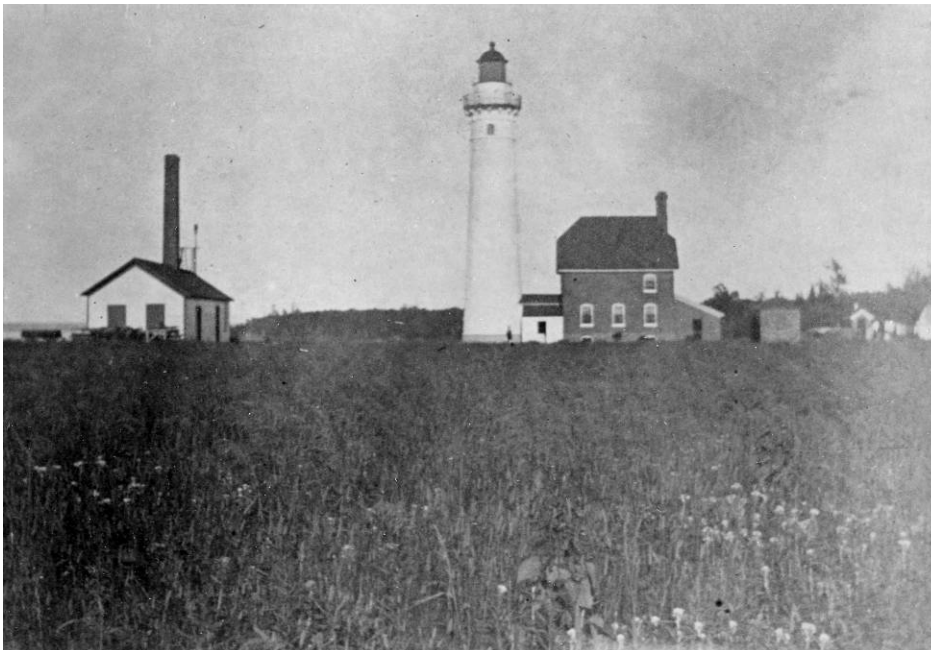
6
7 *Site Image OI-78: Historic condition of cleared area west of the Outer Island Tower/Keepers Quarters and Fog Signal*
8 *Building, c. pre-1901 (Source: NPS APIS Archives)*
