TITLE OF PROJECT CULTURAL LANDSCAPE REPORT	
UNITED STATES DEPARTMENT OF THE INTERIOR APOSTLE ISLANDS NATIONAL LAKESHORE	TITLE OF DRAWING DEVILS ISLAND LIGHT STATION & EAST LANDING NAME OF PARK APOSTLE ISLANDS NATIONAL LAKESHORE REGION MIDWEST COUNTY ASHLAND STATE WISCONSIN

DEVILS ISLAND CLR TREATMENT

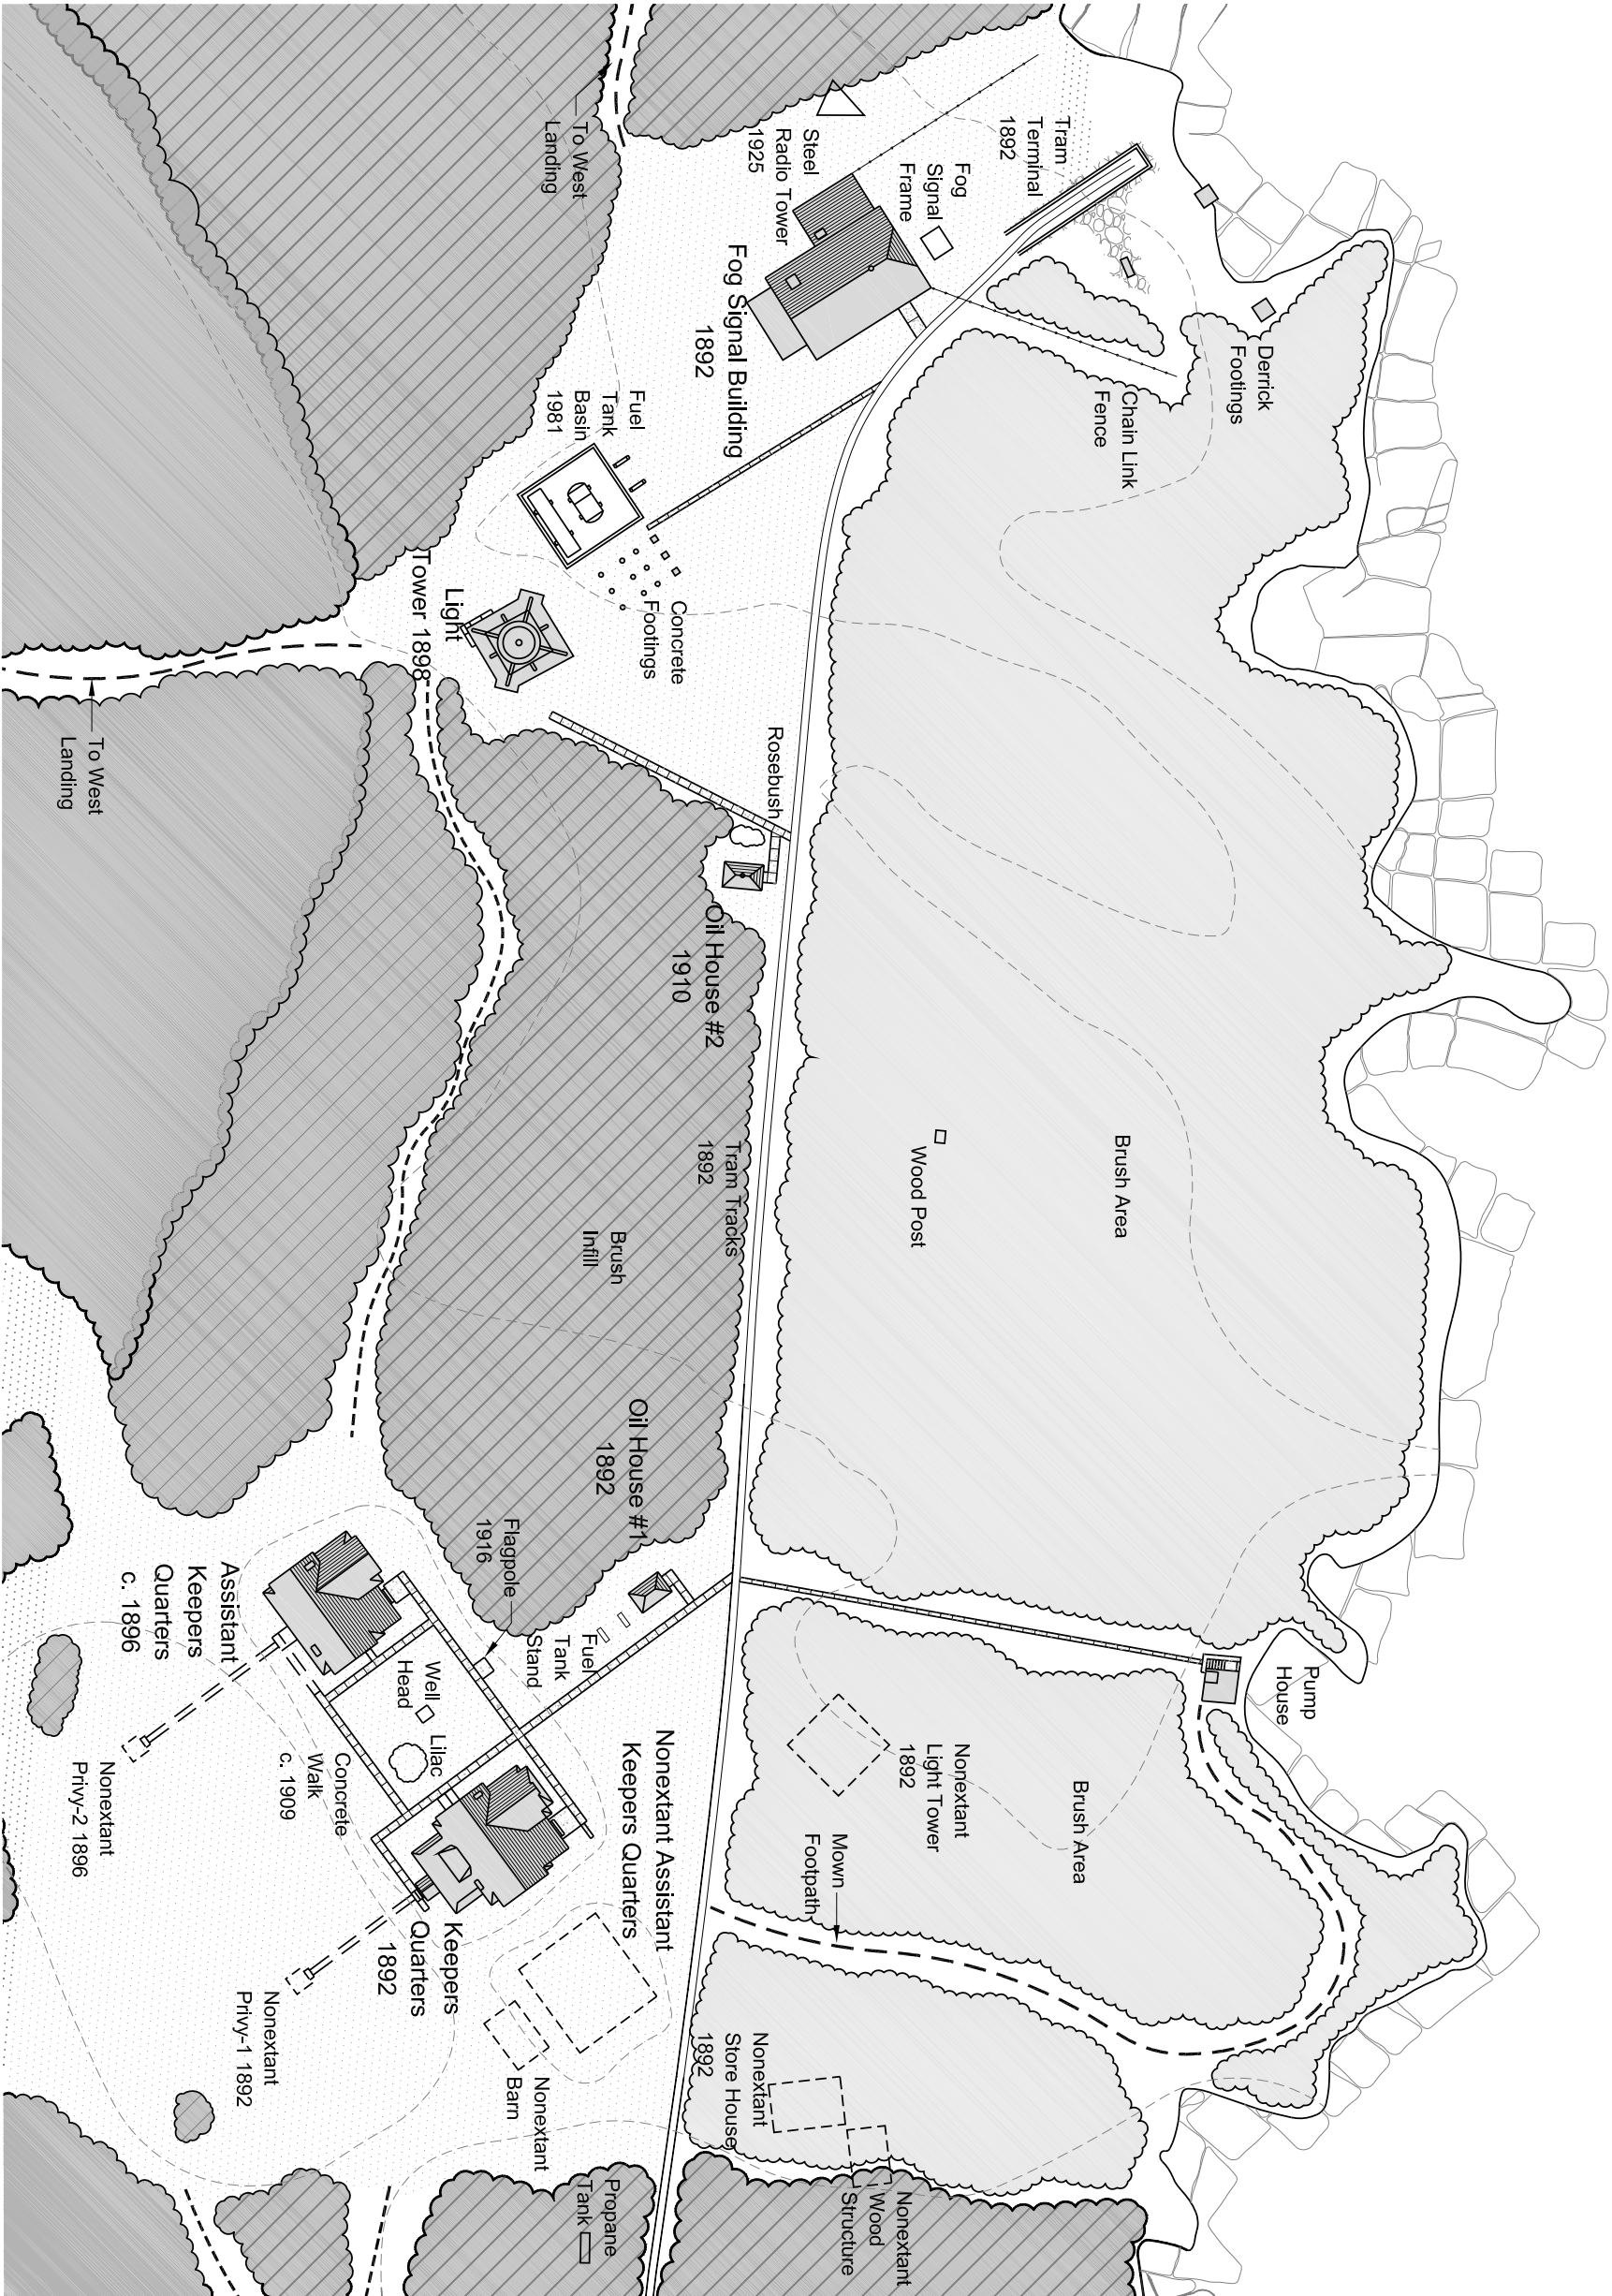
SITE IMAGE DI-67

TITLE OF PROJECT CULTURAL LANDSCAPE REPORT		TITLE OF DRAWING DEVILS ISLAND LIGHT STATION	
EXISTING CONDITIONS		NAME OF PARK APOSTLE ISLANDS NATIONAL LAKESHORE	
UNITED STATES DEPARTMENT OF THE INTERIOR APOSTLE ISLANDS NATIONAL LAKESHORE		REGION MIDWEST	STATE WISCONSIN
